## Arboricultural Impact Assessment

One Sydney Harbour  
Barangaroo South  
1B Basement SSD6960  
Development Application  
Finalisation

Project No 5029/D

August 2015

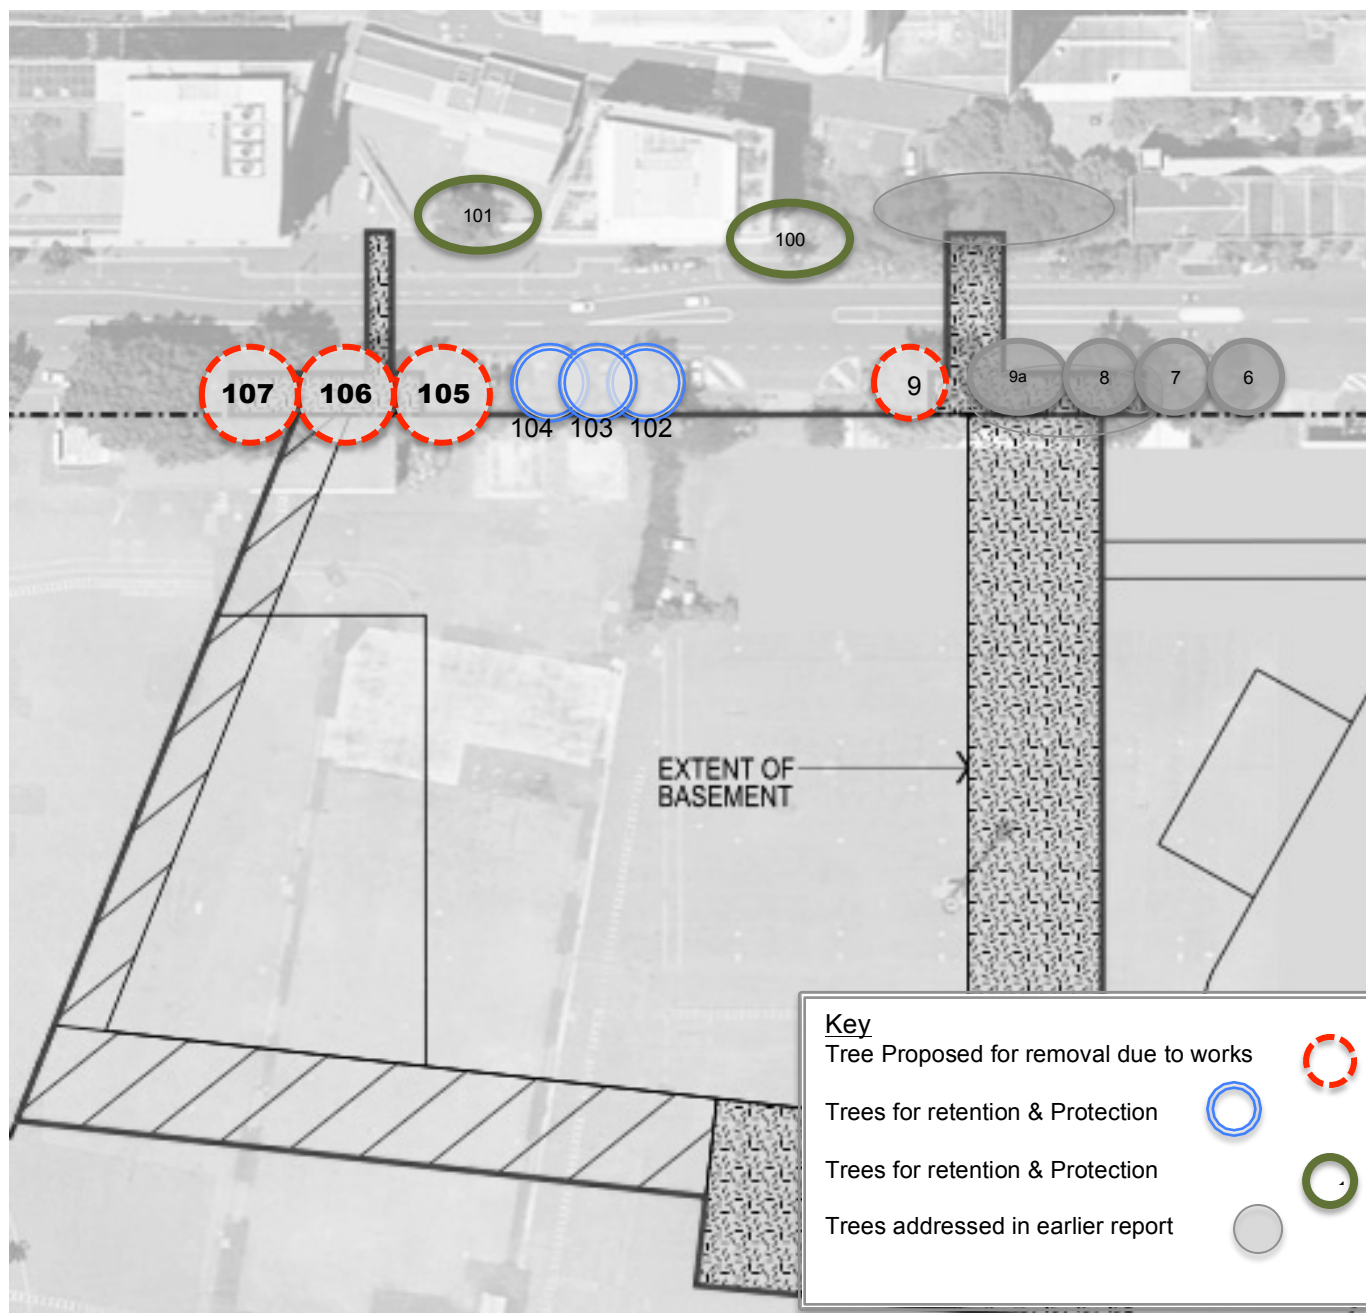
## Tree Location Plan

Tree numbers overlay Plan by: Lend Lease: One Sydney Harbour. Barangaroo. Stage 1B Basement SSD6960.  
Aerial Location Plan. Drawing BB2\_PA2\_A001. Revision A. Development Application. Dated 10 August 2015

Tree numbers have been added to plans provided (see Appendix A1).

The site is part of and adjacent to the Barangaroo South development. The area covered by this report is the section of Hickson Road adjacent to 36 and 38 The Bond. See Plan in Appendix A1 for tree location.

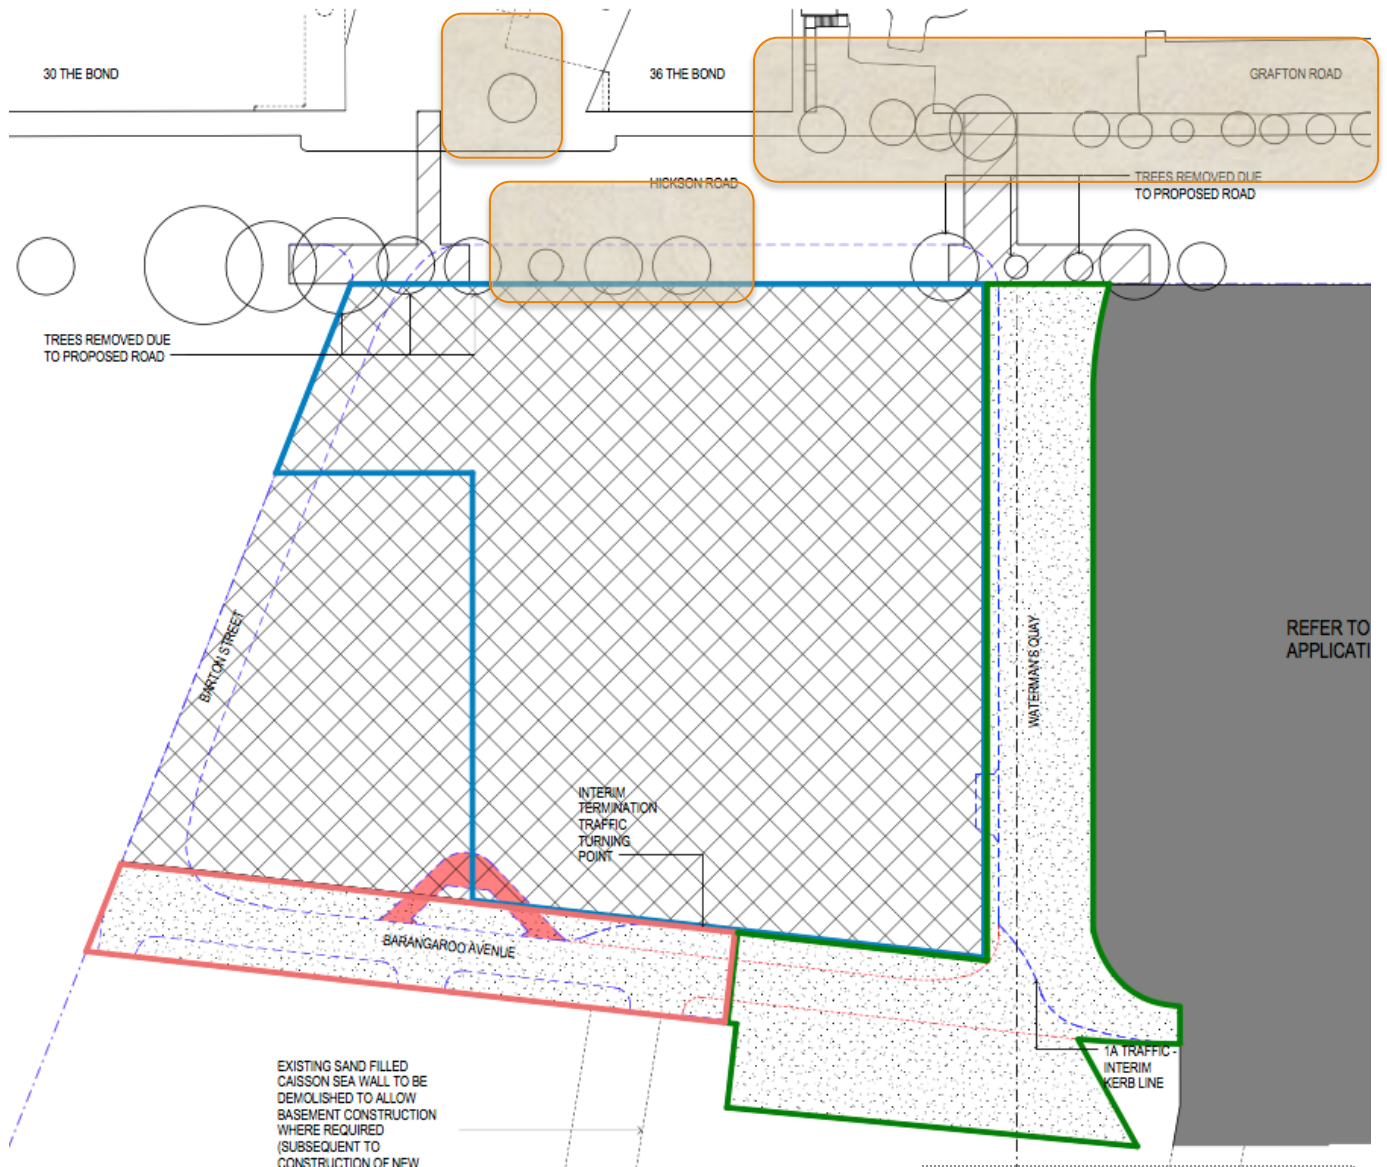
## Tree Protection Plan

Overlays Plan by: Lend Lease: One Sydney Harbour. Barangaroo. Stage 1B Basement SSD6960. Demolition, Excavation & Services Zone Plan. Drawing BB2\_PA2\_A003. Revision 0A. Development Application. Dated 10 August 2015.

- Tree Proposed for removal due to works
- Trees for retention & Protection
- Trees for retention & Protection
- Trees addressed in earlier report

- Fencing should be installed to the extent of works proposed (See Appendices A3, C1 and C2 for diagrammatic representation).
- Protect soil with geotextile fabric, mulch and rumble boards where fencing is not possible.
- Consider branches that may interfere with works process and manage or prune (see Appendix D). Consult your Project Arborist if this involves branches greater than 5cm in diameter at branch collar.
- Consider where materials are to be stored and keep this outside tree protection zones.
- DO NOT CHANGE SOIL LEVELS within TPZ without arboricultural advice. (Tree roots are usually located in the top 30cm of soil. Reductions in soil level can remove most of a tree's roots.
- Increases in soil can reduce available air to roots and cause them to die).

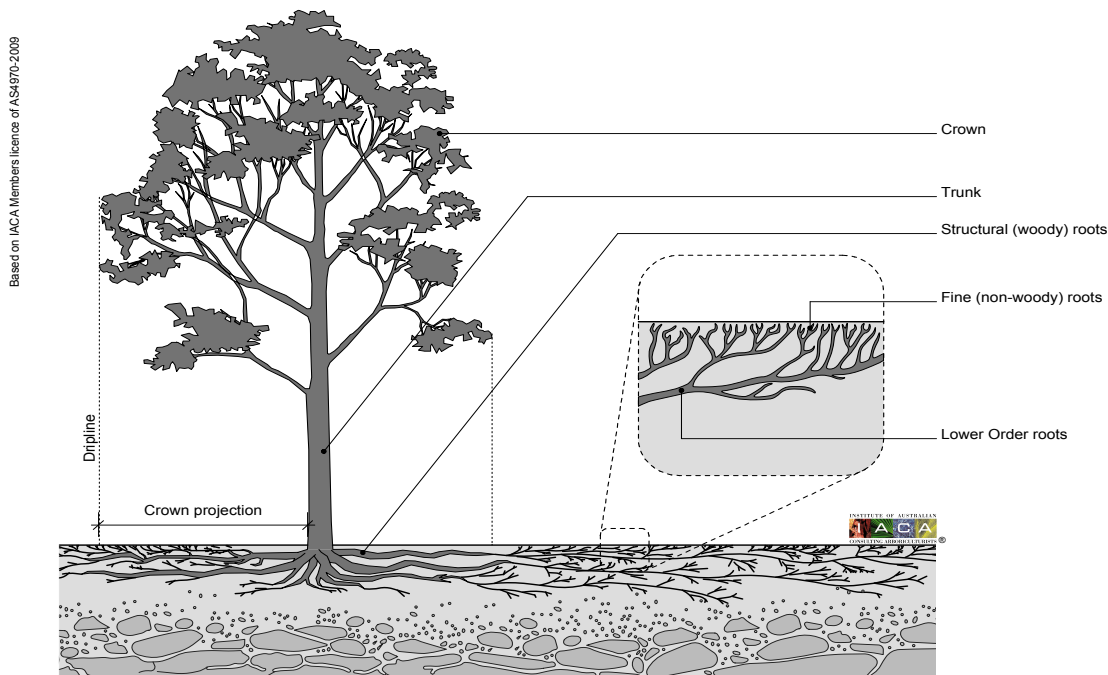
Structure of a Tree in a Typical Growing Environment

- Most tree roots are in the top 30cm of soil and are easily damaged by compaction and the loss of air spaces necessary for healthy survival. Soil compaction is a common cause of tree decline on development sites.

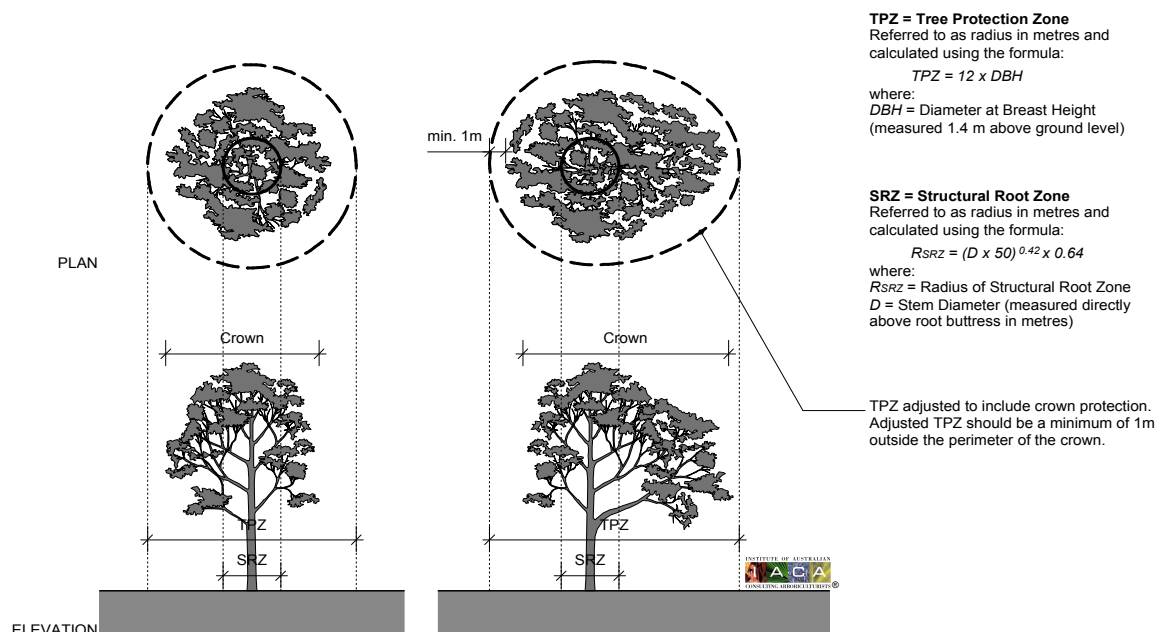
Indicative Tree Protection Zone (TPZ)

*“The Tree Protection Zone is the area around the tree or group of trees in which no grading or construction activity may occur. This area should be large enough to retain sufficient root or crown area to maintain tree health and stability.”<sup>5</sup>*

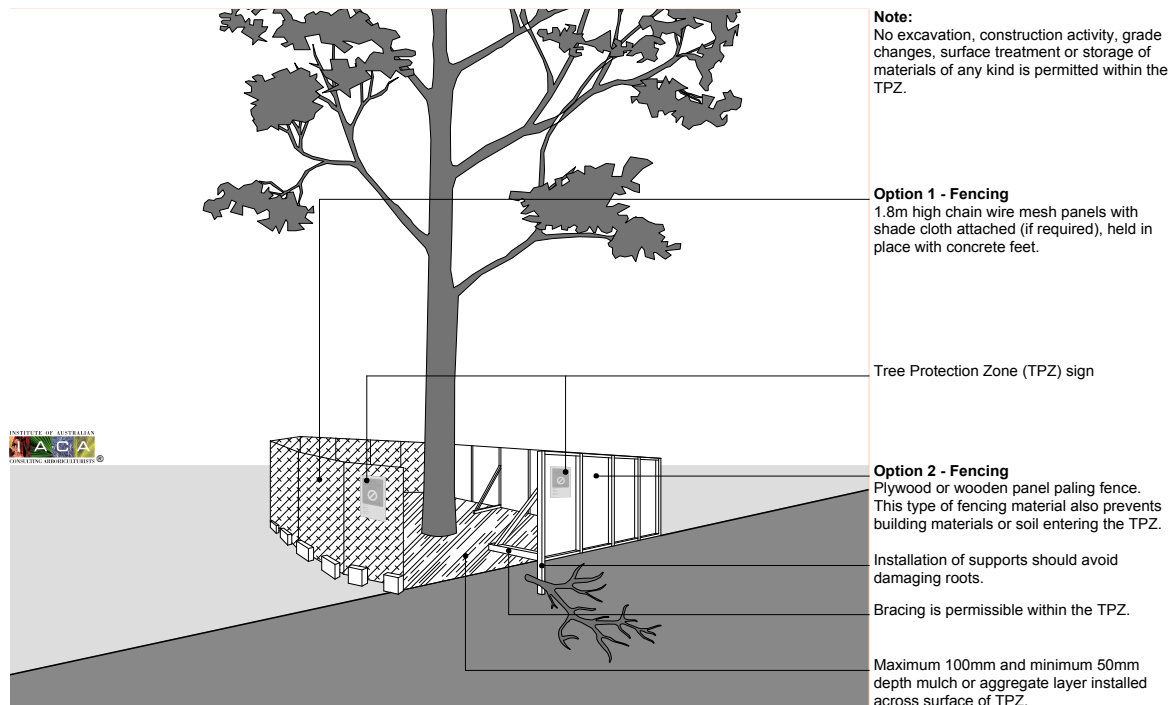
Tree Protection Fencing

**Tree Protection should be the first works on-site:** Protecting existing vegetation by isolating it with fencing. This is easier and far less expensive than later replacement or re-establishment.

*No equipment or materials are to enter or be stored within the fenced area and no chemicals or run off enter this protected zone.*

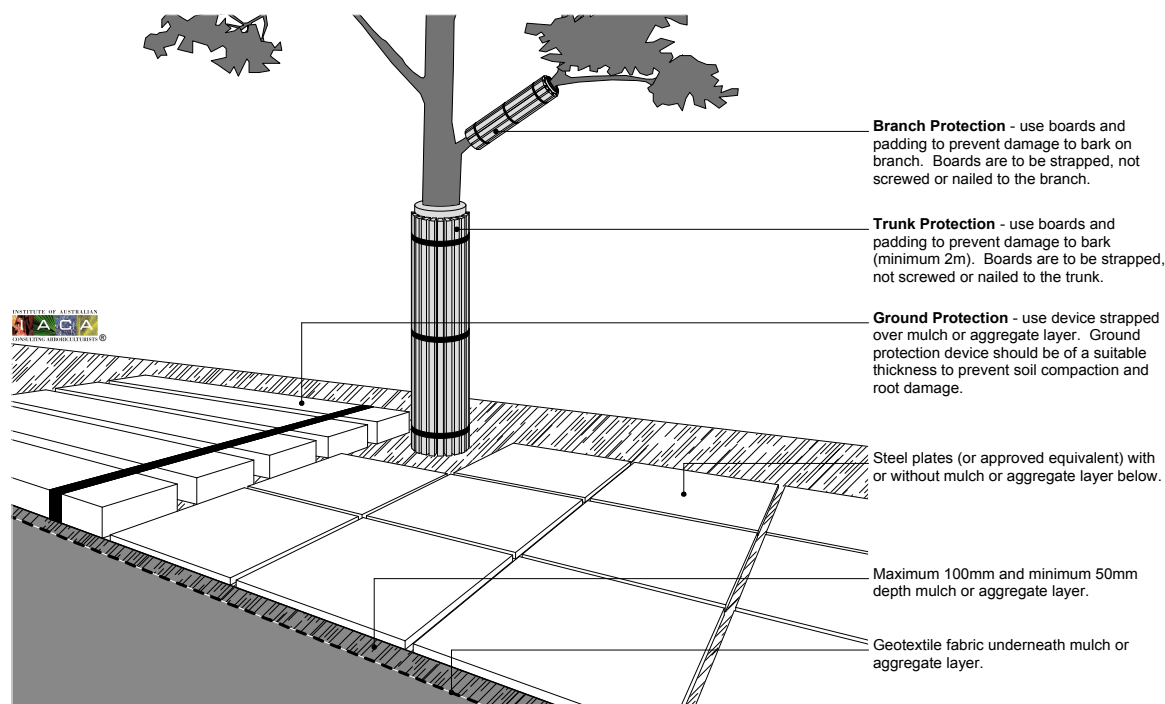
Examples of Branch, Trunk and Ground Protection

Where a tree trunk is likely to be knocked it must be protected from possible damage.

Protection material should cover from the base of the tree to 2m (or to a level that is likely to be damaged by passing equipment) branch protection may be required. Take care that the top and base of the board are not touching the trunk.
