Project 202337.03  
15 May 2025  
R.002.Rev0  
DRC:sam

## Addendum to Geotechnical Investigation Proposed Mixed-Use Development Cnr Mann St & Dwyer St, North Gosford NSW

Project 202337.01  
April 2023

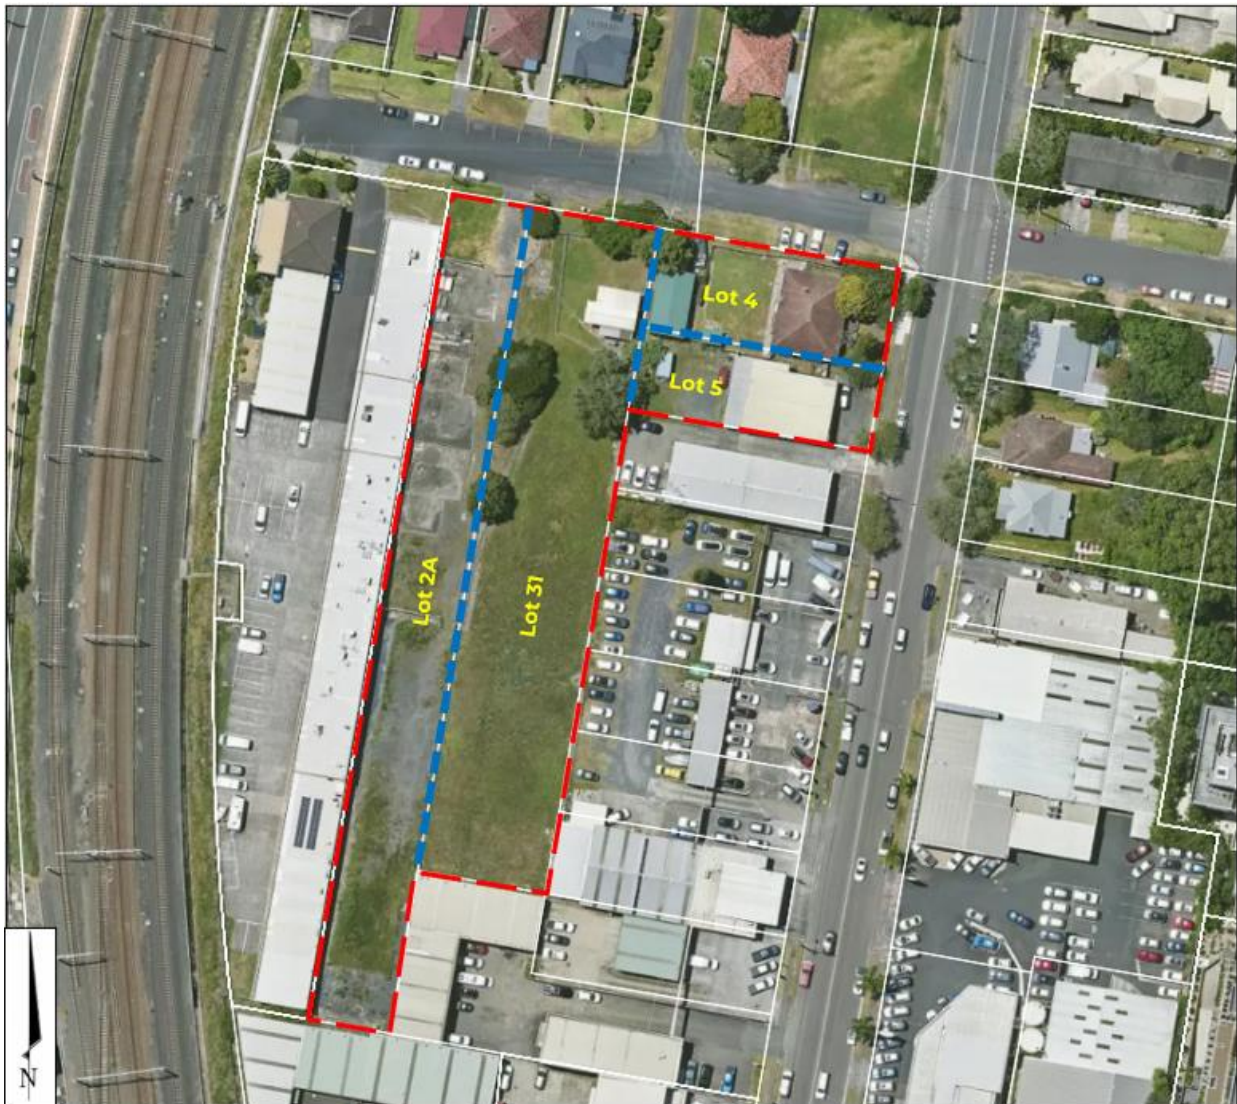
**Figure 1: Aerial view of the site with perimeter boundary in red and internal lot boundaries in blue. Base image sourced from MetroMap dated 17 December 2024.**

It is noted that communal open space areas are to be incorporated into the proposed design. The proposed development plans are attached. Figure 1 shows the site and various lots.

It is noted that the geotechnical report (Douglas, 2023) makes reference to 'Site B'. In the context of this project, Site B refers to the lots shown in Figure 1 of this addendum and is the subject site for the proposed development.

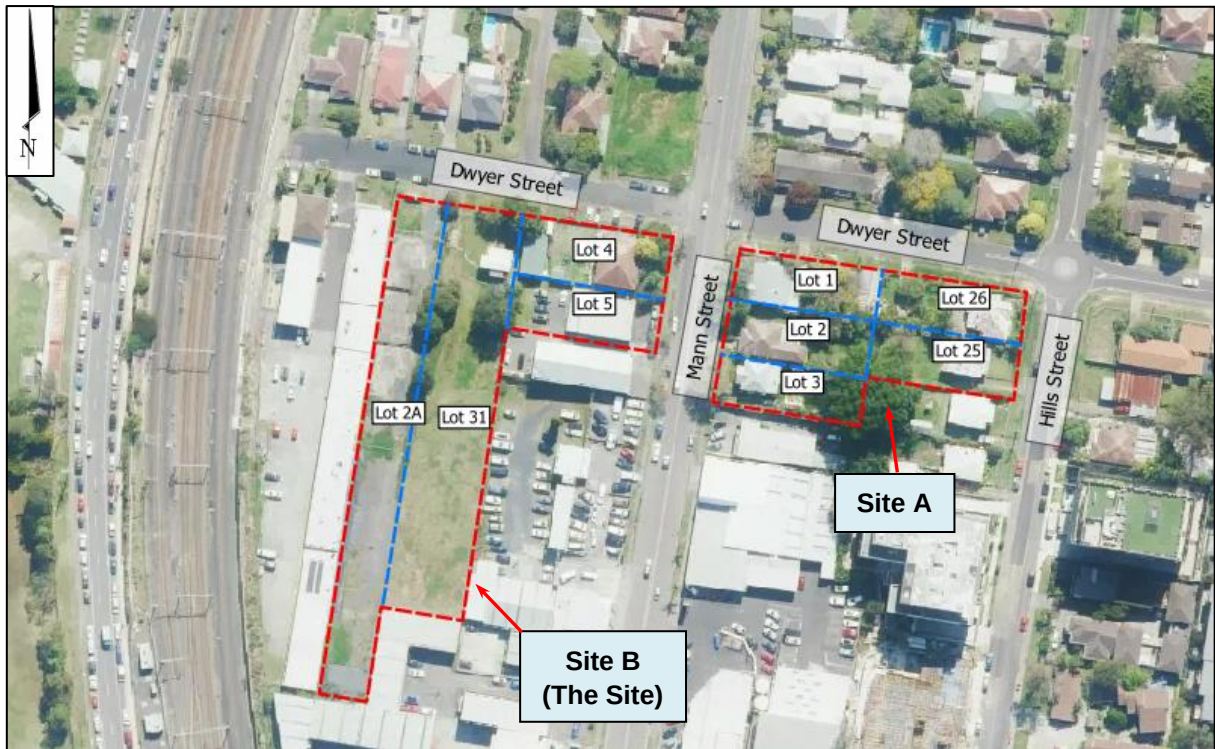
**Figure 1: Site B (the site) and Site A (reported separately) boundary (in red) and lot layout. Aerial image sourced from MetroMap (12 September 2022).**

The site boundary and lot layout are shown in Figure 1.

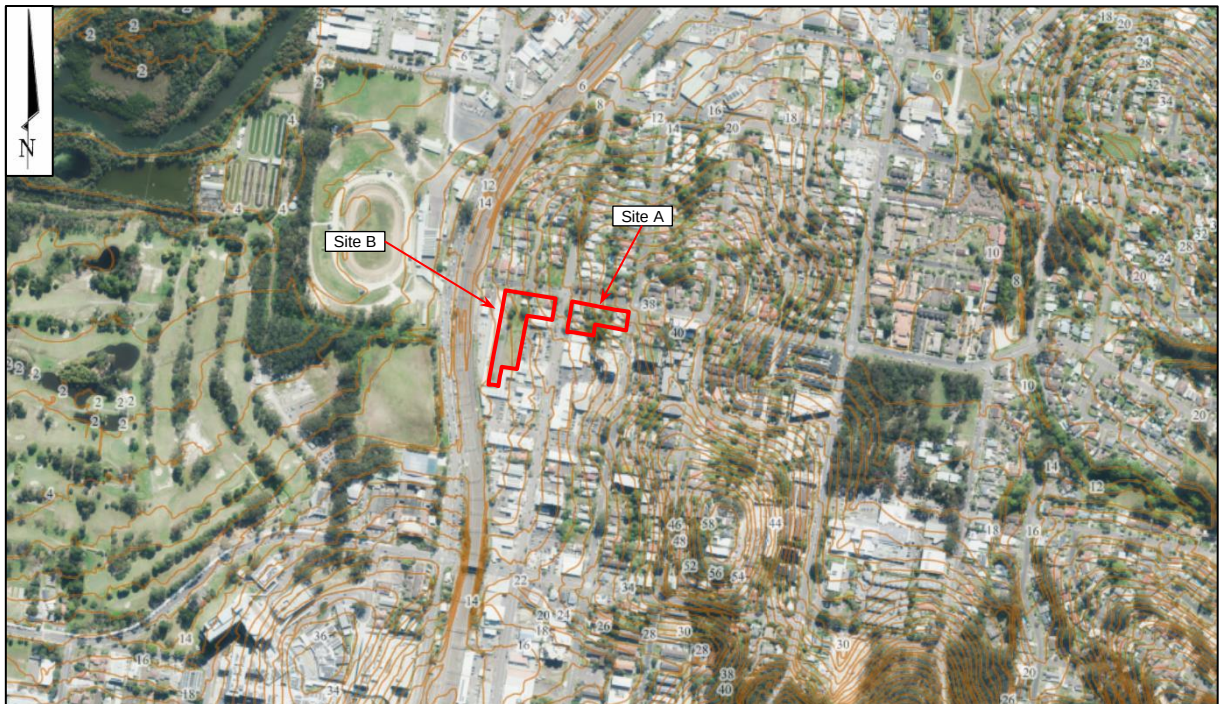
Figure 2 shows an aerial image with the North Gosford development site (red outline) located in the centre and overlain by 2 m contour lines. This shows a local high point at RL 40 m approximately 200 m to the east, and slopes falling down to the west and south-west in the direction of the Main North Railway line and further beyond to Narara Creek which is visible in the top left of Figure 2. Figure 3 shows a closer view of the site.

**Figure 2: Topography of the local area**

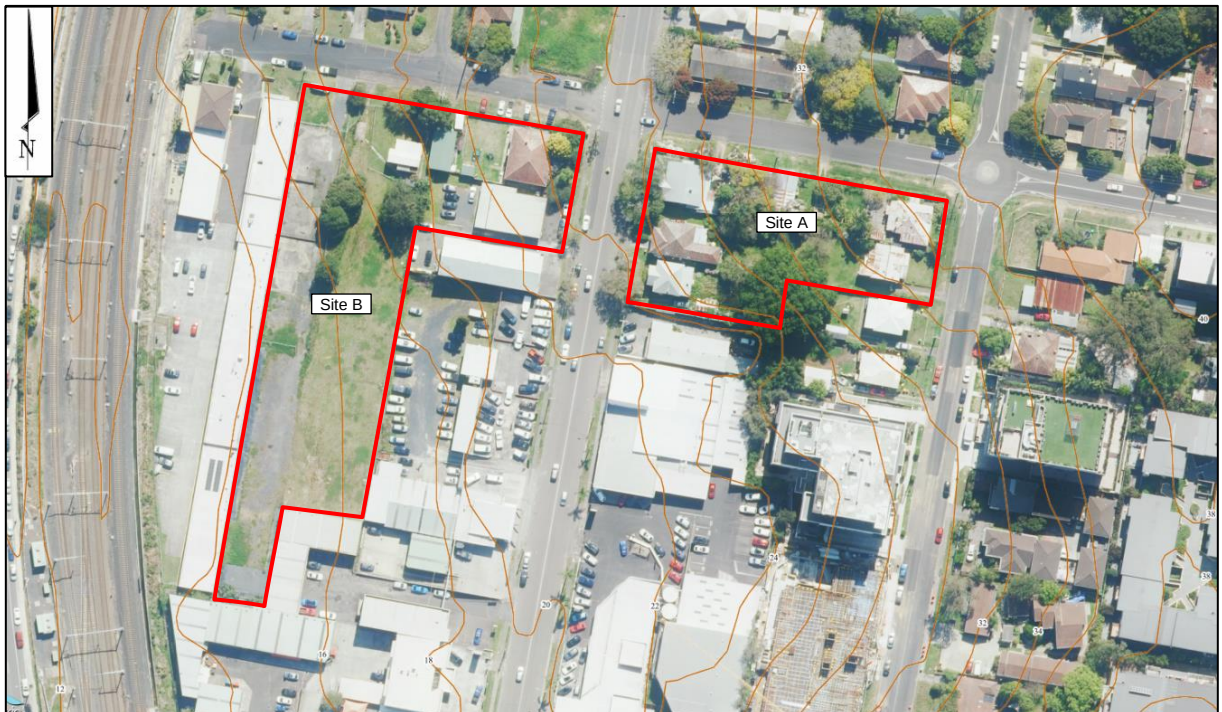
**Figure 3: Close view of the site with 2 m contour lines**

Surface levels across the site fall from about RL 24 m AHD at the north-eastern corner down to about RL 14 m AHD in the south-western corner.

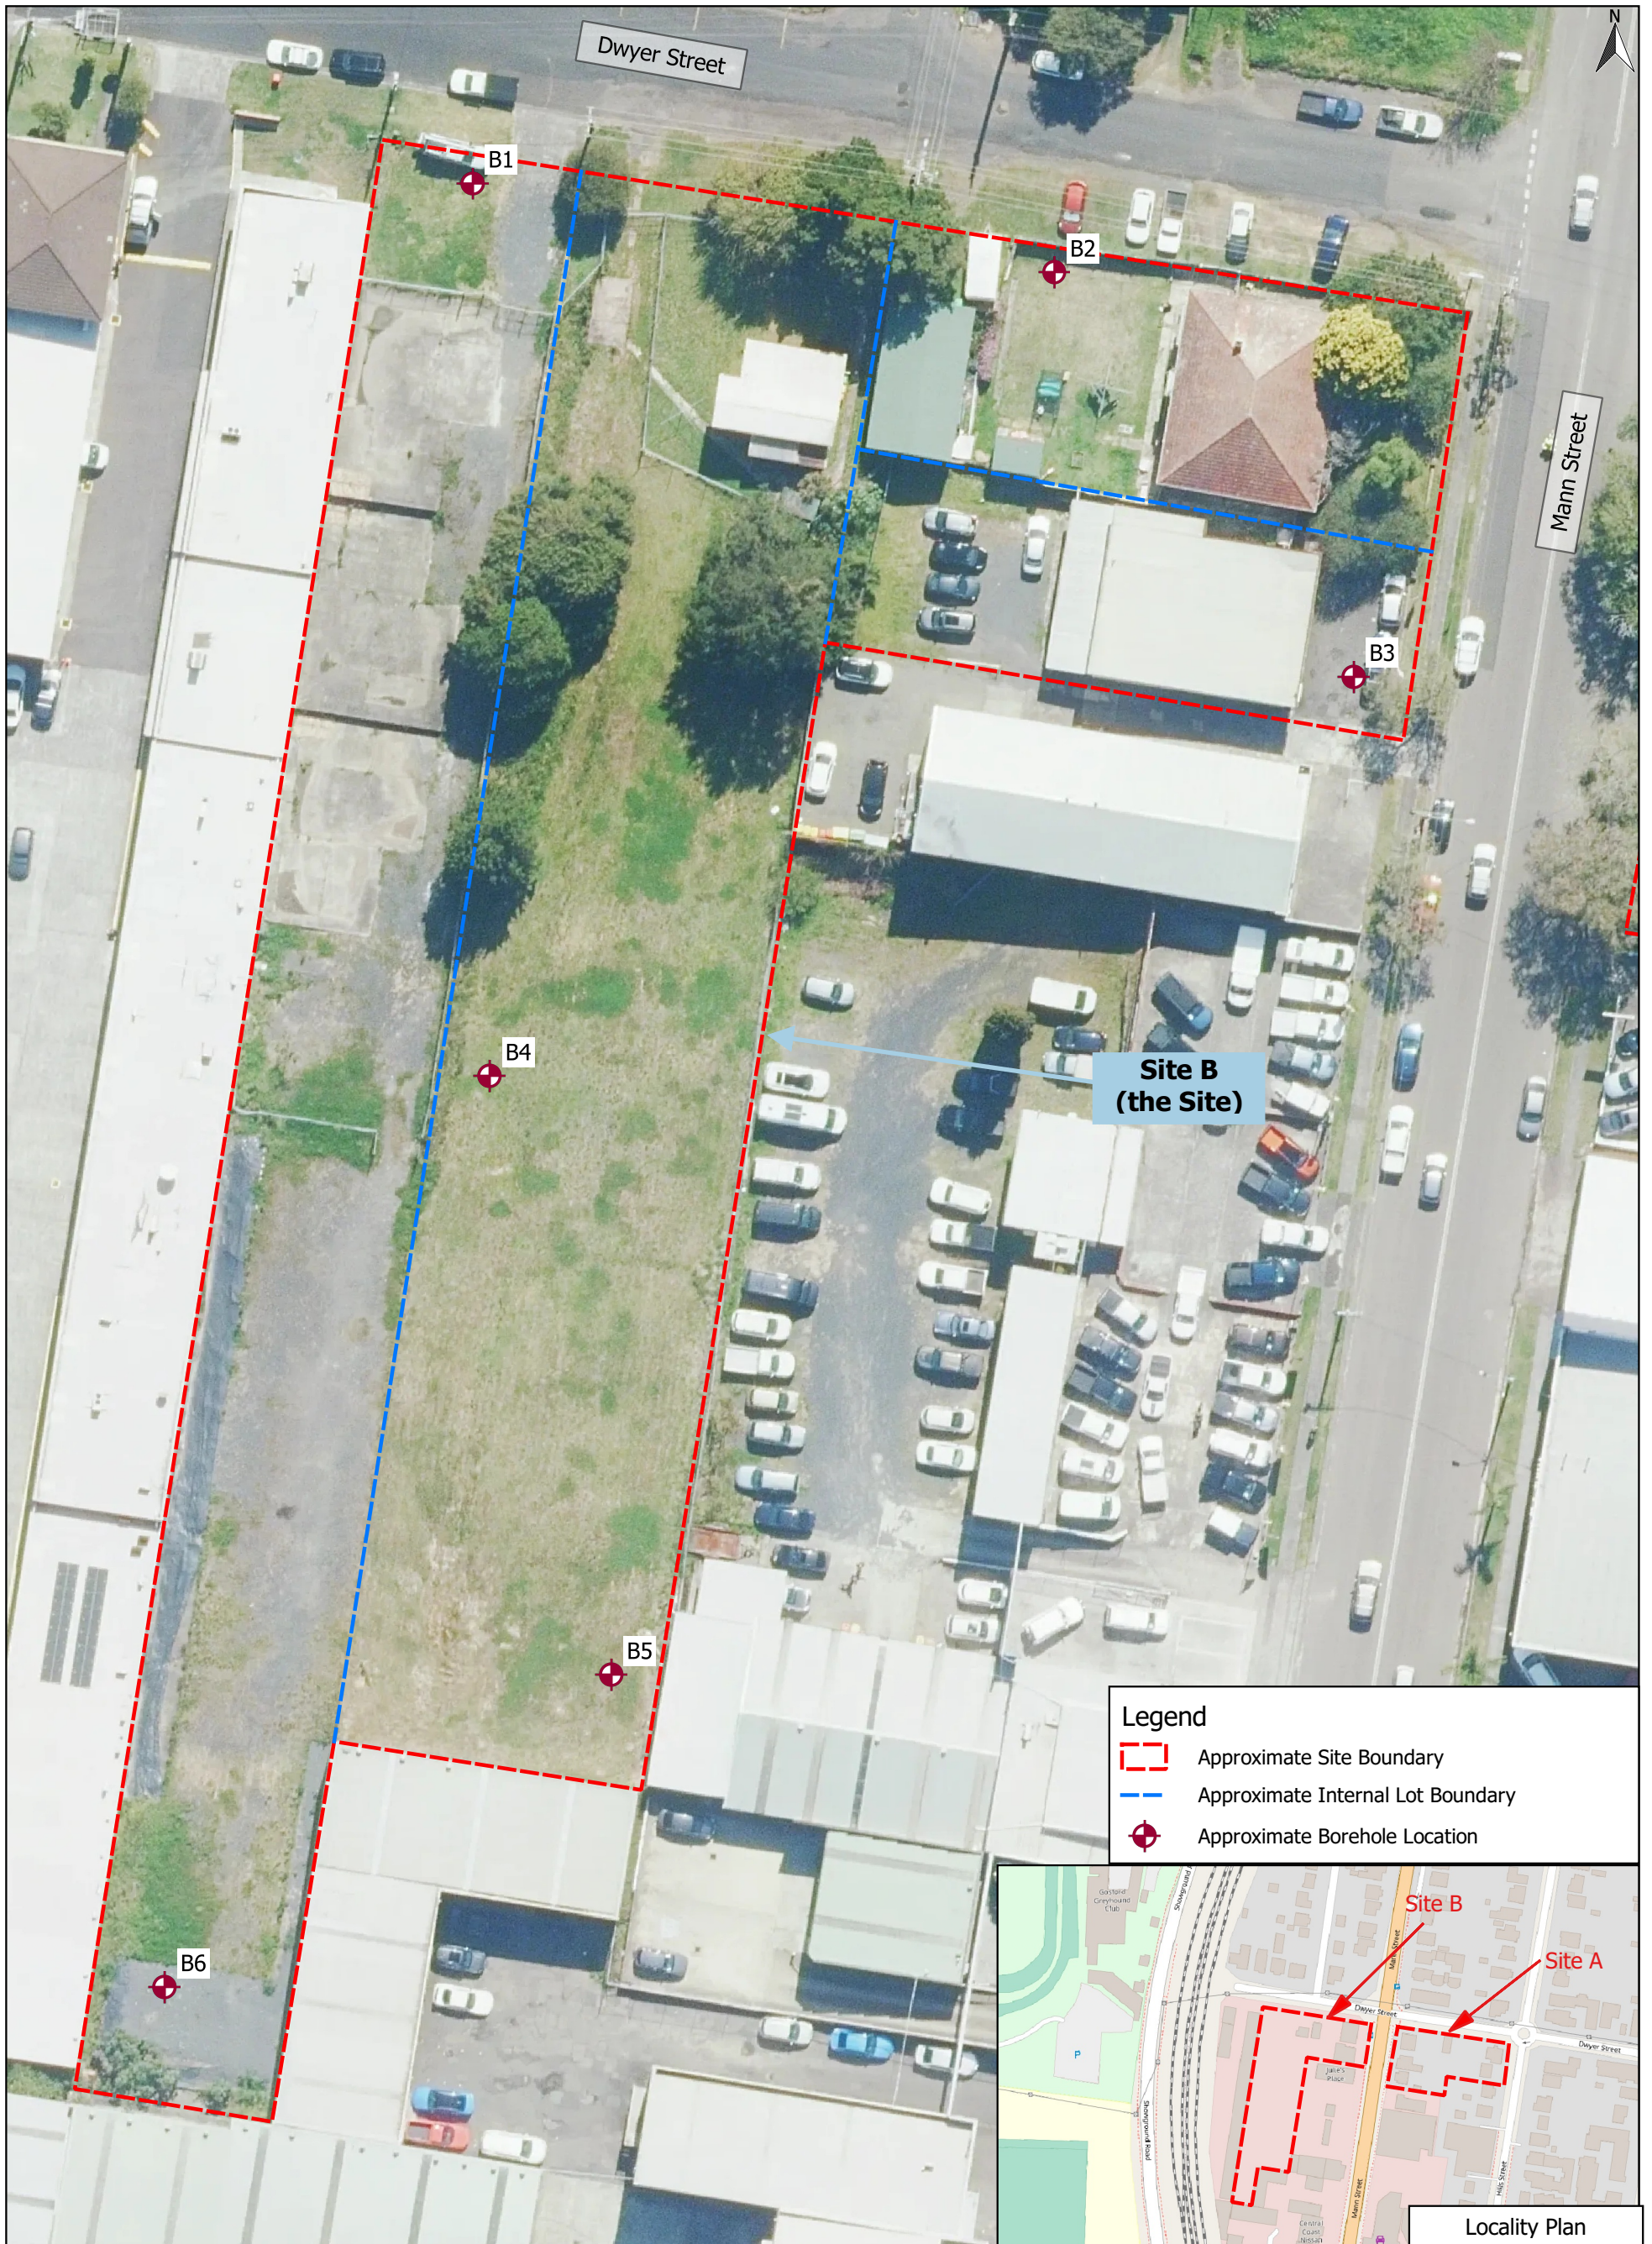
Drawing 1 – Test Location Plan

Drawing adapted from Metromap Image, dated 12 September 2022

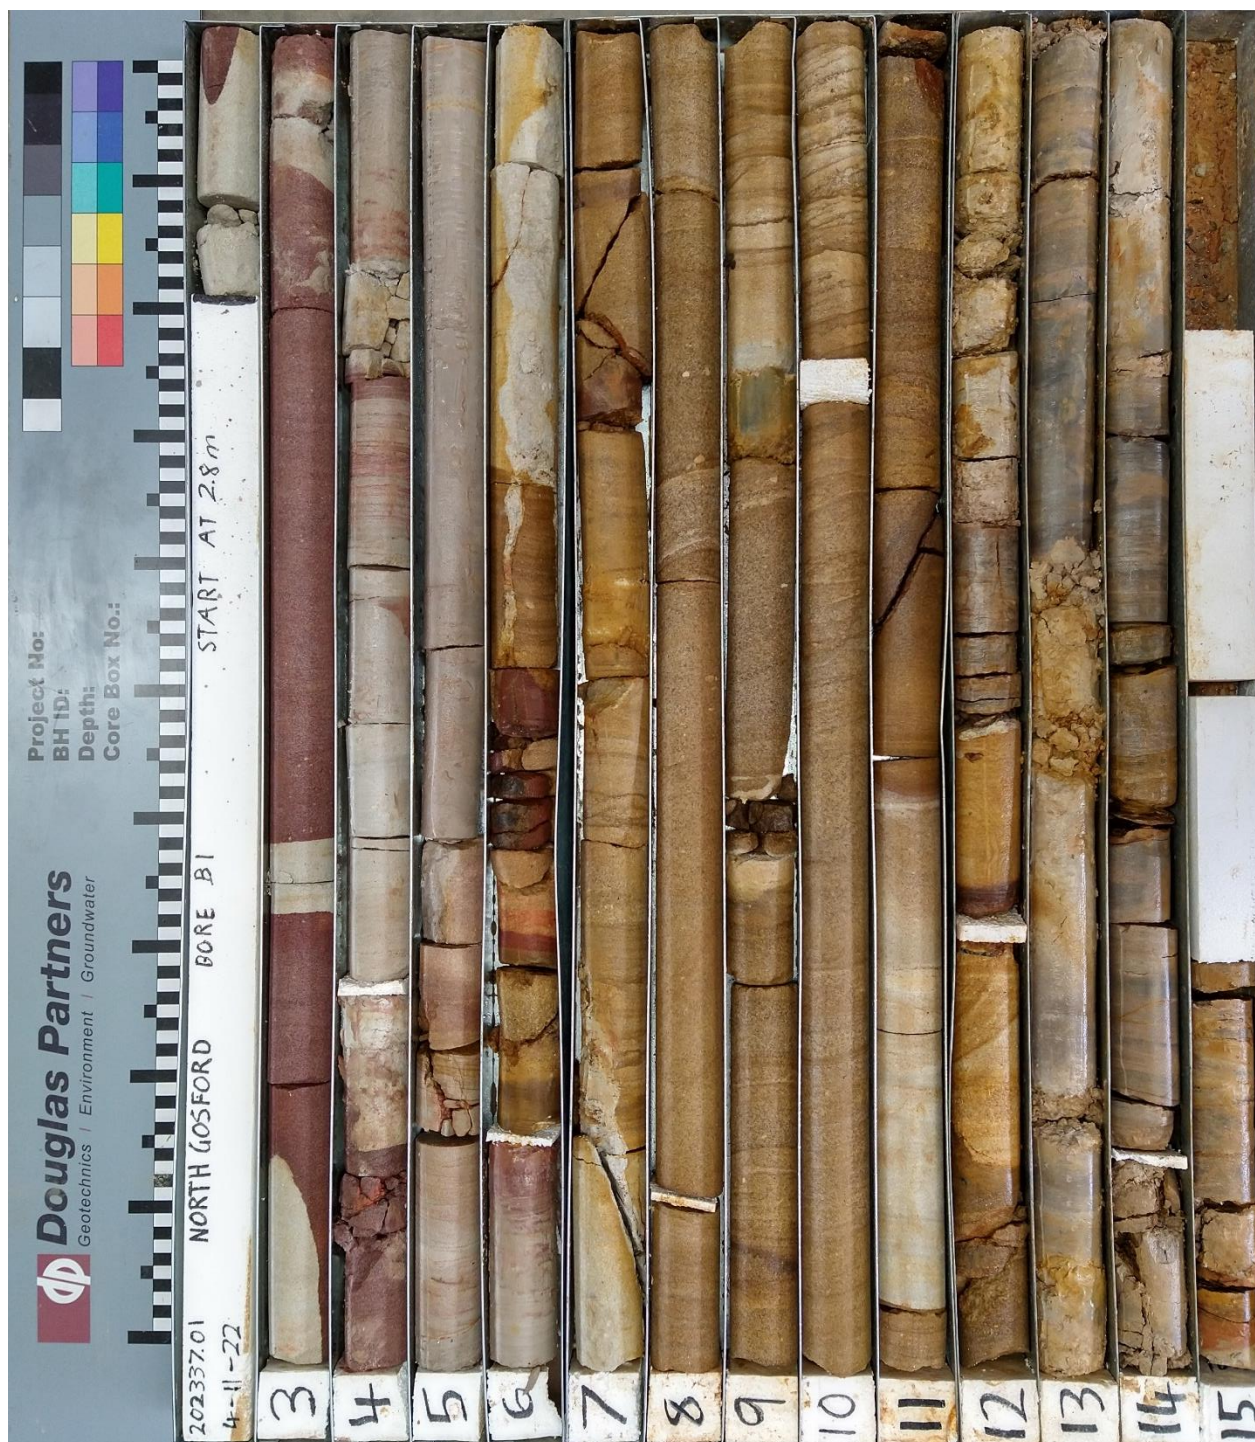
| CLIENT: Stockbridge Property Unit Trust | TITLE: <b>Core Photographs</b><br><b>Proposed Residential Development</b><br><b>Site B – North Gosford</b> | | |

Engineering logs of the subsurface conditions encountered in the boreholes were prepared by a geotechnical engineer who also collected representative samples for identification purposes and photographed the rock core in the core boxes. Details of the conditions encountered in the boreholes are given in the log sheets which are presented in Appendix C. These logs should be read in conjunction with the explanatory notes, which define the descriptive terms and classification methods. Photographic plates of the rock core recovered in each of the boreholes accompany the logs.

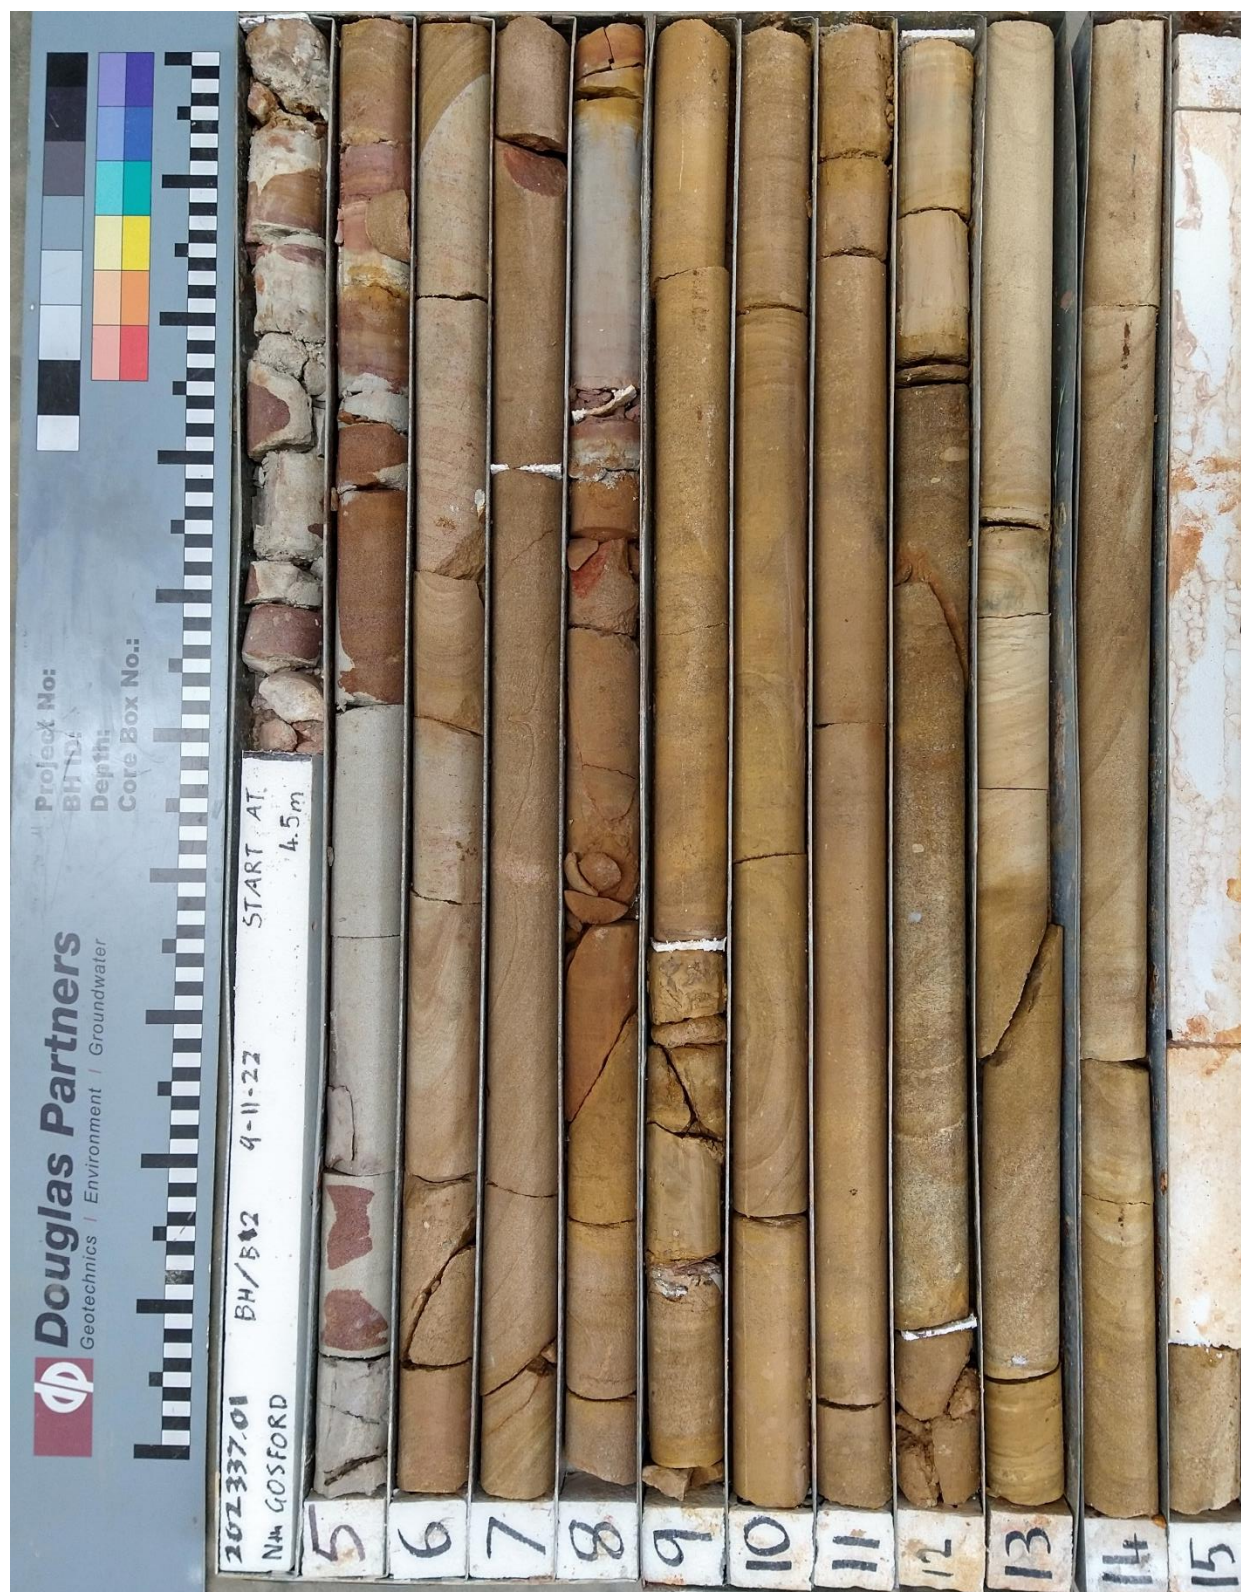
| CLIENT: Stockbridge Property Unit Trust | TITLE: <b>Core Photographs</b><br><b>Proposed Residential Development</b><br><b>Site B – North Gosford</b> | | |

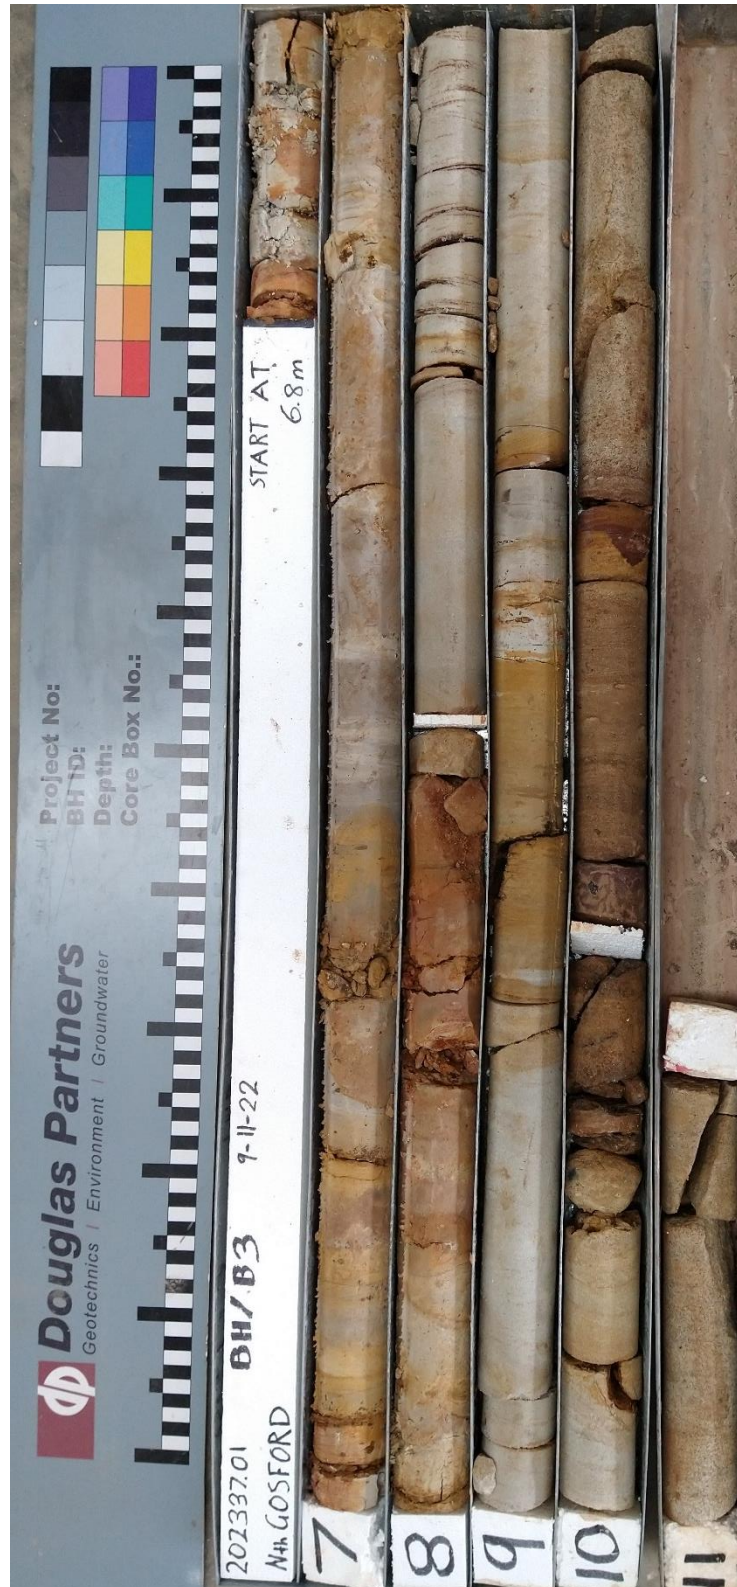
| CLIENT: Stockbridge Property Unit Trust | TITLE: <b>Core Photographs</b><br><b>Proposed Residential Development</b><br><b>Site B– North Gosford</b> | | |

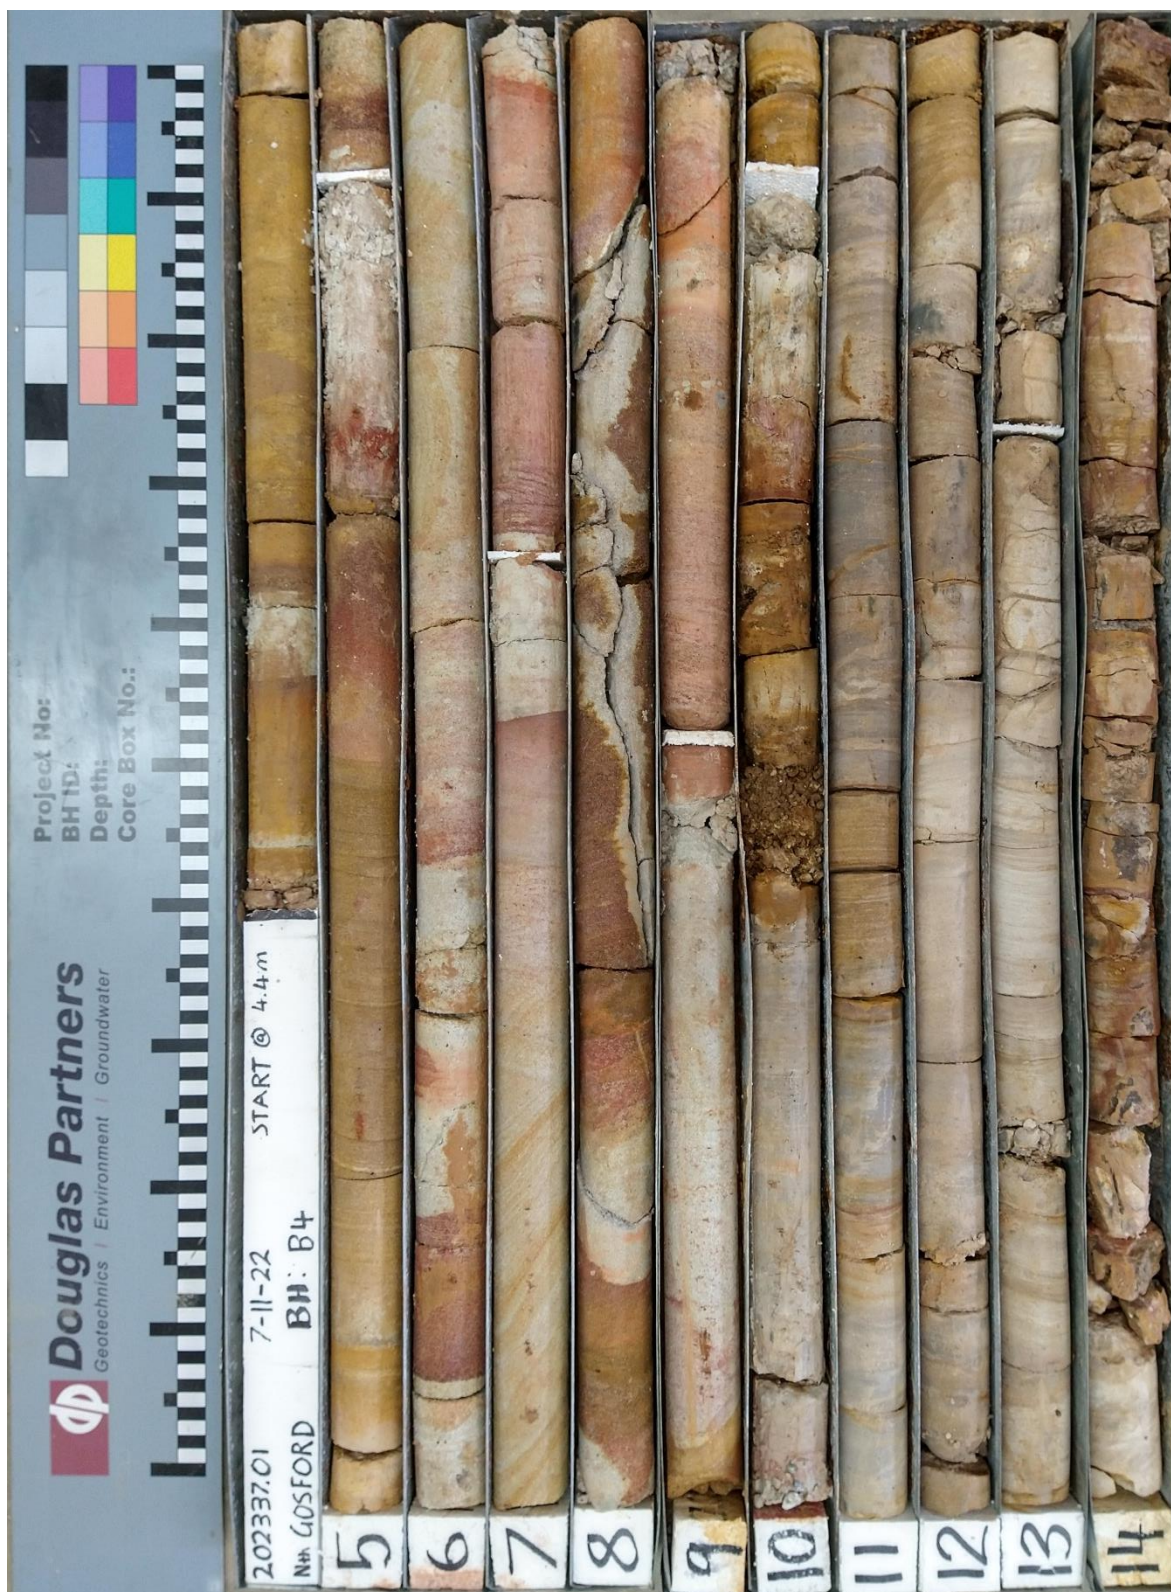
| CLIENT: Stockbridge Property Unit Trust | <b>TITLE: Core Photographs</b><br><b>Proposed Residential Development</b><br><b>Site B – North Gosford</b> | | |

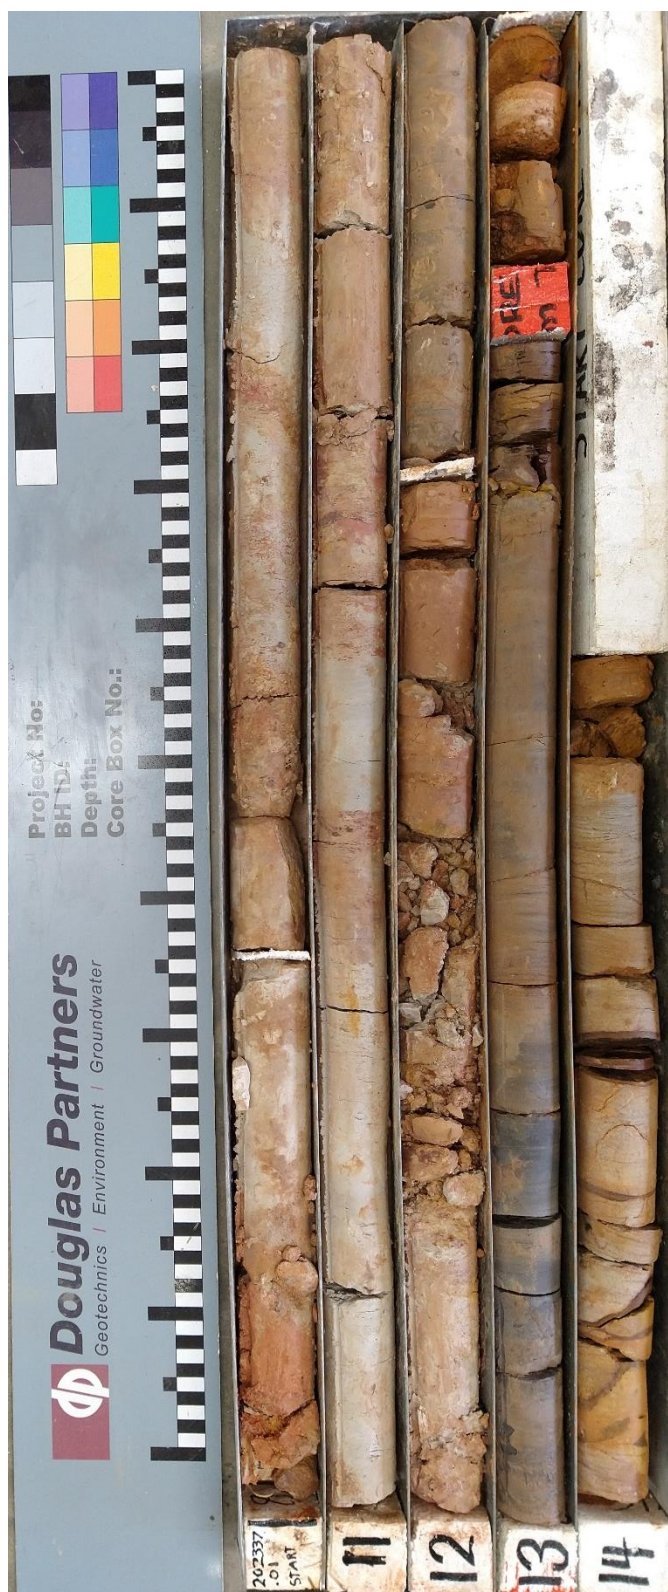
| CLIENT: Stockbridge Property Unit Trust | TITLE: <b>Core Photographs</b><br><b>Proposed Residential Development</b><br><b>Site B – North Gosford</b> | | |

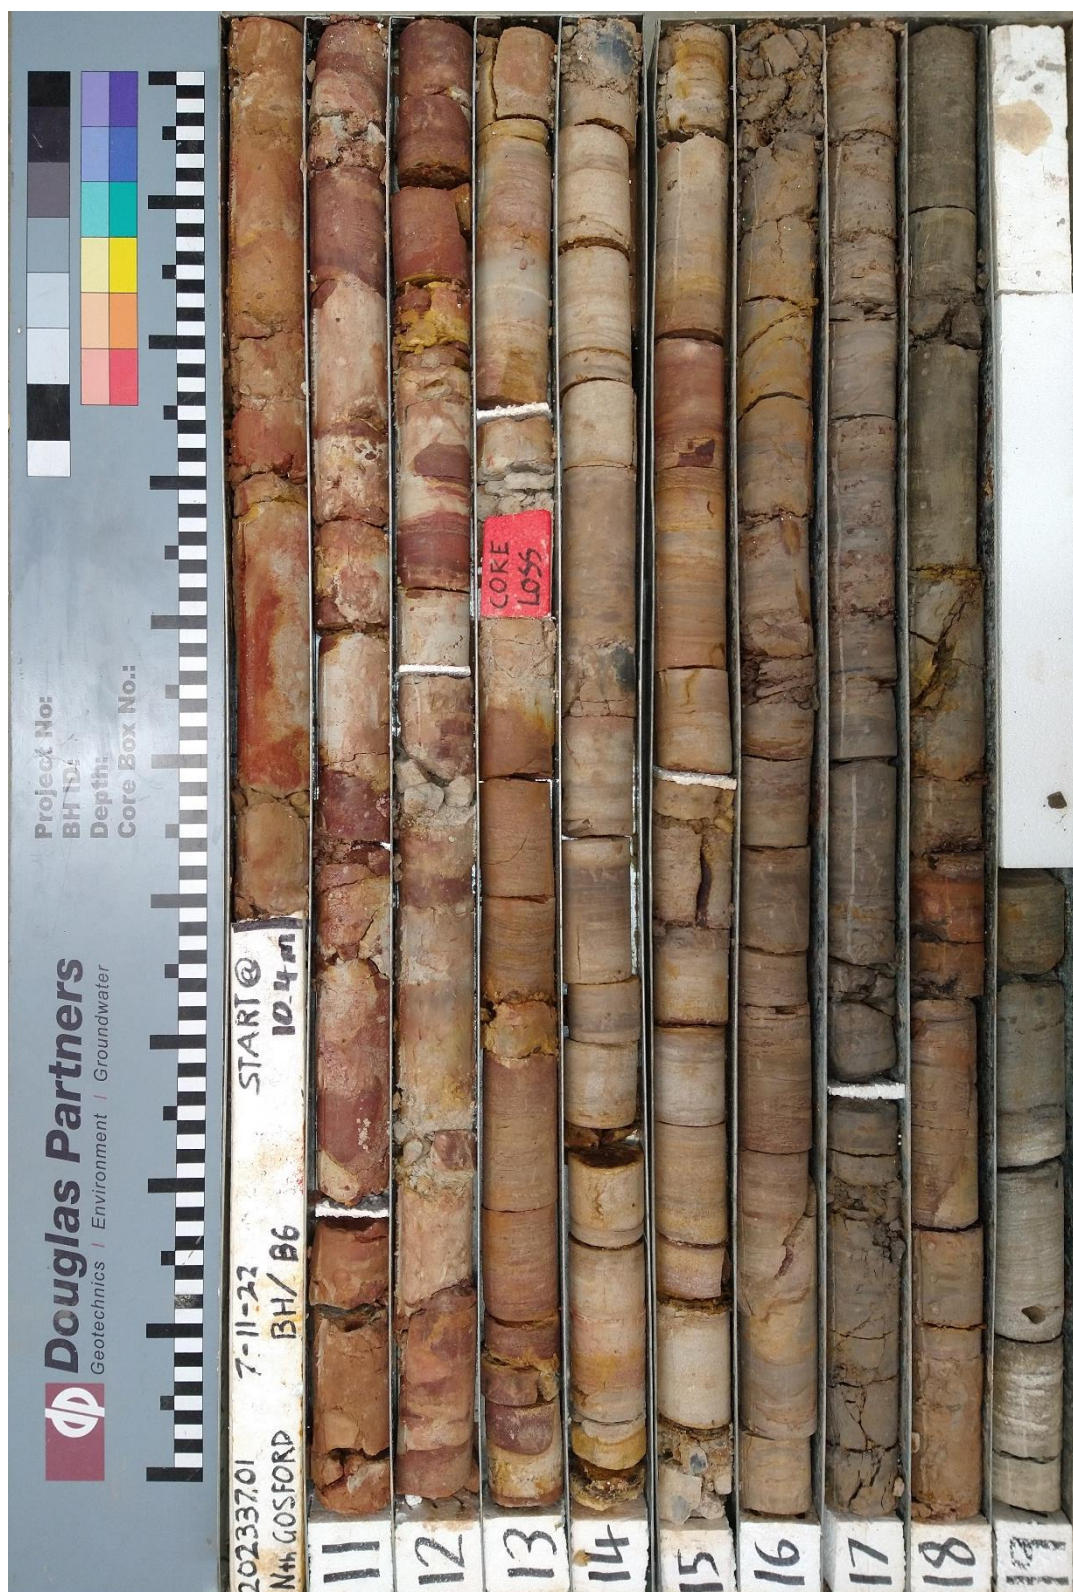
| CLIENT: Stockbridge Property Unit Trust | TITLE: <b>Core Photographs</b><br><b>Proposed Residential Development</b><br><b>Site B – North Gosford</b> | | |
