# **Environment Management Plan for Community Health Centre, 612-624 Pittwater Road, Brookvale NSW**

NSW Health Infrastructure

Project no: 2201675A-CLM-REP-002 RevA  
Date: February 2016

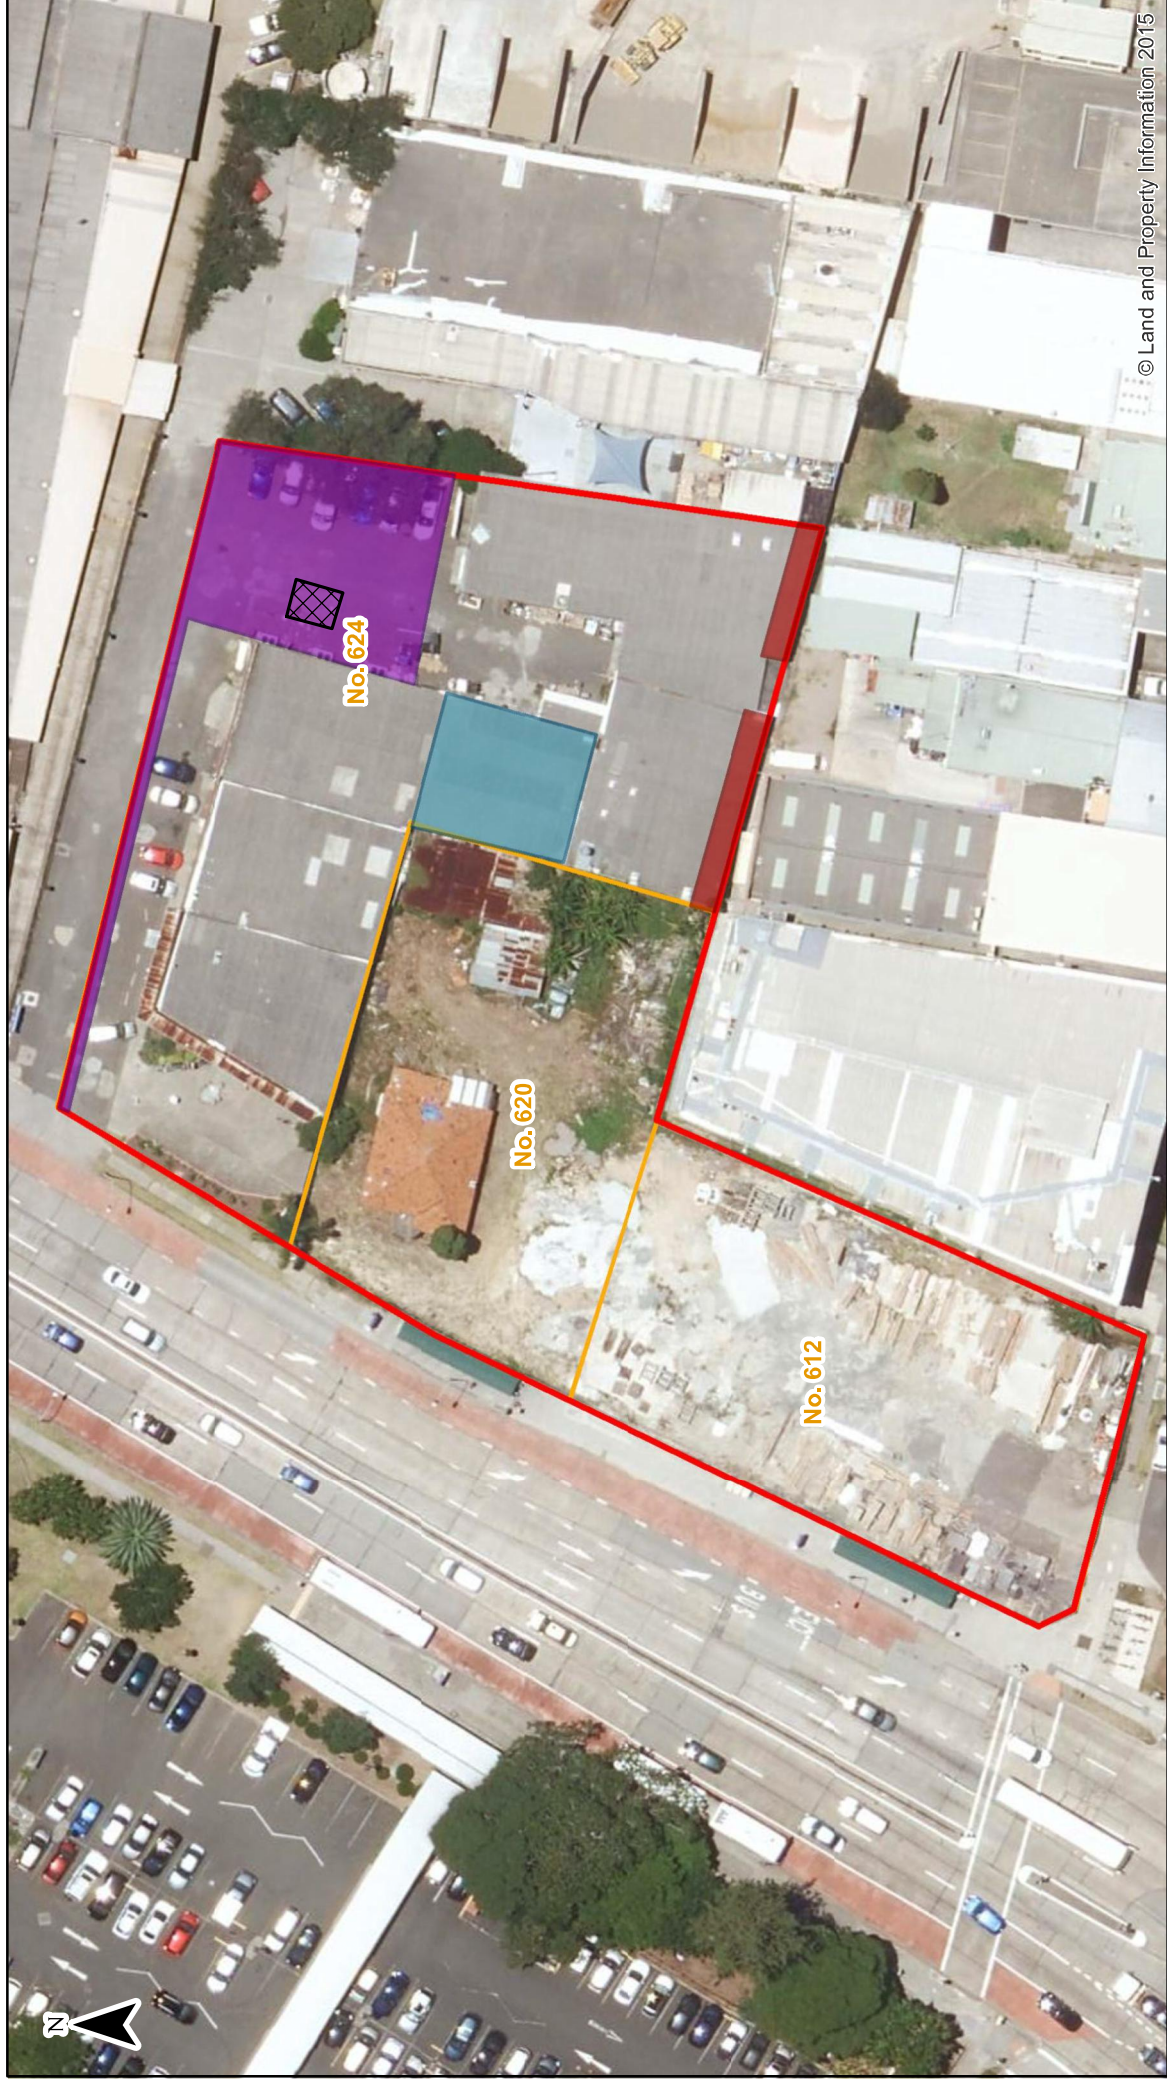
Figure 2 - Remaining Area Requiring Assessment  
Pittwater Rd, Brookvale NSW

A plan of the existing site layout, showing the approximate location of the existing UST, south-eastern batter, and remaining asphalt is provided as Figure 2, Appendix A.
