**Response to Comments and Submissions: Brookvale Community Health Centre (SSD 6980) Modification 2**

## **Attachment C Preliminary Site Investigation and Site Suitability Assessment**

## Phase 1: Preliminary Site Investigation

# Pittwater Rd, Warringah Mall, Brookvale, NSW 2100

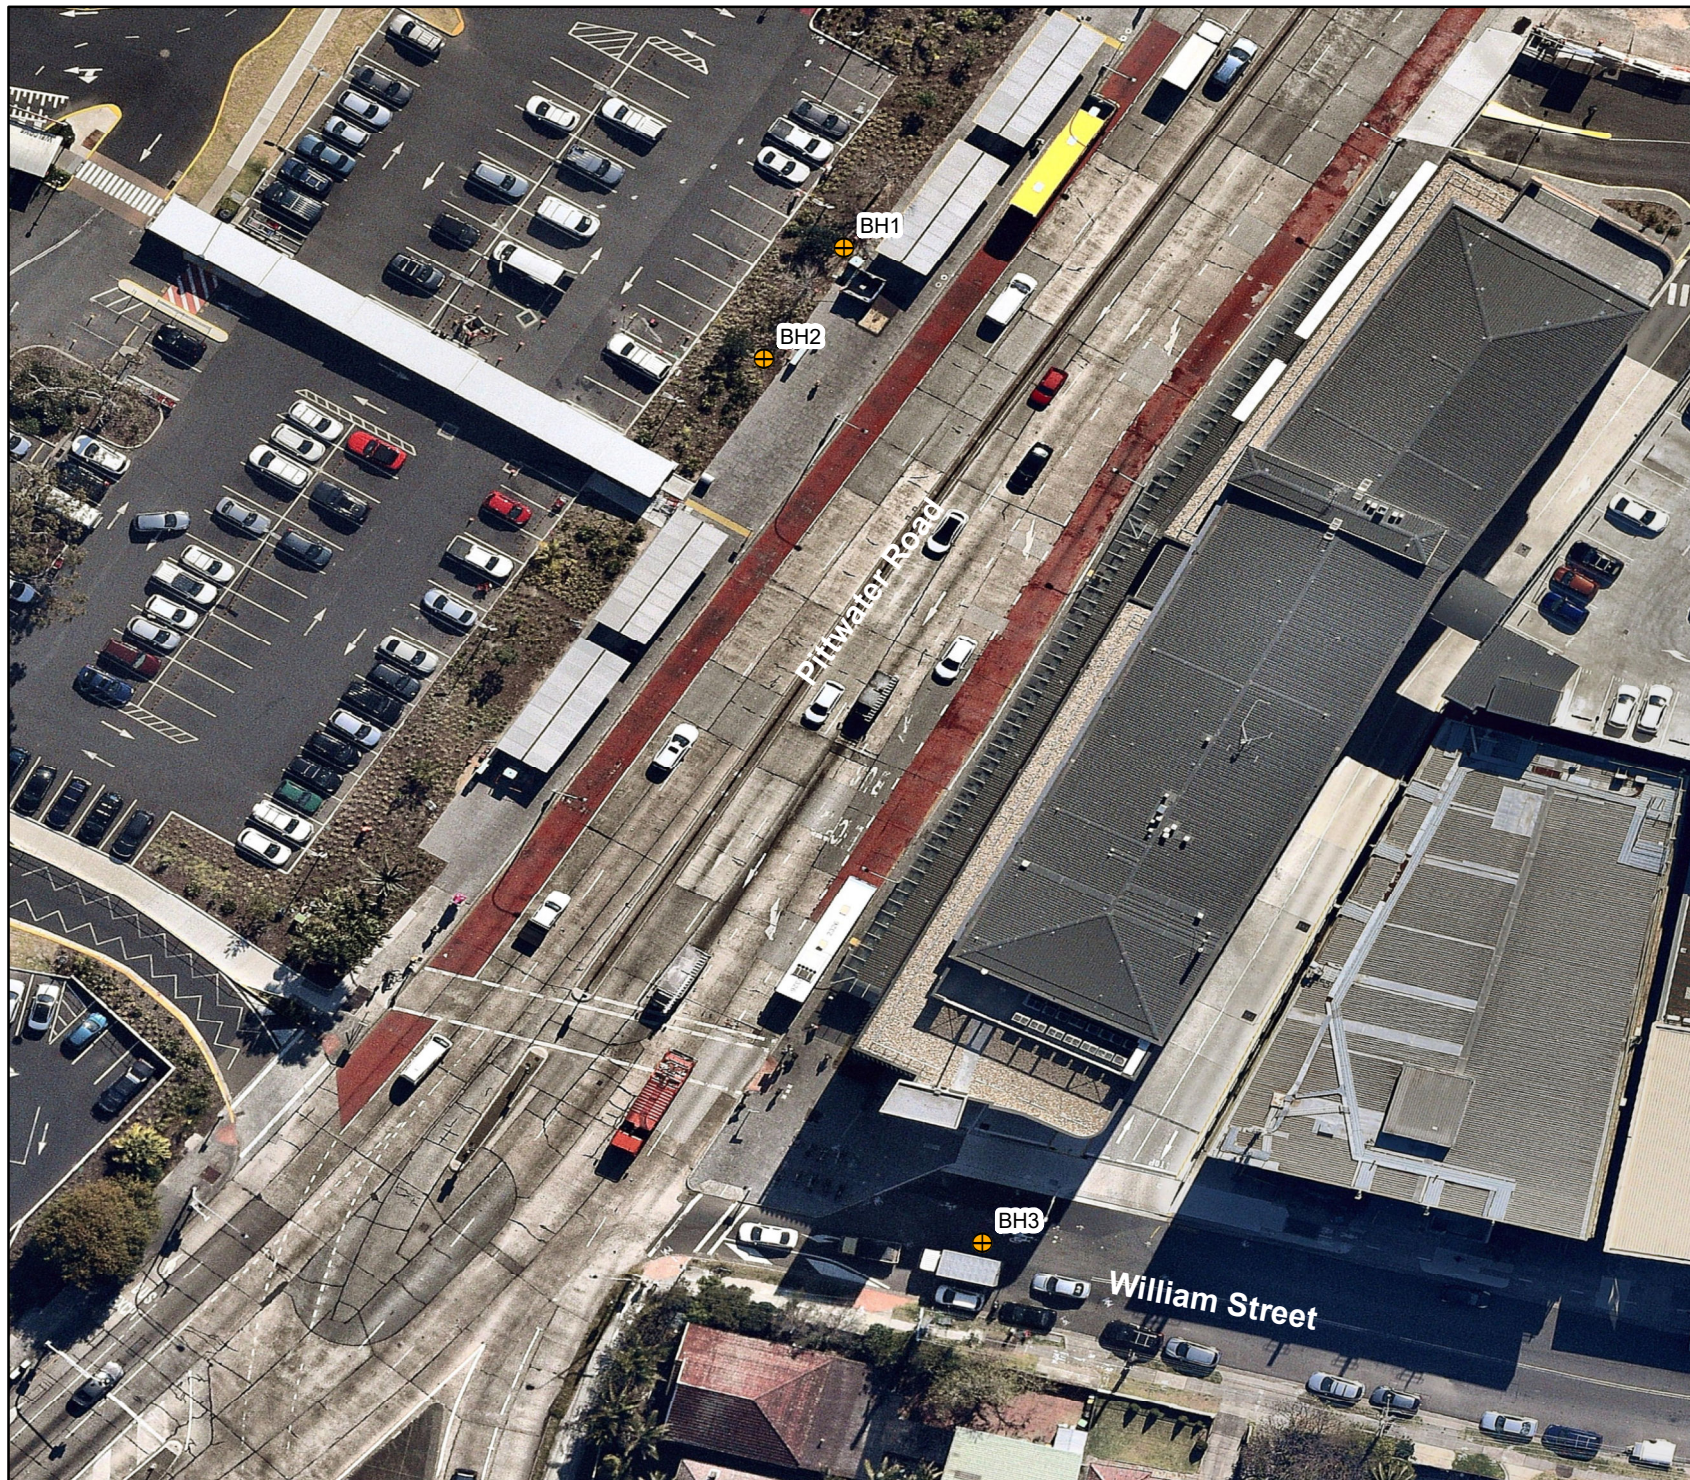
BROOKVALE PED BRIDGE  
FIGURE 1

## Borehole Locations

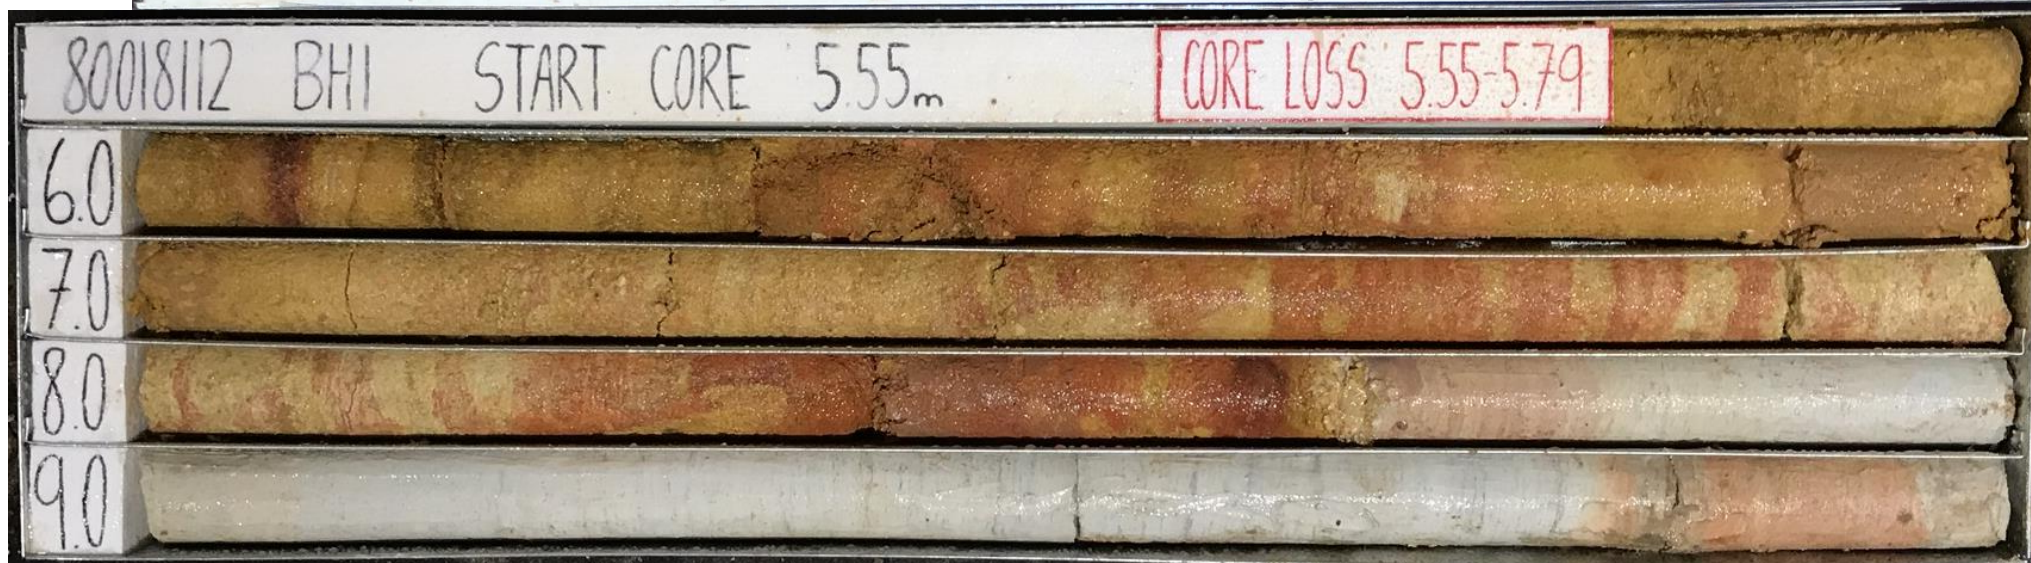
**Borehole Core Photographs – BH1**  
**Geotechnical Investigation – Brookvale Pedestrian Bridge**

PROJECT NO:  
**80018112**TEST DATE:  
**24 August 2018**INCLINATION:  
**90°**CORED LENGTH: **BOX 1 OF 3**  
**5.55m to 10.0m – 4.45m Length**DRILL RIG:  
**Comacchio Geo 205**CONTRACTOR:  
**Terratest**LOGGED BY:  
**AC**CHECKED BY:  
**TH****BH1****5.55m to 10.00m****BOX 1 OF 3**

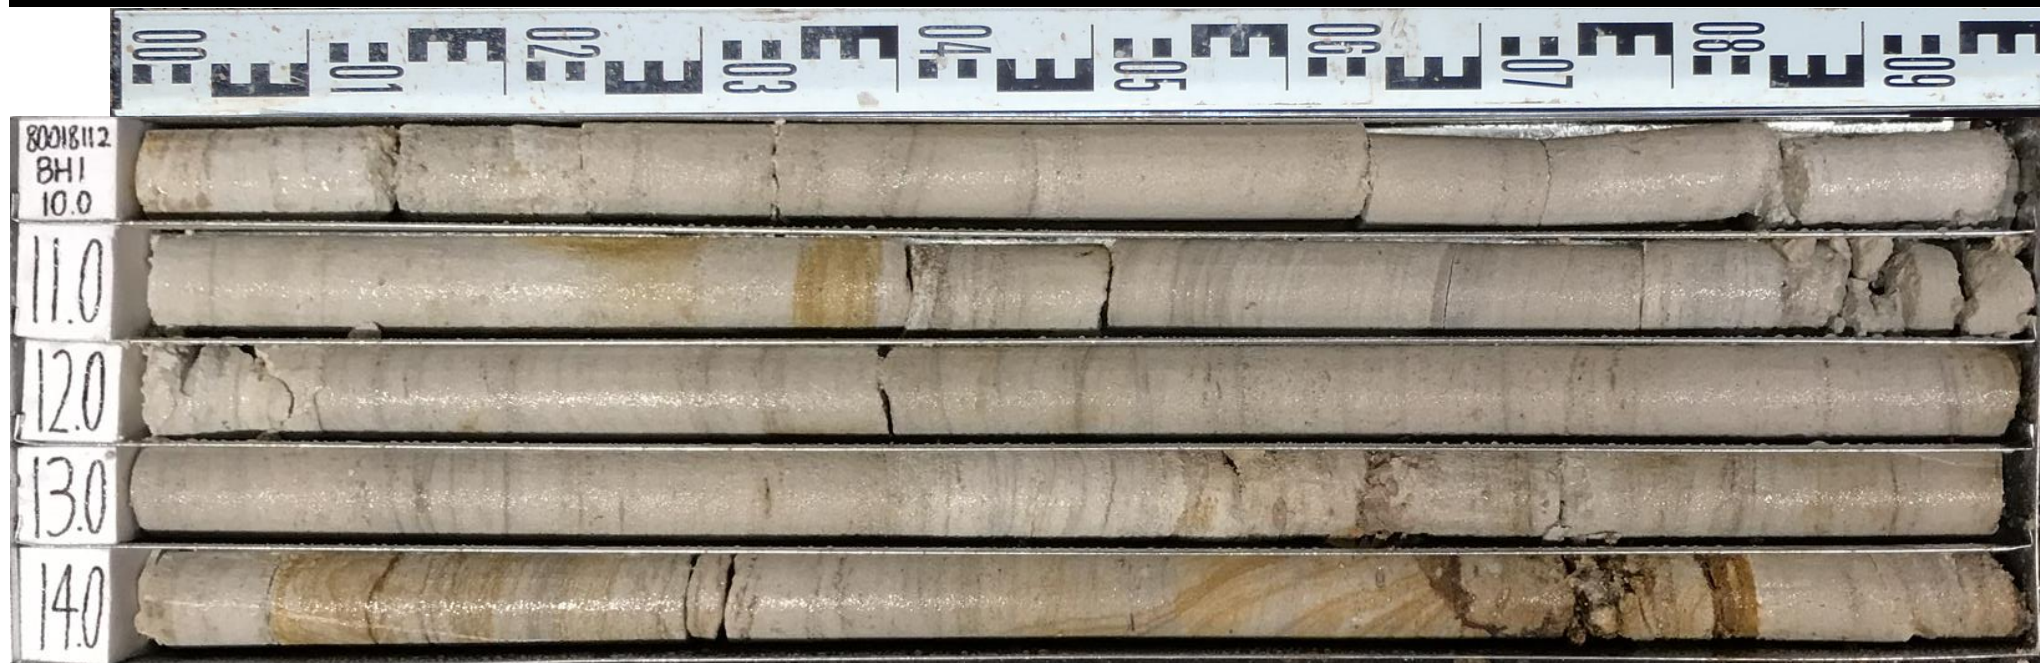
**BH1**  
**10.00m to 15.00m**  
**BOX 2 OF 3**

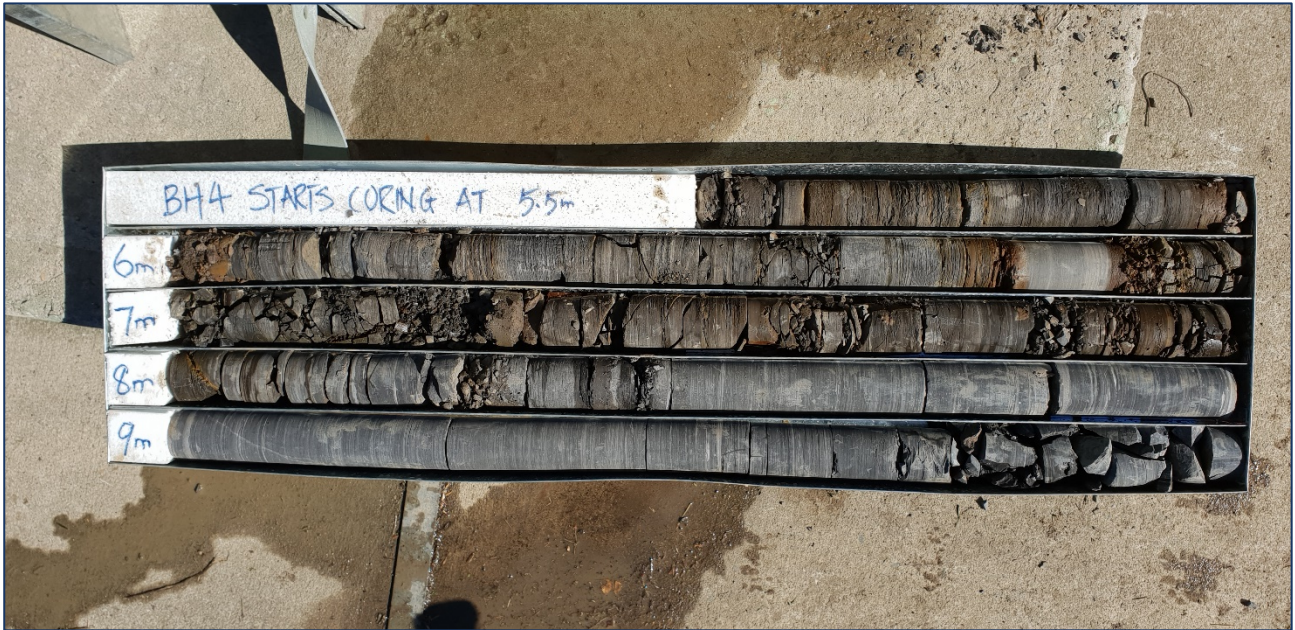
**Photograph 1:** BH4 upper core showing weathered shale with clay banding.

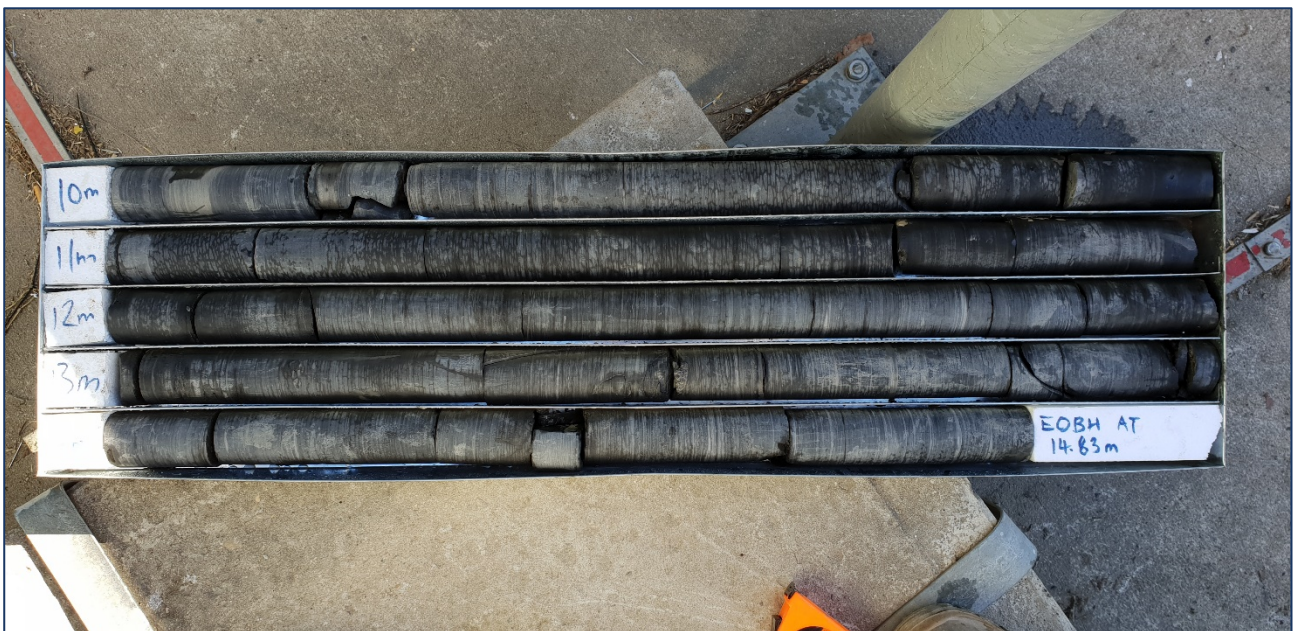
**Photograph 2:** BH4 lower core showing grey thinly laminated shale.

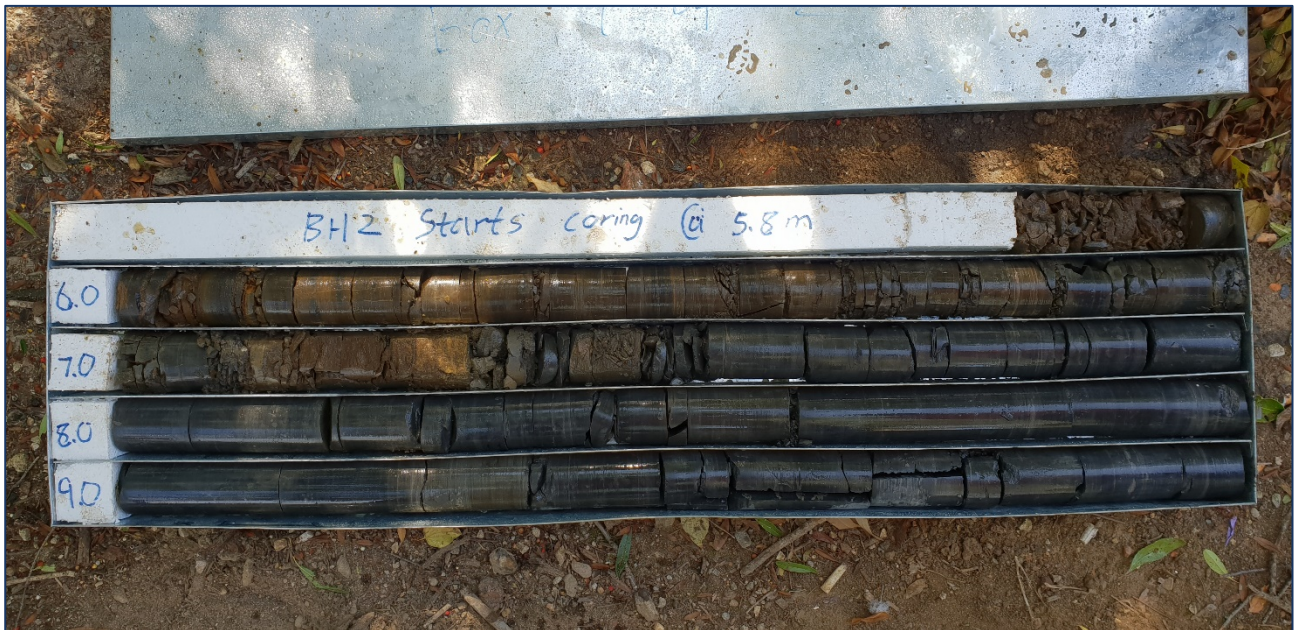
**Photograph 3:** BH2 upper core showing weathered shale with clay banding.

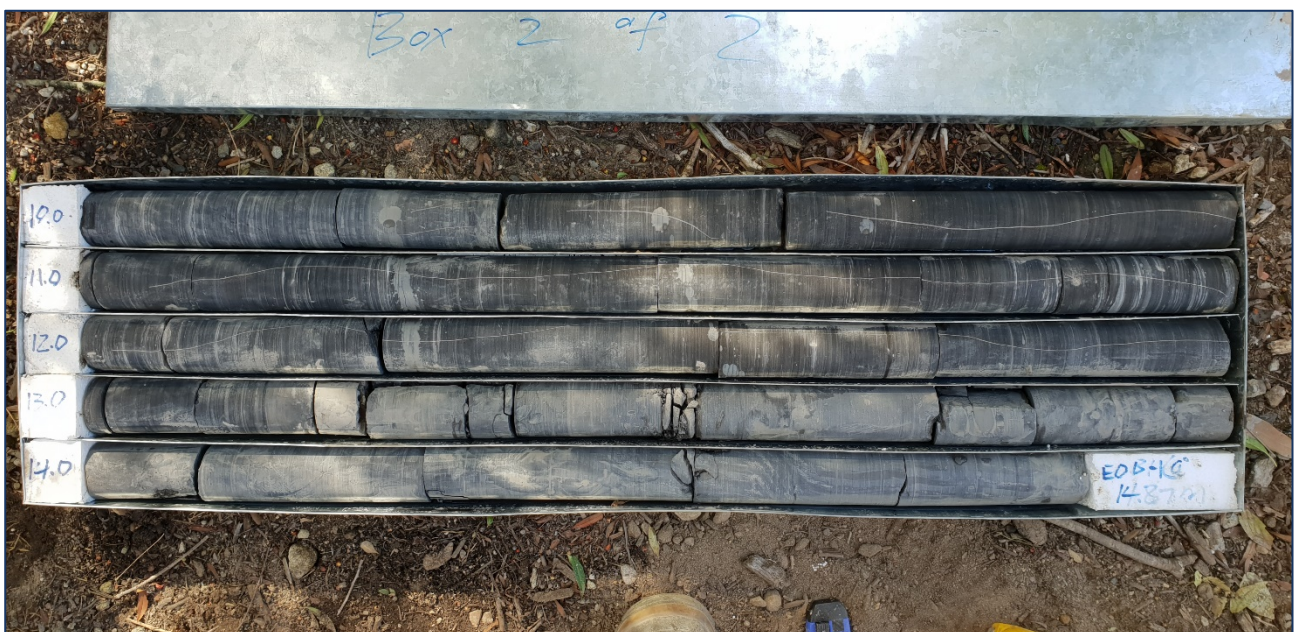
**Photograph 4** BH2 lower core showing grey thinly laminated shale.

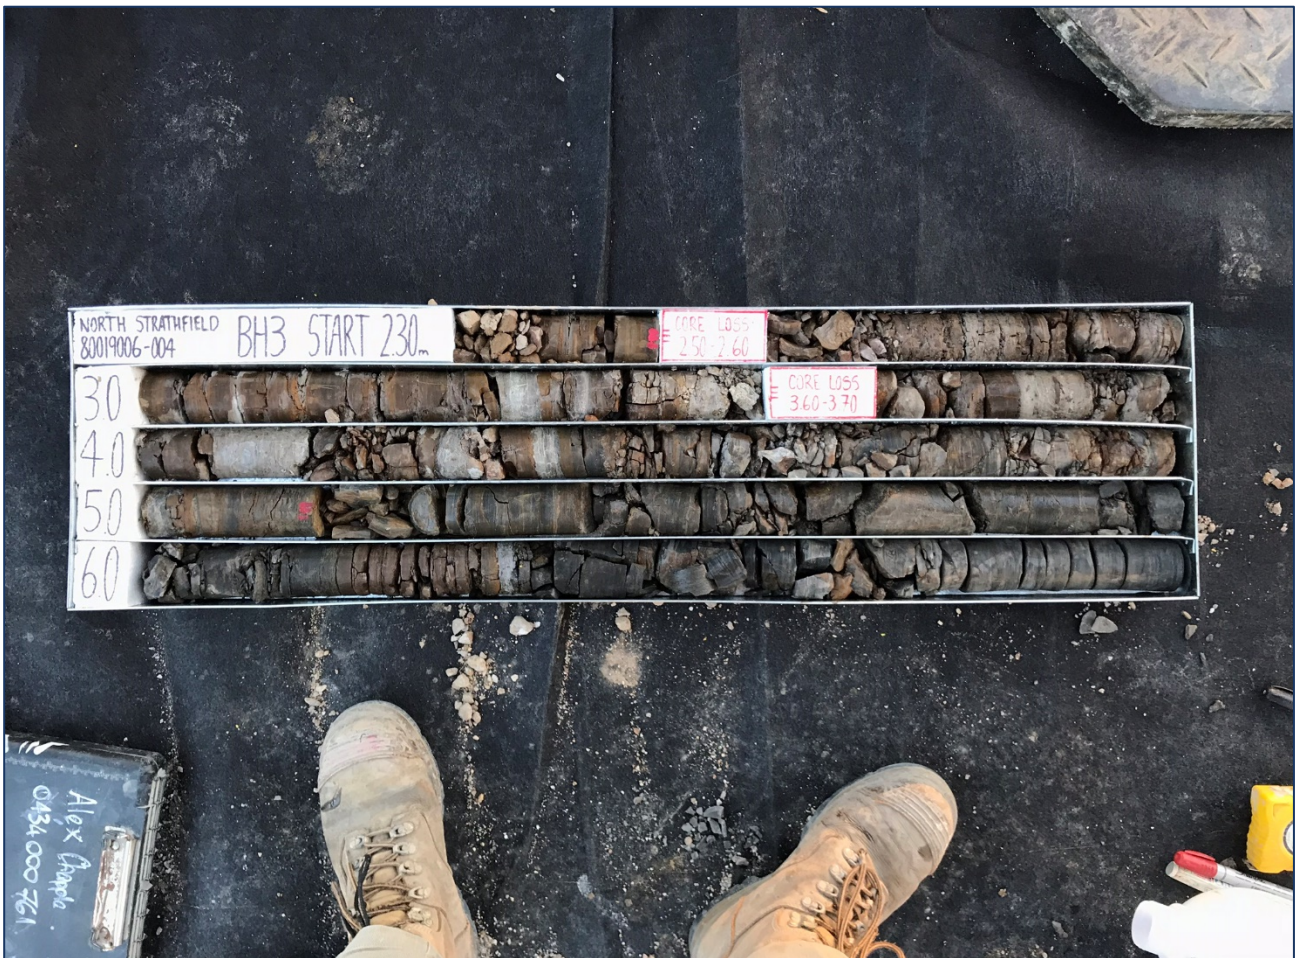
**Photograph 6:** BH3 core showing orange and brown shale with clay.

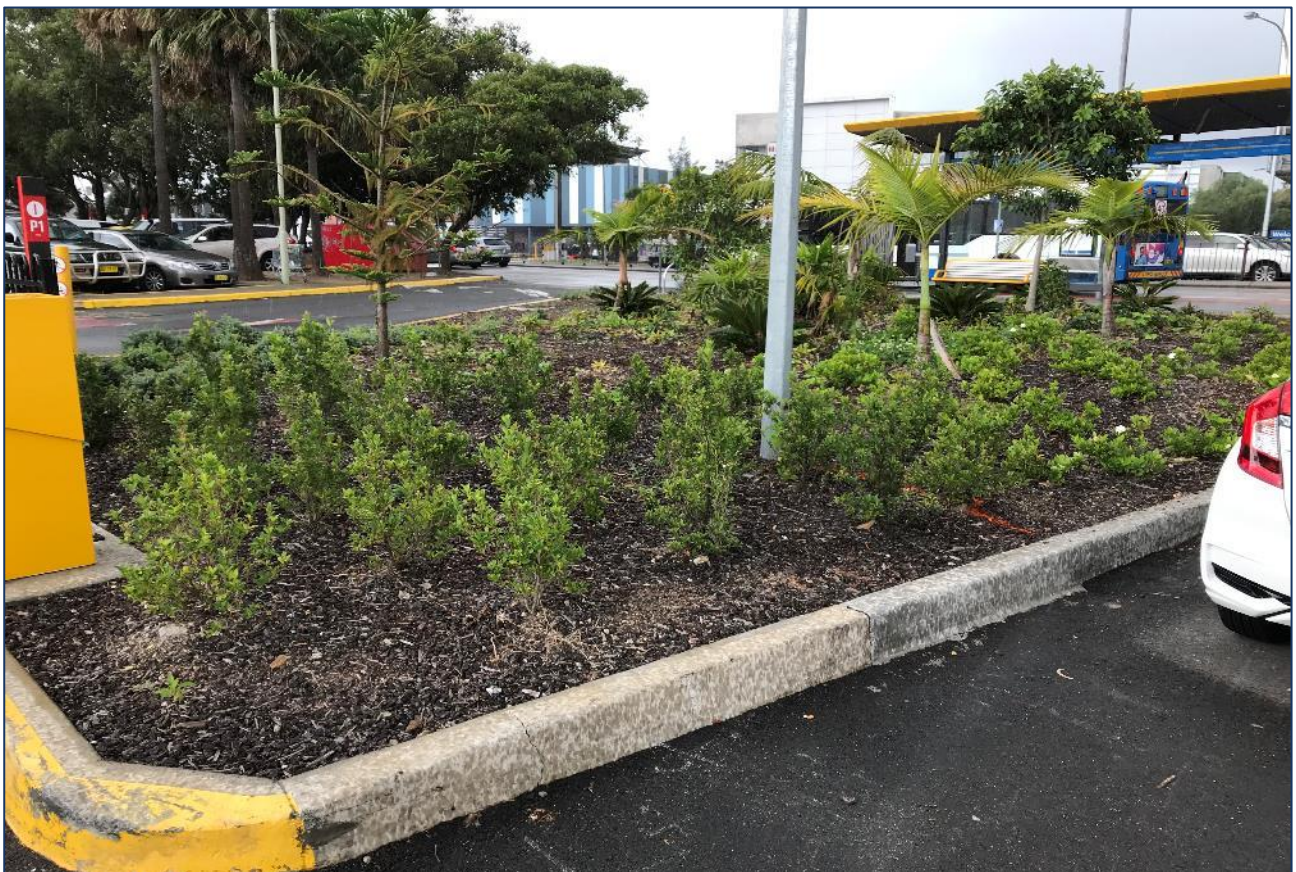
**Photograph 2:** Site layout and HA01 location, facing north east.

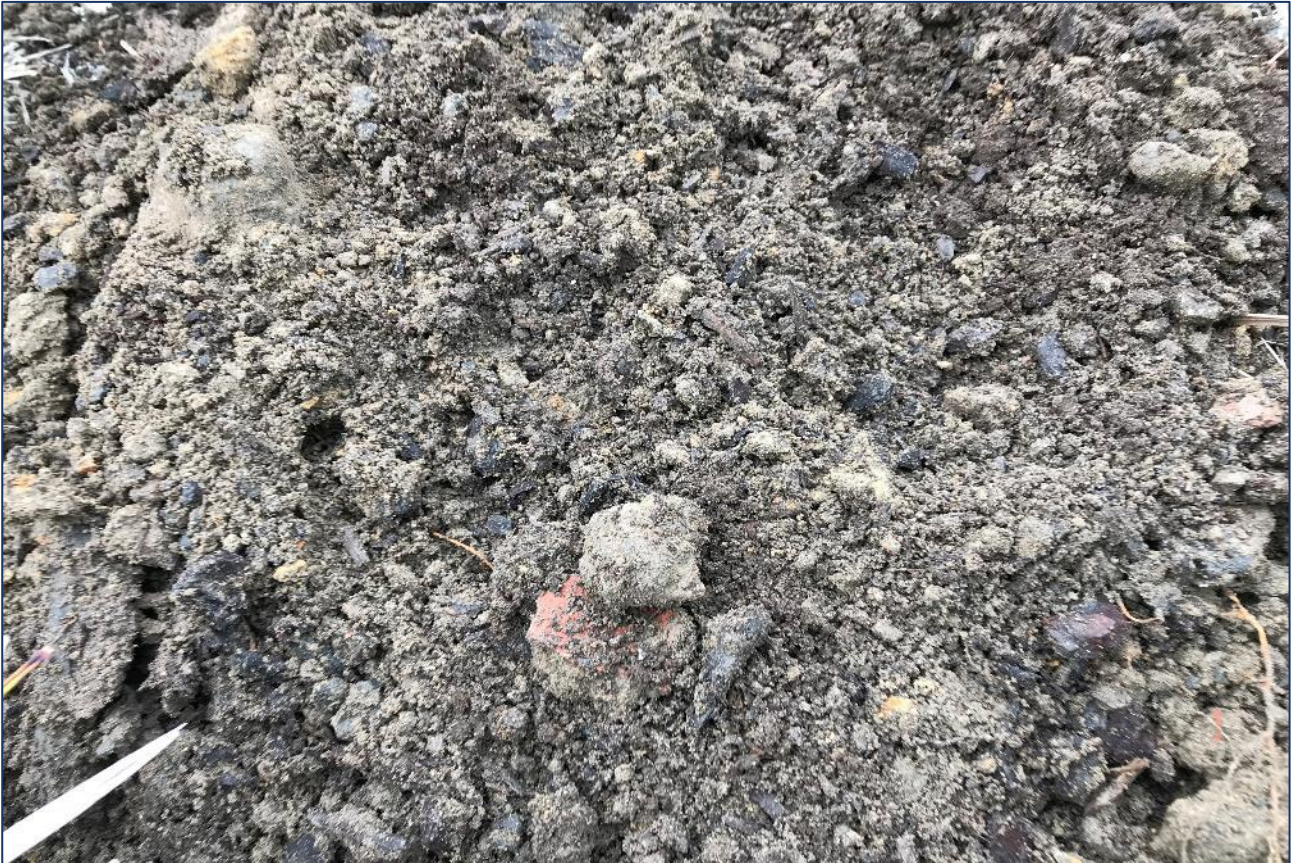
**Photograph 3:** Representative shallow clayey SAND fill material at HA03.

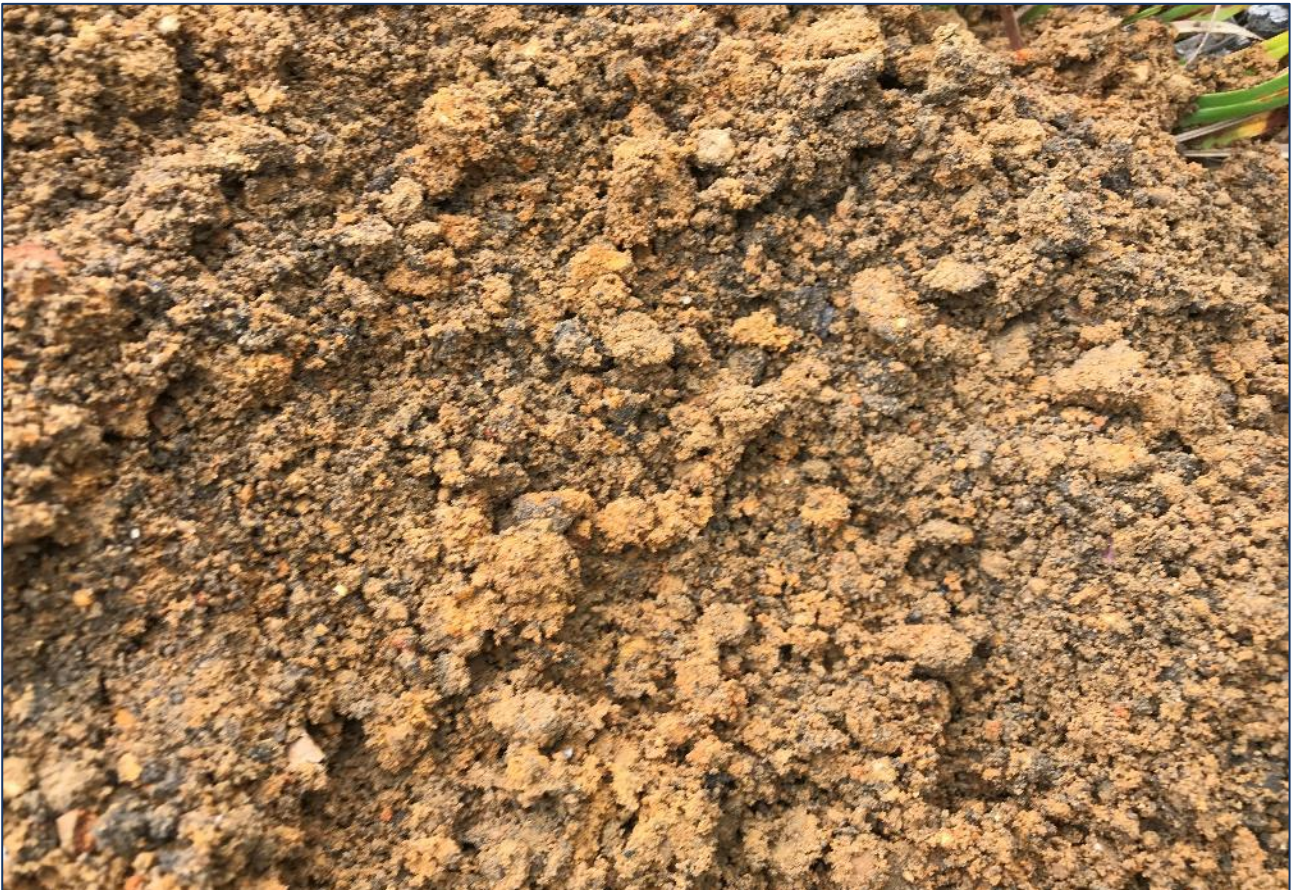
**Photograph 4** Representative sandy CLAY material at HA04.
