Mirvac Developments Pty Ltd
Phase 1 and 2 Environmental Site Assessment

SOPA Site 53
2 Figtree Drive
Sydney Olympic Park, NSW

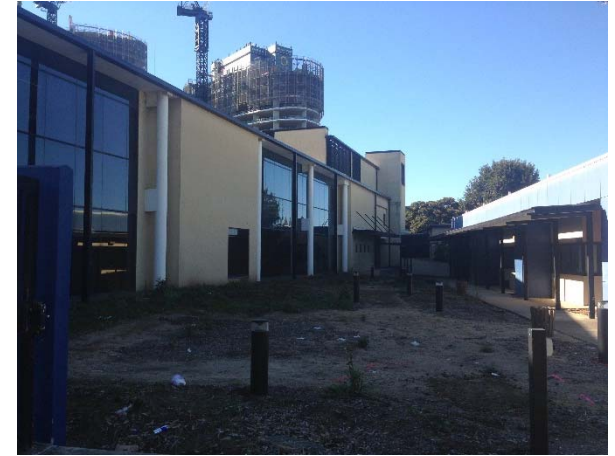
Photograph 3: Southern side of Building one with suspected asbestos eaves and third level containing the air-conditioning units.
