Conservation Management Plan

**Bakers Terrace, 66–68 & 70–72
Gloucester Street, The Rocks**

January 2016

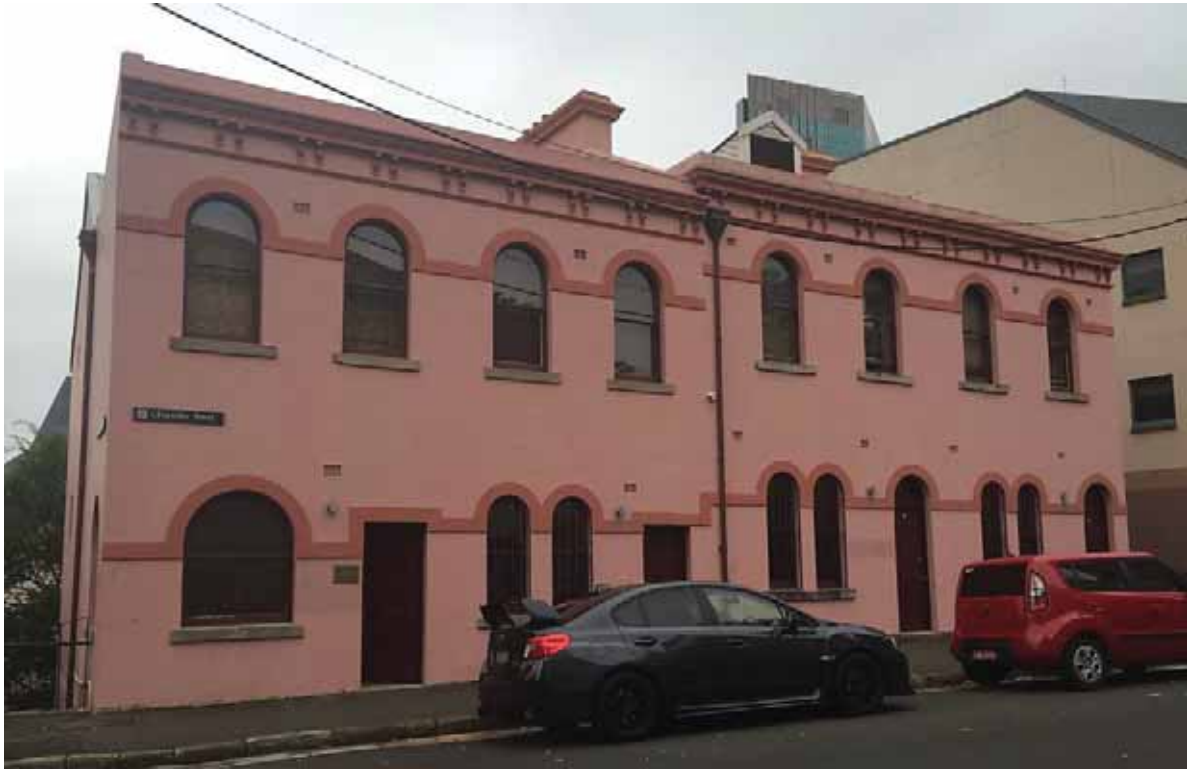
PICTURE 18 – FRONT (EAST) FAÇADE OF BAKERS TERRACE. (NOVEMBER 2015)

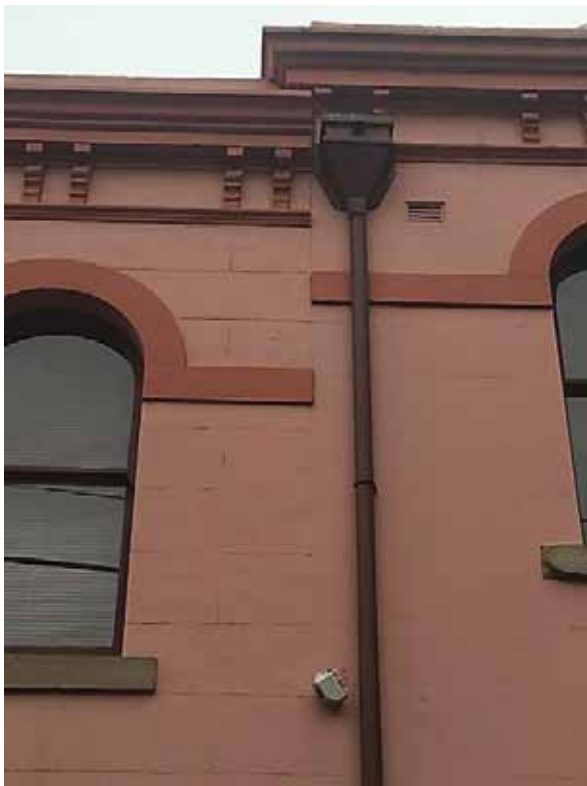
PICTURE 19 – DETAIL FRONT (EAST) FAÇADE SHOWING PAINTED RENDERED MASONRY AND CORNICE ETC. (NOVEMBER 2015)

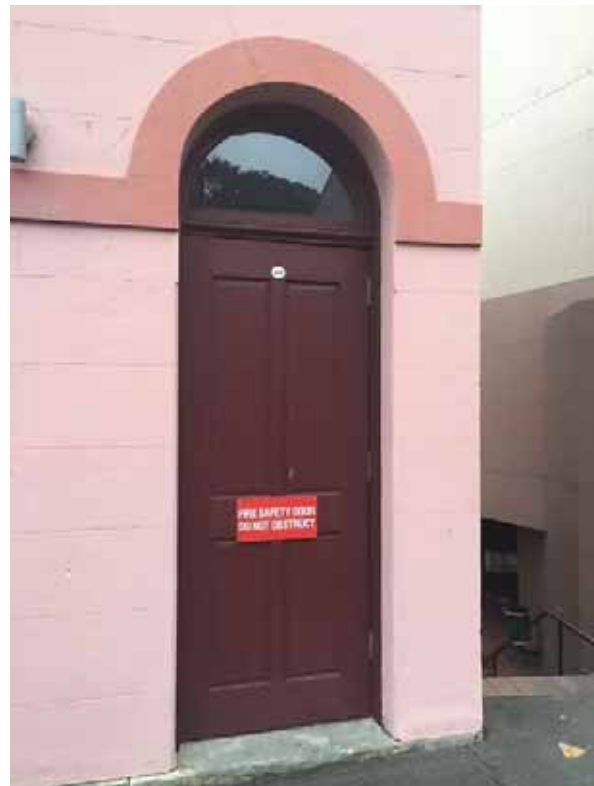
PICTURE 20 – DETAIL OF EXISTING FIRE DOOR ON SOUTHERN END OF NUMBER 72. NOTE ORIGINAL DOOR HIGHLIGHT. (NOVEMBER 2015)

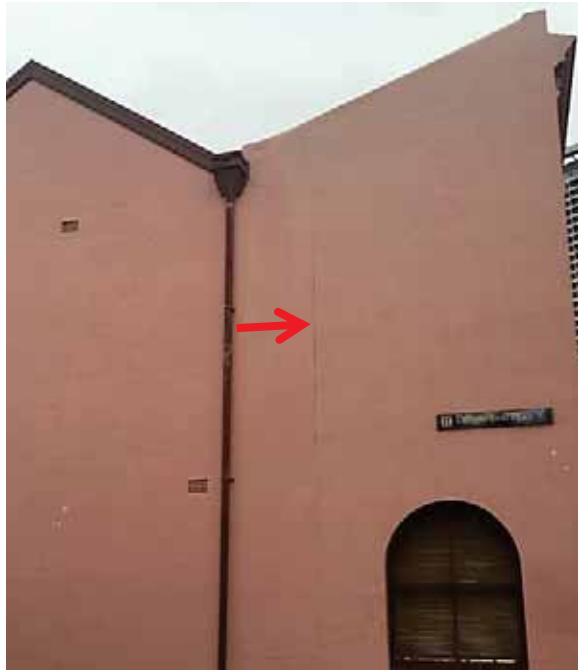
PICTURE 24 – DETAIL OF SIDE (NORTH) FAÇADE WITH RED ARROW SHOWING THE APPROX. LOCATION OF THE LATE 1880S FRONT EXTENSION TO THE NORTHERN TERRACES. (NOVEMBER 2015)

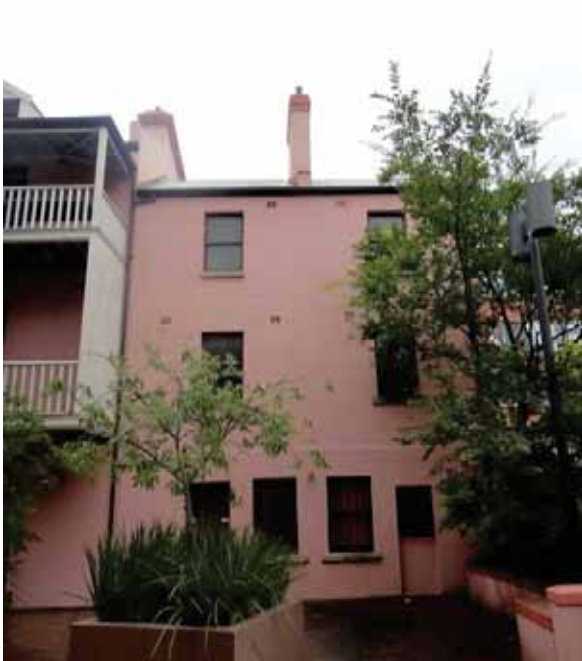
PICTURE 29 – DETAIL OF REAR OF NORTHERN TERRACES. NOTE EXISTING WINDOW ON FAR RIGHT WAS ORIGINALLY A DOOR. (NOVEMBER 2015)

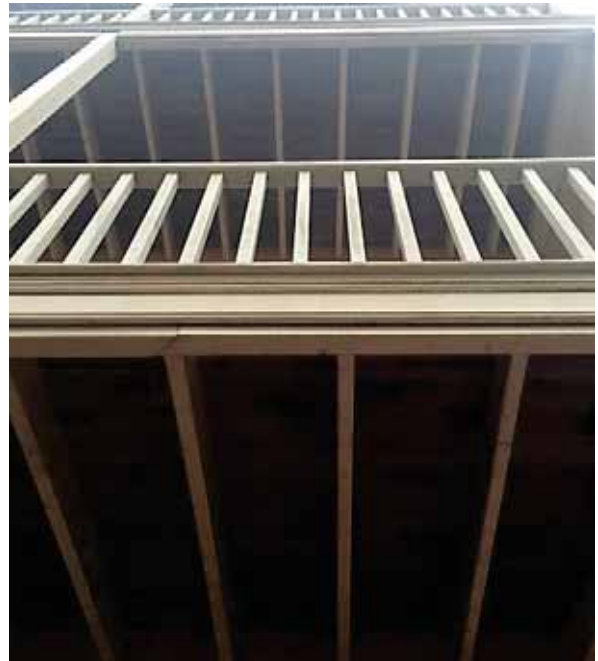
PICTURE 30 – DETAIL OF REAR TIMBER BALCONY. (NOVEMBER 2015)

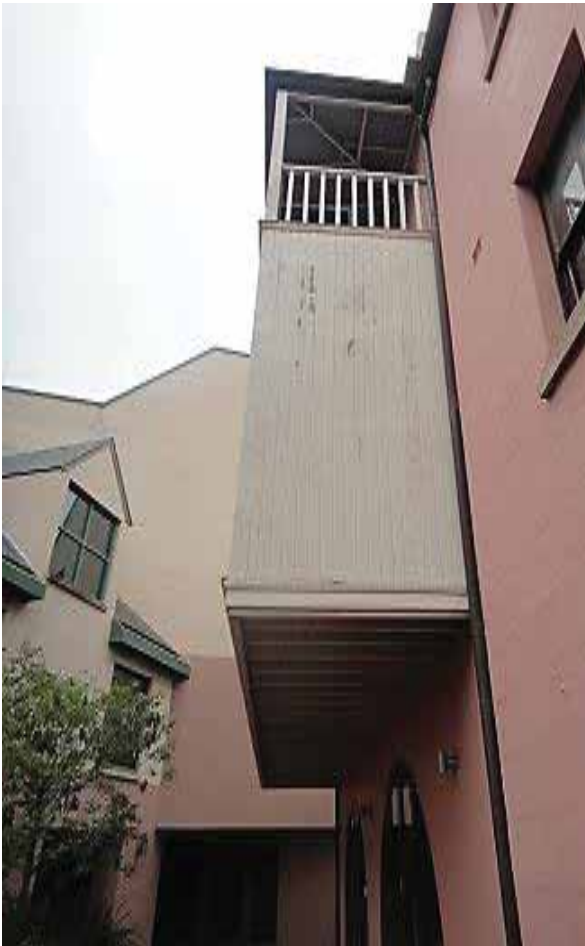
PICTURE 33 – DETAIL OF REAR BALCONY. (NOVEMBER 2015)

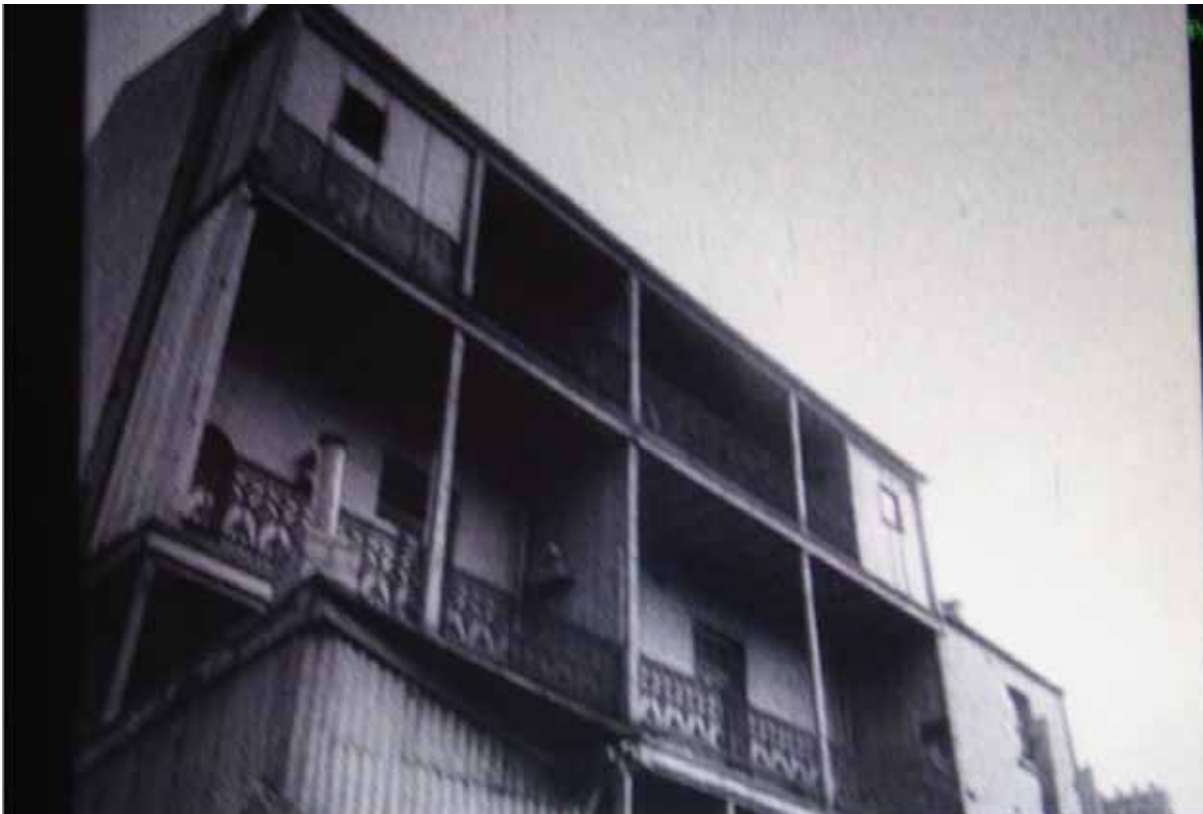
FIGURE 29 – IMAGE OF BAKERS TERRACE, 1910 REAR VIEW OF THE TERRACES TAKEN FROM A FILM OF THE AREA IN C1910, WHICH WAS MADE TO JUSTIFY THE RESUMPTION AND DEMOLITION OF THE ROCKS. NOTE BALCONIES ARE IRON

The first photograph of the terraces dates from 1901 (Figure 26), but only the rear of the terraces is visible. Following this, the next available images date from c1910 (Figure 27) and Figure 28). The 1910 images of Bakers Terrace show that they are in a dilapidated condition at this time. The front façade features wooden shutters to the lower level of the southern terraces. The rear features small skillion structures in the rear yard of the southern terraces, which may have been the kitchens and a small brick structure in the rear yard of the northern terraces. An additional image from 1910 (Figure 29) shows the rear balconies were originally iron.

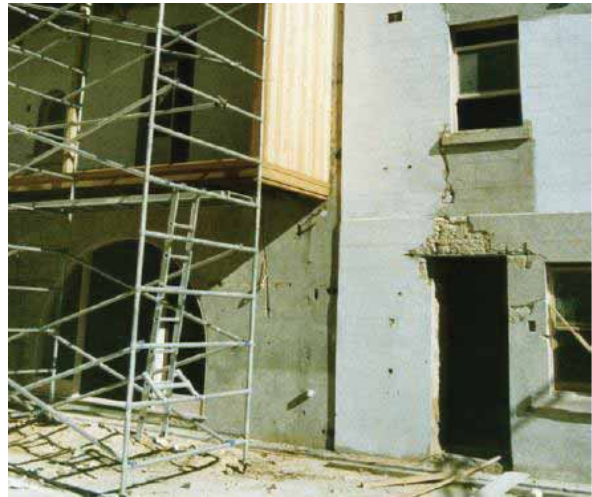
PICTURE 81 – REAR FAÇADE IMMEDIATELY SHOWING RESTORATION, 1991. NOTE MUCH OF THE EXTERNAL RENDER APPEARS TO HAVE BEEN REPLACED (SOURCE: BAKERS TERRACE CMP, 2007)

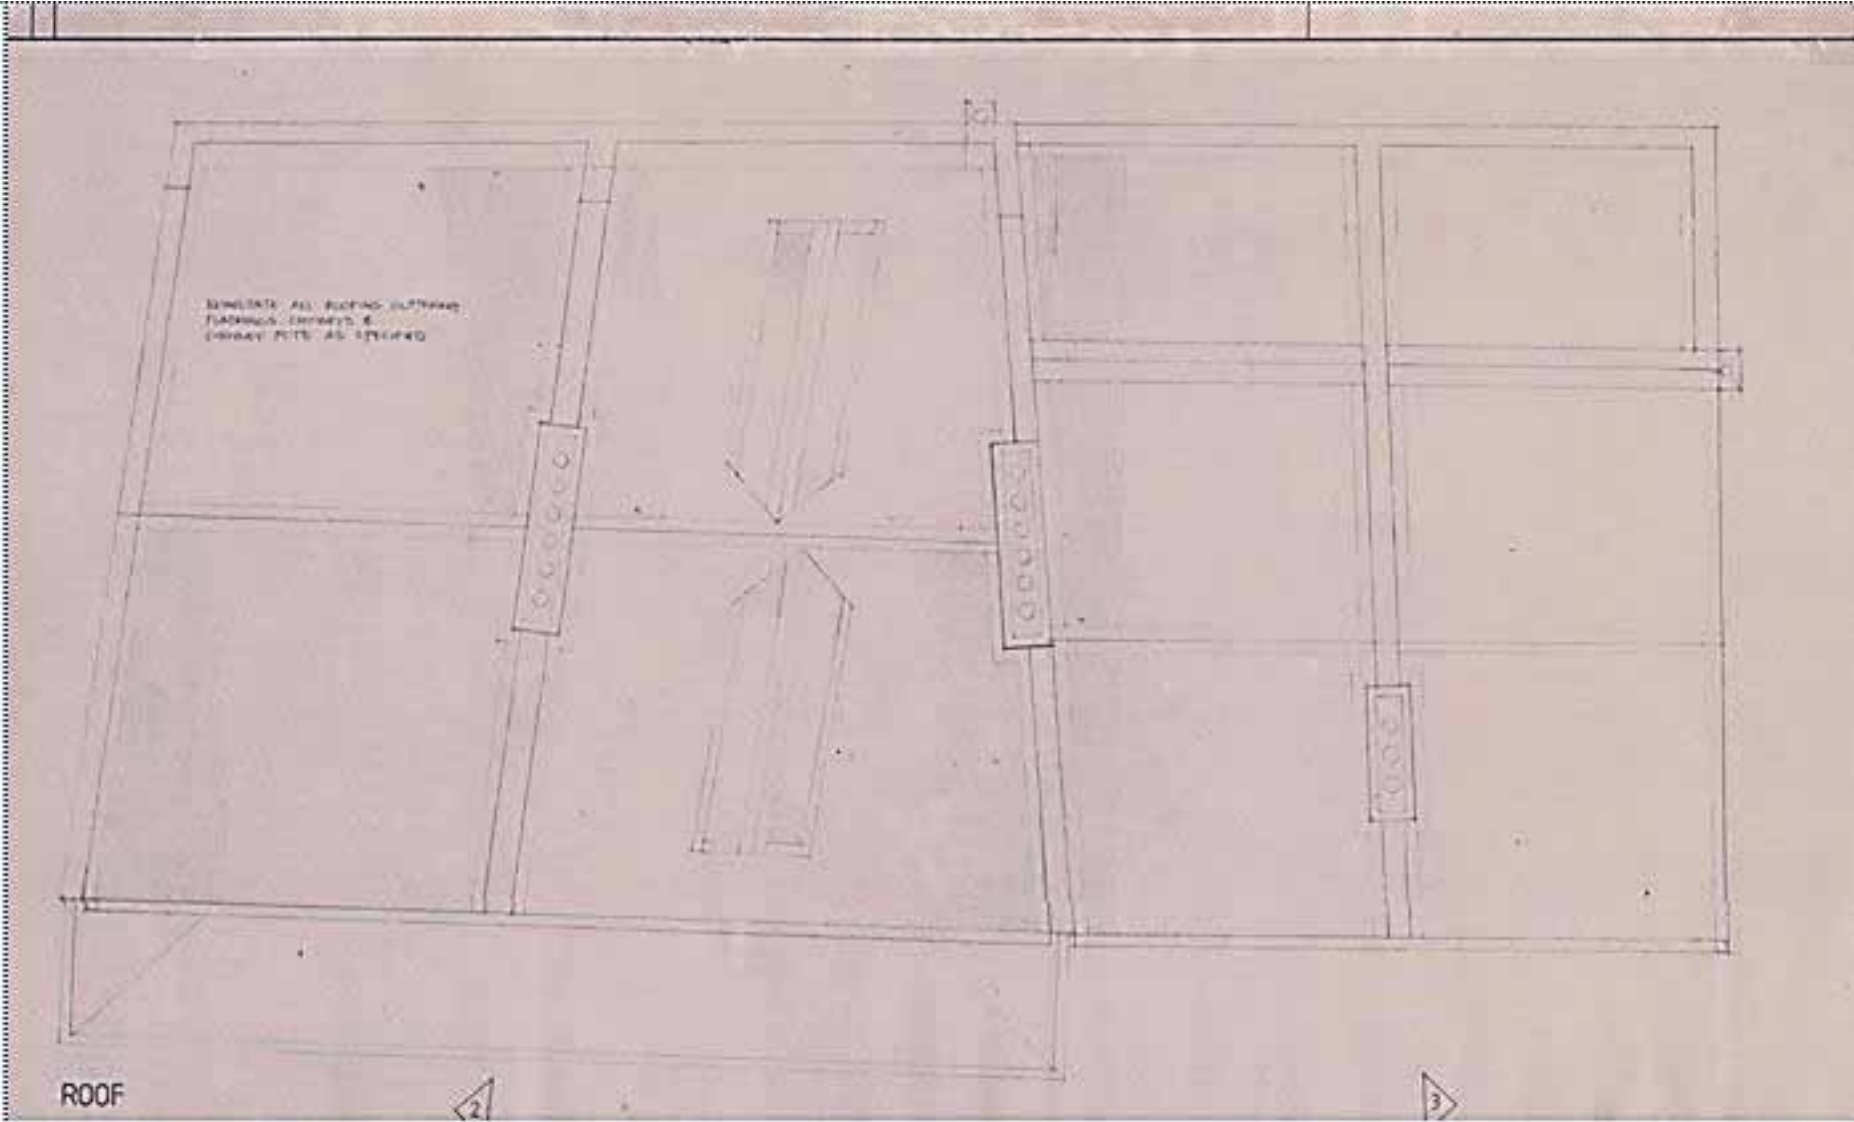
FIGURE 36 – 1988-90 PLANS FOR BAKERS TERRACE (ROOF LEVEL) SHOWING NEW WORK
