# Archaeological Assessment

## **85 Harrington Street, The Rocks**

January 2016

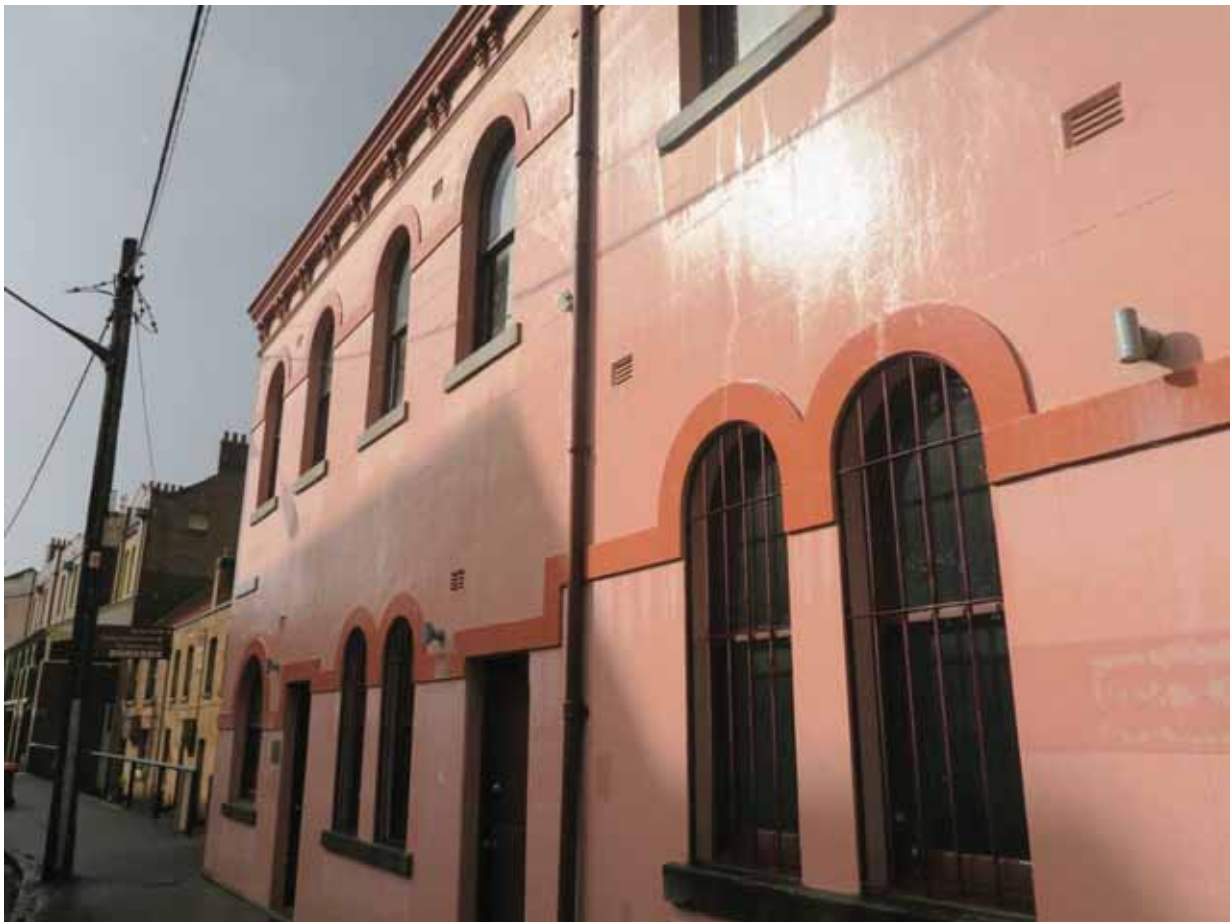
FIGURE 2 – GLOUCESTER STREET FRONTAGE OF BAKER'S TERRACE

The two pairs of terraces read as similar buildings to the street, however have different forms and features behind the façade and to the rear and 70-72 Gloucester Street is wider and taller than its neighbour. The buildings were originally constructed as typical Victorian terraces, consisting of two rooms up and two rooms down, however the buildings were extensively renovated in the 1980s which included reconfiguration of internal spaces, removal of the majority of the original internal fabric and changes to the levels at the rear of the building. The buildings now function as office space.

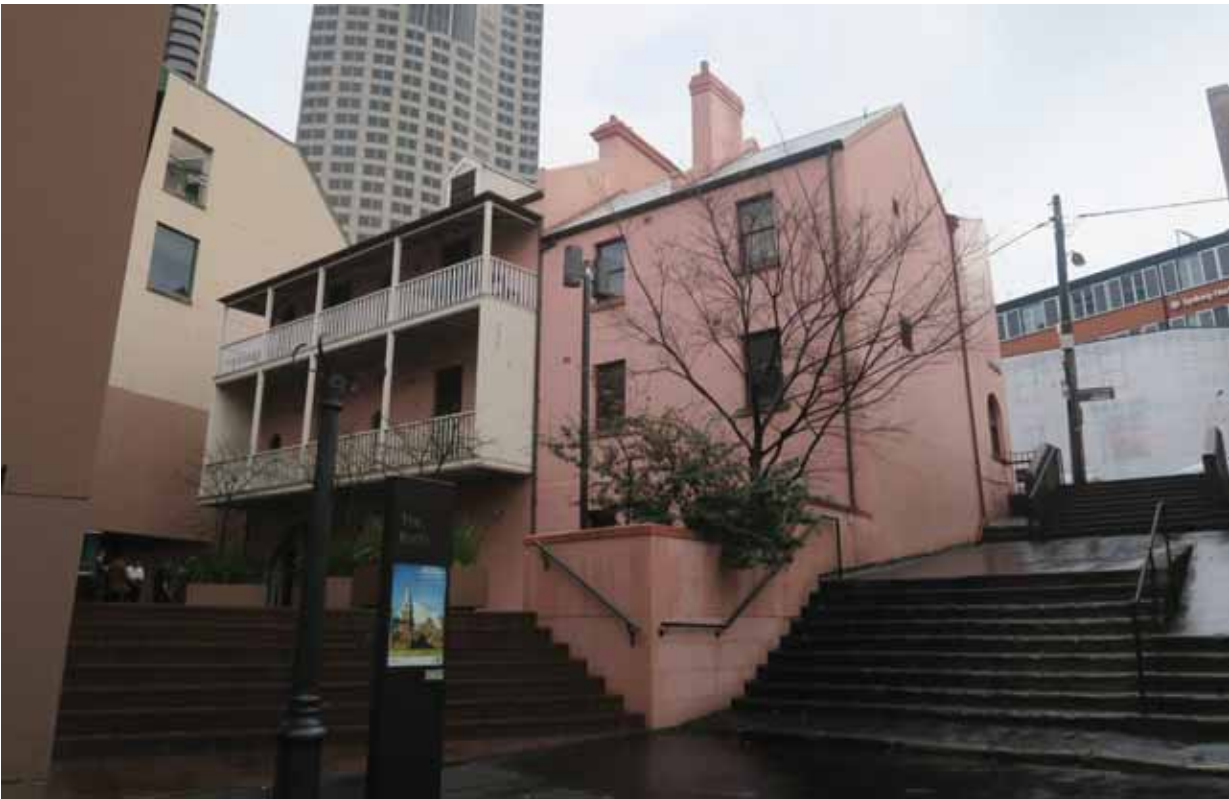
Cambridge Street formerly joined Harrington Street to the south of the study area. The construction of Harrington Court truncated Cambridge Street, incorporating it into the new building and forming a courtyard. Harrington Court has an entrance from Harrington Street and is constructed stepping up the slope between Harrington Street and Gloucester Street. The complex has basement parking accessed from Harrington Street.

FIGURE 3 – REAR OF BAKER'S TERRACE AND STAIRS LEADING TO CAMBRIDGE STREET ON THE LEFT AND TO CUMBERLAND PLACE ON THE RIGHT.

The stairs adjacent to the rear of Bakers Terraces were also constructed between 1880 and 1887 which would have required the erection of the retaining wall between the rear yard of the terraces and the new stairs. It appears that the rear yard of Bakers Terraces was excavated into the original slope and that there were several steps leading from the rear basement door to the back yard.

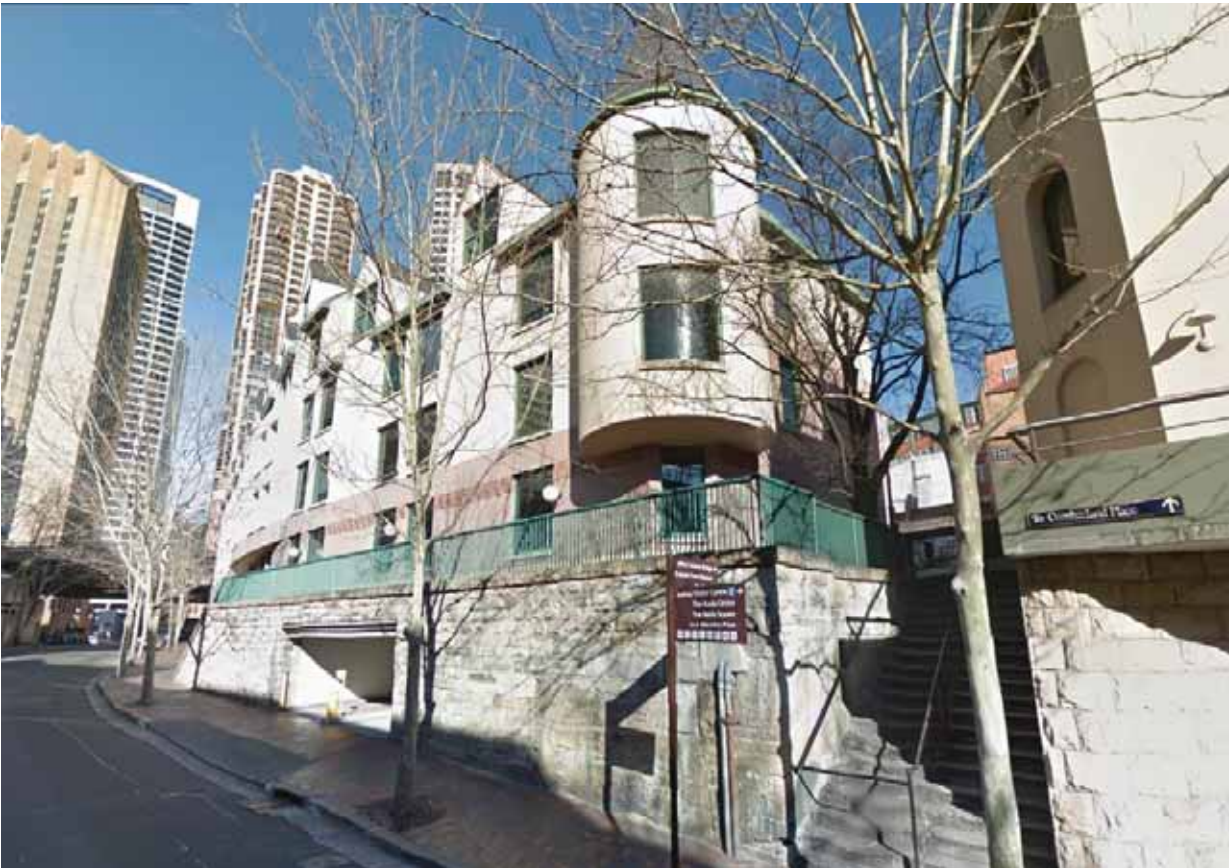
FIGURE 4 – HARRINGTON COURT AND HARRINGTON STREET ENTRANCE TO THE CAR PARK, WITH THE CUMBERLAND PLACE STAIRS ON THE RIGHT. SOURCE: GOOGLE MAPS

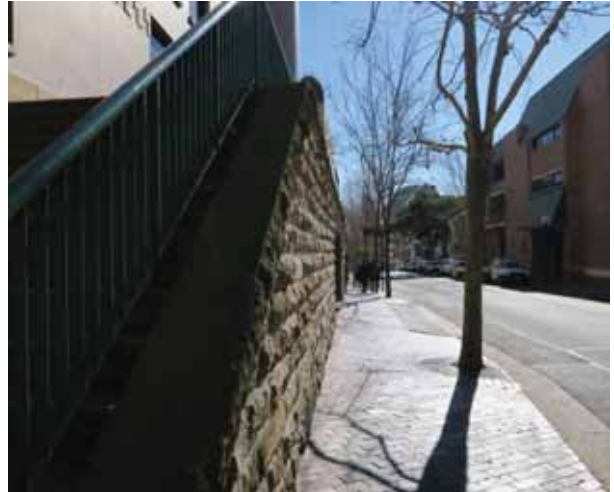
PICTURE 1 – BEDROCK AND RETAINING WALL ON HARRINGTON STREET

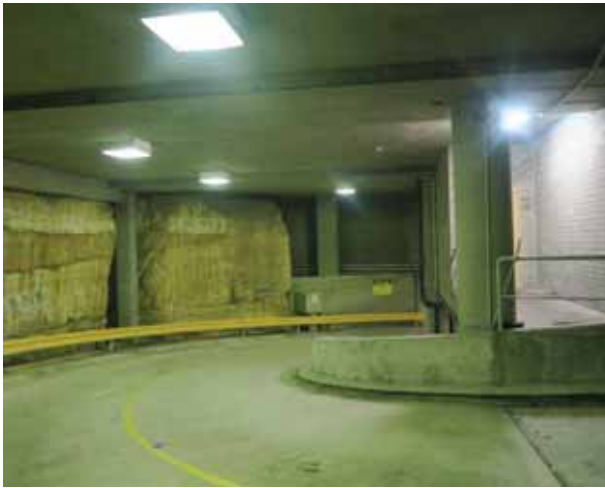
PICTURE 3 – BASEMENT PARKING CUTTING INTO THE BEDROCK

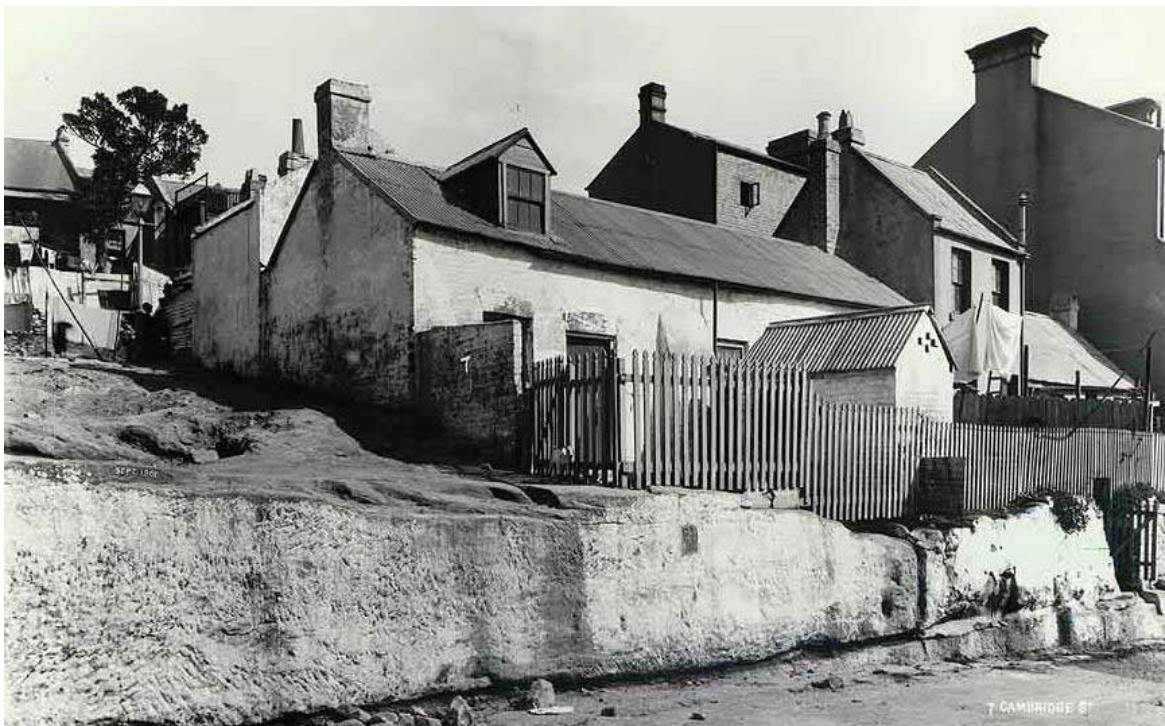
FIGURE 6 – HOUSES ON CAMBRIDGE STREET STEPPING UP THE ROCKY TERRAIN, C1900

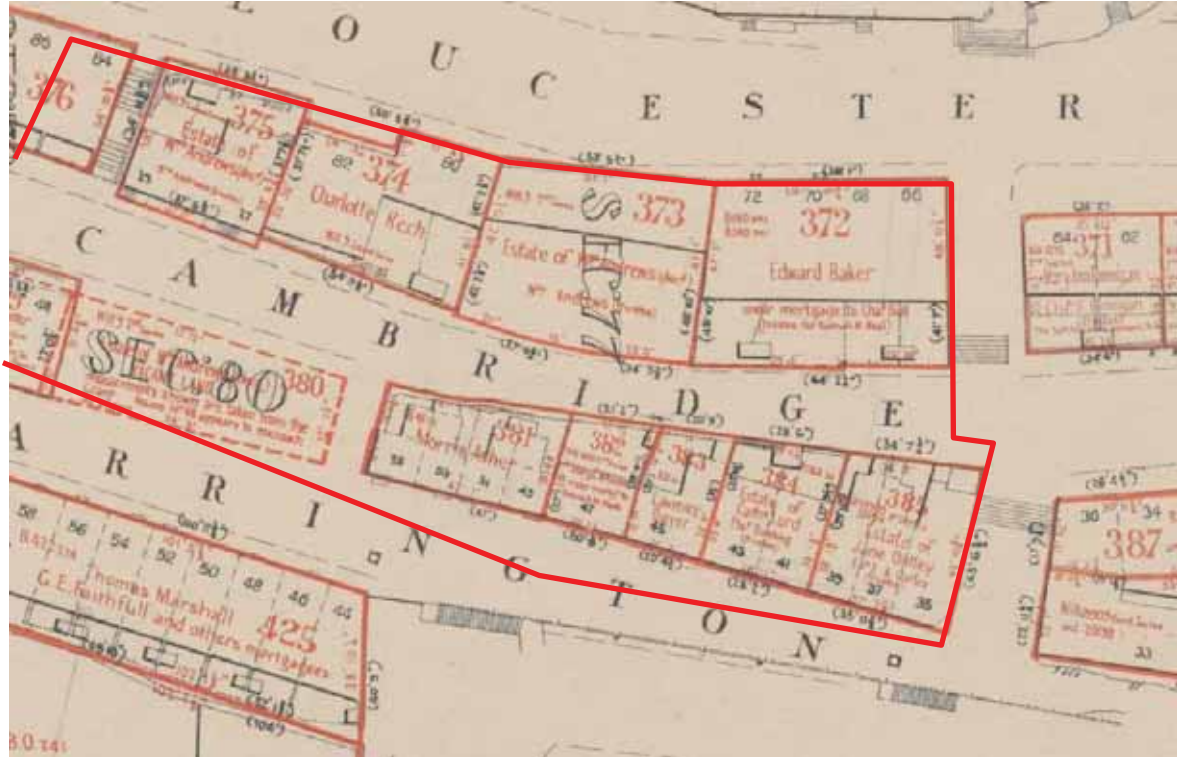
FIGURE 10 – BUILDINGS IN THE STUDY AREA IN 1900, BETWEEN GLOUCESTER STREET AND HARRINGTON STREET WITH SITE OVERLAY

In 1900 the study area consisted of around 30 buildings which included single and double storey houses, stables, the four storey 'Ship and Mermaid Hotel' (Figure 12) that was operating as a boarding house, shops and additional sheds and outbuildings. The topography in Harrington Street was so steep that the road was divided into an upper and lower level in front of the study area. Cambridge Street was more like a lane than a street and joined the upper level of Harrington Street at its southern end. The lower level of Harrington Street is the road we know now, while the upper level now has the Harrington Court Building constructed on it.

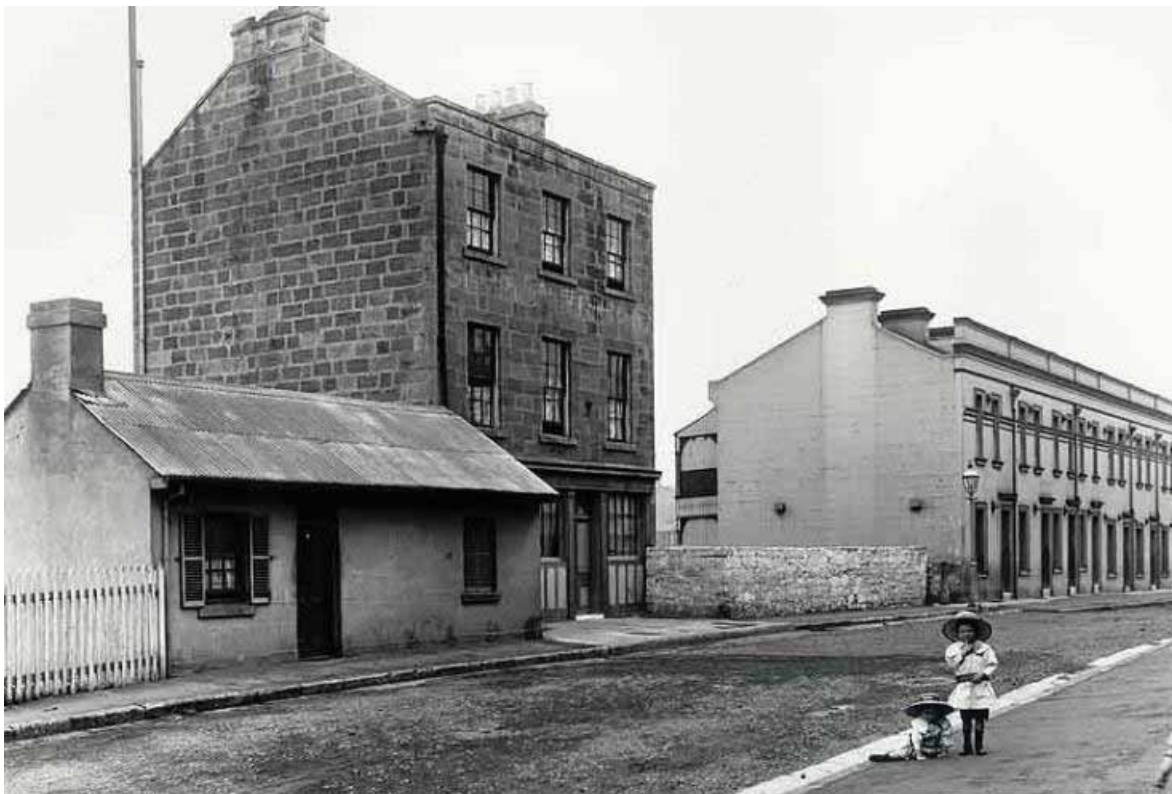
FIGURE 11 – GLOUCESTER STREET 1901, PART OF THE STUDY AREA INCLUDING THE STONE SHIP AND MERMAID HOTEL, COTTAGE AND TERRACES. ALL OF THESE BUILDINGS WERE DEMOLISHED BY 1949.

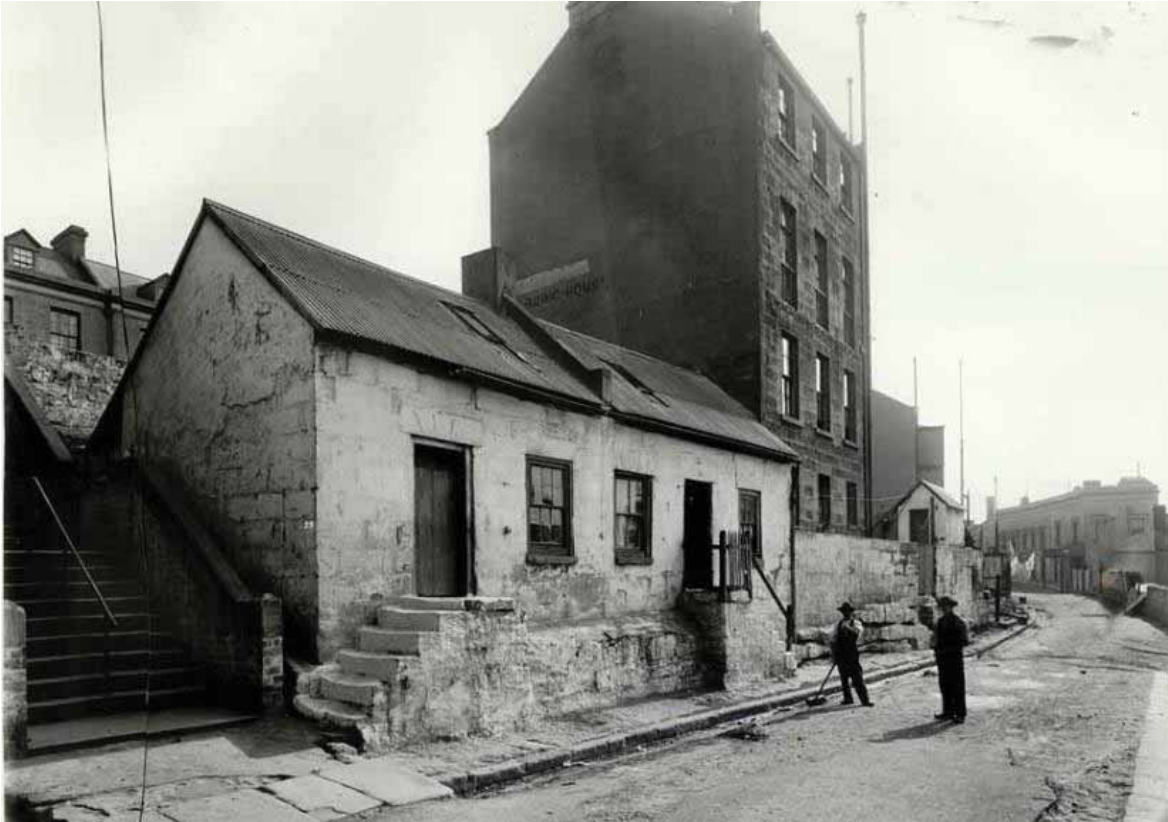
FIGURE 12 – CAMBRIDGE STREET (UPPER LEVEL HARRINGTON STREET) 1901 - PART OF THE STUDY AREA INCLUDING SMALL COTTAGES, THE SHIP AND MERMAID HOTEL AND BAKERS TERRACES IN THE BACKGROUND

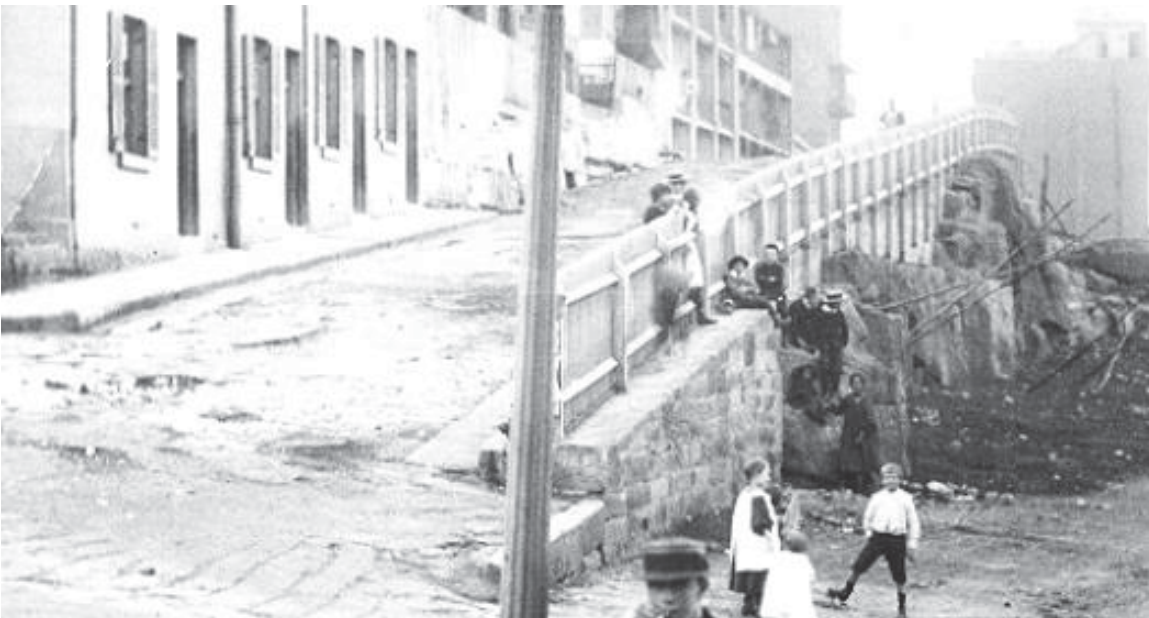
FIGURE 13 – C1901 SHOWING THE CUTTING BACK OF THE ROCK FACE ON HARRINGTON STREET AND PARTIAL CONSTRUCTION OF THE STONE FACING OF THE WALL.

In 1900 Harrington Street had a raised cut rock face and timber picket fence presenting to the street. A set of timber stairs attached to the rock face provided access to the upper level of Harrington Street. Harrington Street underwent some realignment and levelling around 1905 and the timber stairs may have been removed and the stairs leading to Cumberland Place may have been constructed at the same time. The Cumberland Place stairs were certainly in place by 1912 according to pictorial images.<sup>11</sup> The original stairs were much narrower than those that exist today. They were widened to twice their original width during the 1970s. Due to wear, the older side of Harrington Street Steps were fenced off and the other side capped with concrete in the 1990s.<sup>12</sup>

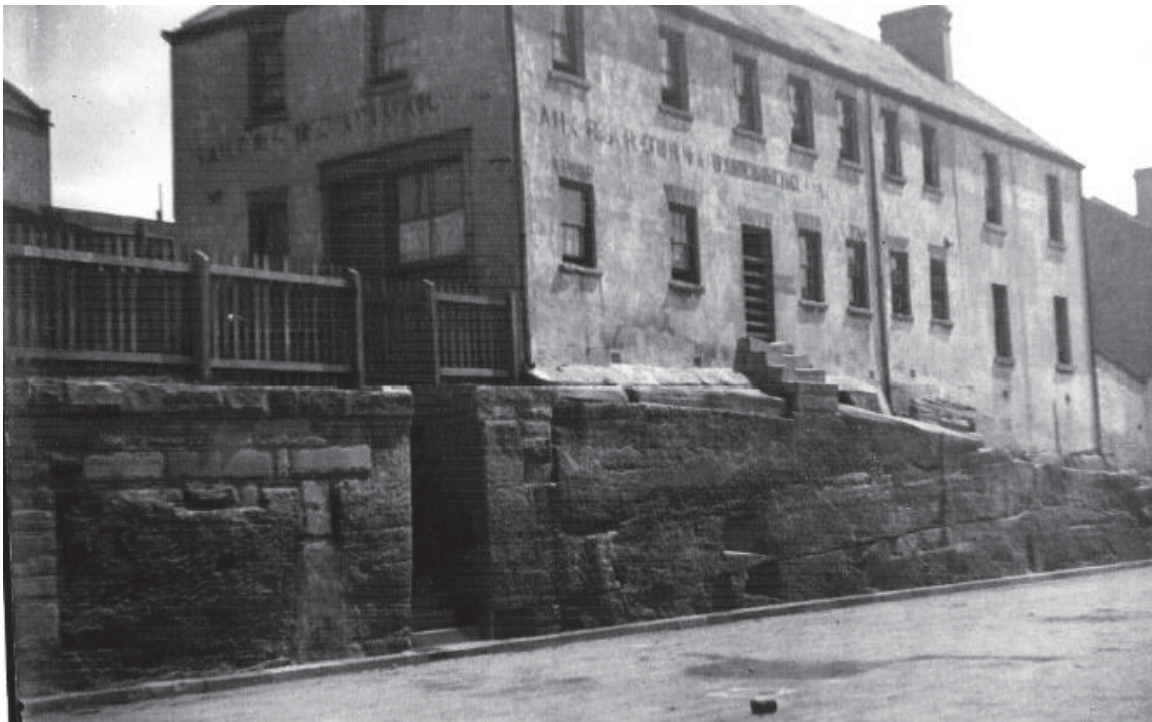
FIGURE 14 – THE SAILORS RETURN TO THE NORTH OF STUDY AREA ON HARRINGTON STREET AROUND 1915. THE STAIRS TO CUMBERLAND PLACE CAN BE SEEN CUT INTO THE BEDROCK AND THE SANDSTONE WALL ON THE LEFT REMAINS IN THE STREET TODAY.

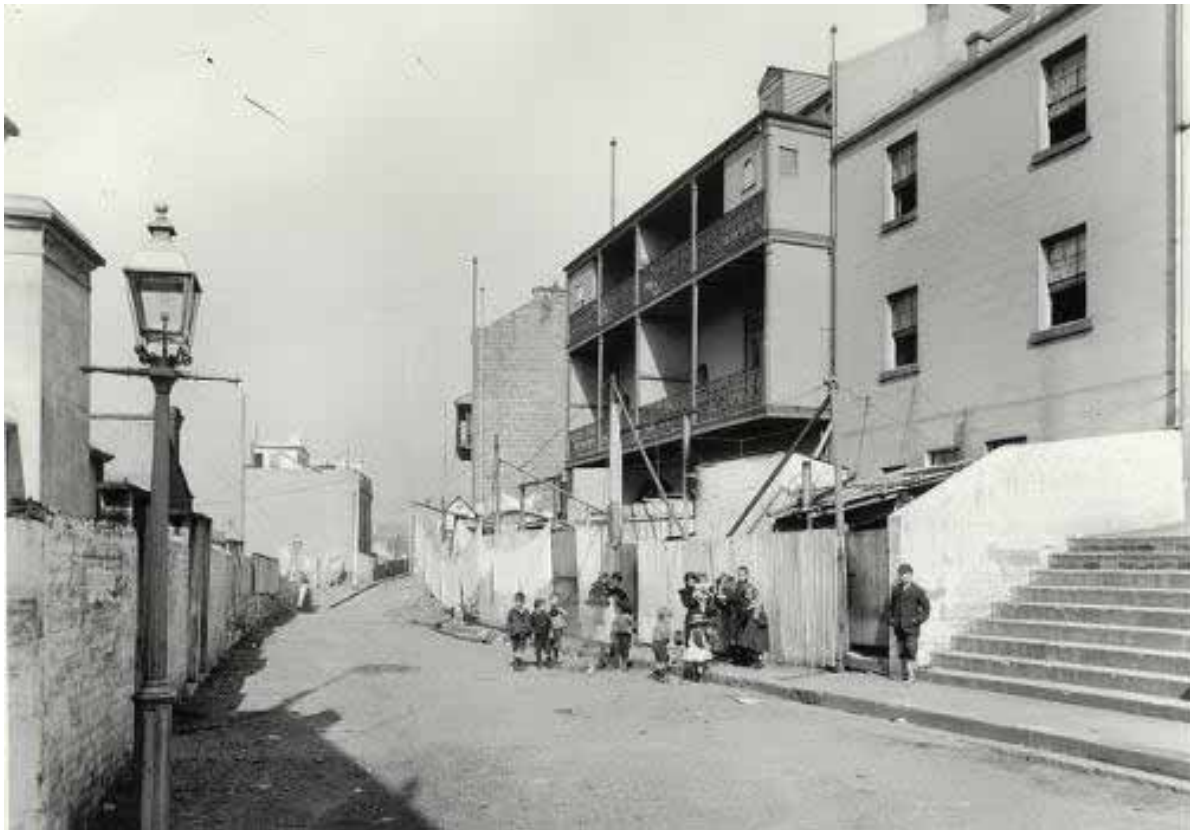
FIGURE 15 – C1900 - CAMBRIDGE STREET-PART OF THE STUDY AREA INCLUDING CUMBERLAND PLACE IN THE FOREGROUND AND REAR OF BAKERS TERRACES.

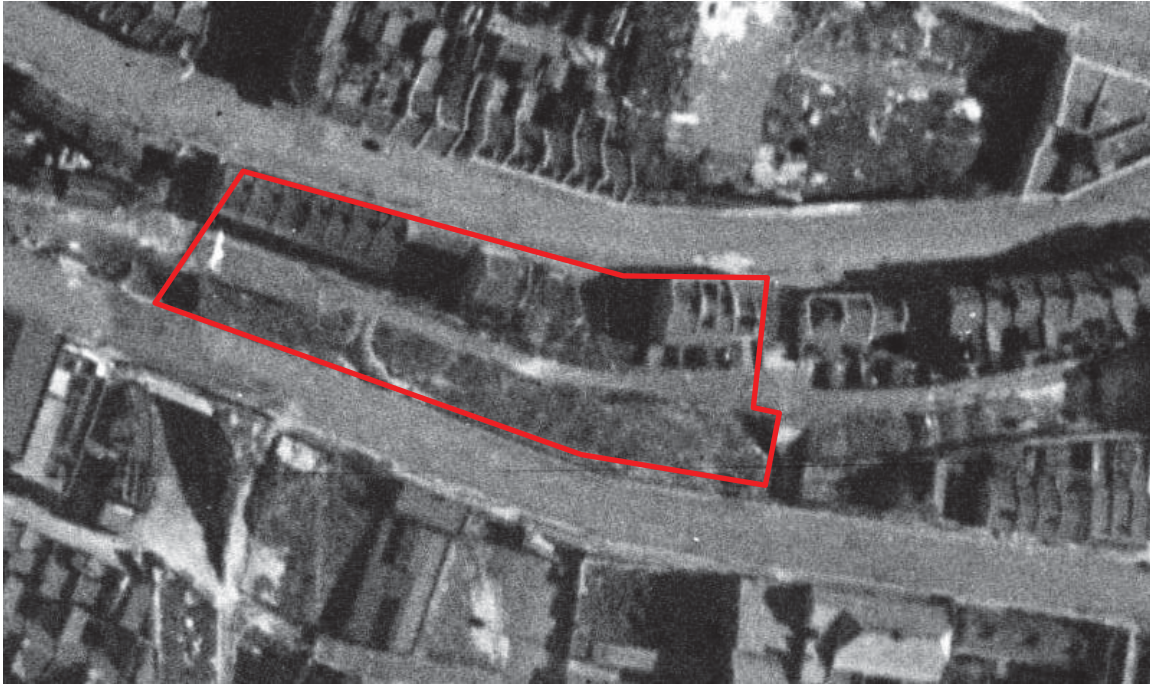
FIGURE 16 – BUILDINGS IN THE STUDY AREA IN 1943, BETWEEN GLOUCESTER STREET AND HARRINGTON STREET WITH APPROXIMATE SITE OVERLAY, MUCH OF THE STUDY AREA IS VACANT AT THIS TIME.

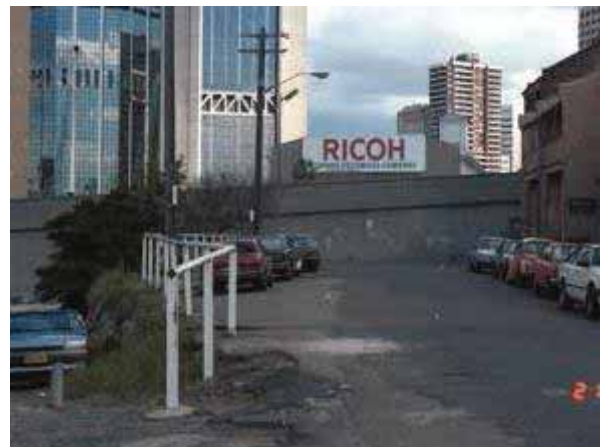
PICTURE 12 – VACANT LOTS IN THE LOCATION OF HARRINGTON COURT. NOTE THE TERRACING OF THE SITE.

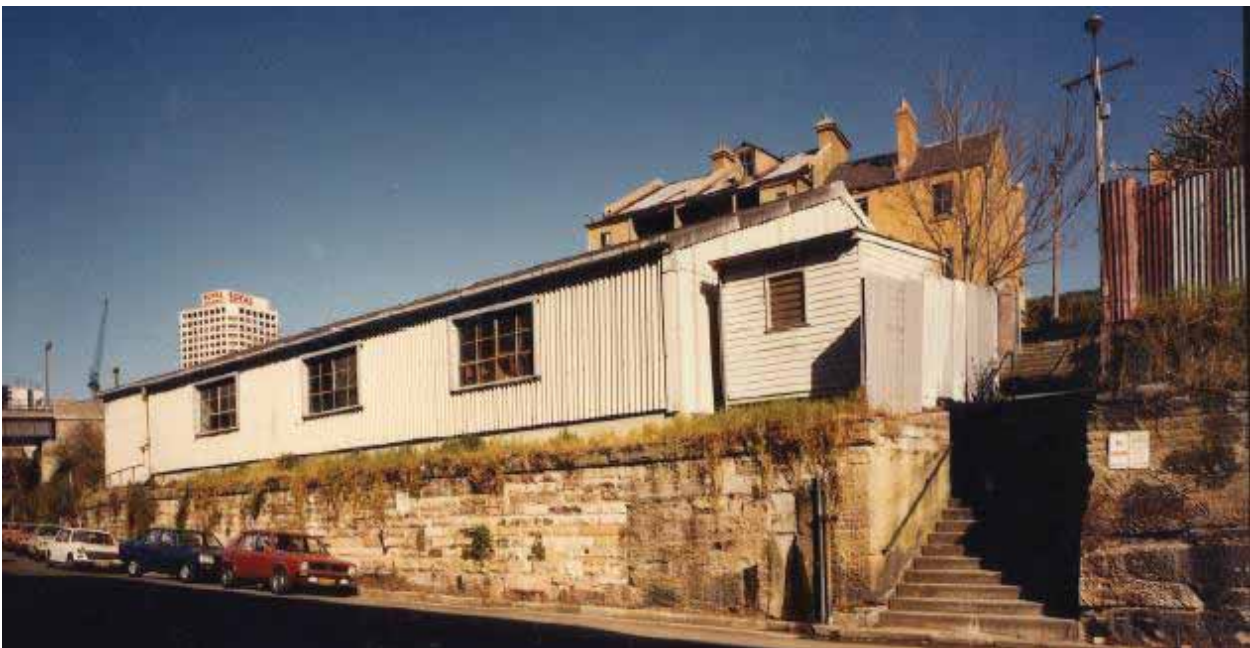
FIGURE 18 – THE STUDY AREA IN 1980 INCLUDING THE STAIRS OF CUMBERLAND PLACE, THE STONE RETAINING WALL AND BAKERS TERRACES IN THE REAR.

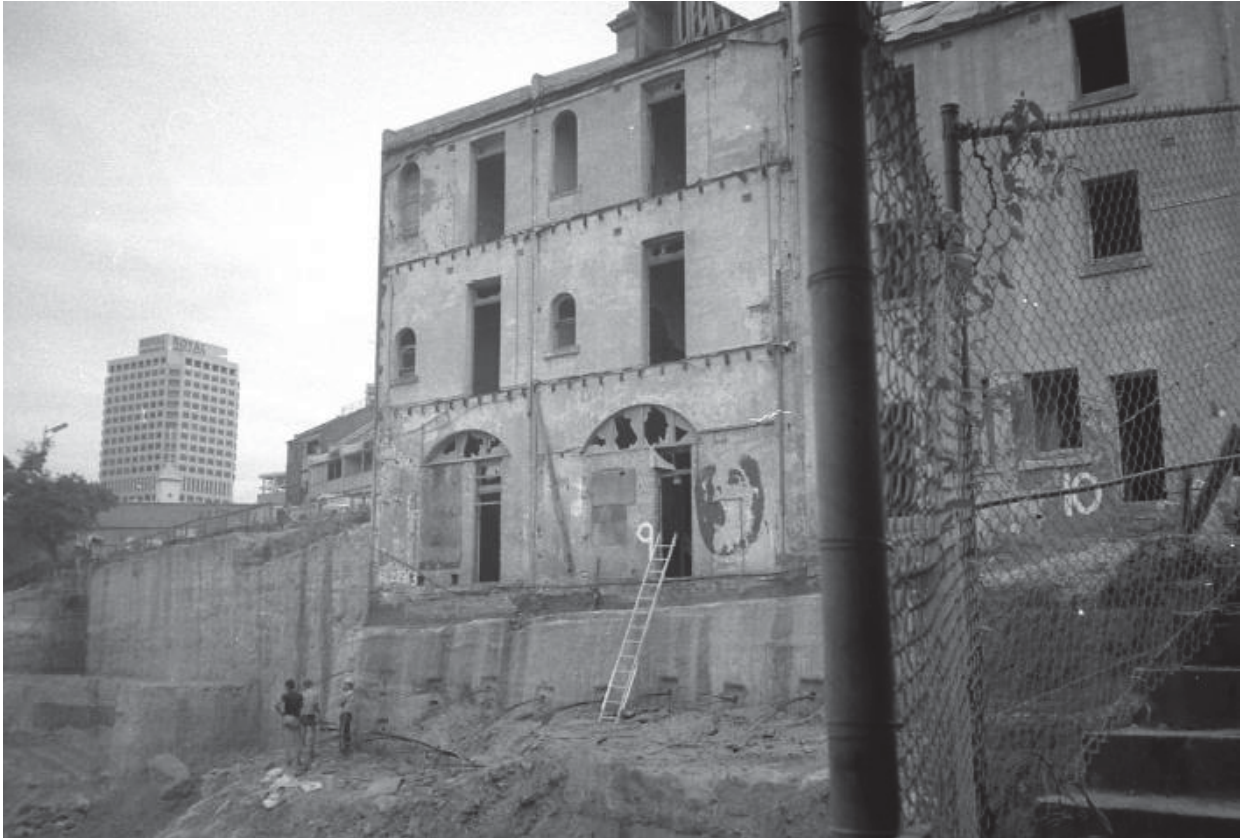
FIGURE 19 – EXCAVATION OF CAMBRIDGE STREET FOR THE CONSTRUCTION OF HARRINGTON COURT, 1980S

In 1988 major excavation of Cambridge Street was undertaken for the construction of the new Harrington Court complex (Figure 19). Cambridge Street was then reconstructed at a higher level (approximately 1.0m) as is clearly seen in the stairs leading from the original street level in Cumberland Place. This work will have removed all archaeological potential from those areas. The interiors of the buildings have also

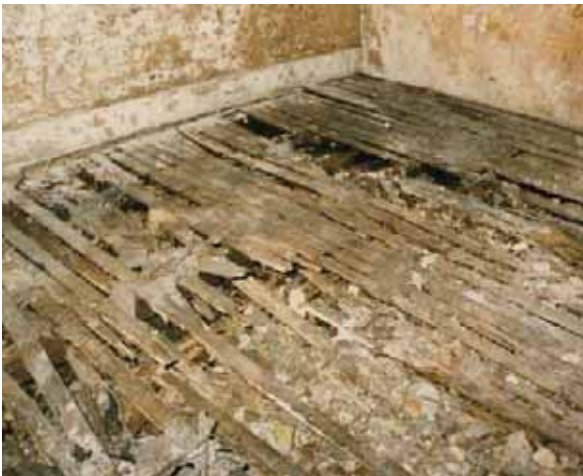
FIGURE 20 – ARCHAEOLOGICAL EVIDENCE 1988 – CONDITION OF THE BUILDING PRIOR TO CONSERVATION.

PICTURE 13 – BASEMENT OF NO.72 SOURCE: FUTUREPAST CMP 2006

been completely reconstructed, and levels in the basements have been altered. Concrete slabs have replaced all original floors and all underfloor deposits are likely to have been cleared during the 1988/89 conservation works. The brief for the development of the site held instructions to prevent any removal or destruction of artefacts, or the return to the Authority of any which had to be removed.<sup>31</sup> Pictorial evidence of the development process suggests this was not the case. Any archaeological deposits remaining will be limited to the vicinity of Bakers Terraces and will be disturbed due to extensive modification of the exterior and interior of the building and the loss of their rear yards in the development process.

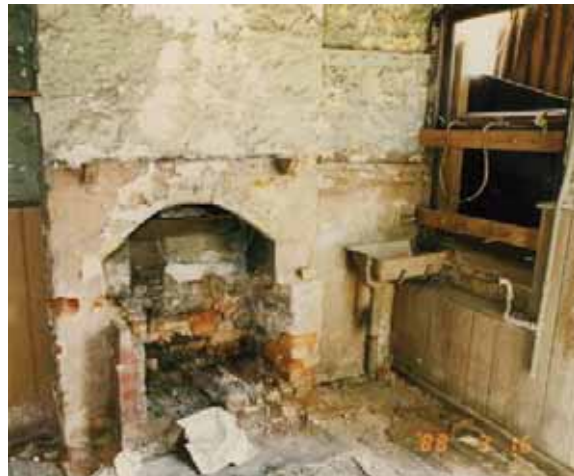
PICTURE 14 – BASEMENT OF NO. 68 SOURCE: FUTUREPAST CMP 2006

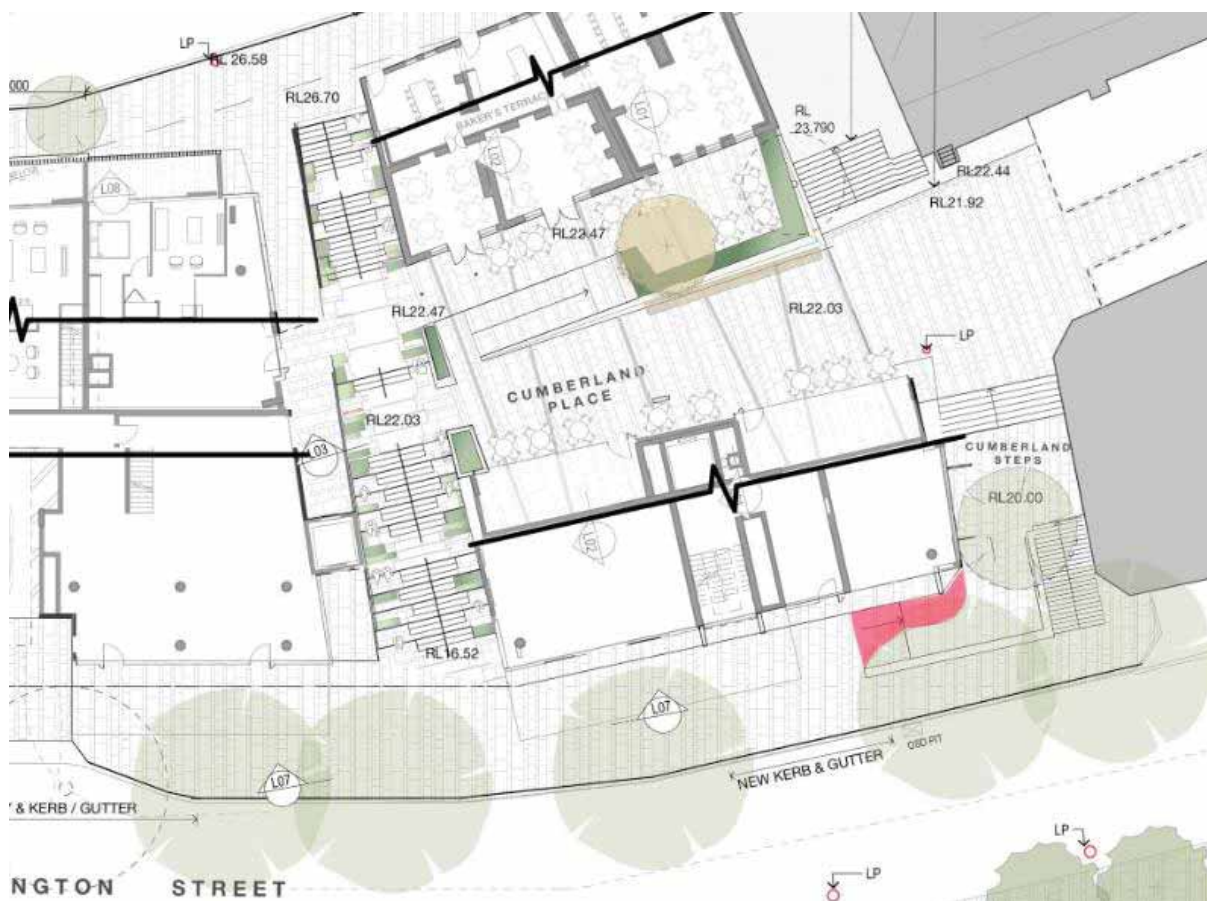
FIGURE 21 – PROPOSED DEVELOPMENT OF THE SITE SHOWING AREA TO BE EXCAVATED AT THE NORTH EASTERN CORNER OF THE SITE (PINK).

Excavation of fill and bedrock behind the stone retaining wall to the north of the existing car park entrance will have no archaeological impact. The original bedrock can be seen in the face of the wall. Several courses of stone were added to it in the early decades of the 20<sup>th</sup> Century and it has gained three additional courses of stone after the development of the Harrington Court. The top of the bedrock is likely to have been levelled in the early 20<sup>th</sup> century and backfilled in the 1980s. Excavation of this area for the foundation of the existing building has already occurred behind the retaining wall and most of the wall adjacent to the existing car park entrance had been reconstructed.
