Project 84897.05
29 April 2016
84897.05.R.001.Rev0
DW:jlb

Regarding SEPP55 (Contamination)
Proposed F23 Administrative Building
Eastern Avenue, The University of Sydney

Report on
Geotechnical Investigation

Project 84897.02
July 2015

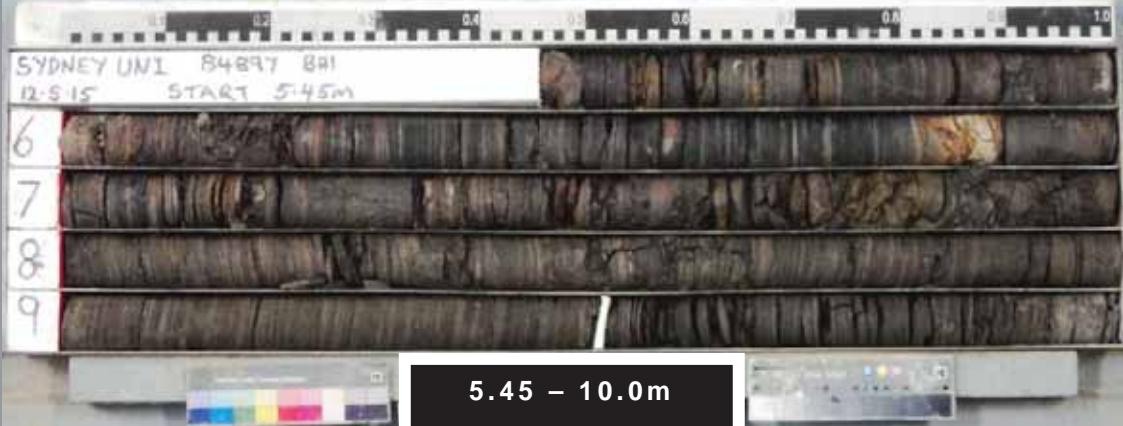
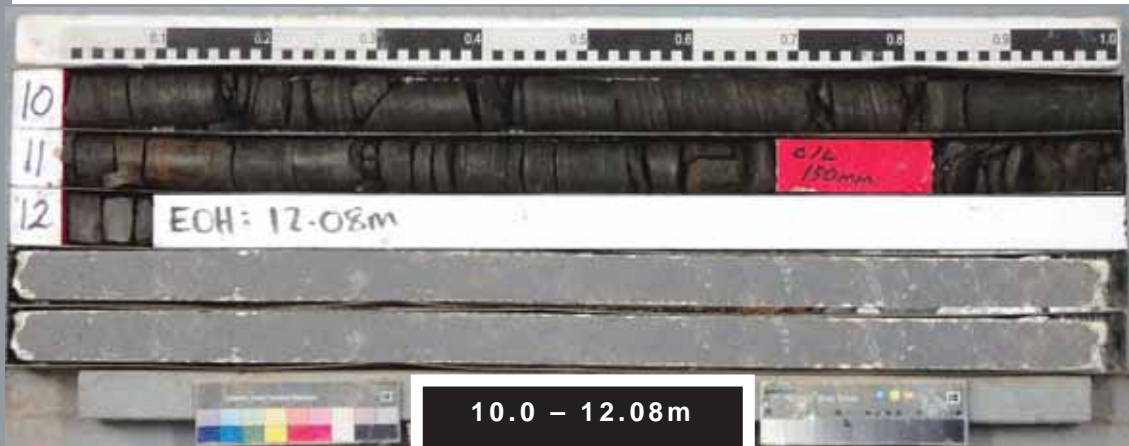
DOUGLAS PARTNERS PTY LTD
PROPOSED F23 ADMIN. BUILDING – THE UNIVERSITY OF SYDNEY
BORE 1 PROJECT 84897-02 MAY 2015

0.8	FILLING - brown, slightly gravelly, slightly sandy, silty clay																				A/E				
	1																					S				5,4,5 N = 9
	2.5	SILTY CLAY - very stiff to hard, grey mottled orange, silty clay, moist																				S				5,10,20 N = 30

4.0	SHALY CLAY - very stiff to hard, grey mottled red and orange, shaly clay with some ironstone bands and gravel, moist																				S				10,12,18 N = 30

5.5	LAMINITE - low and medium strength, slightly weathered, fractured, dark grey and grey-brown, laminite with approximately 20% fine sandstone laminations																				C	100	40		PL(A) = 0.8
	6																					C	100	10		PL(A) = 0.4
	7																					C	100	0		PL(A) = 0.9
	8																					C	100	76		PL(A) = 0.6

8.65	SHALE - medium and high strength, highly and slightly weathered, fractured and slightly fractured, grey shale with some fine sandstone laminations																				C	100	41		PL(A) = 1.6
	9																					C	100	41		PL(A) = 0.7

RIG: DT-100 **DRILLER:** SM **LOGGED:** CG **CASING:** HW to 2.5m
TYPE OF BORING: Solid flight auger to 2.5m; Rotary to 5.45m; NMLC-Coring to 12.08m
WATER OBSERVATIONS: No free groundwater observed whilst augering
REMARKS:

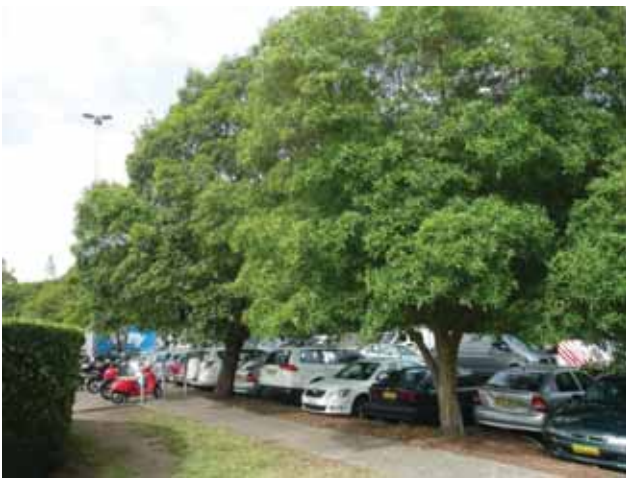
Figure 1: The site of proposed building F23

Both projects are located within the Darlington Campus of the University of Sydney. The F23 building is being constructed to co-locate and consolidate administrative functions. It is going to be constructed on an area currently used for car parking (Figure 1) and is likely to include two basement levels.

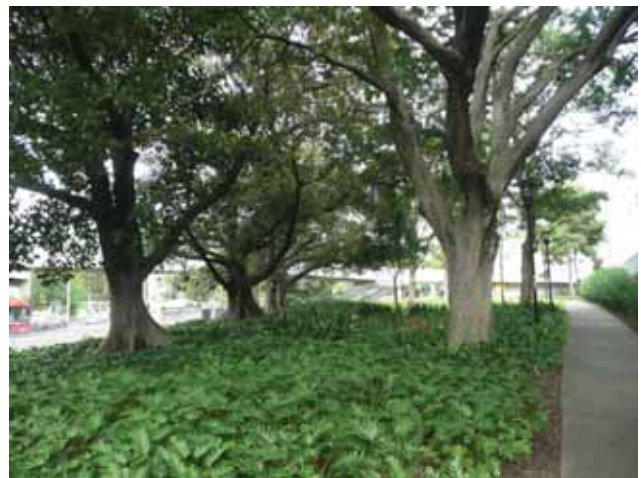
Figure 2: The site of the F07 extension

The F07 extension will be used to co-locate the schools of Molecular Bio-Science and Biological Sciences (Figure 2). The extension to the existing Carlslaw building is likely to include one basement level.
