5th February 2025

Geology Report for Proposed Hillview Hard Rock Quarry SSD 8239

67 Maytoms Lane, Booral, NSW

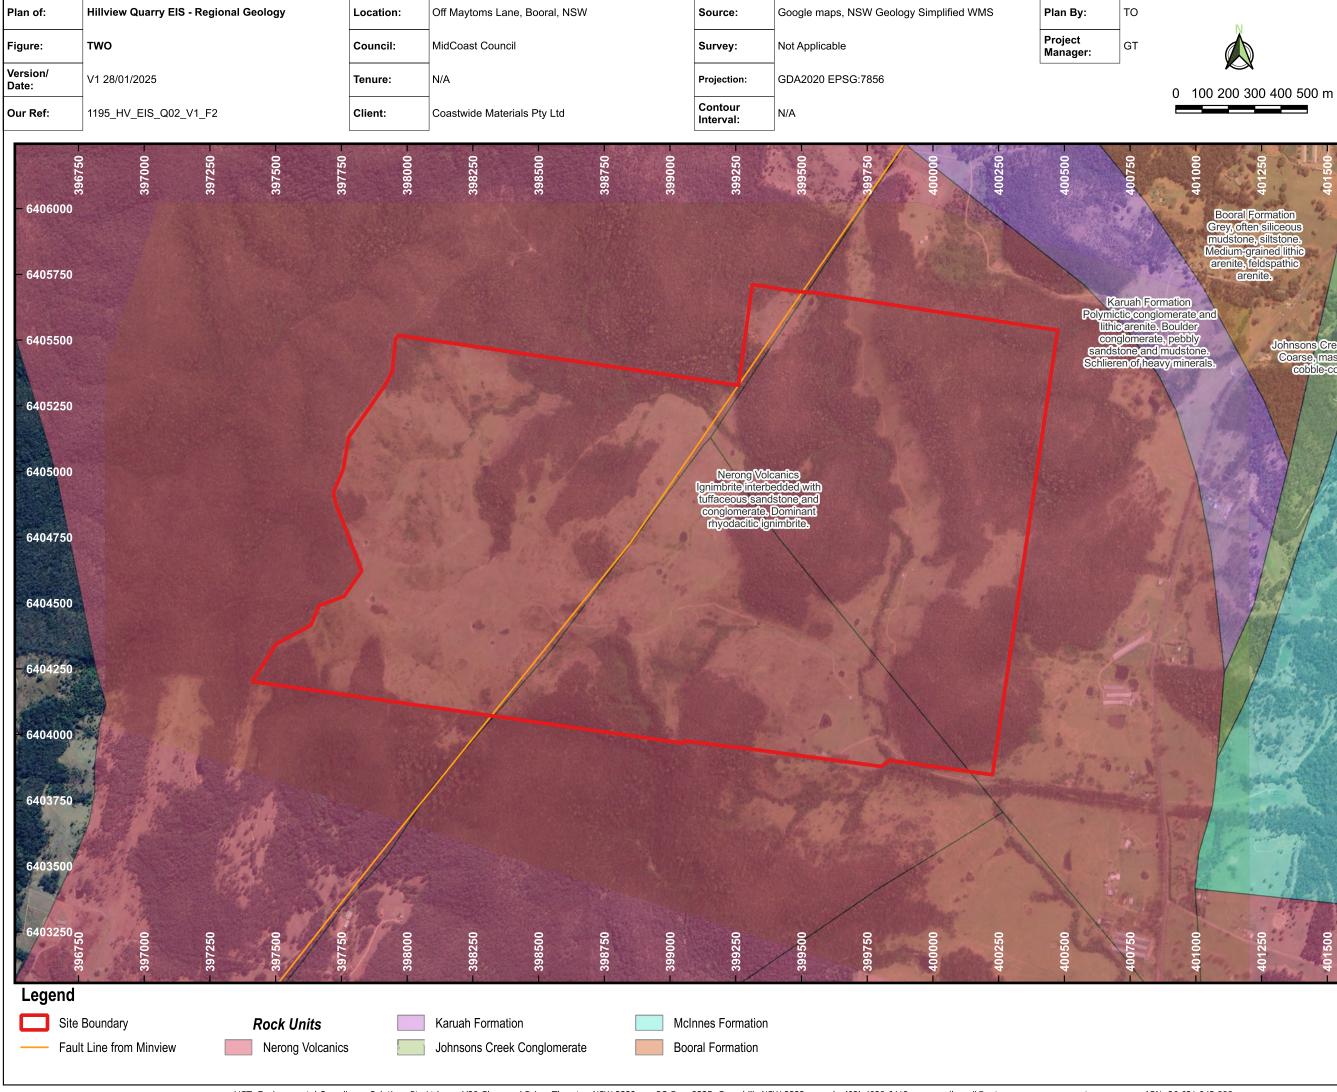
The Nerong Volcanics has all of these rocks described in it. The age of the rocks also leads to post depositional change, which can be faulting, folding, and weathering. These activities put strain on the crystals within the rock which can weaken them creating cracks and fissures which allows water in to modify hard rock into clays. One of these post depositional events is shown below in *Figure Two*, where a North East / South West trending fault has been identified in the Minview 3, NSW Mines Department web site ^{Ref 1}.

Johnsons Creek Conglomerate Coarse, massive, pebble-to cobble-conglomerate.

McInnes Formation Lithic arenite with minor interbeds of conglomerate breccia and mudstone.

Around 330 million years ago, during the Carboniferous Period, the environment in this area was volcanically active; ash clouds and lavas (Rhyodacites, Andesites, Ignimbrites, Breccias etc) flowed violently down steep sloped volcanoes. These events were interspersed with less active times where rivers flowed depositing conglomerates, sandstones and siltstones.

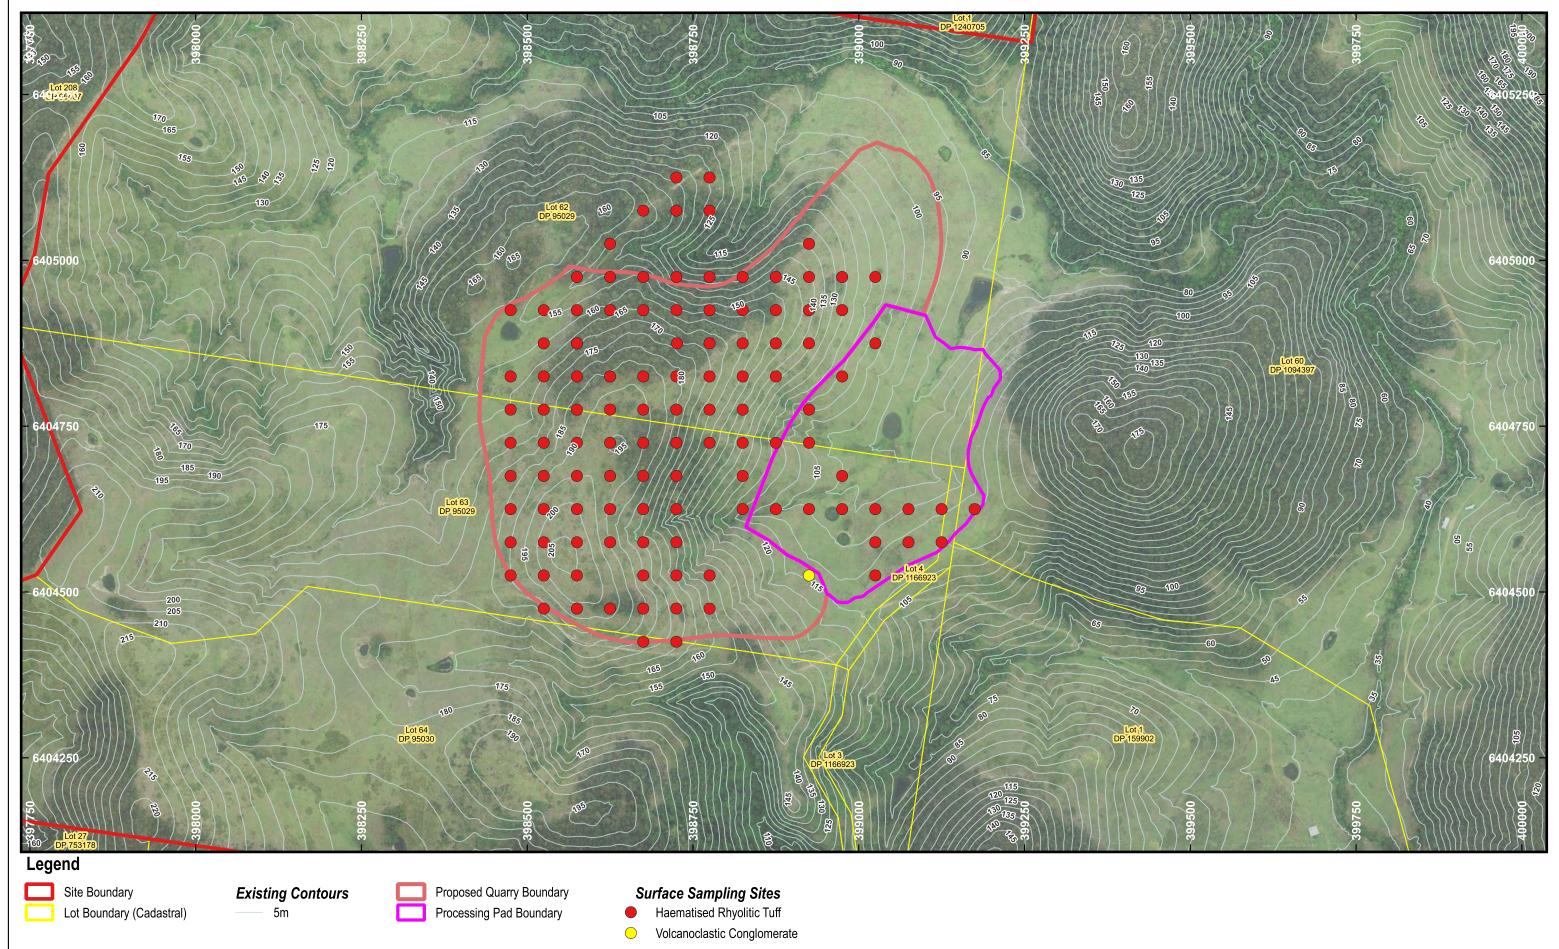
Figure Three shows the distribution of samples and rock types over the area of interest.

A 50 metre by 50 metre grid was developed, and samples were taken where found. *Appendix A* has the summary table with all samples described and photographed. 116 samples were collected and one of these was identified as Volcanoclastic Conglomerate (sedimentary), the remaining 115 were identified as Hematized Rhyolite Tuff (Volcanic), with varying degrees of weathering.

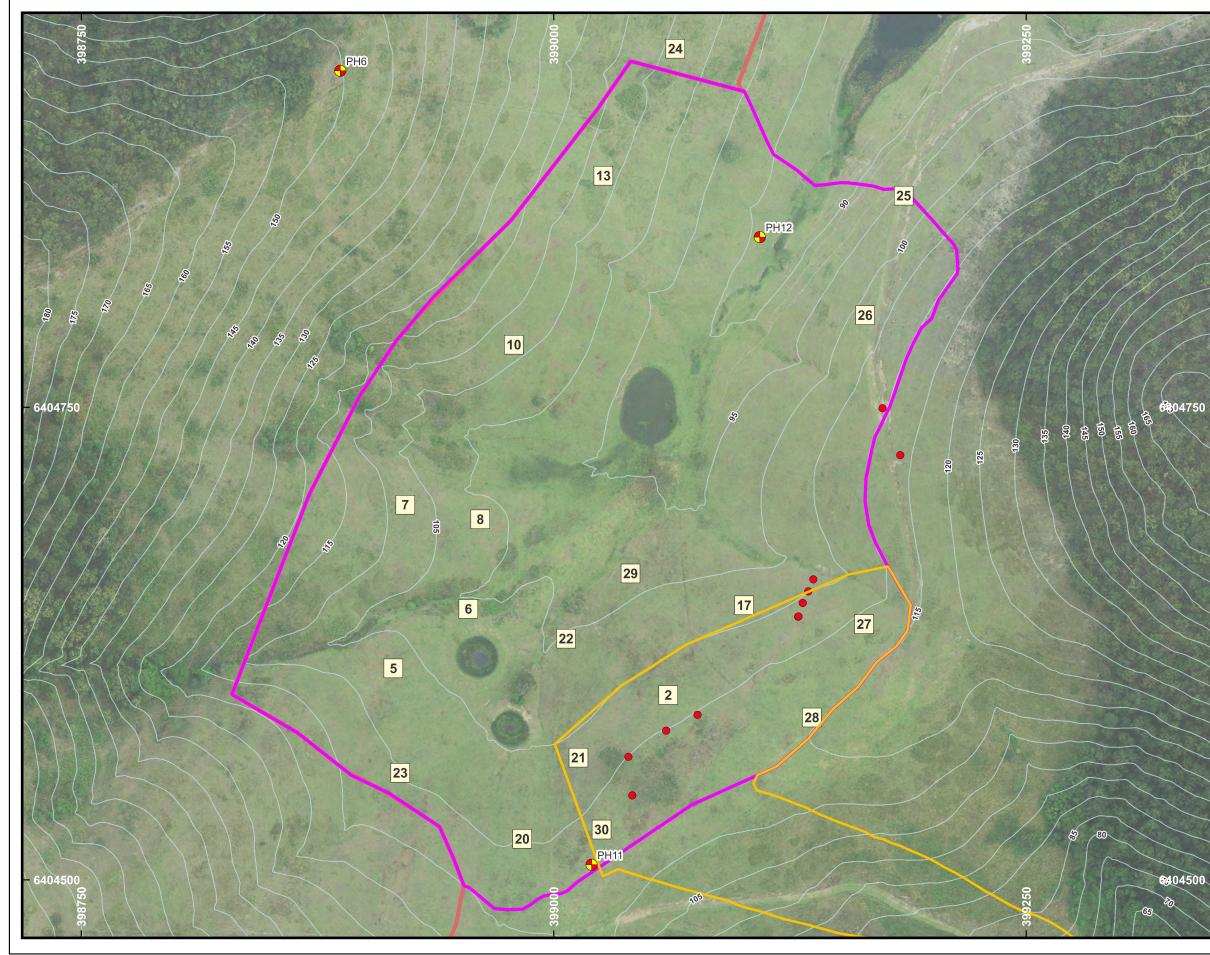
- Proposed Quarry Boundary
- Processing Pad Boundary
 - Stage 1 Haul Road and Processing Pad

- 5m
- Drill Holes
- Volcanic Rock Outcrop Markers
- Test Pits July 2024

On the 23rd of July 2024 investigations into near-surface geology and soil depths were undertaken in the proposed Processing Pad area (see *Figure Five*). 19 test pits were sunk with a 20 tonne excavator to determine soil depth and underlying rock type. Pit depths varied from 0.5 to 3.2m with an average depth of 1.5m, sunk to the level of exposed rock or equipment refusal. All pits exposed volcanic rock at their base with varying levels of weathering, no sedimentary units were intersected, see *Photoplate 1*. Pits were not sunk in the central zone along the creek line below a surface RL of 95 as this area will be filled for the Processing Pad. No test pits were sunk in drainage lines above RL95 due to site access constraints. Test pit locations are shown on *Figure Four* and results are outlined in *Appendix B – VGT Test Pit Logs*.

Pit No	Depth	Eastings	Northings	Elevation
1	Deleted			
2	1.20	399060.57	6404597.77	108.03
3	Deleted			
4	Deleted			
5	0.50	398915.09	6404611.88	106.49
6	2.20	398954.77	6404643.31	101.06
7	1.40	398921.42	6404698.42	108.02
8	1.50	398961.09	6404690.73	101.83
9	Deleted			
10	1.80	398978.86	6404783.10	106.43
11	Deleted			
12	Deleted			
13	1.10	399026.22	6404872.50	107.04
14	Deleted			
15	Deleted			
16	Deleted			
17	0.60	399100.70	6404645.24	103.41
18	Deleted			
19	Deleted			
20	3.20	398983.28	6404521.67	109.98
21	1.60	399013.05	6404564.65	106.55
22	2.40	399006.47	6404627.59	100.34
23	2.50	398918.75	6404556.60	110.33
24	1.20	399064.29	6404939.68	103.75
25	1.10	399185.14	6404861.94	95.82
26	1.05	399164.73	6404798.70	102.22
27	0.90	399164.18	6404635.28	111.31
28	0.90	399136.57	6404585.88	114.79

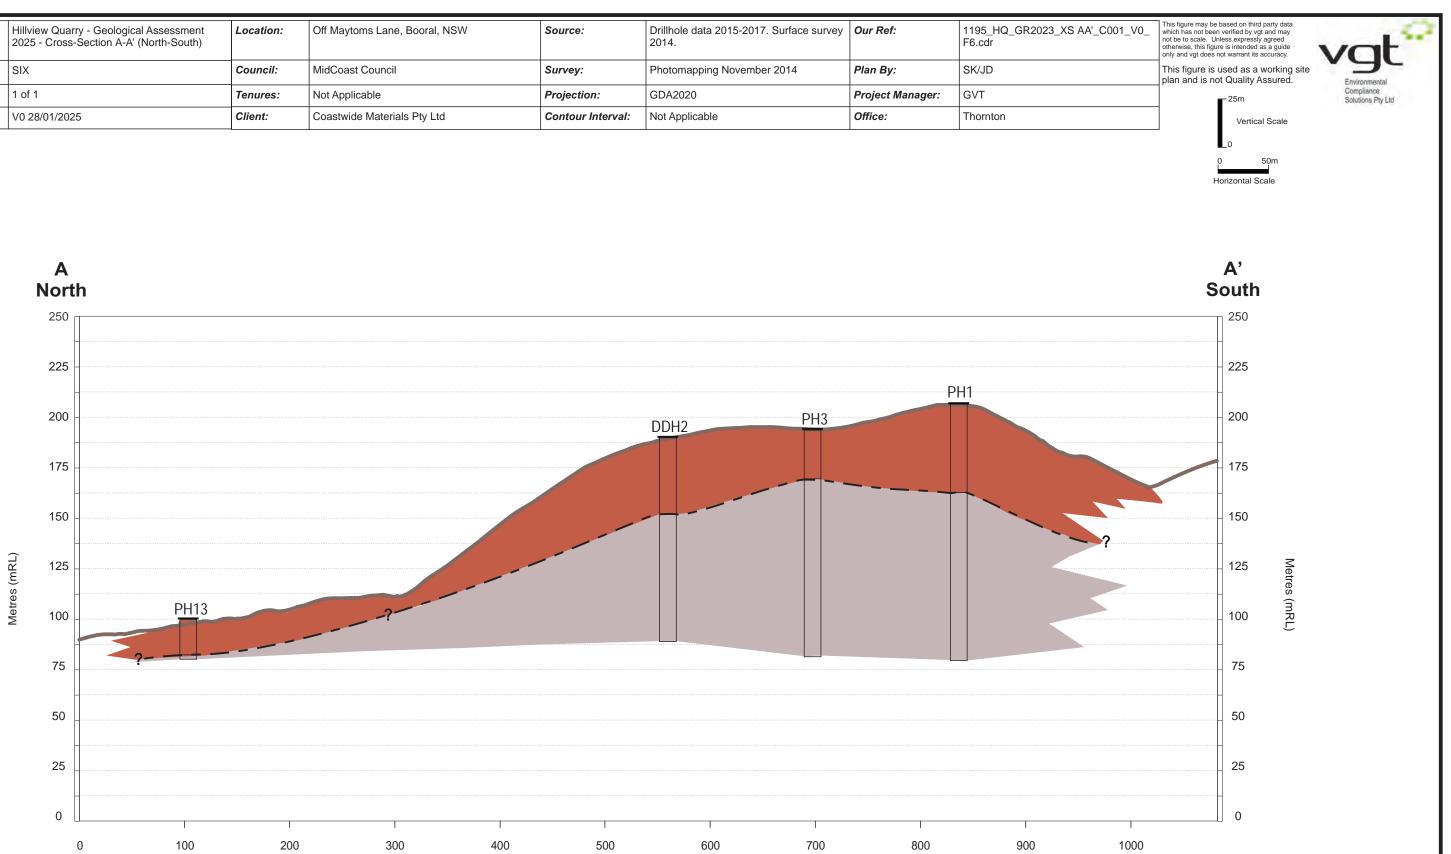
Hematized Rhyolite Tuff

Rhyolite Tuff

---- Dislocation

Diamond drill hole 2 (DDH2) was the principal hole used for assessing the main resource area. The upper 38 metres of red/pink material were identified as hematized rhyolitic tuff (HRT). The lower 63 metres of grey material were identified as rhyolitic tuff, called rhyolite within this report. Five basaltic dykes from 0.5 to 0.75 metres thick were intersected at approximately 9, 11.5, 17, 31 and 33 metres down the hole, all in the hematized zone.

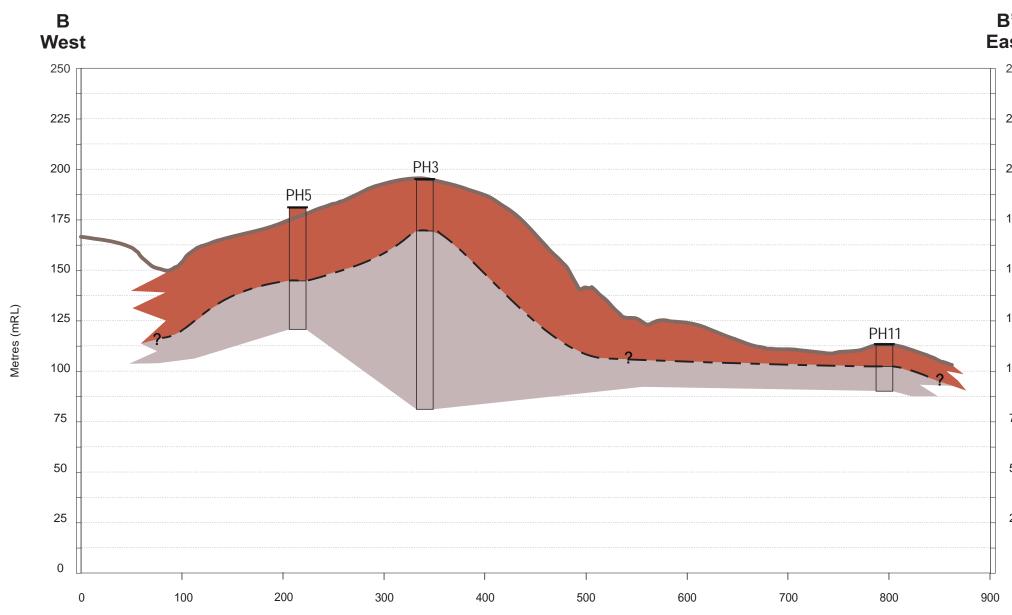
Hematized Rhyolite Tuff

Rhyolite Tuff

---- Dislocation

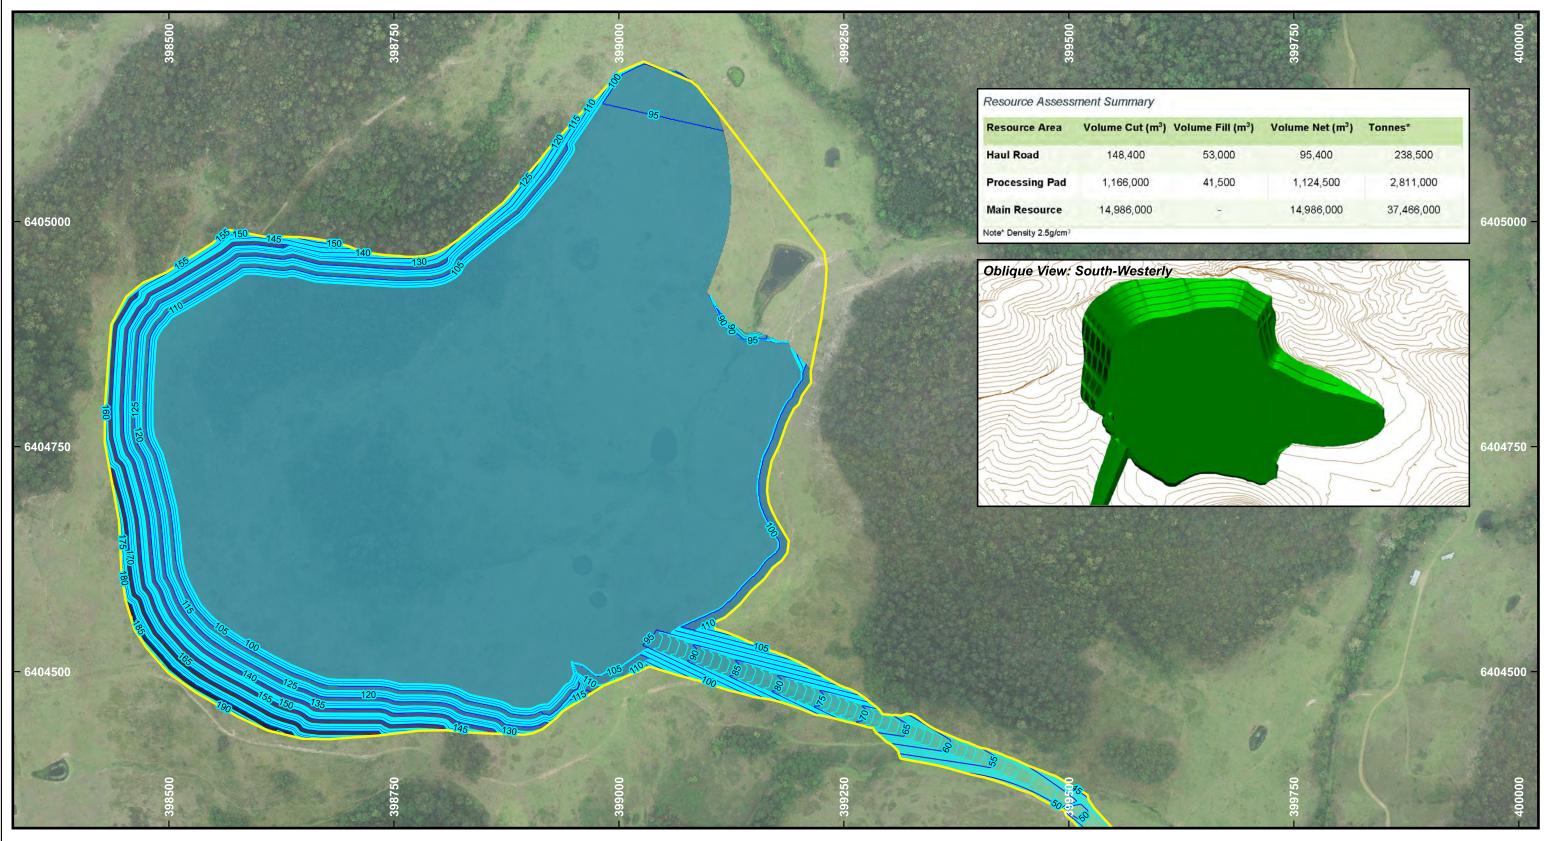
Project Disturbance

Conceptual Final Contours

Elevation Final Landform 190.7mRL 21.2mRL

This assessment relies upon geological investigations undertaken in 2015 – 2017, and 2020 surface mapping. Data from 15 drill holes and surface mapping has been reviewed. Three-dimensional modelling using 12D software, based upon the provided constraints has calculated, refer to *Table 4*. The conceptual final landform is included in *Figure Eight.*

Rhyolite within the main resource area is estimated at 14.9 million metres cubed and based upon a density of 2.5 g/cm³ a total resource of 37.5 million tonnes is available, to RL95 m.
