# Appendix A: VGT Surface Sampling

## Hillview Surface Mapping June 2020

BOREHOLE LOG											
Name of Hole: DDH2					Hillview						
Project Number: 3430					Date Logged: 03/01/2017						
Client: Tricon Mining Equipment					Date Commenced: 08/12/2016						
Project: Geological Assessment					Date Completed: 13/12/2016						
Location: Off Maytoms Lane, Booral					Surface RL: 189.85 AHD						
Logged by: MA/SK					Coordinates: E:398672.97 N:6404803.67						
					Drilling Contractor: D and E Drilling						
1 of 21											
Drilling Method	Elevation (RL)	Depth (m)	Core Recovery (%)	Diametral Strength (Mpa)	Axial Strength (Mpa)	UCS Strength (Mpa)	Fracture Frequency /m	Fracture Log	Graphic Log	Lithological Description	Additional Information
Auger	189	0		0.74	0.76					Hematized Rhyolitic Tuff- brown, grey to pink, weathered, porphyritic	Becoming competent
		60					2				
Diamond Drill	188	1					5				
		95									
		2		10.11	5.62						
		100					>5				
		187									
		3									
		100					3

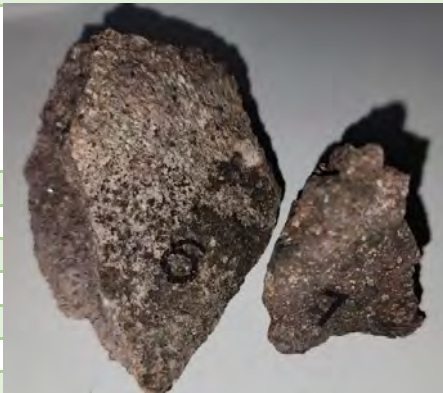
Grid Square	Transect No	Eastings	Northings	Sampling Comments	Lithology	Specimen Comment	Transect Photo
1	1	398825	6405175	FNS			
2	1	398875	6405175	FNS			
3	1	398925	6405175	FNS			
4	1	398975	6405175	FNS			
5	1	399025	6405175	FNS			
6	2	398725	6405125	Large boulder nearby too. Floats	HRT	Fresh. Creamy - white plagioclase laths, opaque - clear quartz, mica crystals set in a pink - red fine grained matrix. Possibly orthoclase and/or haematite.

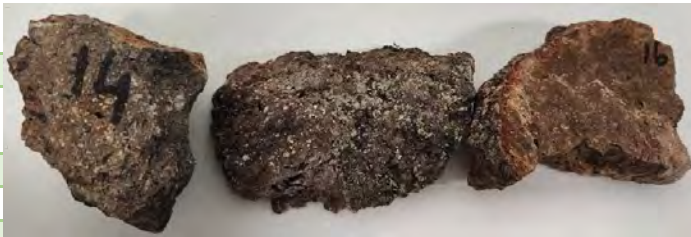
7	2	398775	6405125	Outcrop but float	HRT		
8	2	398825	6405125	FNS			
9	2	398875	6405125	FNS			
10	2	398925	6405125	FNS			
11	2	398975	6405125	FNS			
12	2	399025	6405125	FNS			
13	2	399075	6405125	FNS			
14	3	398675	6405075		HRT	Weathered. Plag, Qtz, Mica set in cream - brown matrix.

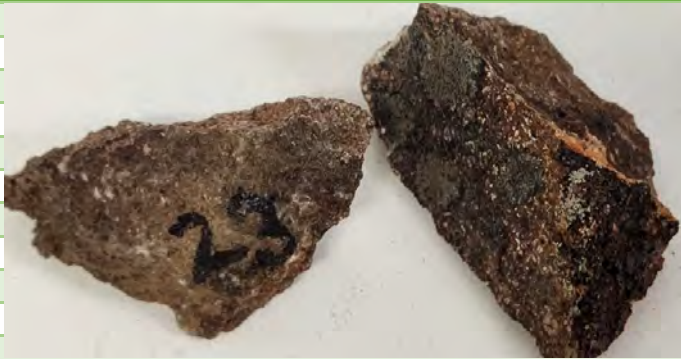
Grid Square	Transect	Eastings	Northings	Sampling Comments	Lithology	Specimen Comment	Transect Photo
23	4	398625	6405025		HRT	Slightly weathered.

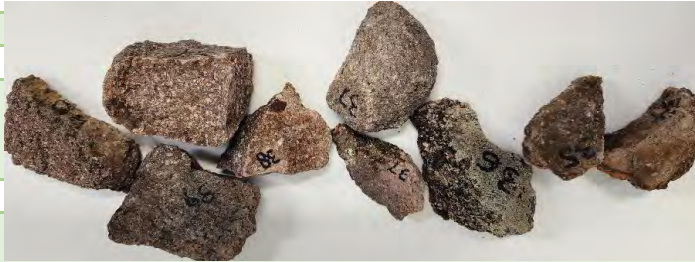
24	4	398675	6405025	No Sample. Hard			
25	4	398725	6405025	No Sample. Hard			
26	4	398775	6405025	FNS			
27	4	398825	6405025	FNS			
28	4	398875	6405025	No Sample. Float			
29	4	398925	6405025	Float	HRT	Fresh.	
30	4	398975	6405025	FNS			
31	4	399025	6405025	FNS			
32	4	399075	6405025	FNS			
33	4	399125	6405025	FNS			
34	5	398575	6404975		HRT	Weathered.

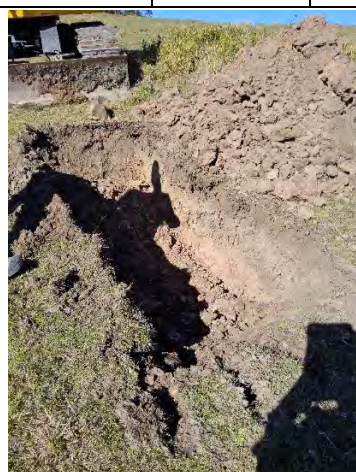
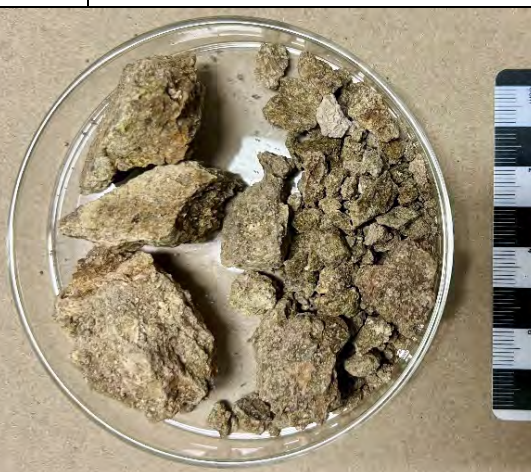
Test pit 2

Eastings	399060.57	Elevation	108m
Northings	6404597.77	Date	17.07.2024
Logged By	TF	Checked	RG
Depth	1.2	Rock at base?	Volcanic, extremely weathered

From	To	Thickness	Description
0	0.3m	0.3m	A1 soil horizon, brown clay
0.3m	1.2m	0.9m	B1 soil horizon, grey brown sandy clay
1.2m			Extremely weathered volcanic rock at base, end of hole.

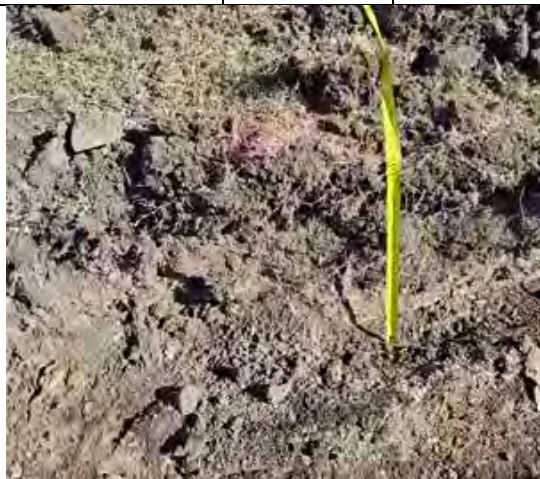
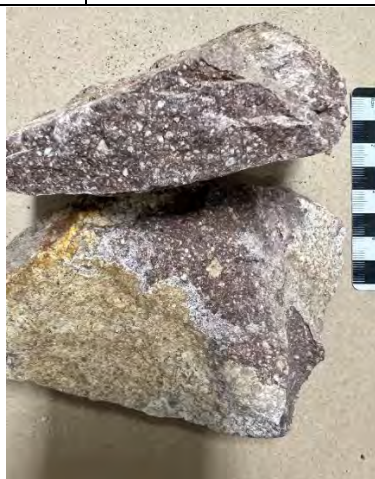
Test pit 5

Eastings	398915.09	Elevation	106.5m
Northings	6404611.88	Date	17.07.2024
Logged By	TF	Checked	RG
Depth	0.5	Rock at base?	Volcanic, fresh

From	To	Thickness	Description
0	0.13m	0.13m	Dark brown clay/sand
0.13m	0.5m	0.27m	B1 soil horizon, grey brown sandy clay
0.5m			Fresh, red volcanic rock – end of hole 0.5m

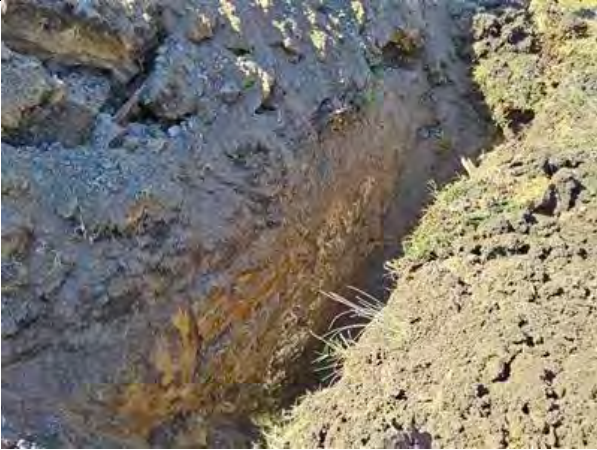
Test pit 6

Eastings	398954.77	Elevation	101m
Northings	6404643.31	Date	17.07.2024
Logged By	TF	Checked	RG
Depth	2.2	Rock at base?	Volcanic, slightly weathered

From	To	Thickness	Description
0	1.0m	1.0m	A1 soil horizon, dark brown sandy clay
1.0m	2.2m	1.2m	Grey, silty and hard with green rock
2.2m			Hard volcanic rock – end of hole at 2.2m

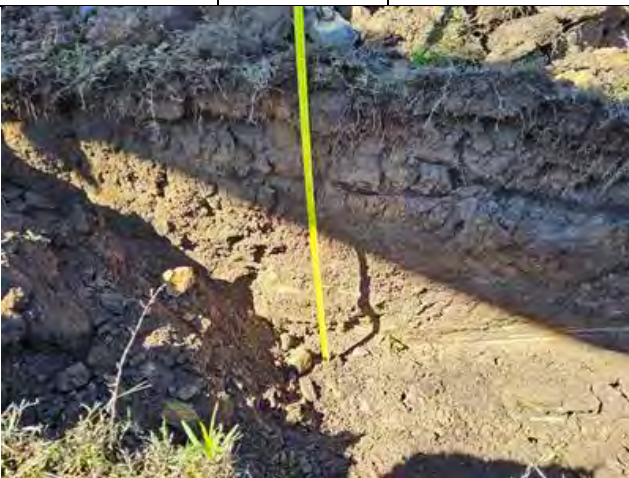
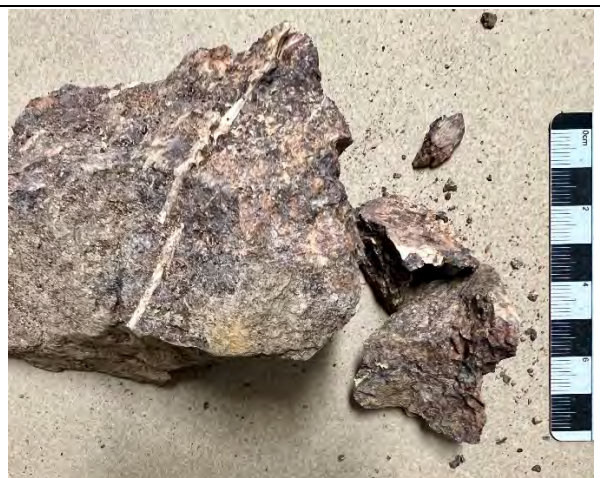
Test pit 7

From	To	Thickness	Description
0	0.7m	0.7m	Dark brown high quality soil
0.7m	1.4m	0.7mm	Yellow/grey clay
1.4m			Hard volcanic rock – end of hole 1.4m

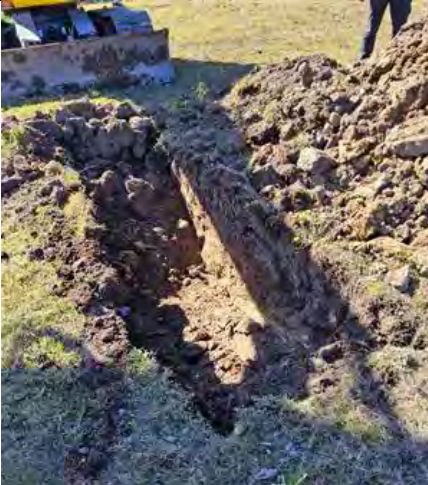
Test pit 8

Eastings	398961.09	Elevation	101.8m
Northings	6404690.73	Date	17.07.2024
Logged By	TF	Checked	RG
Depth	1.5	Rock at base?	Volcanic, highly weathered

From	To	Thickness	Description
0	0.3m	0.3m	Dark brown muddy soil
0.3m	1.5m	1.2m	Yellow/grey clay
1.5m			Weathered rock, End of hole at 1.5m

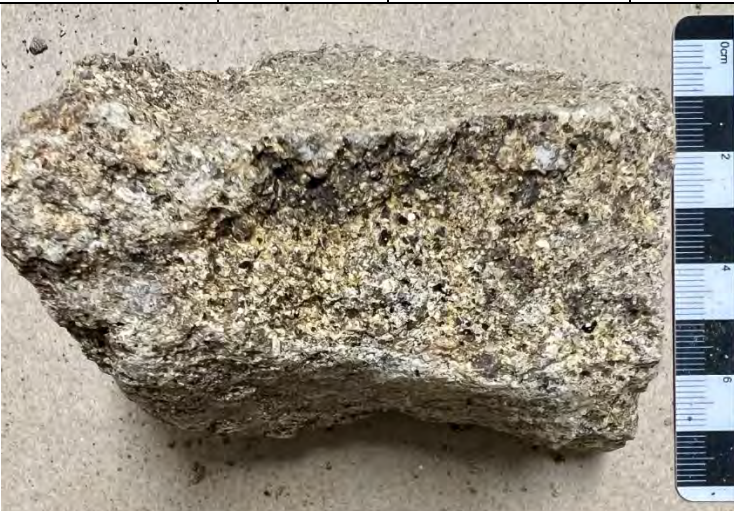
Test pit 10

Eastings	398978.86	Elevation	106.43m
Northings	6404783.10	Date	17.07.2024
Logged By	TF	Checked	RG
Depth	1.8	Rock at base?	Volcanic, slightly weathered

From	To	Thickness	Description
0	0.3m	0.3m	Dark brown mud, A1 soil horizon
0.3m	1.5m	1.2m	Yellow/grey clay
1.5m	1.8m	0.3m	Hard volcanic rock, end of hole 1.8m

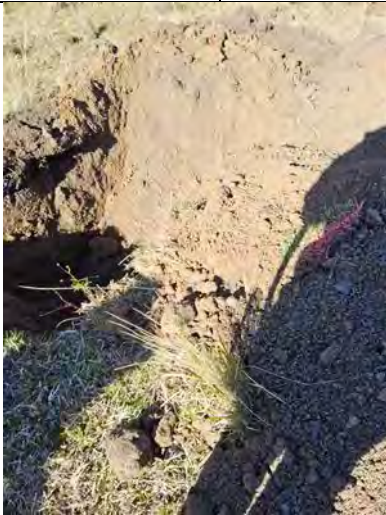
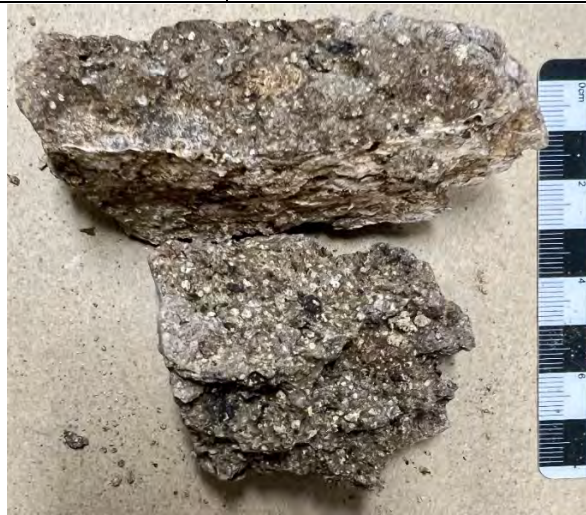
Test pit 13

Eastings	399026.22	Elevation	107.04m
Northings	6404872.50	Date	17.07.2024
Logged By	TF	Checked	RG
Depth	1.1m	Rock at base?	Volcanic, highly weathered

From	To	Thickness	Description
0	1.1m	1.1m	Grey / brown clay
1.1m			Weathered rock, End of hole

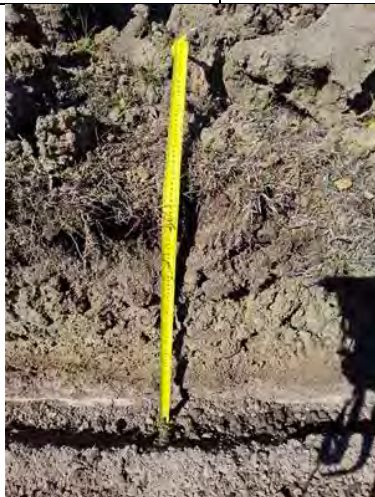
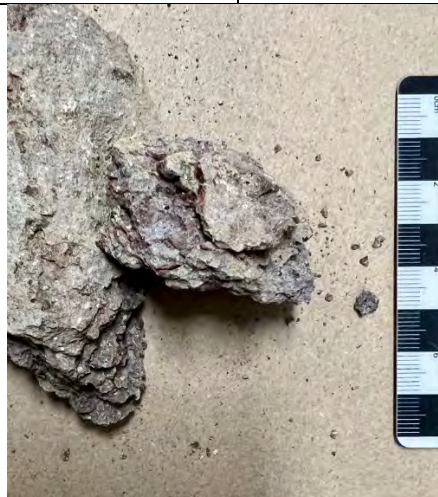
Test pit 17

Eastings	399100.70	Elevation	103.41m
Northings	6404645.24	Date	17.07.2024
Logged By	TF	Checked	RG
Depth	0.6m	Rock at base?	Volcanic, moderately weathered

From	To	Thickness	Description
0	0.15m	0.15m	A1 soil horizon, dark brown clay
0.15m	0.35m	0.2m	A2 – grey brown clay
0.35m	0.55m	0.2m	B1 horizon, orange sandy clay
0.55m	0.6m	0.05m	Rock at base, end of hole 0.6m

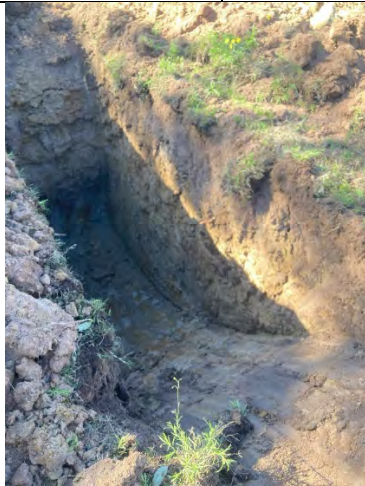
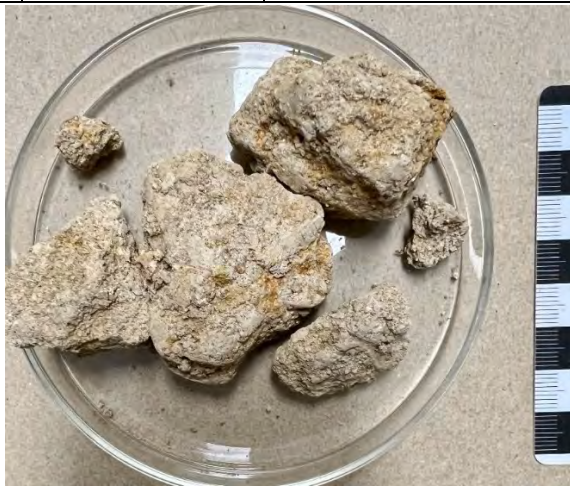
Test pit 20

Eastings	398983.28	Elevation	110m
Northings	6404521.67	Date	17.07.2024
Logged By	TF	Checked	RG
Depth	3.2m	Rock at base?	Volcanic, extremely weathered
From	To	Thickness	Description
0	0.5m	0.5m	A1 soil horizon, dark brown clay
0.5m	2.0m	1.5m	Sandy orange brown clay
2.0m	3.2m	1.2m	Increasing sand in clay
3.2m			Equipment refusal, extremely weathered rock at base, end of hole 3.2m

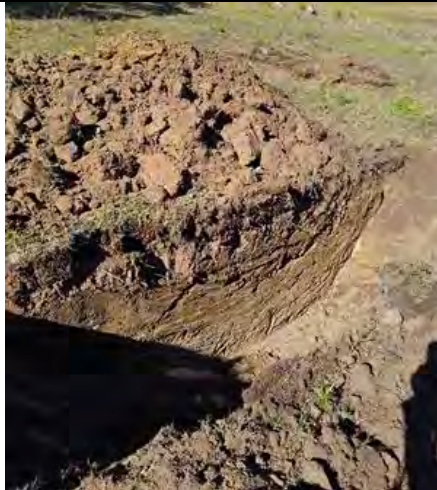
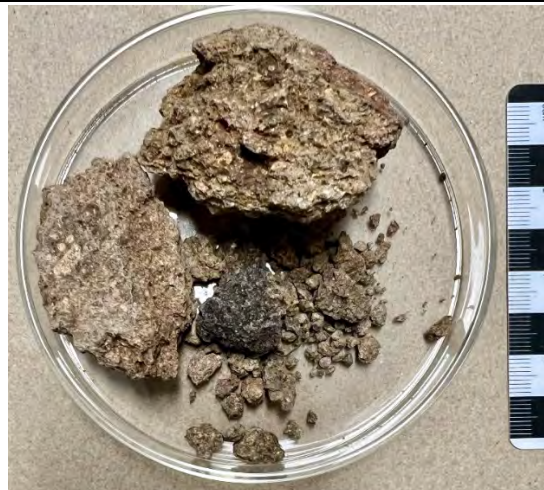
Test pit 21

Eastings	399013.05	Elevation	106.55m
Northings	6404564.65	Date	17.07.2024
Logged By	TF	Checked	RG
Depth	1.6m	Rock at base?	Volcanic, extremely weathered
From	To	Thickness	Description
0	0.4m	0.4m	Brown sandy clay, A1 soil horizon
0.4m	1.4m	1.0m	Brown/grey streaky clay
1.4m	1.6m	0.2m	Pale grey clay
1.6m			Extremely weathered rock at base, end of hole 1.6m

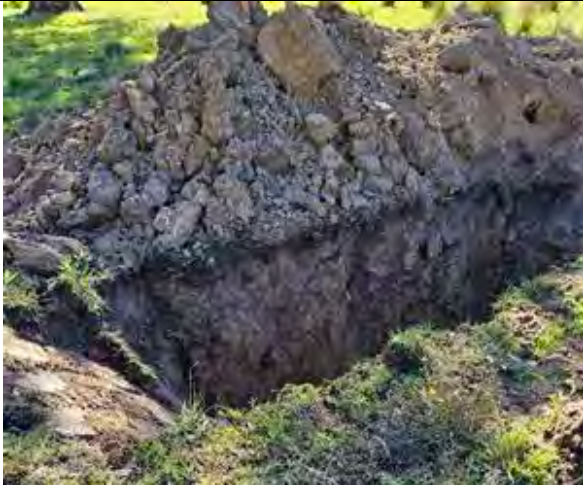
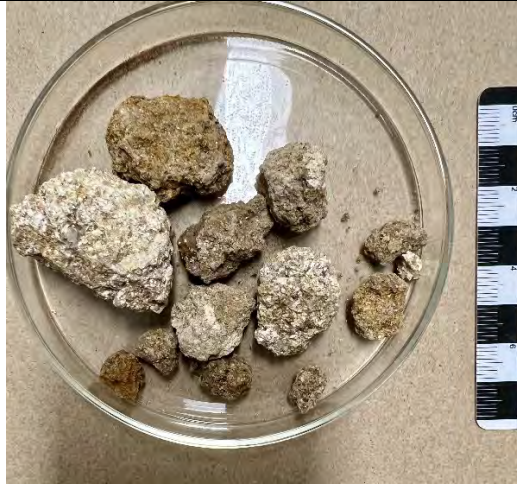
Test pit 22

Eastings	399006.47	Elevation	100.34m
Northings	6404627.59	Date	17.07.2024
Logged By	TF	Checked	RG
<b>Depth</b>	<b>2.4m</b>	Rock at base?	Volcanic, extremely weathered

From	To	Thickness	Description
0	0.3m	0.3m	Brown sandy clay, A1 soil horizon
0.3m	1.9m	1.6m	Brown / orange clay
1.9m	2.4m	0.5m	Extremely weathered & soft volcanic rock
2.4m			Equipment refusal, end of hole

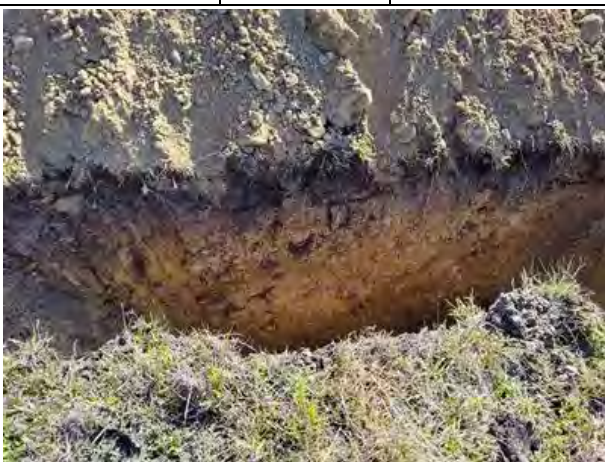
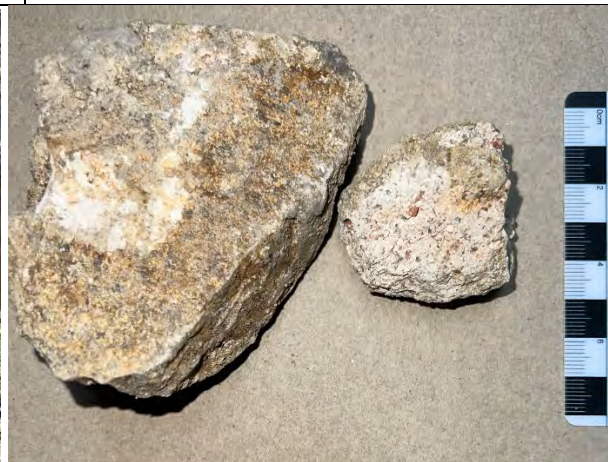
Test pit 23

Eastings	398918.75	Elevation	110.33m
Northings	6404556.60	Date	17.07.2024
Logged By	TF	Checked	RG
<b>Depth</b>	<b>2.5m</b>	Rock at base?	Volcanic, Moderately weathered

From	To	Thickness	Description
0	0.4m	0.4m	Dark brown sandy soil, A1 soil horizon
0.4m	2.5m	2.1m	Brown / orange clay
2.5m			Volcanic rock at 2.5m, end of hole

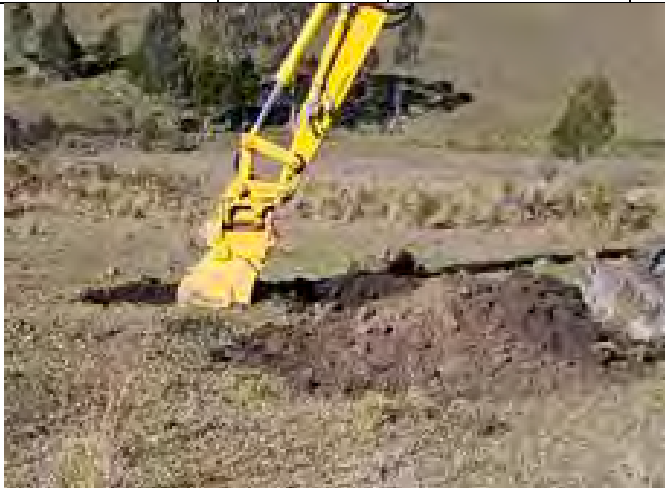
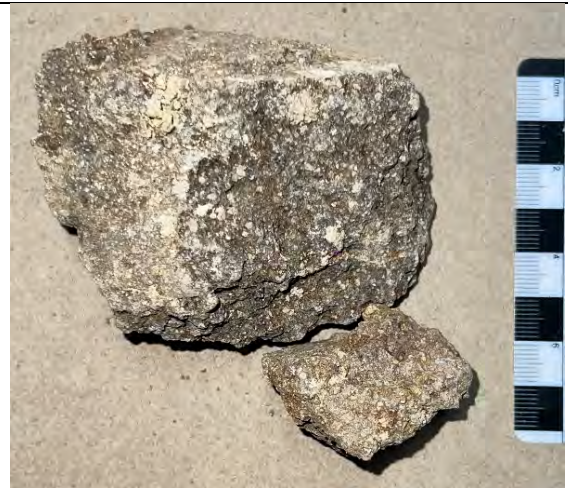
Test pit 24

Eastings	399064.29	Elevation	103.75m
Northings	6404939.68	Date	17.07.2024
Logged By	TF	Checked	RG
Depth	1.2m	Rock at base?	Volcanic, slightly weathered

From	To	Thickness	Description
0	0.5m	0.5m	Dark brown good quality soil, A1 soil horizon
0.5m	1.2m	0.7m	Red / brown clay
1.2m			Very hard volcanic rock at 1.2m, end of hole

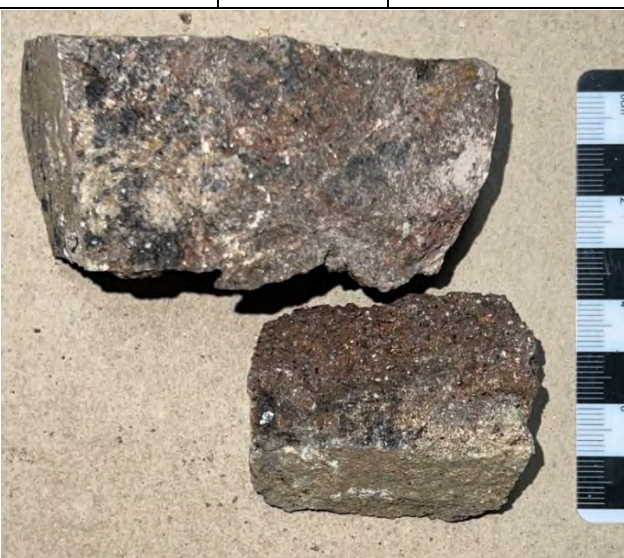
Test pit 25

Eastings	399185.14	Elevation	95.82m
Northings	6404861.94	Date	17.07.2024
Logged By	TF	Checked	RG
Depth	1.1m	Rock at base?	Volcanic, fresh

From	To	Thickness	Description
0	0.5m	0.5m	Dark brown soil, A1 soil horizon
0.5m	1.0m	0.5m	Red / brown clay
1.0m	1.1m	0.1m	Hard, red volcanic rock at 1.1m, end of hole

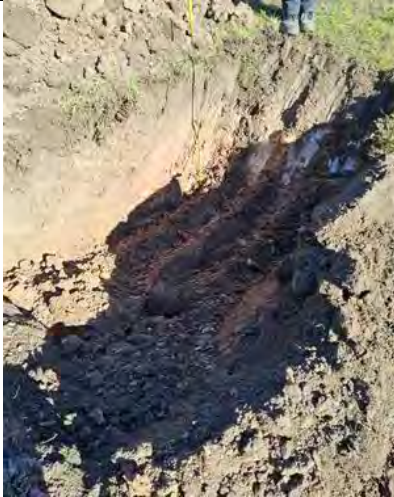
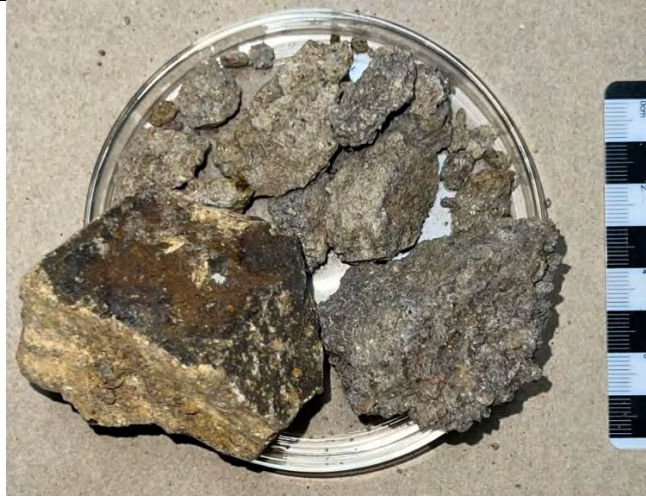
Test pit 26

Eastings	399164.73	Elevation	102.22m
Northings	6404798.70	Date	17.07.2024
Logged By	TF	Checked	RG
Depth	1.05m	Rock at base?	Volcanic, moderate weathering

From	To	Thickness	Description
0	0.3m	0.3m	Dark brown soil, A1 soil horizon
0.3m	0.6m	0.3m	Brown clay
0.6m	1.05m	0.45m	Sandy clay
1.05m			Hard rock at 1.05m, end of hole

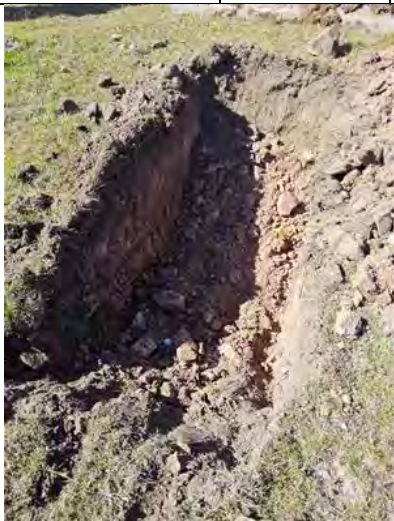
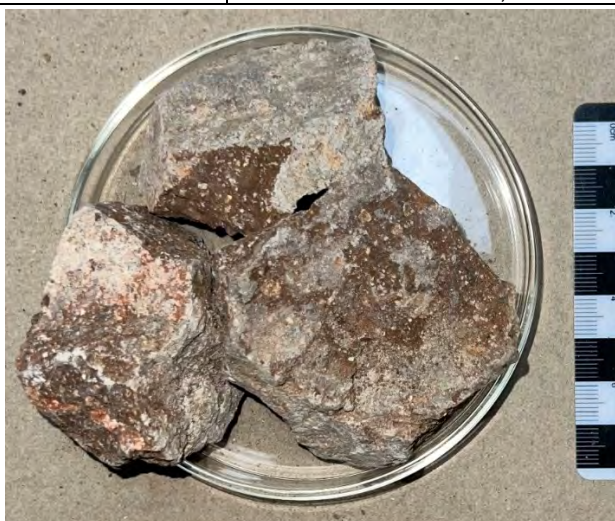
Test pit 27

Eastings	399164.18	Elevation	111.31m
Northings	6404635.28	Date	17.07.2024
Logged By	TF	Checked	RG
Depth	0.9m	Rock at base?	Volcanic, fresh

From	To	Thickness	Description
0	0.3m	0.3m	Dark brown soil, A1 soil horizon
0.3m	0.7m	0.4m	Red/brown streaky clay
0.7m	0.9m	0.2m	Weathered red volcanic rock
0.9m			Hard red rock at 0.9m, end of hole

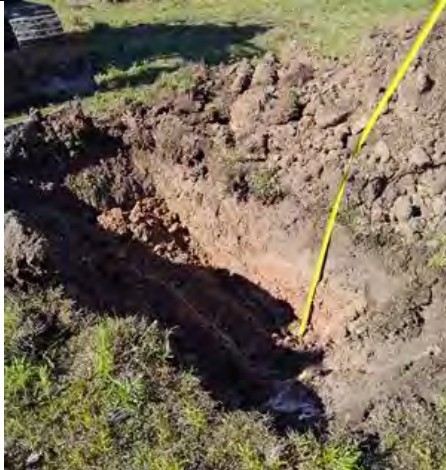
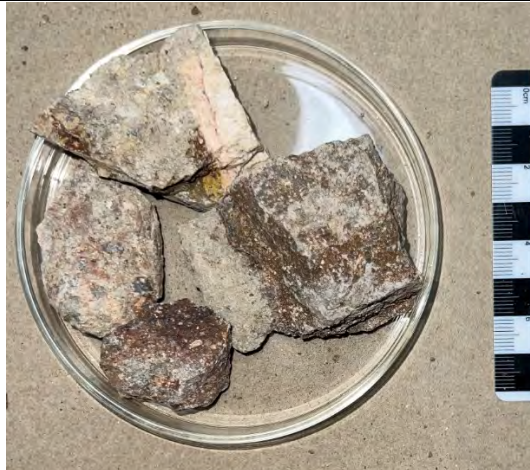
Test pit 28

Eastings	399136.57	Elevation	114.79m
Northings	6404585.88	Date	17.07.2024
Logged By	TF	Checked	RG
Depth	0.9m	Rock at base?	Volcanic, slightly weathered

From	To	Thickness	Description
0	0.3m	0.3m	Dark brown soil, A1 soil horizon
0.3m	0.7m	0.4m	Grey clay
0.7m	0.9m	0.2m	Weathered red volcanic rock
0.9m			Hard red rock at 0.9m, end of hole

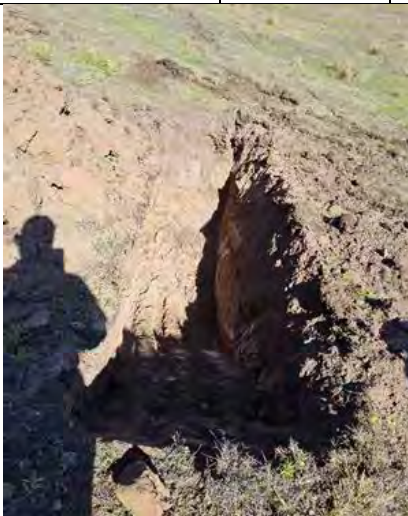
Test pit 29

Eastings	399040.60	Elevation	98.47m
Northings	6404662.08	Date	17.07.2024
Logged By	TF	Checked	RG
Depth	2.1m	Rock at base?	Volcanic, extremely weathered

From	To	Thickness	Description
0	0.4m	0.4m	Grey / brown sandy soil, A1 soil horizon
0.4m	2.1 m	1.7m	Red / orange and brown clay
1.7m			Weathered red volcanic rock, end of hole 1.7m

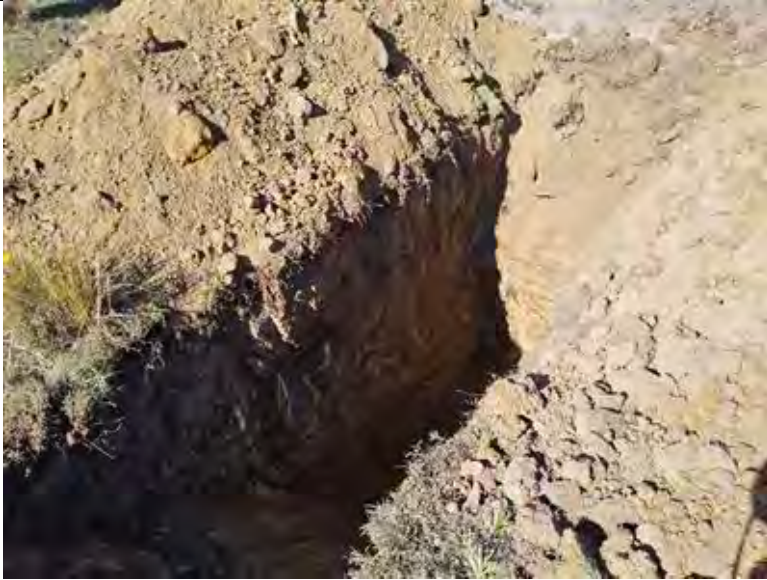
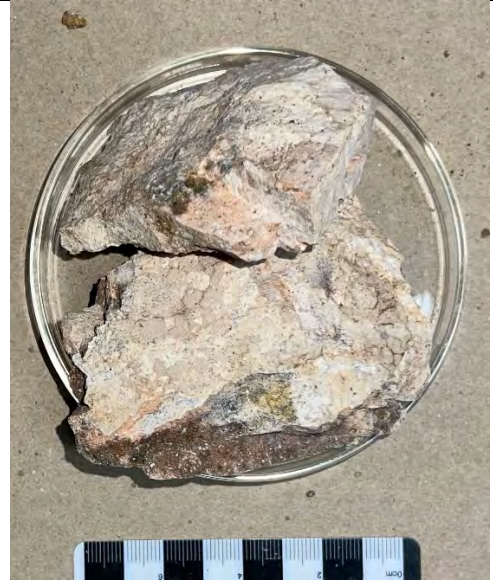
Test pit 30

Eastings	399025.27	Elevation	111.92m
Northings	6404526.61	Date	17.07.2024
Logged By	TF	Checked	RG
Depth	1.1m	Rock at base?	Volcanic, Fresh
From	To	Thickness	Description
0	0.4m	0.4m	Dark brown soil, A1 soil horizon
0.4m	1.1 m	0.7m	Sandy orange grey clay
1.1m			Weathered red volcanic rock, end of hole 1.1m

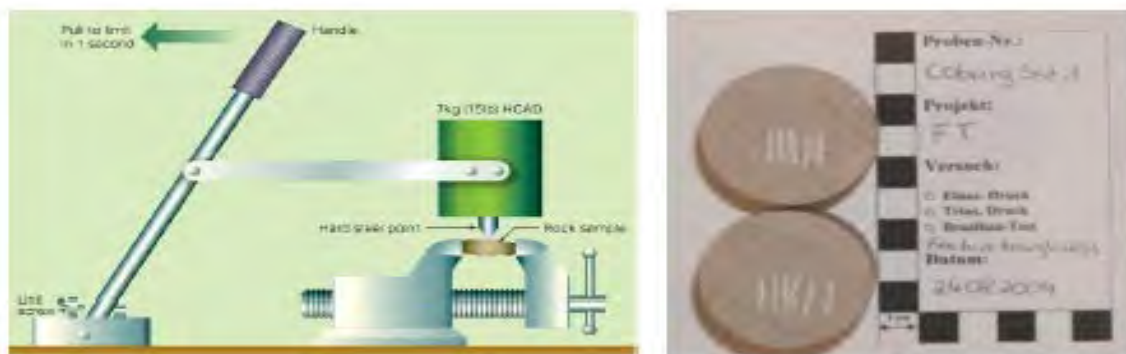
The Cerchar Scratch test (1986) was developed in France in the mid-1980s to help predict the wear of cutters on the tunnel boring machines. The test is a useful low cost method of predicting the rate of wear of cutter heads, excavator bucket teeth, and crushing and screening plant. The test is performed on a small freshly broken rock sample, requiring less than 25mm in size. The sample is scratched by a hardened sharp heat treated alloy steel needle of defined geometry over a length of 10mm in 1 second, under a static load of 70N. This provides a wear classification referred to as the Cerchar Abrasivity Index (CAI). The CAI is calculated as the average measure of the worn-flat diameters (in tenths of mm) on the testing needle.

Figure 1 above shows the cerchar abrasivity machine and the 10mm long scratches on rock samples.

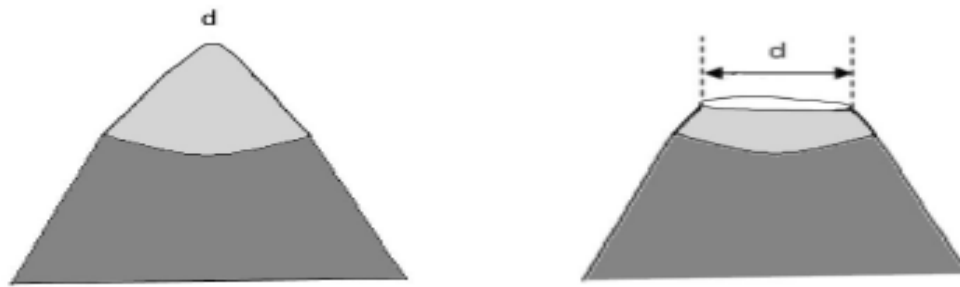
Figure 2 above shows how the CAI is obtained from a steel needle's "sharp point" (left); the test produces a conical blunt surface where its new diameter is measured in integers of 0.1mm, with a scale going from 1 to 6.

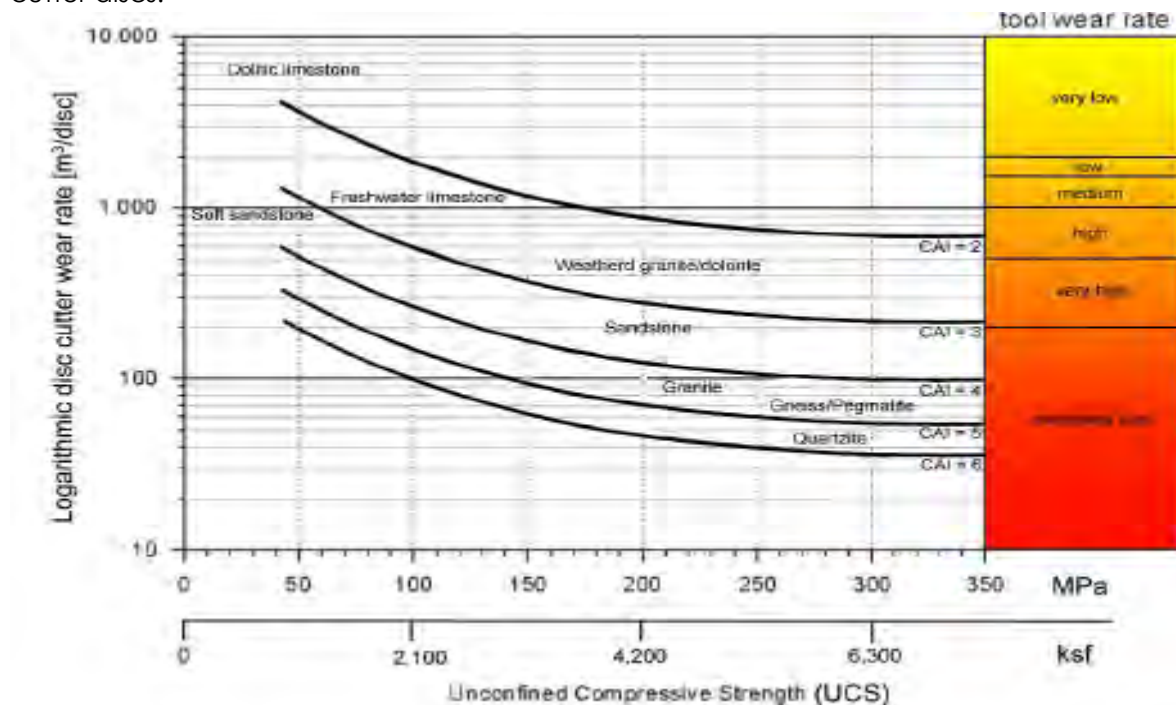
The table shown below modified from Maidl (2001) shows the comparison of field unconfined compressive strength, tool wear rate and predicted excavated cubic metre wear rate for cutter discs.

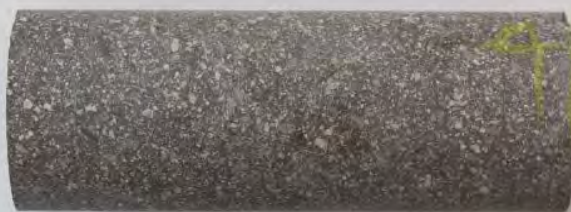
<b>Client</b>	Qualtest Laboratory (NSW) Pty Ltd	<b>Report No.</b>	17010483-MOD
Average Sample Diameter (mm)	60.8	Moisture Content (%)	0.5
Sample Height (mm)	158.7	Wet Density (t/m <sup>3</sup> )	2.61
Duration of Test (min)	12.95	Dry Density (t/m <sup>3</sup> )	2.59
Rate of Loading (MPa/min)	16.63	Bedding (°)	Nil
Mode of Failure	Disintegration	Test Apparatus	Kelba 1000kN Load Cell

<b>CLIENT:</b>	Qualtest Laboratory (NSW) Pty Ltd	
<b>PROJECT:</b>	NEW15P-0045 - Material Testing, Thornton NSW	<b>BEFORE TEST</b>
<b>LAB SAMPLE No.</b>	17010483	<b>DATE:</b> 23/1/17
<b>BOREHOLE:</b>	NEW17W-0173-S01 - DDH2	<b>DEPTH:</b> 4.20-4.35

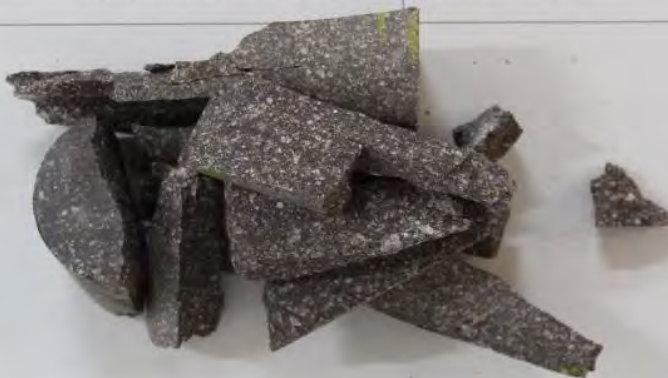
<b>CLIENT:</b>	Qualtest Laboratory (NSW) Pty Ltd	
<b>PROJECT:</b>	NEW15P-0045 - Material Testing, Thornton NSW	<b>AFTER TEST</b>
<b>LAB SAMPLE No.</b>	17010483	<b>DATE:</b> 23/1/17
<b>BOREHOLE:</b>	NEW17W-0173-S01 - DDH2	<b>DEPTH:</b> 4.20-4.35

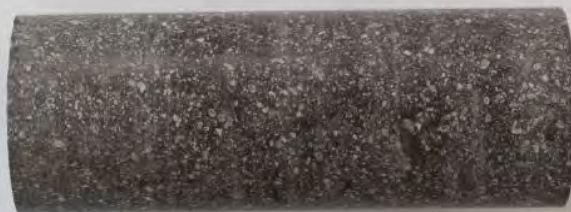
<b>Client</b>	Qualtest Laboratory (NSW) Pty Ltd	<b>Report No.</b>	17010484-MOD
Average Sample Diameter (mm)	60.7	Moisture Content (%)	0.4
Sample Height (mm)	158.1	Wet Density (t/m <sup>3</sup> )	2.61
Duration of Test (min)	8.73	Dry Density (t/m <sup>3</sup> )	2.60
Rate of Loading (MPa/min)	23.94	Bedding (°)	Nil
Mode of Failure	Disintegration	Test Apparatus	Kelba 1000kN Load Cell

<b>CLIENT:</b>	Qualtest Laboratory (NSW) Pty Ltd	
<b>PROJECT:</b>	NEW15P-0045 - Material Testing, Thornton NSW	<b>BEFORE TEST</b>
<b>LAB SAMPLE No.</b>	17010484	<b>DATE:</b> 23/1/17
<b>BOREHOLE:</b>	NEW17W-0173-S02 - DDH2	<b>DEPTH:</b> 24.70-24.90

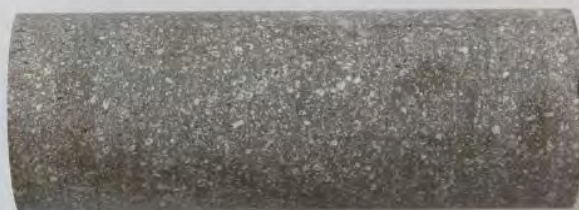
<b>CLIENT:</b>	Qualtest Laboratory (NSW) Pty Ltd	
<b>PROJECT:</b>	NEW15P-0045 - Material Testing, Thornton NSW	<b>BEFORE TEST</b>
<b>LAB SAMPLE No.</b>	17010485	<b>DATE:</b> 23/11/17
<b>BOREHOLE:</b>	NEW17W-0173-S03 - DDH2	<b>DEPTH:</b> 44.90-45.10

<b>Client</b>	Qualtest Laboratory (NSW) Pty Ltd	<b>Report No.</b>	17010485-MOD
Average Sample Diameter (mm)	60.6	Moisture Content (%)	0.6
Sample Height (mm)	160.2	Wet Density (t/m <sup>3</sup> )	2.60
Duration of Test (min)	10.20	Dry Density (t/m <sup>3</sup> )	2.59
Rate of Loading (MPa/min)	19.71	Bedding (°)	Nil
Mode of Failure	Disintegration	Test Apparatus	Kelba 1000kN Load Cell

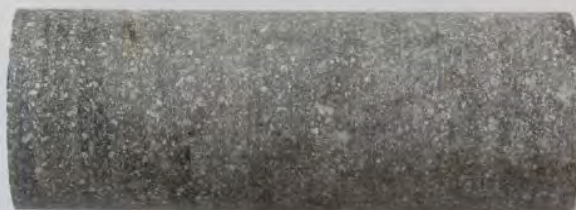
<b>CLIENT:</b>	Qualtest Laboratory (NSW) Pty Ltd	
<b>PROJECT:</b>	NEW15P-0045 - Material Testing, Thornton NSW	<b>BEFORE TEST</b>
<b>LAB SAMPLE No.</b>	17010486	<b>DATE:</b> 23/11/17
<b>BOREHOLE:</b>	NEW17W-0173-S04 - DDH2	<b>DEPTH:</b> 48.70-49.30

<b>Client</b>	Qualtest Laboratory (NSW) Pty Ltd	<b>Report No.</b>	17010486-MOD
Average Sample Diameter (mm)	60.7	Moisture Content (%)	0.5
Sample Height (mm)	161.2	Wet Density (t/m <sup>3</sup> )	2.60
Duration of Test (min)	9.35	Dry Density (t/m <sup>3</sup> )	2.59
Rate of Loading (MPa/min)	14.68	Bedding (°)	Nil
Mode of Failure	Disintegration	Test Apparatus	Kelba 1000kN Load Cell

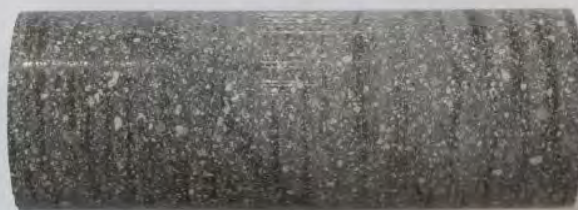
<b>CLIENT:</b>	Qualtest Laboratory (NSW) Pty Ltd	
<b>PROJECT:</b>	NEW15P-0045 - Material Testing, Thornton NSW	<b>BEFORE TEST</b>
<b>LAB SAMPLE No.</b>	17010487	<b>DATE:</b> 23/1/17
<b>BOREHOLE:</b>	NEW17W-0173-S05 - DDH2	<b>DEPTH:</b> 99.80-100.00

<b>Client</b>	Qualtest Laboratory (NSW) Pty Ltd	<b>Report No.</b>	17010487-MOD
Average Sample Diameter (mm)	60.4	Moisture Content (%)	0.4
Sample Height (mm)	160.0	Wet Density (t/m <sup>3</sup> )	2.64
Duration of Test (min)	10.73	Dry Density (t/m <sup>3</sup> )	2.63
Rate of Loading (MPa/min)	21.22	Bedding (°)	Nil
Mode of Failure	Disintegration	Test Apparatus	Kelba 1000kN Load Cell

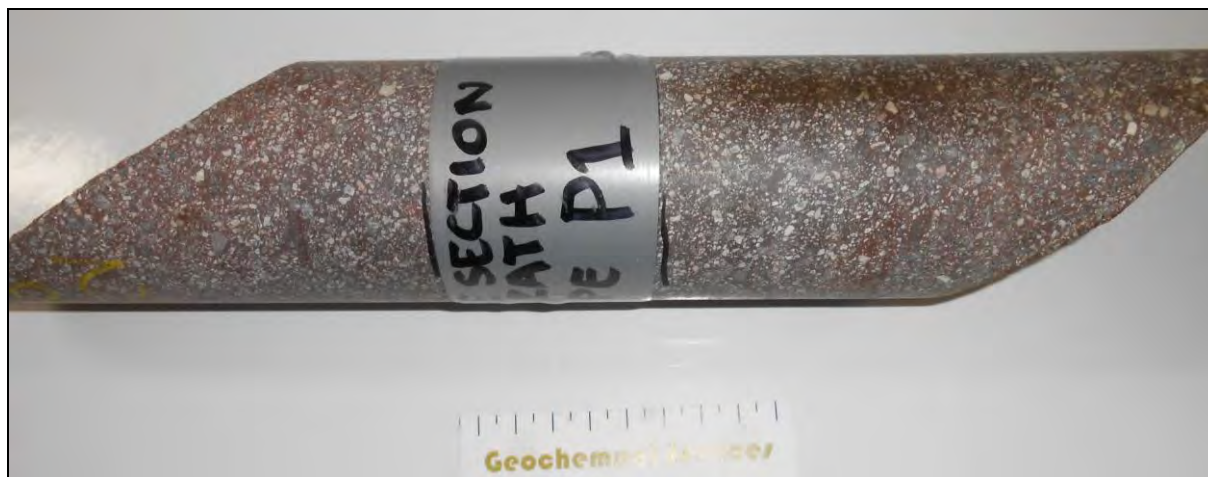
**Plate 1.** Photograph of the supplied drill core sample.

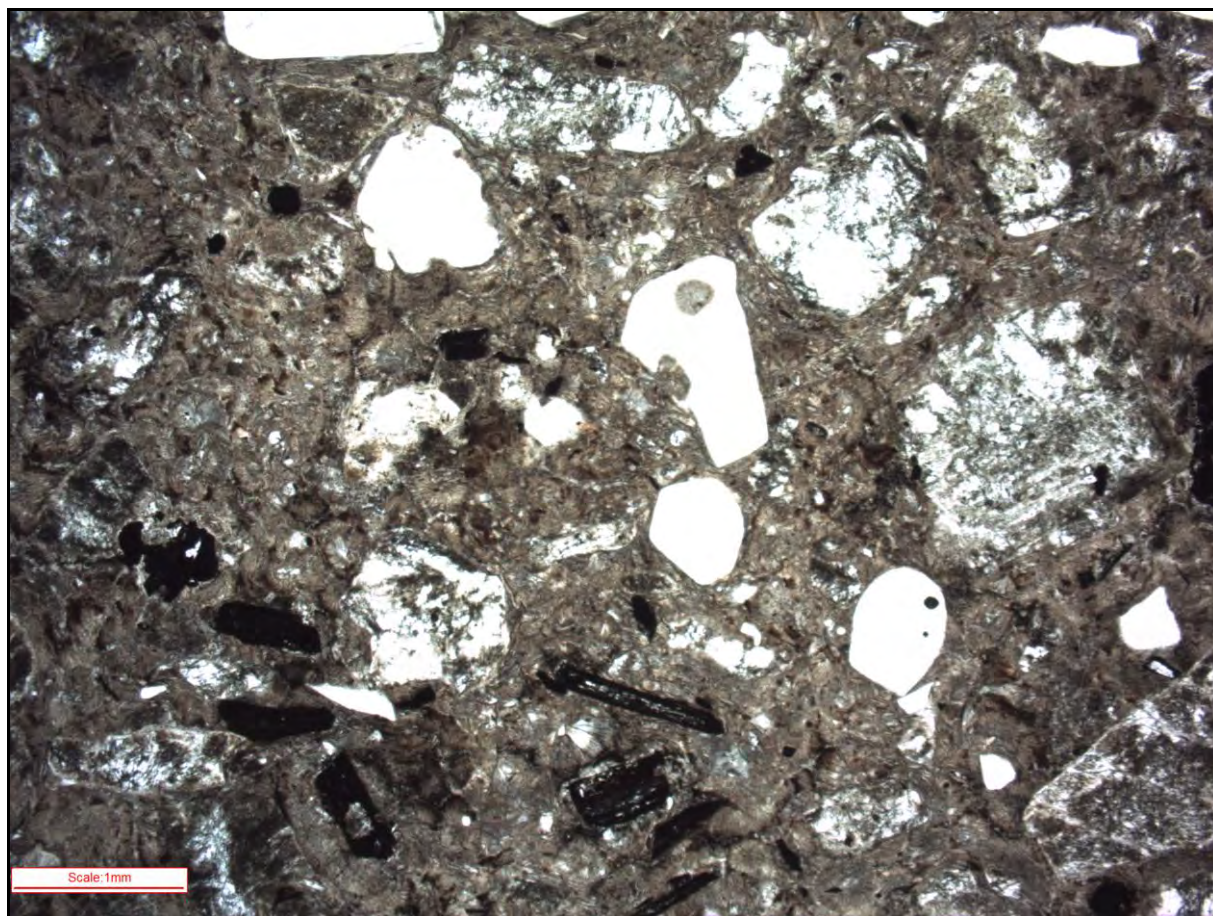
**Plate 2.** Low magnification, plane transmitted light image of part of hematitized acid tuff showing phenoclasts of quartz, feldspar, opaque oxide and altered biotite flakes in a finely devitrified matrix with obvious ghosts of former welded vitric shards showing fine pigmentation of hematite

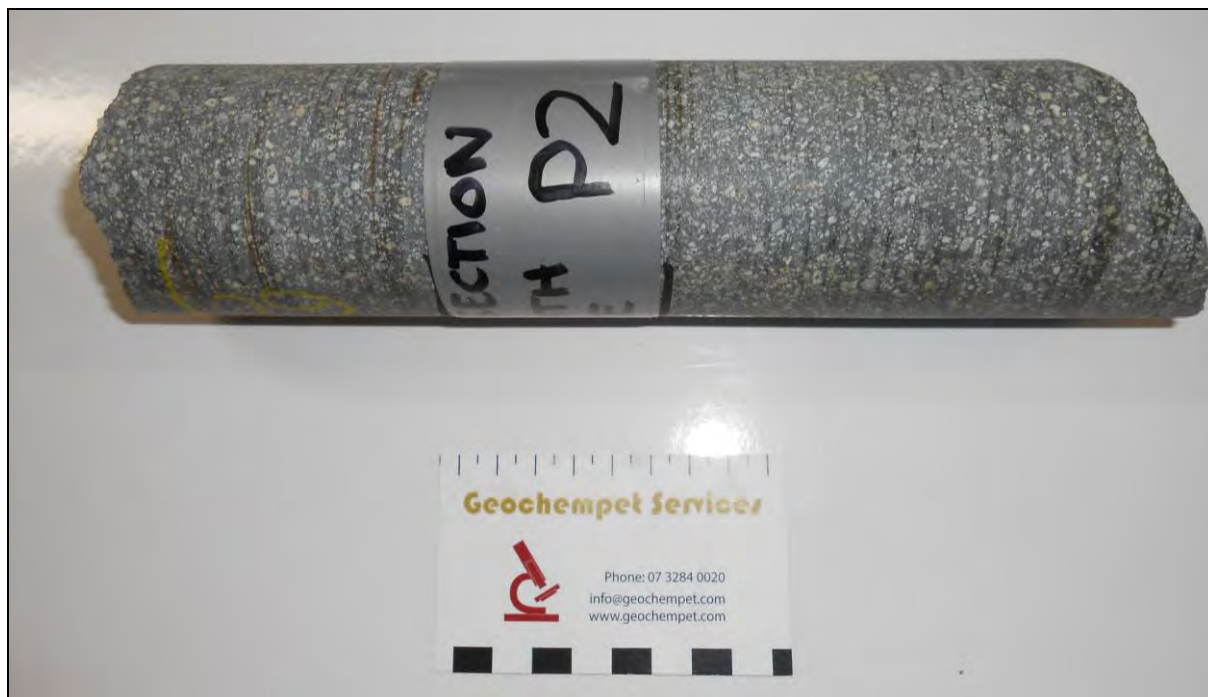
**Plate 1.** Photograph of the supplied drill core sample.

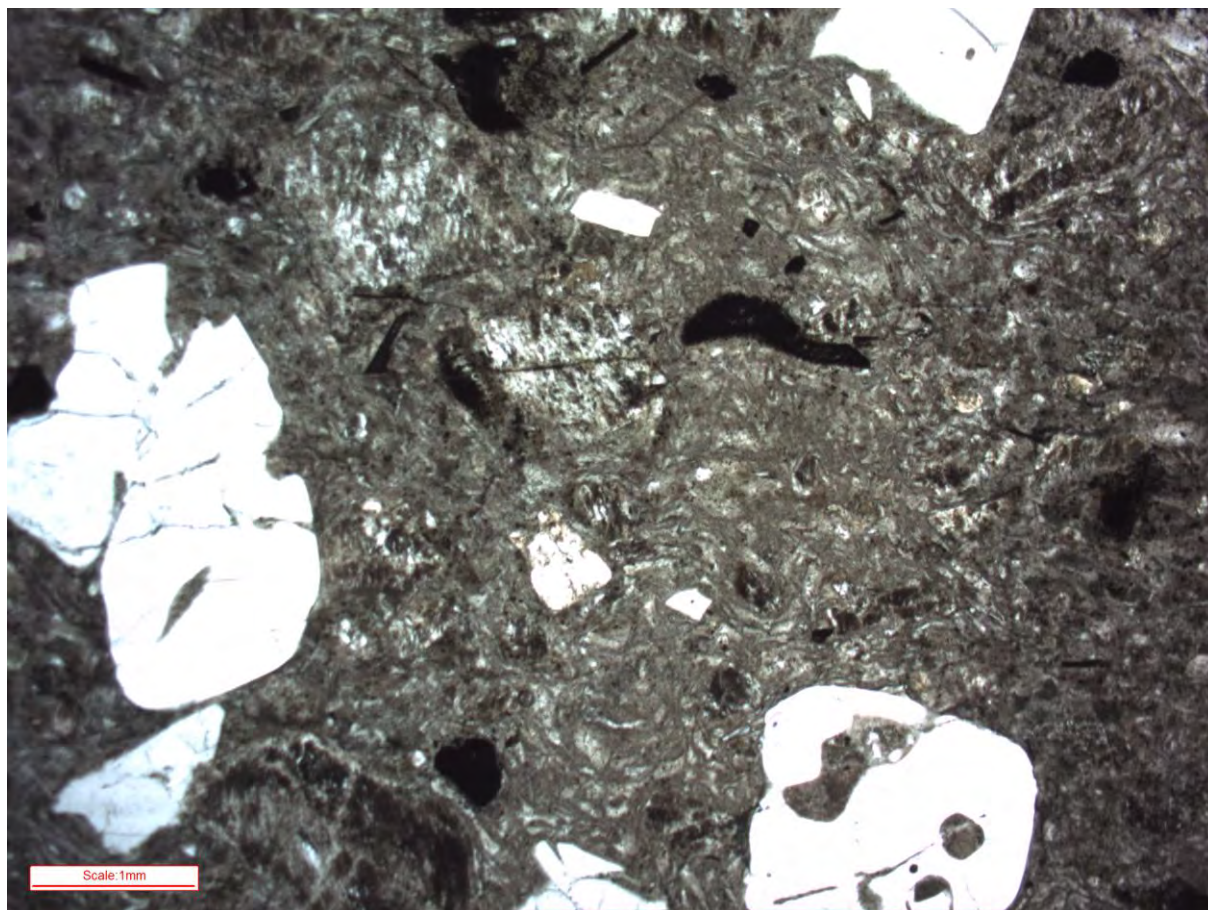
**Plate 2.** Low magnification, plane polarised, transmitted light image of part of acid tuff showing phenoclasts of white quartz, finely clouded feldspar, hematized and leucoxenized biotite and opaque oxide in a finely devitrified matrix with obvious ghosts of former welded vitric shards
