Faculty of Arts and Social Sciences (FASS) Building

Prepared for
University of Sydney
Lend Lease Building
Level 2. IXL Garage
2-10 Golden Grove Street
Darlington NSW 2008

Prepared by
Coffey Geotechnics Pty Ltd
Level 19, Tower B, 799 Pacific Highway
Chatswood NSW 2067 Australia
t: +61 2 9406 1000 f: +61 2 9406 1002
ABN: 93 056 929 483

17 May 2016

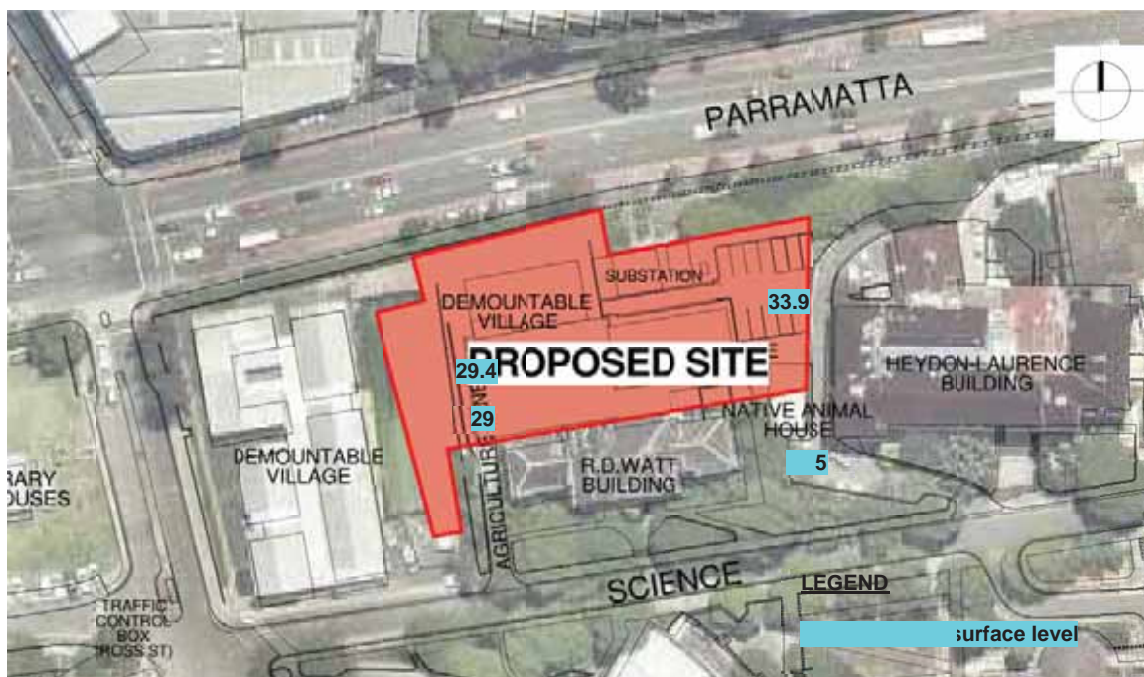
Figure 1- Site of the proposed FASS building

The existing ground surface slopes up from 29 mAHd in the south-west corner of the site to 33.9 mAHd to north-east corner of the site. Figure 1 shows the location of the proposed FASS building relative to other existing buildings and features.

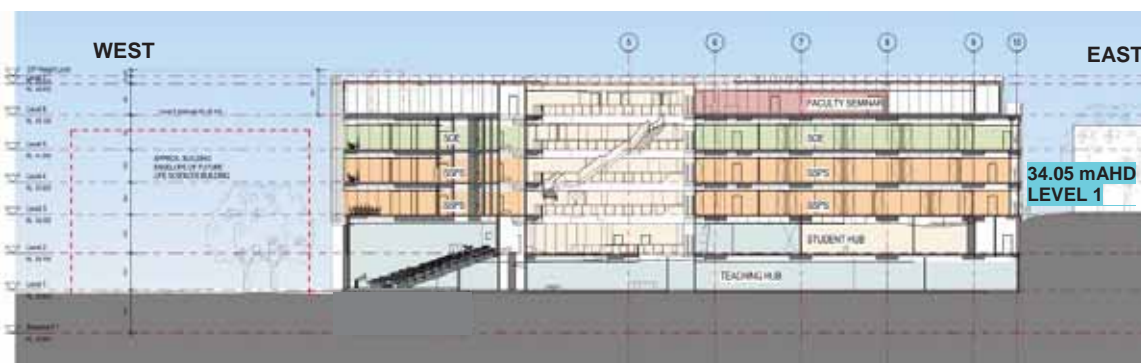
Figure 2- Section through the proposed FASS building looking north

The proposed development will be constructed between the demountable village in the west and access road in the east. Figure 2 shows a section through the FASS building looking north.

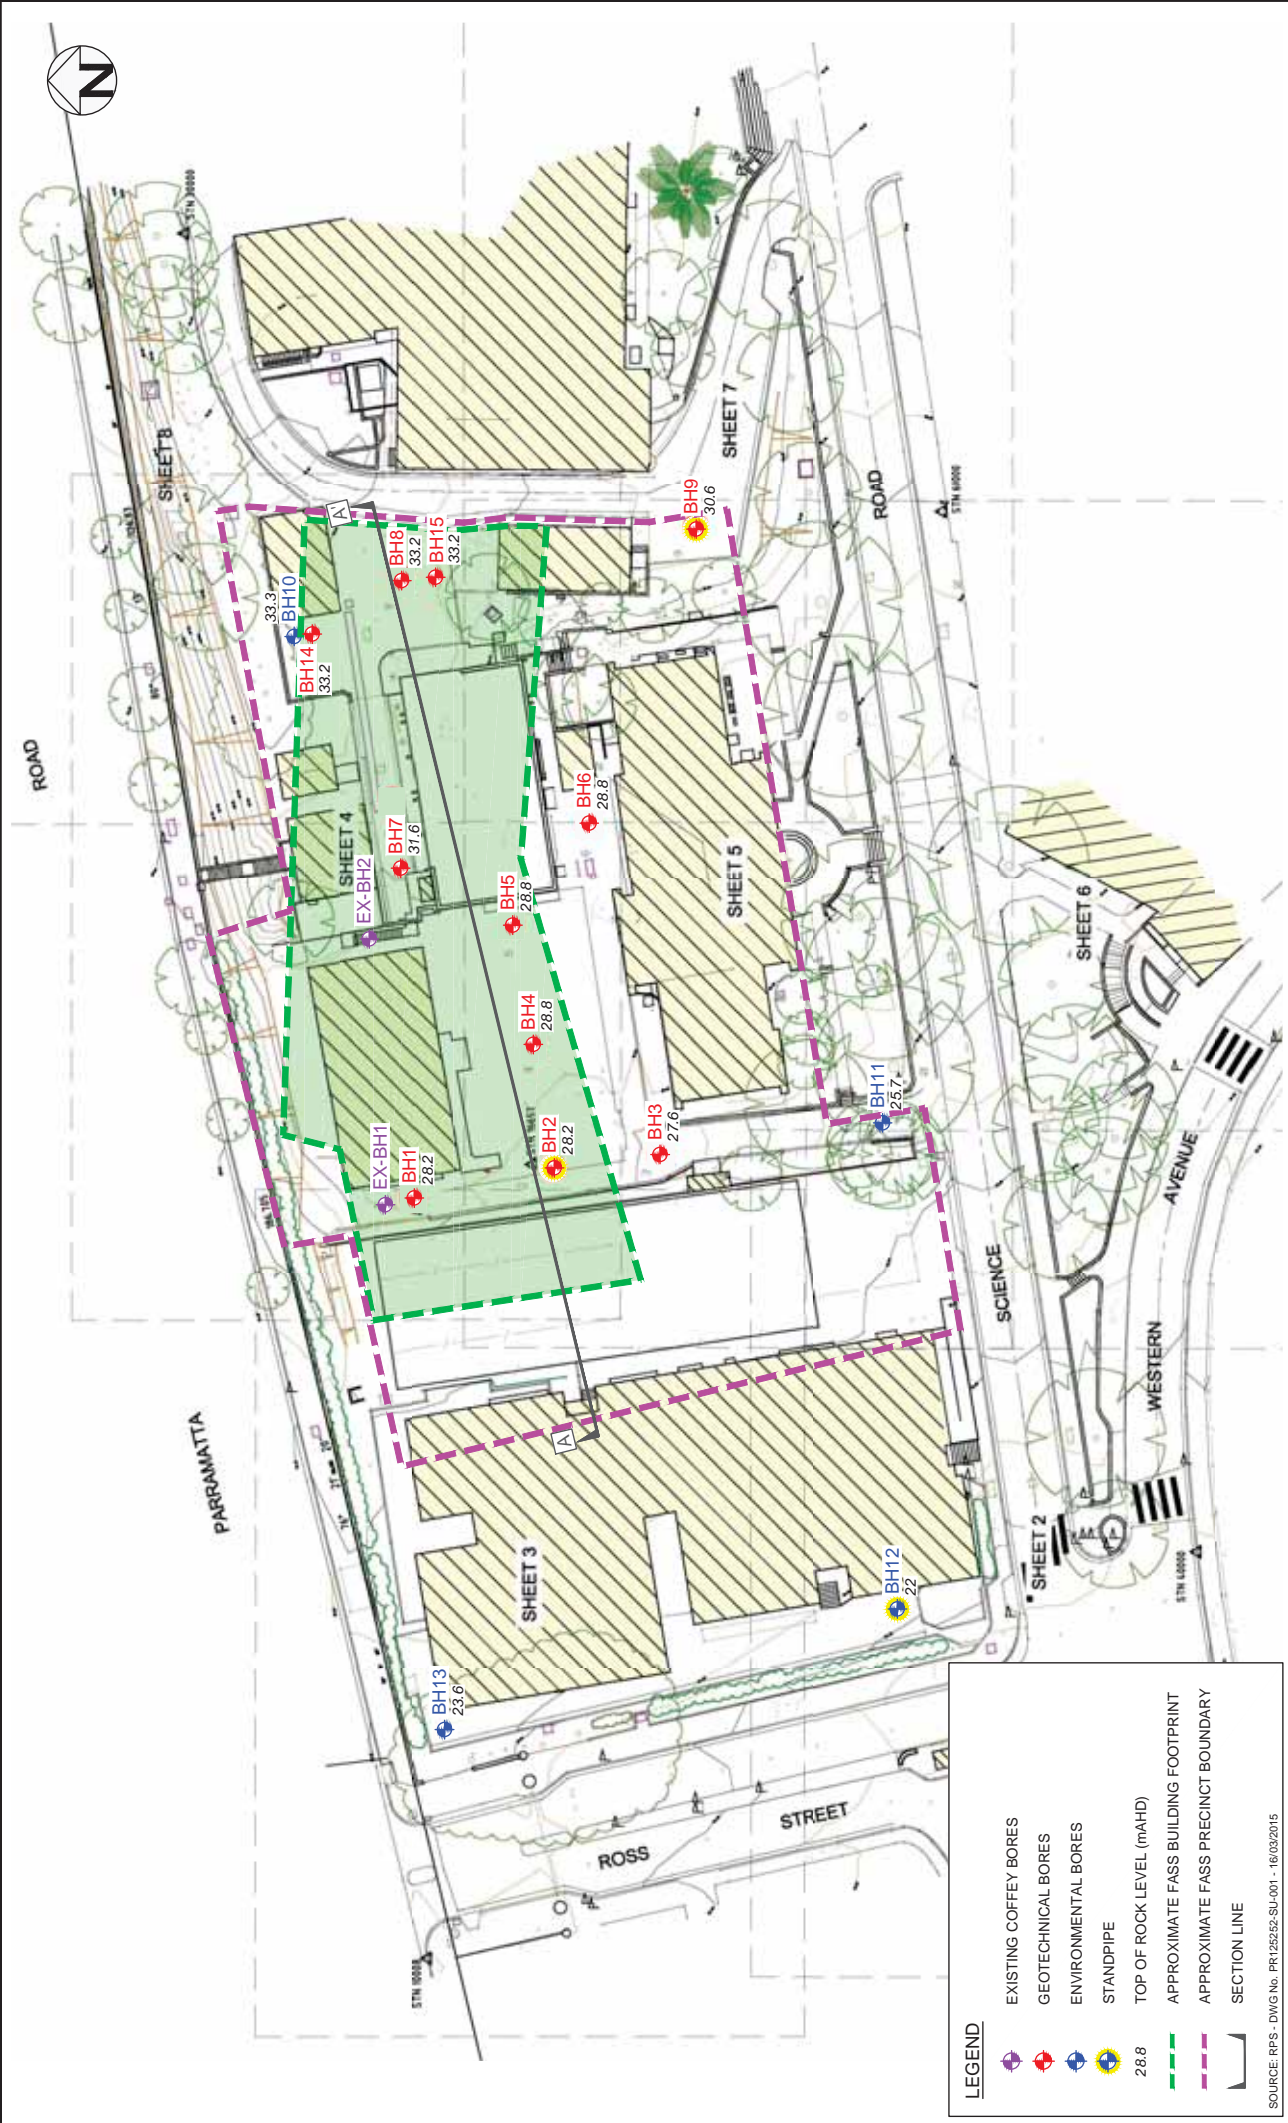
client:	UNIVERSITY OF SYDNEY C/O LEND LEASE BUILDING
project:	UNIVERSITY OF SYDNEY FASS BUILDING UNIVERSITY OF SYDNEY, NSW
title:	SITE AND BOREHOLE LOCATION PLAN
project no.:	GEOTLCOV25283AE-AC
figure no.:	DRAWING 1
rev.:	A

- EXISTING COFFEY BORES
- GEOTECHNICAL BORES
- ENVIRONMENTAL BORES
- STANDPIPE
- 28.8 TOP OF ROCK LEVEL (mAHd)
- APPROXIMATE FASS BUILDING FOOTPRINT
- APPROXIMATE FASS PRECINCT BOUNDARY
- SECTION LINE

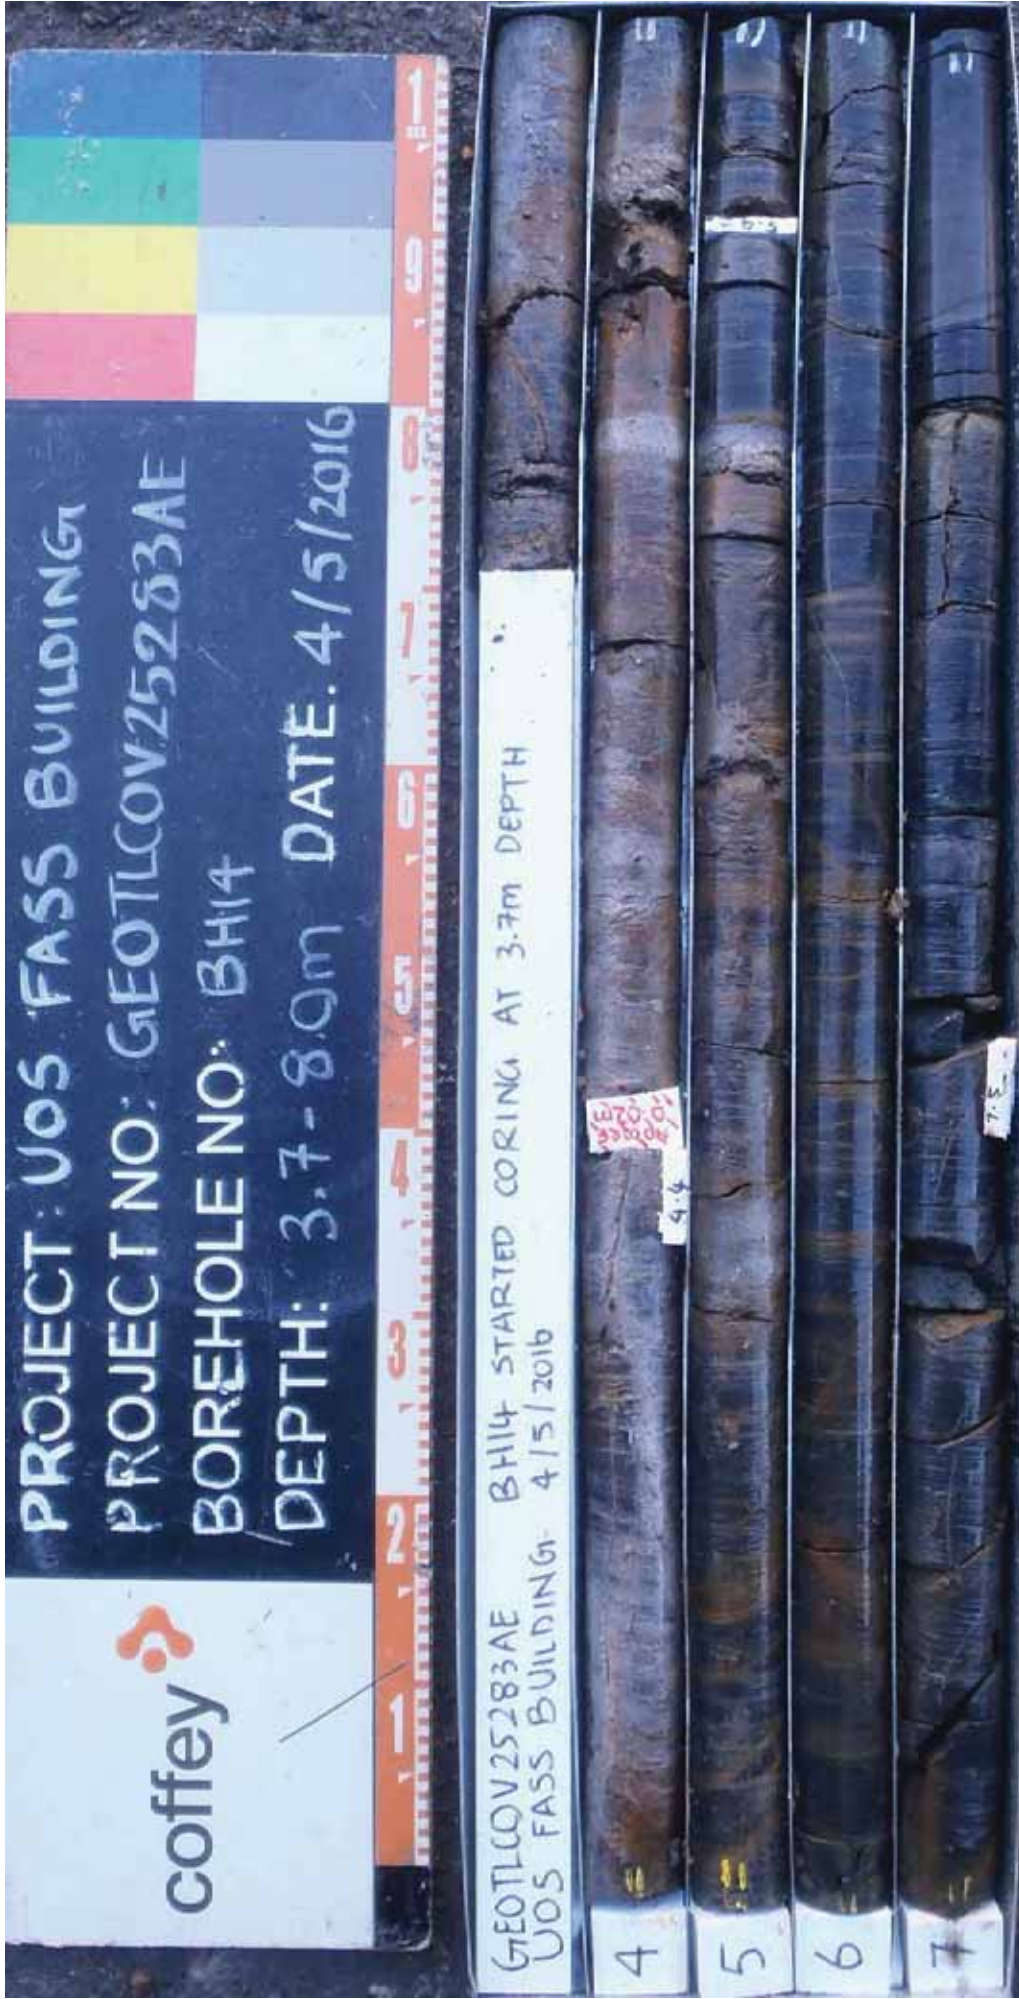
drawn	DK			client:	University of Sydney c/o- Lend Lease Building
approved	RT			project:	University of Sydney FASS Building
date	10/05/2016			title:	CORE PHOTOGRAPH BH14
scale	N.T.S.			project no:	GEO TLCOV25283AE
original size	A4			fig no:	FIGURE 1
				rev:

PointID : BH14 Depth Range: 3.70 - 8.00 m

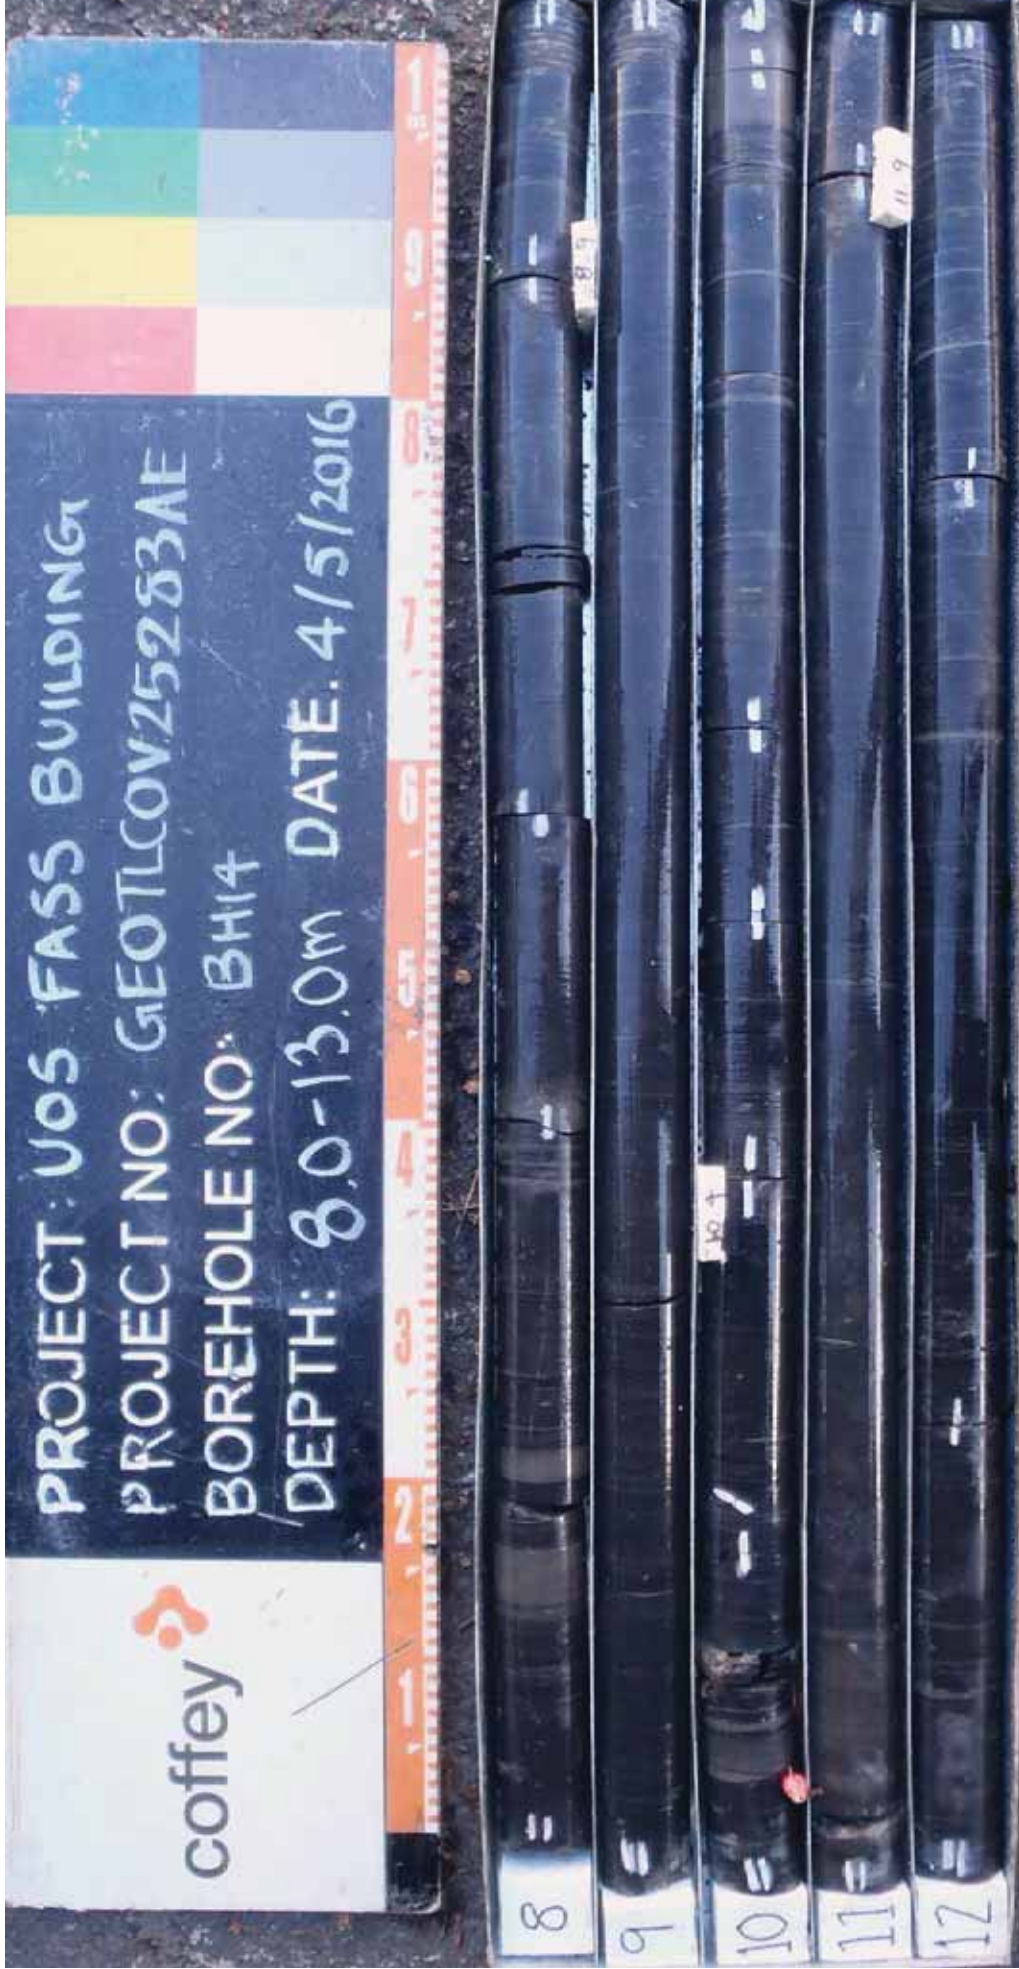
client:	University of Sydney c/o- Lend Lease Building
project:	University of Sydney FASS Building
title:	CORE PHOTOGRAPH BH14
project no:	GEOTLCOV25283AE
fig no:	FIGURE 2
rev:

PointID : BH14 Depth Range: 8.00 - 13.00 m

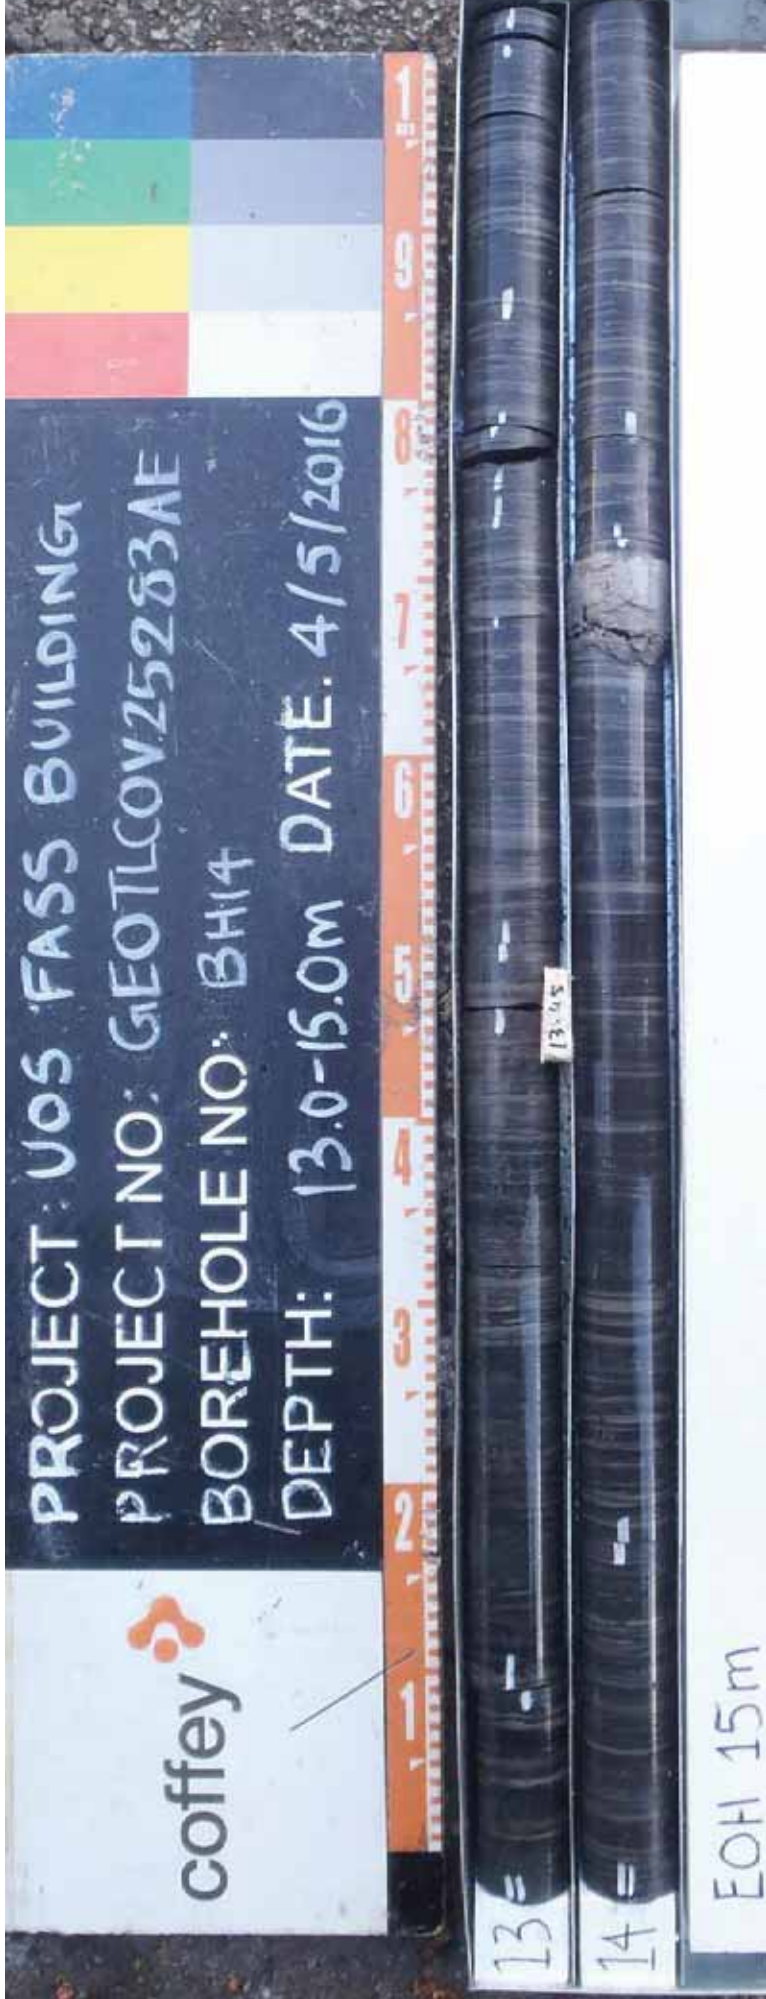
PointID : BH14 Depth Range: 13.00 - 15.00 m

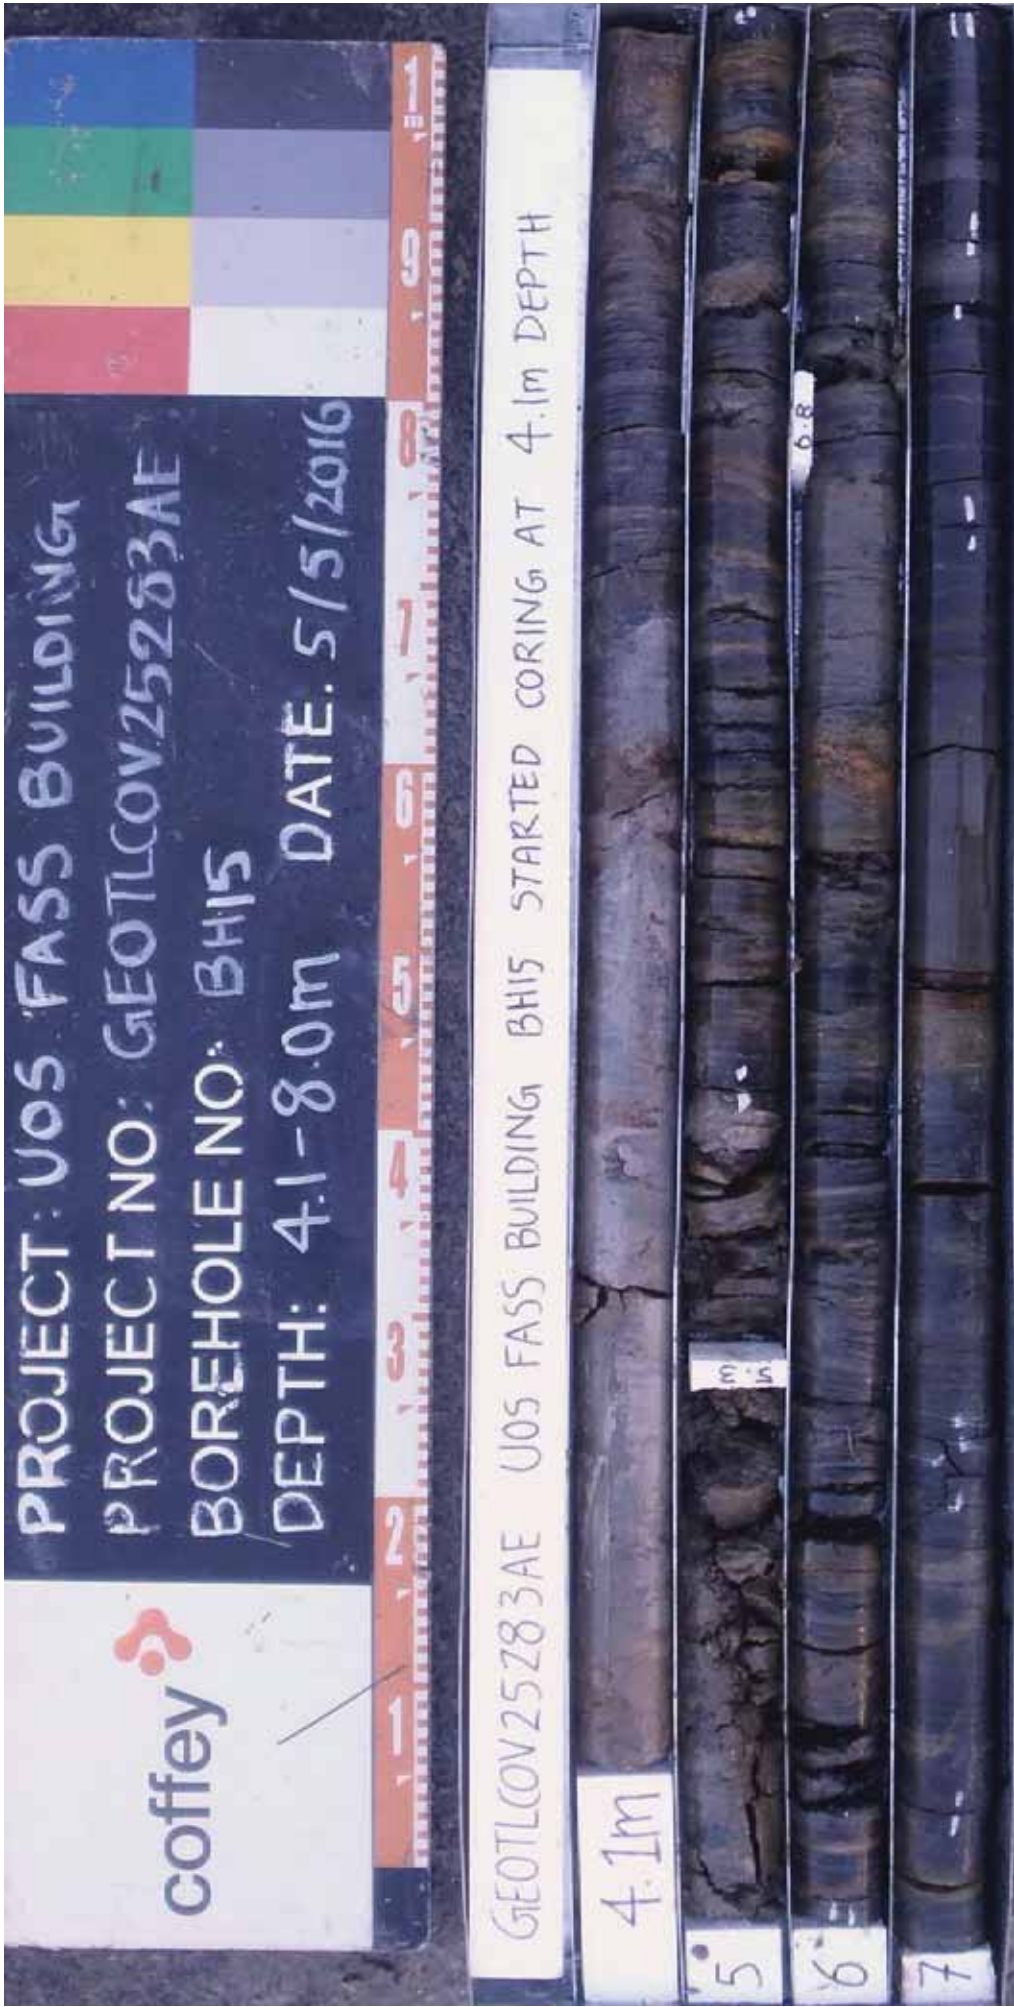
client:	University of Sydney c/o- Lend Lease Building
project:	University of Sydney FASS Building
title:	CORE PHOTOGRAPH BH15
project no:	GEOTLCOV25283AE
fig no:	FIGURE 1
rev:

PointID : BH15 Depth Range: 4.10 - 8.00 m

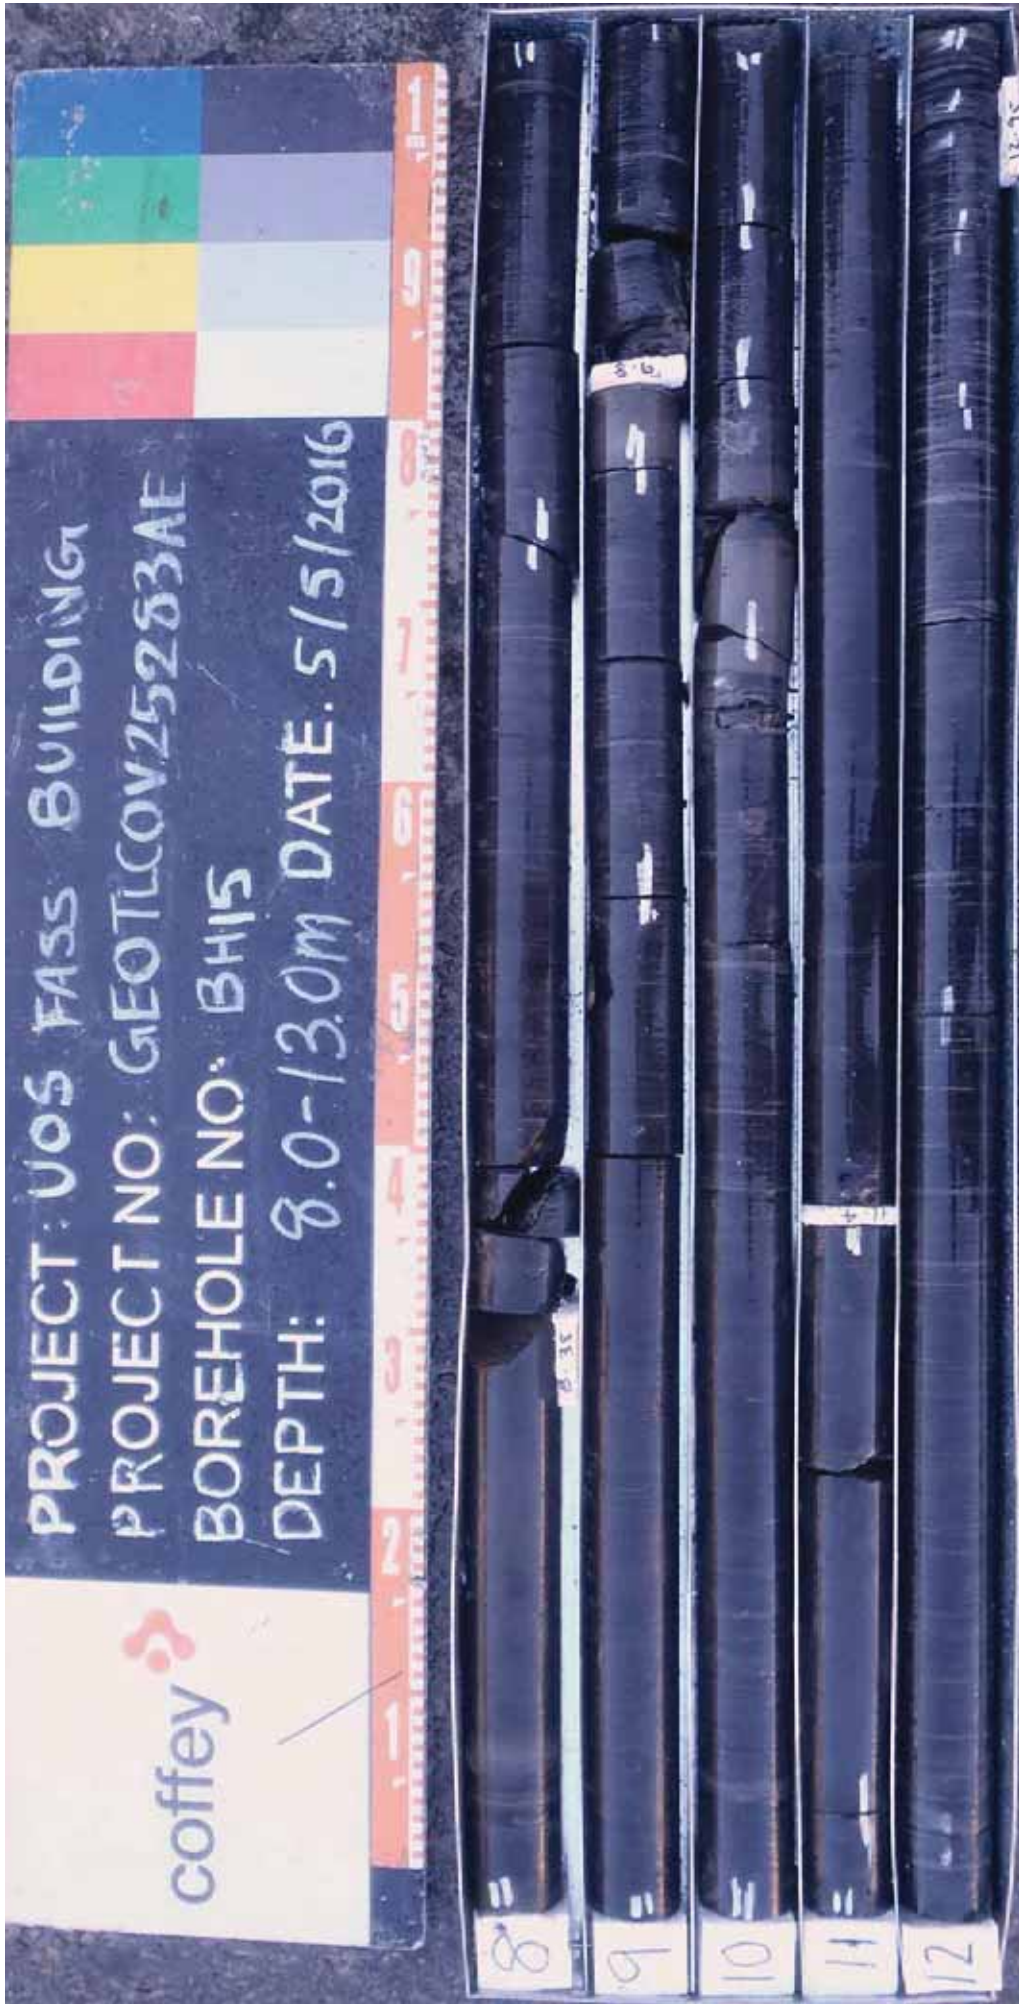
drawn	DK		client:	University of Sydney c/o- Lend Lease Building
approved	RT		project:	University of Sydney FASS Building
date	10/05/2016		title:	CORE PHOTOGRAPH BH15
scale	N.T.S.		project no:	GEOTLCOV25283AE
original size	A4		fig no:	FIGURE 2
			rev:

PointID : BH15 Depth Range: 8.00 - 13.00 m

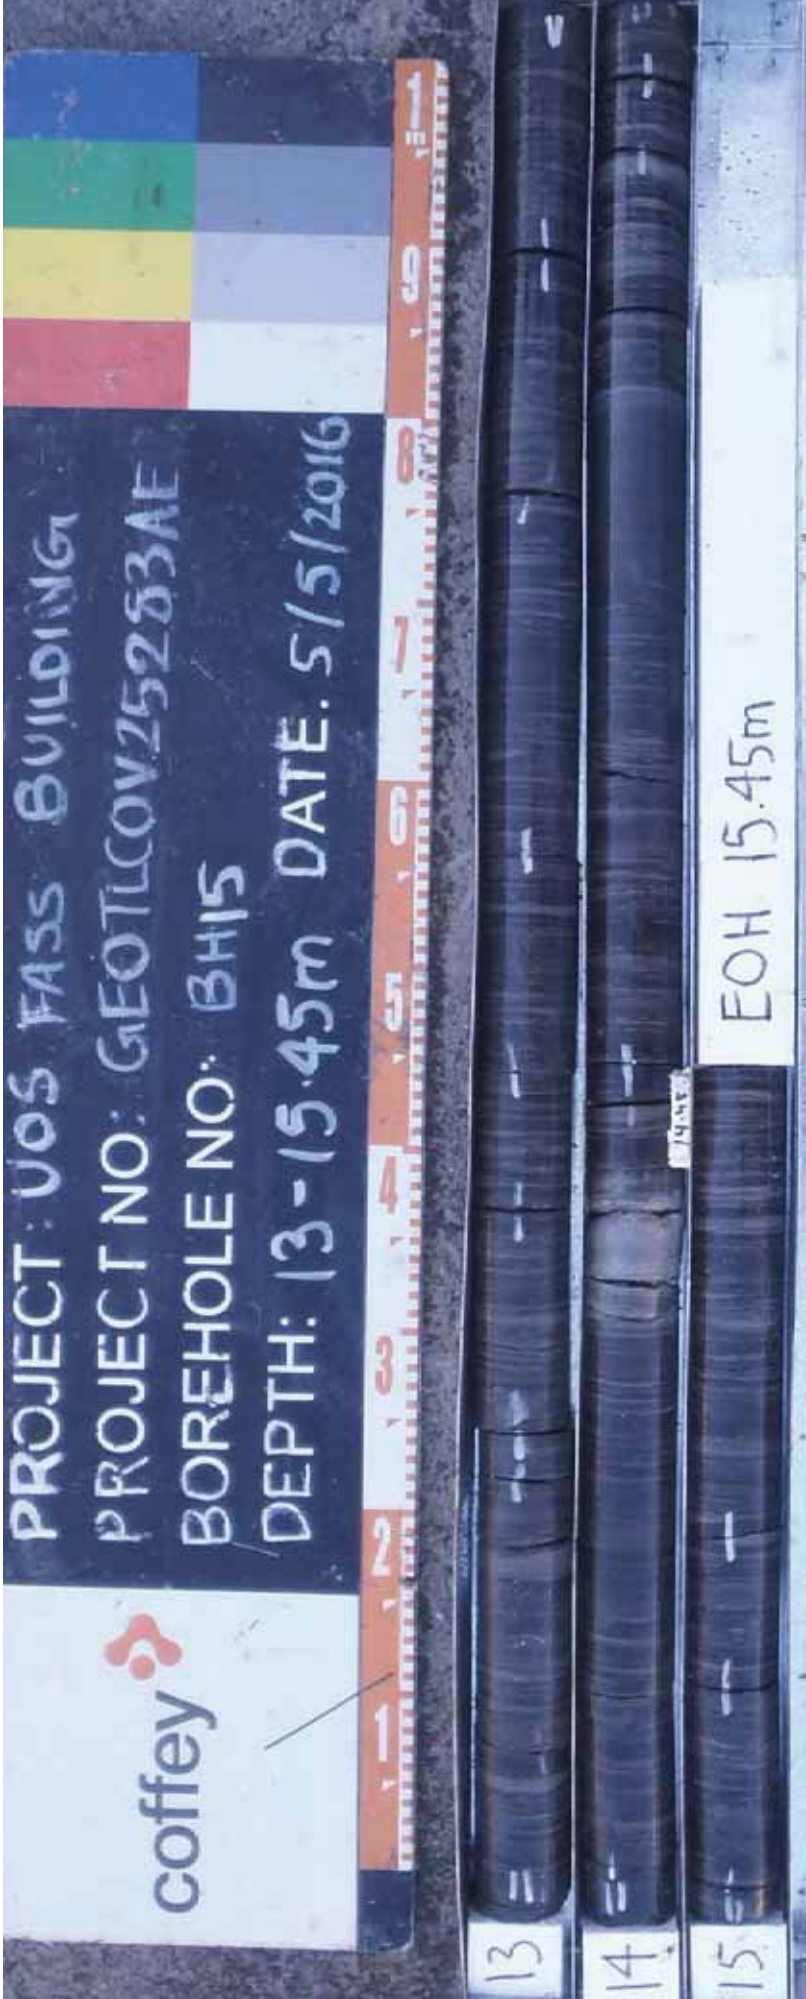
drawn	DK		client:	University of Sydney c/o- Lend Lease Building
approved	RT		project:	University of Sydney FASS Building
date	10/05/2016		title:	CORE PHOTOGRAPH BH15
scale	N.T.S.		project no:	GEOTLCOV25283AE
original size	A4		fig no:	FIGURE 3
			rev:

PointID : BH15 Depth Range: 13.00 - 15.45 m
