SSD-71052213: Gow Street Manufacturing and Warehouse Facility.

15 and 20 Gow Street, Padstow, NSW

28 October 2024

Remediation Action Plan

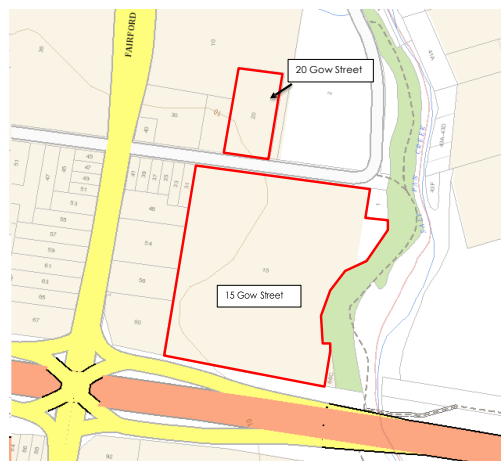
Figure A: Property Layout

The main portion of the property (15 Gow Street) is shared by two DuluxGroup owned entities, Selleys and Dulux, operating on separate portions in the east and north (Selleys) and west and central (Dulux) (refer **Figure 1**). The main chemical manufacturing activities currently occur at the Selleys factory. The premises at 20 Gow Street is on the opposite side of Gow Street, which consists of an open space carpark to service the Dulux facility. The property layout is provided on **Figure A**.

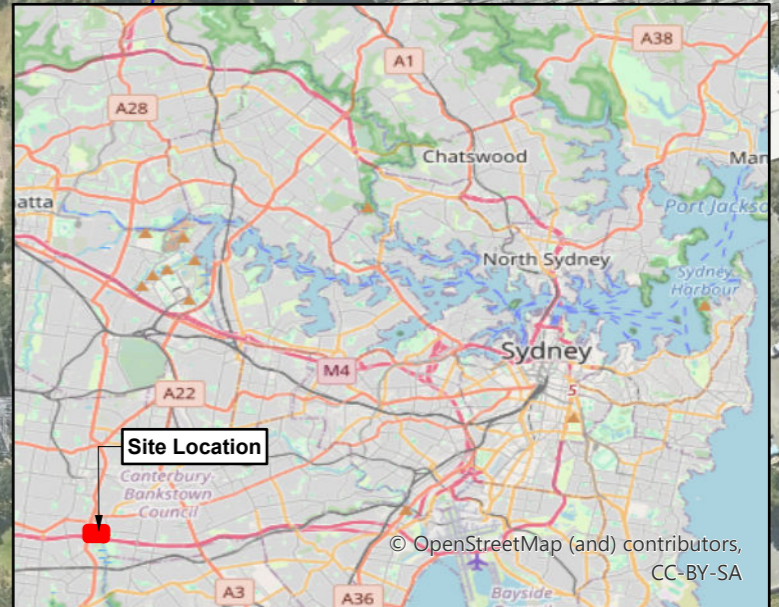
Figure No:	1
Title:	Site Location and Key Features
Project:	Remedial Action Plan
Location:	15 Gow Street, Padstow, NSW 2211
Client:	Dulux Group (Australia) Pty Ltd

Figure 4-1: Historic Investigation Locations

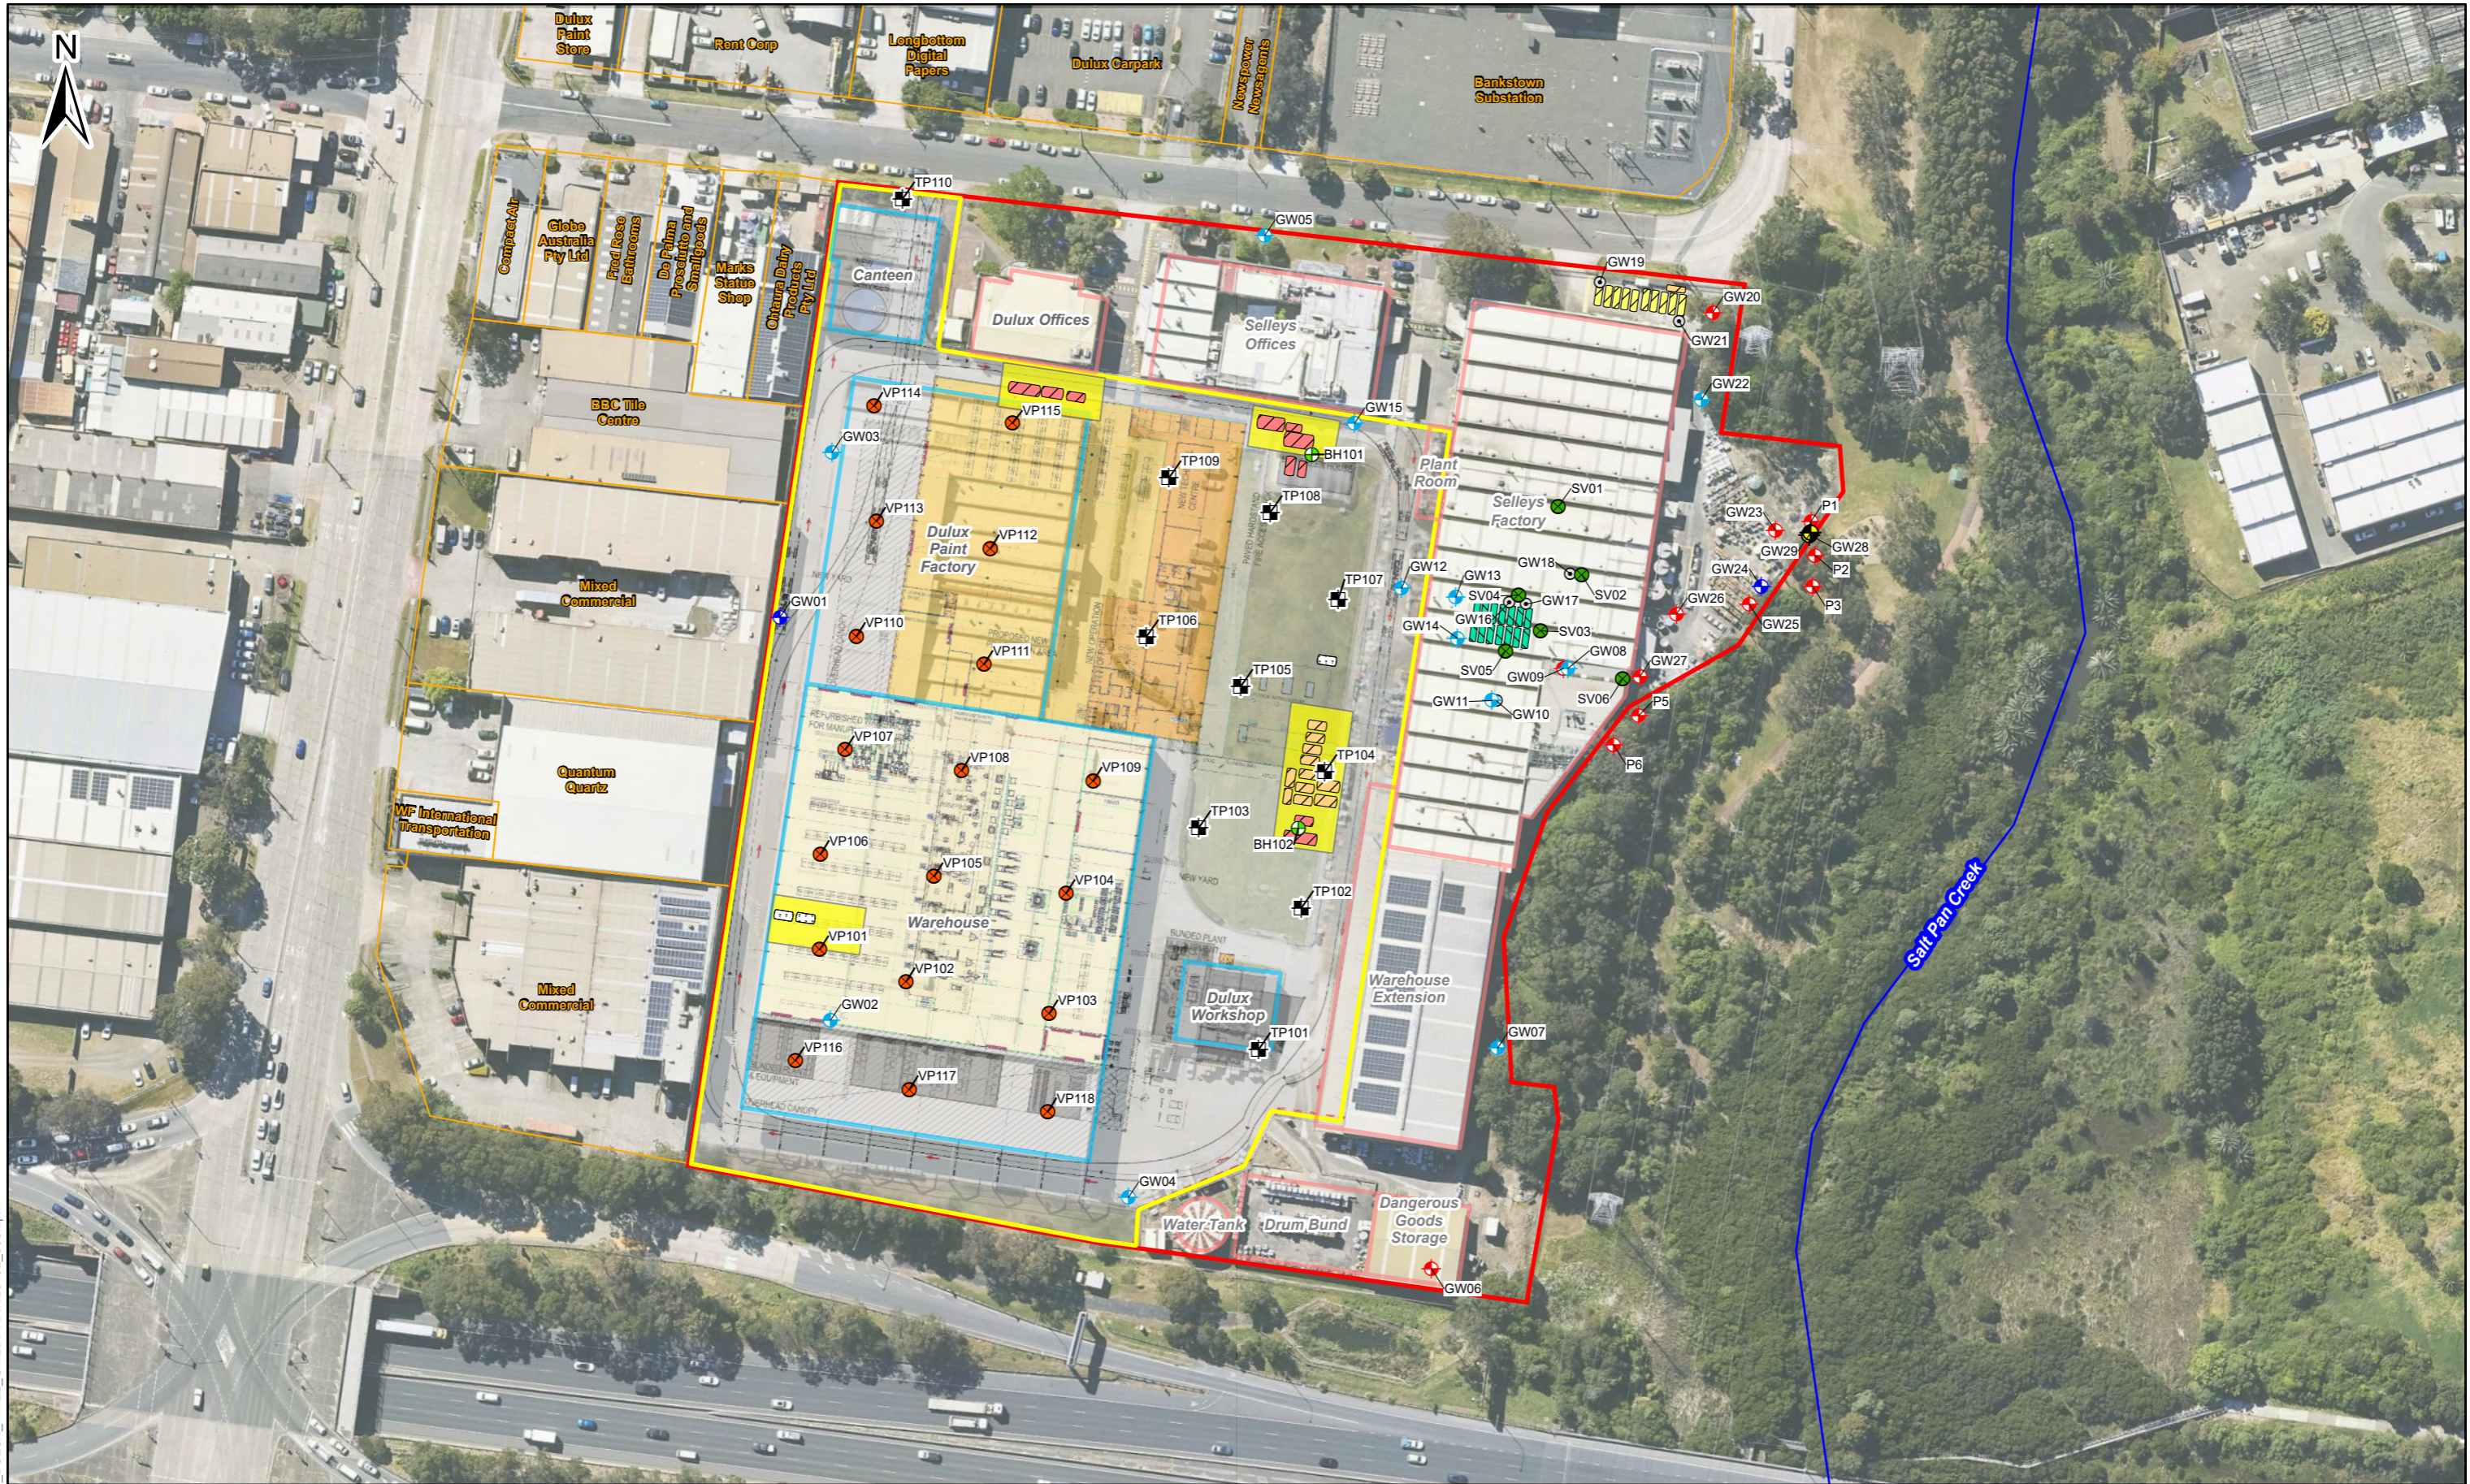
Figure No:	2
Title:	Future Land Use Type
Project:	Remedial Action Plan
Location:	15 Gow Street, Padstow, NSW 2211
Client:	Dulux Group (Australia) Pty Ltd

Notes:
Aerial Imagery (25/03/2024) © Metromap
Future Land Use Plan - 21202_SK15i

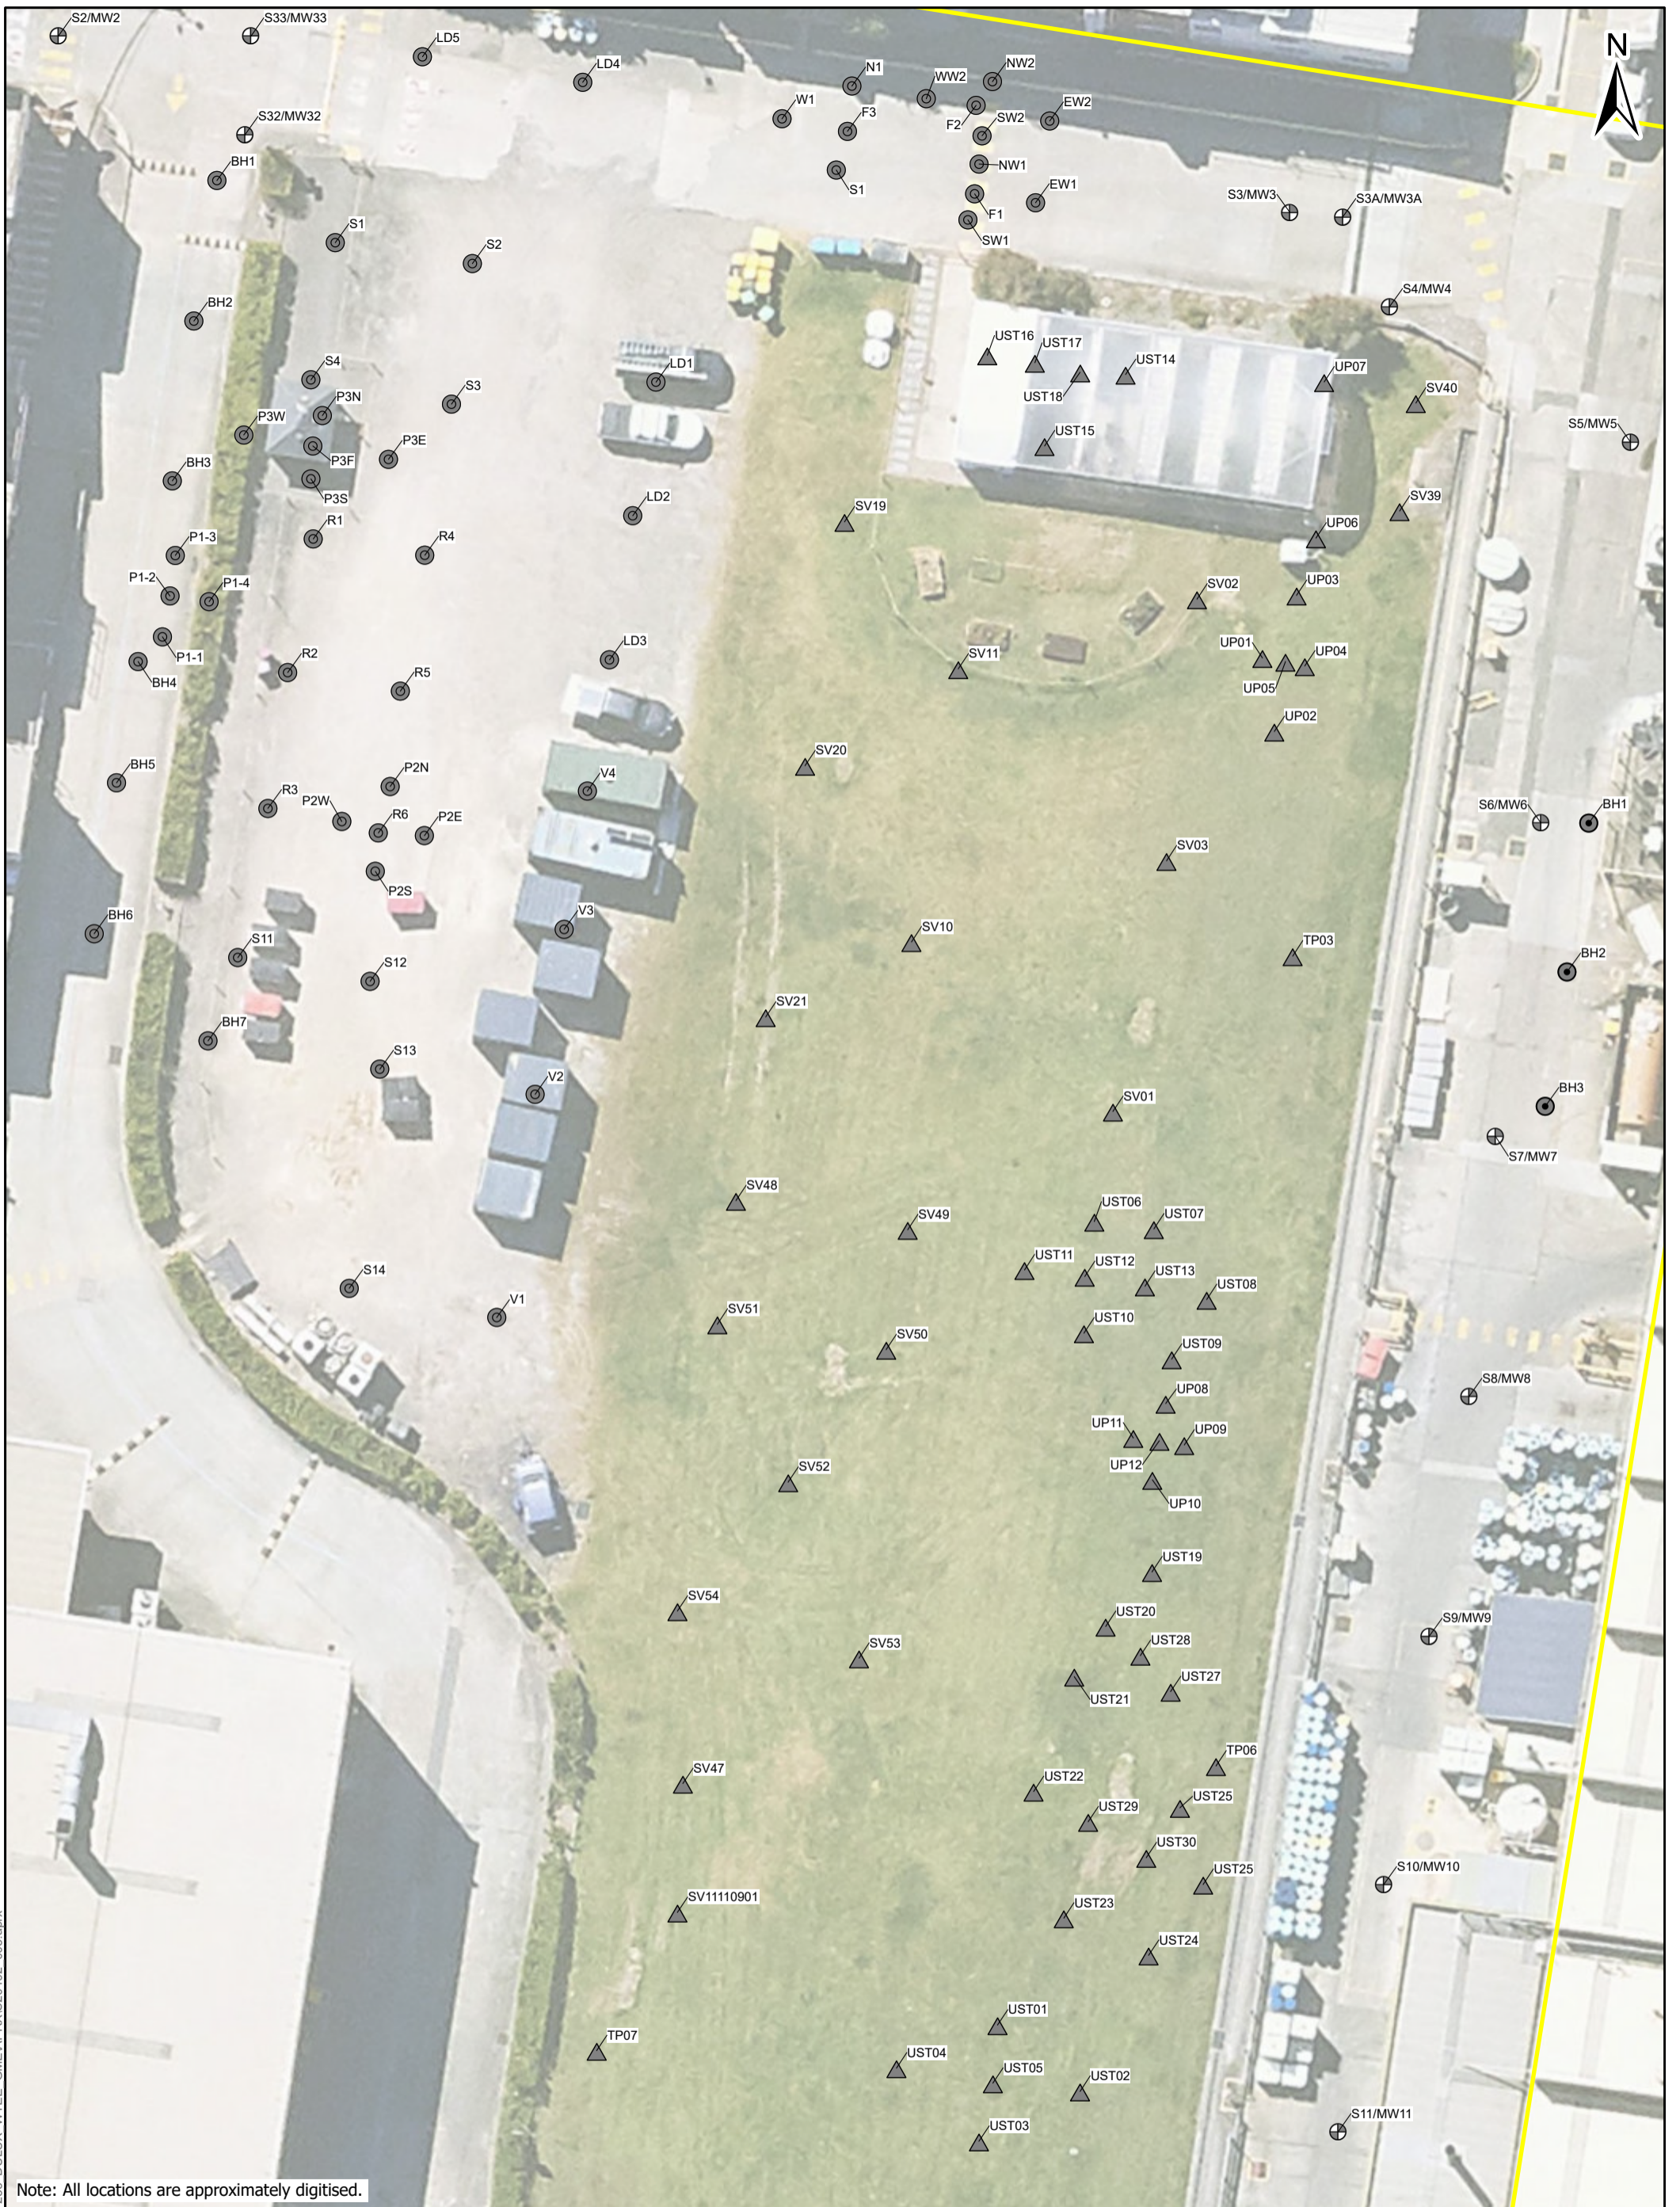
Figure No: 3
Title: Investigation Locations

Note: All locations are approximately digitised.

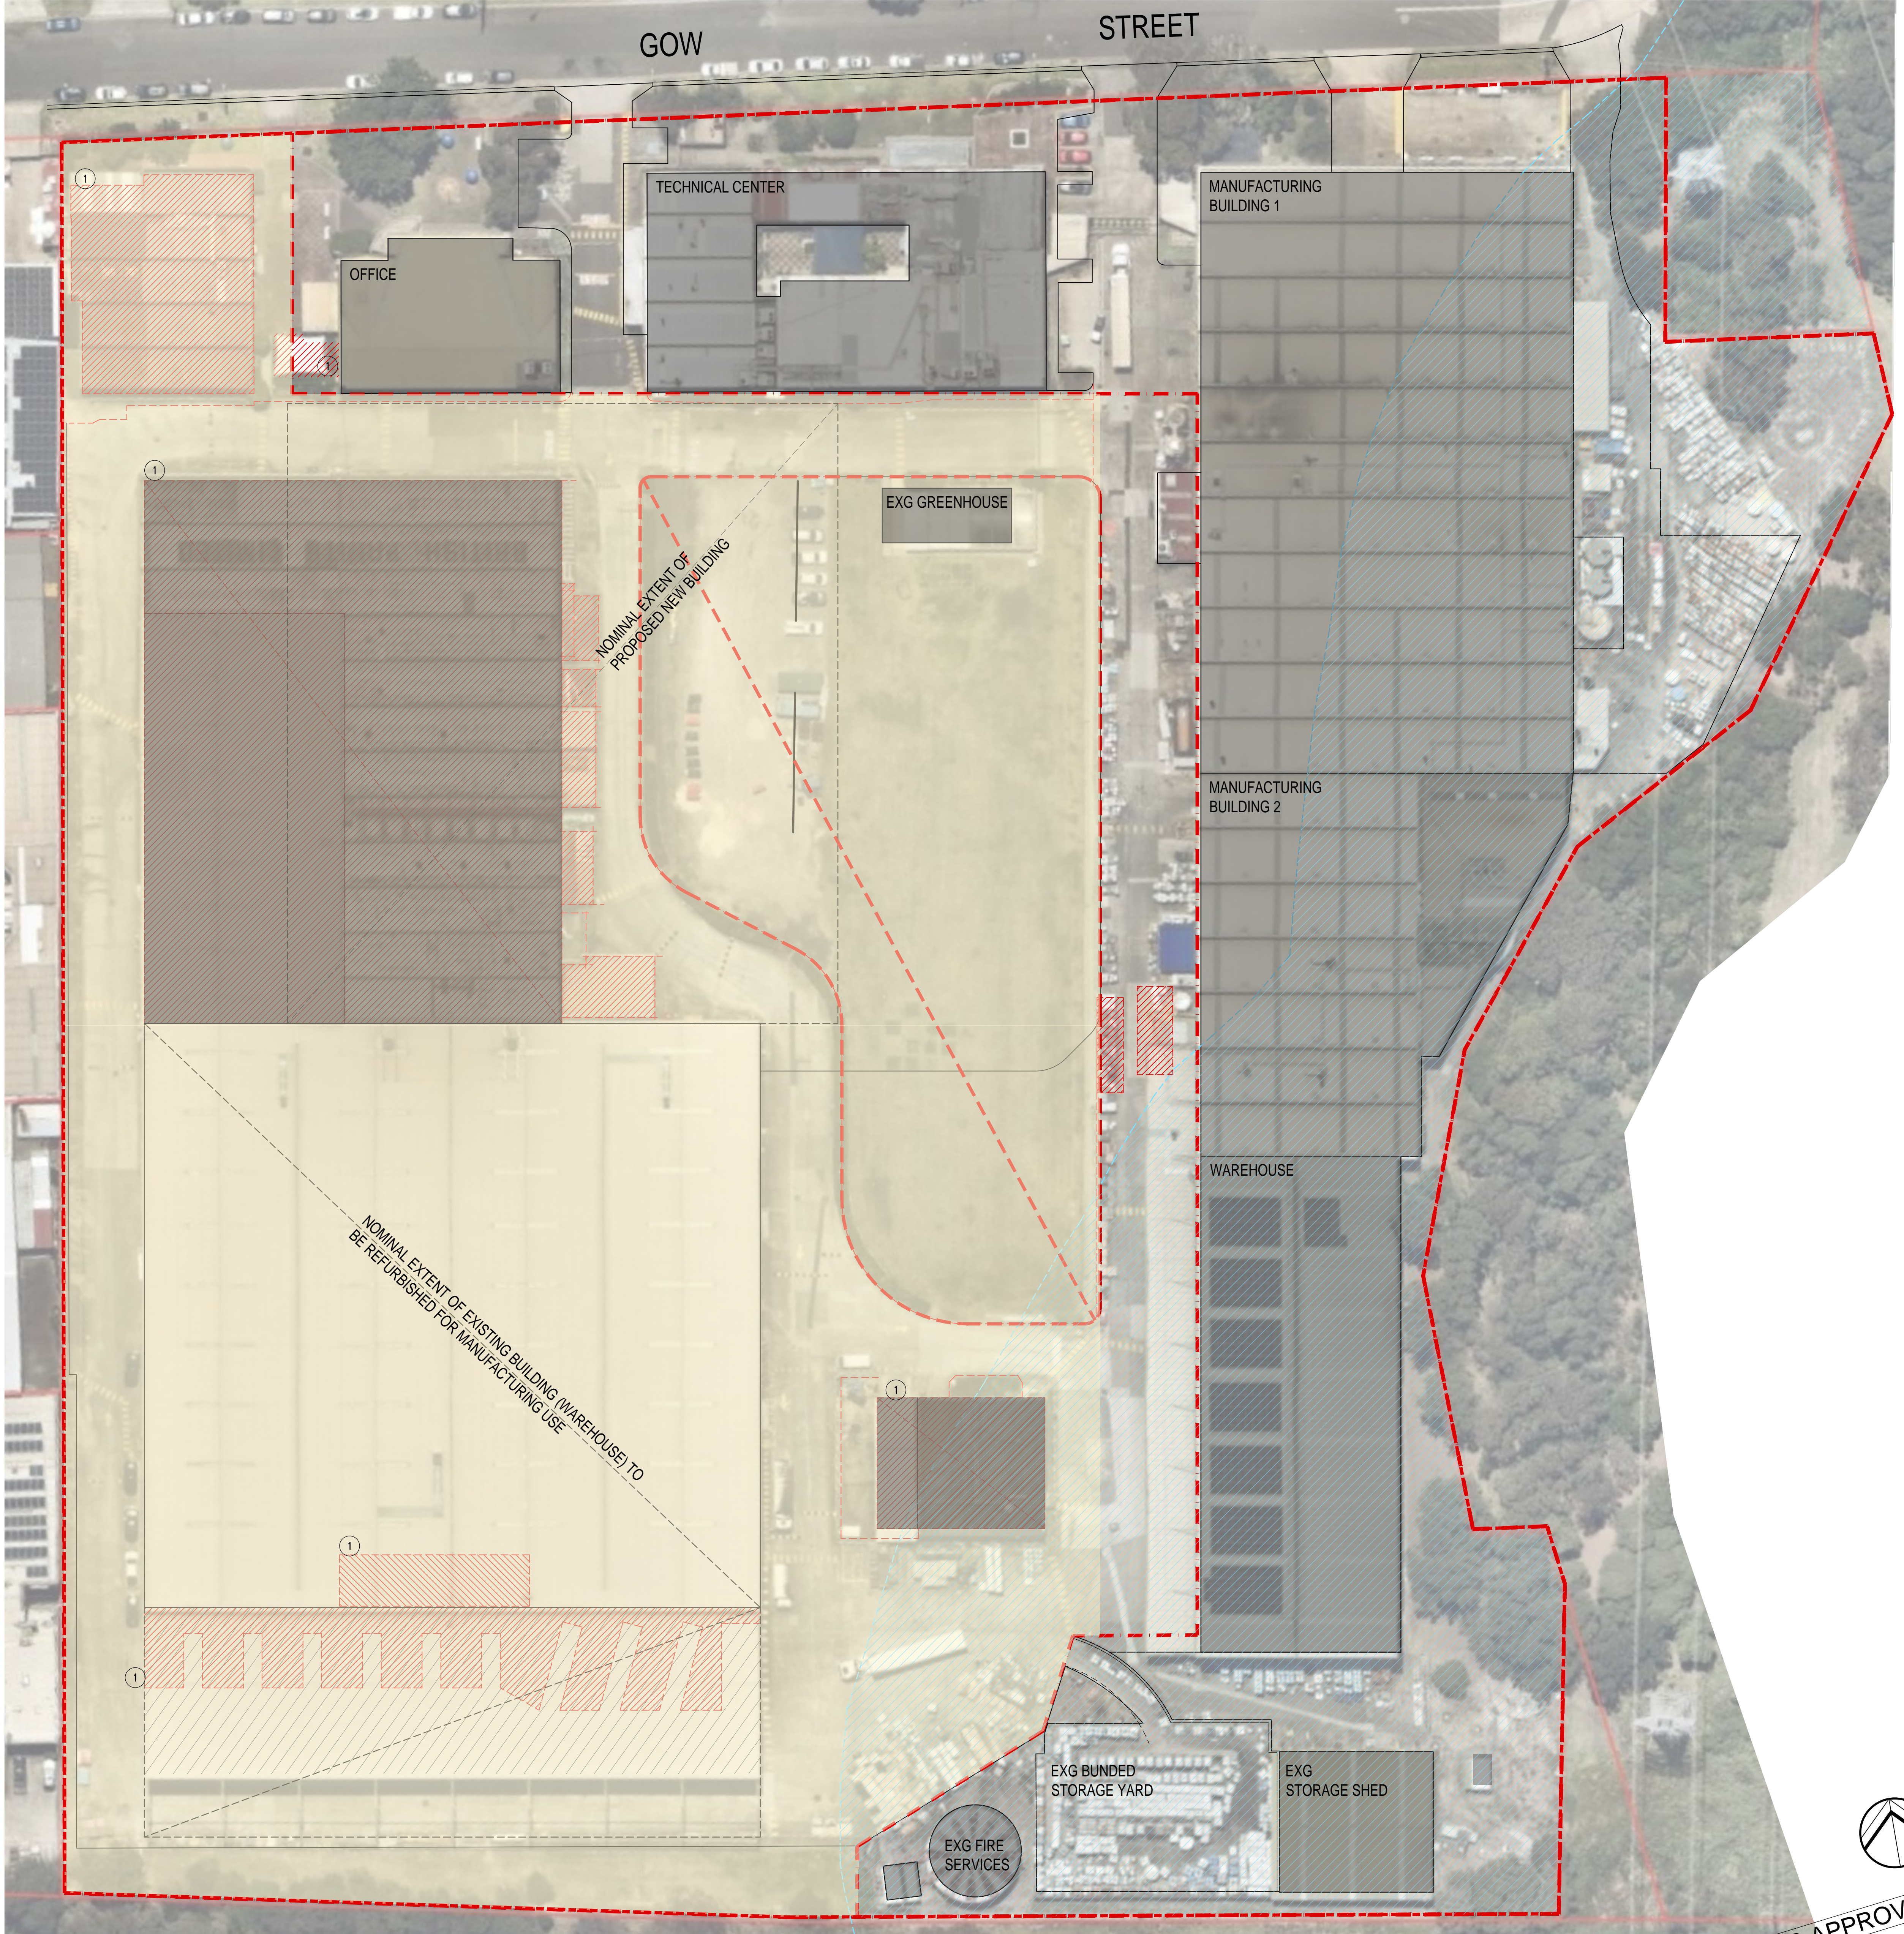
① EXISTING PRODUCTION / PLANT BUILDING

- NOMINAL EXTENT OF WORKS AREA MODIFICATION TO EXTERNAL PAVEMENTS TO BE CONFIRMED BY ENGINEER
- DEMOLISH EXISTING BUILDINGS INCLUDING WALLS AND STRUCTURE CUT AND SEAL EXISTING SERVICES
- RETAIN EXISTING GROUND PAVING
- EXTENT DENOTES EXISTING SOFT SCOPE TOP SOIL TO BE TAKEN UP
- HATCHED AREA DENOTES NOMINAL EXTENT OF ENVIRONMENTAL CONTROL
- HATCHED AREA DENOTES EXISTING BUILDINGS TO BE RETAINED, AND OPERATIONS TO CONTINUE DURING DEVELOPMENT
