2 & 10-22 Kent Road and 685 Gardeners Road, Mascot NSW

Remedial Action Plan

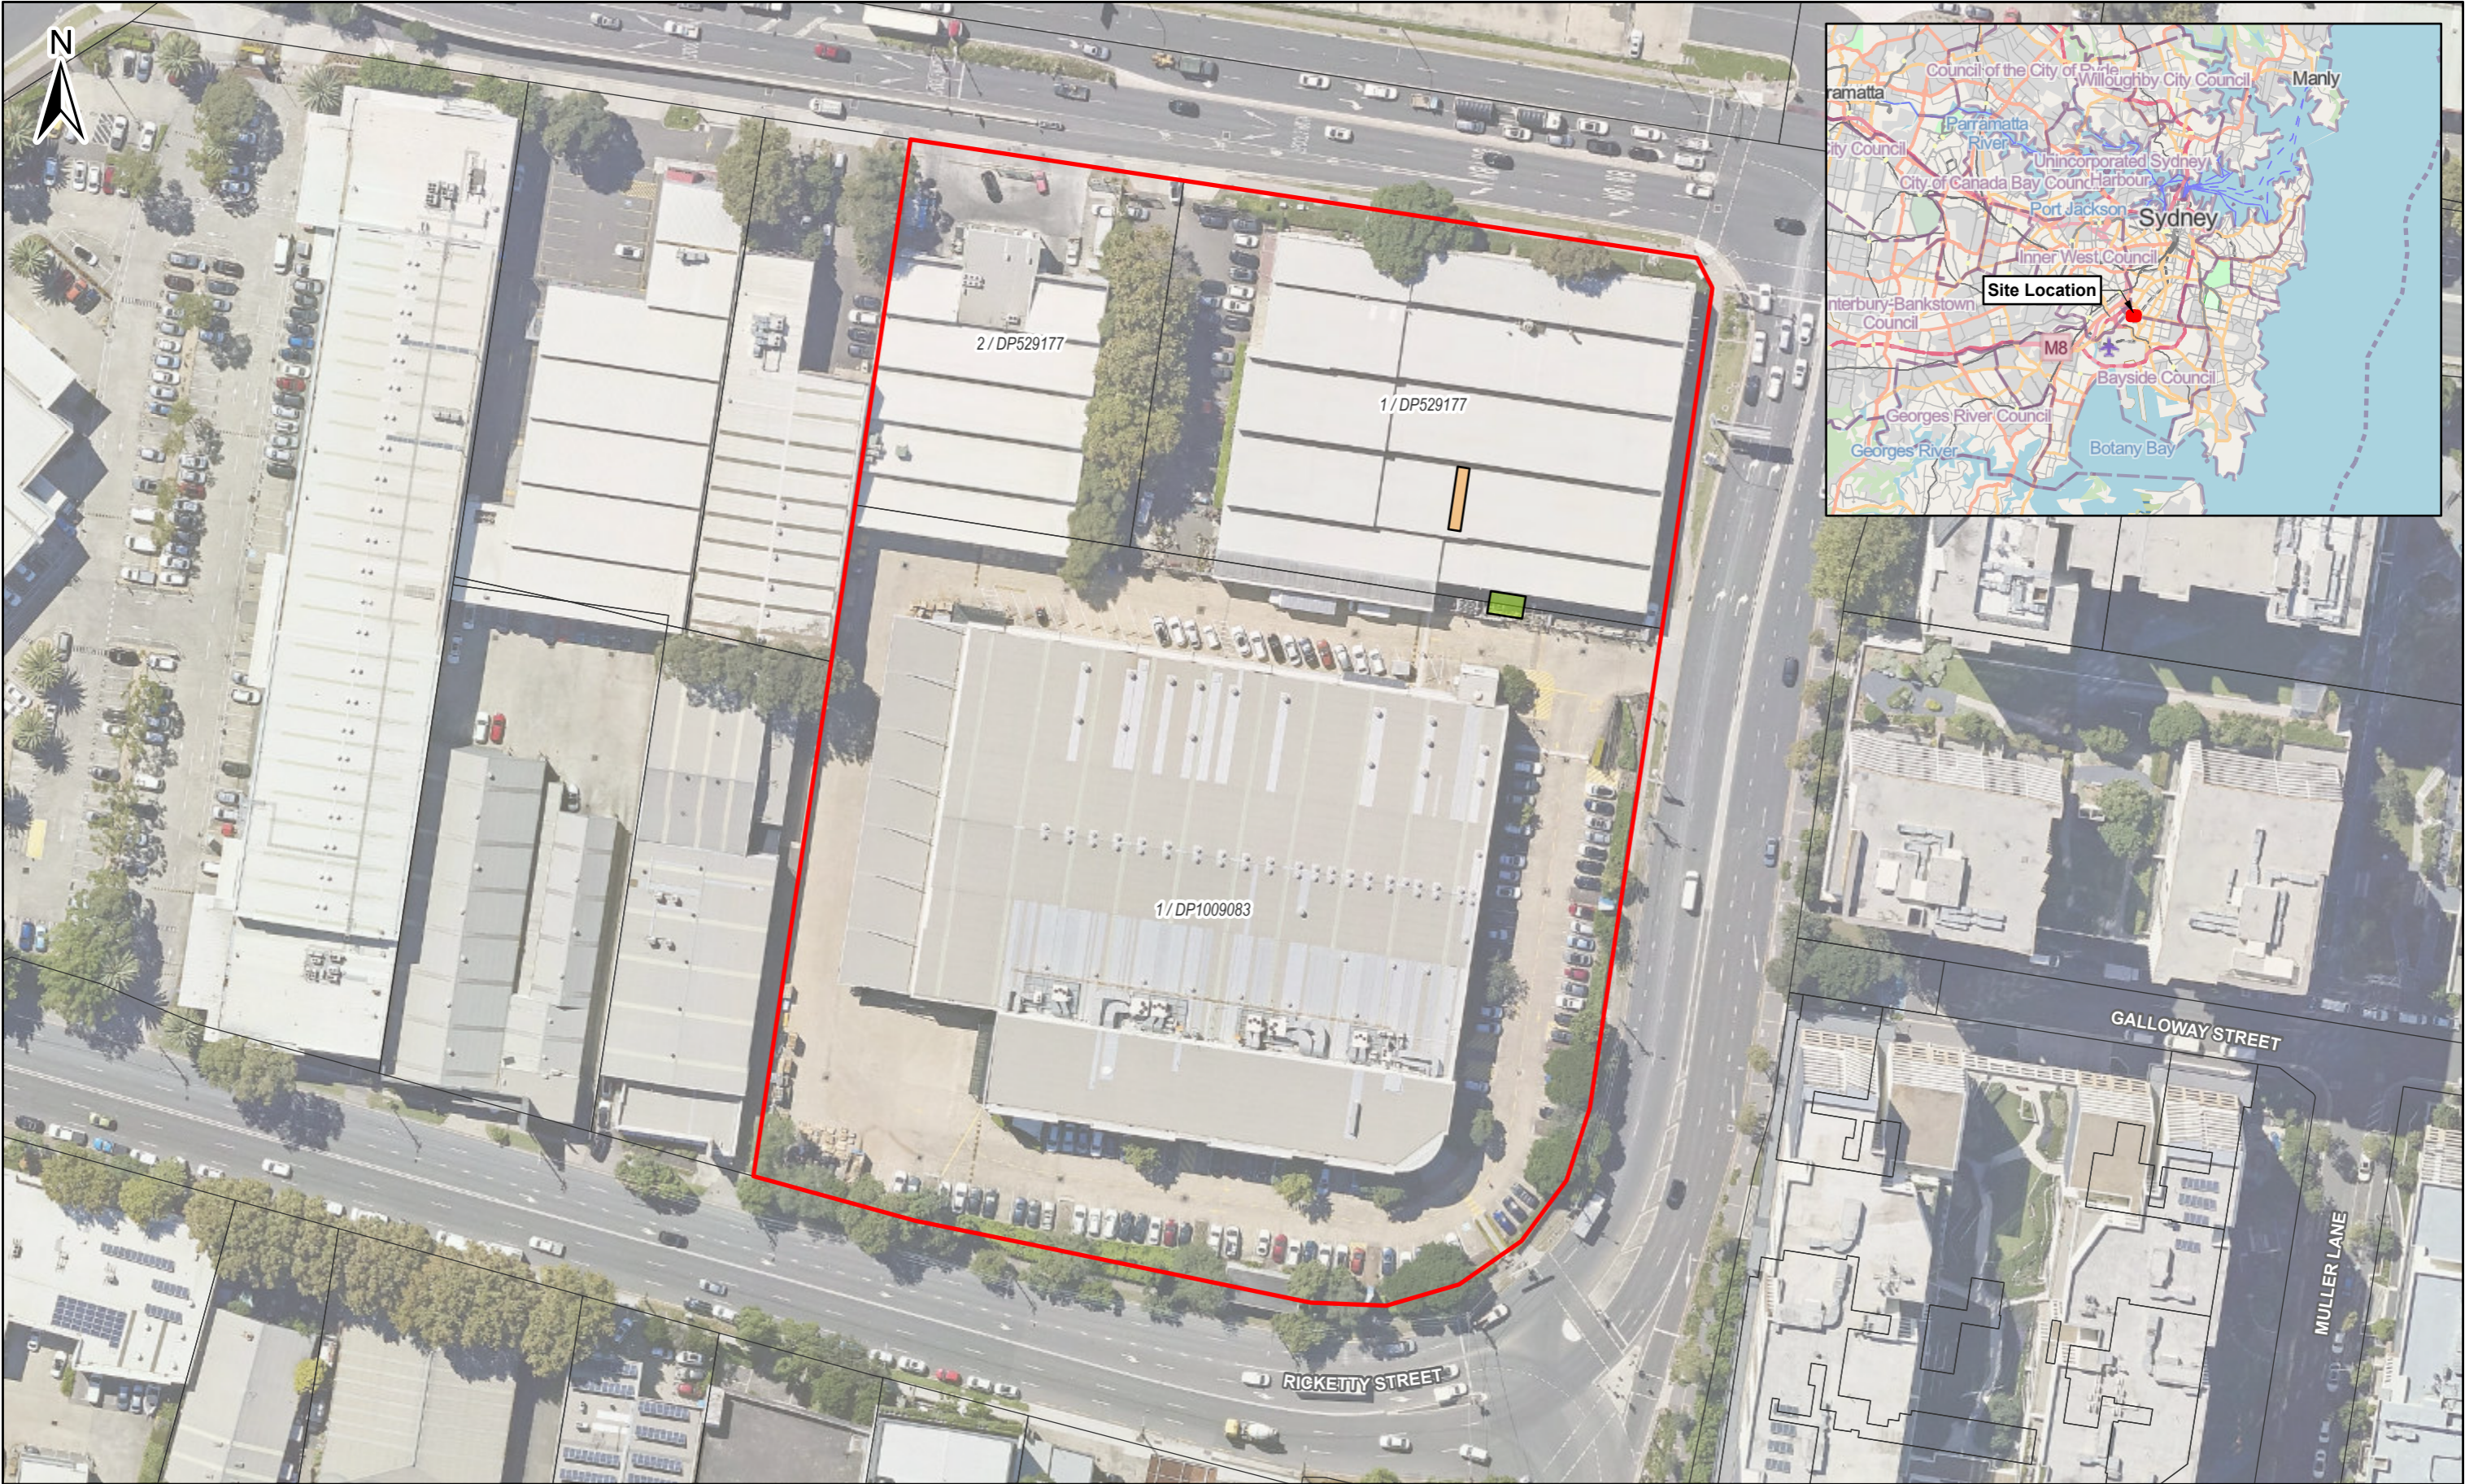
Figure 1: Site Location and Key Features

- Potential UST Identified by SafeWork NSW Hazardous Chemicals Search
- Potential USTs Identified During Site Inspection
- Lot Boundary
- Site Boundary

Senversa Pty Ltd (Senversa) was engaged by Goodman Property Services (Aust) Pty Ltd (GPSA) to prepare a remedial action plan (RAP) to manage identified contamination at 2 & 10-22 Kent Road and 685 Gardeners Road, Mascot NSW (the site). The site location is indicated on **Figure 1**.

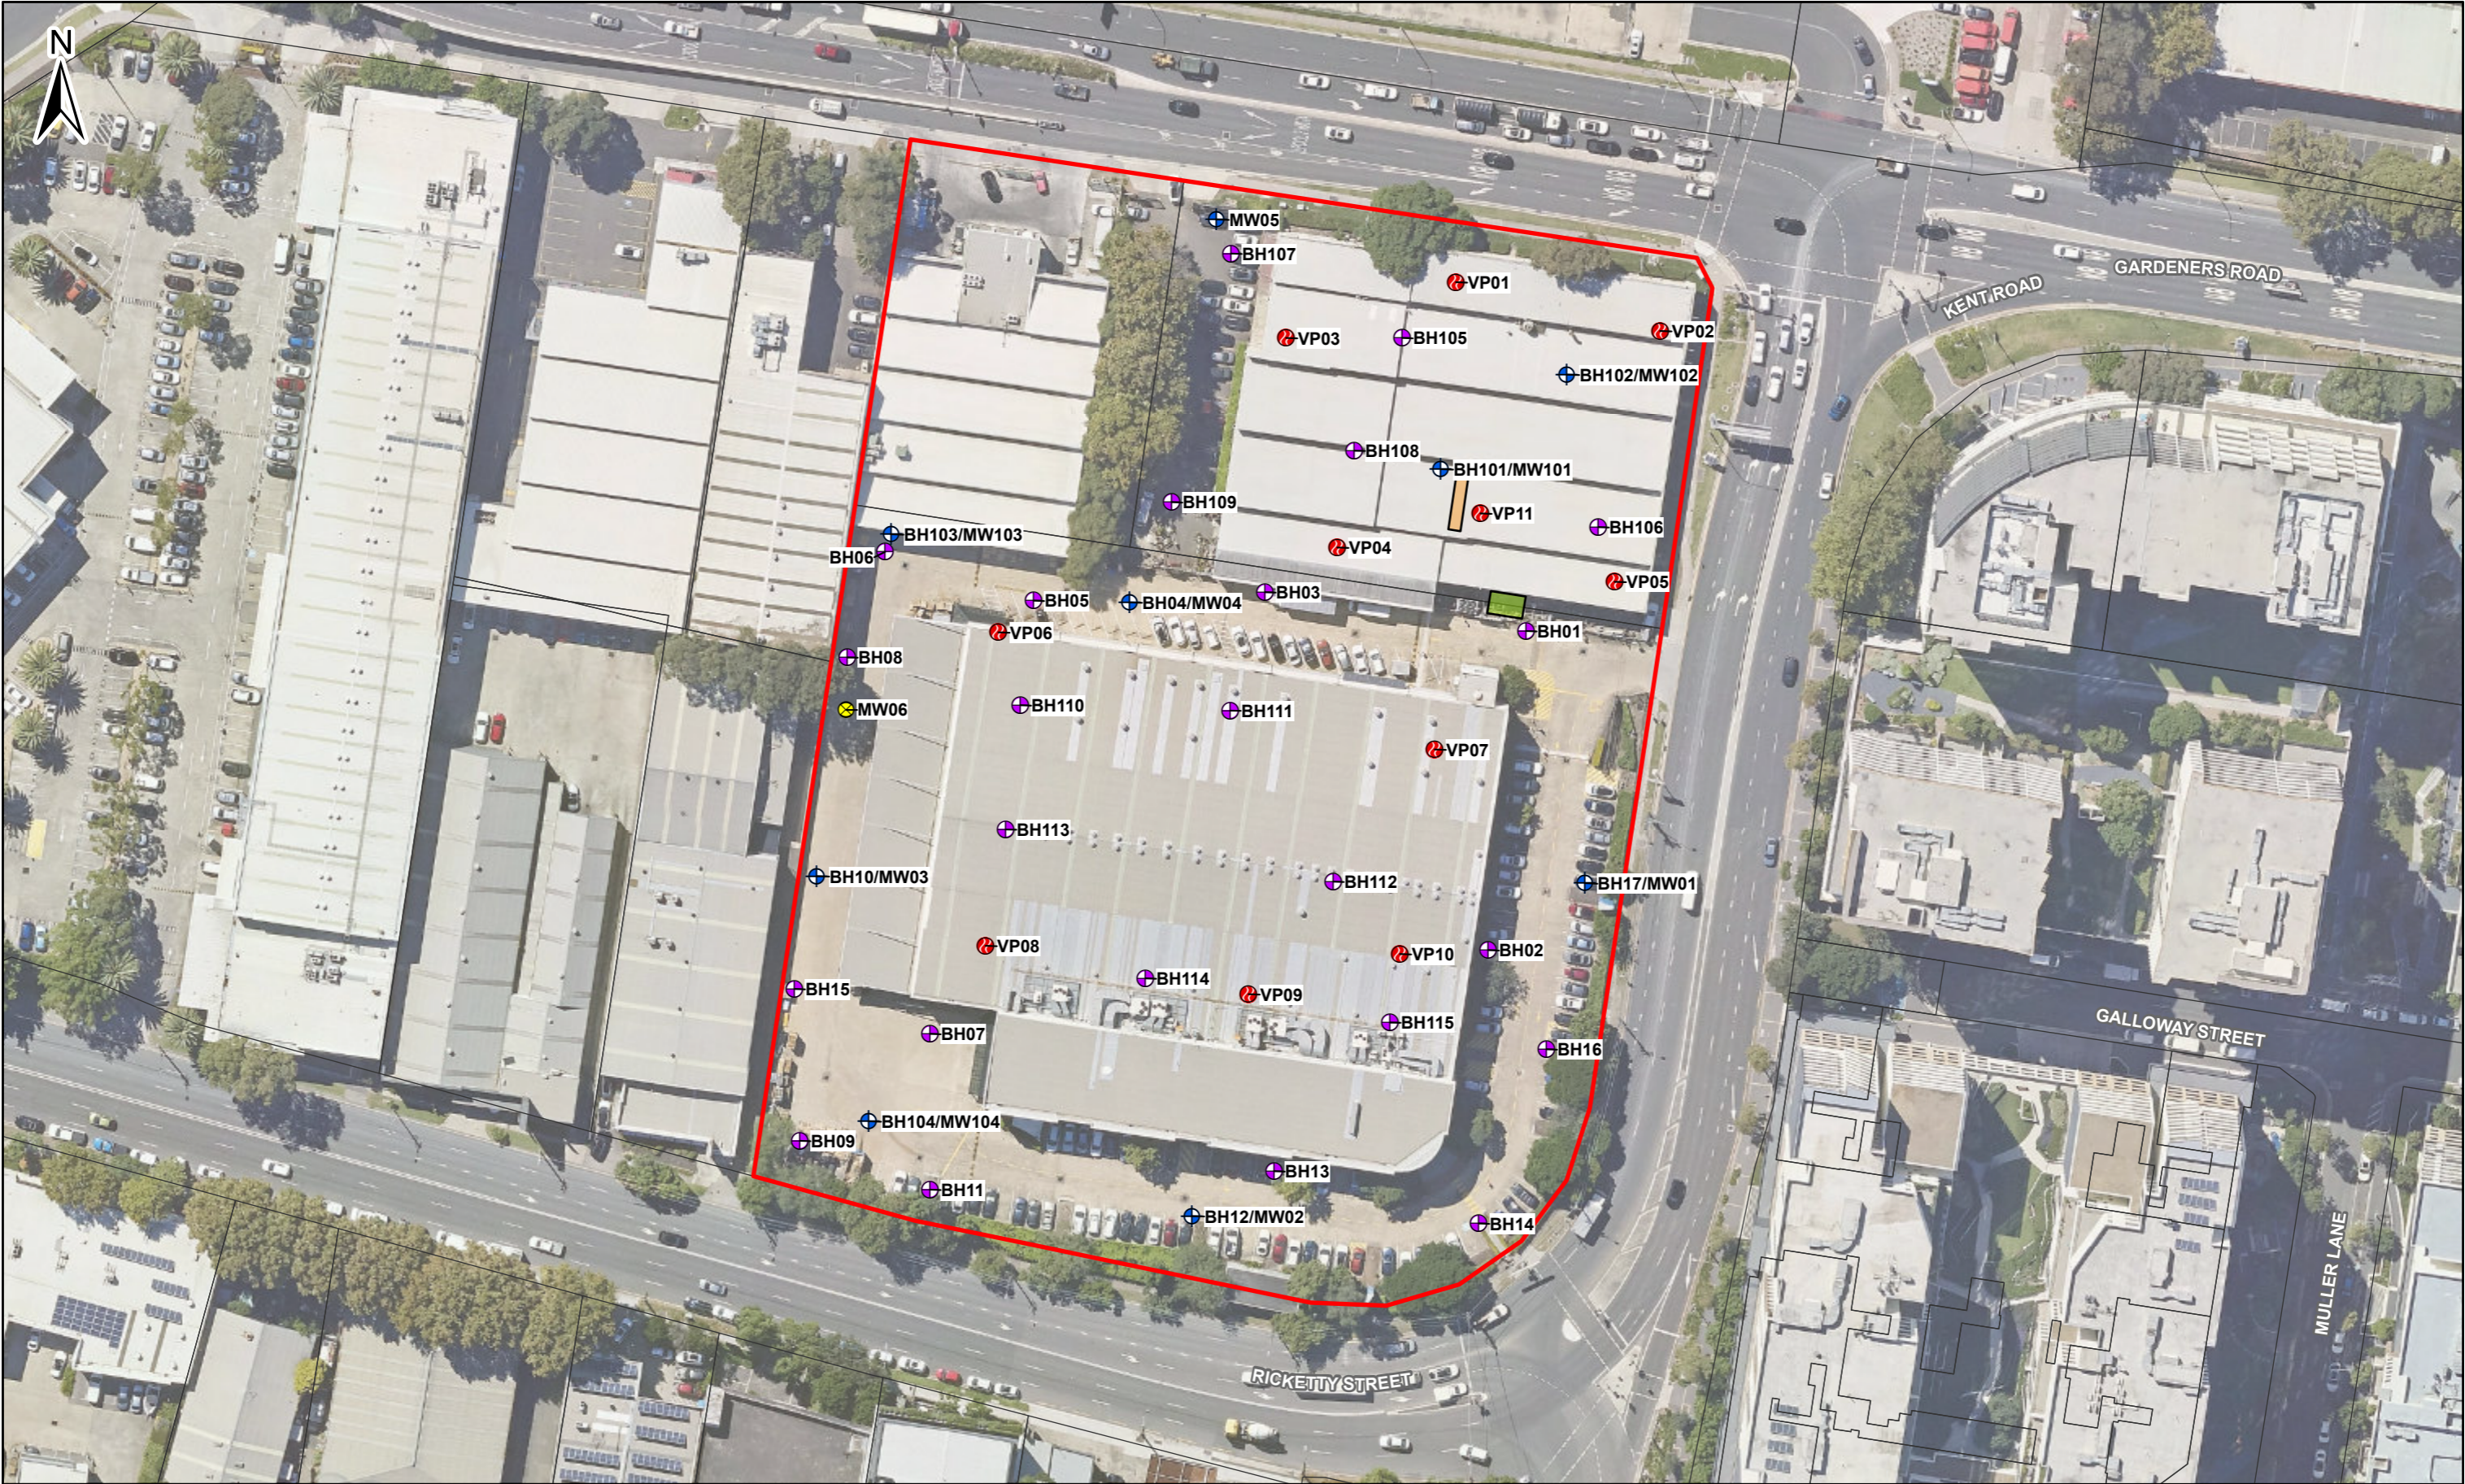
Figure 2: Historic Investigation Locations

Historical Investigation Locations	Potential UST Identified by SafeWork NSW Hazardous Chemicals Search
Groundwater Monitoring Well	Potential USTs Identified During Site Inspection
Soil Bore	Lot Boundary
Sub-slab Vapour Pin	Site Boundary
Vapour Well
