Report on  
Preliminary Site Investigation  
for Contamination

Proposed Future Development Areas of Senior School  
Saint Ignatius' College  
Riverview

Project 85108.00.R.001  
October 2015

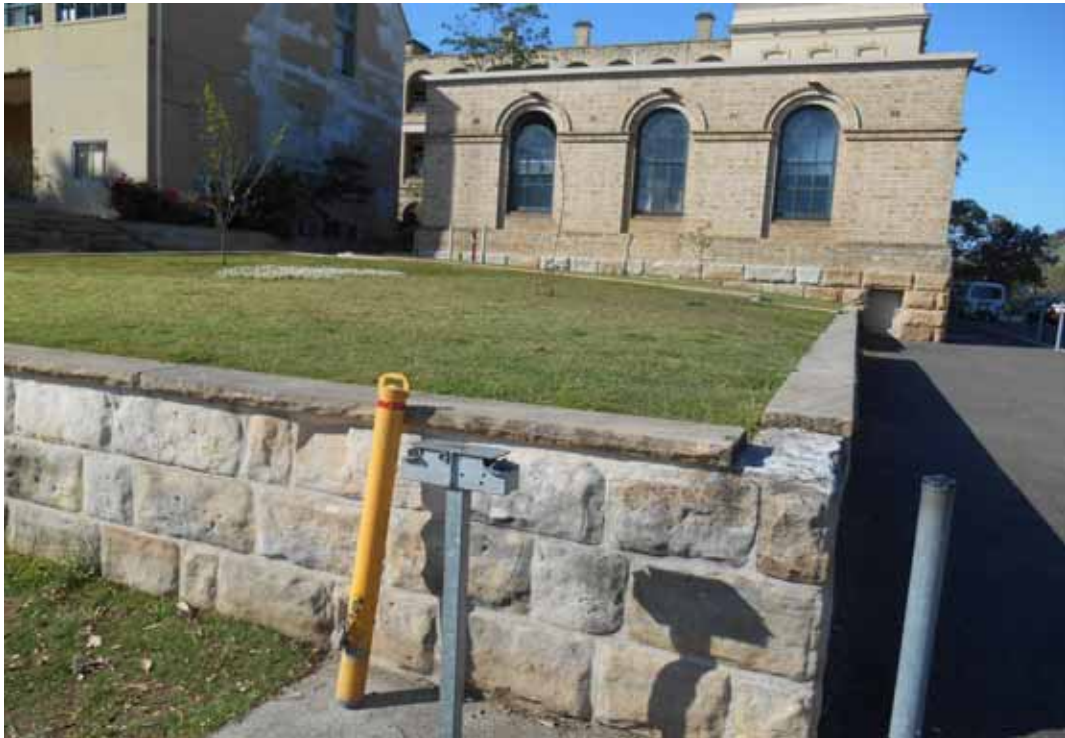
| Part of Site | Observations |
|---|---|
| Saint Michaels House & Main Building | Some small retaining walls at garden areas around older school buildings (Photograph 1, Appendix B). |

Photograph 1 - Retaining wall near Saint John's House

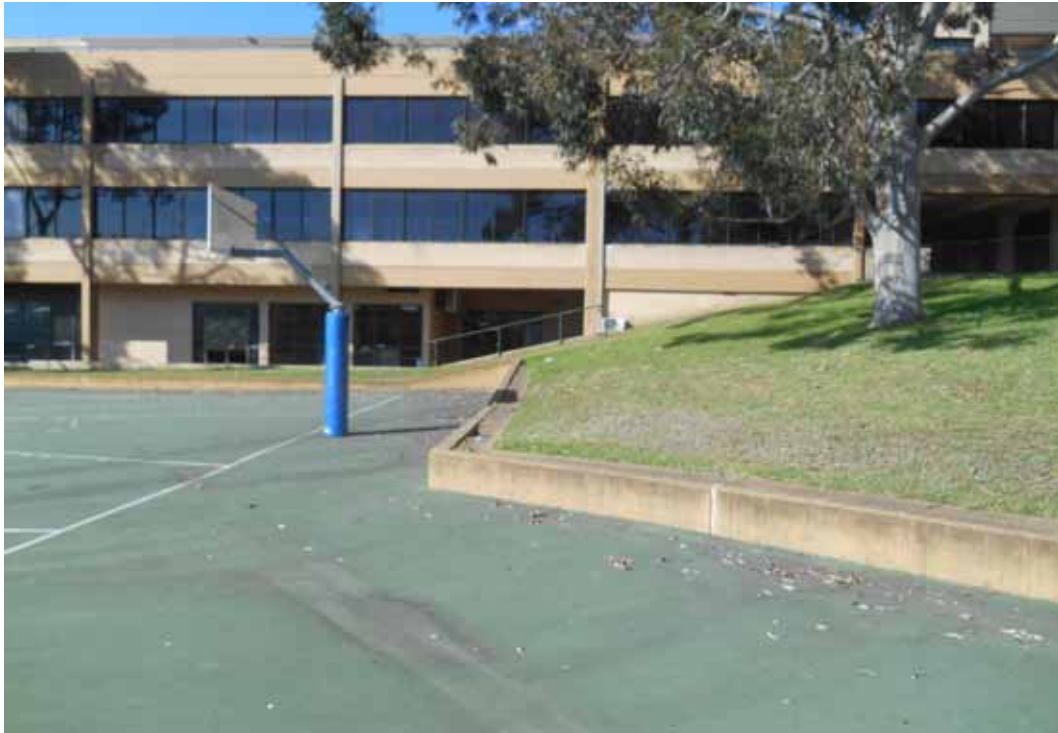
| Part of Site | Observations |
|---|---|
| Between Therry Building and Gartlan Sports Centre | Some cut and fill likely to provide level basketball courts and grassed slopes either side as well as roadway and car park (Photographs 3 and 4, Appendix B). Fill likely behind low retaining walls. |

Photograph 3 - Slope and small retaining wall next to basketball courts

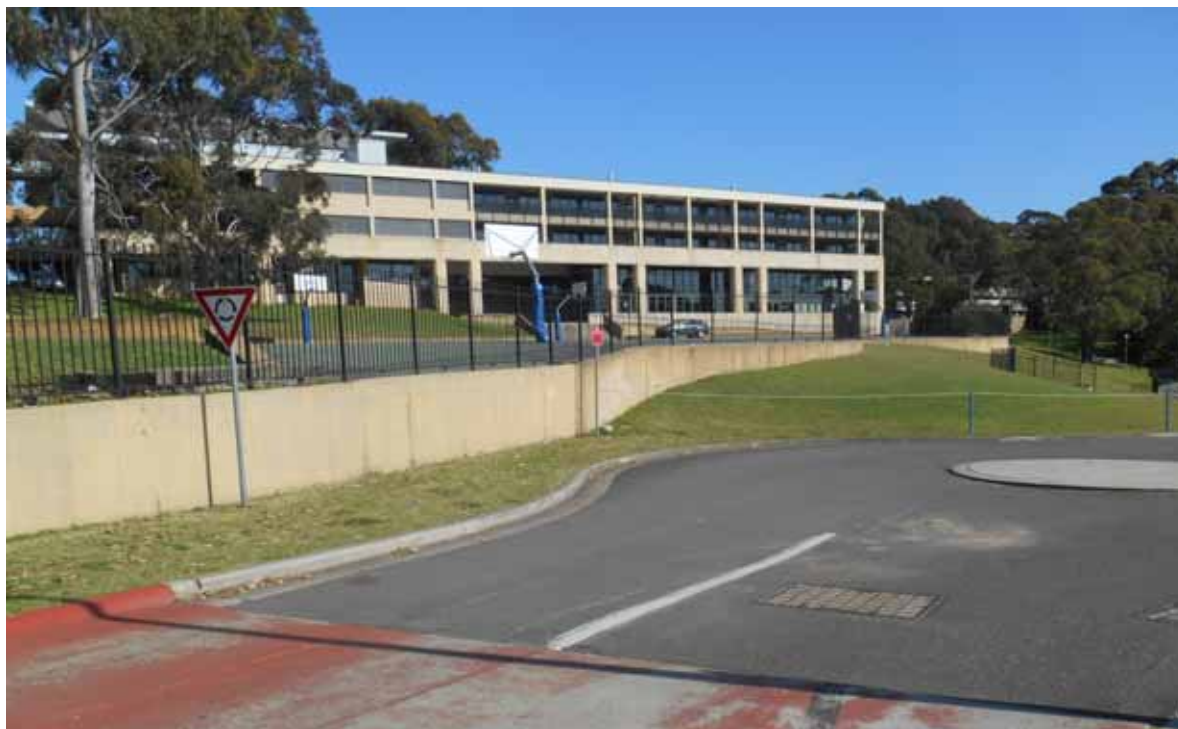
Photograph 4 - Retaining wall at basketball courts

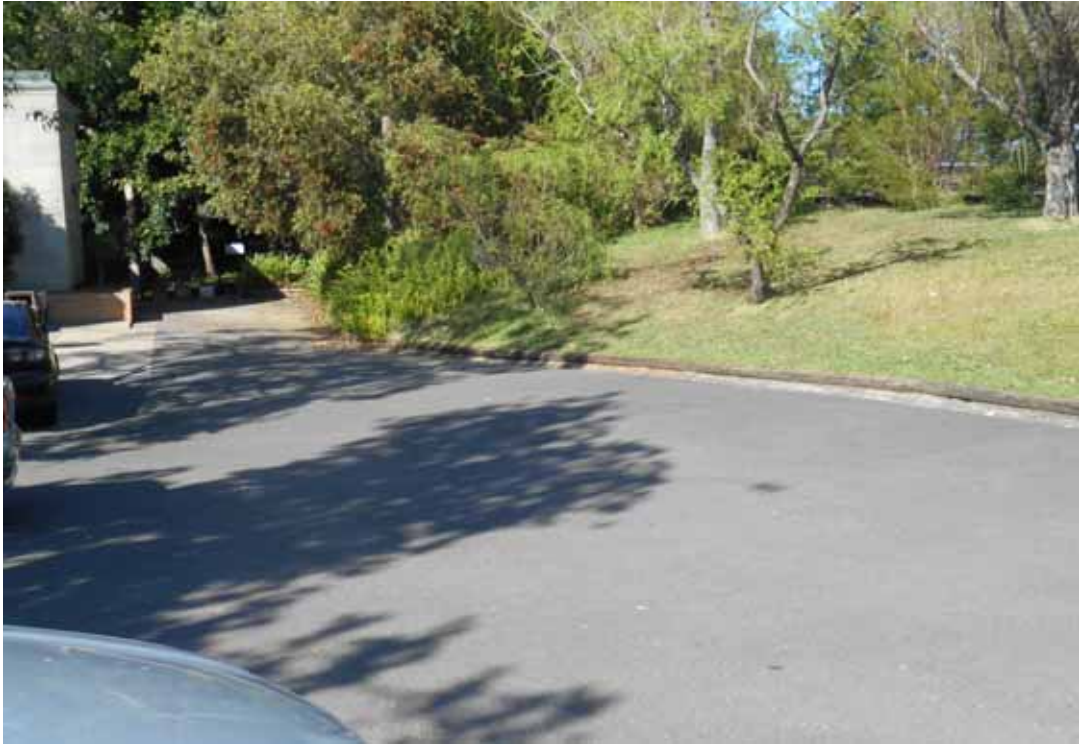
| Part of Site | Observations |
|---|---|
| Saint John's House and adjacent land to the east | Multistorey residential building positioned on slope. Sandstone outcrops observed around building. Some cut and fill likely to provide relatively level parking area and grassed slope next to the tennis courts (Photograph 5, Appendix B) as well as roadway. Retaining walls present. A ground level storage area with a skip bin of "E-waste" materials had concrete slab in good condition and no staining (Photograph 6, Appendix B). |

Photograph 5 - Parking area between Saint John's House & tennis courts

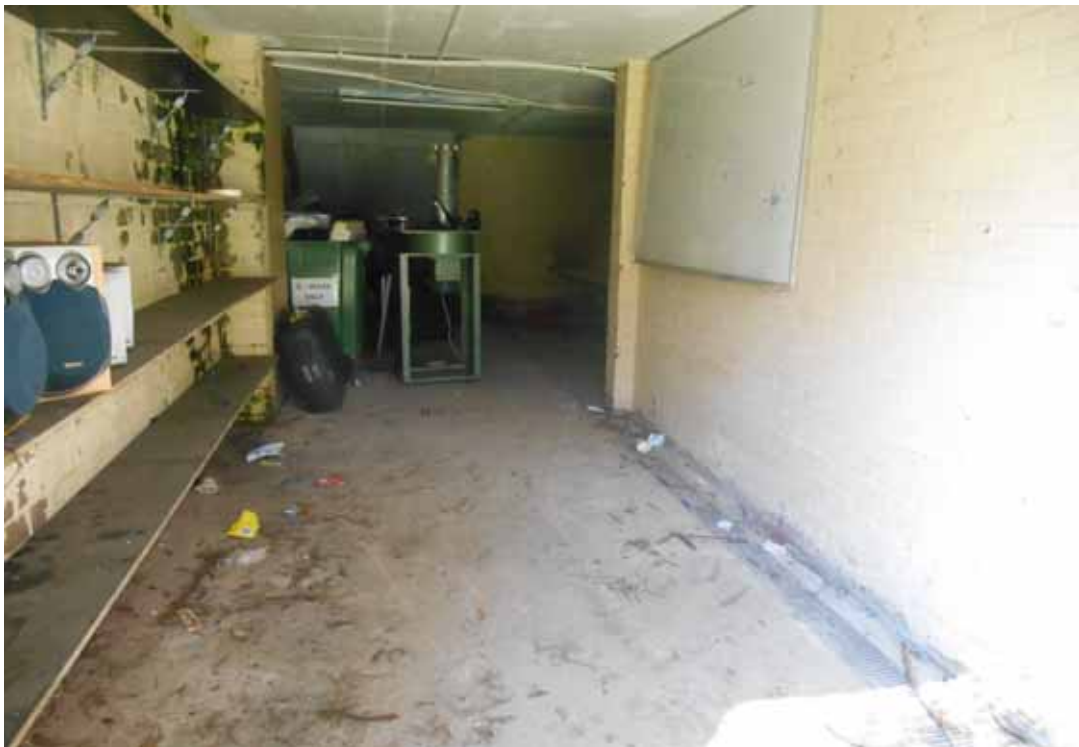
Photograph 6 - Storage area to east of Saint John's House

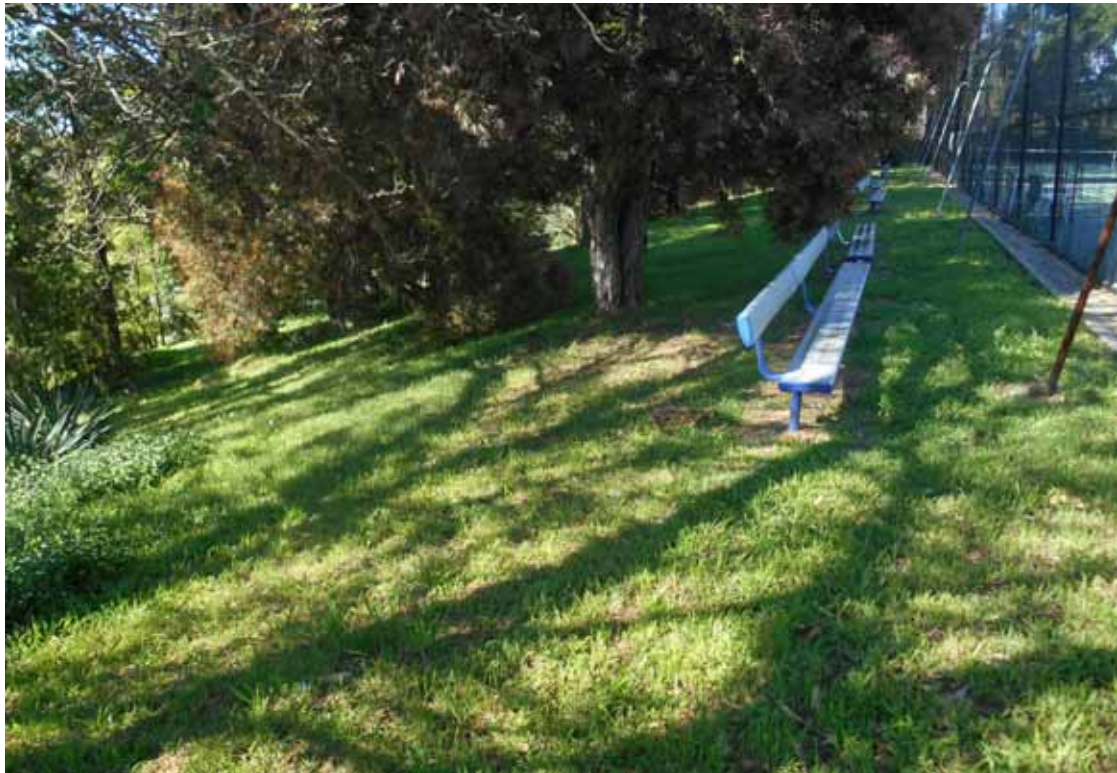
| Part of Site | Observations |
|---|---|
| Tennis Courts (6-9) and adjacent land to the east | Cut and fill likely to provide level tennis courts. Steep slopes with vegetation are present at the east of the courts with sandstone outcrops present (Photographs 7 and 8, Appendix B). |

Photograph 7 -Slope down from tennis courts

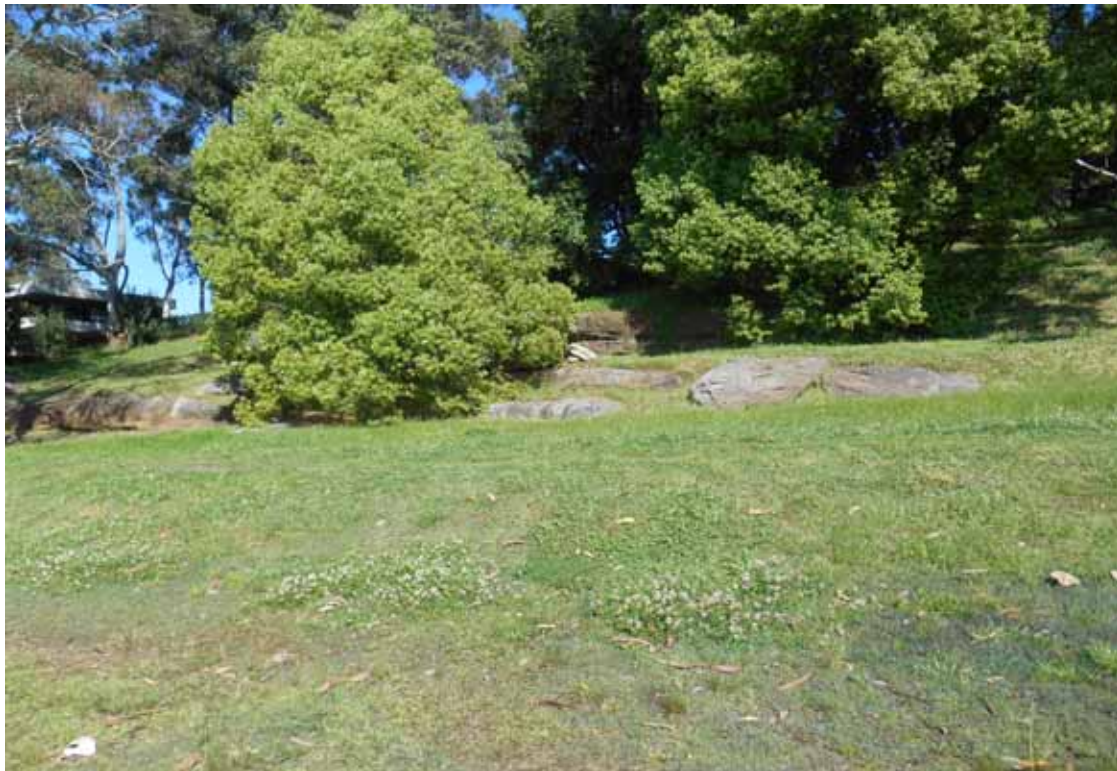
Photograph 8 - Slope and sandstone outcrops

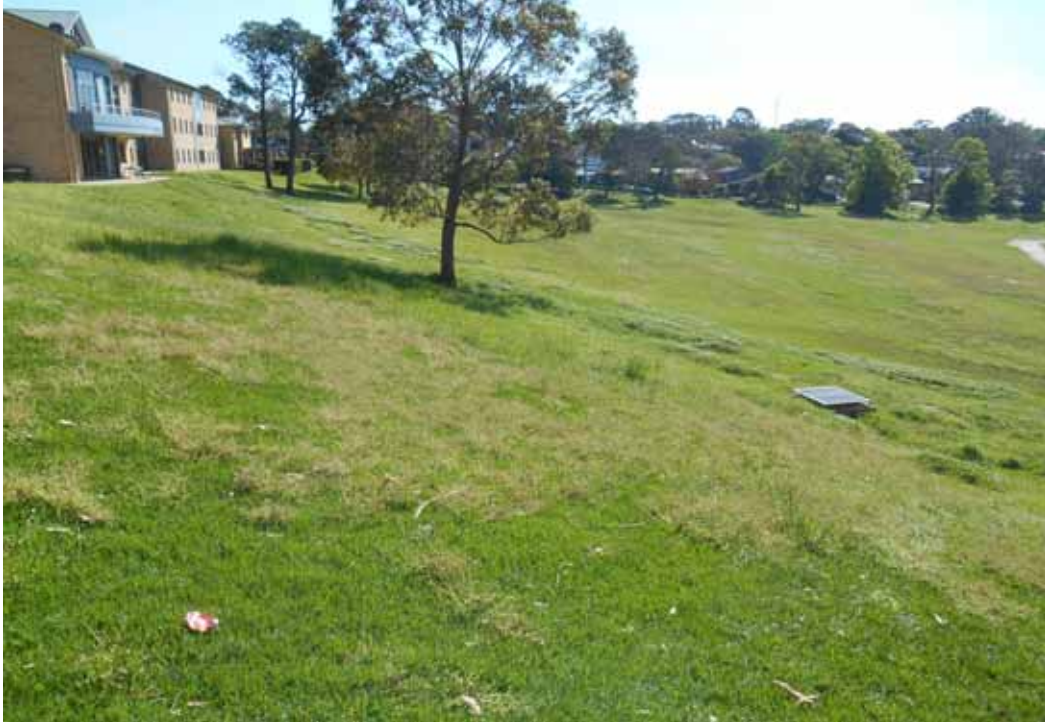
| Part of Site | Observations |
|---|---|
| East and north-east of Kevin Fagan House | Grassed slope in front of boarding house (Photograph 9, Appendix B). Sandstone outcrops present, particularly near northern senior school boundary (Photograph 10, Appendix B). Some cut and fill likely for in-ground structure (for services) at north of building (Photograph 11, Appendix B). |

Photograph 9 - Slope next to Kevin Fagan House

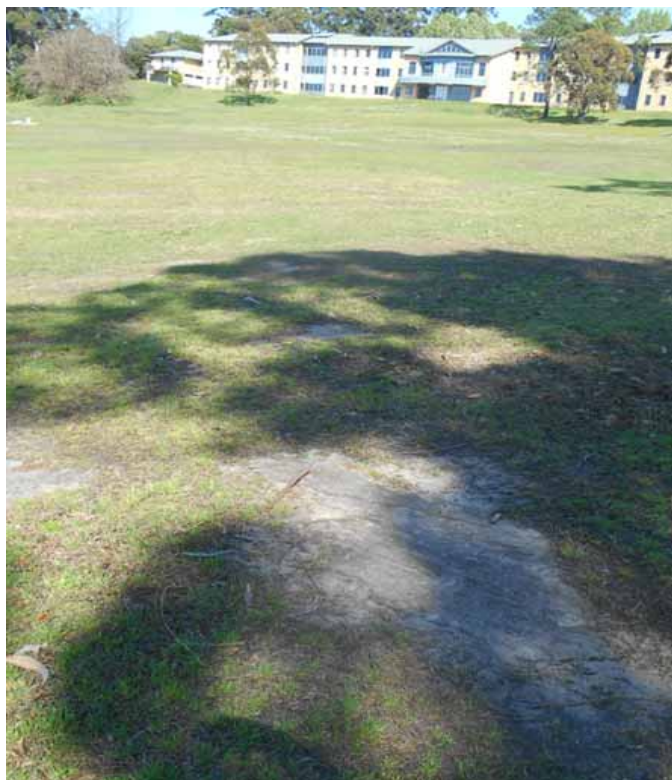
Photograph 10 - Sandstone outcrop

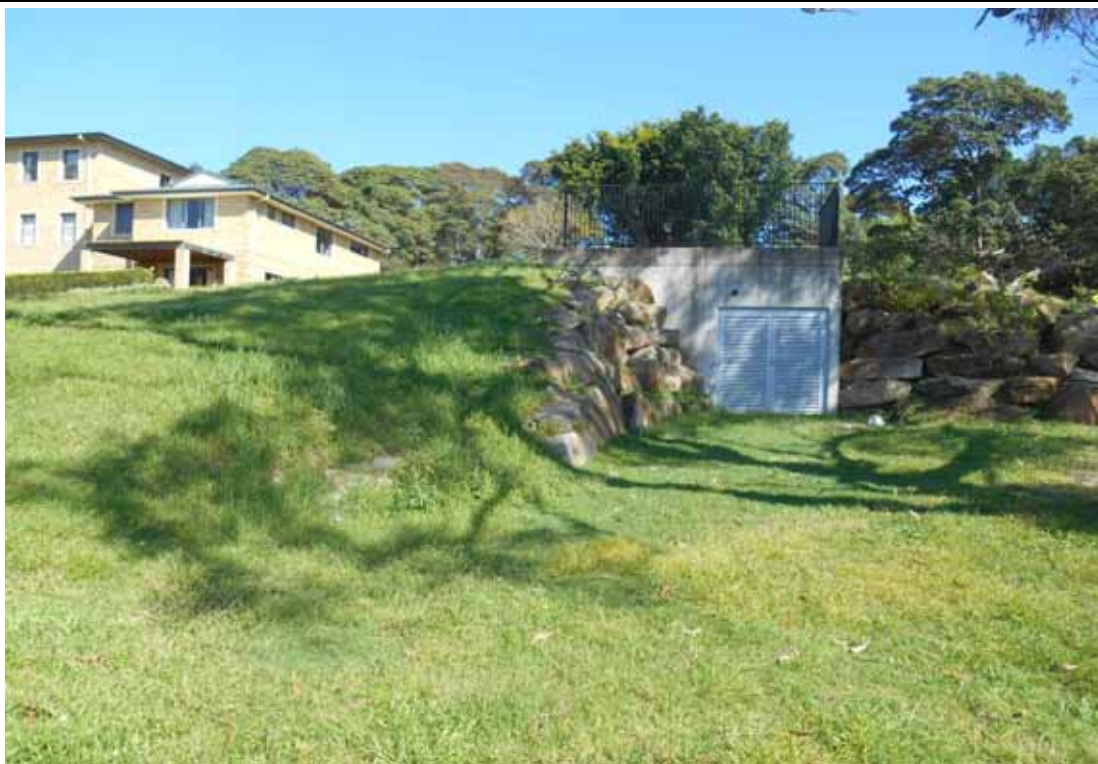
Photograph 11 - Buried structure next to Kevin Fagan House

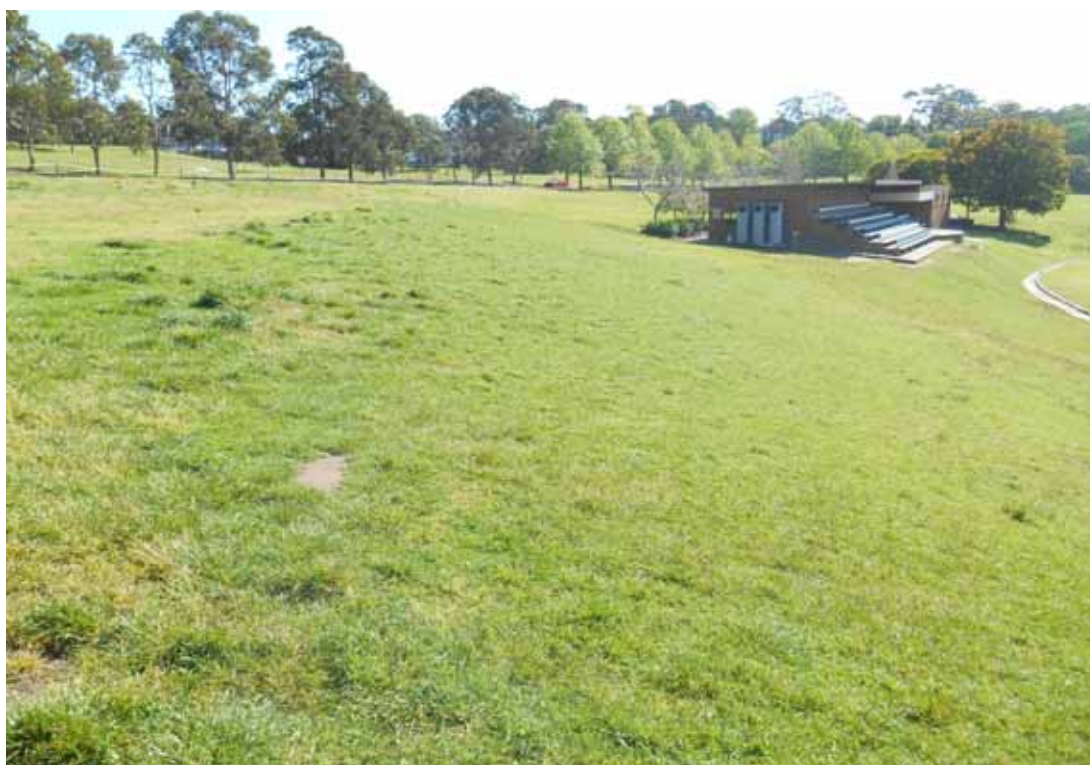
| Part of Site | Observations |
|---|---|
| South of Old Pavilion | Grassed slope where some cut and fill likely to shape land at and around playing field (Photograph 12, Appendix B). |

Photograph 12 - Slope next to Old Pavilion

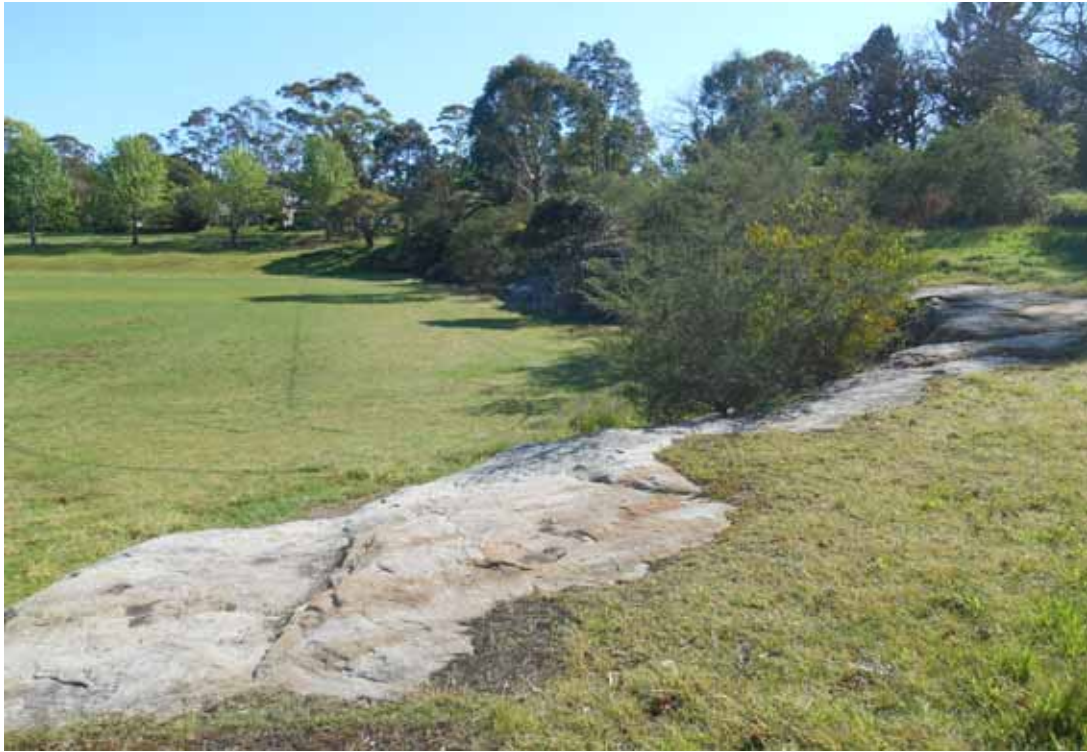
| Part of Site | Observations |
|---|---|
| East of Field 1B | Vegetated area on sandstone outcrops (Photograph 13, Appendix B) |

Photograph 13 - Vegetation and sandstone outcrops to east of Field 1B

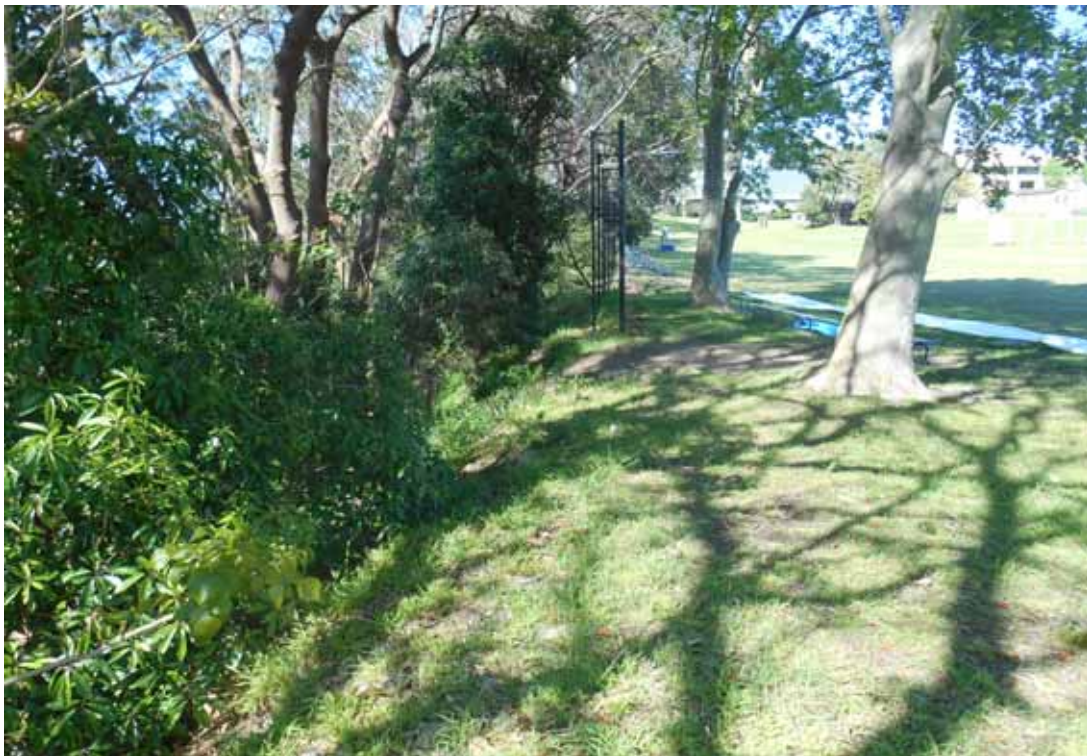
| Part of Site | Observations |
|---|---|
| East of First Field | Filled and grassed area to provide level playing field. Steep fill batter slope at eastern boundary down to neighbouring land (Photograph 14, Appendix B). |

Photograph 14 - Fill batter slope down from First Field

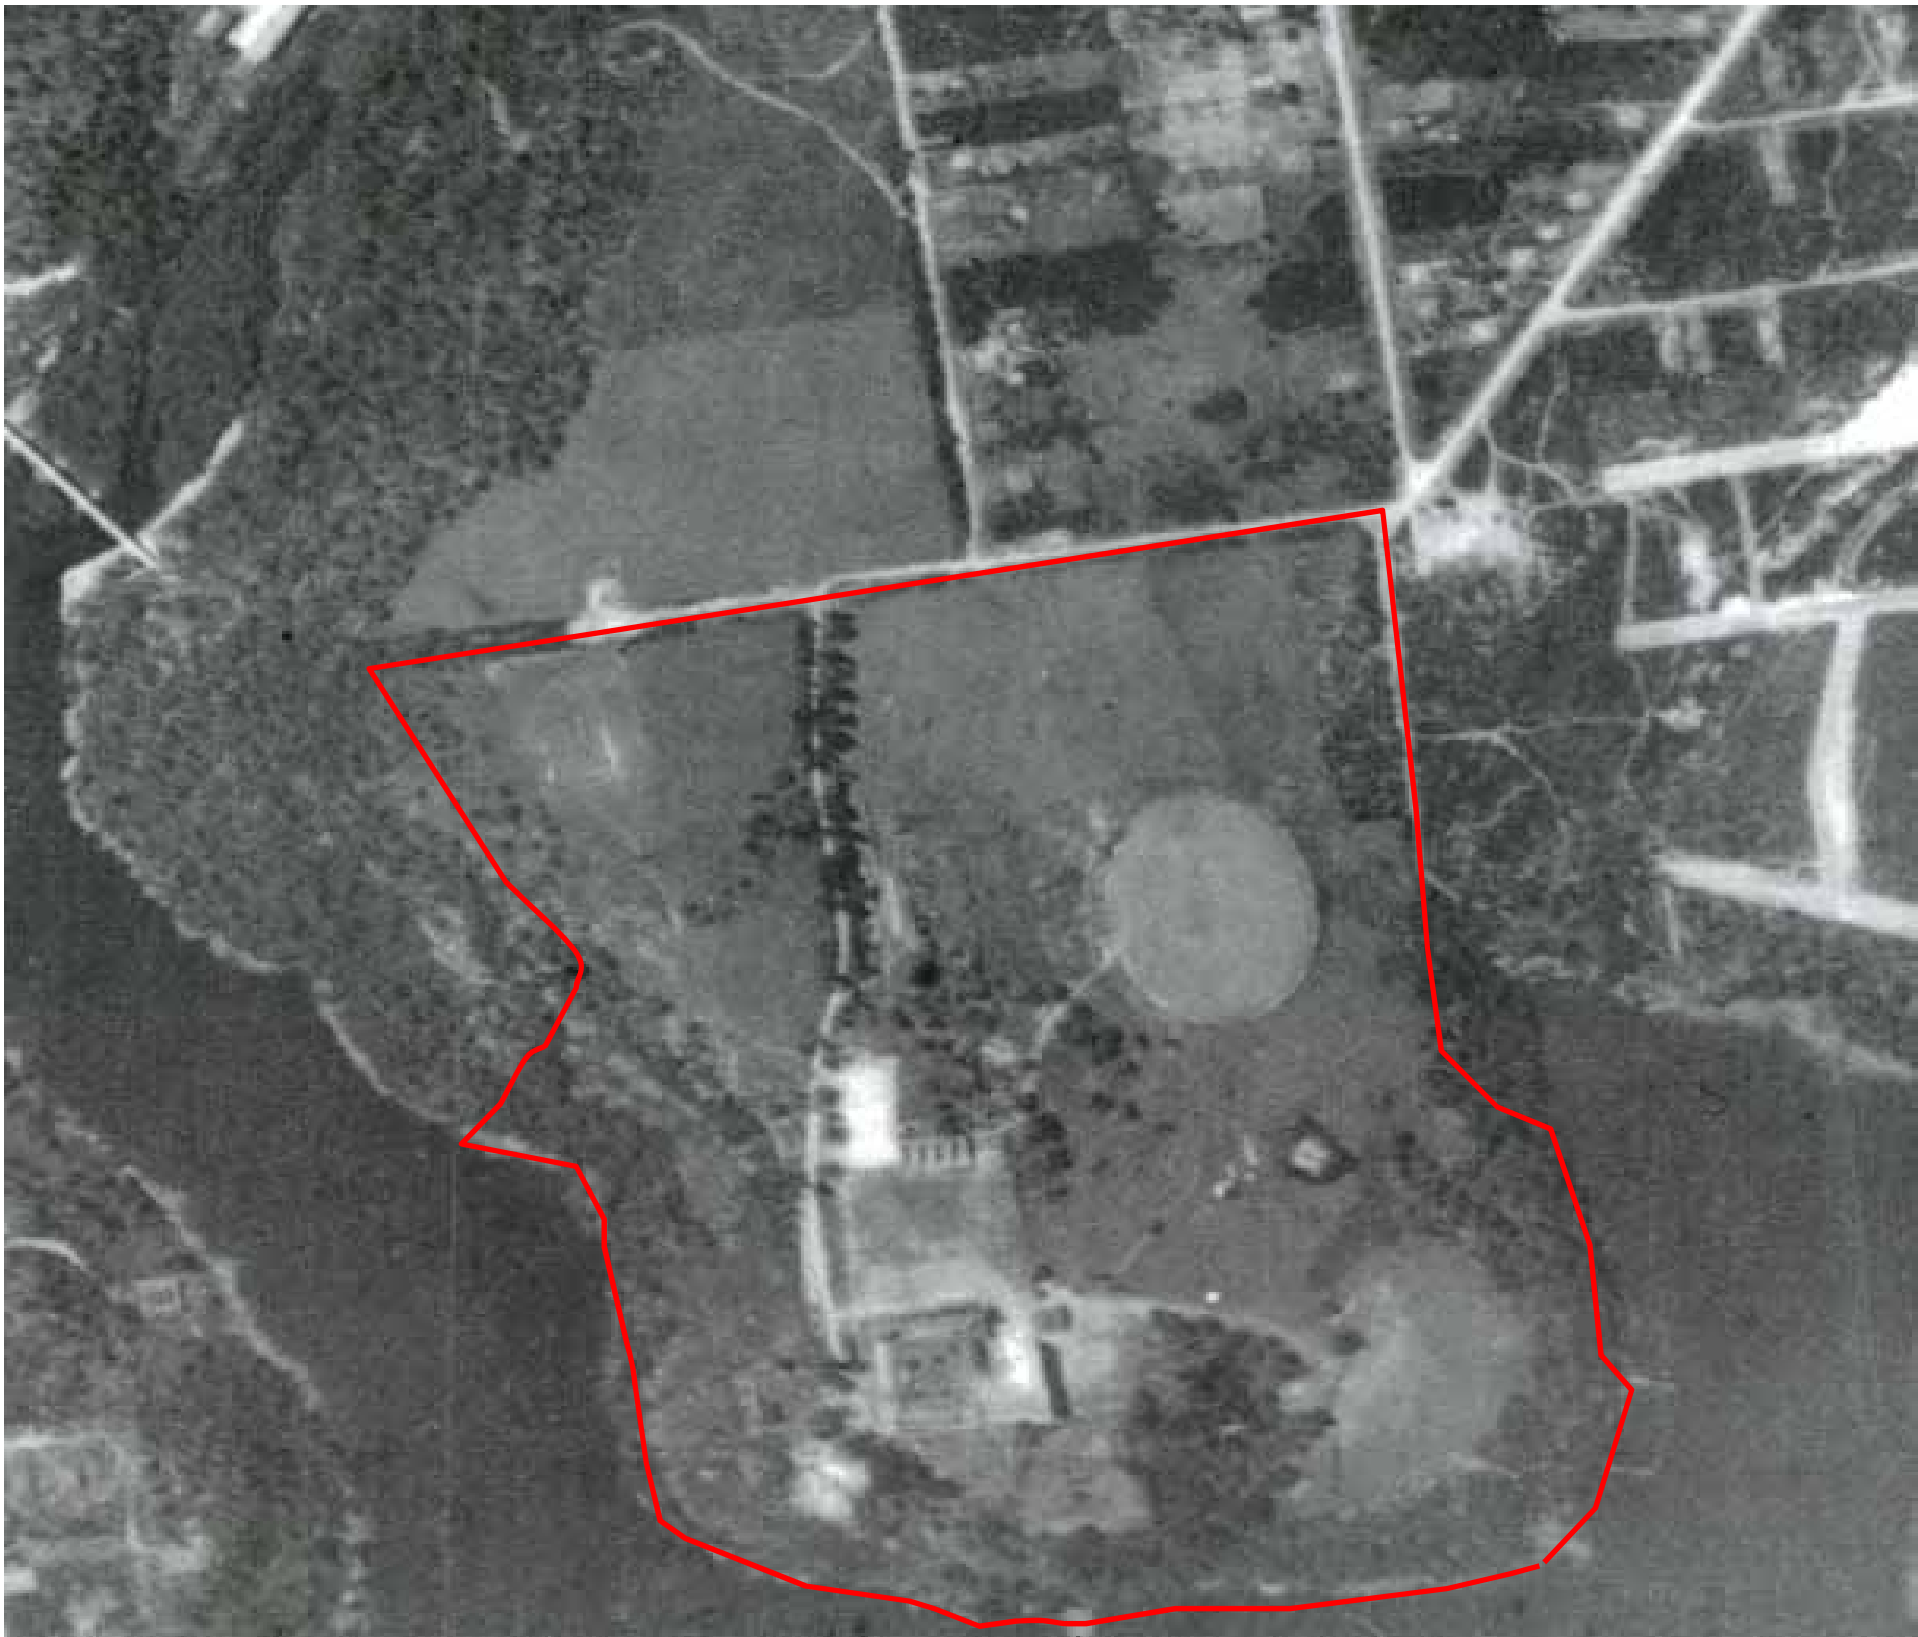
| PLATE No: | D1 |

The 1930 aerial photograph shows that much of the senior school grounds were undeveloped, although the grounds had been subject to clearing of vegetation. A cluster of buildings were present at the south-western part of the school and were accessed via a roadway from the northern site boundary. A field was present to the north of the cluster of buildings and a cricket oval was present at the north-eastern part of the grounds. Relatively small structures were present to the south of the cricket oval. Boating facilities were present at Lane Cover River.

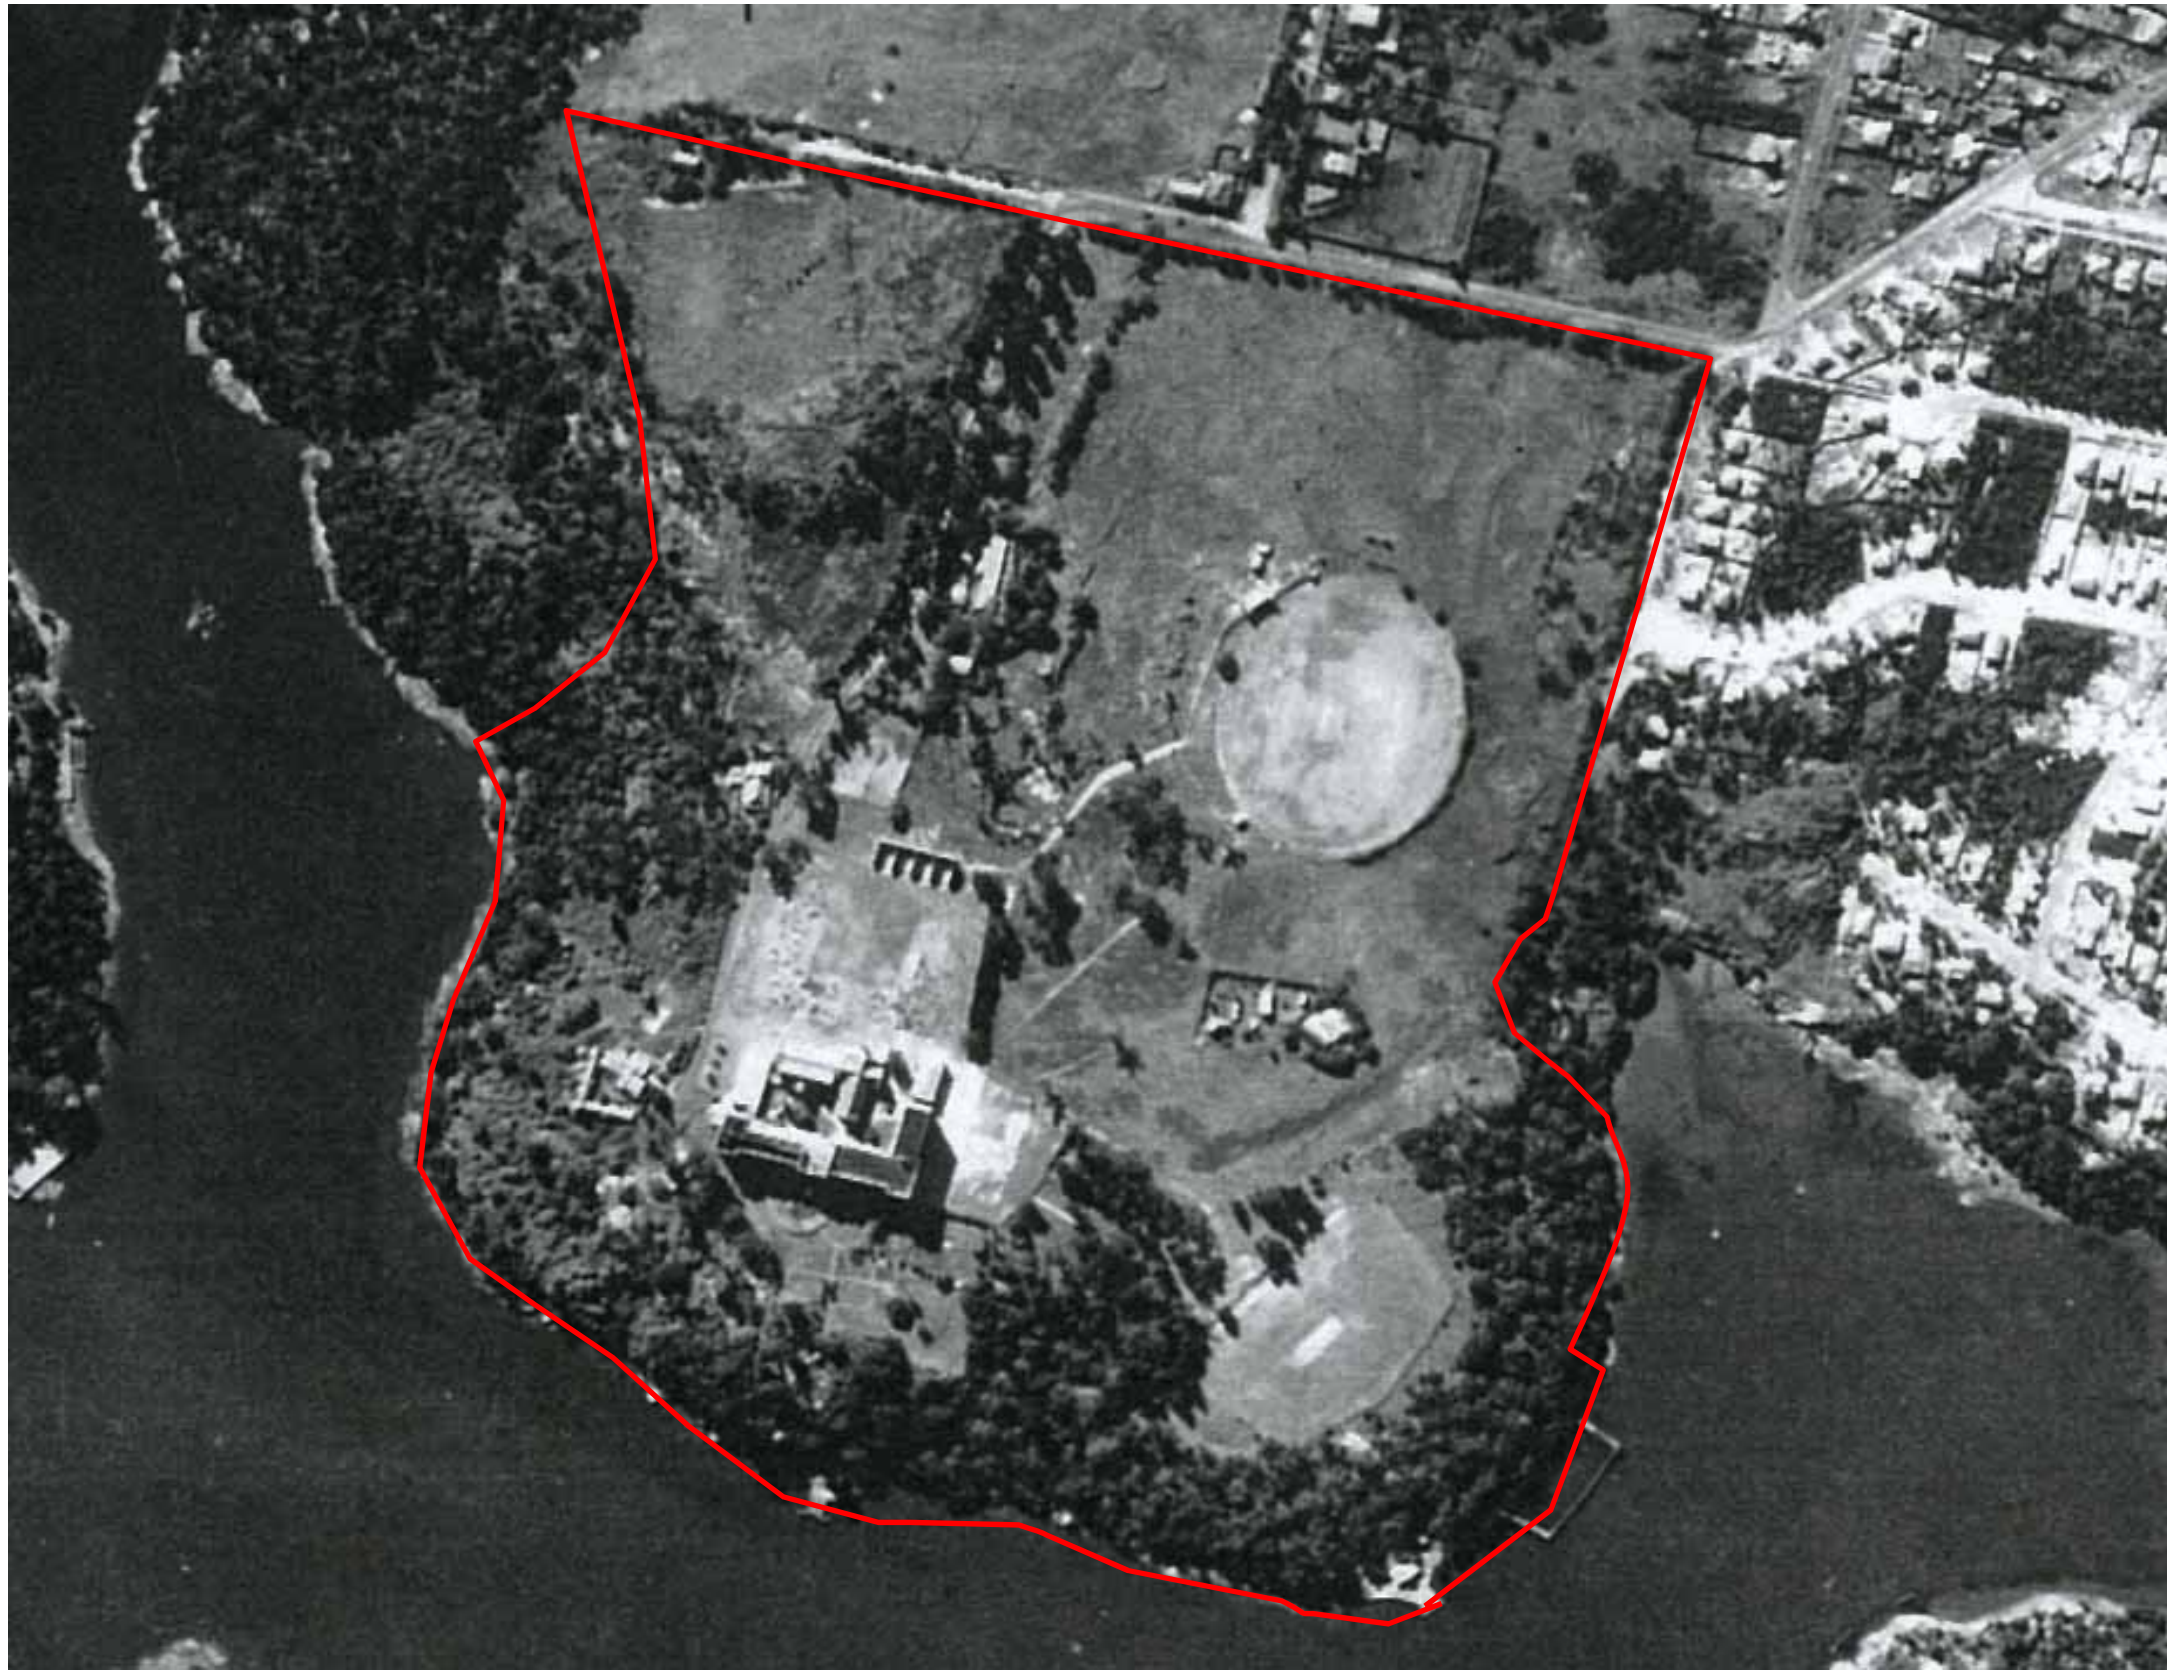
| PLATE No: | D3 |

The 1951 image shows that the school grounds had not changed significantly since 1943, however, the north-western part of the site did not appear to be used for agricultural purposes. The dam at the north-eastern part of the site in 1943 appears to have been filled.
