UNITED WAMBO  
JOINT VENTURE

## Historic Heritage Management Plan

Number: UWOC-1796953183-3

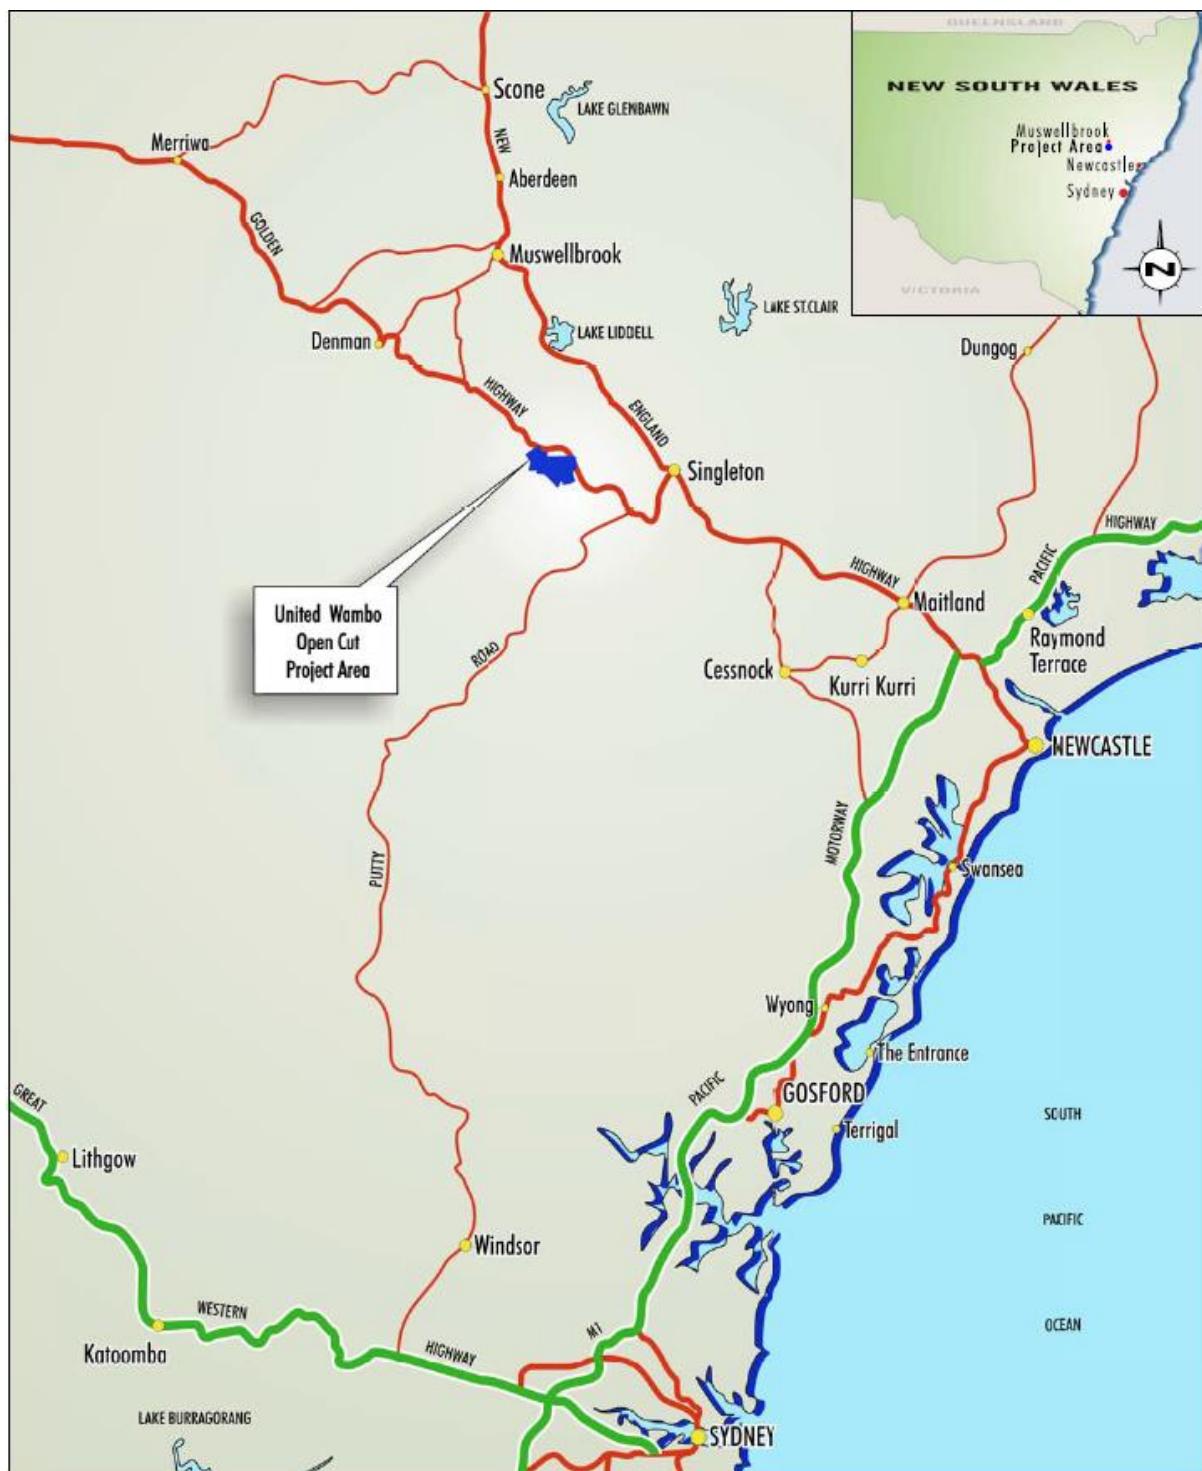
Figure 1-1: Locality Plan

The United Wambo Open Cut Coal Mine (United Wambo) is situated approximately 15 kilometres west of Singleton, near the village of Warkworth, New South Wales (*Figure 1-1*). United Wambo Joint Venture (United Wambo) is a 50:50 joint venture between neighbouring mines operated by United Collieries Pty Limited (United) and Wambo Coal Pty Limited (Wambo).

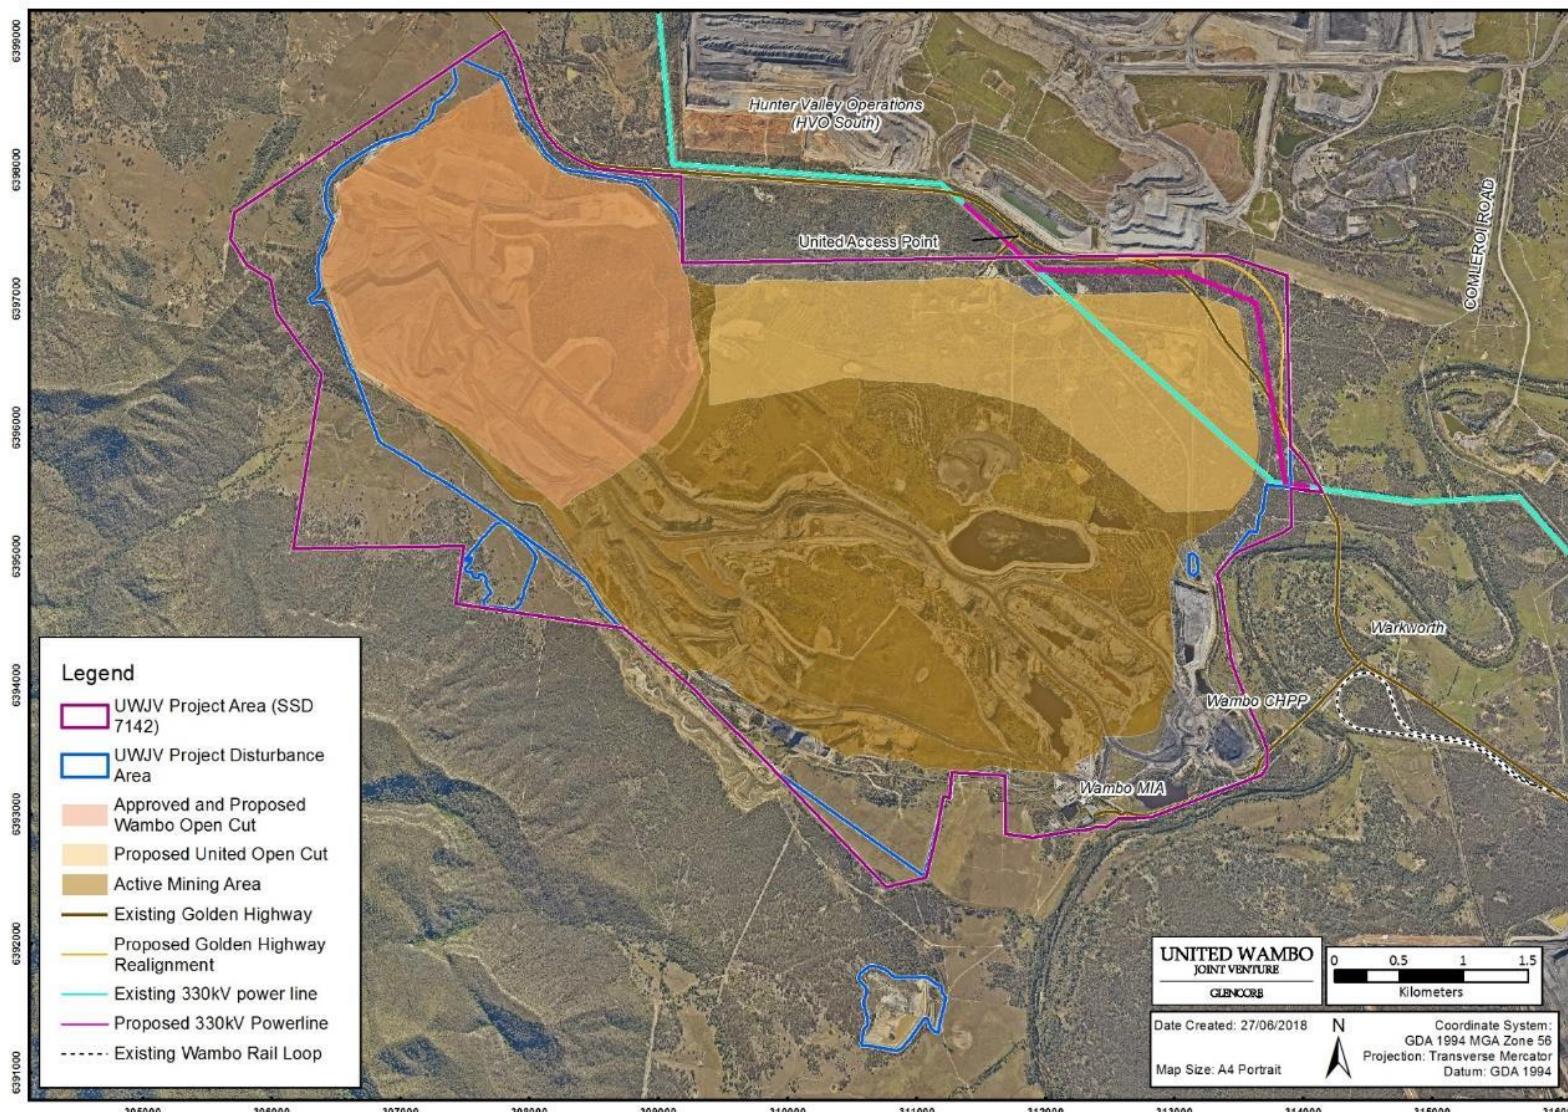
Figure 1-2: United Wambo Project Overview

*Figure 1-2* shows an overview of the project and the project approval boundary for United Wambo.

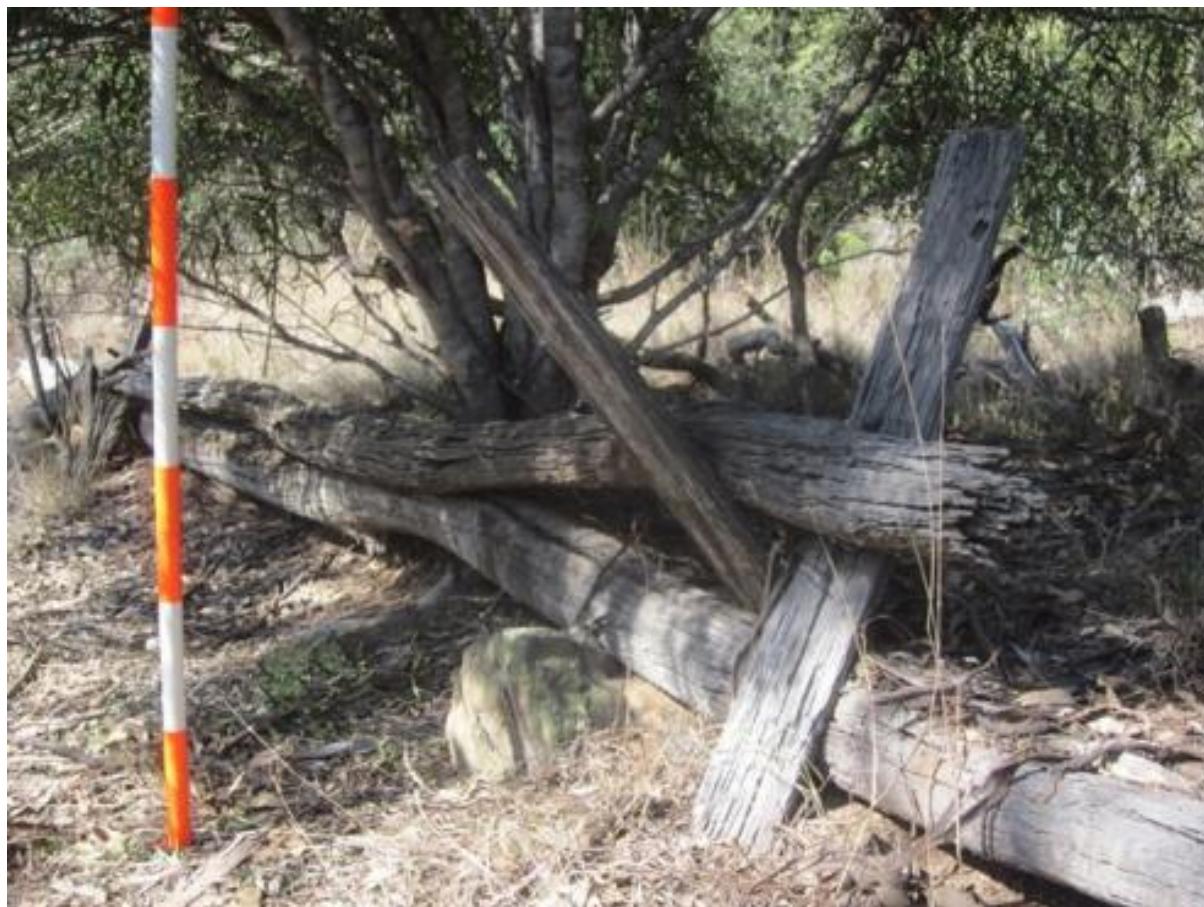
*Plate 7-1: Relatively Intact Section of the Dog-Leg Fence Located Within the Project Area*

The main section of fence comprises approximately 1.7 kilometres of dog-leg fence located both within and outside (on land owned by Hunter Valley Operations) the Project Area (refer **Figure 6-1**). The second, smaller section of fence, is located wholly within the proposed United Open Cut. Photographs of the fence are provided in *Plate 7-1* and *Plate 7-2* for reference.

The fence was erected before 1920, most likely in the 1870s, along boundaries of Conditional Purchases. The fence comprises two horizontal logs, both ironbark, the lower supported on sandstone blocks. Pairs of dog-legs rest across the lower log and support the higher log in their crutch. The dog legs are split ironbark, and like the logs, were sourced from trees that would have been present in the immediate area of the fence. The sandstone blocks have shallow circular channels chiselled across their tops forming a more secure bed for the lower log. While the overall structure is typical of dog-leg fences, the use of sandstone blocks is considered unique. These blocks are all that remain at the eastern end of the fence alignment; the logs having been burnt in bushfires. There are no truly intact portions of the fence, and considerable lengths simply comprise logs lying on the ground or alignments of the sandstone blocks.

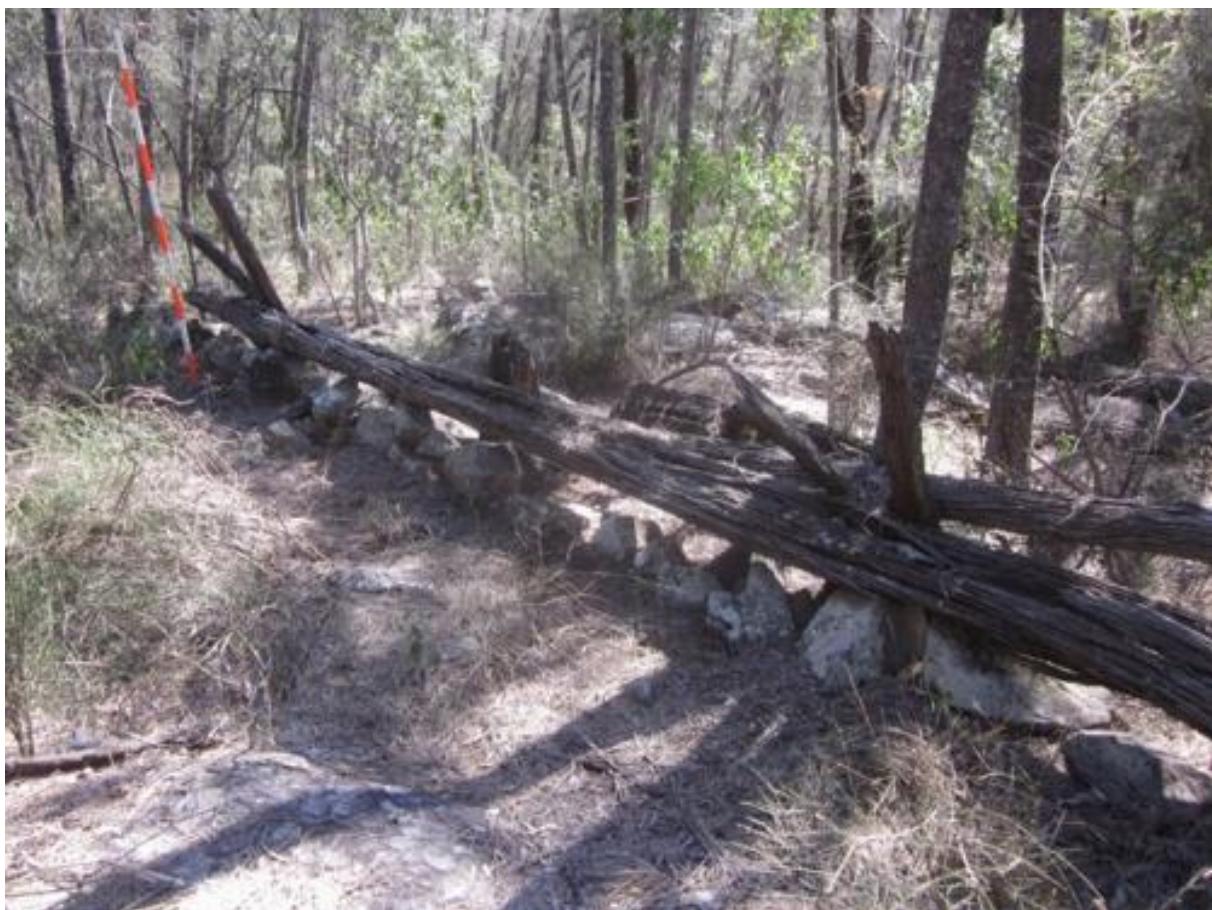
provides an example of rocks packed under the bottom log to reduce the gap and prevent stock escaping.

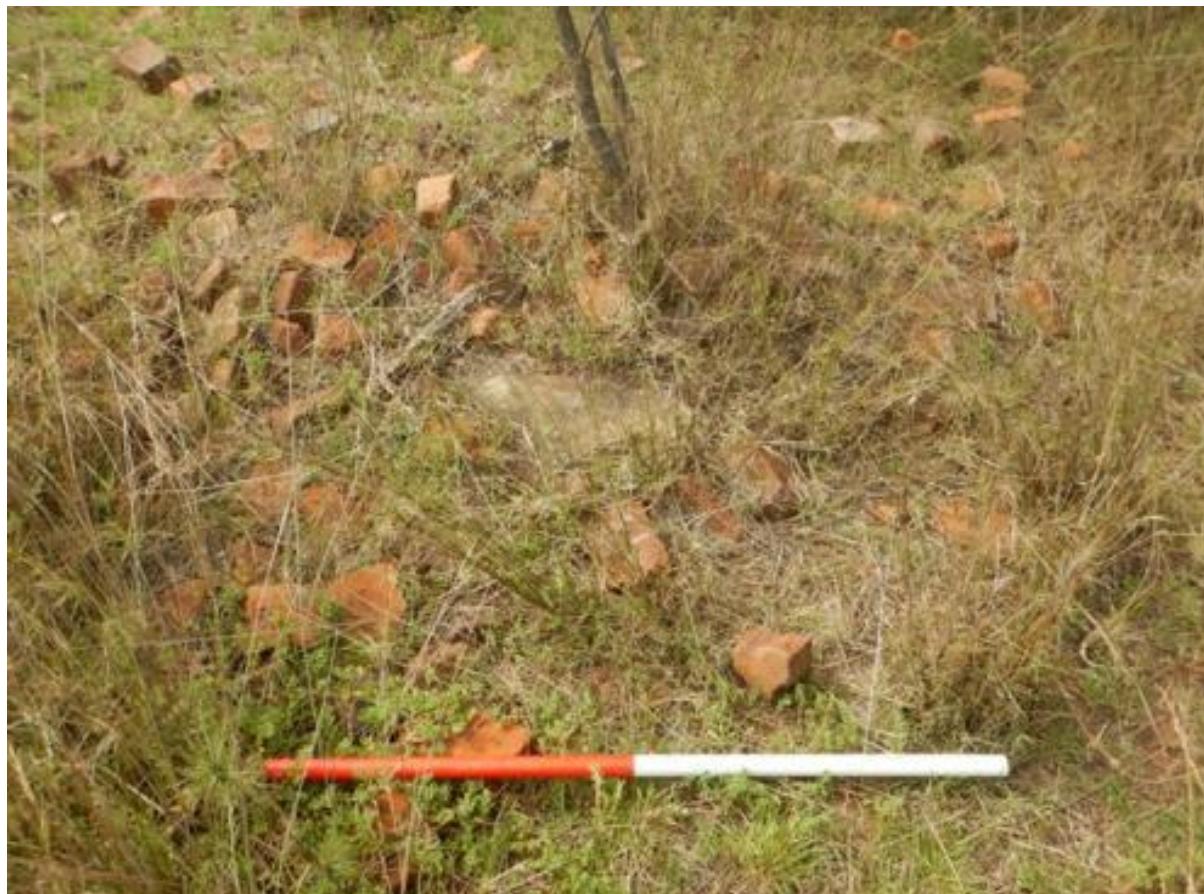
*Plate 7-3: Detail of Concentration of Brick Rubble at Former House Site*

The former house site is located to the north of Redbank Creek within Lot 55 DP 753792 and comprises evidence of three former structures in the form of brick and sandstone rubble and concrete slabs (refer to *Plate 7-3* and *Plate 7-4*).

There are several different sized bricks within the areas of brick rubble; each size seemingly relating to a different former structure. A number of the bricks appear to be made from local clay and were likely fired on site, however, there was no evidence of any clay pits or brick clamps found. A timber block is located within the concrete slab area and may have been a support for an anvil or the base of a butcher's block.

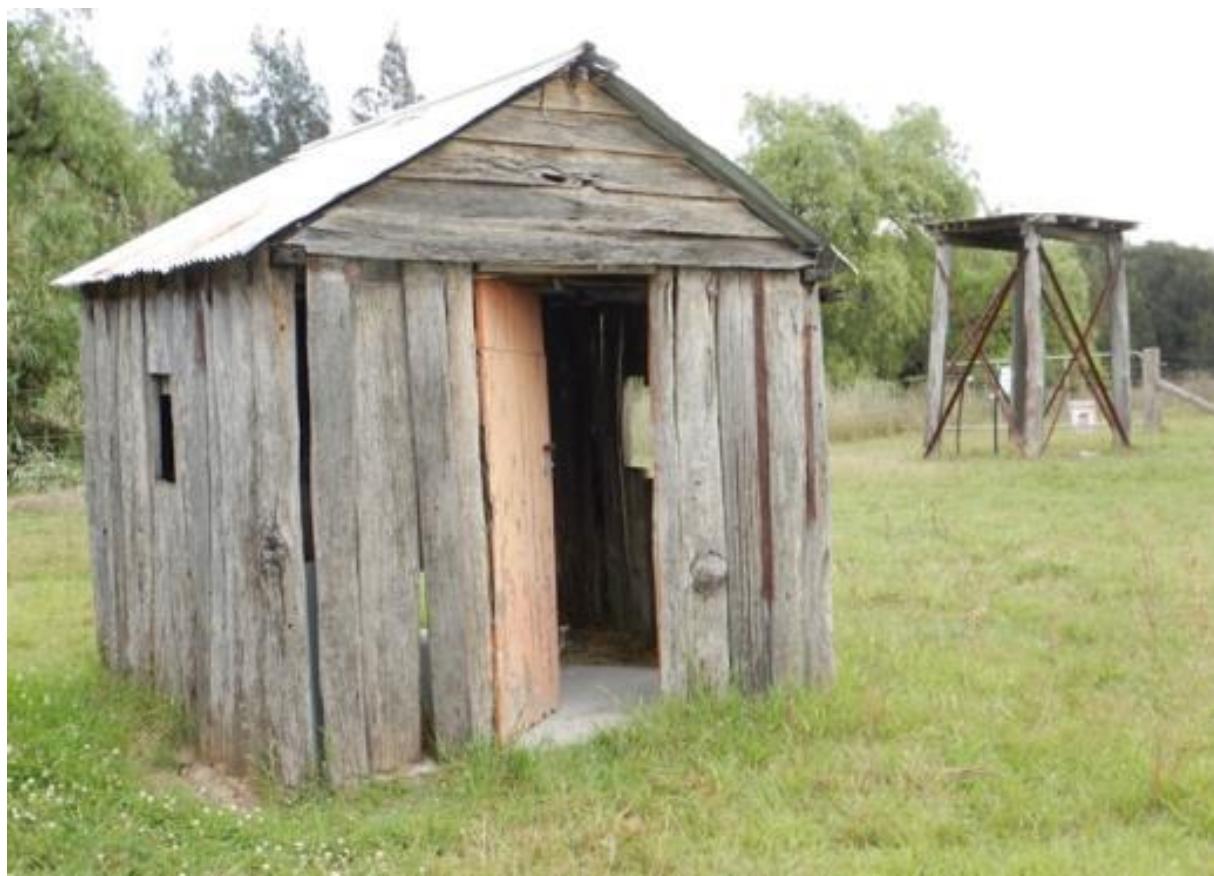
*Plate 7-5: View to West of Creamery and Timber Tank Stand*

The corrugated iron cladding used in the creamery's construction is trademarked 'Lysaght Australia Orb'. The original Lysaght brand of corrugated iron (under the trademark 'ORB') was exported in large quantities to Australia from 1897. John Lysaght had first established his company in Bristol and commenced manufacture (and export) of corrugated iron in 1857 (Warr 2000:3). John Lysaght (Australia) Ltd was established in 1921 to manufacture uncoated and coated steel sheet (National Library of Australia n.d). The Lysaght Australia Orb stamp on the corrugated iron cladding dates the

creamery to post 1921, assuming the corrugated iron comprises the creamery's cladding moved from Cheshunt.

*Note, new concrete slab floor of creamery*

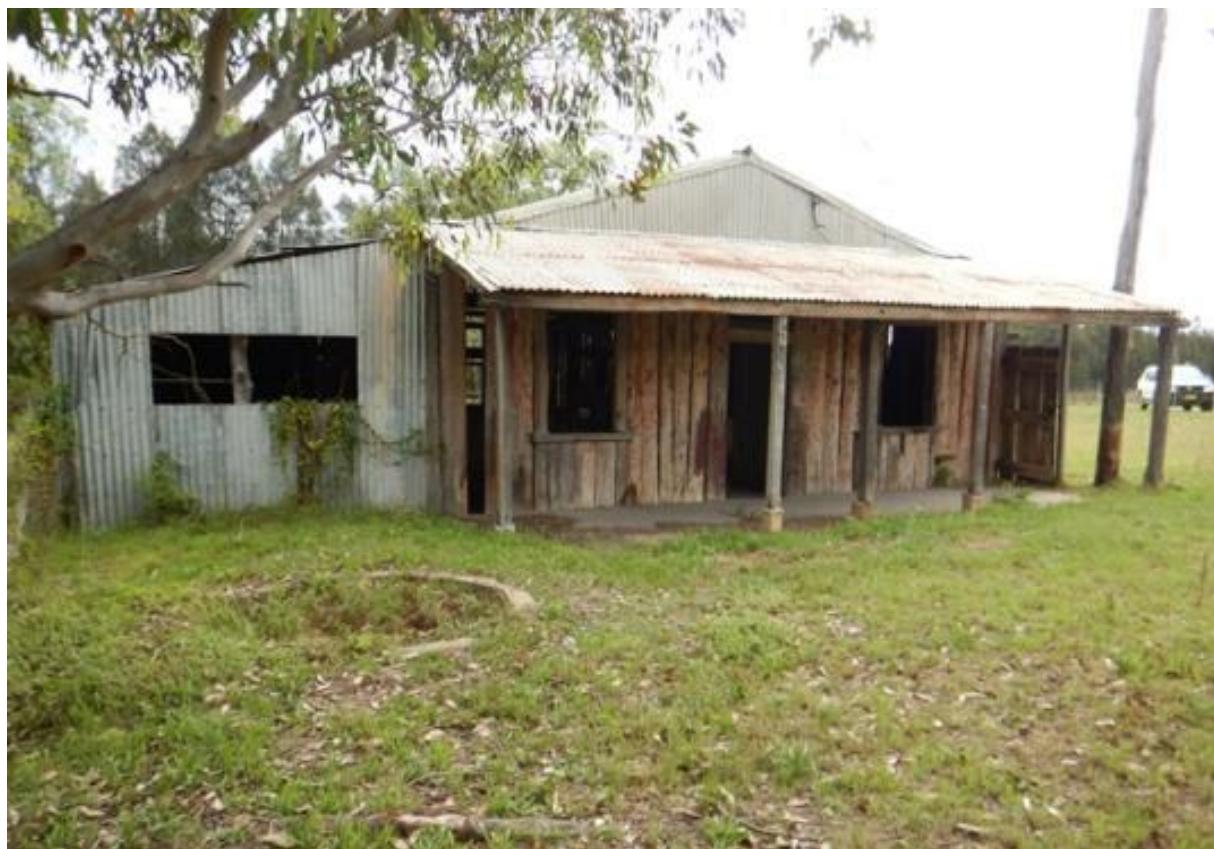
*Plate 7-6: View to West of Shearing Shed*

*Note, in-ground cistern in front of shed*

The corrugated iron cladding used has the brand 'Redcliffe Trademark'. This brand of imported British corrugated iron was a cheaper version of the original Lysaght brand of corrugated iron (ORB) exported in large quantities to Australia from 1897. John Lysaght was established in Bristol and commenced manufacture of corrugated iron on 1857 (Warr 2000:3).

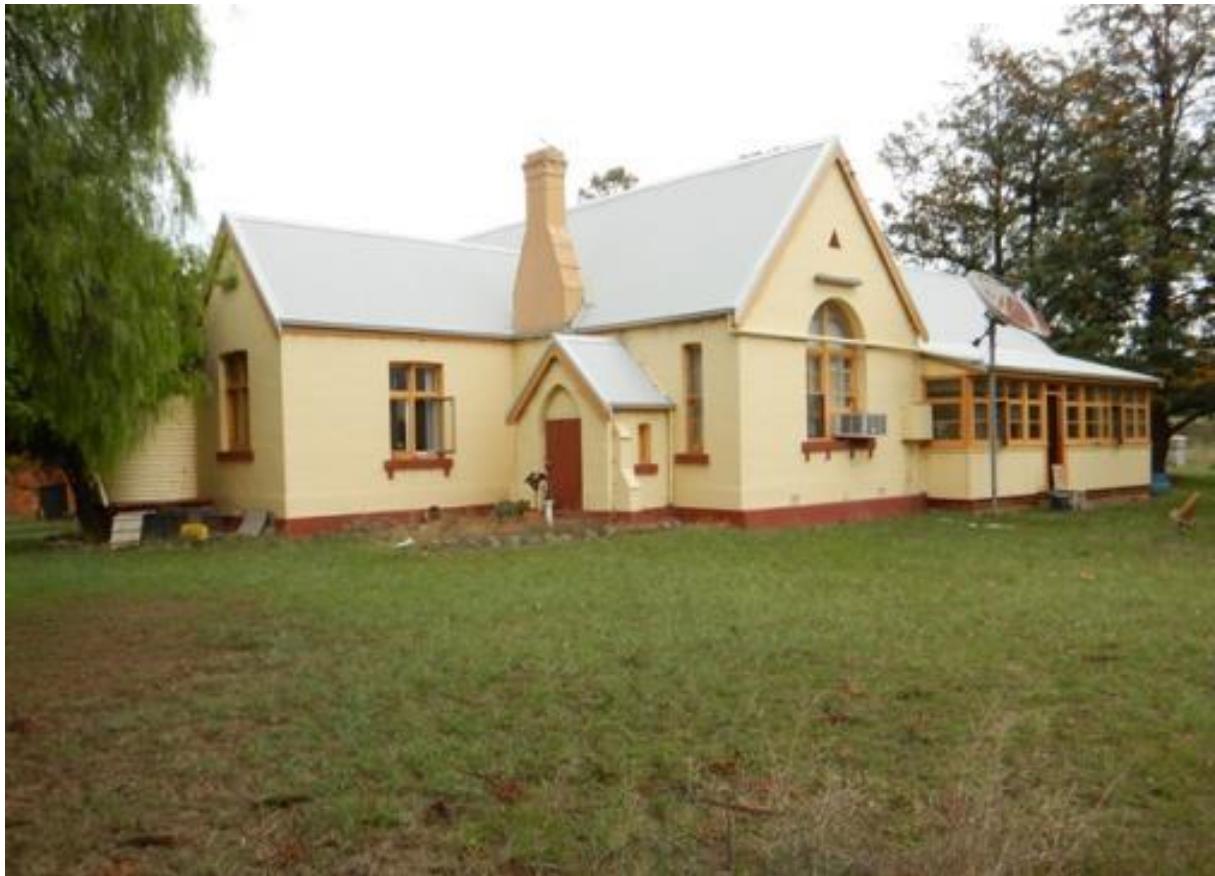
*Plate 7-9: View to West of the Former Warkworth Public School*

The former school is assessed to have limited historical significance on a local level, being representative of the historical development of the local area as well as the historical provision of education within the local area. The former school is shown in *Plate 7-9*.

The maximum predicted ground vibration level for building is 6.7 mm/s. As such, the former Warkworth Public School may be susceptible to damage from ground vibration.

United Wambo committed to complete a baseline condition assessment of the former Warkworth Public School prior to blasting as part of the Project, subject to landowner consent. Due to being

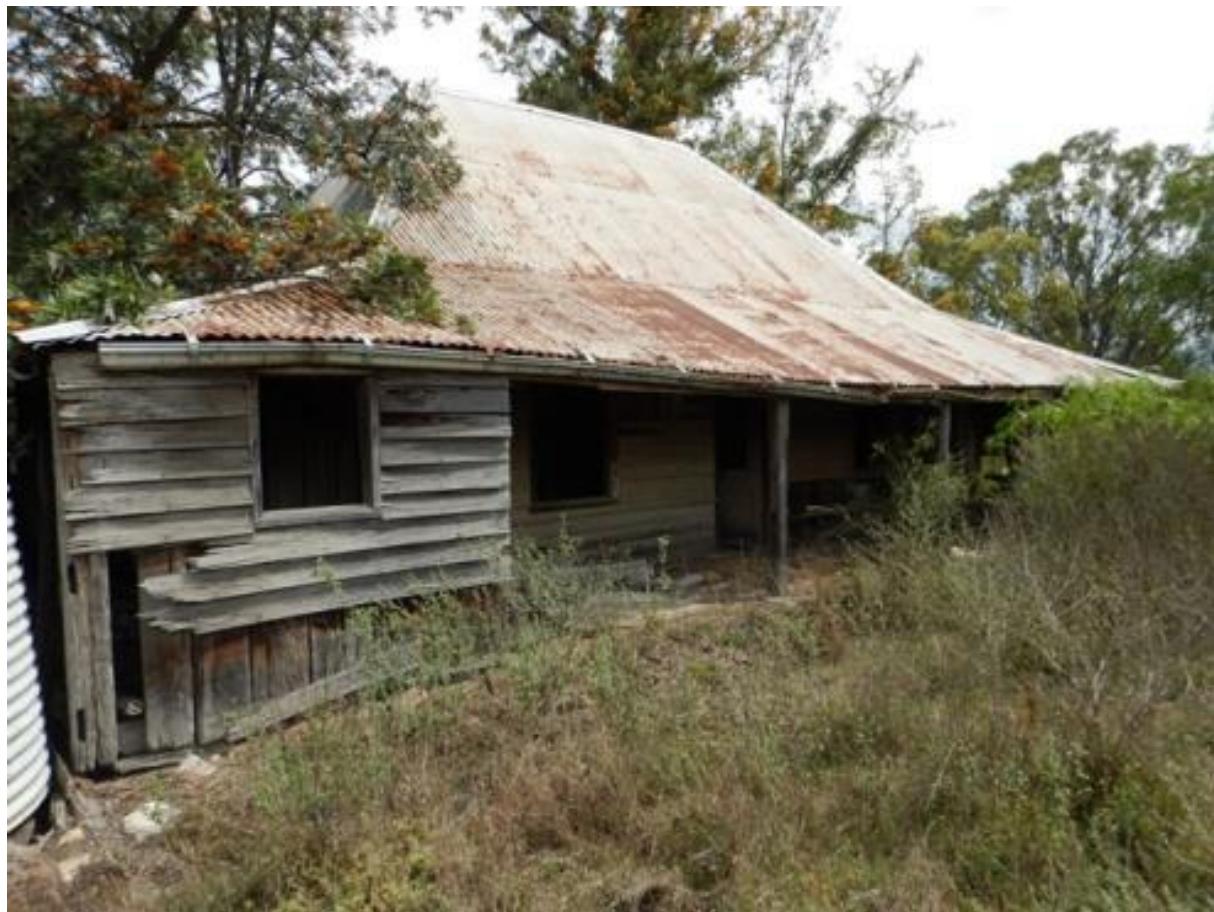
Plate 7-10: View to South-West Showing Front Elevation of Cottage

The Springwood Estate comprises approximately 102 hectares of land and the Springwood Homestead. The Homestead is likely to have been constructed c1860 and displays a number of characteristics of late Old Colonial Georgian to Victorian Georgian architecture. The Homestead consists of a timber slab cottage with a wrap-around verandah, a dressed sandstone chimney and later exterior weatherboard cladding. The building had a shingle broken-back roof with dormer windows. The Homestead is shown in *Plate 7-10*.
