Remedial Action Plan

195-213 Fitzgerald Avenue & 40-64 Yorktown Parade, Maroubra

17716.2-ER-1-2 Rev 2

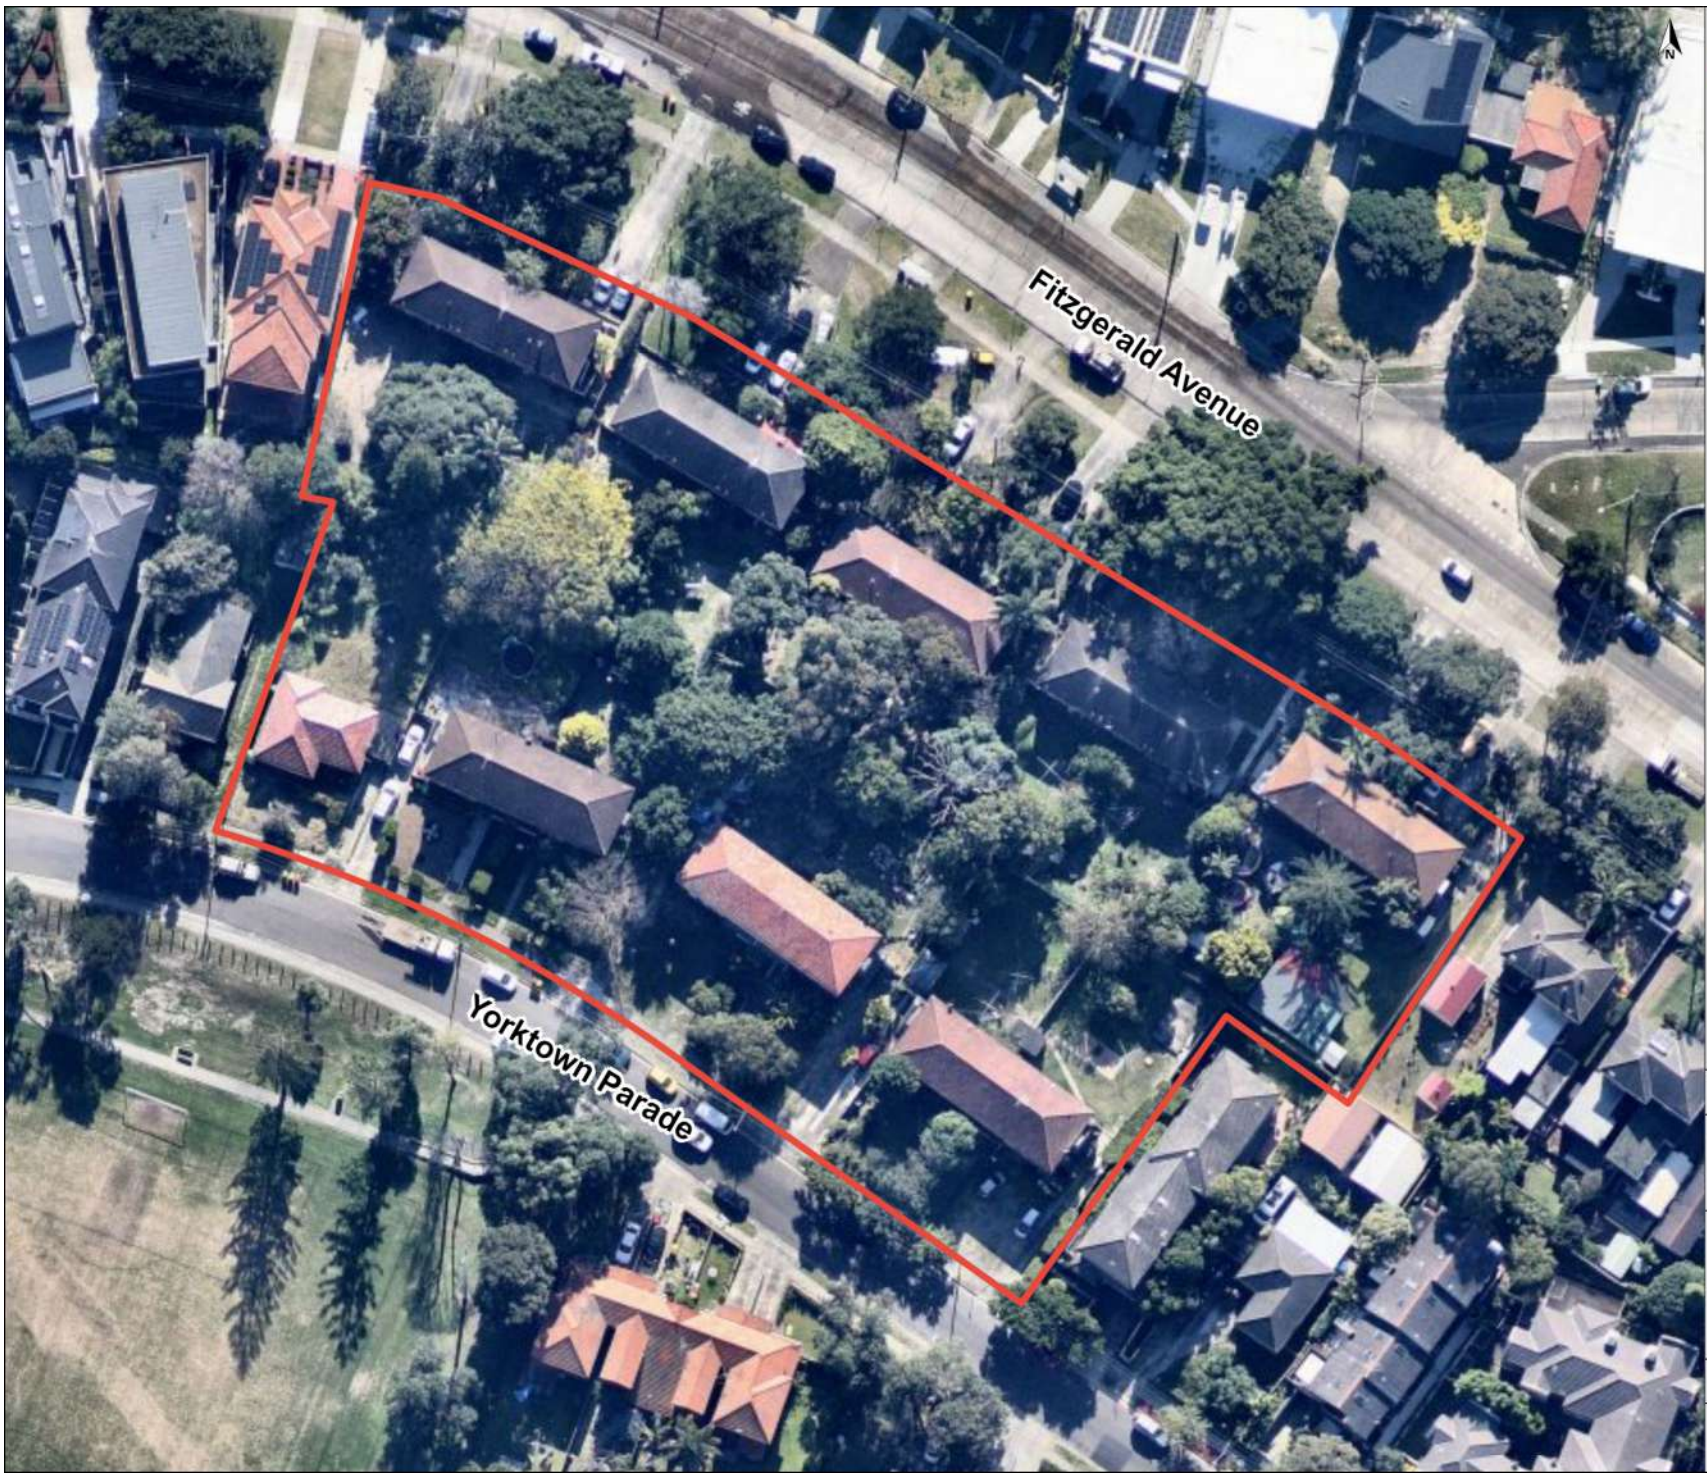
Title: Site Layout Plan		
Client: New South Wales Land and Housing Corporation		Size: A4
Project: 195-213 Fitzgerald Avenue & 40-64 Yorktown Parade, Maroubra NSW	Drawn: GS	Figure No.: 2
Date: 15-07-2024	Checked: SW	
Proj No: 17716.2	Scale: 1:870	Version: ER-1-2

Legend
□ Approximate Site Boundary

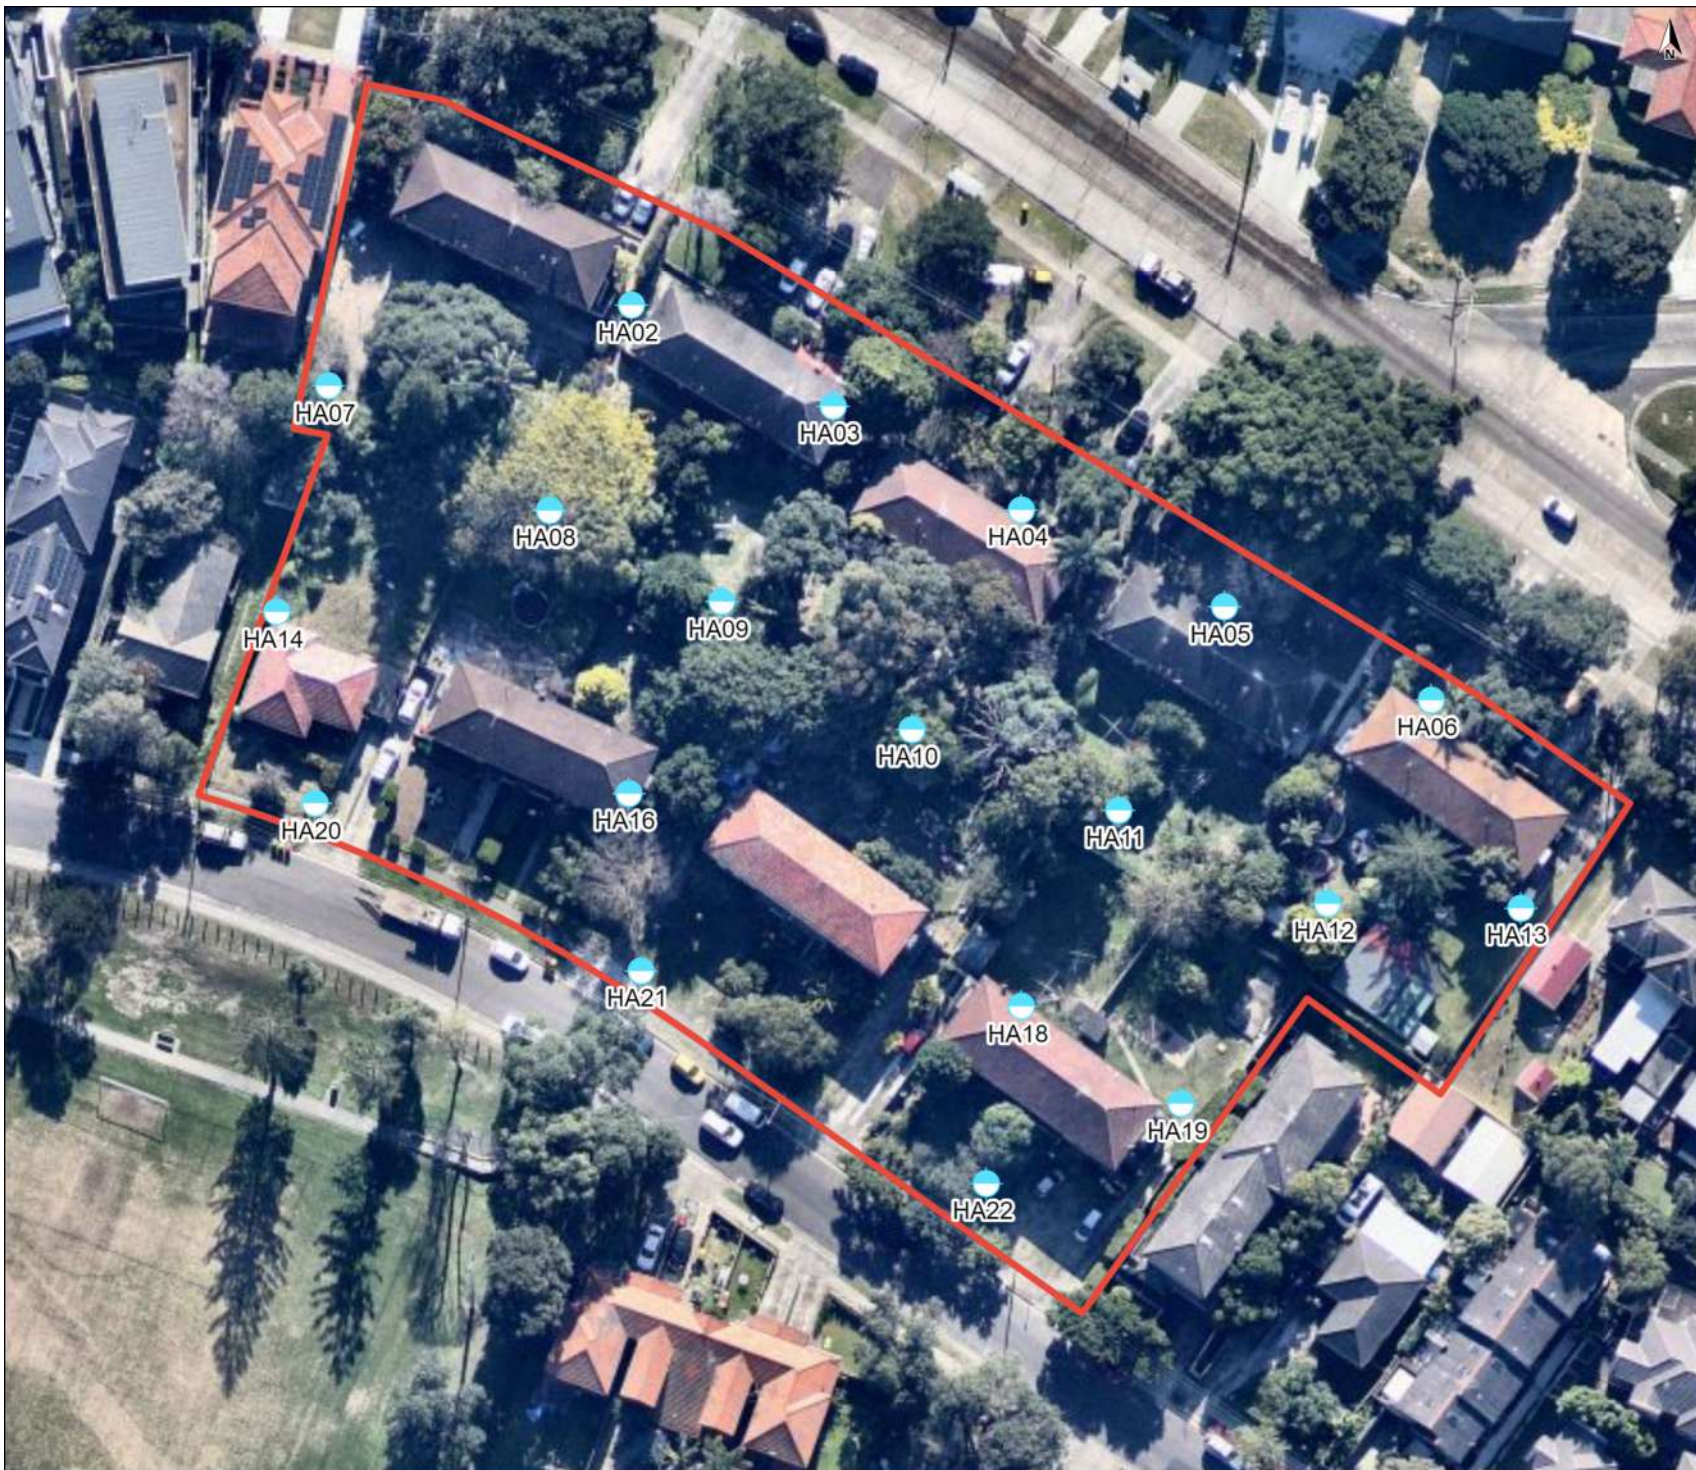
Title: Previous Sampling Points		
Client: New South Wales Land and Housing Corporation		Size: A4
Project: 195-213 Fitzgerald Avenue & 40-64 Yorktown Parade, Maroubra NSW	Drawn: GS	Figure No.: 3
Date: 15-07-2024	Checked: SW	
Proj No: 17716.2	Scale: 1:793	Version: ER-1-2

- Approximate Hand Auger Locations
- Approximate Site Boundary

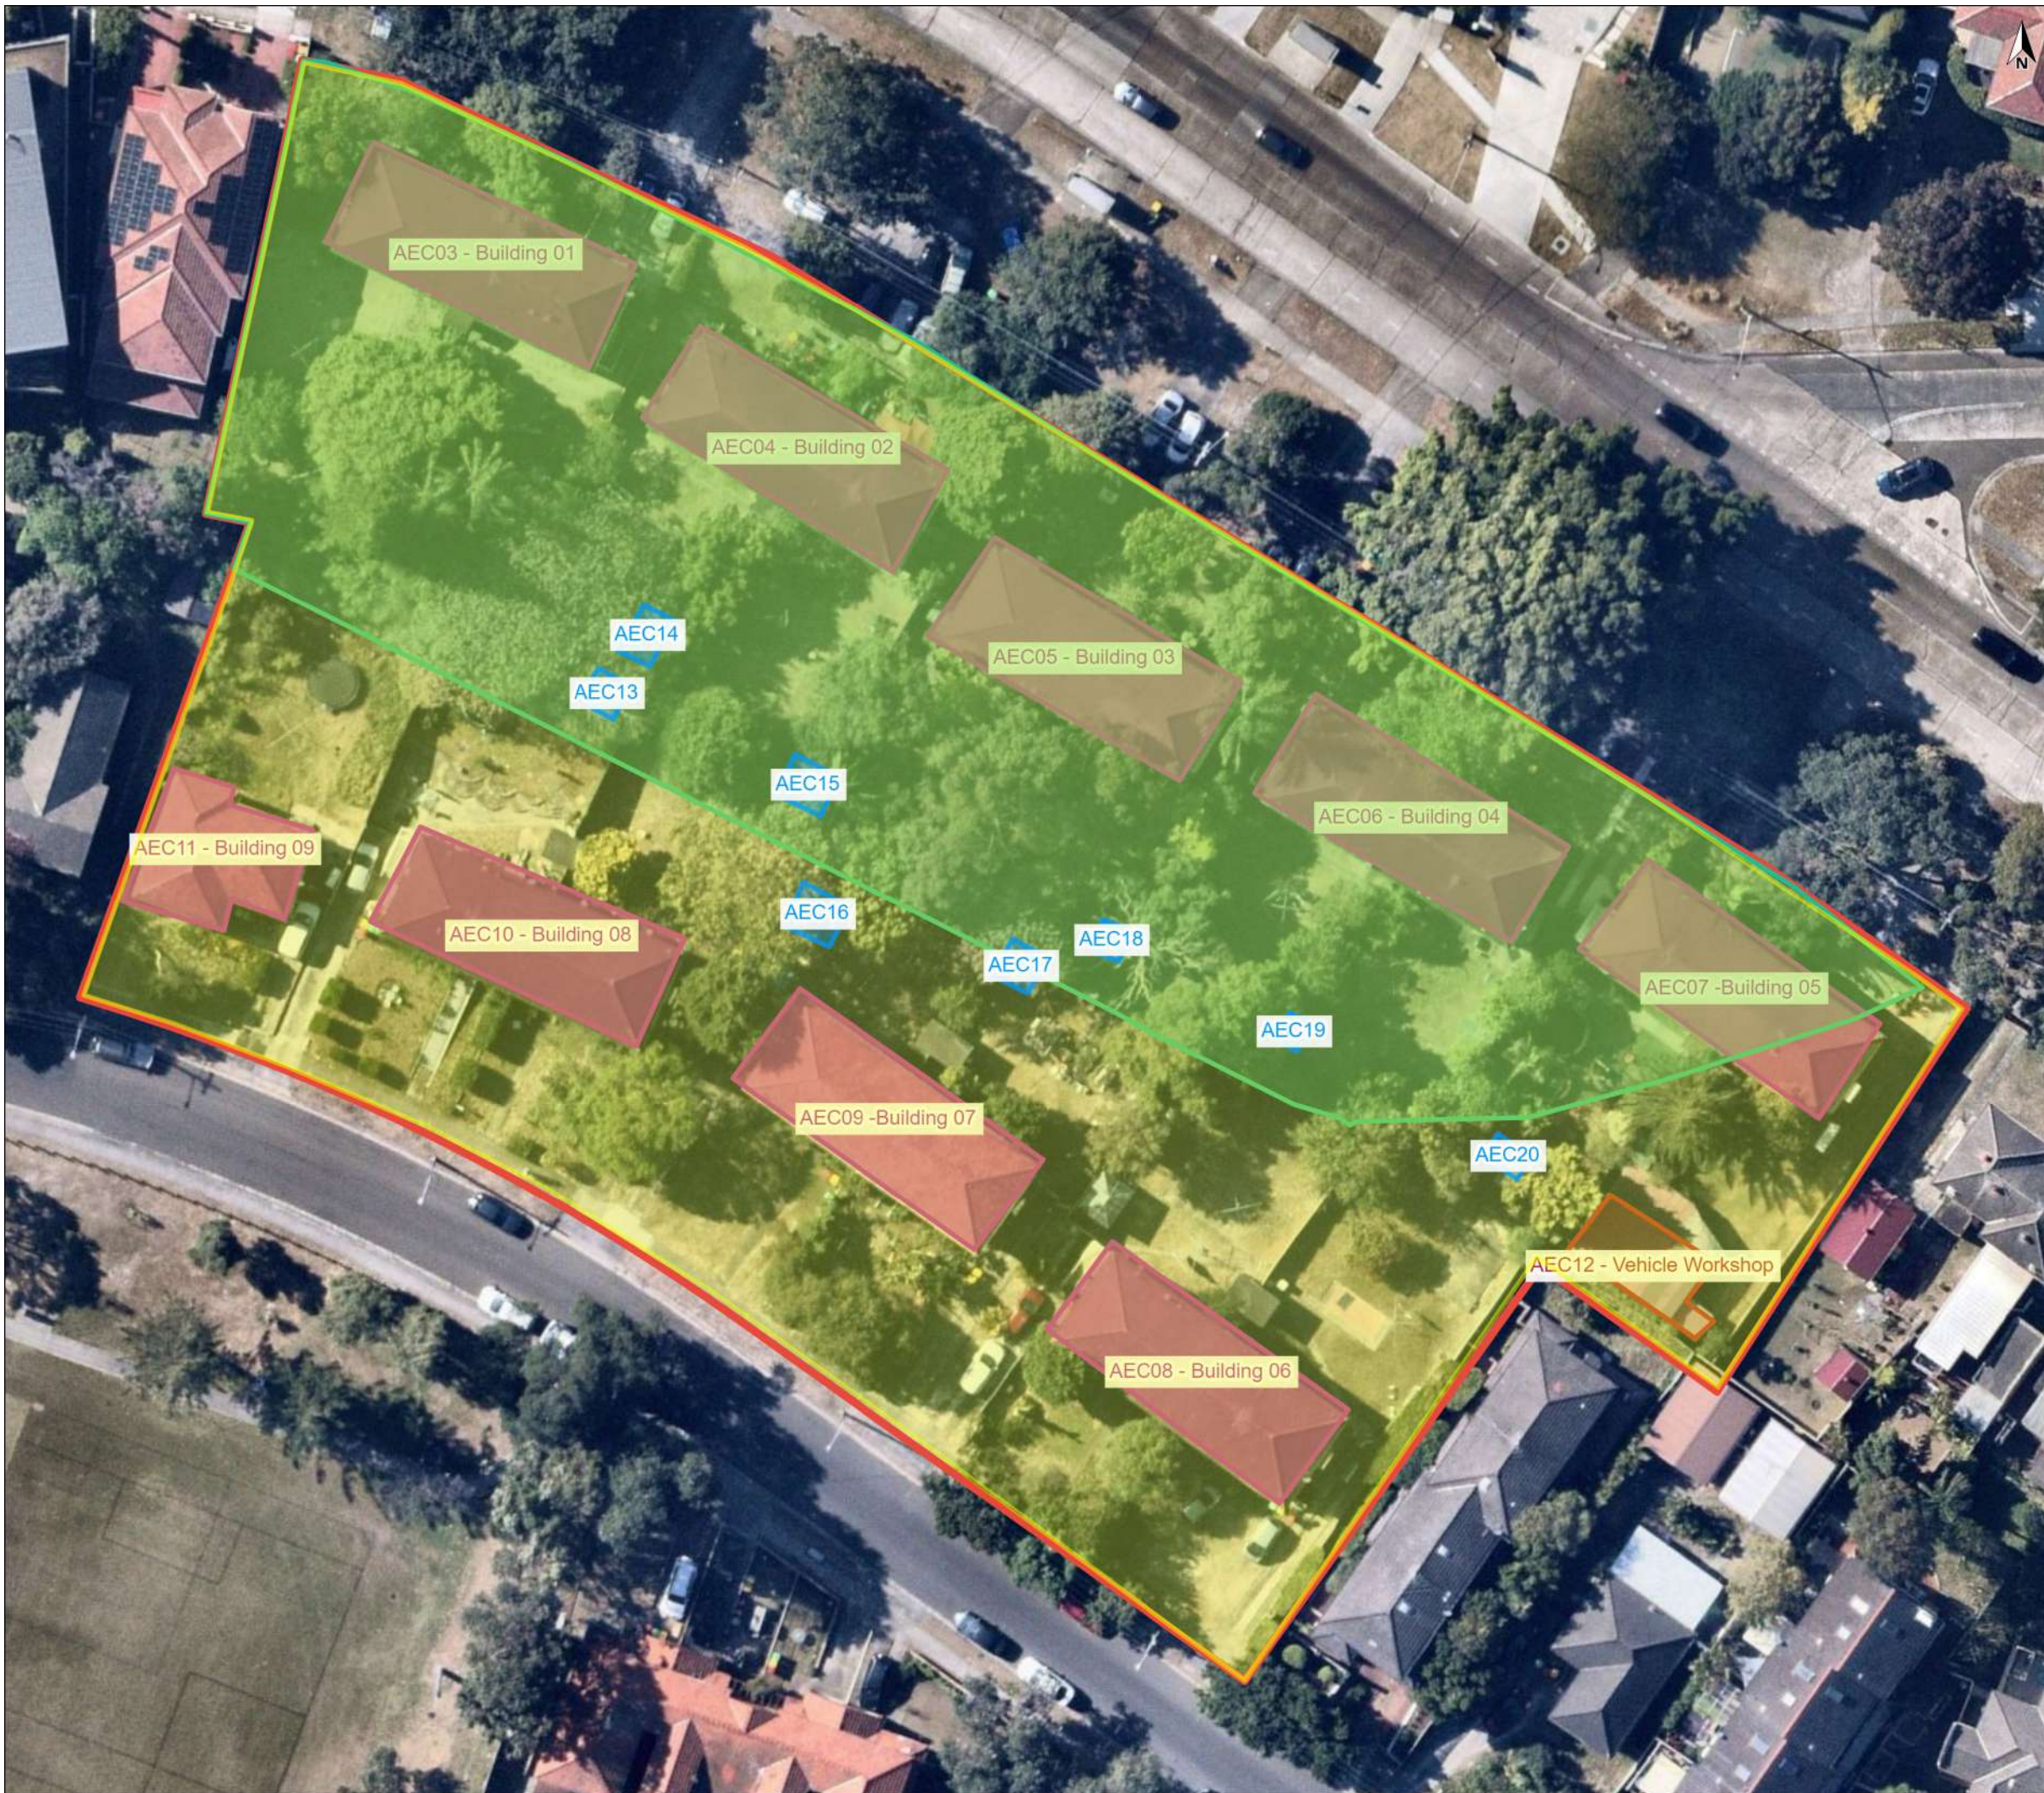
Project: 195-213 Fitzgerald Avenue & 40-64 Yorktown Parade, Maroubra NSW	Drawn: MC	Figure No.: 4
Date: 09-09-2024	Checked: SW

- AEC01 - Site Footprint
- AEC02 - Historical Sheds
- Site Boundary

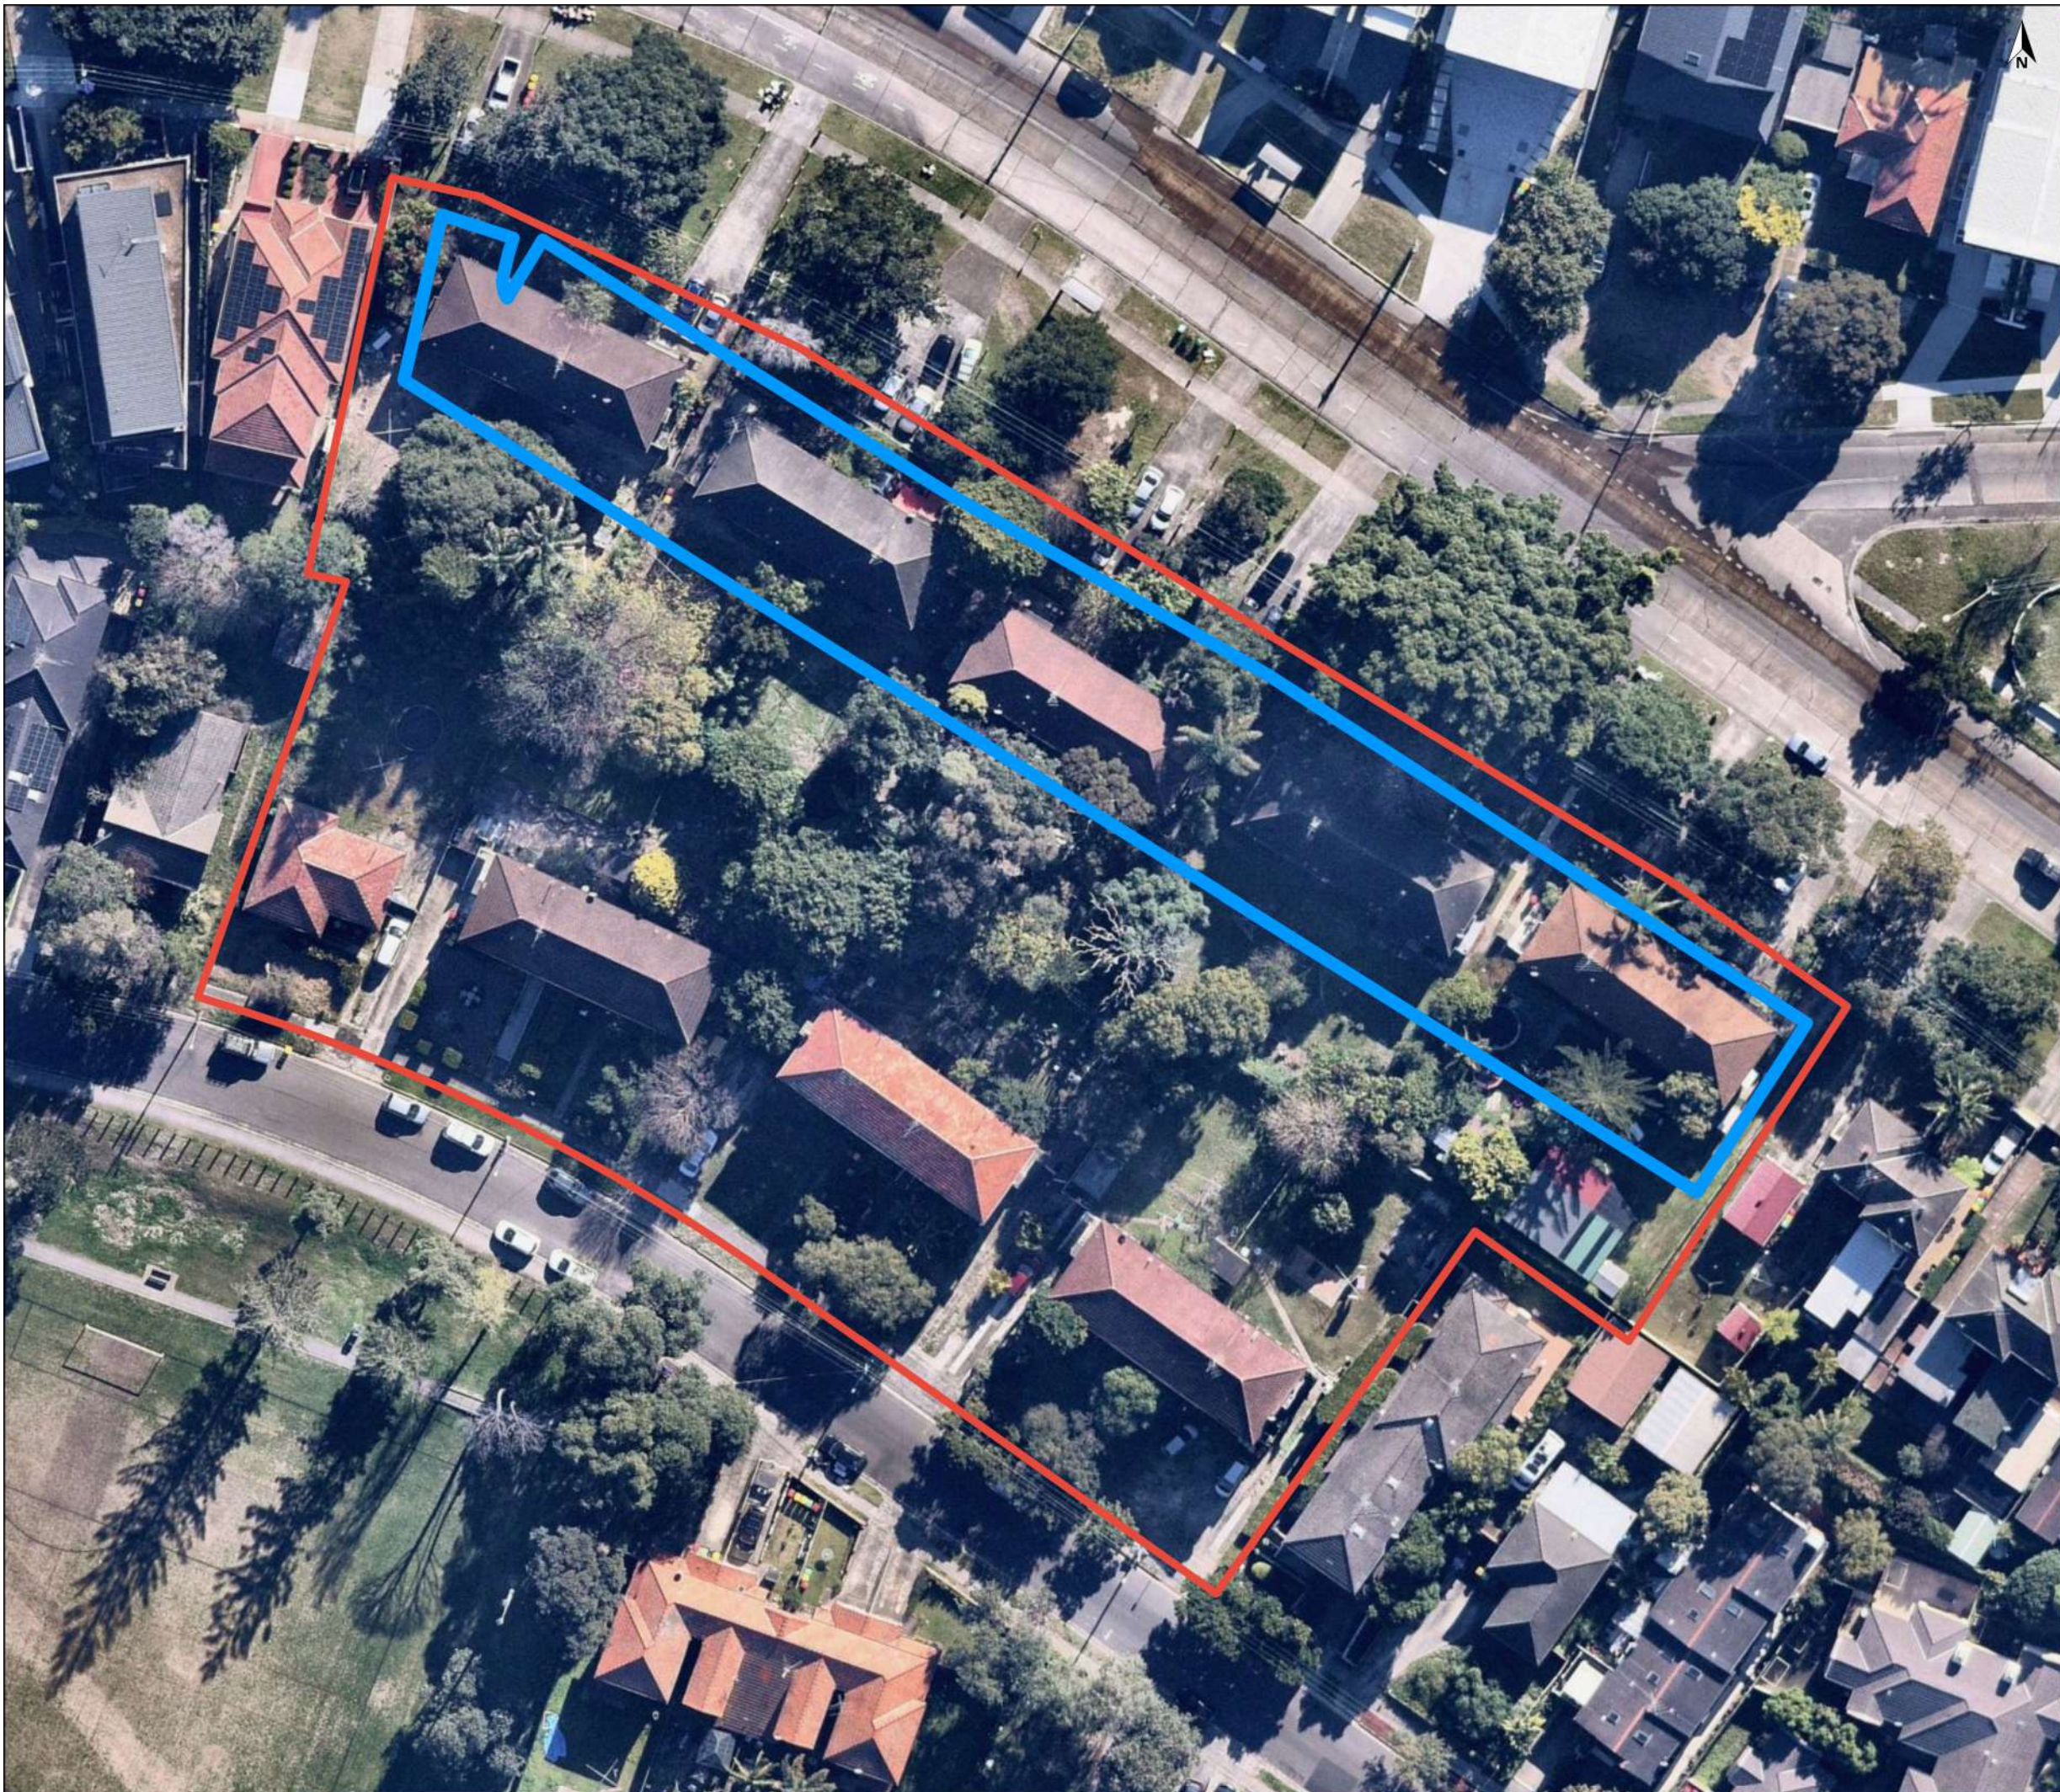
Title: Basement Plan		
Client: New South Wales Land and Housing Corporation		Size: A3
Project: 195-213 Fitzgerald Avenue & 40-64 Yorktown Parade, Maroubra NSW		Drawn: MC Figure No.: 5
Date: 02-09-2024	Checked: SW	
Proj No: 17716.2	Scale: 1:580	Version: ER-1-2

- ▭ Approximate extent of proposed basement
- ▭ Approximate Site Boundary

- Use of hazardous building materials within the extent of the basement as shown in **Figure 5**.

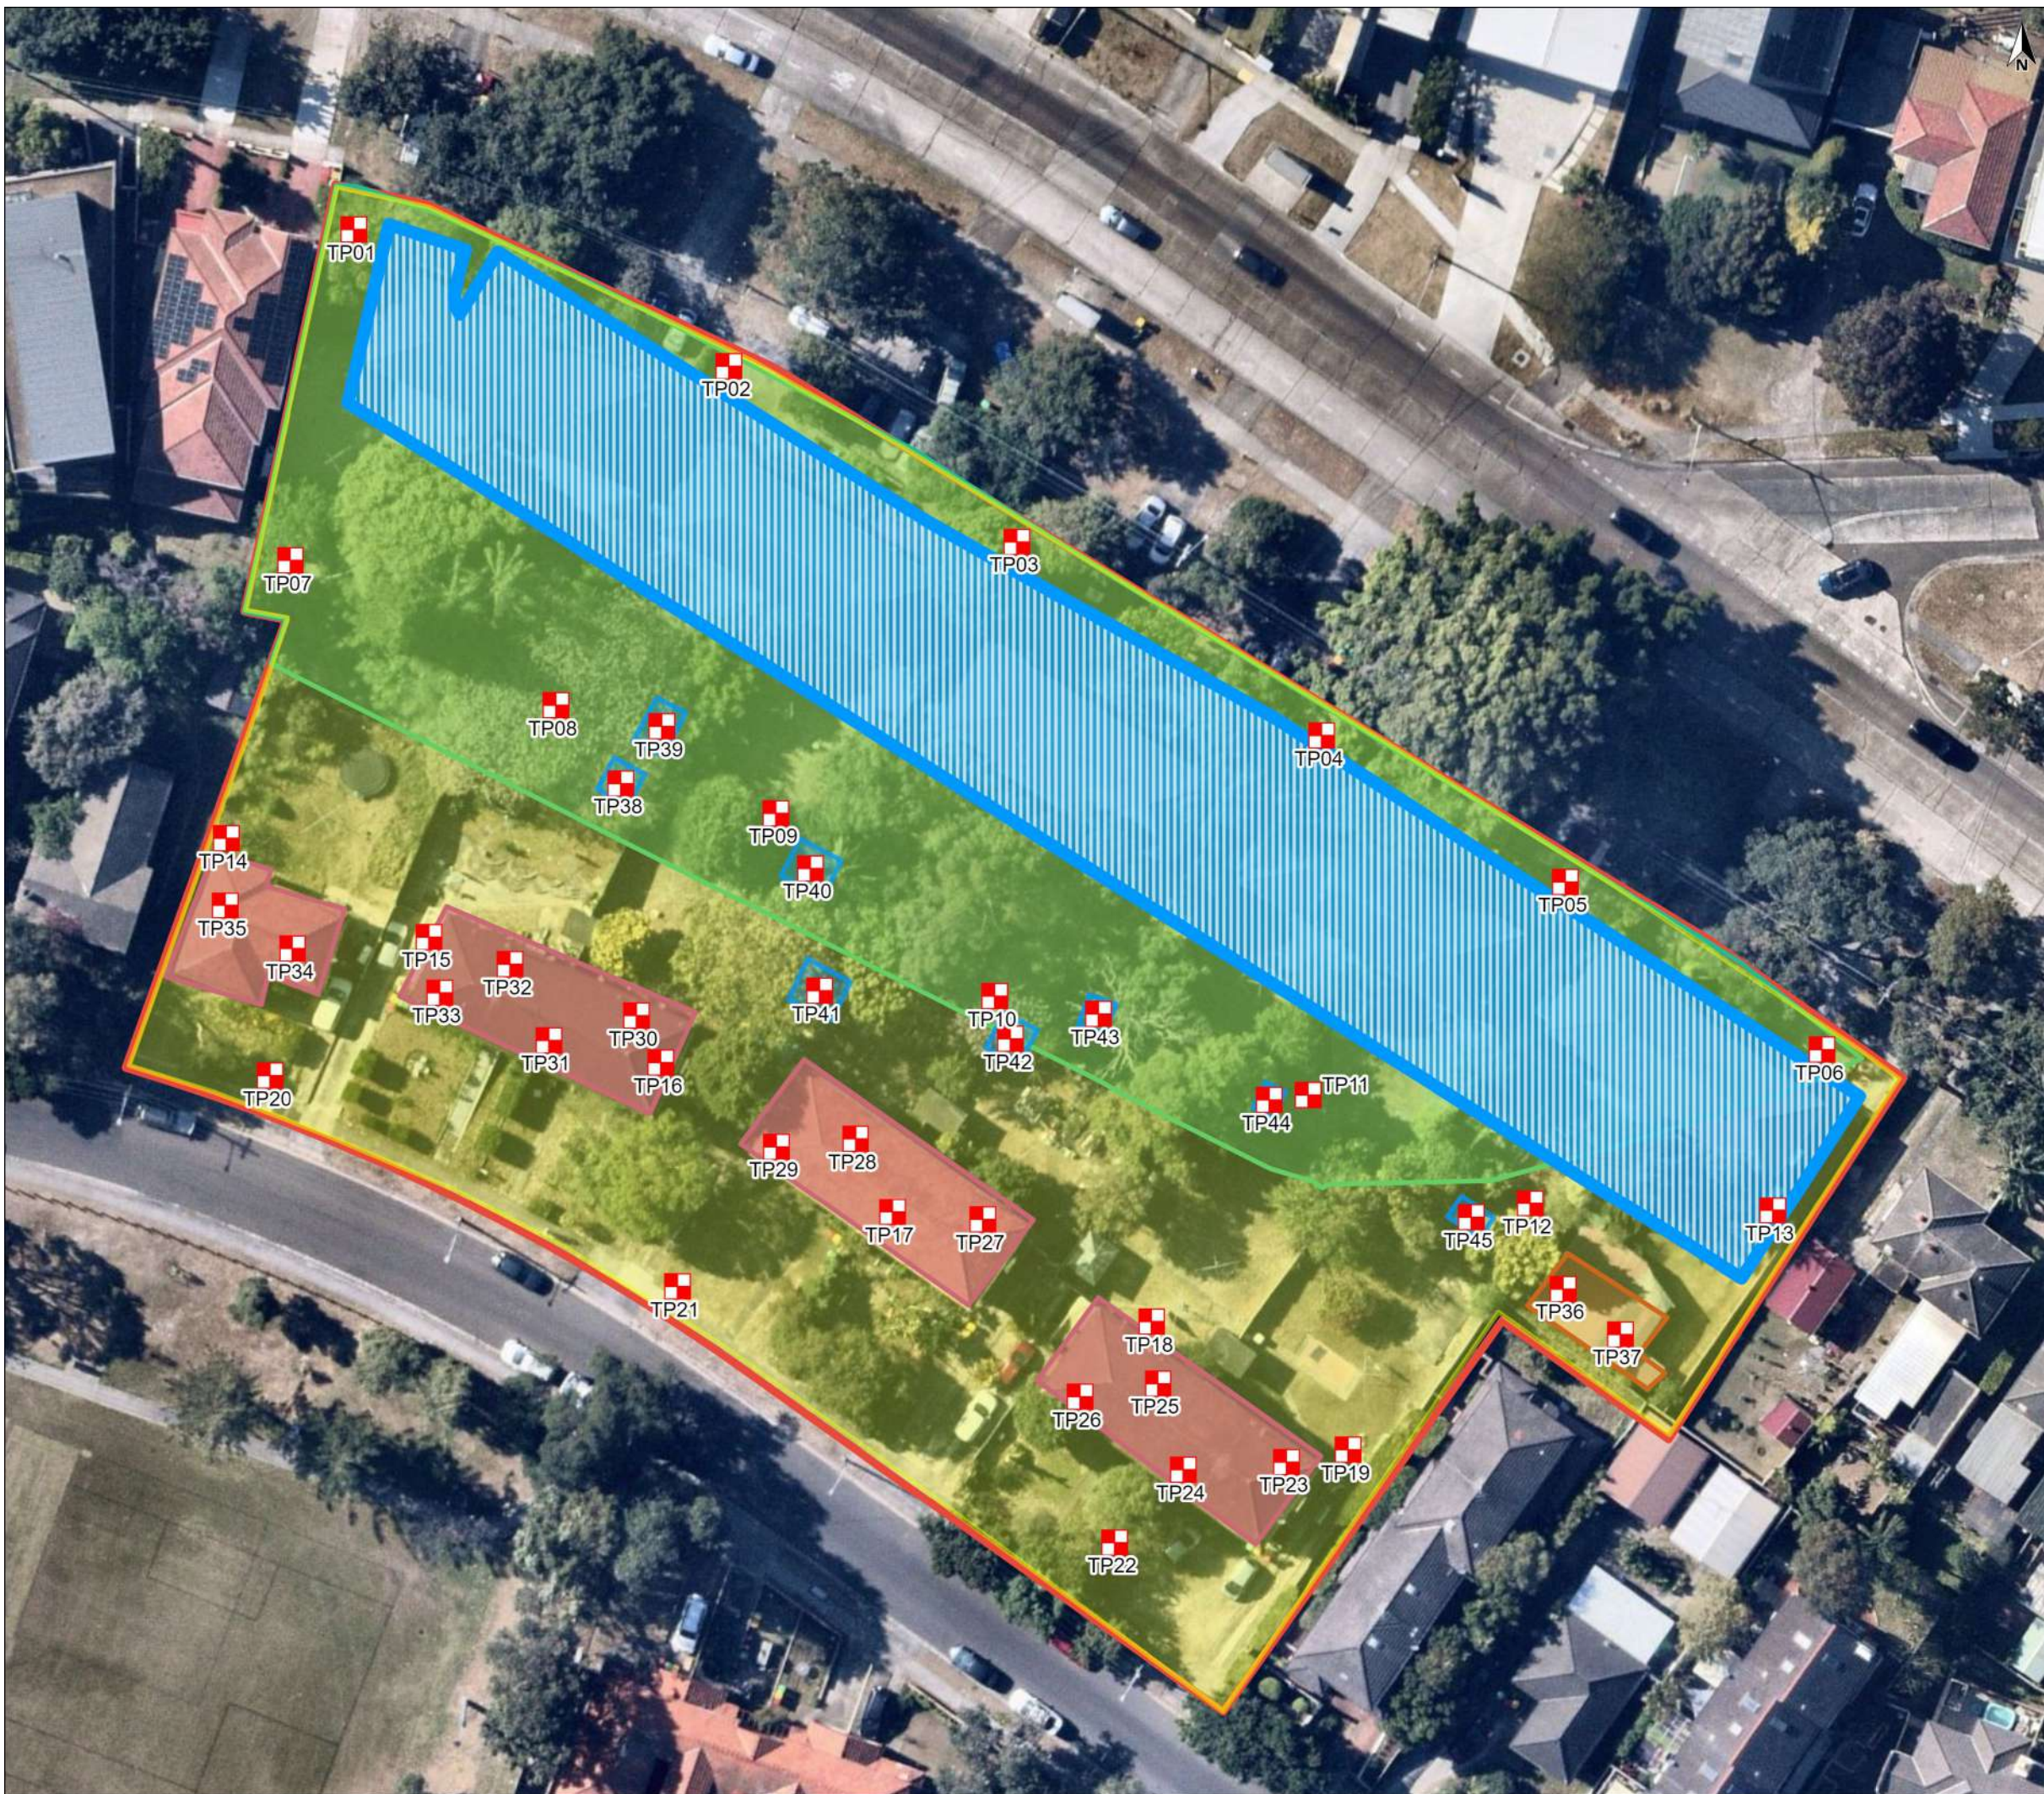
- SCA Sampling Points
- Approximate extent of proposed basement
- AEC01 - Site Footprint
- AEC02 - Historical Sheds
- Site Boundary

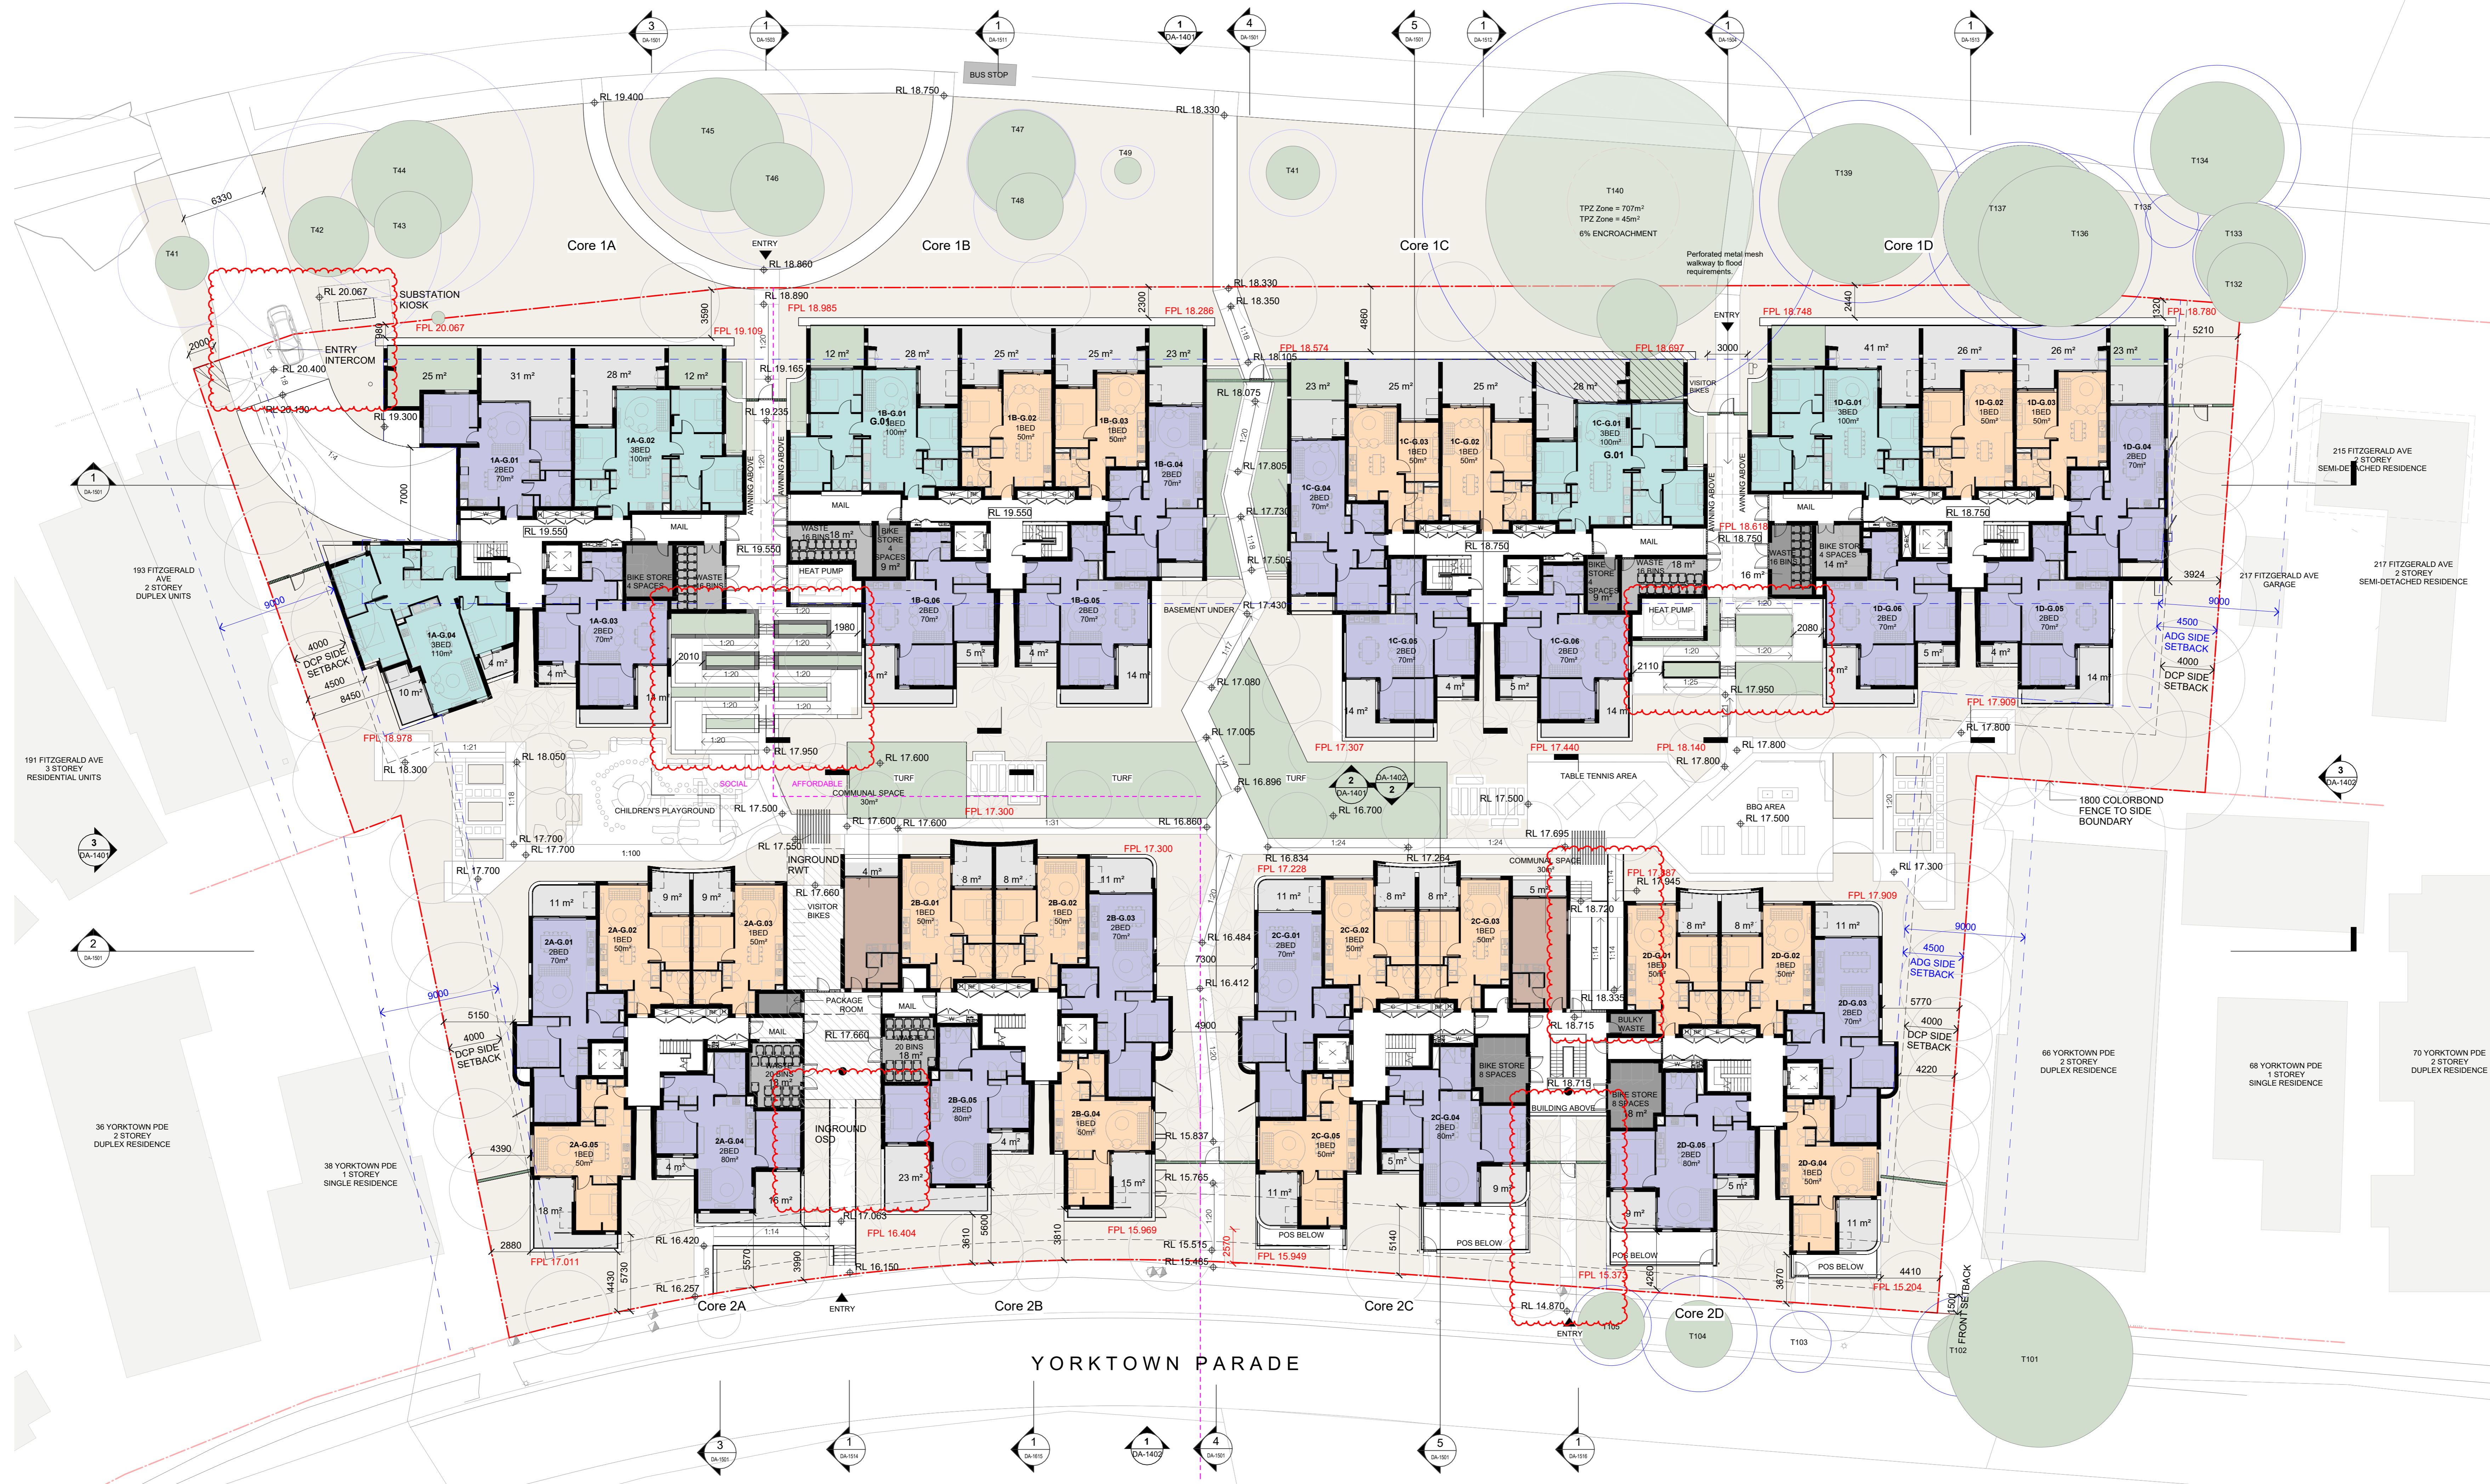
Drawing No.	Revision	Scale
DA-1003	/ H	1:200

Project: 6962 - MAROUBRA
Drawing Name: FLOOR PLAN - GROUND
Date: 2024-10-01
Scale: 1:200
Sheet Size: @ A0
