GTE549 - Salinity Report
27 October 2015

RE: SALINITY INVESTIGATION at 34 Yarrunga Street, Prestons.

This letter presents a geotechnical report on the inspection and testing services associated with the salinity investigation undertaken at the above project.

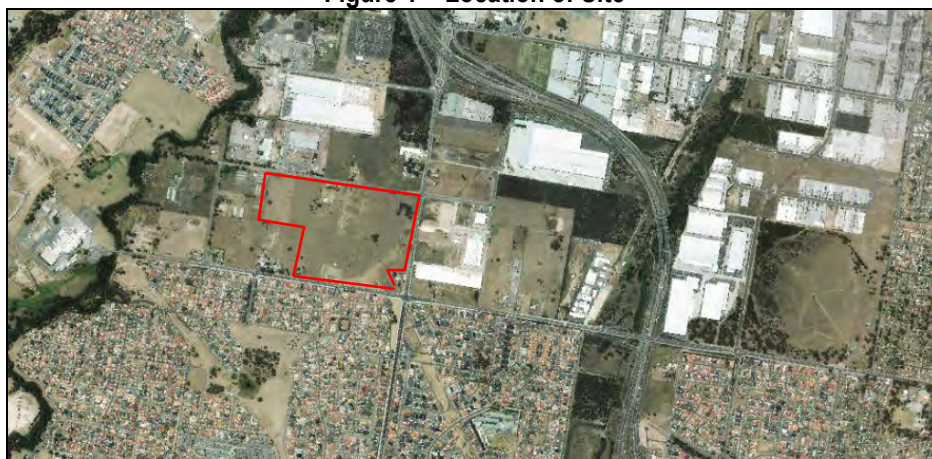
Figure 1 – Location of Site

The subject property is irregular in shape, measuring approximately 625m wide along the Yarrunga Street frontage, and 305m deep along the Bernera Road frontage.

The subject property covers an area of approximately 20.7ha, with the majority of it vacant and grass covered. A high point is located within lot 34, behind the metal shed, with gradients falling away from this point in all directions by grades of up to 3° to 7°.

The geotechnical investigation included drilling five (5) boreholes using a 4WD Toyota Landcruiser Ute mounted drill rig with 100mm diameter solid flight spiral augers at the locations shown on drawing Figure 1. Seventeen (17) disturbed samples were recovered from the boreholes and submitted to an external laboratory for the salinity suite of chemical testing. This report provides a salinity assessment on the existing soil conditions.

Fieldwork was undertaken on the 7th of October 2015 and included drilling five boreholes (TS13 –TS17) using a 4WD Toyota Landcruiser Ute mounted drill rig with 100 mm solid flight spiral augers at locations shown on Figure 1. The boreholes were terminated at a depth of 3.0m below existing ground surface levels.

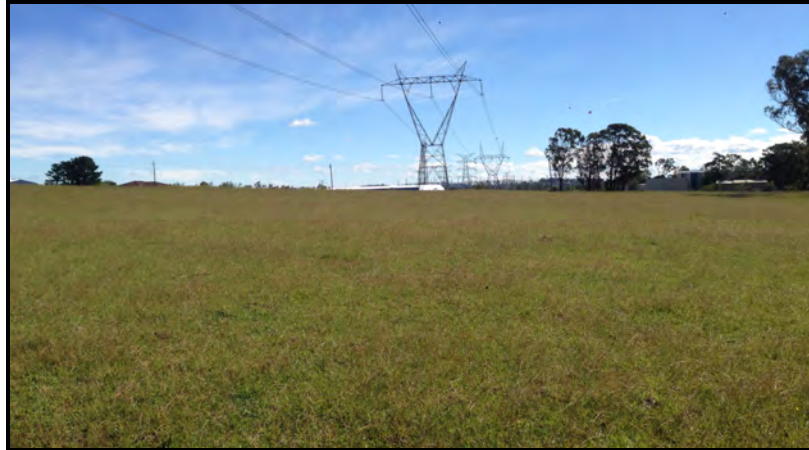
Photograph 1 – Lot 33

Lot 33 and 35 are grass covered and vacant. High voltage power lines traverse through the site in a north / south alignment.

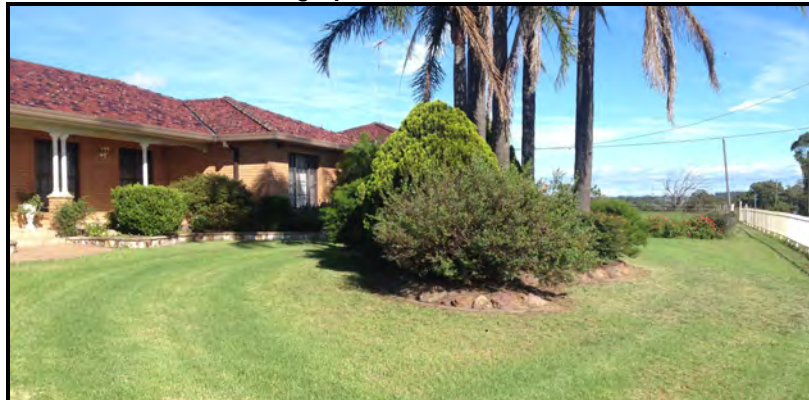
Photograph 2 – House on Lot 33

Lot 34 contains a single storey residential house, a metal shed and equipment for loading cattle onto trucks within the northern (front) portion of the lots.

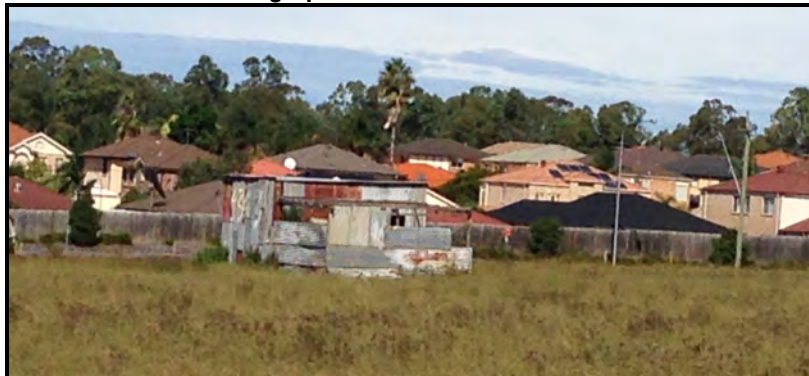
Photograph 5 – Metal Shed on Lot 43

Lot 43 contains a metal shed located centrally within the lot

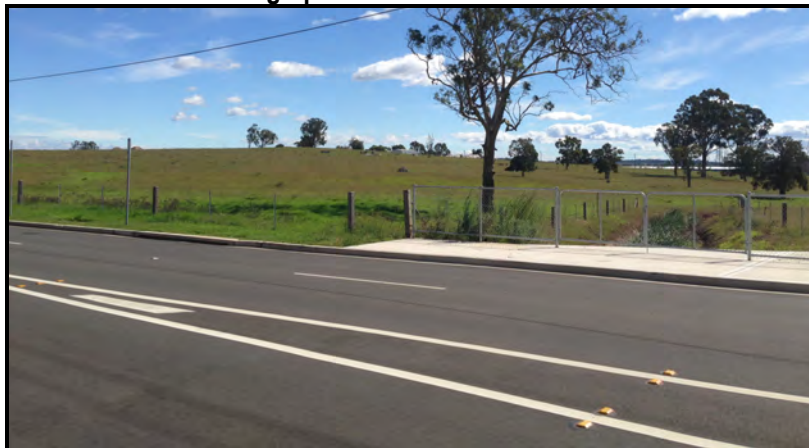
Photograph 6 – Fill area within Lot 20

Lot 20 of DP1173483 is predominately vacant. An old drainage line has been re-aligned within this site with a new culvert placed under Kurrajong Road.

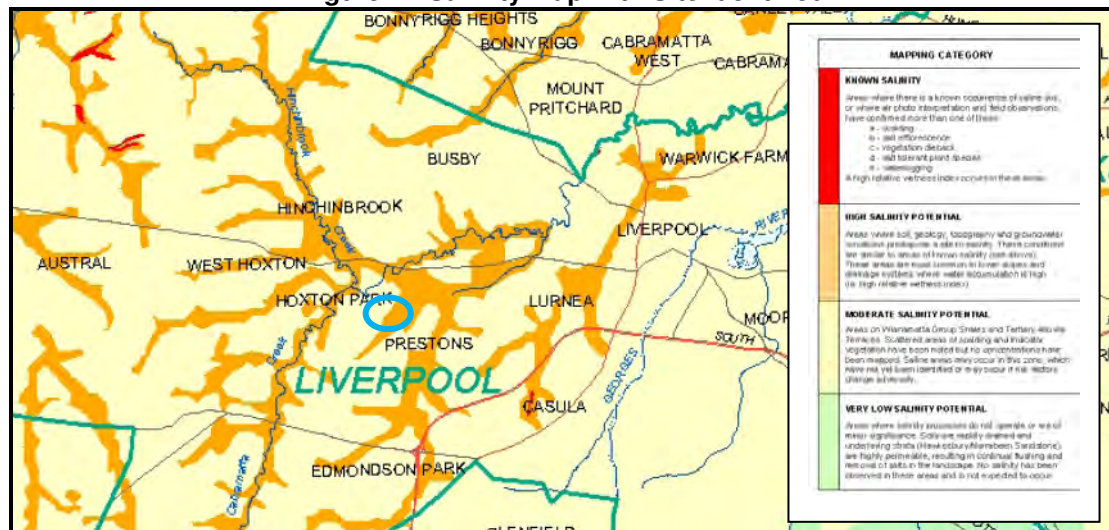
Figure 2 - Salinity Map with Site Identified

The Department of Infrastructure and Planning (2002) Salinity Potential in Western Sydney map “Salinity Potential in Western Sydney 2002” indicates that the subject site is situated in a region with a moderate to high risk of saline soils.

The moderate classification is attributed to scattered areas of scalding and vegetation indicators in areas where the concentrations have not been mapped. There is the possibility of encountering saline areas which were not identified due to localised factors. Saline soils could occur within areas of lower slopes and drainage systems where water accumulation is high or where movement of water through the soil profile is low.
