Lot 34 DP2359  
Yarrunga Street, Prestons, NSW  
(Site of the former Benera Homestead)  
**Preliminary Historical Archaeological Appraisal**

**30 April 2015**

*Report prepared by MDCA  
for DBL Property Pty Ltd  
& Logos Australian Logistics Venture Trust*

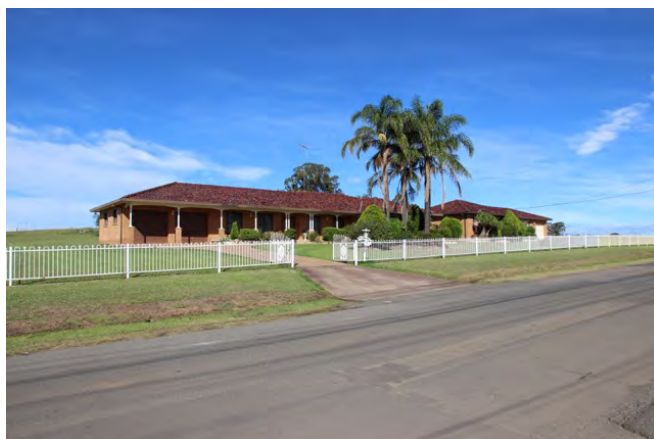
**Figure 5:**  
**General view across the**  
**northern frontage of Lot**  
**34 showing modern**  
**brick residences**  
View SSW - D. Tuck 2015

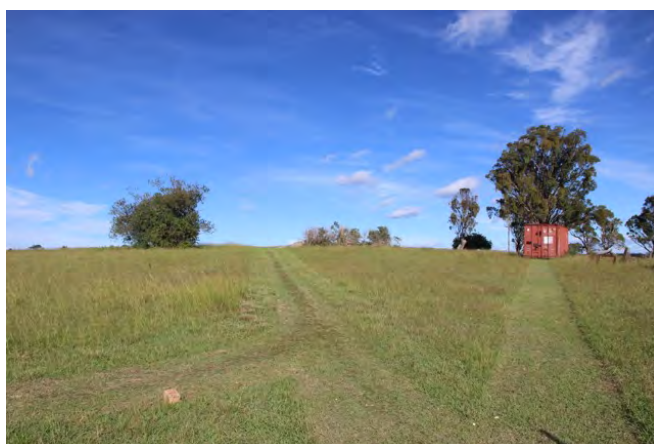
**Figure 6:**  
**View across study area**  
**towards site of former**  
**Benera Homestead**  
View WSW - D. Tuck 2015

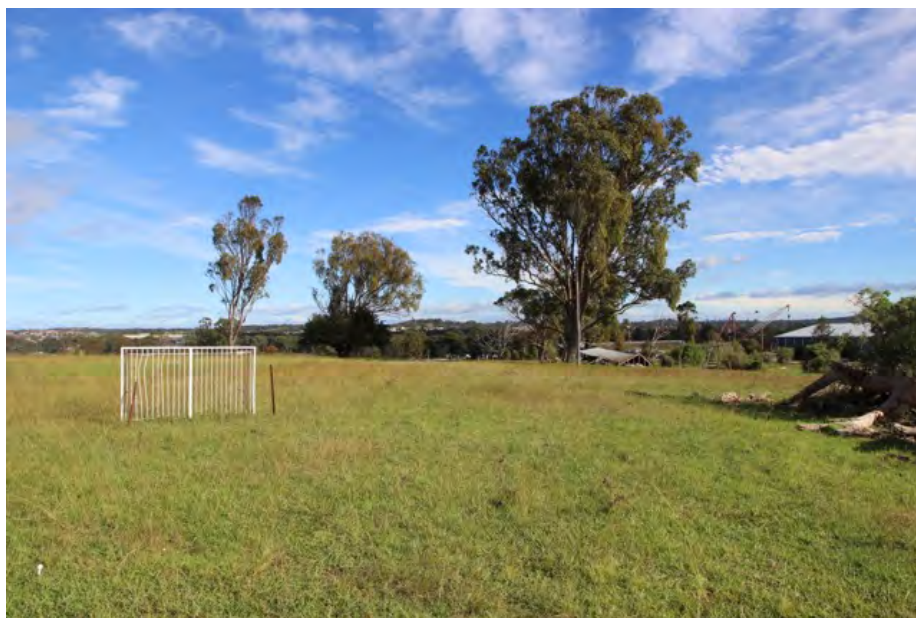
**Figure 7: Site of the former Benera Homestead**  
View WSW - D. Tuck 2015

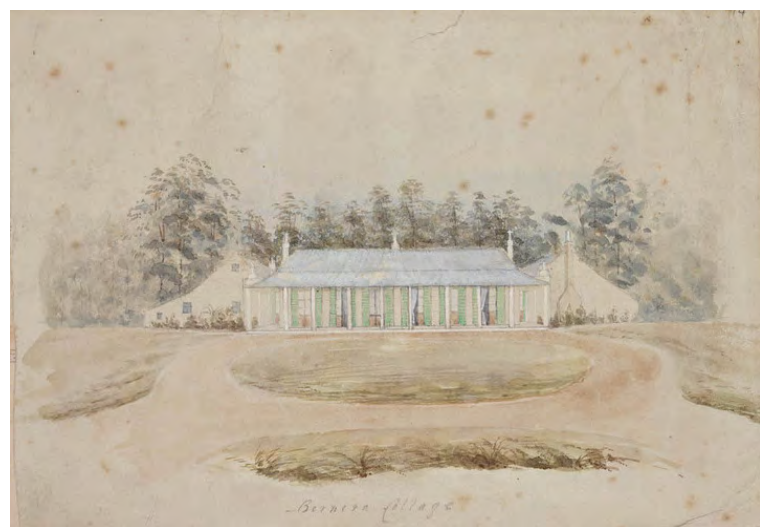
**Figure 9: Benera Cottage (c.1856/57)**  
From Mrs Allan Macpherson's 'Scenes in NSW 1856-57' SLNSW

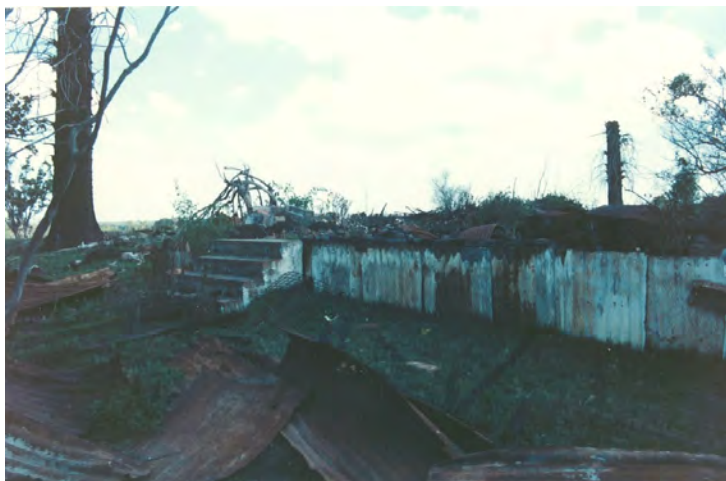
**Figure 19: Benera (1992)**

House remains include sandstone piers/footings supporting timber log bearers morticed to take floor joists and many burnt structural timbers. The U-shaped plan of the house is clearly evident. Remains of at least 2 stone chimneys and carved stone thresholds at entry points. All internal fittings destroyed although major items such as the sink and fridge are still recognisable. Much burnt corrugated iron roofing is scattered across the house site and the knoll on which the house is situated. The concrete cistern at the rear has been infilled. The fill includes some recent material. On the southern side of the knoll is a shed constructed of corrugated iron and timber posts (not significant). "

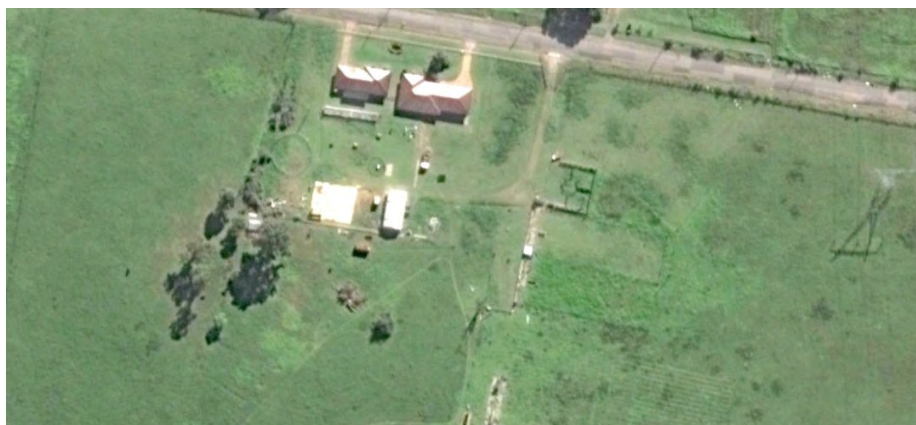
**Figure 24: Study Area (2014)**  
*Google Earth*

At present, the homestead site presents as a grassed up knoll-top. While there are occasional surface undulations, the setting and arrangement of the home is not distinguishable and the only item marking the locale is the burnt out and termite afflicted remnants of the Moreton Bay Fig that once stood to the immediate NE of the homestead.

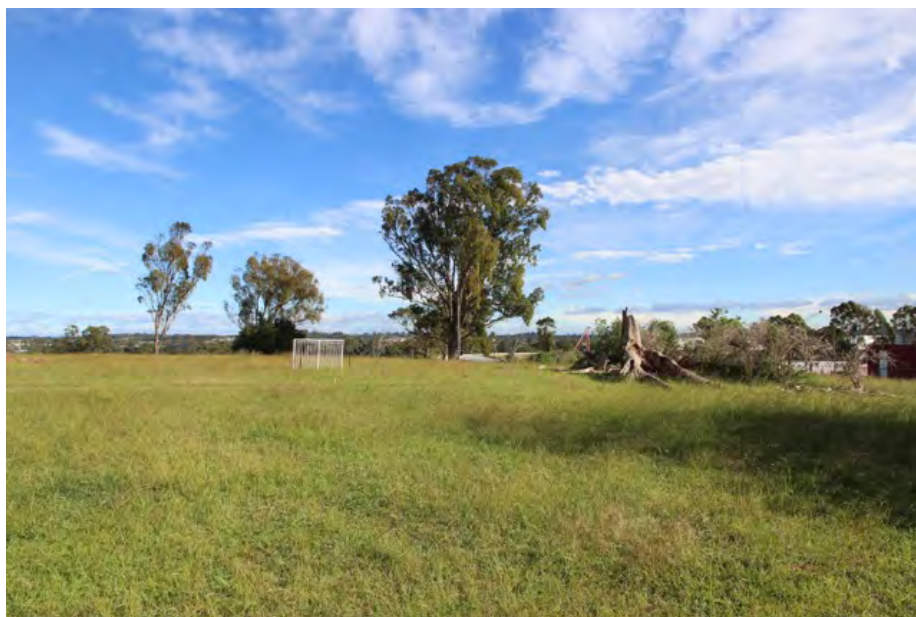
The homestead site presents as a grassed up knoll top. While there are some surface undulations, and the remains of some of the vegetation that formerly dotted the site, there is no clear surface evidence of the homestead *per se*. Consequently, its location can only be inferred by the location of the remains of a termite infested Morton Bay Fig trunk (which was situated to the immediate northeast of the homestead) and an infilled depression that marks the location of a former concrete lined cistern that stood just off the end of the northern (east-west) wing of the homestead.

**Figure 25: Site of the former Benera Homestead site (general)**

1. In advance of development, the Benera House site should be subject to a historical archaeological investigation (testing/salvage excavation). This will require:
  - Application to the NSW Heritage Division of the OEH for a s140 excavation permit. Application will involve preparation of an excavation permit application proforma and its submission (along with a supporting document that includes a Statement of Heritage Impact, a Research Design and an Excavation Methodology).

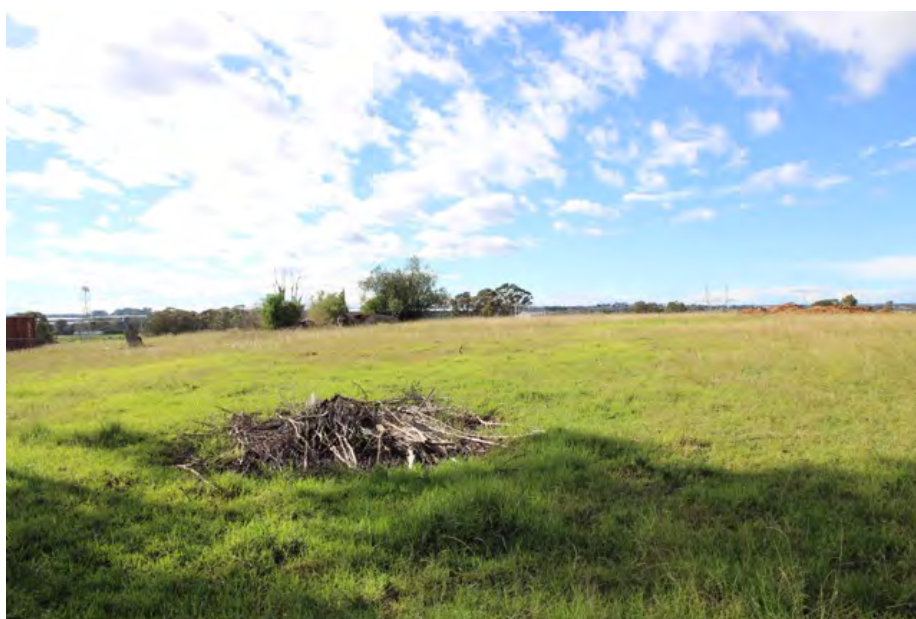
**Figure 26: Former Benera Homestead site (infilled cistern)**

House remains include sandstone piers/footings supporting timber log bearers morticed to take floor joists and many burnt structural timbers. The U-shaped plan of the house is clearly evident. Remains of at least 2 stone chimneys and carved stone thresholds at entry points. All internal fittings destroyed although major items such as the sink and fridge are still recognisable. Much burnt corrugated iron roofing is scattered across the house site and the knoll on which the house is situated. The concrete cistern at the rear has been infilled. The fill includes some recent material.

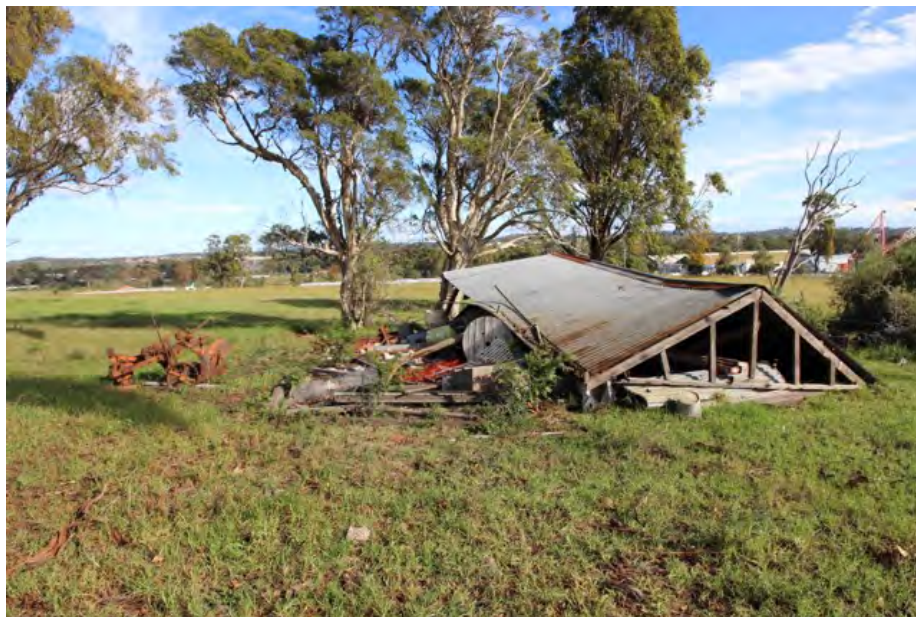
**Figure 27: Collapsed 20th century shed (NW of homestead site)**

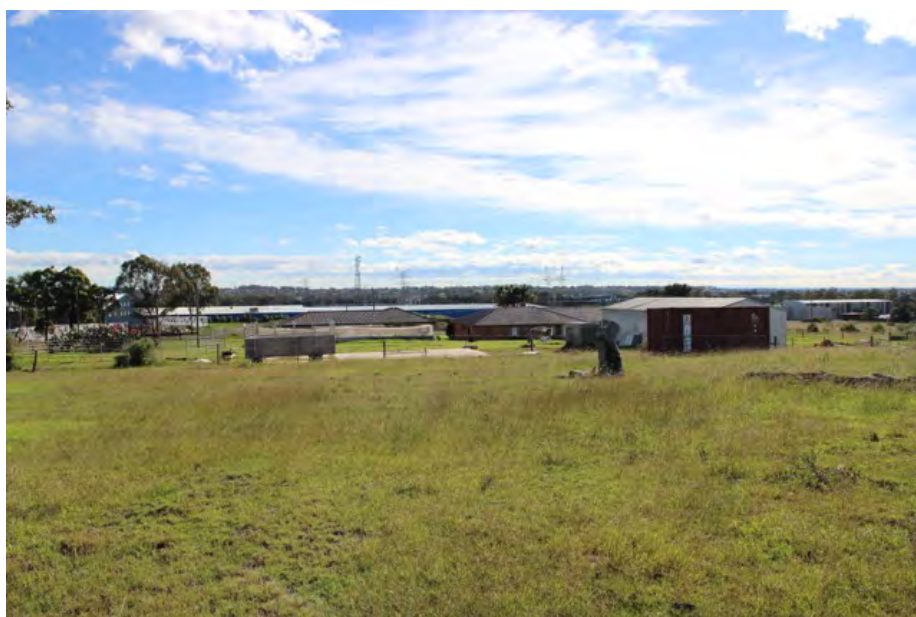
**Figure 28: View north towards Yarrunga Road from Benera Homestead site**
