GTE849-Report

**RE: Preliminary Geotechnical and Environmental Investigation at 48B Kurrajong Road, Prestons.**

**Ground Technologies Pty Ltd**

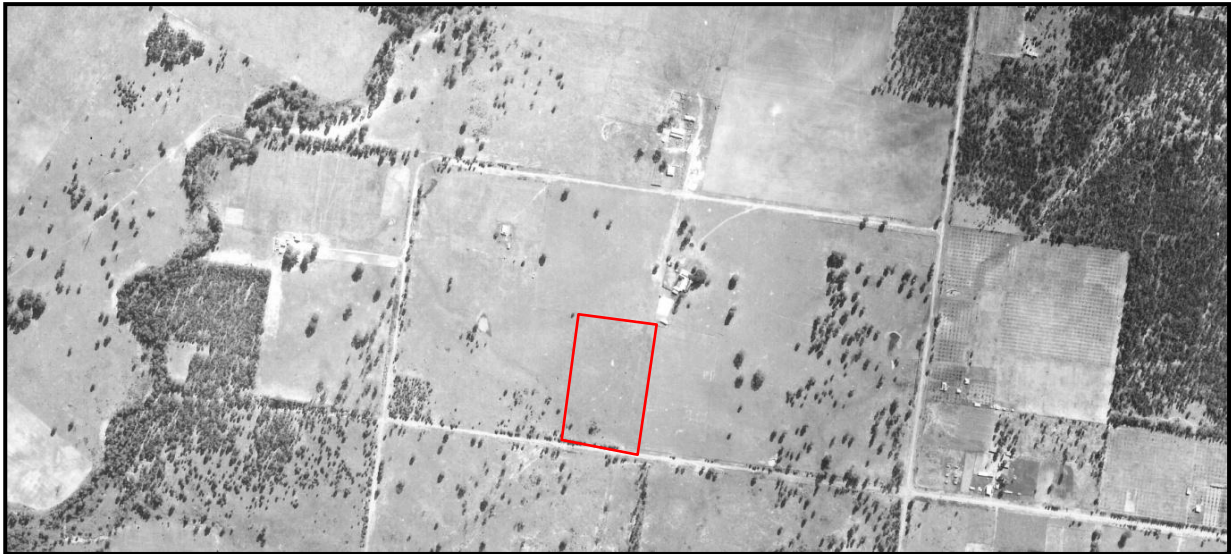
**Figure 2 – Aerial Photograph from 1947**

1947 – In 1947 the site is vacant, largely free of trees except for the southern boundary. Adjoining sites are vacant whilst the region appears to be rural / farming properties. No industrial or manufacturing plants could be identified within the aerial photograph. The subject site is highlighted in figure 2.

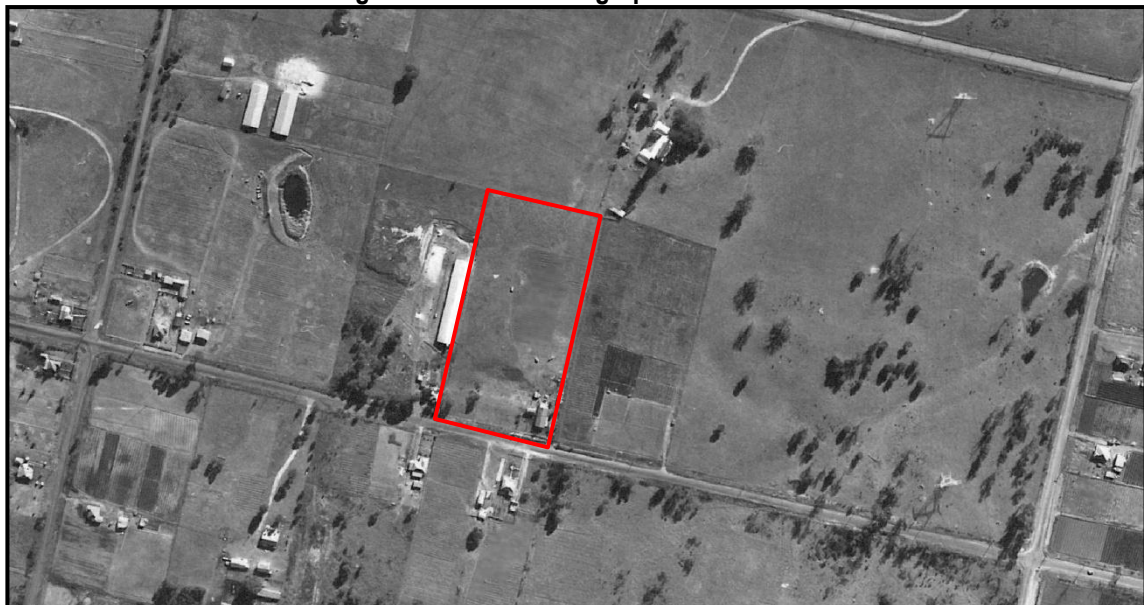
**Figure 3 – Aerial Photograph from 1970**

1970 – In 1970 the northern part of the site remains predominantly vacant. Market gardening appears to be occurring in the central eastern part of the site. A house and two to three small sheds have been constructed in the south-eastern corner. A large warehouse or shed and houses have been constructed in the neighbouring allotment to the west. No industrial or manufacturing plants could be identified within the aerial photograph, however a large industrial warehouse has been constructed about 330m north of the site (not shown in photograph). The subject site is highlighted in figure 3.

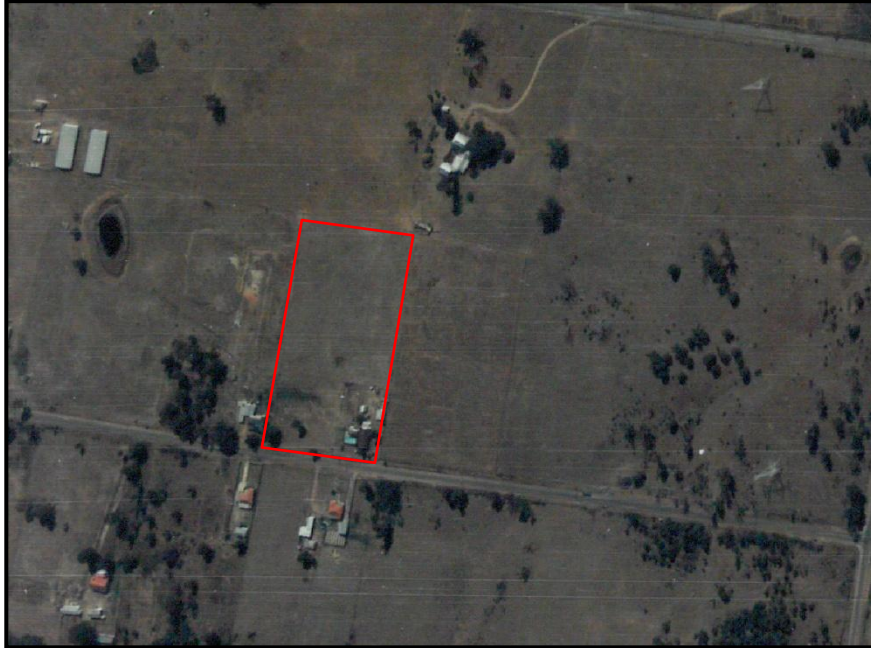
**Figure 4 – Aerial Photograph from 1982**

1982 – In 1982 the subject site remains largely unchanged. Market gardening in the central east appears to have ceased. A pool has been added west of the house. The large shed in the neighbouring site in the west has been removed. No industrial or manufacturing plants could be identified within the aerial photograph. The subject site is highlighted in figure 4.

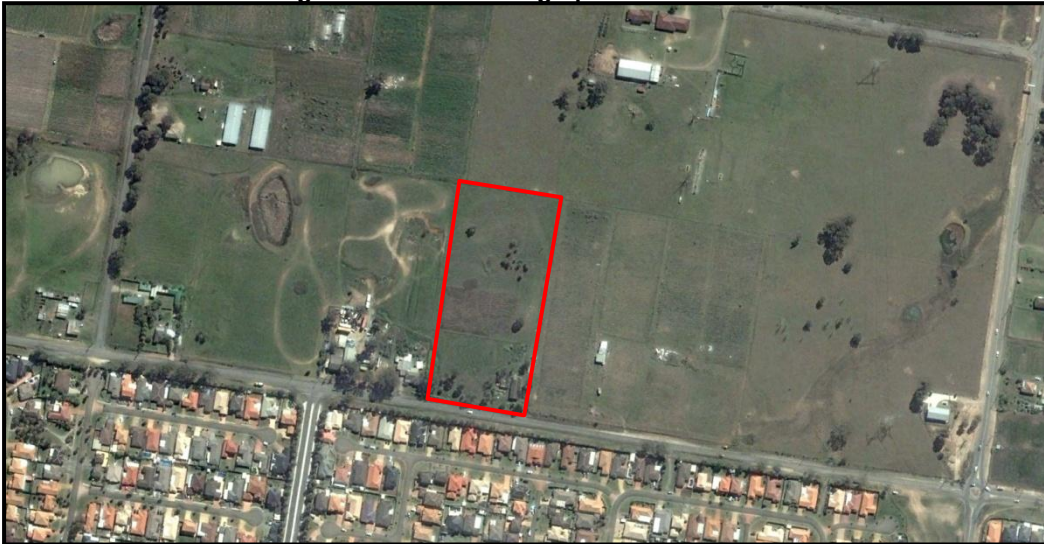
**Figure 6 – Aerial Photograph from 2006**

2006 – In 2006 the subject site remains moist unchanged. Tilling of the land appears to have occurred in the central part of the site. From the neighbouring sites, most of the green houses have been removed however market gardening is ongoing. Two neighbouring sites about 330m to the north (not shown in photograph) appear to have ongoing industrial type activity; these sites are used by a crane manufacturer and as a repair depo for tanker trailers at 2016, and are inferred to have similar activity in 2006. The neighbouring area to the south has been developed as a residential subdivision. The subject site is highlighted in figure 6.

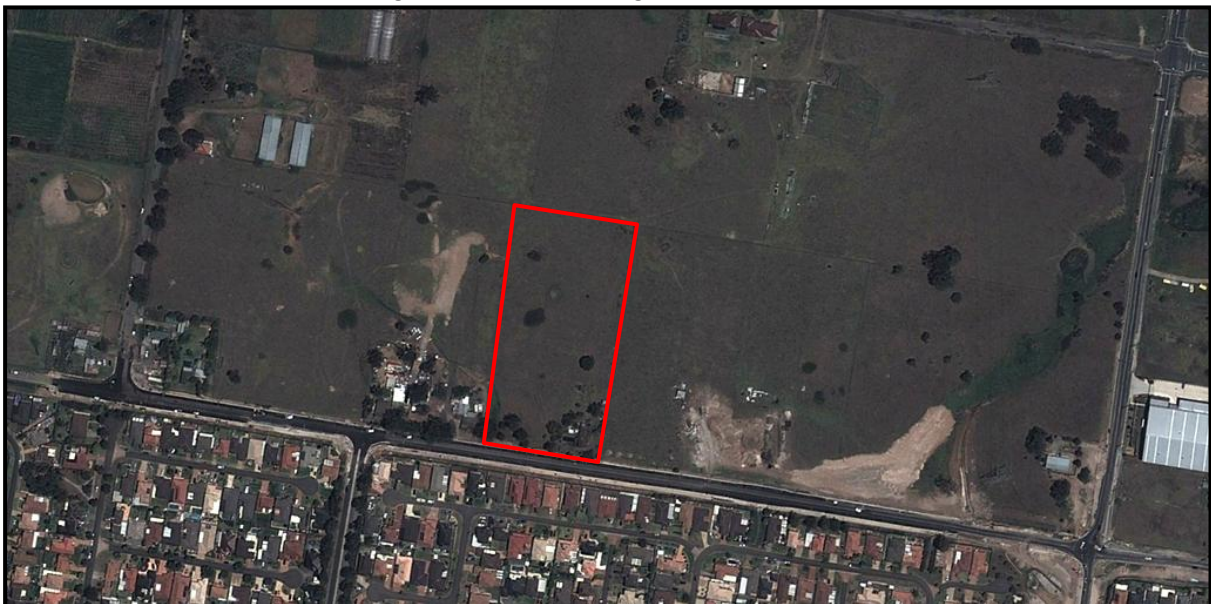
**Figure 7 – Aerial Photograph from 2012**

2012 – In 2012 no significant changes to the land usage were observed from 2006. The subject site is highlighted in figure 7.

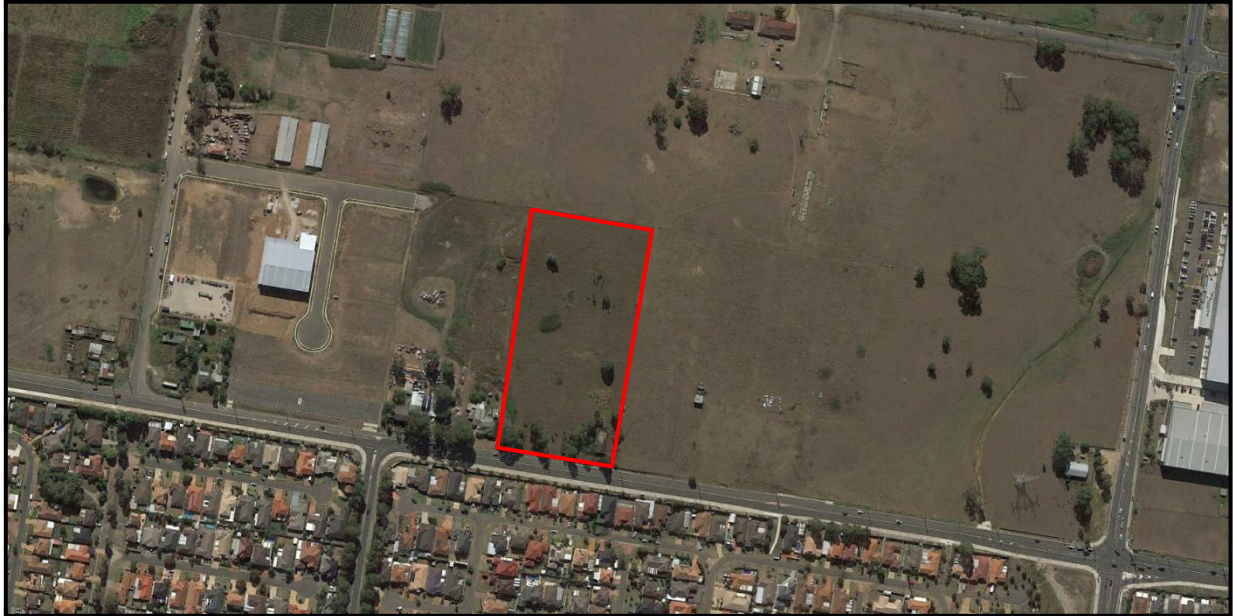
**Figure 8 – Aerial Photograph from 2016**

2016 – In 2016 no significant changes to the land usage were observed from 2012. The subject site is highlighted in figure 8.

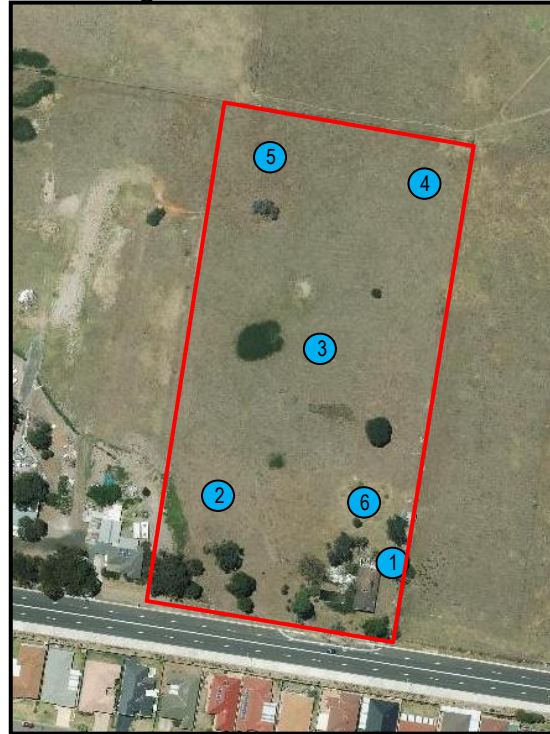
**Figure 9 – Borehole Locations**

Fieldwork was undertaken on the 20<sup>th</sup> of May 2016 and included drilling ten boreholes (BH1-BH5 ) using a 4WD Toyota Landcruiser Ute mounted drill rig with 100 mm solid flight spiral augers at the locations shown on Figure 9. Pocket Penetrometer tests were undertaken within the clay profile recovered from the boreholes. One bulk sample was recovered and sent to the Ground Technologies NATA accredited laboratory in order to determine the California Bearing Ratio (CBR) and Atterberg Limits of the subgrade profile.

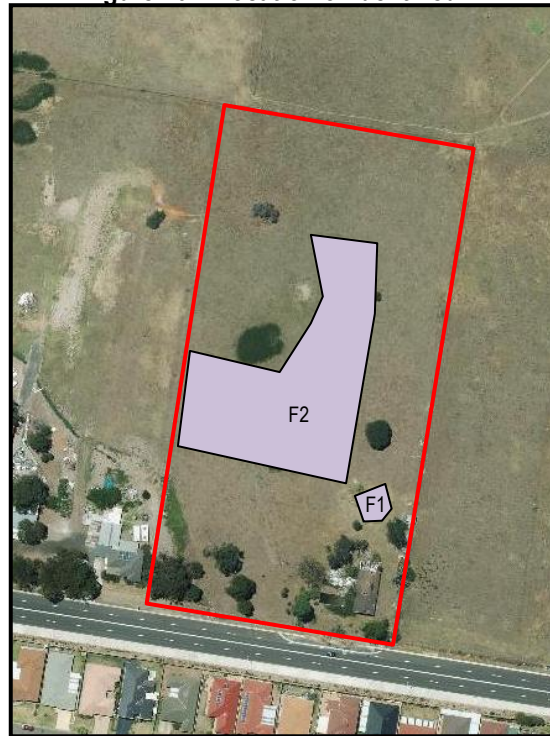
**Figure 10 – Location of Identified Fill**

Ground slopes within the site were observed to be relatively flat over the majority of the site, with the exception of two zones.

Preliminary contamination testing and classification of the fill has been undertaken within section 5.7 of this report.
