# Preliminary Site Investigation (PSI)

86 Woodlands Road Armidale NSW

(Lot 1 DP246878, Lot 1 DP573787 and Lot 145 DP755826)

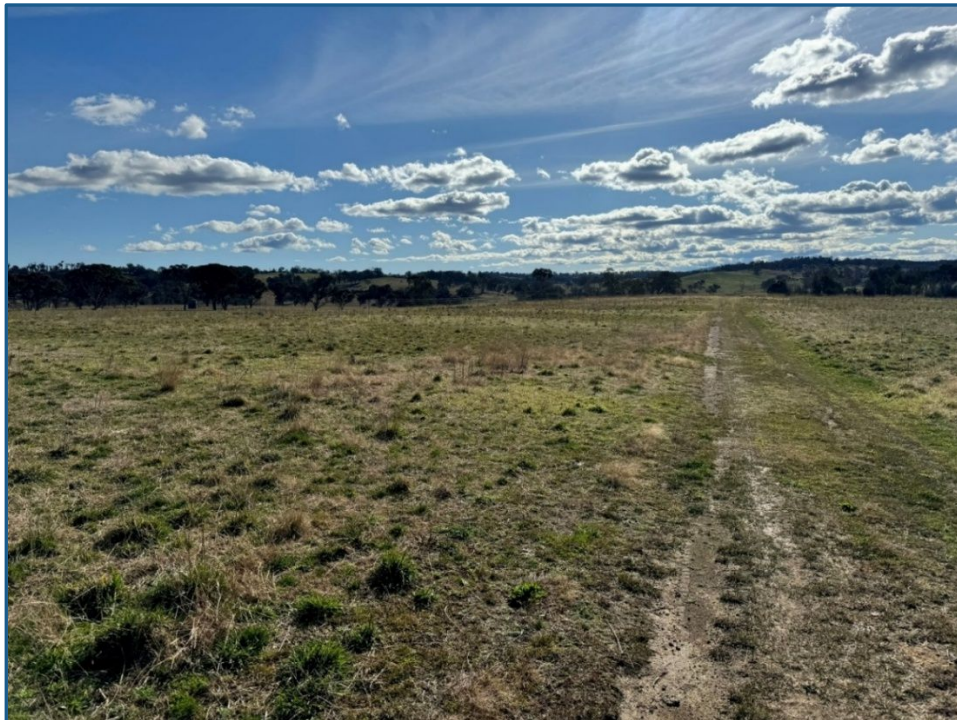
**Image 1:** The centre of the site, facing towards the southern boundary. High voltage power lines pictured in the horizon on the hill which the BESS will connect into.

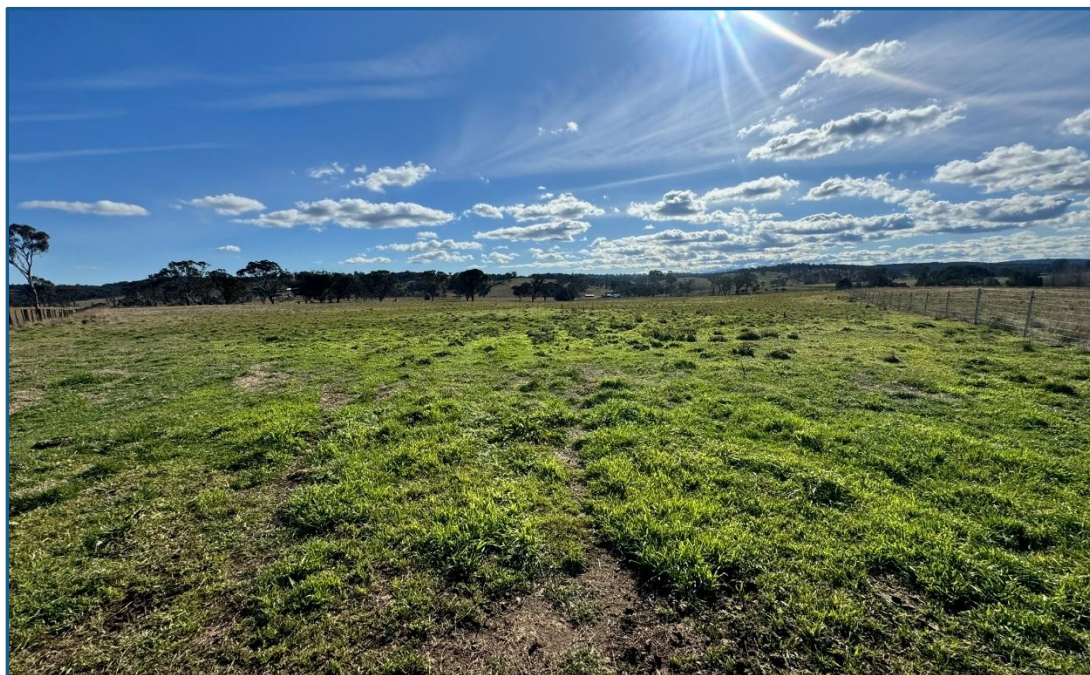
**Image 3:** Facing east across the undulating dryland northern paddock on the study site: farming infrastructure in the background (pictured).

The study site is primarily used for agricultural activities, such as dryland grazing and is positioned within an undulating, rural area. (*Image 3*) The landowner indicated he took ownership of the land approximately 10 years ago and advised that the property was historically used for sheep and beef grazing. The landowner advised that he currently conducts rotational grazing on the study site, growing predominately winter crops (Ryegrass, Fescue, Phalaris and Clover) in the north and west paddocks. The landowner indicated that in the past 12 months he has also included perennial grasses such as Cocksfoot, Chickery, Plantain, Peri grass into the pasture mix in the north and west paddocks. Pasture species are not sown in the southern paddocks due to the poor draining waterlogging soils (*Image 4*).

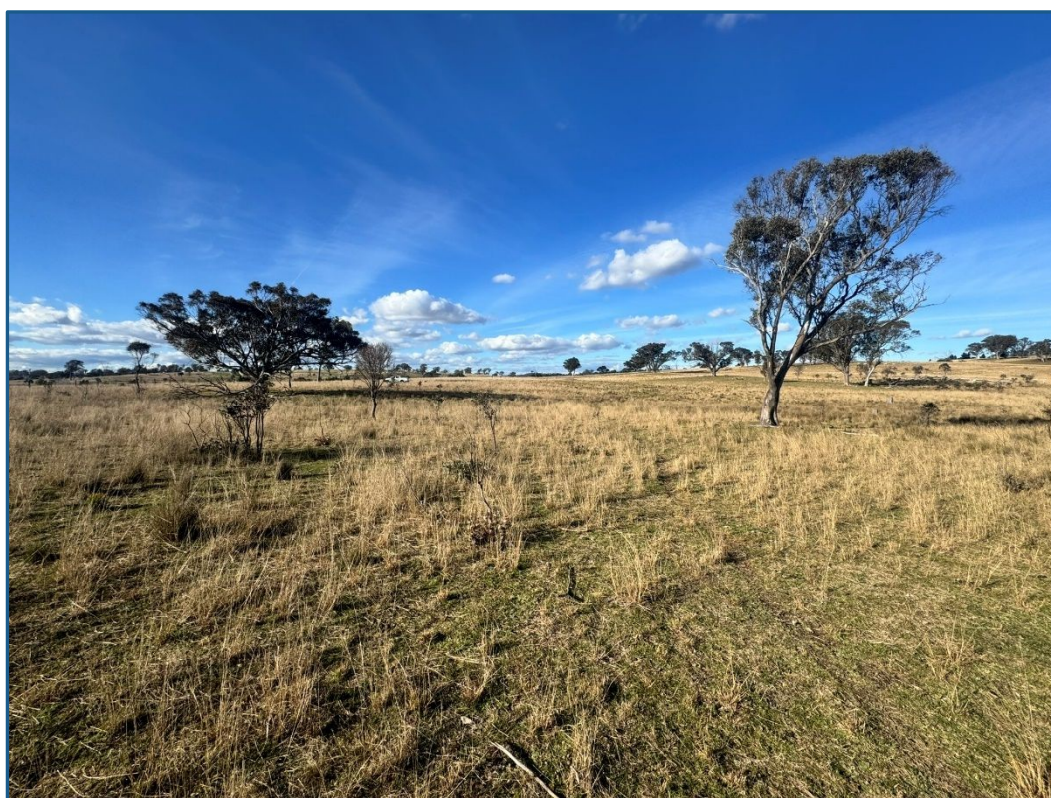
**Image 4:** Looking north across the southern paddock, which is not sown with agricultural pasture species, remnant trees pictured.

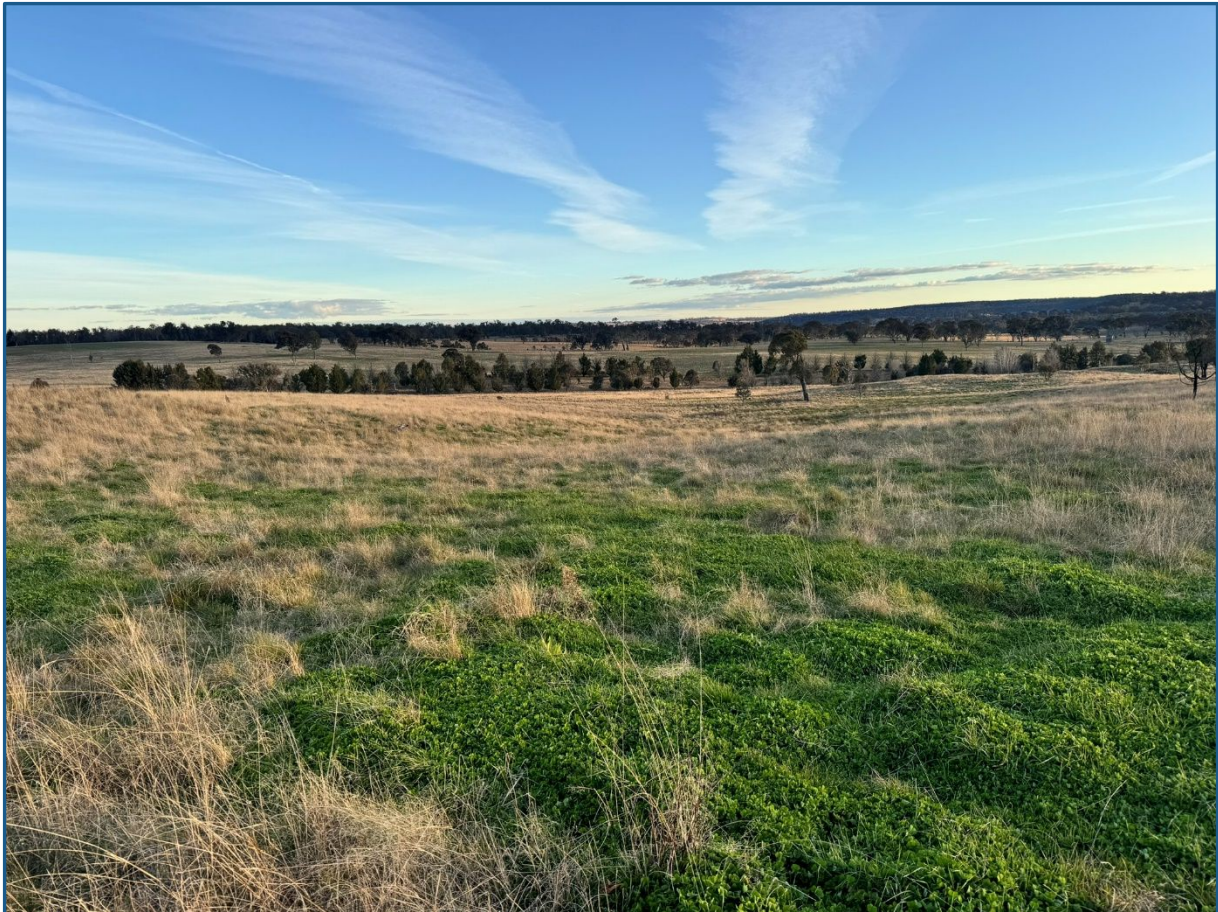
**Image F1:** Positioned at the most northern boundary of Lot 1 DP755286, looking south towards the study site which is within an undulating rural landscape.

The study site is predominantly within an undulating rural landscape where elevation ranges between 990 - 1090 m Australian Height Datum (AHD). The study site is predominately cleared for grazing with some scattered vegetation and dams evident (*Image F1*). The topography of the northern part of the study site slopes northwest towards an existing drainage line and farm dam, while the central and southern sections of the study site slope southwest towards Burying Ground Creek. There was no evidence of excessive surface water pooling or water accumulation on the study site.

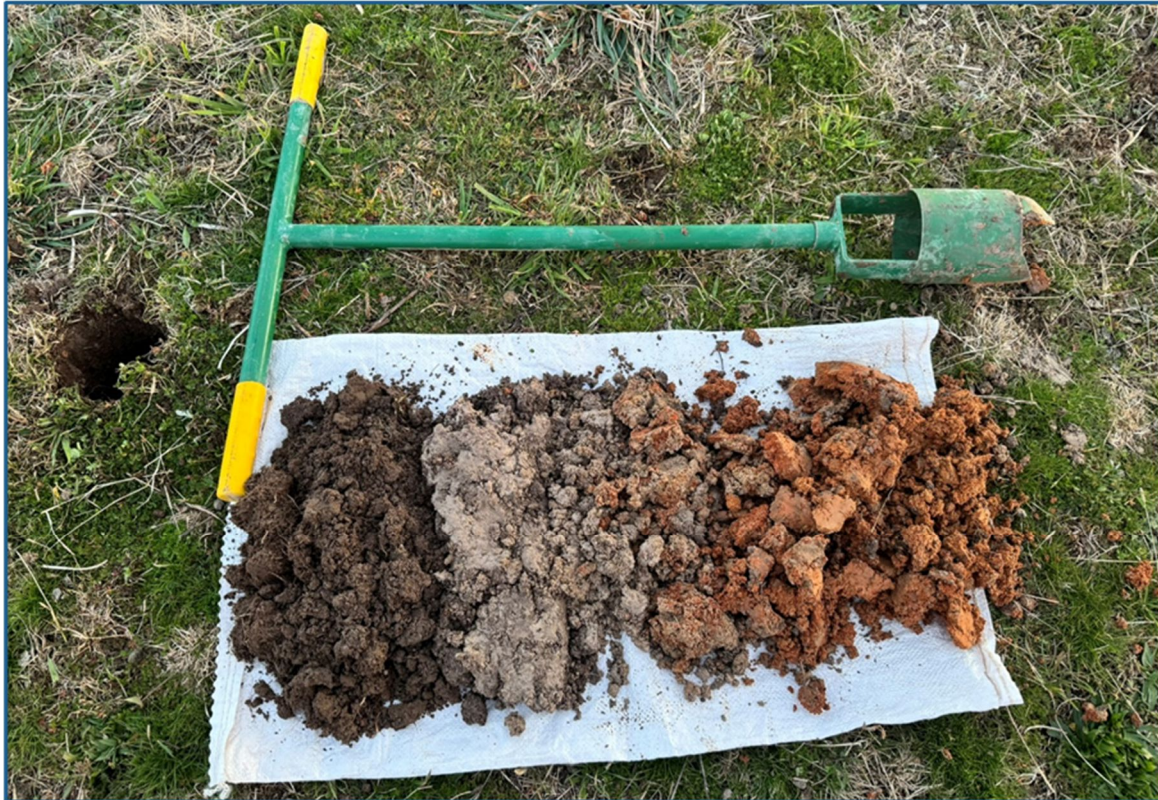
**Image F2:** The soils on the site are duplex and consist of approximately 10-20 cm of brown silty loam with a relatively abrupt change to a light grey brown bleach, structureless light clay and bright yellow-orange, medium clay subsoil layers.

The soils on the study site were investigated utilising a 100 mm (4 inch) diameter hand soil auger (*Image F2*) with the soil profile examined to depths of 40 to 80 cm below the surface at numerous locations across the study site. This soil survey facilitated detailed assessment of soil physical characteristics and of soil variations across the study site.

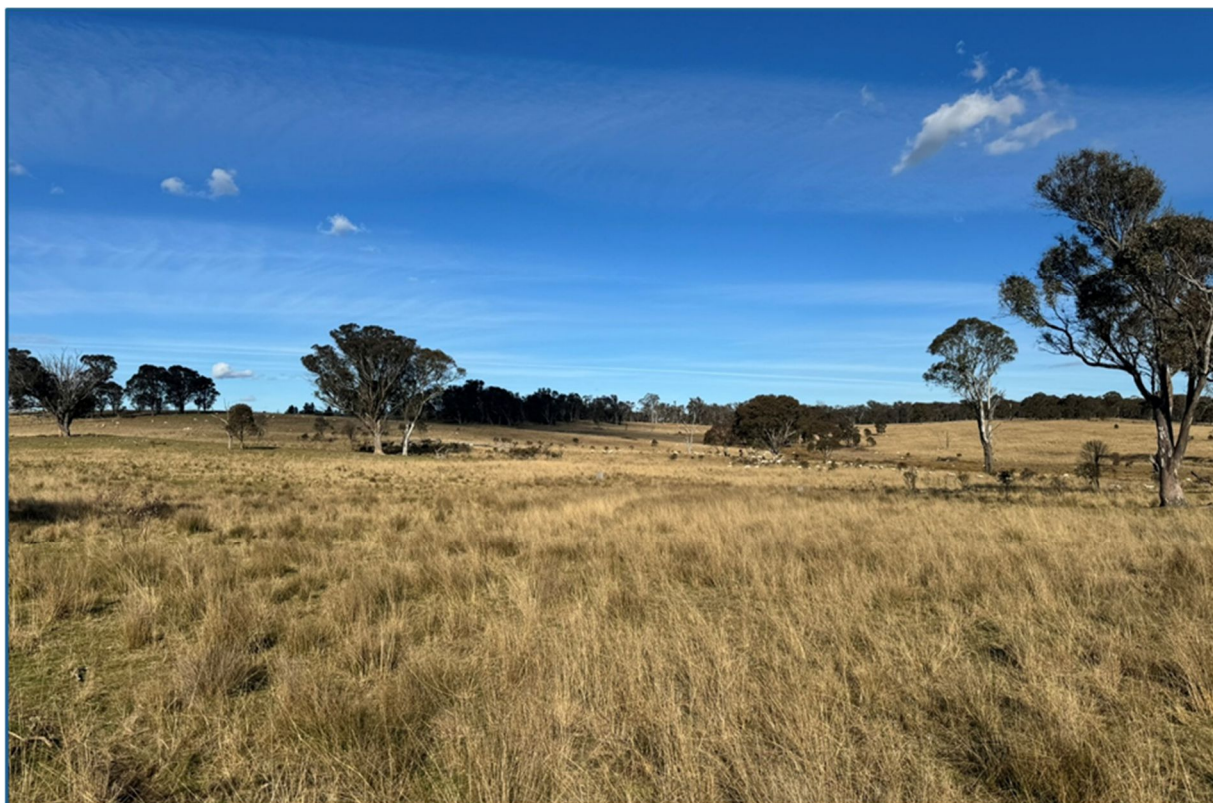
**Image F3:** Looking south across the proposed study site which contains some scattered trees and native vegetation.

The study site occurs on the Armidale plateau and contains some scattered trees and native vegetation (*Image F3*). Much of the study site has been extensively cleared of native vegetation and has been modified by historical farming practices. Remnant vegetation within the study site is restricted to fragment areas and isolated paddock trees. The Armidale plateau landscape which would have originally supported New England Grass Woodlands which would naturally have consisted of New England Hills Stringybark-Box Woodland, which includes *Eucalyptus blakelyi* (Blakely's red gum), *Eucalyptus bridgesiana* (apple box), *Eucalyptus caliginosa* (broad-leaved stringybark), *Eucalyptus laevopinea* (silver-top stringybark), *Eucalyptus melliodora* (yellow box), and *Eucalyptus youmanii* (Youmans stringybark). A small area of open woodland exists in the southwest of the study site that may fall within the definition of the NSW BC ACT and the Commonwealth EPBC ACT CEEC – White Box - Yellow Box Blakely's Red Gum Grassy Woodland and Derived Native Grassland.

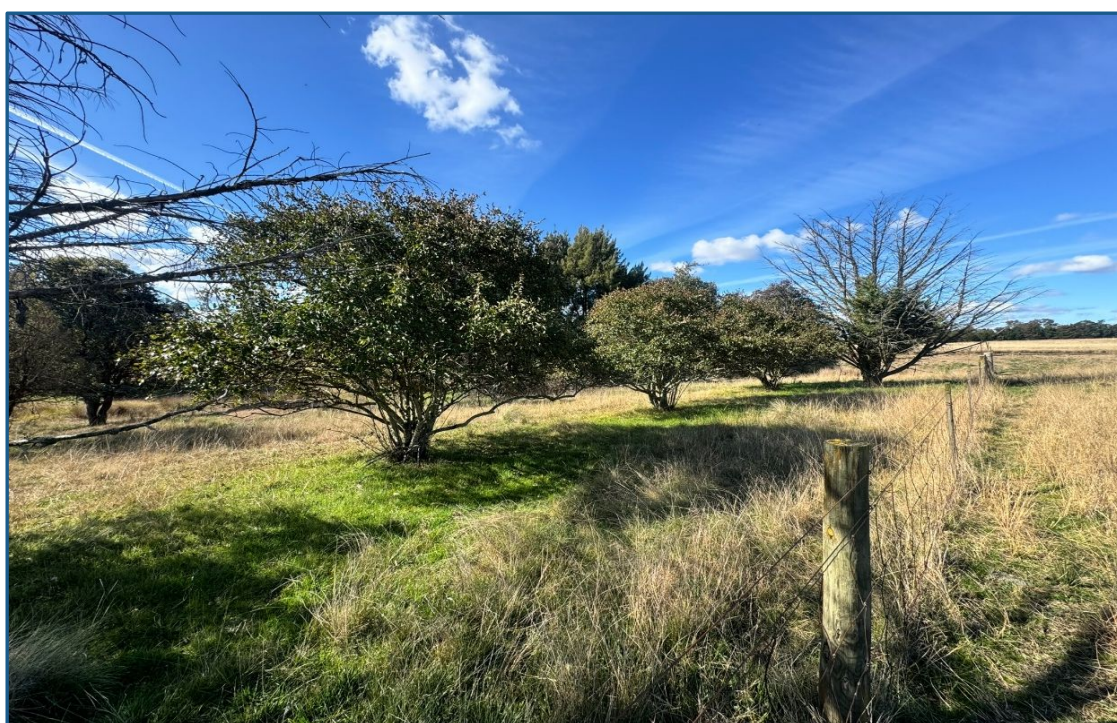
**Image F4:** Planted native and exotic vegetation within a drainage line fenced area north of the study site

Planted native and exotic trees are located within a fenced area parallel to drainage line north of the study site (*Image F4*). Land on the study site has been utilised for rotational dryland grazing. Areas in the west and north of the study site contain pasture species such as Ryegrass, Clover, Fescue and Phalaris. The landowner indicated that in the previous 12 months other species such as Cocksfoot, Chickery and Plantain have been sown in these areas.
