## **Groundwater Dependent Ecosystems, Key Fish Habitat and Riparian Assessment**

**585-649 Mamre Road, Orchard Hills,  
Western Sydney Employment Area**

Prepared for ALTIS Property Partners Pty Ltd

**23 March 2016**

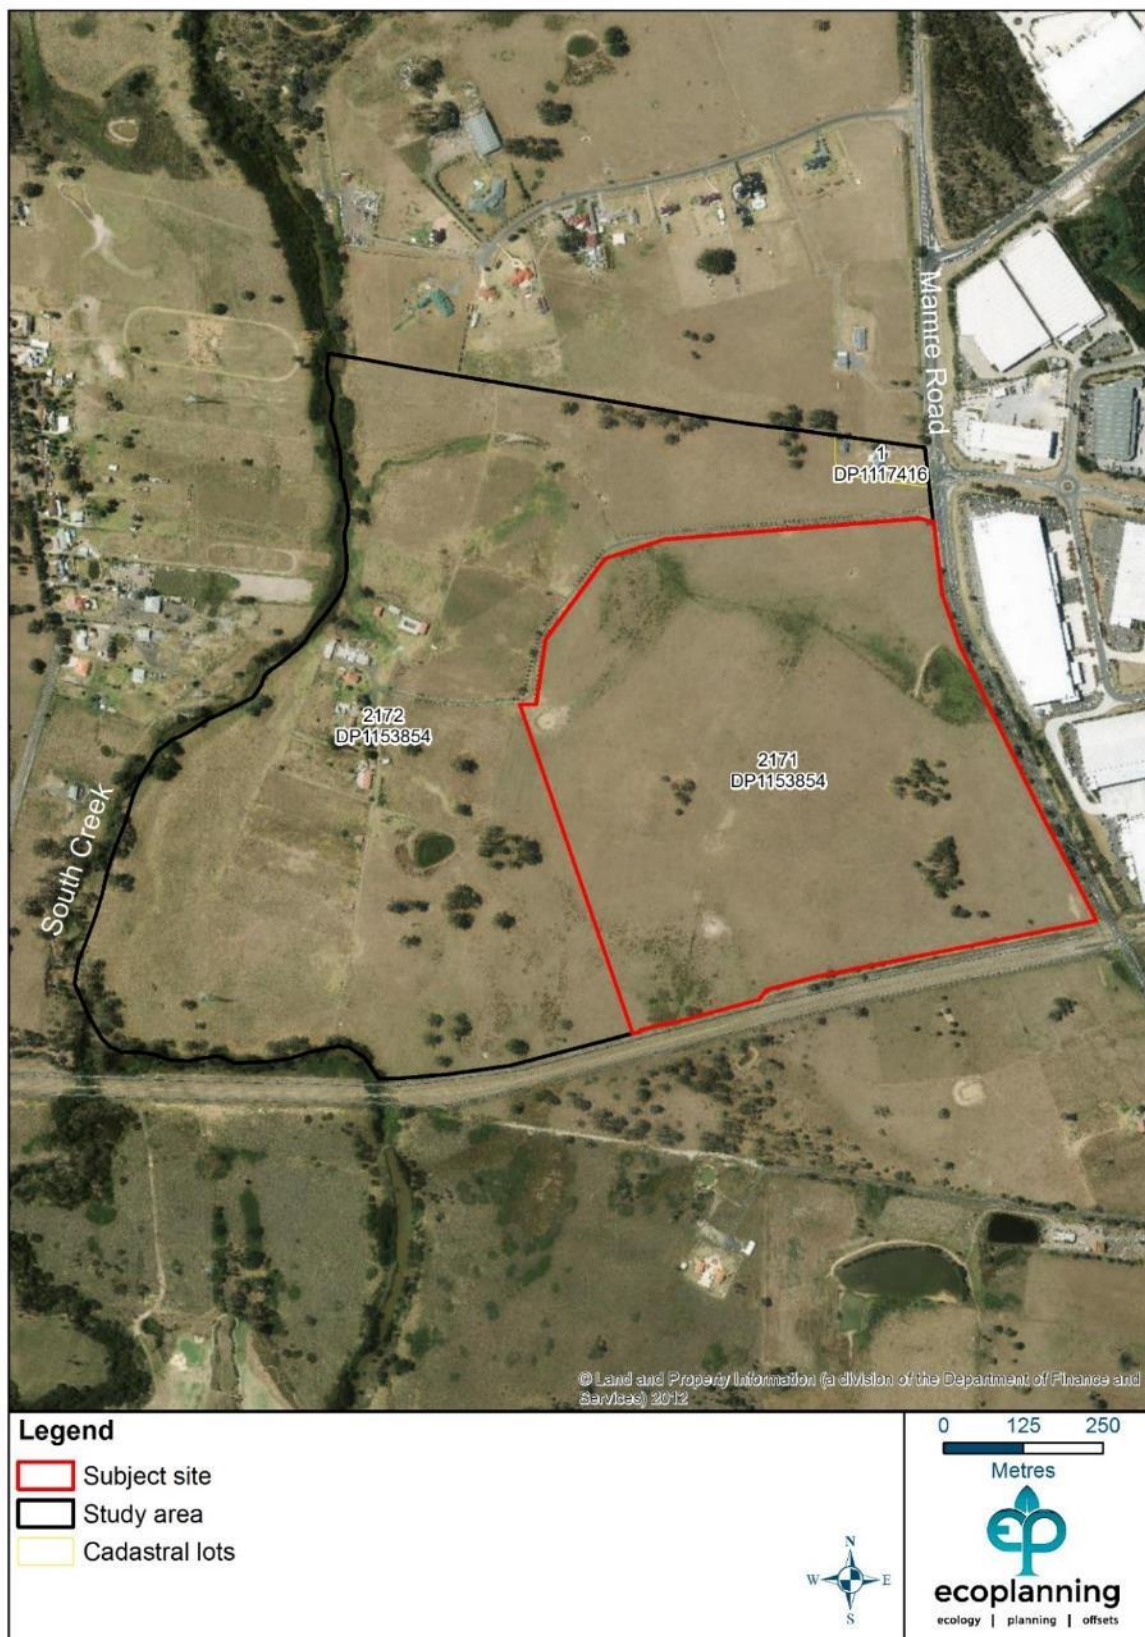
Figure 1.2: Subject site and study area.

The **study area** is located at Mamre Road, Orchard Hills within the Penrith Local Government Area (LGA) (**Figure 1.1**). The study area is bounded by Mamre Road in the east, a Sydney Water pipeline in the south, South Creek in the west and the northern boundary of Lot 1 // DP 1117416 and Lot 2172 // DP 1153854. The study area currently

consists of the two lots aforementioned and Lot 2171 // DP 1153854 and totals 117.8 ha (**Figure 1.2**).

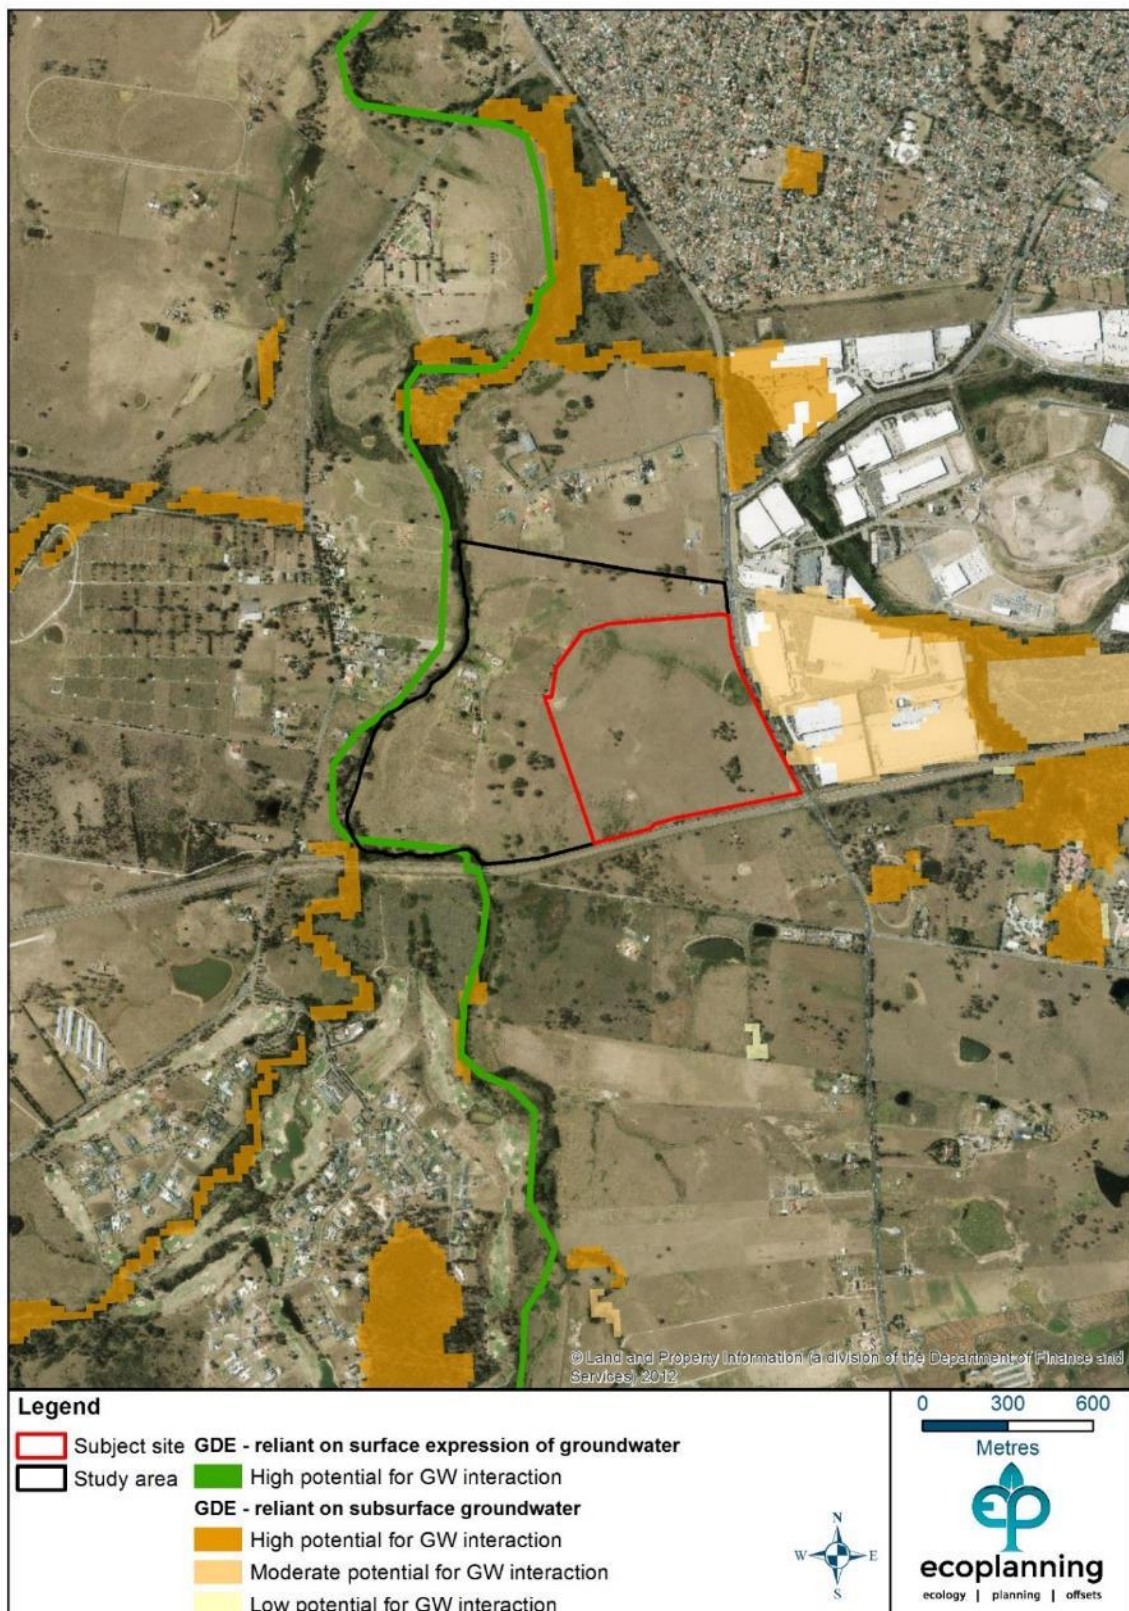
Figure 2.4: Groundwater Dependent Ecosystems (from Atlas of Groundwater Dependent Ecosystems - BOM).

However, GDE's are mapped as occurring within the South Creek and Cosgrove Creek corridors that form the western border of the study area. The GDE Atlas (BOM 2012) shows South Creek as being reliant on the surface expression of groundwater (**Figure 2.4**). In addition, the riparian community of Cosgrove Creek is identified as having high potential for groundwater interaction (**Figure 2.4**), with the developed area directly to the east of the subject site identified as having a moderate potential for groundwater interaction (**Figure 2.4**).

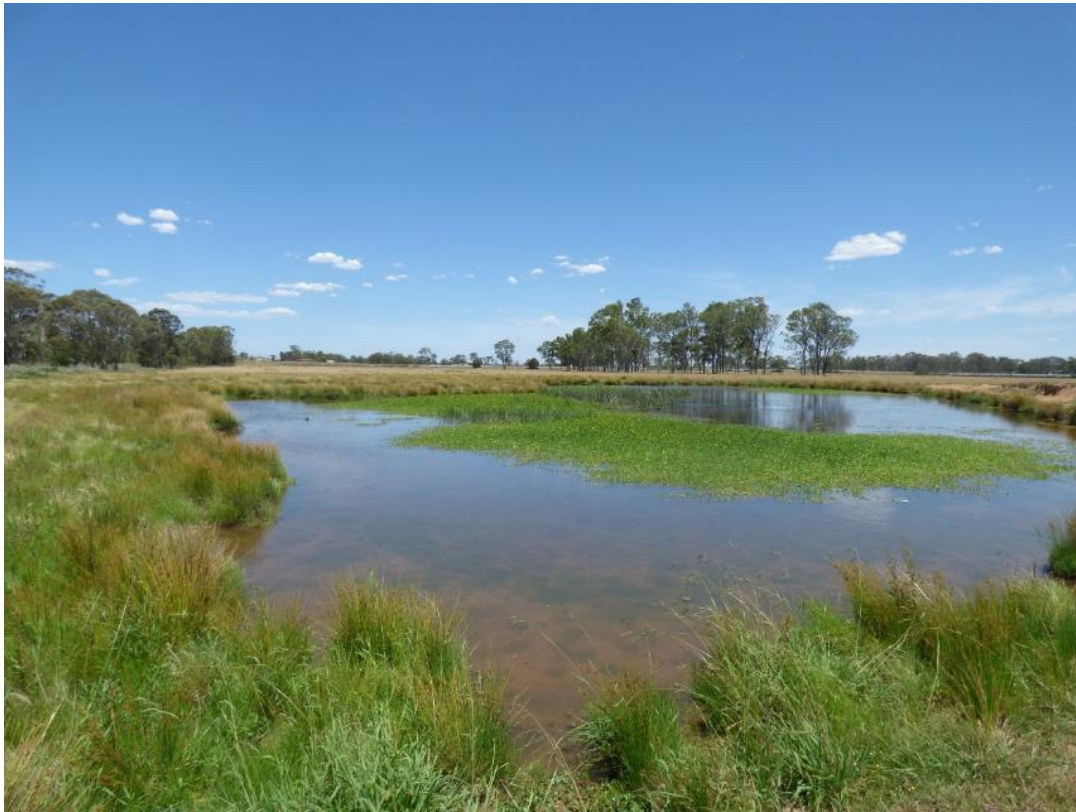
Four dams of varying size are mapped across the study area, three of which lie within the subject site. All dams across the subject site have been constructed to water stock and review of aerial photos (Google 2015) shows fluctuating water levels and near dry conditions at times (**Figure 3.3**).

Figure 3.3: A large farm dam onsite, colonised by native and exotic aquatic and semi-aquatic flora.

Although there are multiple constructed dams within the subject site water supply for these is derived from rainfall and resulting overland flows and stormwater runoff from the adjacent industrial estate. Therefore, the ecological communities found within these dams and associated drainage depressions are not groundwater dependent.

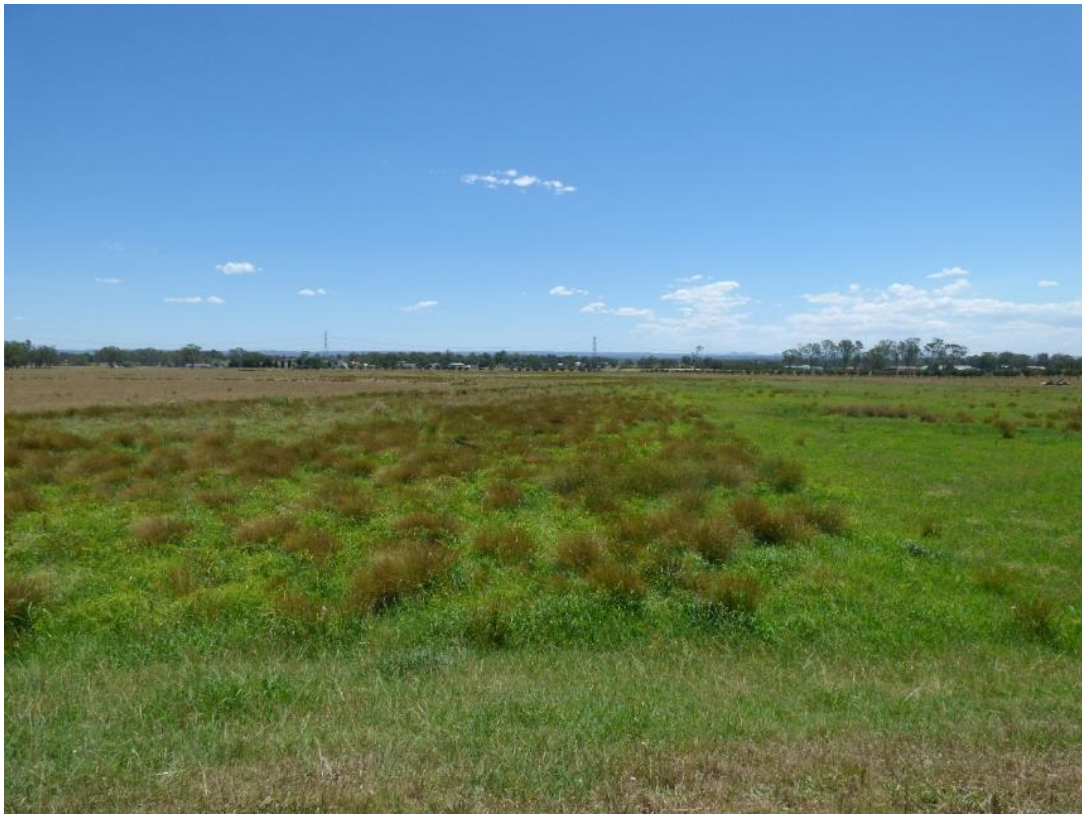
Wet pasture is present in the shallow modified draining depression that runs east-west across the site and in the south-western corner of the subject site (**Figure 3.4**). This depression is colonised by native rushes/sedges such as *Juncus* spp., *C. appressa*, and exotic the *C. eragrostis*\*. Native and exotic pasture grasses dominate higher points surrounding the depression and include *A. fissifolius*\*, *C. gayana*\*, *C. dactylon*\*, *E. erecta*\*, *E. curvula*\*, *H. vulgare*\*, *Microlaena stipoides*, *P. dilatatum*\*, *P. clandestinum*\* and *P. aquatica*.\*

Figure 3.4: Wet pasture colonised by native and exotic sedge and rush species.

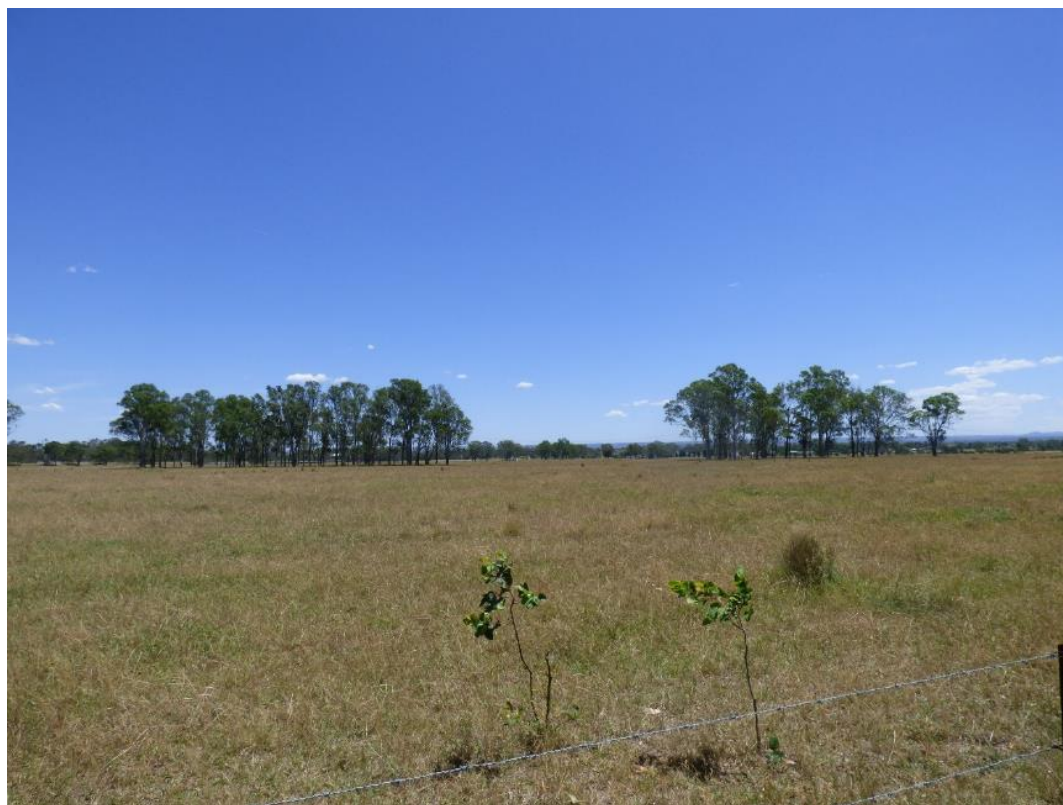
This vegetation type is found as scattered remnants across the study area, usually as underscrubbed scattered paddock trees with little to no native midstorey or understorey (**Figure 3.5**). It is distinguished from the more common Alluvial Woodland by the presence of *Eucalyptus moluccana* (Grey Box), and also retains individuals of the canopy species, *E. tereticornis* (Forest Red Gum) and *E. amplifolia* (Cabbage Gum). All species are also associated with Alluvial Woodland, but the presence of *E. moluccana* appears to correspond closely to the distribution of shale derived soils and geology and has consequently been mapped as Shale Plains Woodland by NPWS (2002). Further analysis of the vegetation assemblage was not possible due to the highly degraded and depauperate state of the vegetation. This vegetation is mostly regrowth <80 years of age, with few hollows observed in the remnants surveyed.

Figure 3.5: Remnant trees of underscrubbed Shale Plains Woodland within the subject site.

Several degraded and isolated patches of Shale Plains Woodland and Alluvial Woodland occur within the subject site (Ecoplanning 2015). Although this vegetation maintains year round green foliage the most likely water source to these is rainfall.

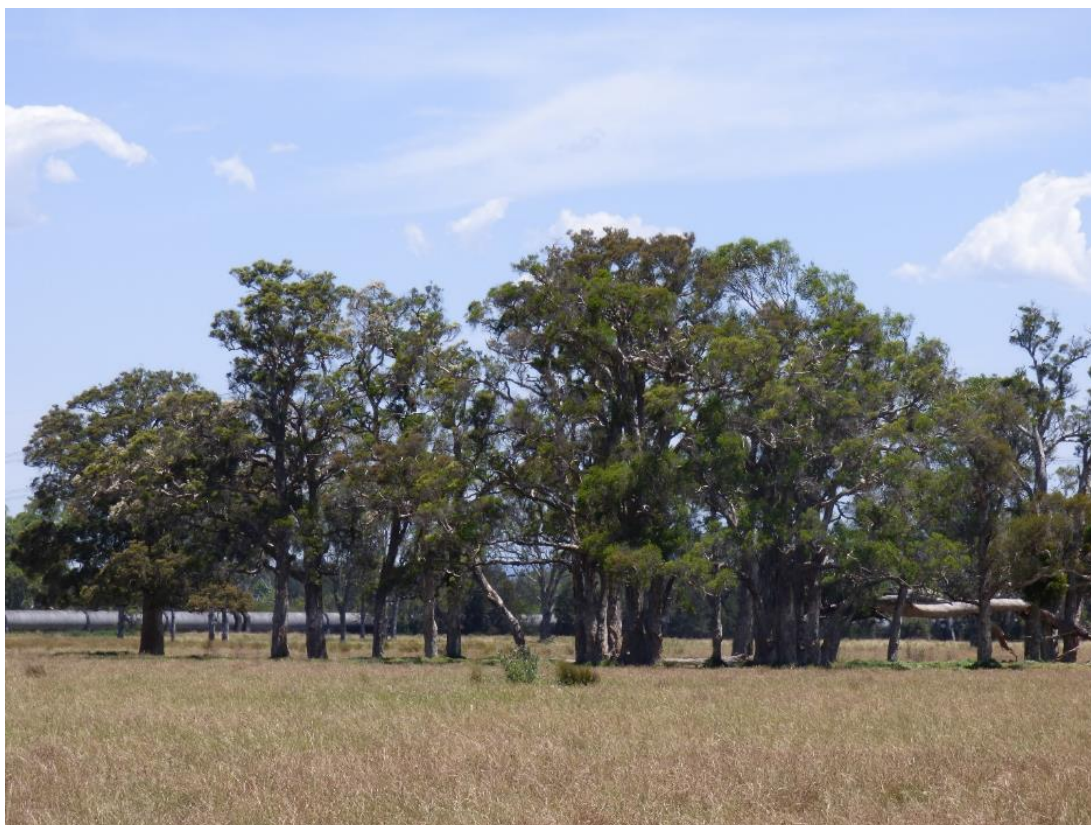
This vegetation type is found in association with the riparian corridor and alluvial soils on the terraces of the associated floodplain (**Figure 3.6**). The community is dominated by *E. amplifolia*, with *Casuarina glauca* (Swamp Oak) and *C. cunninghamiana* (River Oak) occurring as sub-dominants on the banks of South Creek. *Angophora floribunda* (Rough-barked Apple) is also present, which is indicative of this vegetation type. Small stands containing *E. moluccana* have been distinguished from the Alluvial Woodland as described above.

This community is also found as underscrubbed canopy trees and scattered paddock trees, but is predominantly in the form of degraded regrowth along the South Creek river bank. In this form it is dominated by regrowth *Acacia mearnsii* (Black Wattle), *A. parramattensis* (Parramatta Wattle) and *Bursaria spinosa* subsp. *spinosa* (Native Blackthorn), and exotic shrub species including, *Rubus fruticosus*\* (Blackberry), *Ligustrum* spp.\* (Privet), *Cestrum parqui*\* (Green Cestrum), *Solanum mauritianum*\* (Wild Tobacco Bush), *Senecio madagascariensis*\* (Fireweed) and *Verbena* spp.\* (Purpletop).

**Figure 3.6: Underscrubbed Alluvial Woodland in the north-east of the site, with some regrowth vegetation to the left.**

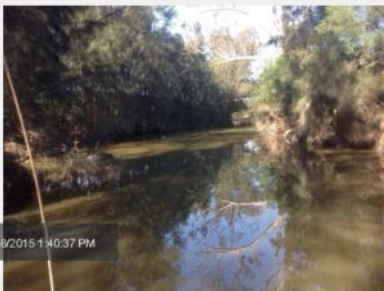
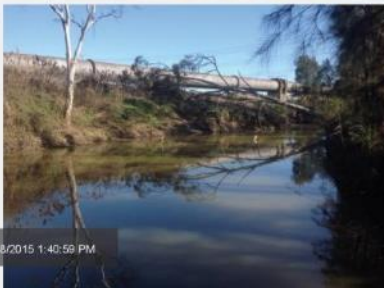
The site is in fair condition, with a score of 10.9 overall.

Within the 50 meter assessment radius, left bank vegetation structure is 10% shrubland, 20% open woodland, 70% open grass/pasture, approximately. Right bank vegetation structure is 10% shrubland, 20% open woodland, 60% open grass/pasture, 10% native grassland, approximately. This is reflected in the vegetation structure subtotal.

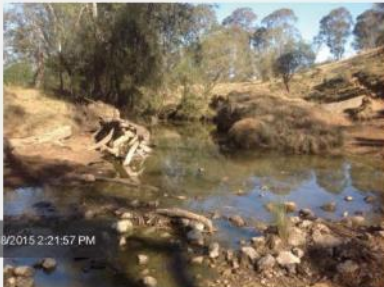
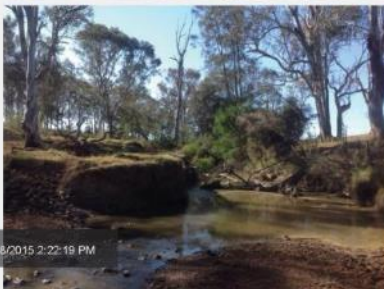
The site is in fair condition, with a score of 22.1 overall.

Within the 50 meter assessment radius, left bank vegetation structure is 10% open woodland, 90% open grass/pasture, approximately. Right bank vegetation structure is 20% open woodland, 80% open grass/pasture, approximately. This is reflected in the vegetation structure subtotal.

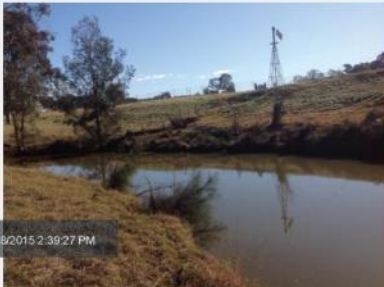
The site is in poor condition, with a score of -1.6 overall.

Within the 50 meter assessment radius, left bank vegetation structure is 100% open grass/pasture, approximately. Right bank vegetation structure is 10% shrubland, 90% open grass/pasture, approximately. This is reflected in the vegetation structure subtotal.

extraction water  
excavation absent  
litter low 1-5  
sewer line/stormwater outlet absent  
odour normal/none  
turbidity medium

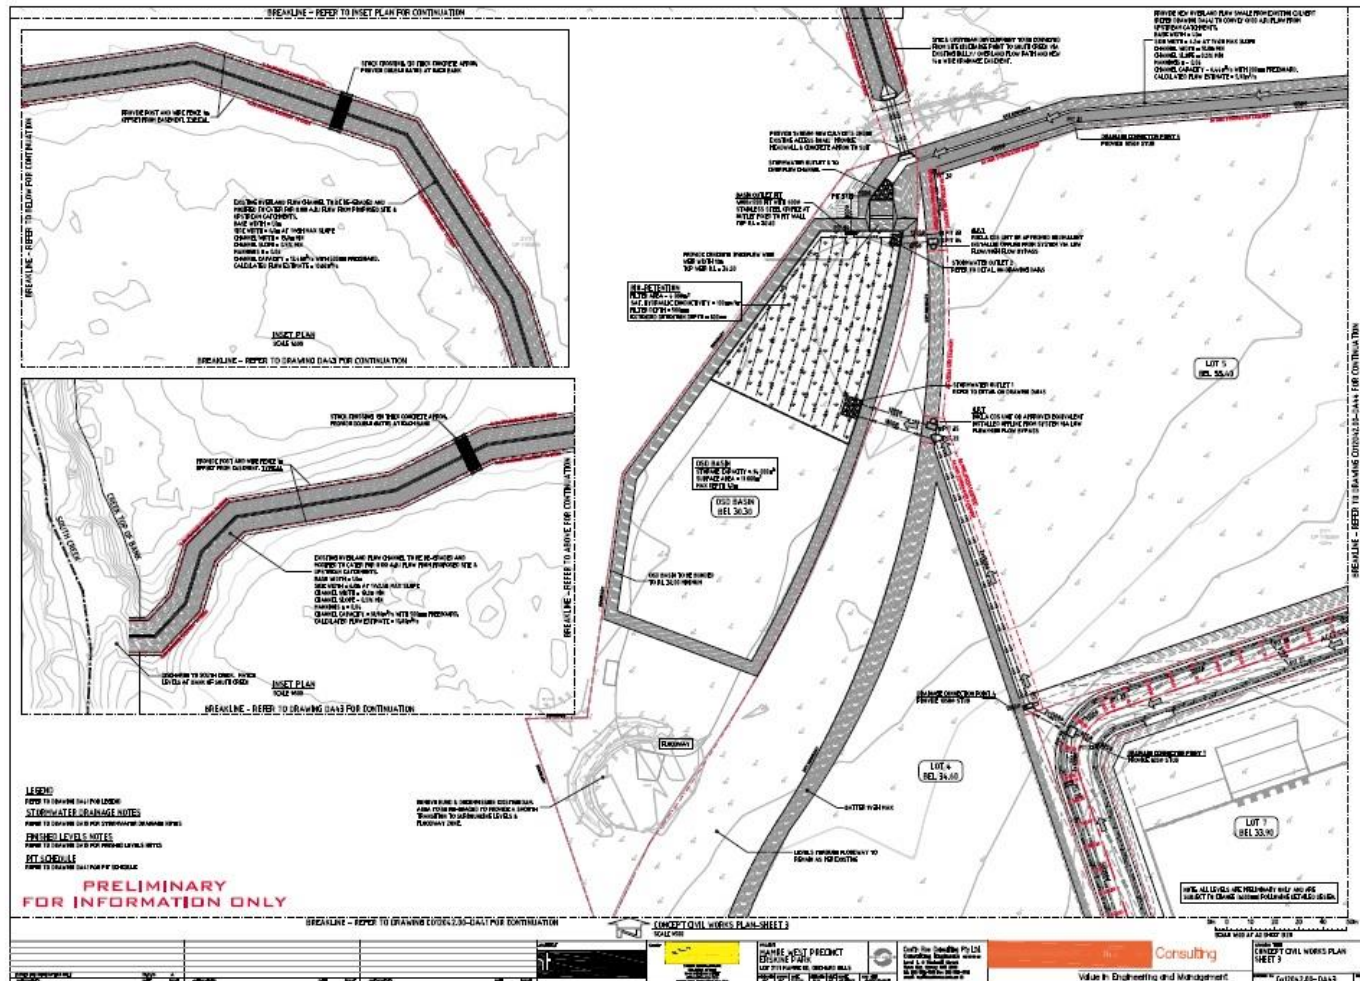
## Appendix B: Concept Civil Works Plan for stormwater

The upper section of the proposed drainage easement follows an existing drainage depression, becoming a mapped (un-named) First Order stream as it approaches South Creek. A 14 m easement encompassing this degraded First Order stream and drainage depression has been negotiated with the adjacent landholder to accommodate the proposed construction works required to complete this stormwater flowpath. Although this short section of creek is degraded, further consultation with NSW Office of Water (NOW) will be necessary with respect to Controlled Activity under the WM Act. Advice received to date from NOW (Gina Potter, Water Regulation Officer), has been that the proposal will be assessed as Integrated Development following submission of this Development Application.
