Moonee Parklands Trust
C/- JW Planning Pty Ltd

Hydrogeological Study:

Lot 1 DP 1097743 and Lot 6 DP252223,
Pacific Hwy, Moonee Beach, NSW

P1002663JR06V02
March 2013

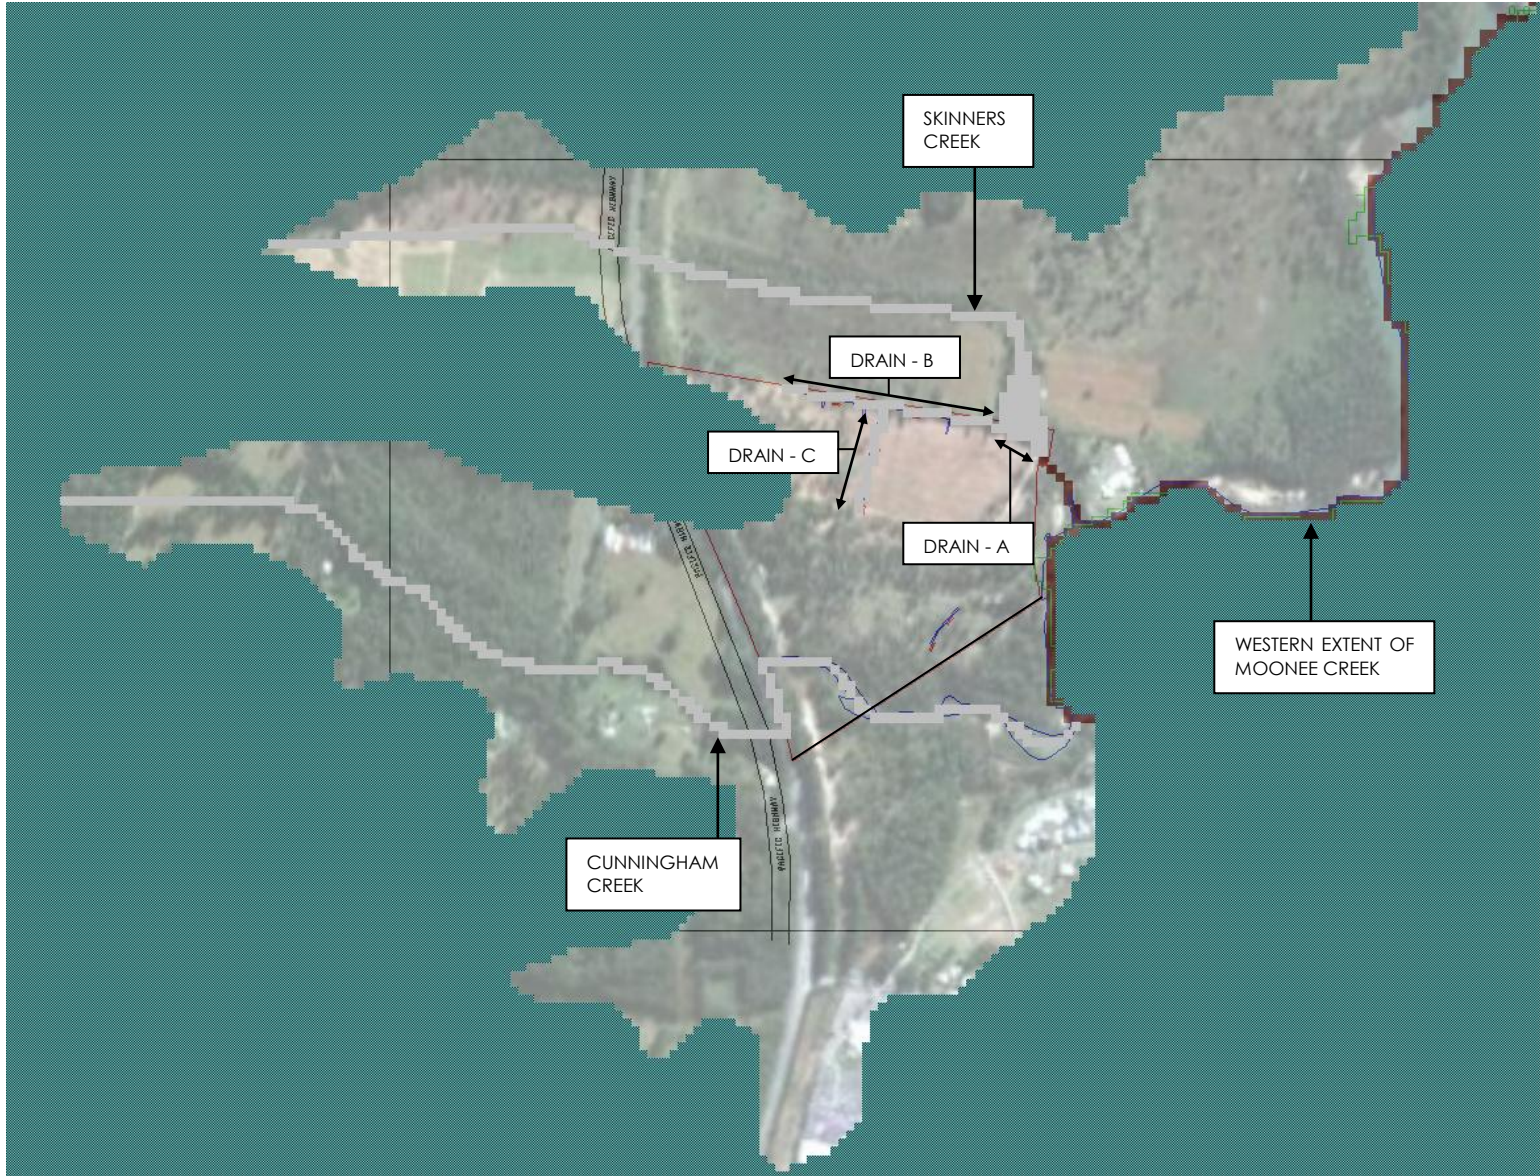
Drawing No:	FIGURE 2
Job No: P1002663

EXISTING DRAINAGE LINES

With respect to Figure 2 boundary conditions were applied as follows:

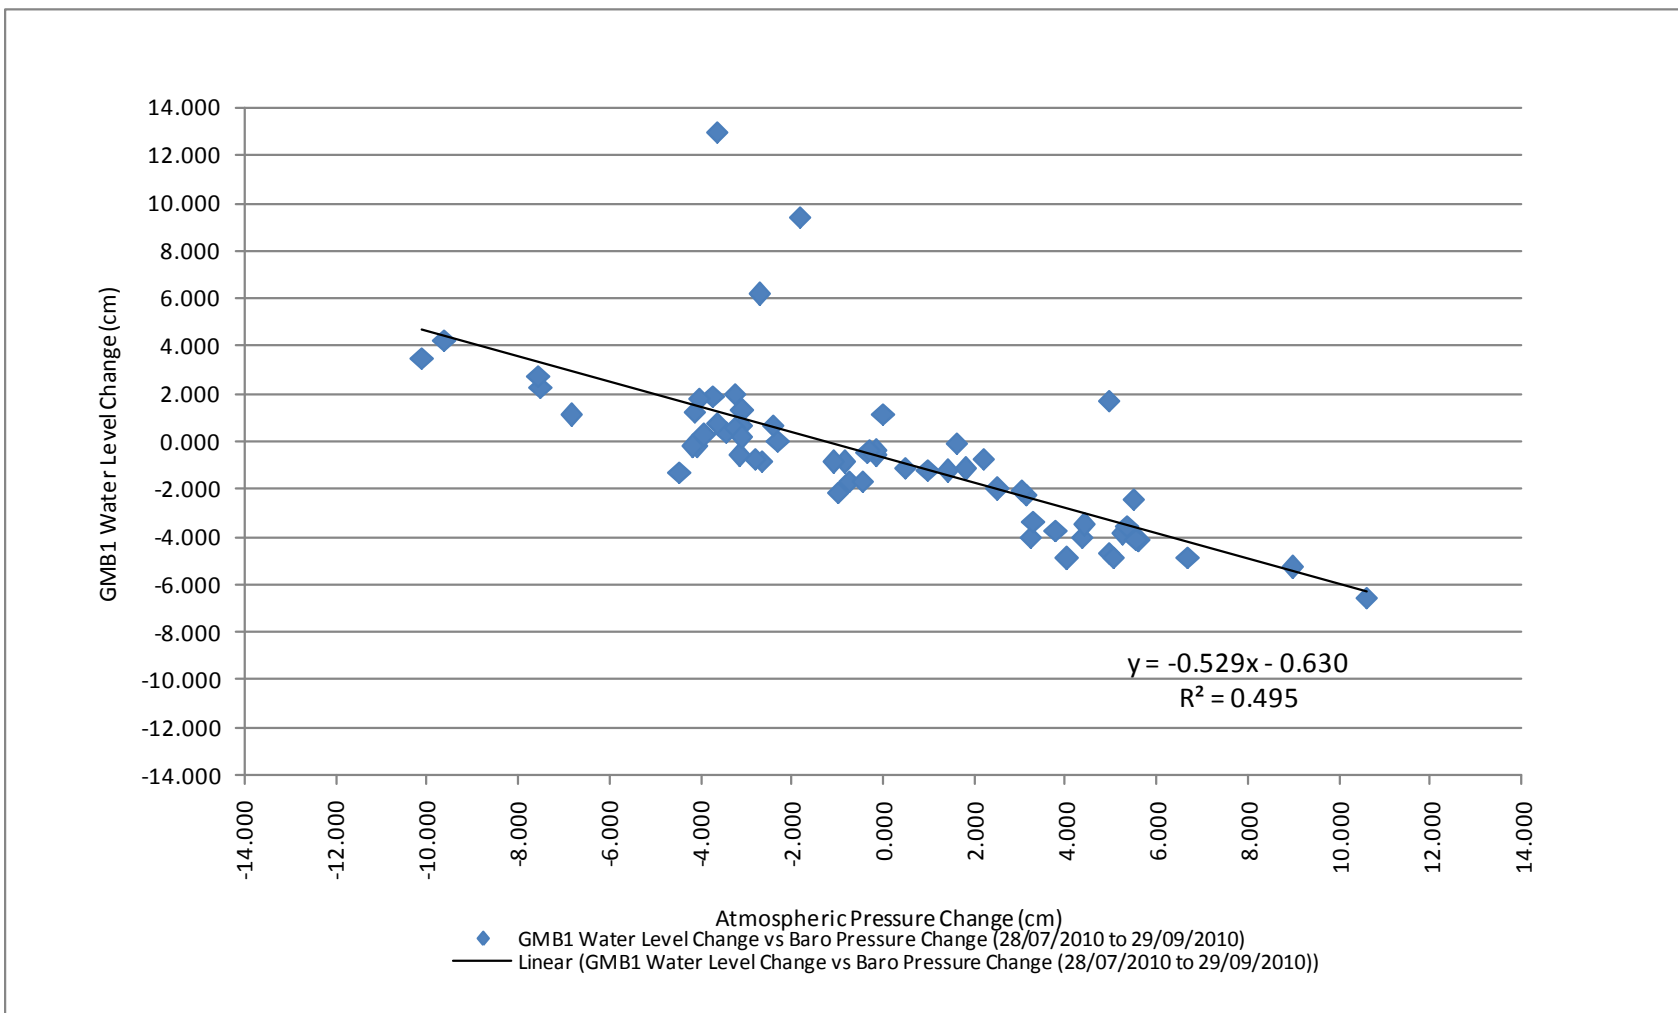
Martens & Associates Pty Ltd ABN 85 070 240 890		Environment Water Wastewater Geotechnical Civil Management	
Drawn:	BR	GMB1 BAROMETRIC EFFECIENCY	Drawing No:
Approved:	GT/DM		FIGURE 7
Date:	16.11.2010		
Scale:	NA		
			Job No: P1002663

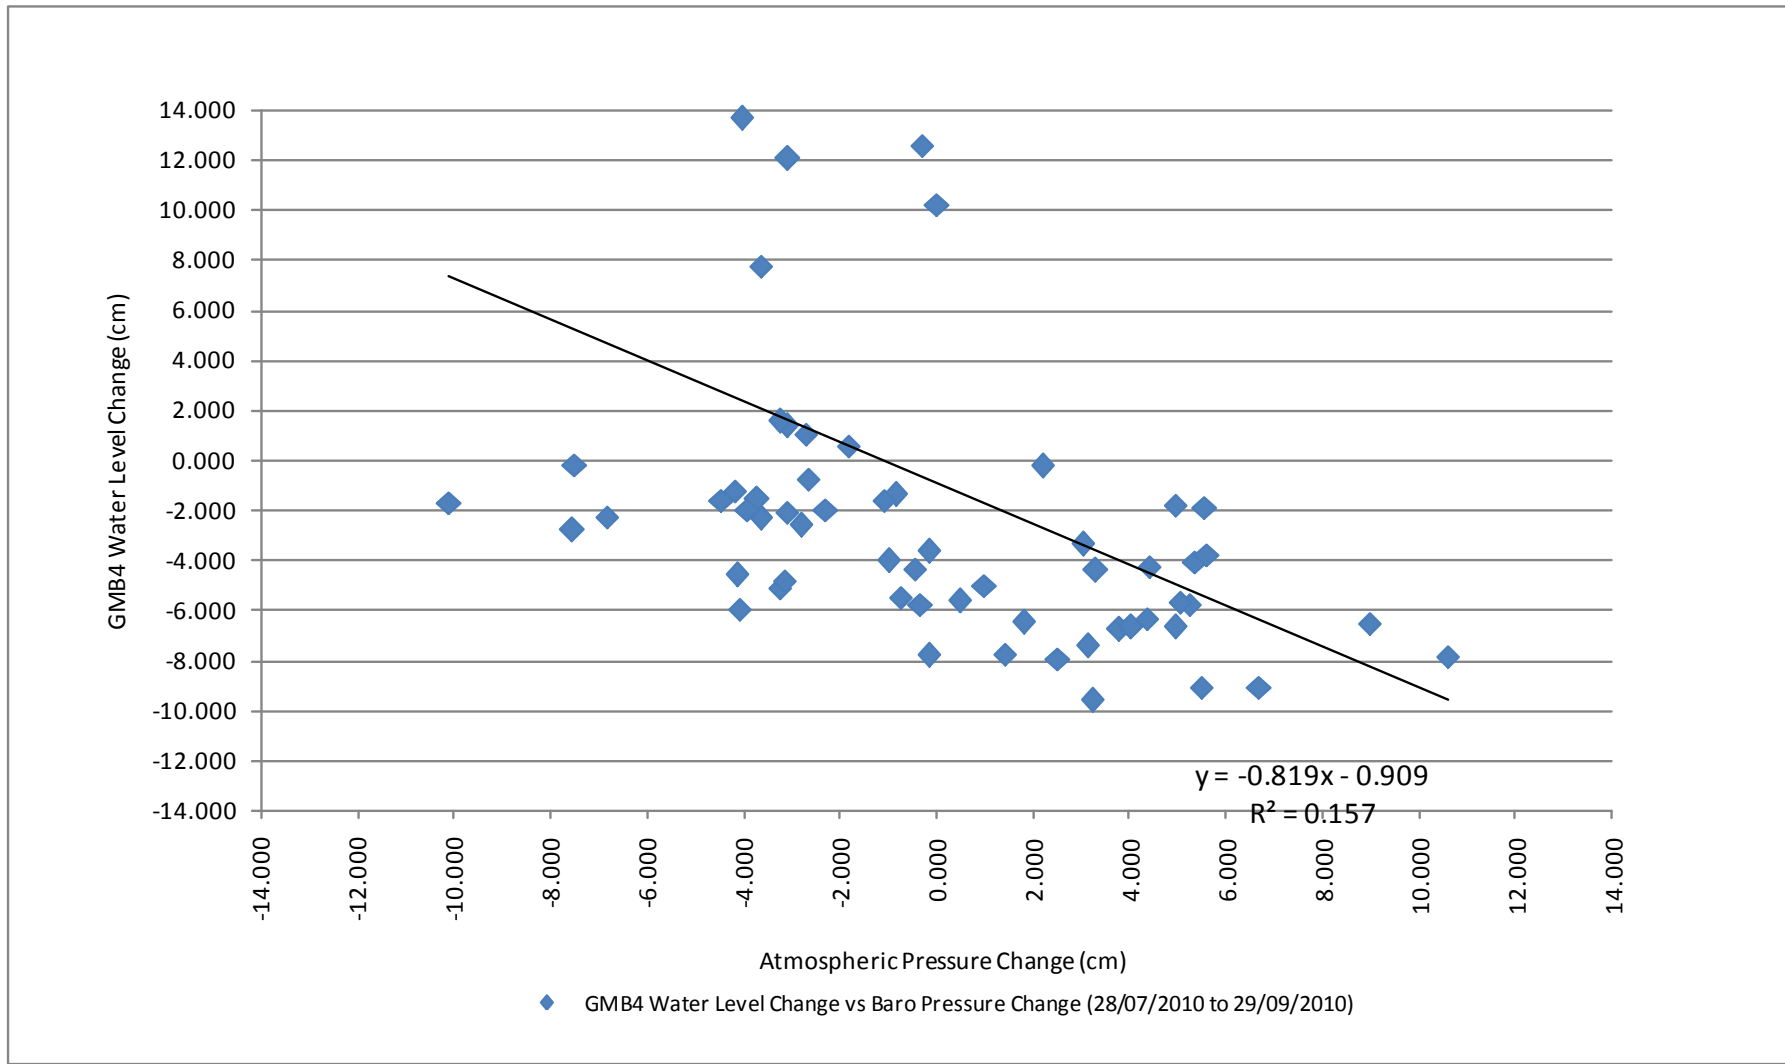
Martens & Associates Pty Ltd ABN 85 070 240 890		Environment Water Wastewater Geotechnical Civil Management	
Drawn:	BR	GMB4 BAROMETRIC EFFECIENCY	Drawing No:
Approved:	GT/DM		FIGURE 9
Date:	16.11.2010		Job No: P1002663
Scale:	NA

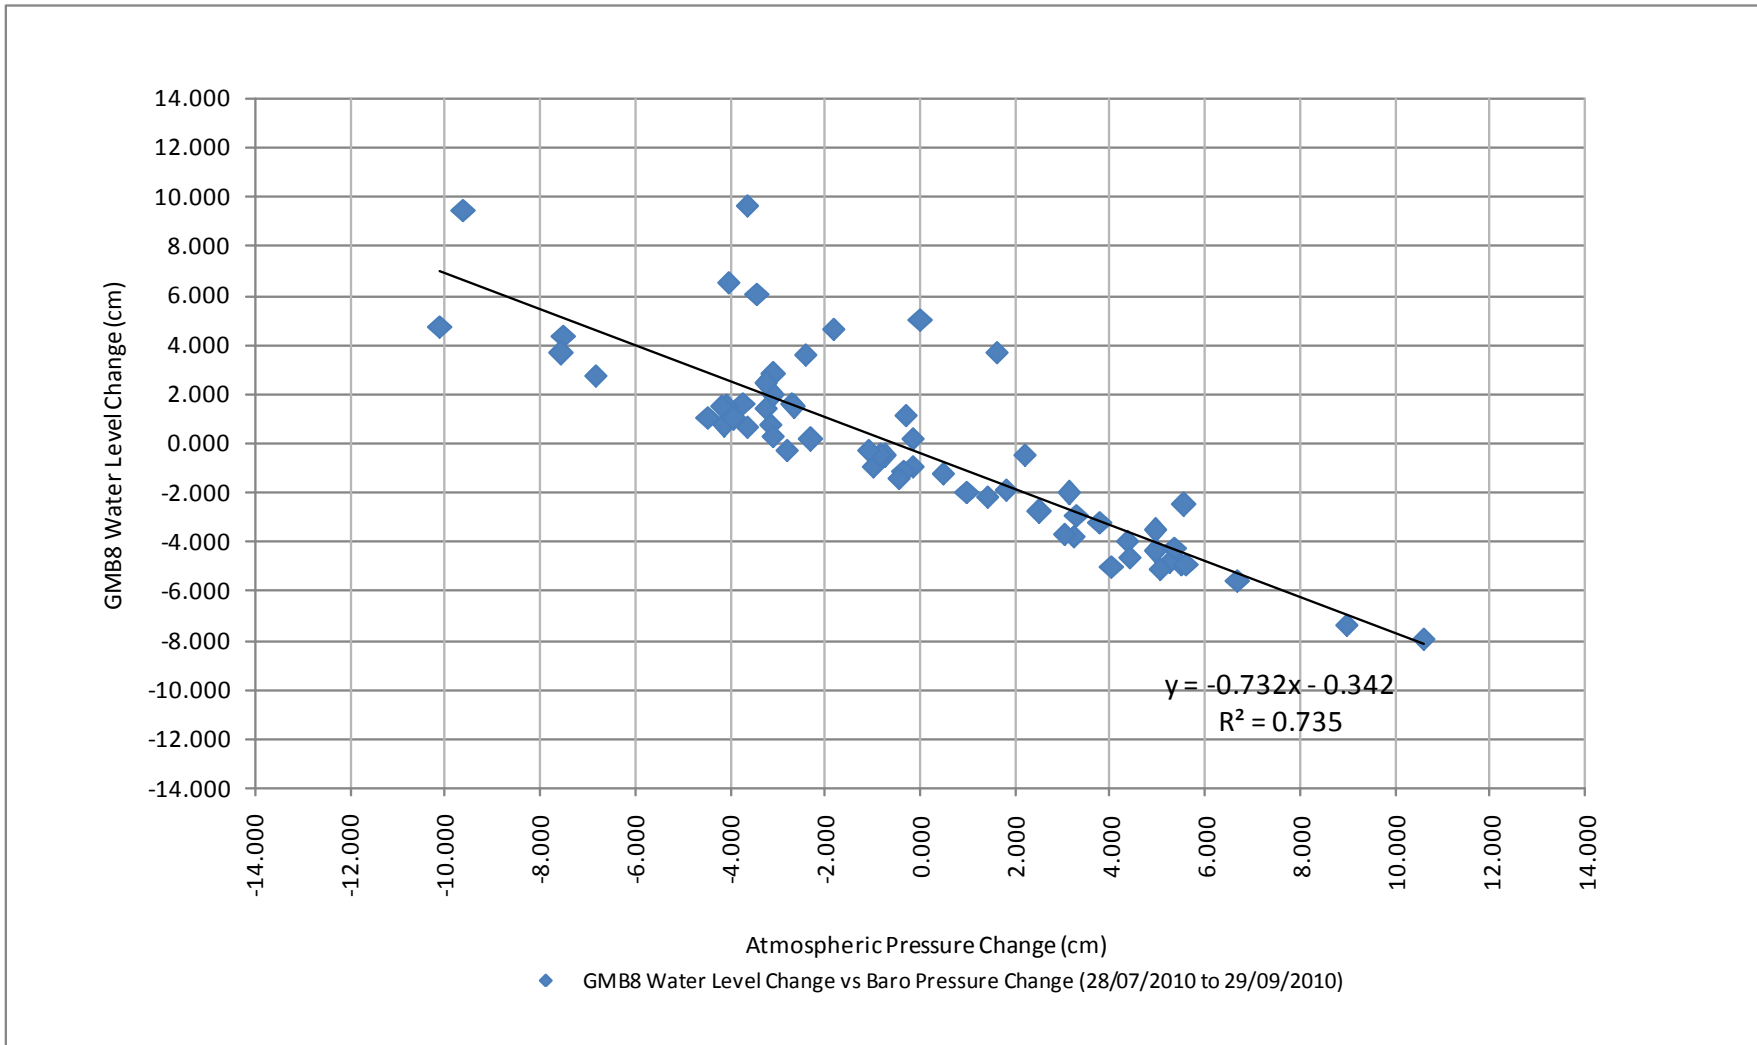
Martens & Associates Pty Ltd ABN 85 070 240 890		Environment Water Wastewater Geotechnical Civil Management	
Drawn:	BR	GMB8 BAROMETRIC EFFECIENCY	Drawing No:
Approved:	GT/DM		FIGURE 12
Date:	16.11.2010		Job No: P1002663
Scale:	NA

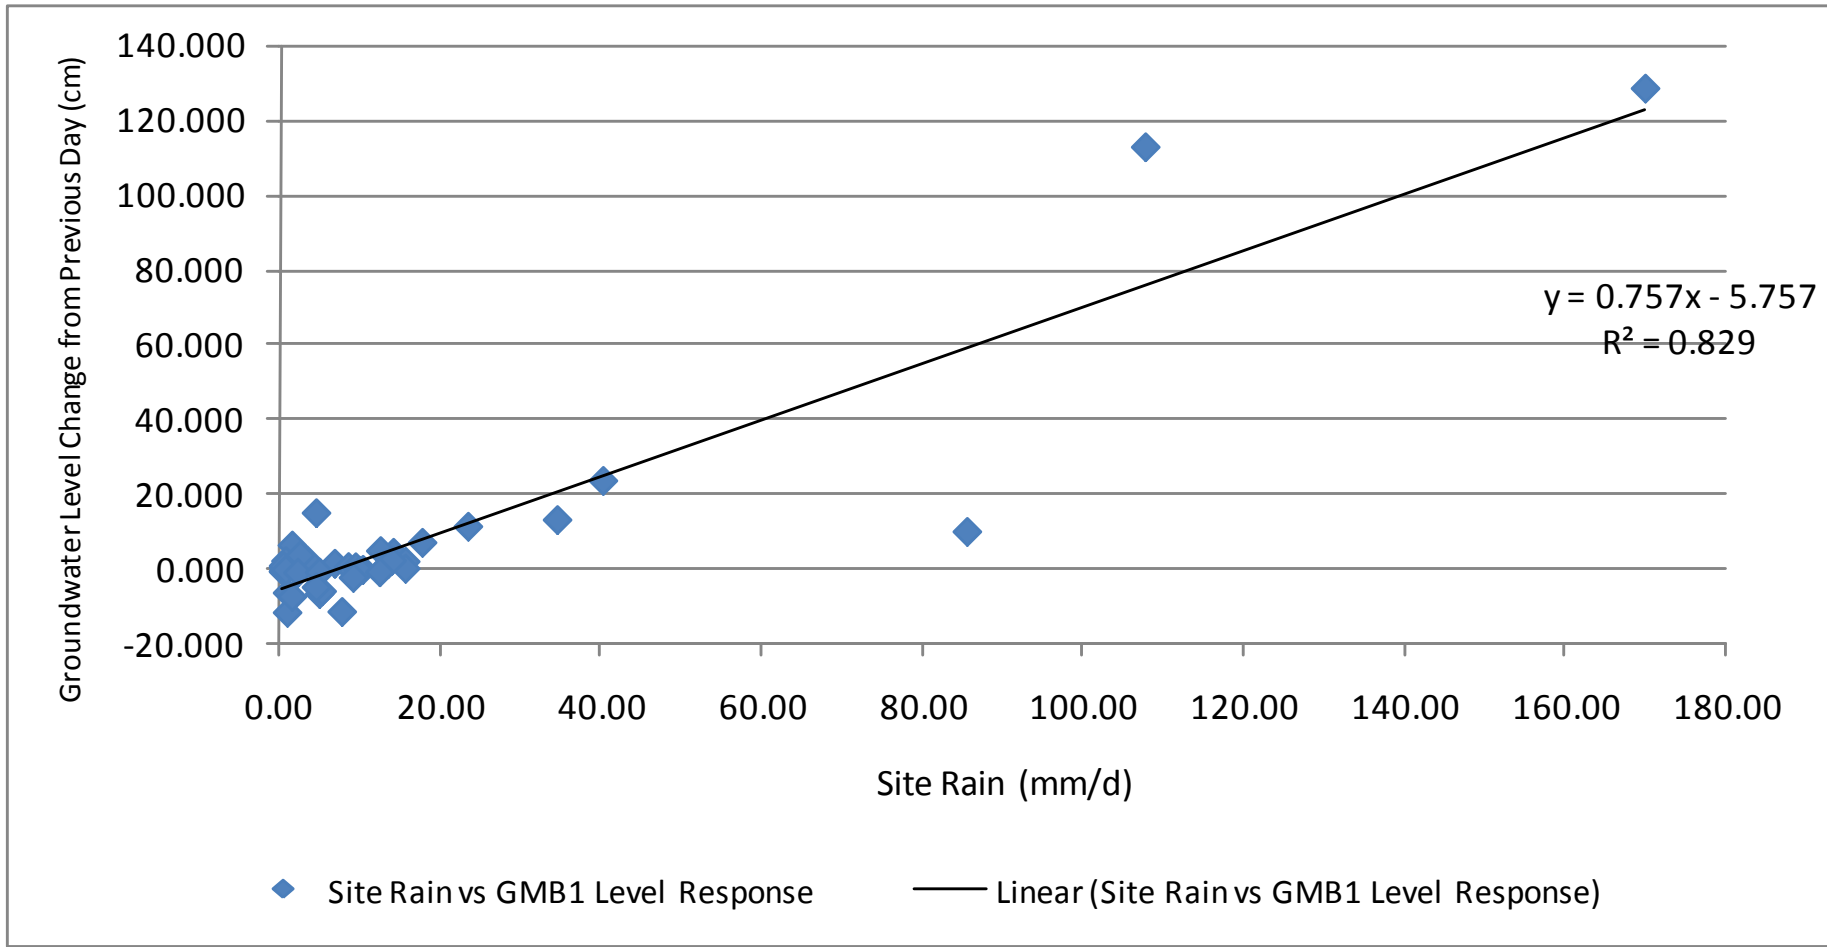
Martens & Associates Pty Ltd ABN 85 070 240 890		Environment Water Wastewater Geotechnical Civil Management	
Drawn:	BR	GMB1 RESPONSE TO RAINFALL	Drawing No:
Approved:	GT/DM		FIGURE 14
Date:	16.11.2010		
Scale:	NA		
			Job No: P1002663

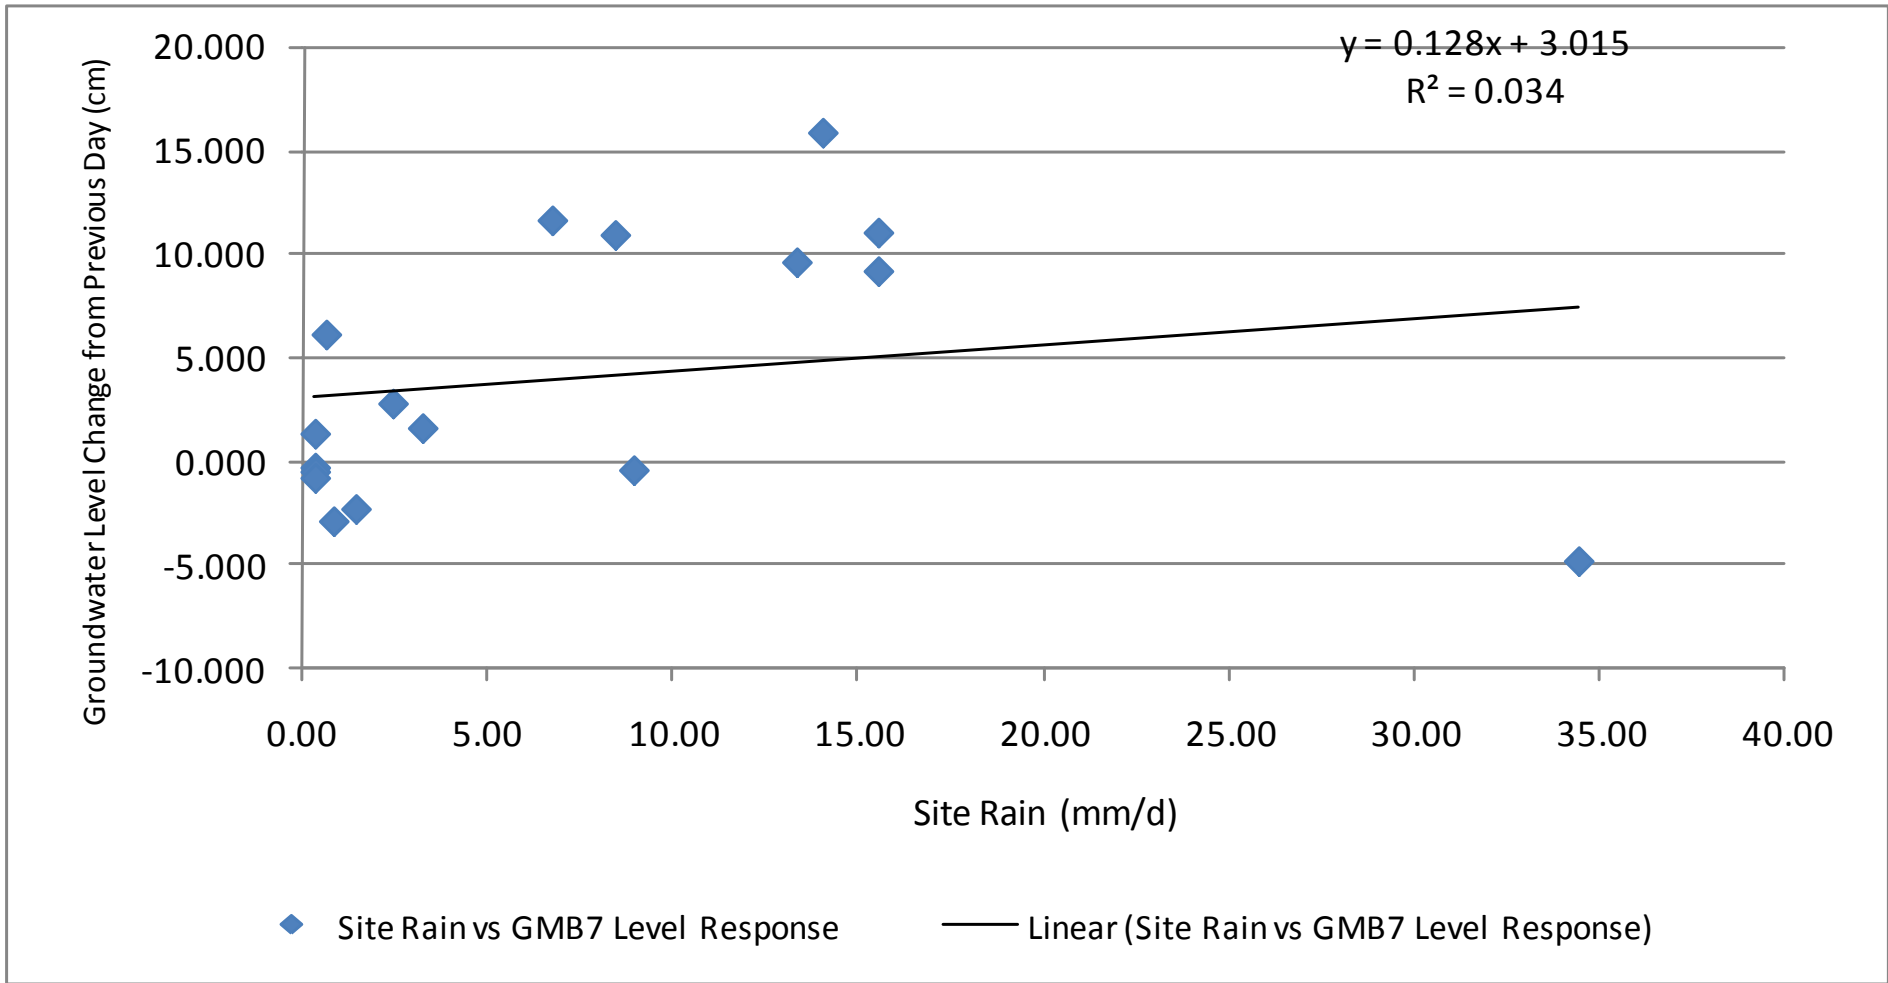
Martens & Associates Pty Ltd ABN 85 070 240 890		Environment Water Wastewater Geotechnical Civil Management	
Drawn:	BR	GMB7 RESPONSE TO RAINFALL	Drawing No:
Approved:	GT/DM		FIGURE 19
Date:	16.11.2010		
Scale:	NA		Job No: P1002663

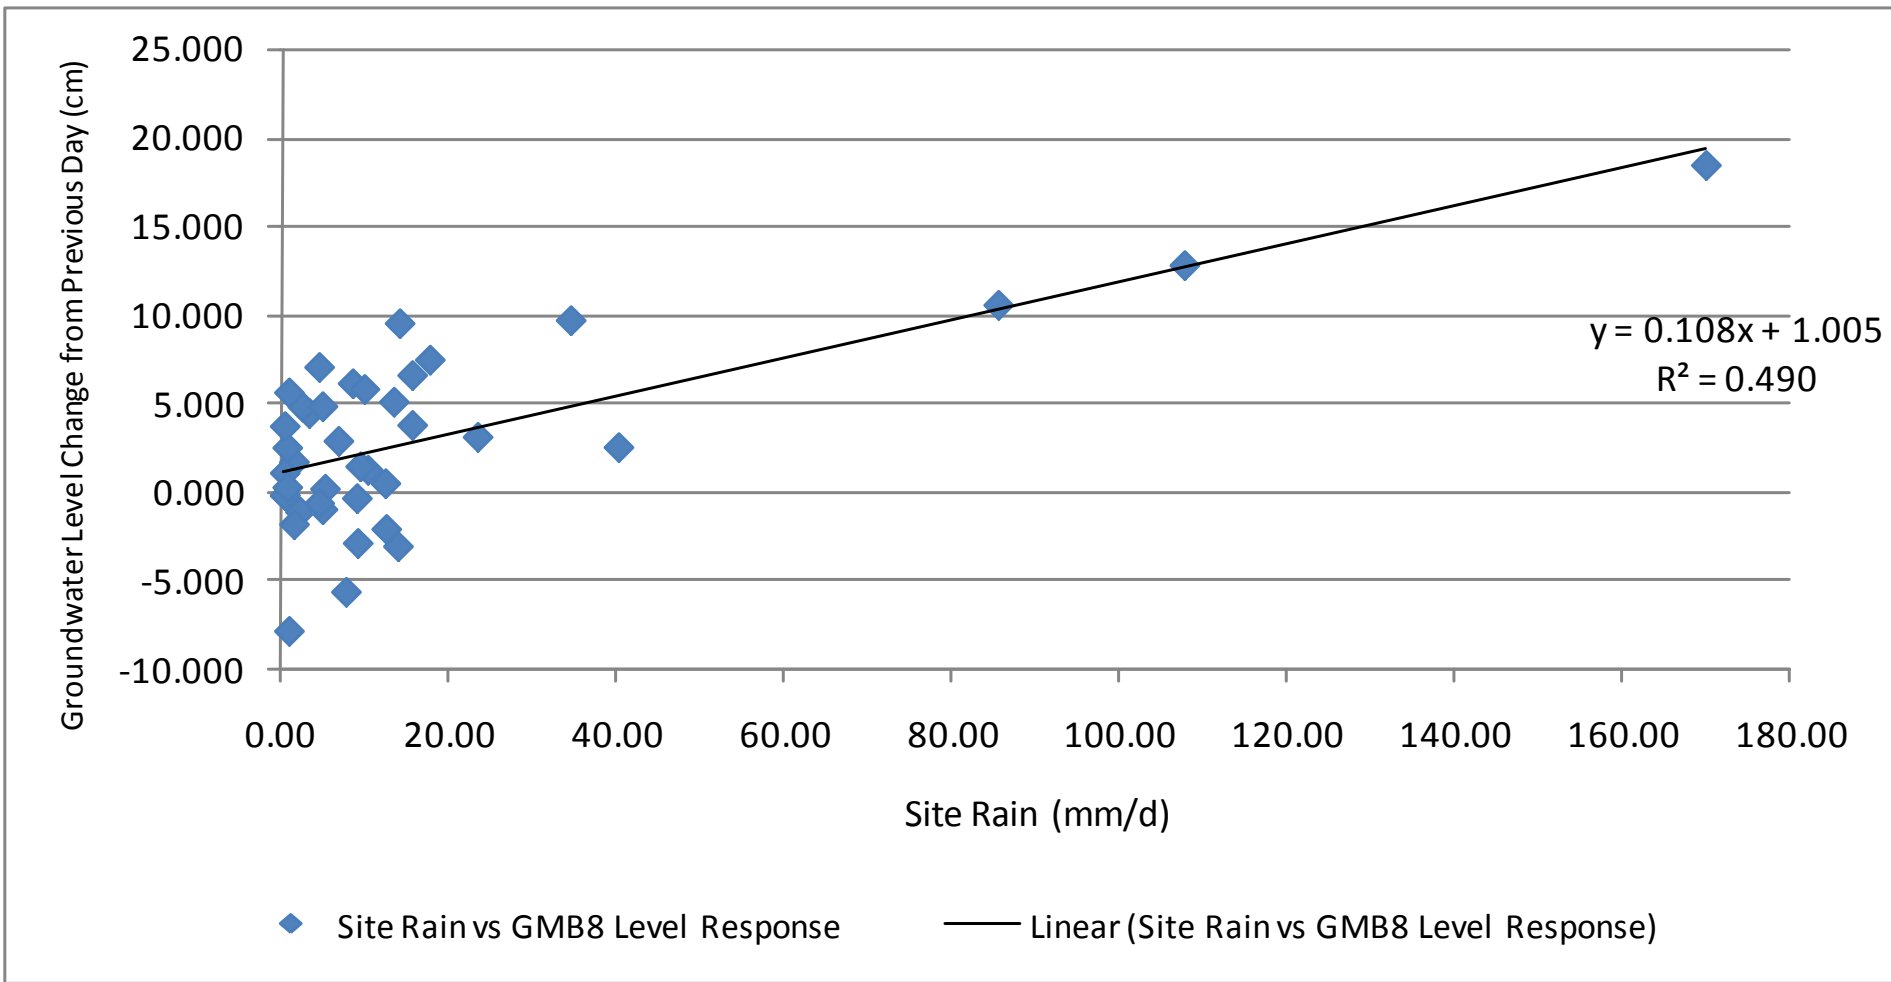
Martens & Associates Pty Ltd ABN 85 070 240 890		Environment Water Wastewater Geotechnical Civil Management	
Drawn:	BR	GMB8 RESPONSE TO RAINFALL	Drawing No:
Approved:	GT/DM		FIGURE 20
Date:	16.11.2010		
Scale:	NA		Job No: P1002663
