Unexpected Finds Protocol  
Proposed New Warehouse and Distribution Facility  
2 Hume Highway, Chullora NSW

Report Number 610.15751-R2

# Unexpected Finds Protocol

## Proposed New Warehouse and Distribution Facility

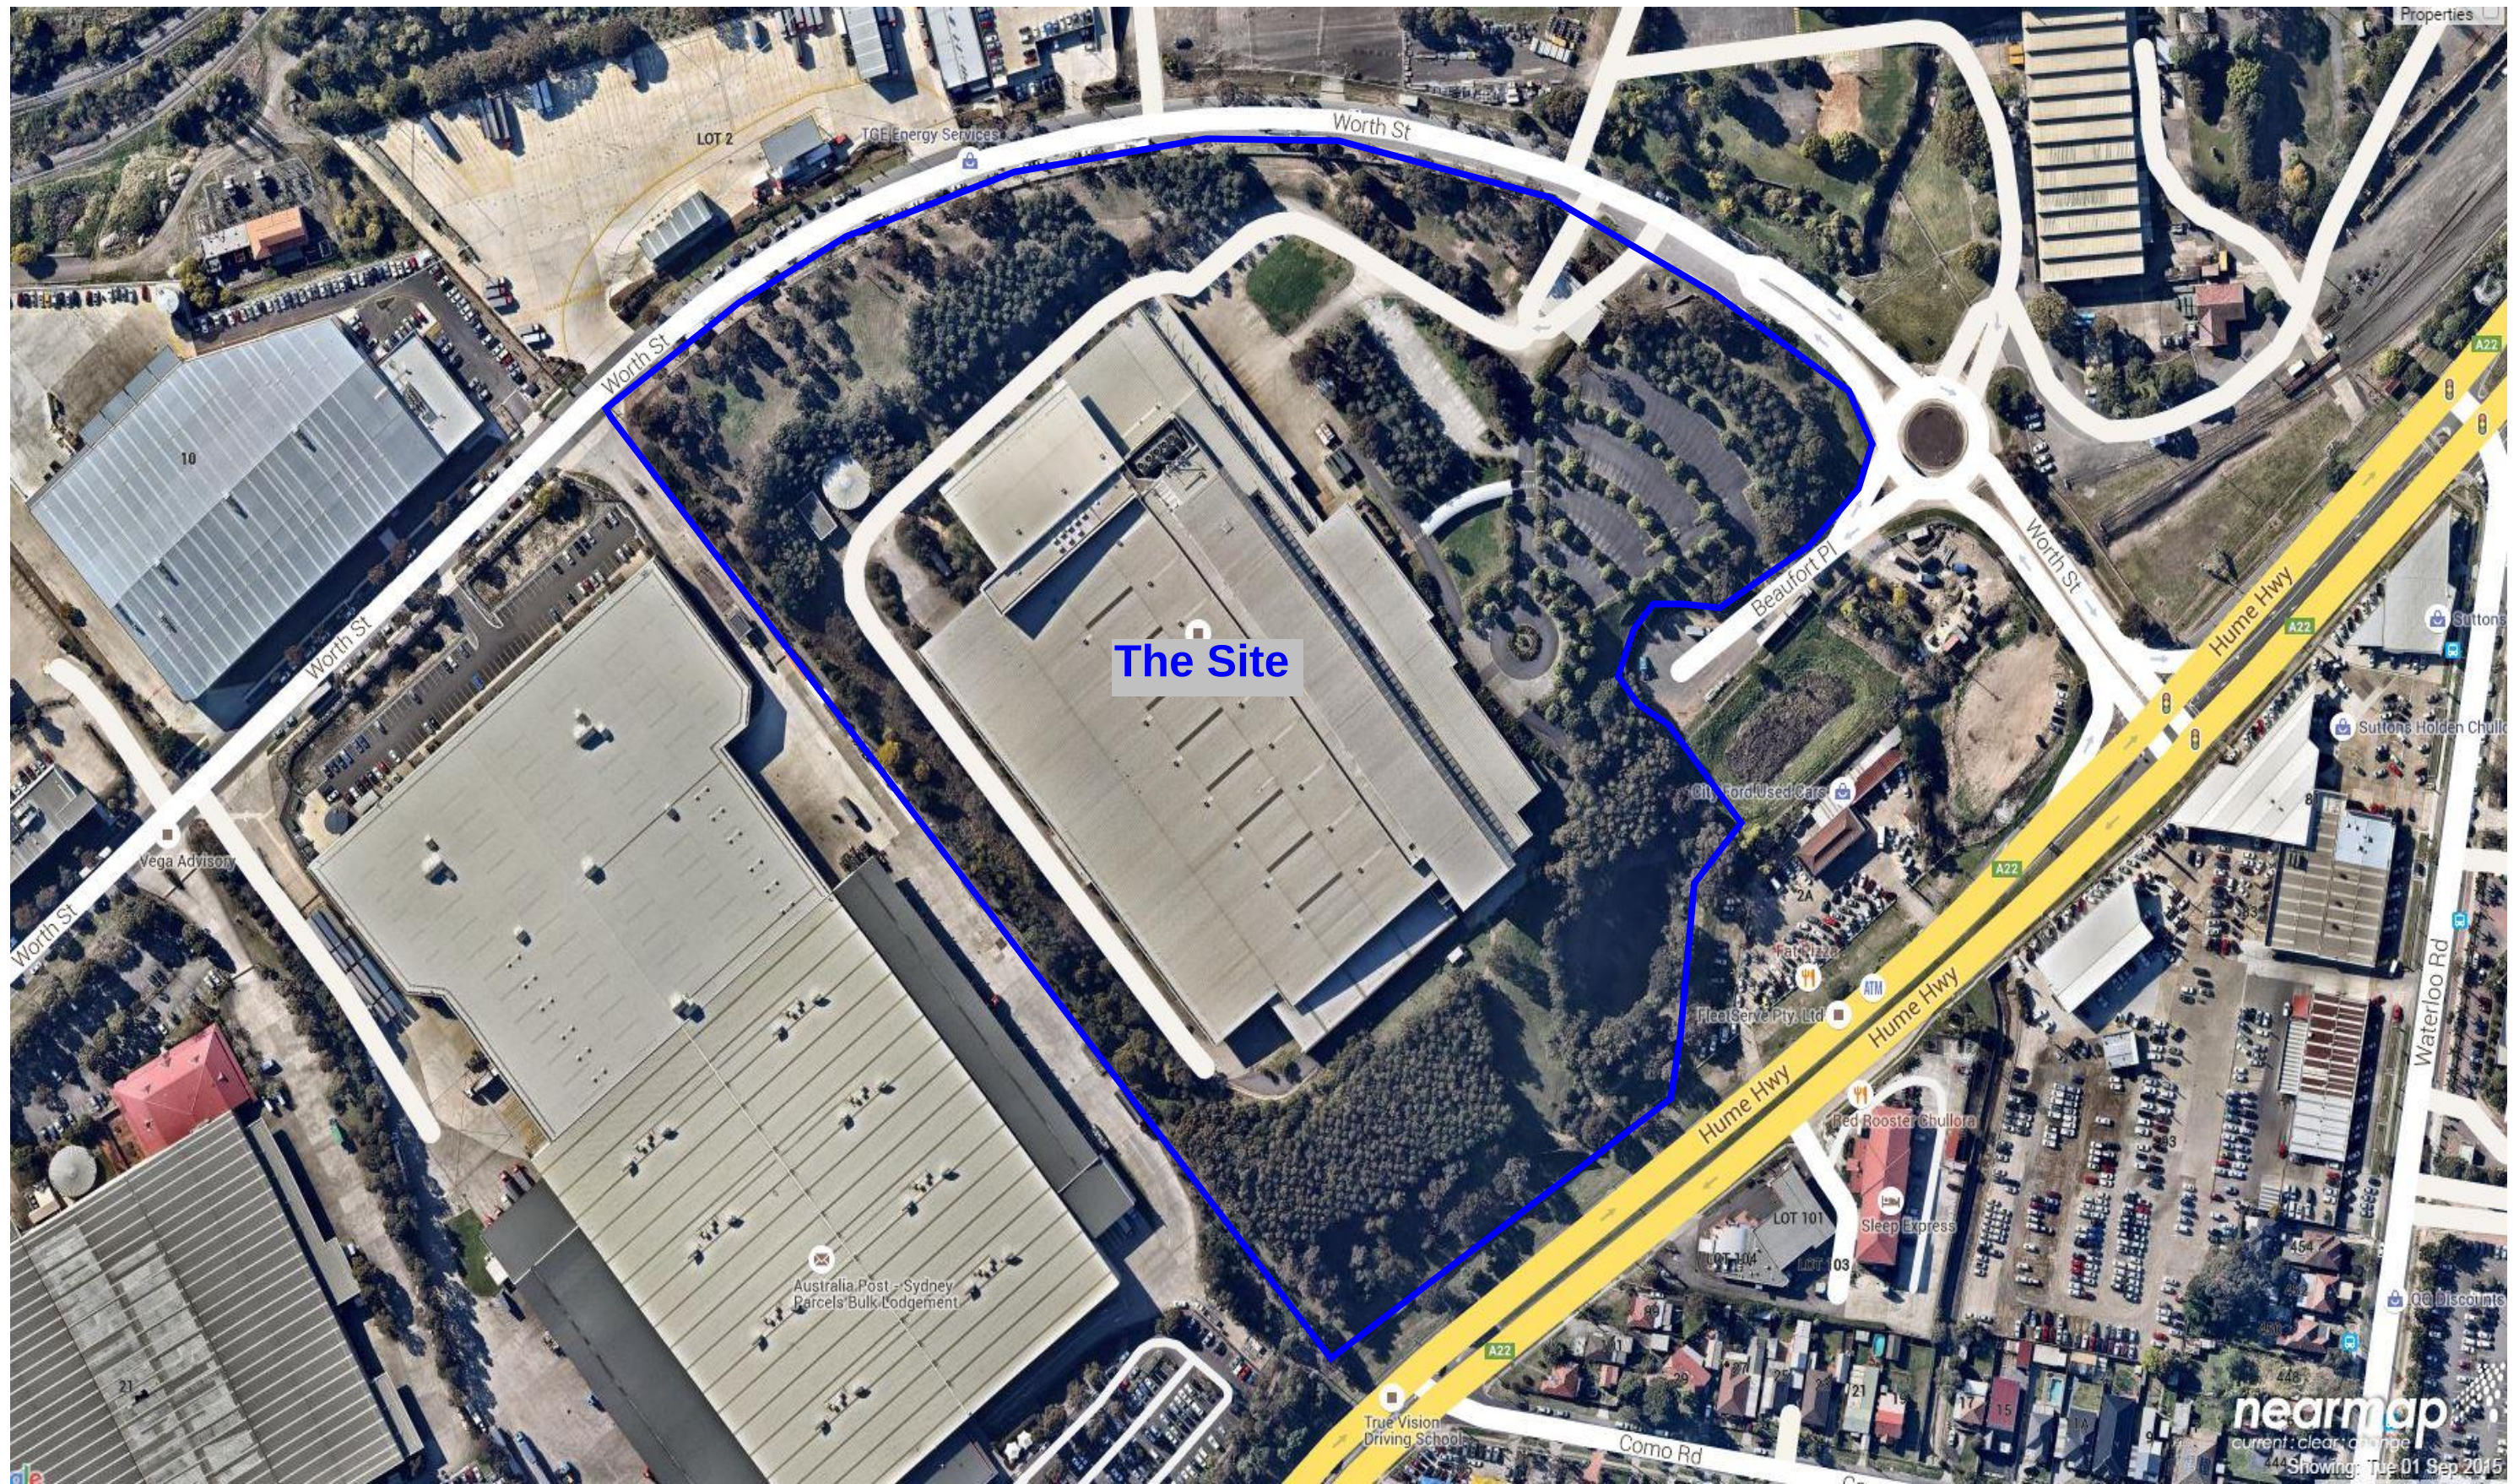
| Figure 2 | Site Layout |

The locality of the site is presented in Figure 1. The layout of the site is presented in Figure 2, which was prepared based on a figure obtained on 24 September 2015 (Nearmap), showing the site features as of 1 September 2015.

The lateral extent of the site is defined by the blue outline on Figure 2.
