# arboricultural impact assessment – parramatta public school & arthur phillip high school

22<sup>nd</sup> April 2016

prepared by Melanie Howden - Ass. Dip. Hort. (Haw. Ag. C.), SoA. Arb. MAIH, MIACA

tree locations & reference numbers

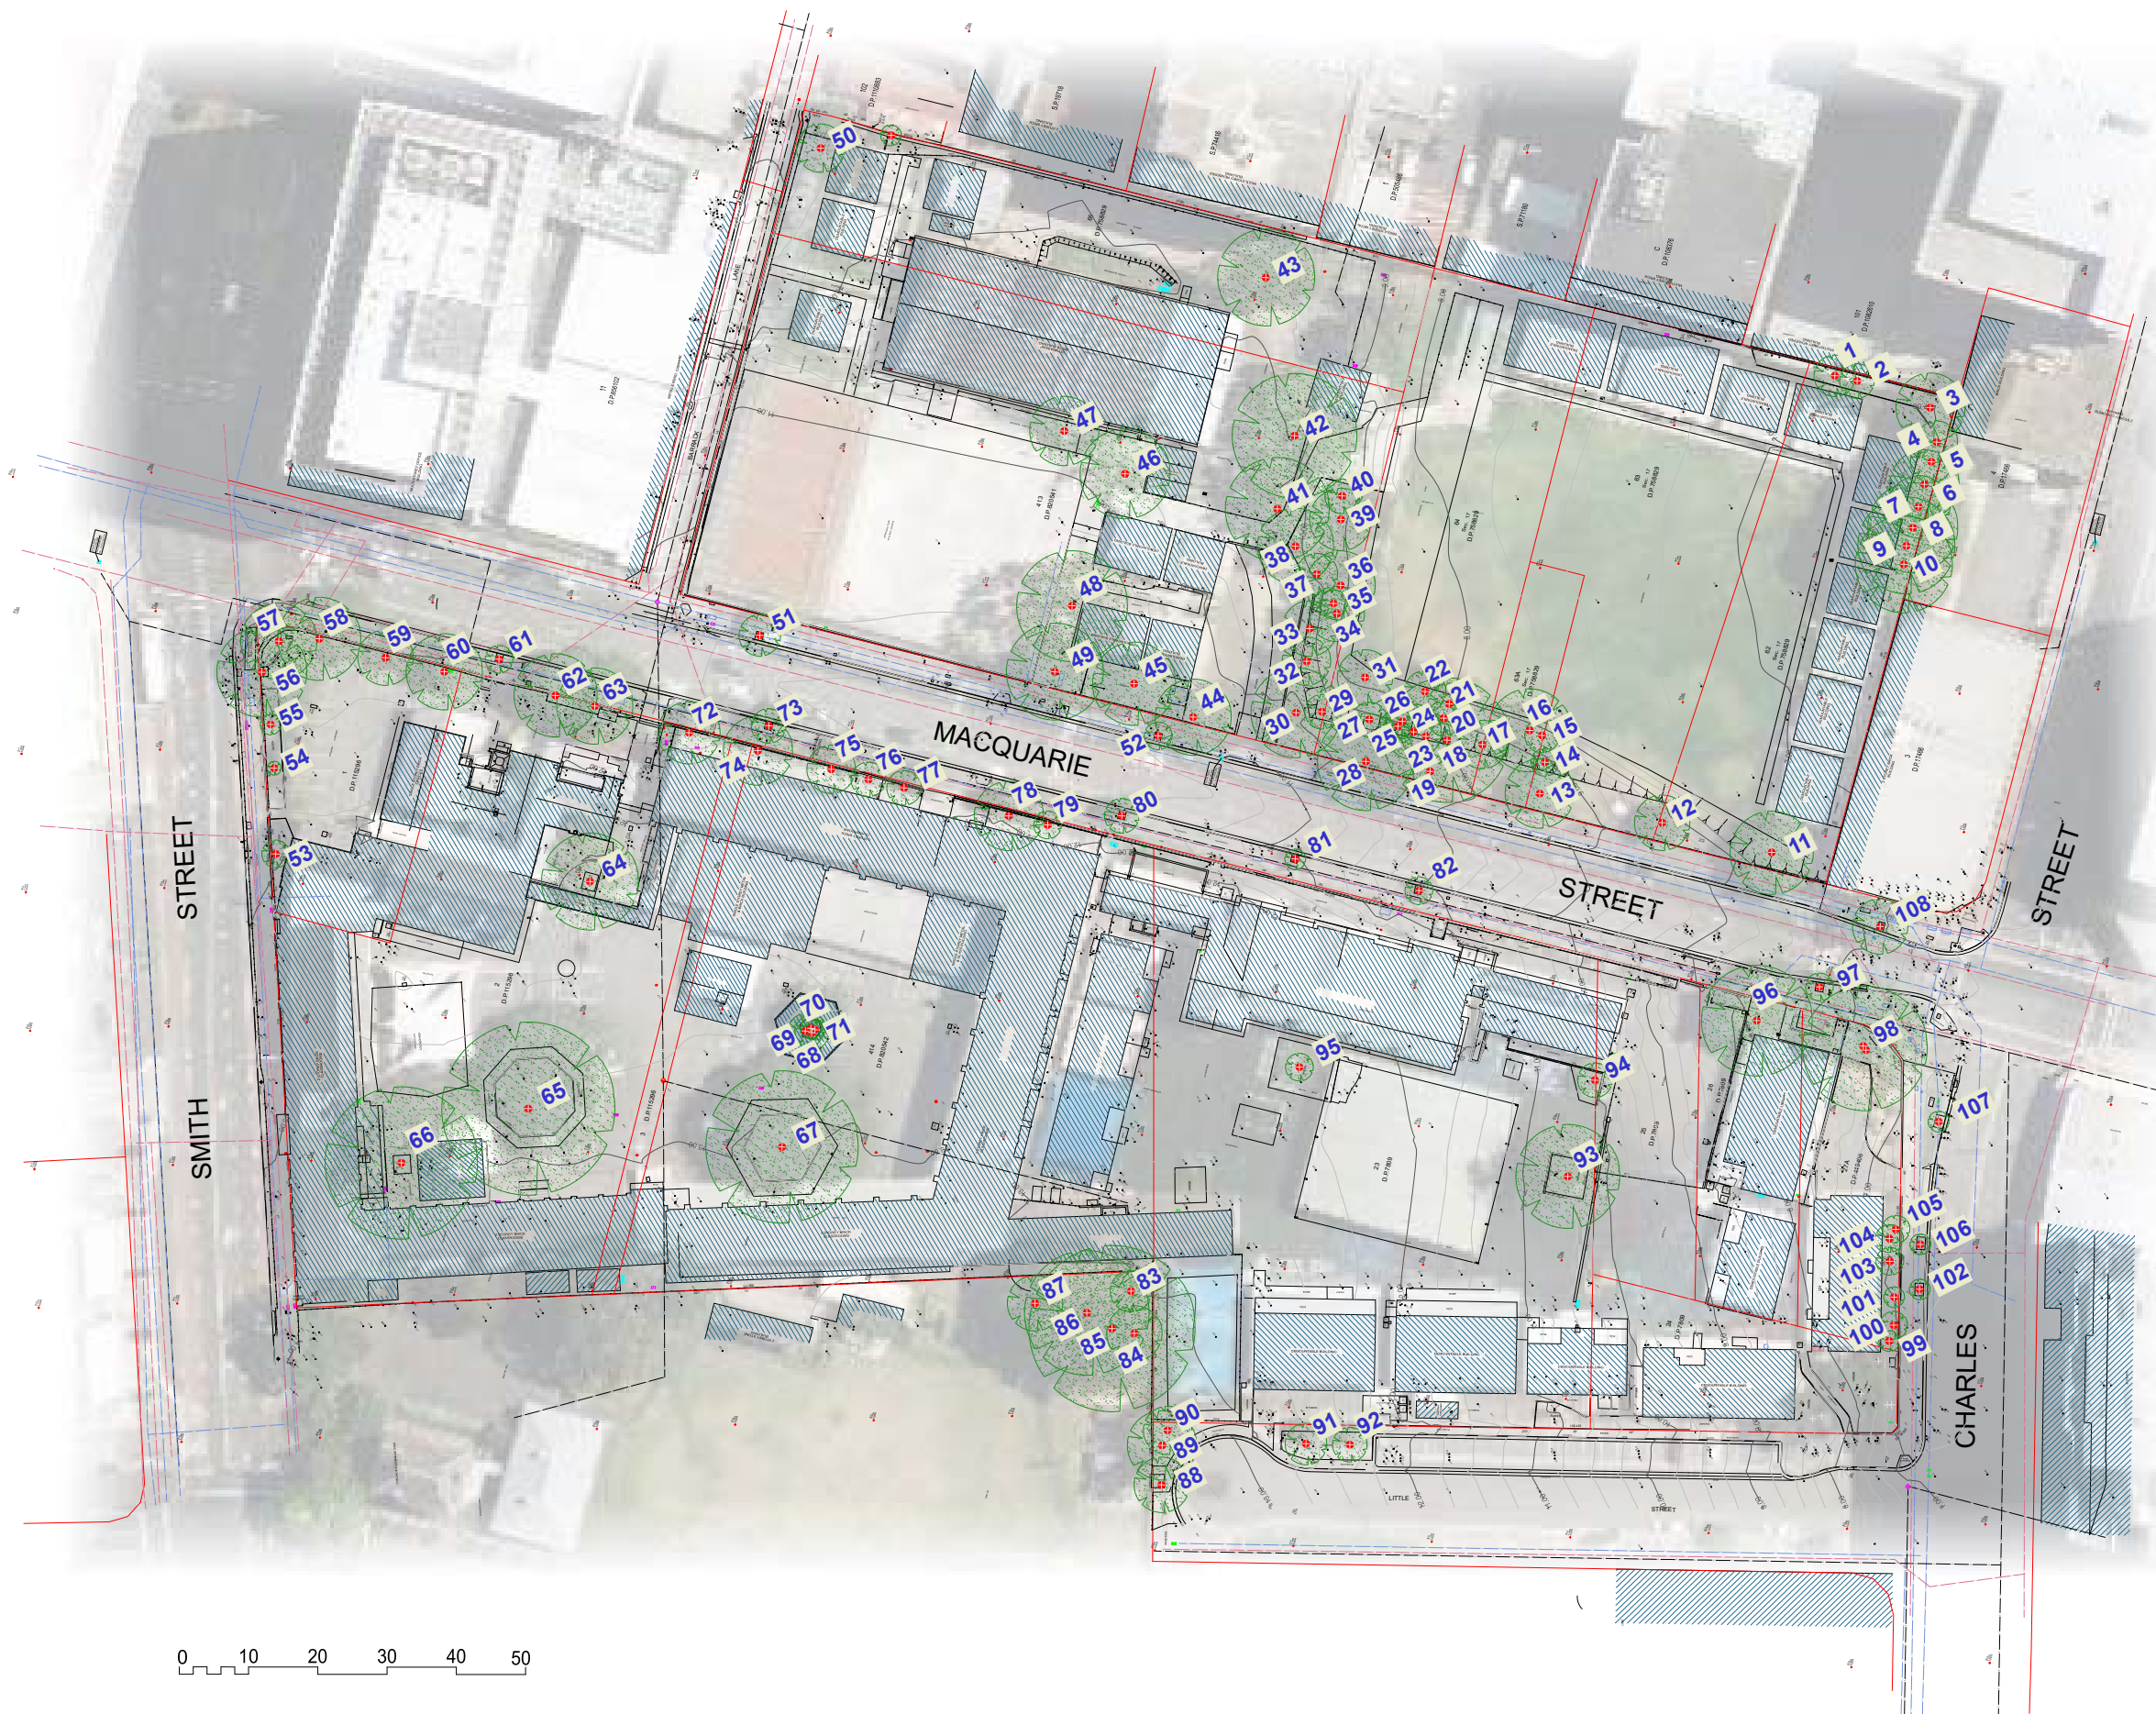
This plan is based upon:

In addition to the trees identified on the survey 11 trees have been added to this plan as they are of a size / dimensions covered by Parramatta City Council's DCP. The additional trees are Tree No's 19, 34, 35, 54, 55, 83 84, 85, 86, 87 & 95 and their locations, whilst based upon surveyed features, are approximate.

Some trees shown on the survey have been deleted from this plan as they no longer exist.

The tree canopy spreads on this plan have been adjusted from those on the survey to better reflect the actual canopy spreads however they remain as indicative graphics.

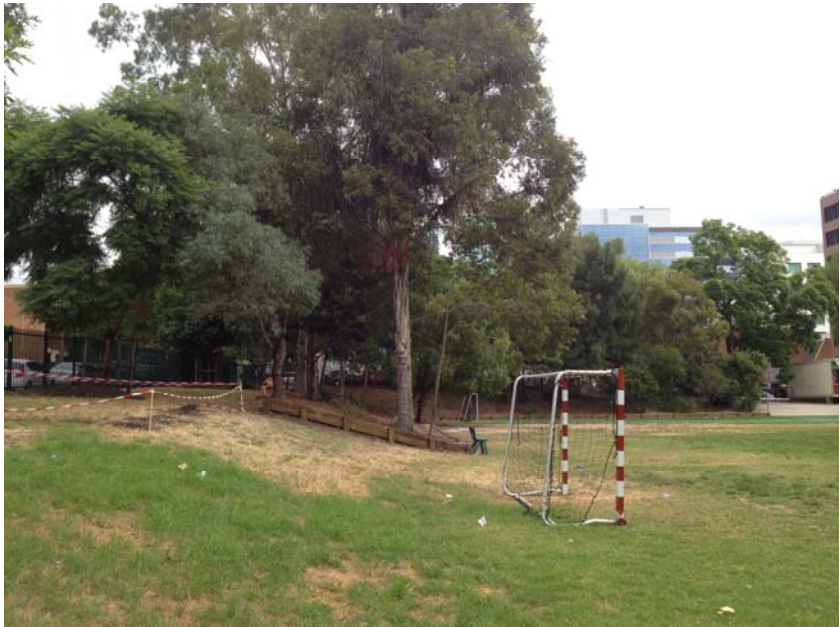
Figure 8.1 Stand of trees on the northern side of Macquarie Street looking west with Tree No15 in the foreground (centre of photo)

| Tree No | Genus Species | Common Name | Height (m) | Canopy Spread (m) | DBH (mm) | DAB (mm) | Description | Environmental / Landscape Significance | Condition | Foliage Condition | % Canopy Dead Wood | Evidence of Pests, Disease, Cavity, Bracket Fungi | SULE | On / off site | TPZ Radius (m) | Area of TPZ (m2) |
|---|---|---|---|---|---|---|---|---|---|---|---|---|---|---|---|---|
| 15 | <i>Syagrus romanzoffianum</i> | Cocos Palm | 12 | 5 | 300 | 300 | Mature single trunk tree with an elevated spreading form; an upright trunk/s and majority of canopy and branch development is towards the south. No evidence of significant branch pruning. | Moderate L/scape Sig. | The tree appears stable and its branch attachment appears sound. The tree is considered to be in good health and displays good vigour. | Good | 5% | The palm appears to be suppressed by the adjacent vegetation | 2 | On site | 3.60 | 40.73 |

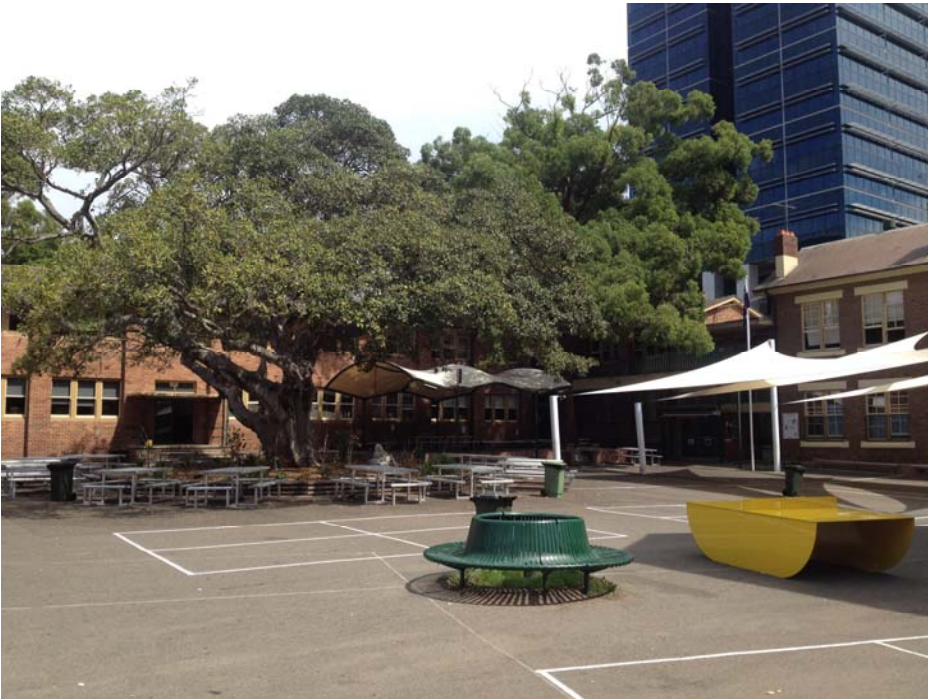
Figure 8.2 Tree No. 65 in the existing courtyard of Phillip Arthur High School with the canopy of Tree No. 66 behind.

| Tree No | Genus Species | Common Name | Height (m) | Canopy Spread (m) | DBH (mm) | DAB (mm) | Description | Environmental / Landscape Significance | Condition | Foliage Condition | % Canopy Dead Wood | Evidence of Pests, Disease, Cavity, Bracket Fungi | SULE | On / off site | TPZ Radius (m) | Area of TPZ (m2) |
|---|---|---|---|---|---|---|---|---|---|---|---|---|---|---|---|---|
| 65 | <i>Ficus rubiginosa</i> | Port Jackson Fig/Rusty Fig | 11 | 25 | 1*660, 1*720, 1*860 | 1600 | Mature multi trunk tree with a broad spreading form; an upright trunk/s and balanced canopy and branch development. Lower limbs of the tree have been pruned to 5m and weight reduction pruning has occurred. | High L/scape Sig. | The tree appears stable and its branch attachment appears sound. The tree is considered to be in good health and displays good vigour. | Good | 10% | Decay is evident on the upper side of the southern trunk and decay is also present in old pruning branch stubs. Some epicormic growth is present. | 1 | On site | 15.00 | 707.14 |

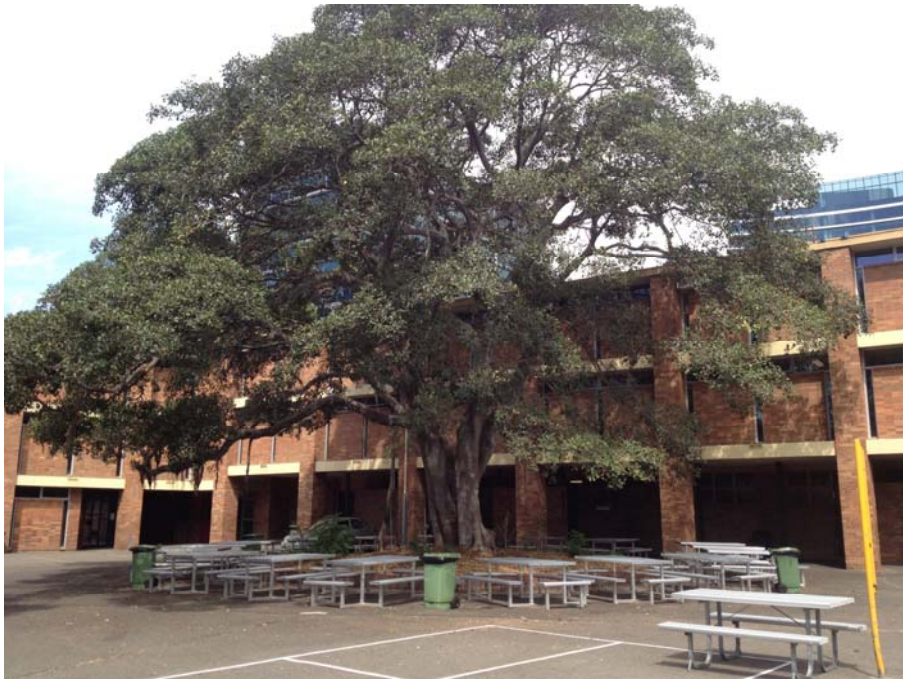
Figure 7.3 Tree No's 66 in the courtyard of Arthur Phillip High School.
