# **Arthur Phillip High School and Parramatta Public School**

## **Heritage Impact Statement**

**Report prepared for Grimshaw Architects on behalf of the NSW Department for Education**

**April 2016**

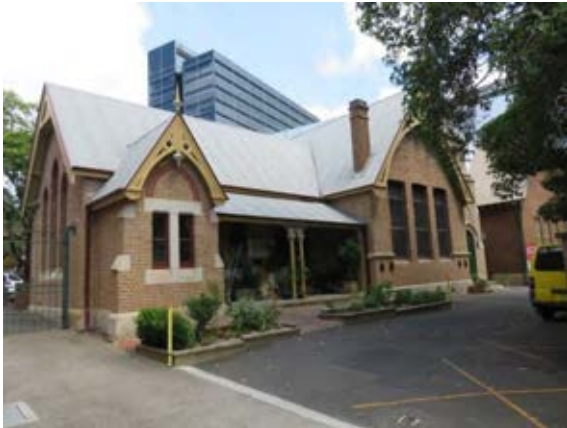
**Figure 3.1** North elevation of the 1875 school building with a small entrance porch at the northeast corner.

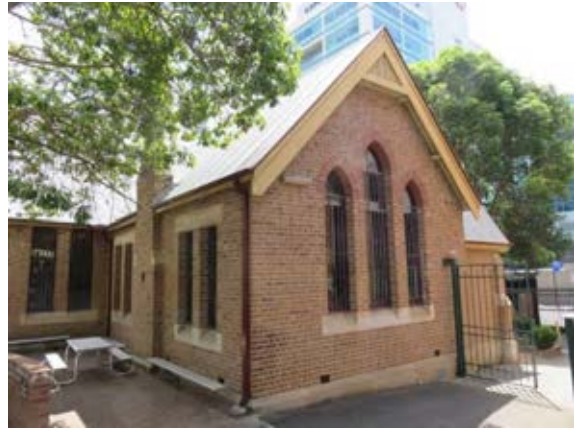
**Figure 3.2** East elevation of the 1875 school building.

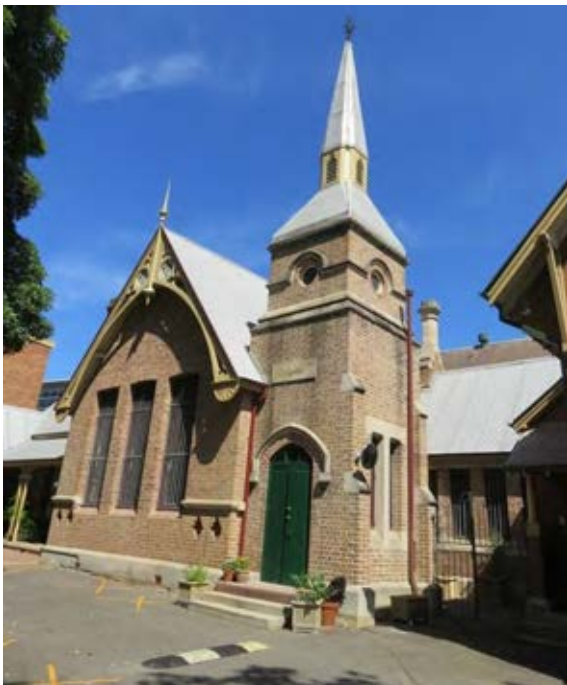
**Figure 3.3** North elevation of the 1875 school building showing the tower and spire and decorative bargeboard to northern gable end. Windows in the gable end wall were replaced in the early twentieth century.

The original building has double hung timber windows, with six-pane sashes, and framed and sheeted timber doors, most of which, except for those in the northern gable end, are original. The windows in the northern gable were rebuilt in the late nineteenth / early twentieth century, when the original five lancet windows were replaced with three large double hung windows with fanlights over. These have sloping brick sills and arched brick heads consisting of three header courses and have nine-pane sashes. They are consistent with those that used to exist in the 1890s wing. The original lancet

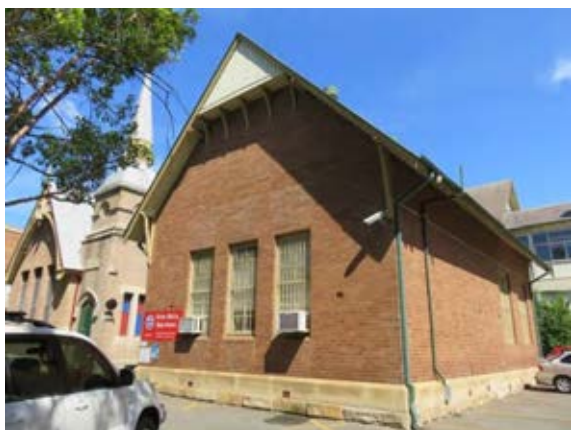
**Figure 3.5** North elevation of the 1890s addition. Note the fanlights above the windows have been removed.

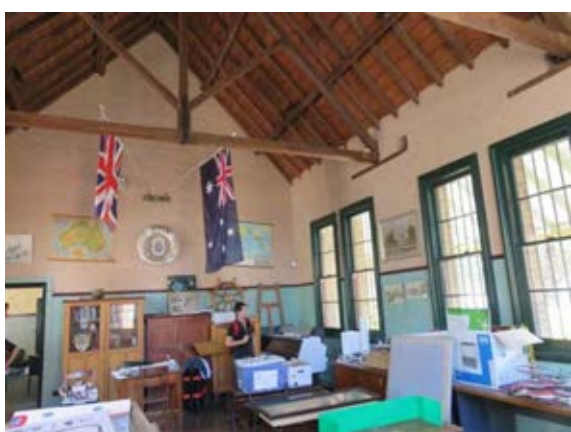
**Figure 3.9** Eastern school room looking west, showing exposed trusses and rafters to the ceiling, the rendered dado around walls and original windows.

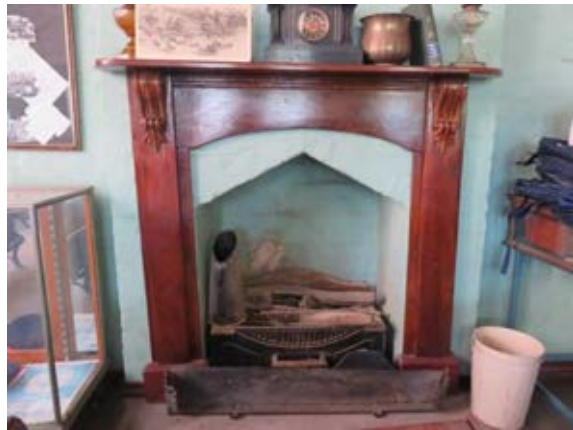
**Figure 3.12** The original fireplace and chimney piece in the eastern school room.

Some of the original and 1890s windows have also been altered or replaced as described above. Some of the fireplaces have been removed or blocked up, although one original fireplace remains in the 1875 eastern school room.

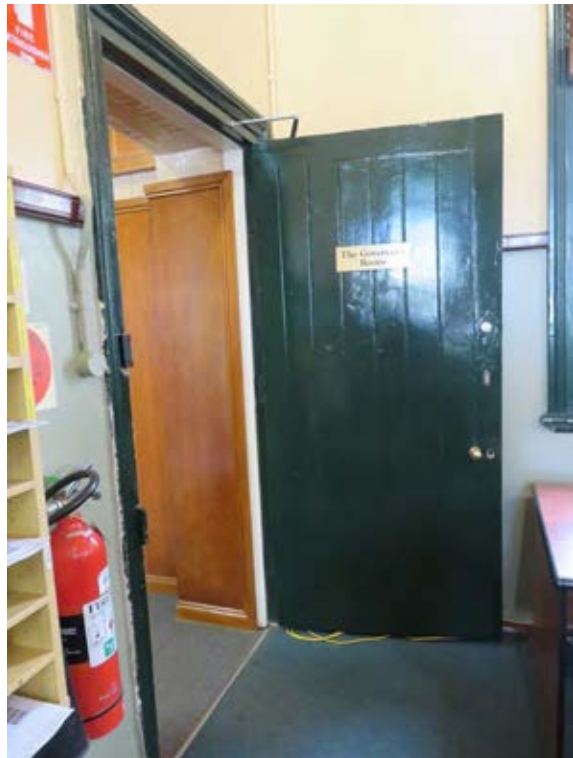
**Figure 3.14** The original framed and sheeted door and architraves in the southern wall of the central school room.

The building retains some original internal doors—framed and sheeted in the 1875 building and four panelled in the 1890s building. The door, sidelights and fanlight to the opening into the office appear to have been replaced.

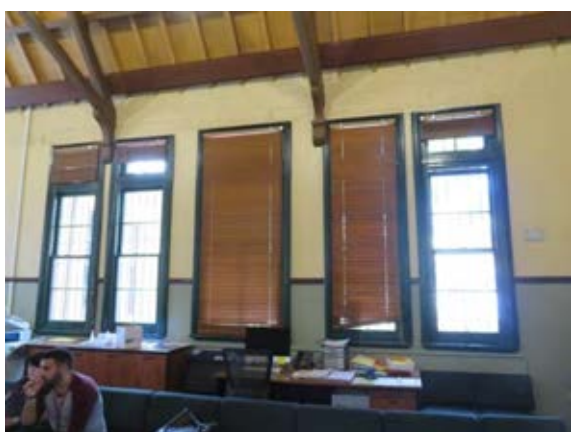
**Figure 3.17** The original windows in the eastern wall of the large central school room.

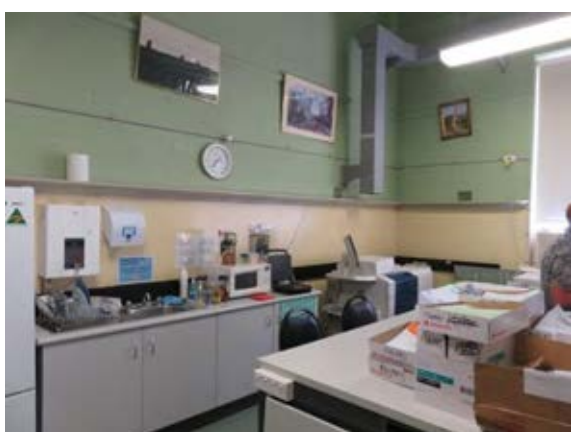
**Figure 3.19** A plate shelf around the walls of the northern school room of the 1890s addition.

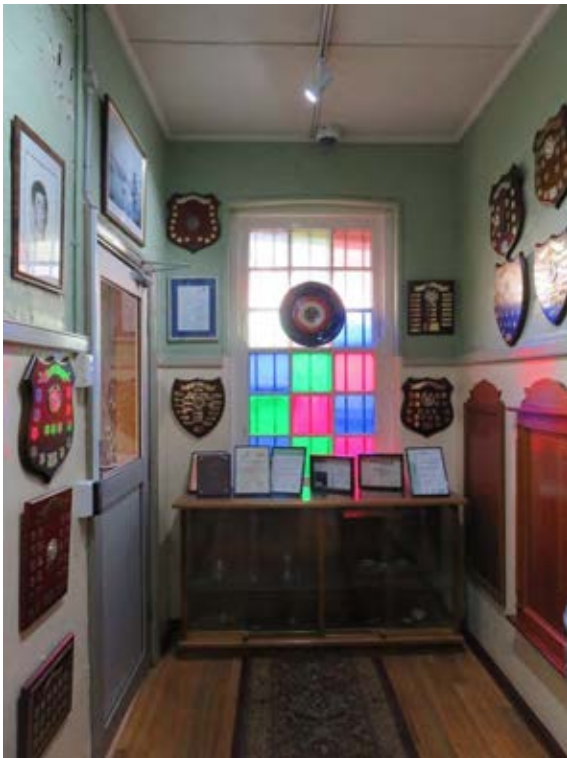
**Figure 3.21** The entrance hall in the 1890s addition with an original double hung window with coloured glass.

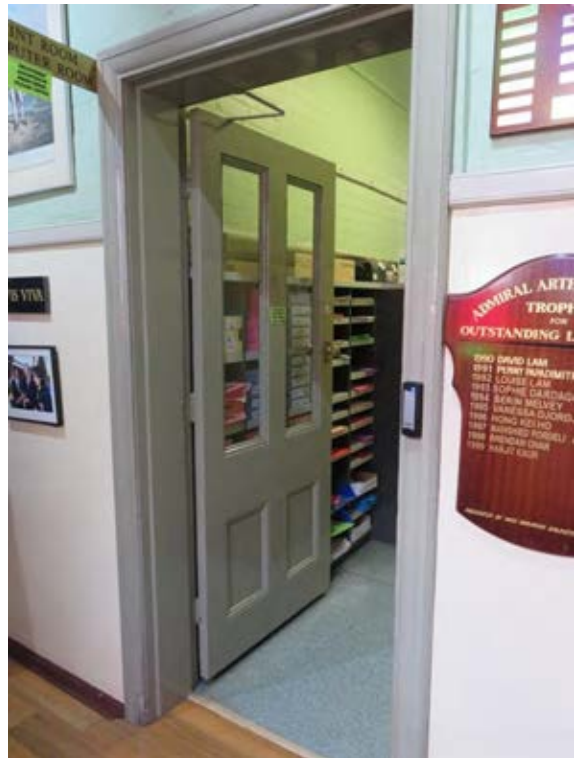
**Figure 3.22** The original panel door to school room in the 1890s addition with the upper panels replaced in glass.

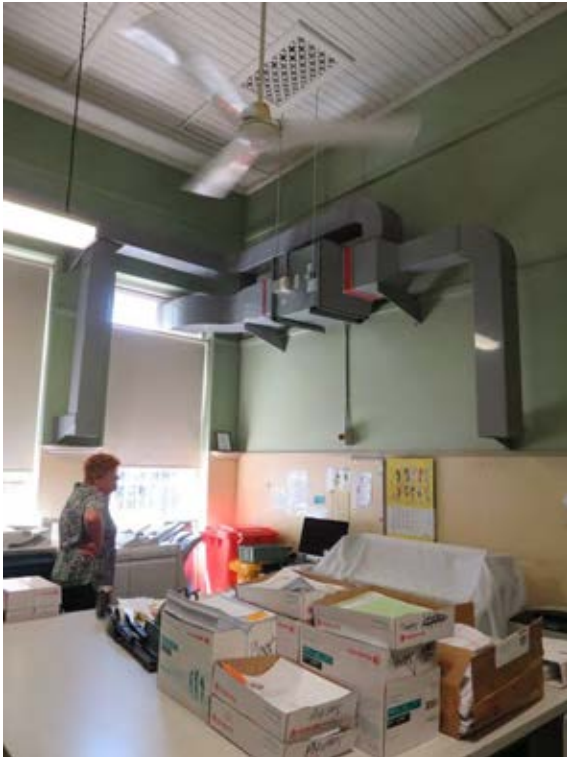
**Figure 3.23** The northern school room in the 1890s addition with air conditioning ductwork mounted on the late twentieth century partition wall dividing school room into two spaces.

The walls are generally painted brickwork, with a rendered dado and timber dado rail in the original building (except the office) and the hallway of the 1890s building. The walls in the larger central room of the original building, however, have cement render to approximately three metres (dating from the late twentieth century). In the 1890s wing, the principal rooms have rendered dados with a moulded timber shelf in place of the dado rail. A lightweight partition wall has been erected to divide the northern room of the 1890s wing into two. Metal air conditioning ducts are intrusive to these spaces.

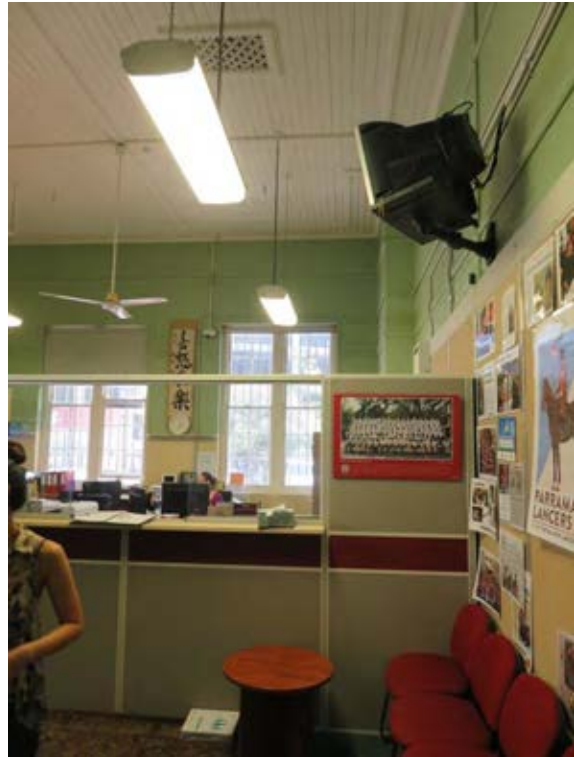
**Figure 3.24** The southern school room in the 1890s addition (now office) showing the chimney breast in the northwest corner.

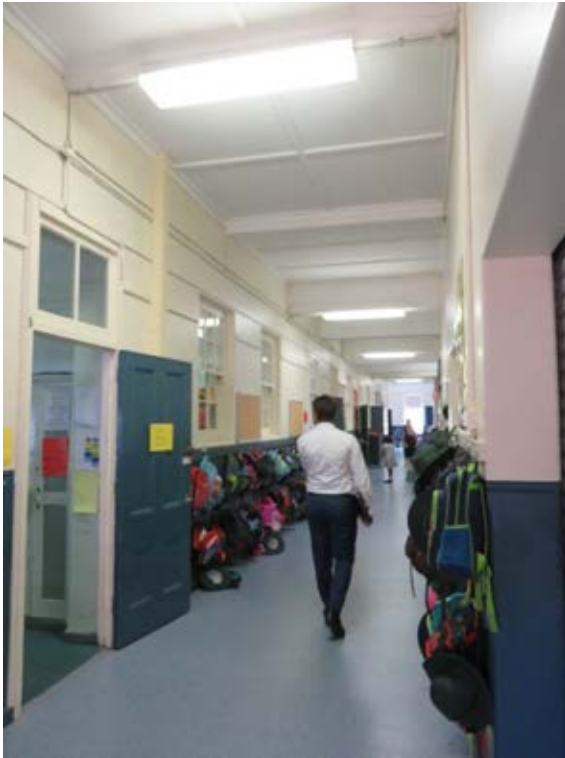
**Figure 3.39** The ground floor corridor looking west, showing windows and doors to the southern classrooms and exposed beams supporting the floor above.

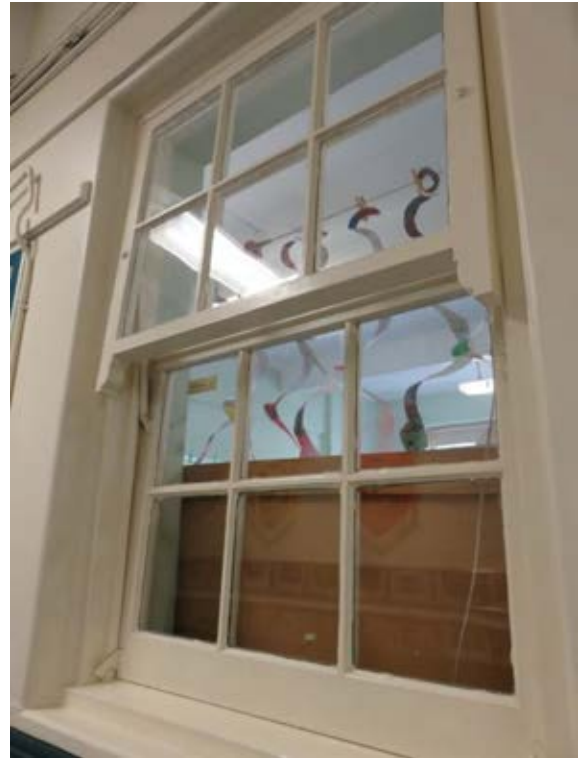
**Figure 3.40** Typical window to the corridor showing the original brackets.

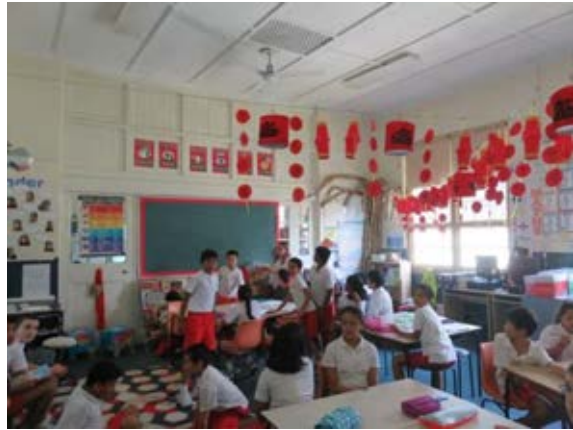
**Figure 3.42** The southern classroom on the first floor showing folding doors, boarded joinery in the opening between classrooms and rectangular ventilation panels in the ceiling.

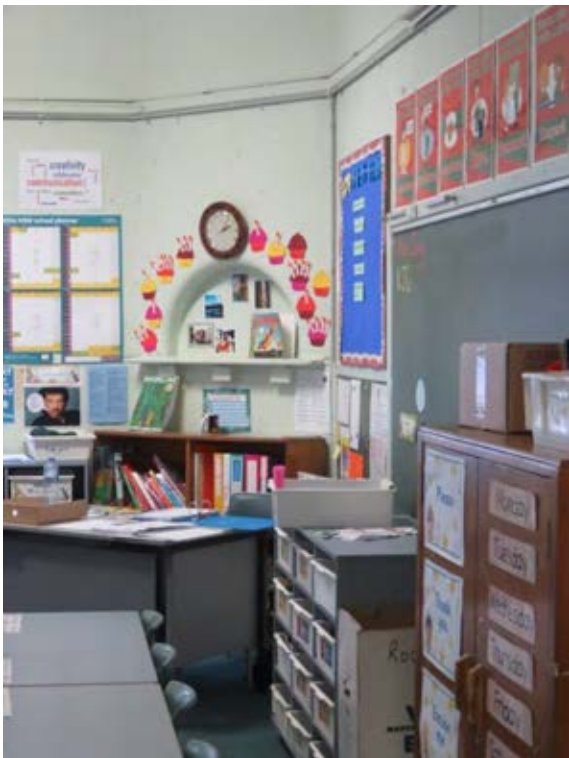
**Figure 3.43** The original corner fireplace with crobelled mantel shelf and recessed overmantel.

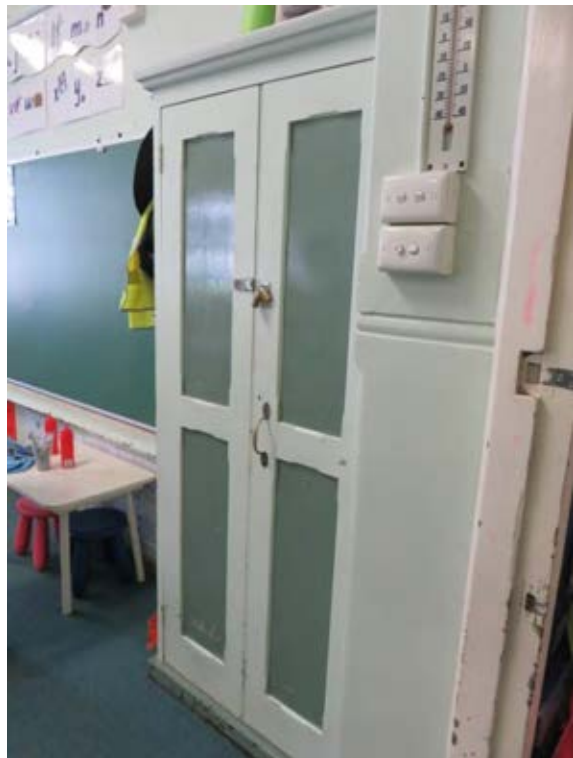
**Figure 3.44** An early cupboard in the classroom. Note the moulded dado line run in the wall render.

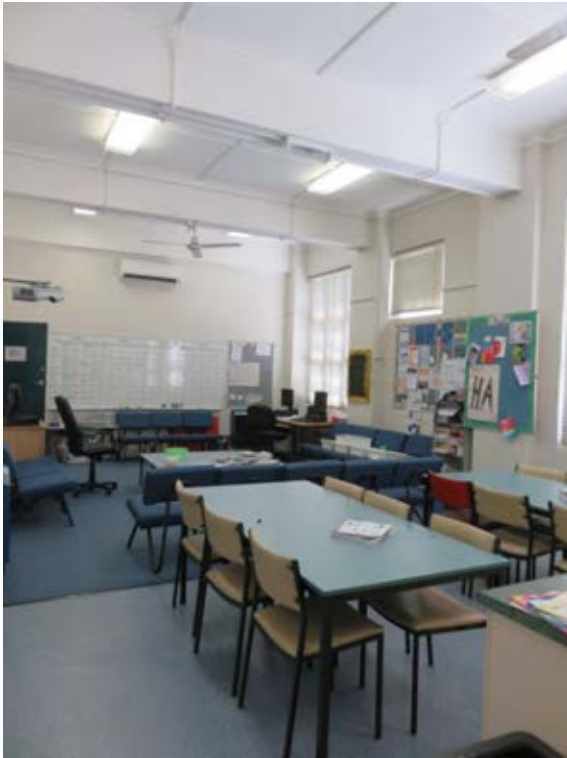
**Figure 3.45** The northern space on the ground floor showing deep beams supporting the floor above.

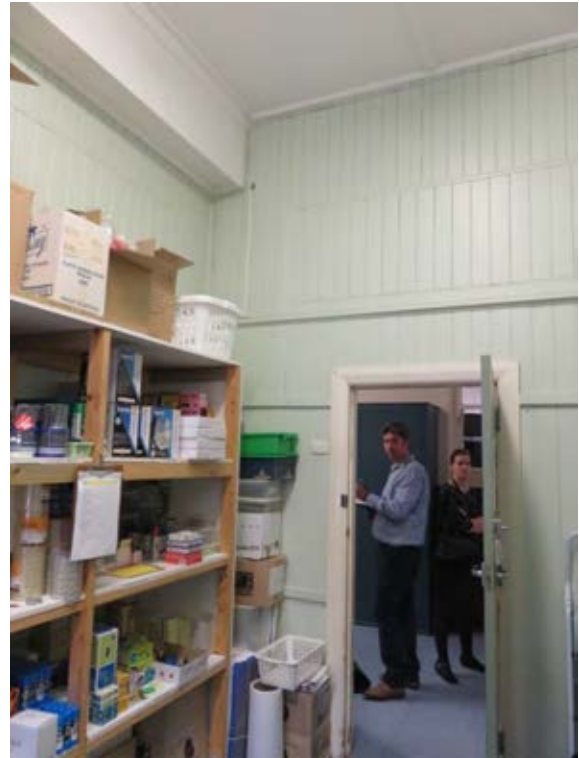
**Figure 3.46** An early vertical boarded partition showing high level openings boarded up.

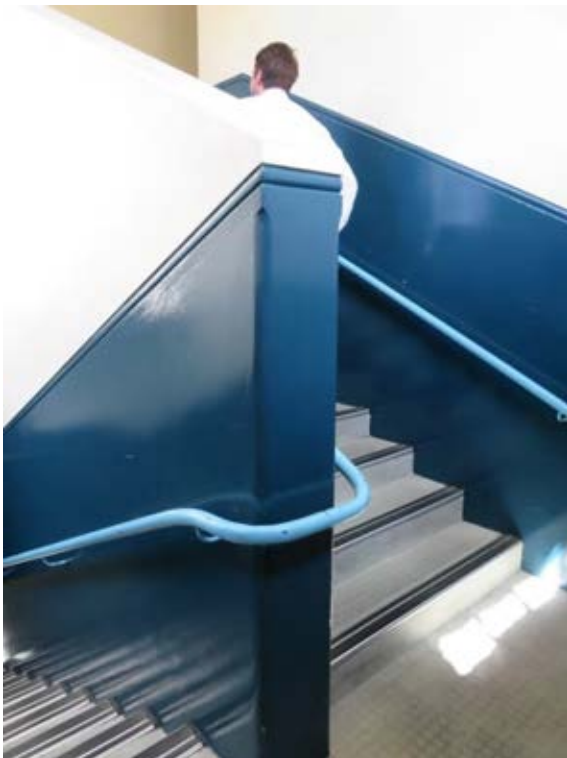
**Figure 3.47** A concrete stair with a run dado in the wall.

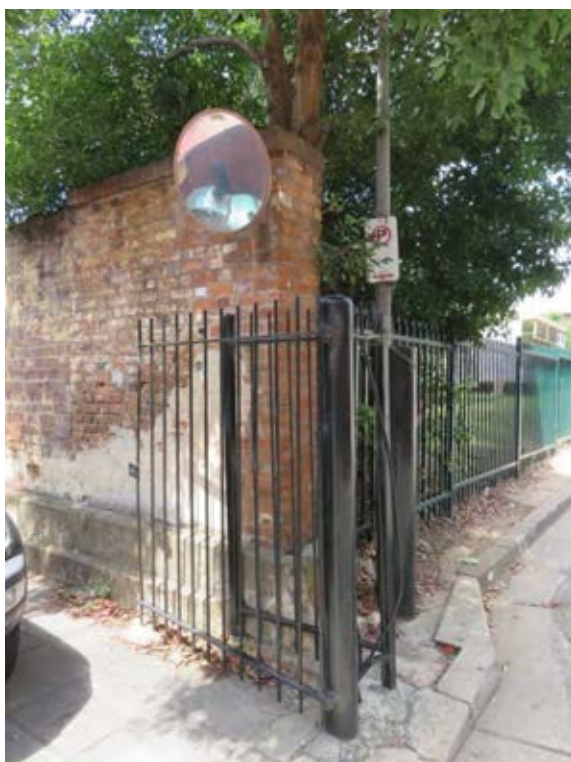
**Figure 3.61** The western end of the convict barracks wall showing a section of early sandstock brickwork. A concrete kerb has been built along the side of the sandstone plinth. A new brick capping has been added to the wall.

The current wall is of variable height, up to about three metres maximum at its western end, with sections of brickwork reduced, replaced and/or repaired using cement mortar. The sandstone blocks appear to survive for the whole length of the wall, although some have been dislodged. A concrete kerb has been built against the stone on the northern side at the western end of the wall. The portion of brickwork adjacent to Barrack Lane (approximately two metres in length) is early, although partially rebuilt. A contrasting brick capping has been added to the top of the wall.

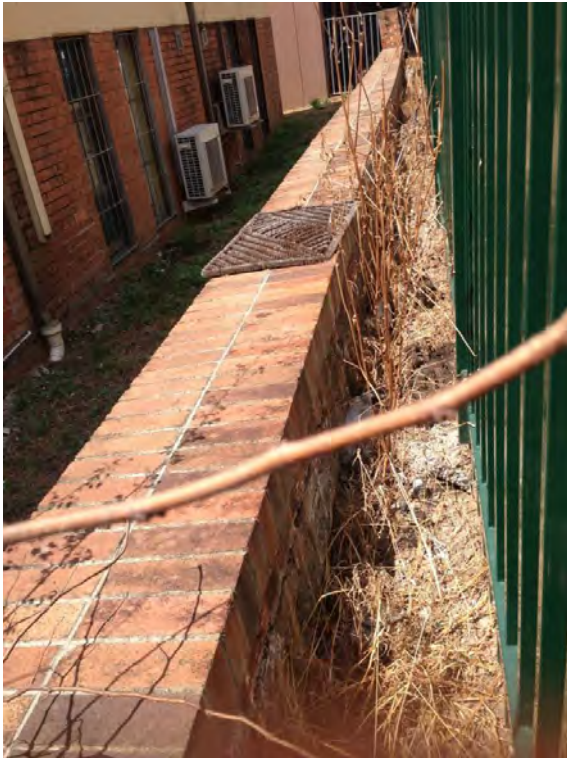
**Figure 3.63** A low section of the convict barracks wall the showing brick capping to the sandstone base.

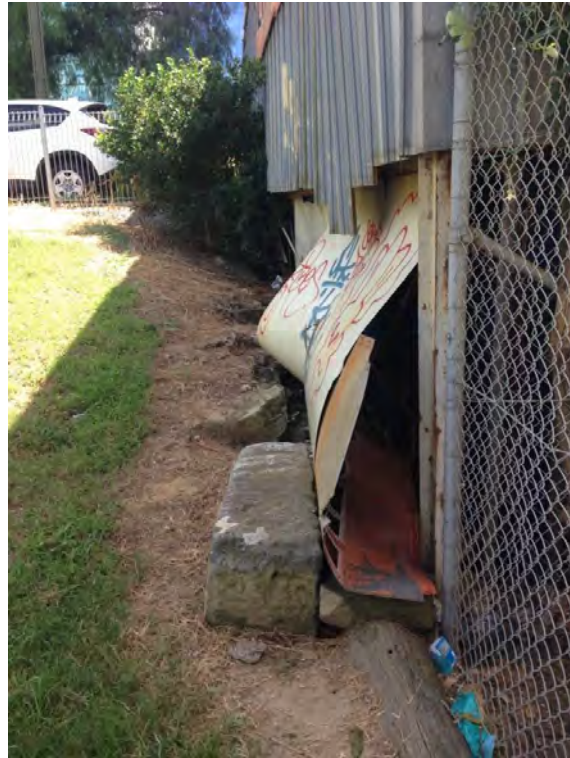
**Figure 3.64** Loose sandstone blocks at the eastern end of the convict barracks wall.
