**Report Type:** Detailed Site Investigation

**Site Address:** Arthur Phillip High School and Parramatta Public School

**Report Number:** 1915/ER-1-1

RE: DETAILED SITE INVESTIGATION – ARTHUR PHILLIP HIGH SCHOOL & PARRAMATTA PUBLIC SCHOOL

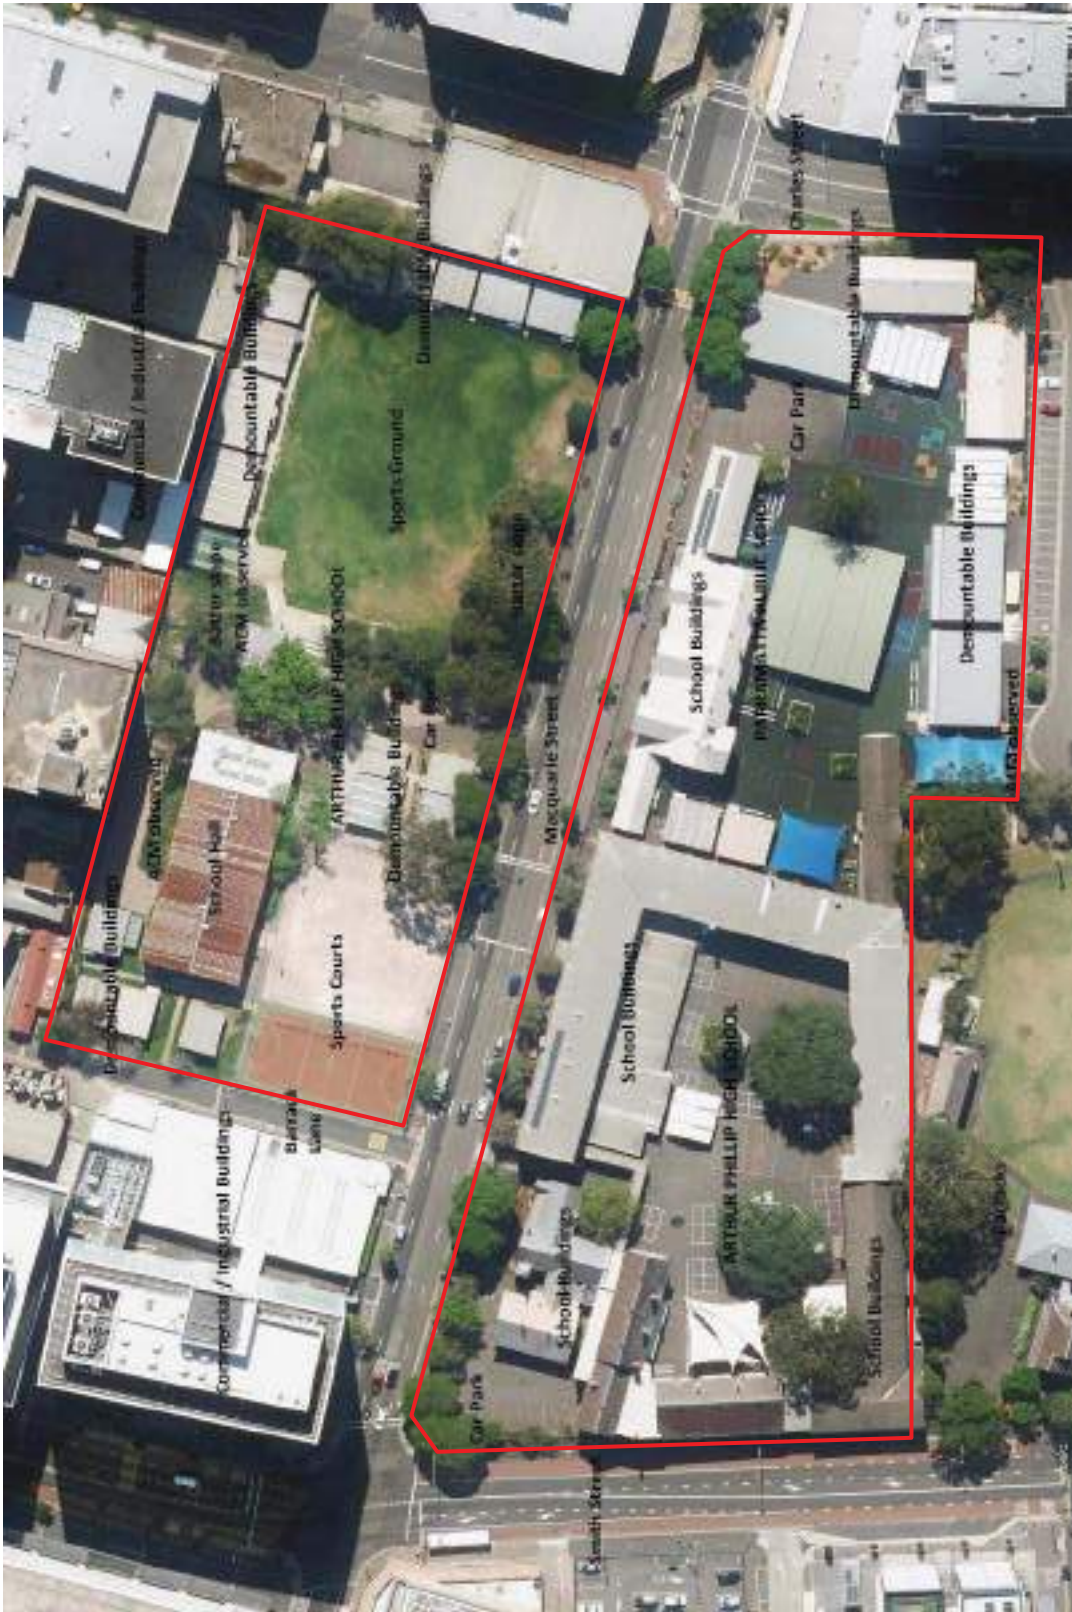
Suspected asbestos containing material (ACM) fragments were observed in the following areas (refer to **Figure 2**):

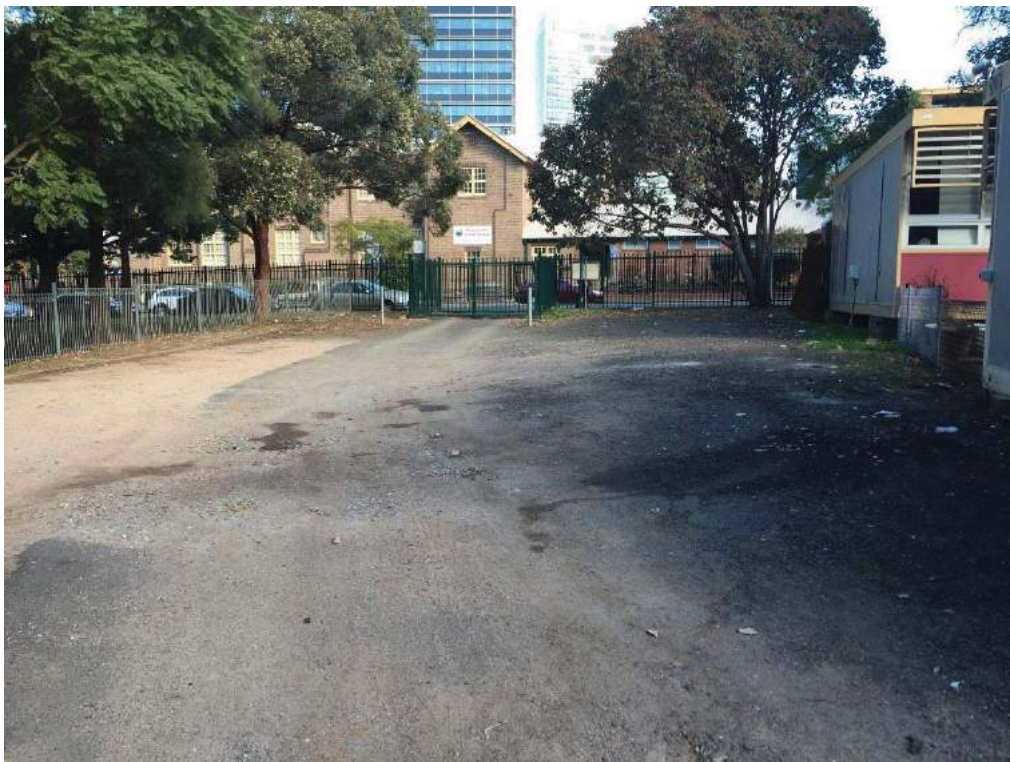
**Photograph 1:** Driveway and car park of northern portion of the site, looking south. Location of boreholes BH4, BH5 and BH6.

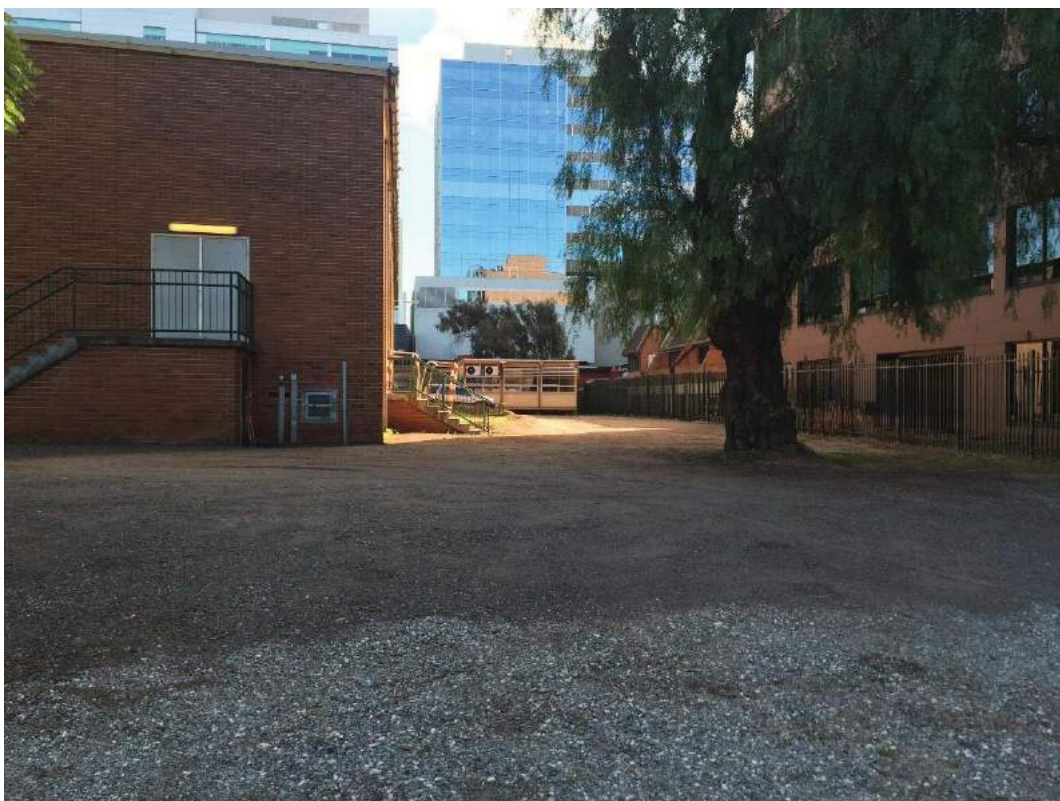
**Photograph 3:** Northern side of school hall and location of samples BH9, HA9 and BH10, looking west.

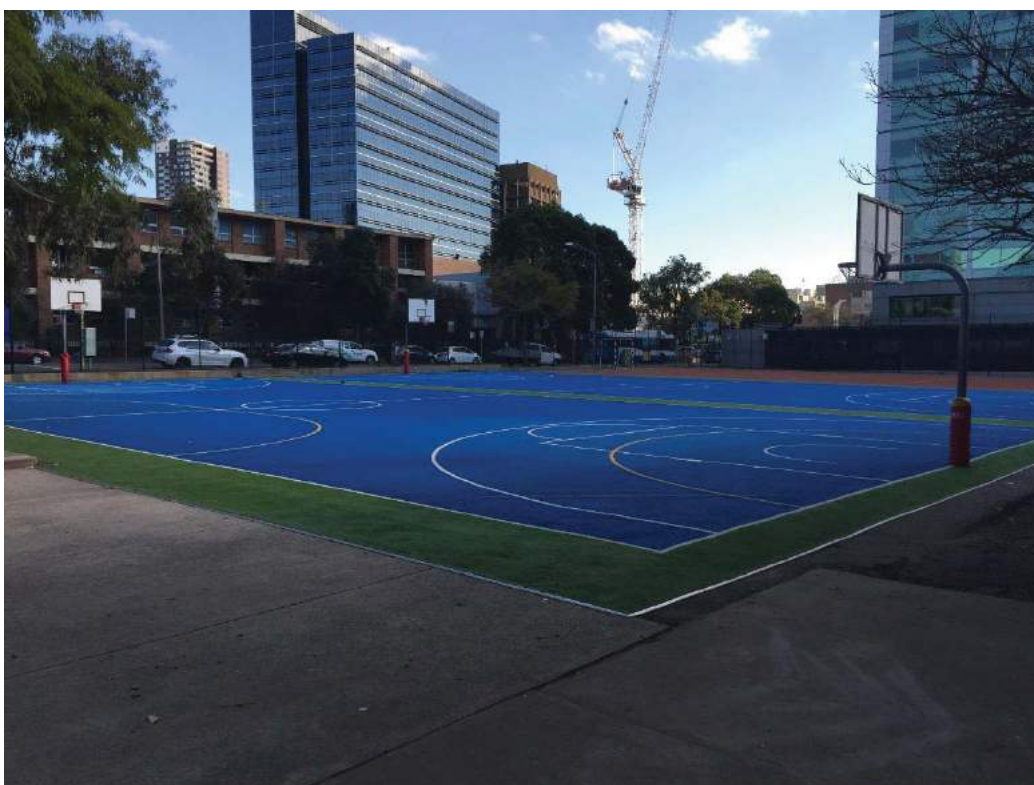
**Photograph 4:** Sports Courts at Arthur Phillip High School, looking south-west. Inaccessible area for borehole drilling.

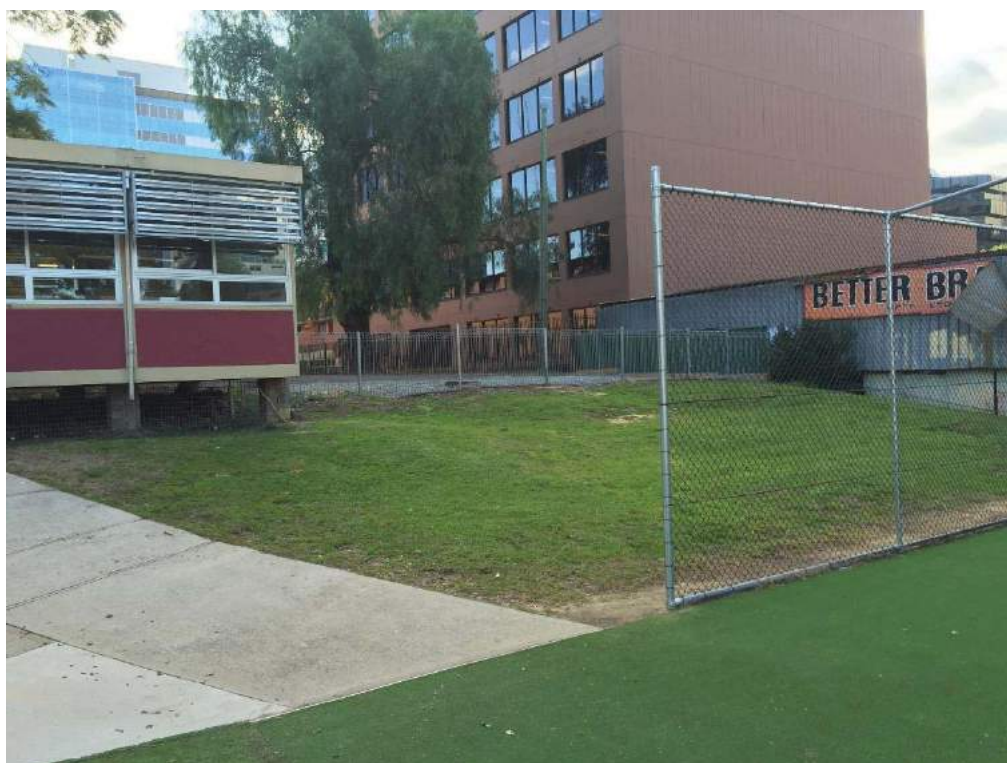
In addition, ACM fragments were observed on the surface in the locations of samples BH7, HA9 and HA16. No asbestos was identified in any of the other soil samples analysed for asbestos.

**Photograph 5:** Area to the west of the sports ground, looking west. Location of borehole BH7.

The ACM observed at these locations was removed to the laboratory during this site assessment. It is anticipated that all asbestos will be appropriately managed or removed during site remediation earthworks in accordance with a pre-approved RAP and AMP.

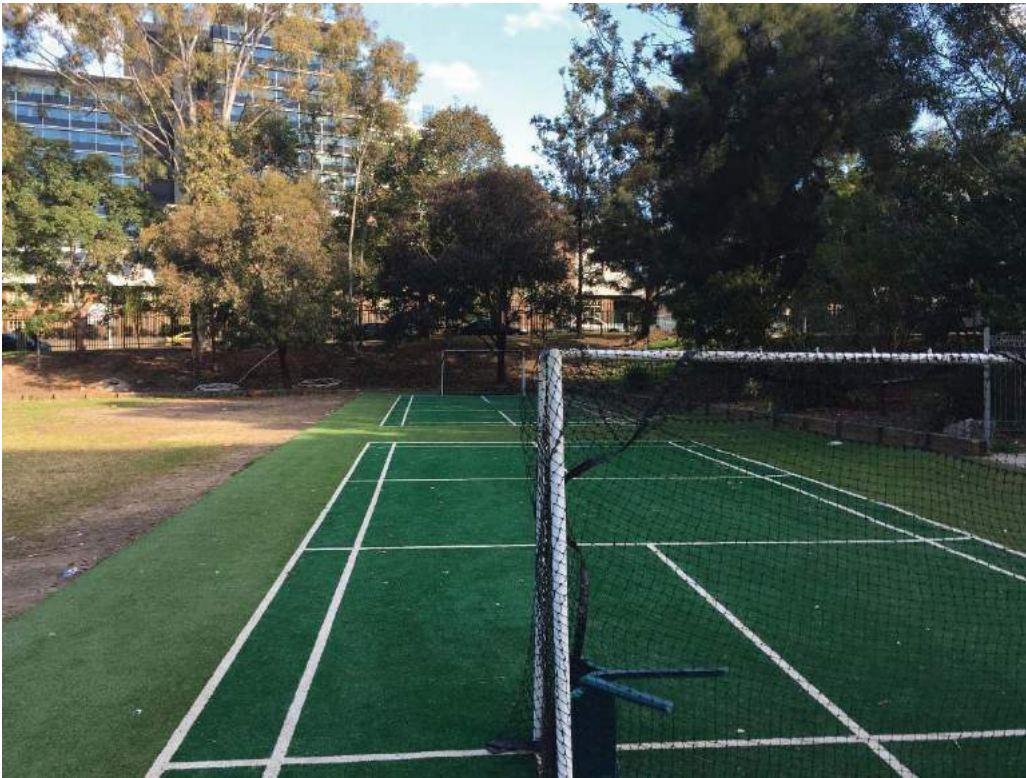
**Photograph 7:** Sports ground with batter / slopes in the background, looking south.

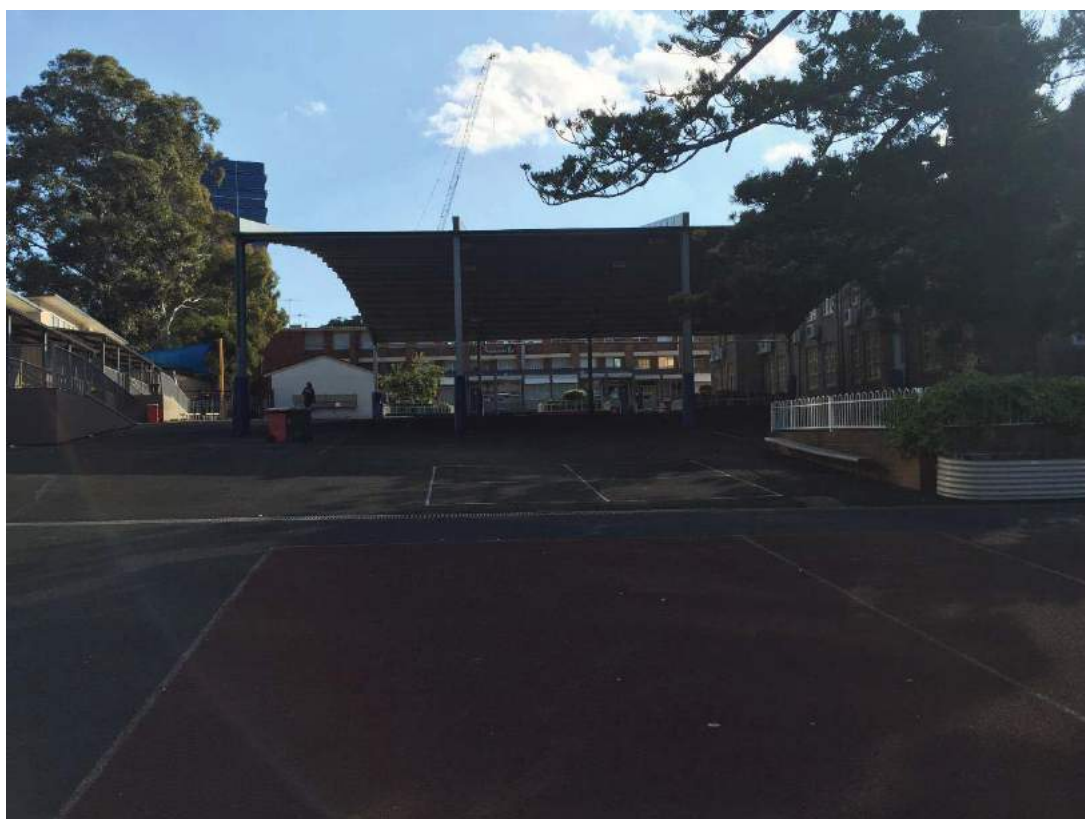
**Photograph 11:** Parramatta Public School playground with soft bitumen on surface, looking west.

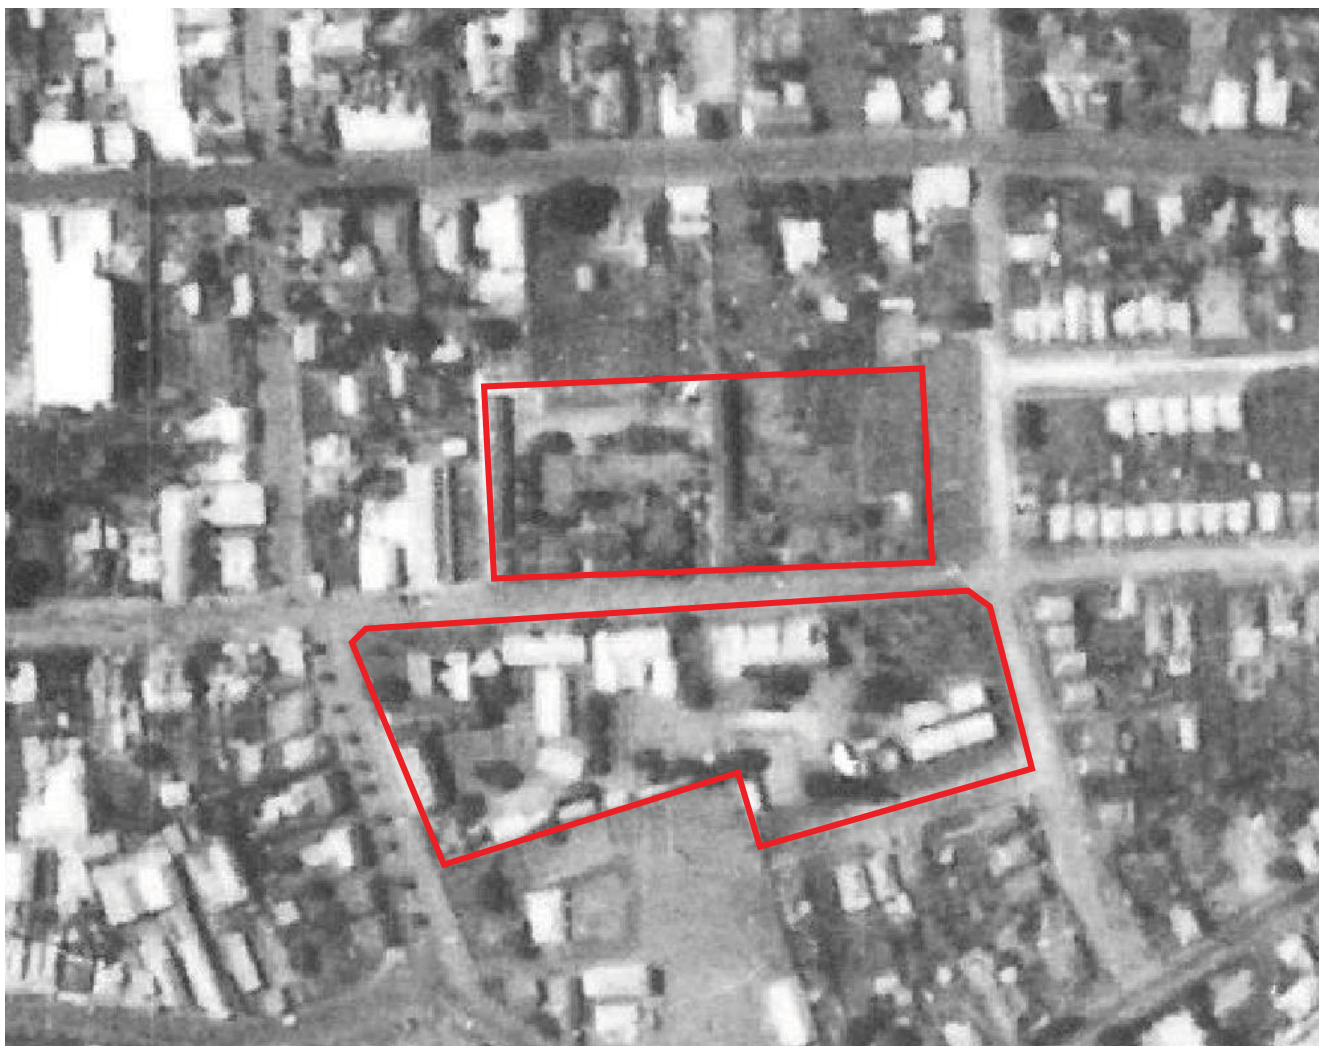
1930

- 1930:** In the northern portion of the site, three large buildings, including two long, narrow buildings were observed. The long narrow buildings were consistent with the size and layout of barracks. The area to the east of the buildings appeared to be an unsealed, vacant area.

In the southern portion of the site, approximately eleven buildings were observed. All observed buildings were consistent with the size, age and layout of the present day site layout with the exception of a number of small buildings on the southern boundary and in the south-eastern corner of the site. The remainder of the site area appeared to comprise unsealed areas with a number of trees.

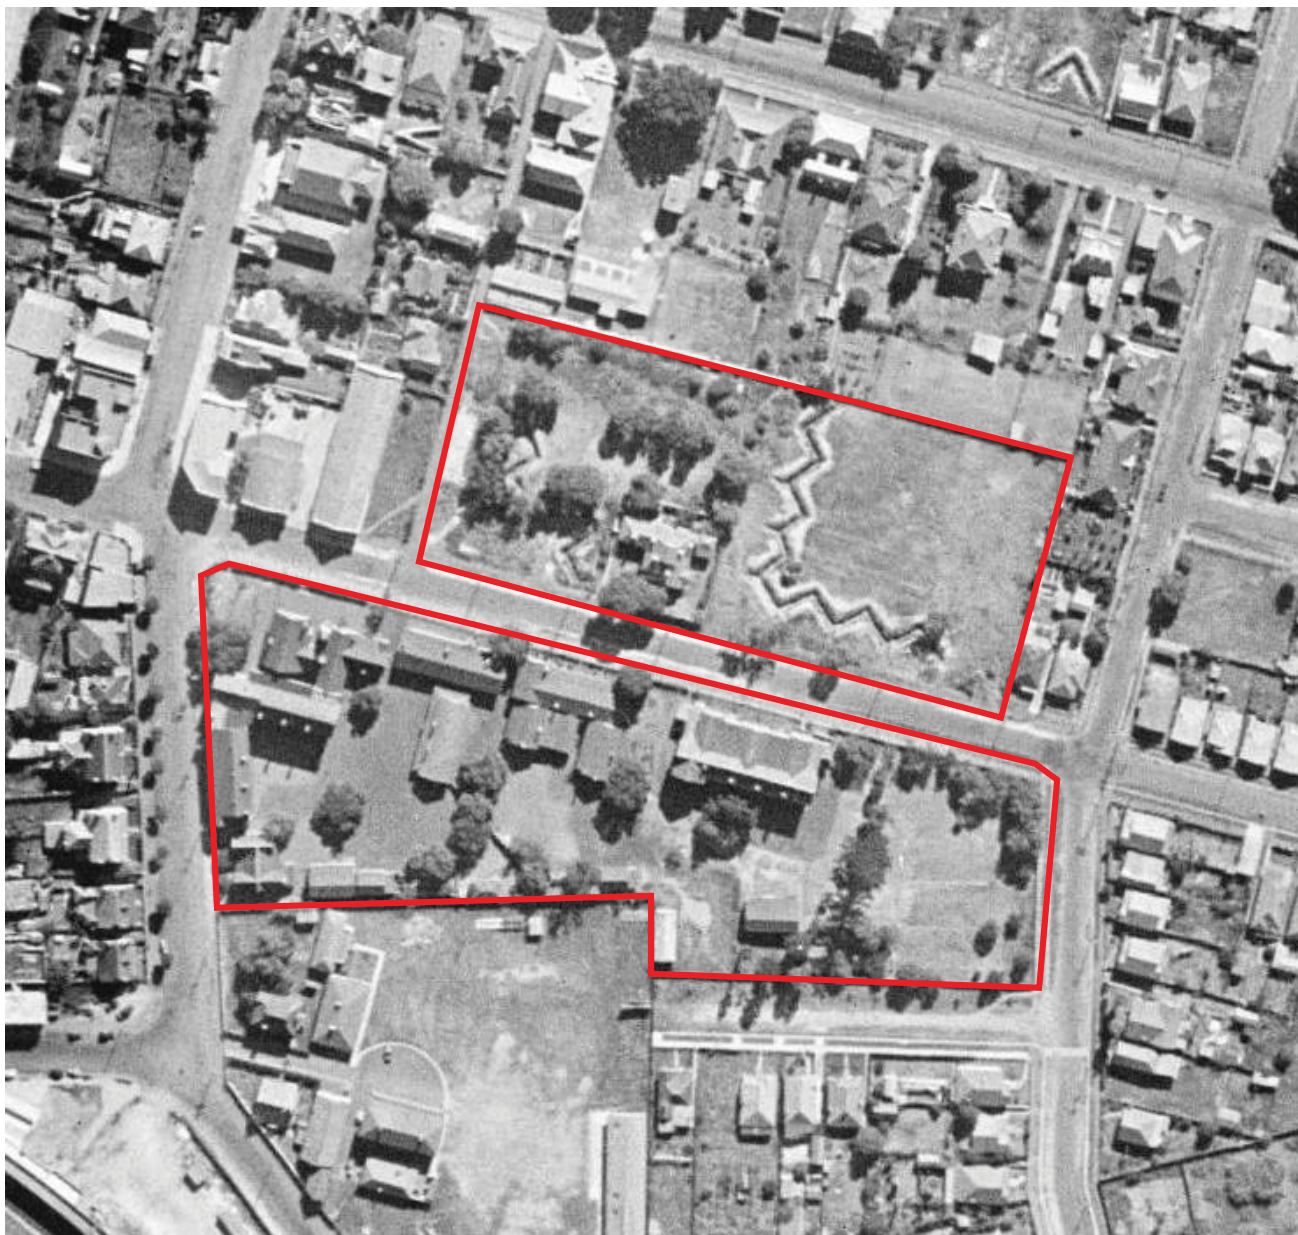
1943

The areas to the north and east appeared to comprise residential dwellings. The areas to the south and west appeared to comprise commercial with minor residential land use.
- 1943:** In the northern portion of the site, all site buildings appeared to have been removed with the exception of a large dwelling or small commercial/industrial building on the southern boundary. A small building had been constructed on the western boundary. In the cleared areas of the site vegetation and grassed vacant areas were observed. 'Zig zag trenches' were observed in the cleared areas of the site, suspected to have been constructed due to World War II.
