GEOTECHNICAL INVESTIGATION & ACID SULFATE SOIL (ASS) ASSESSMENT

HOMES NSW

776, 792 – 794 Botany Road & 33 – 37 Henry Kendall Crescent, Mascot (BGWHL)

Report No: 24/0856A

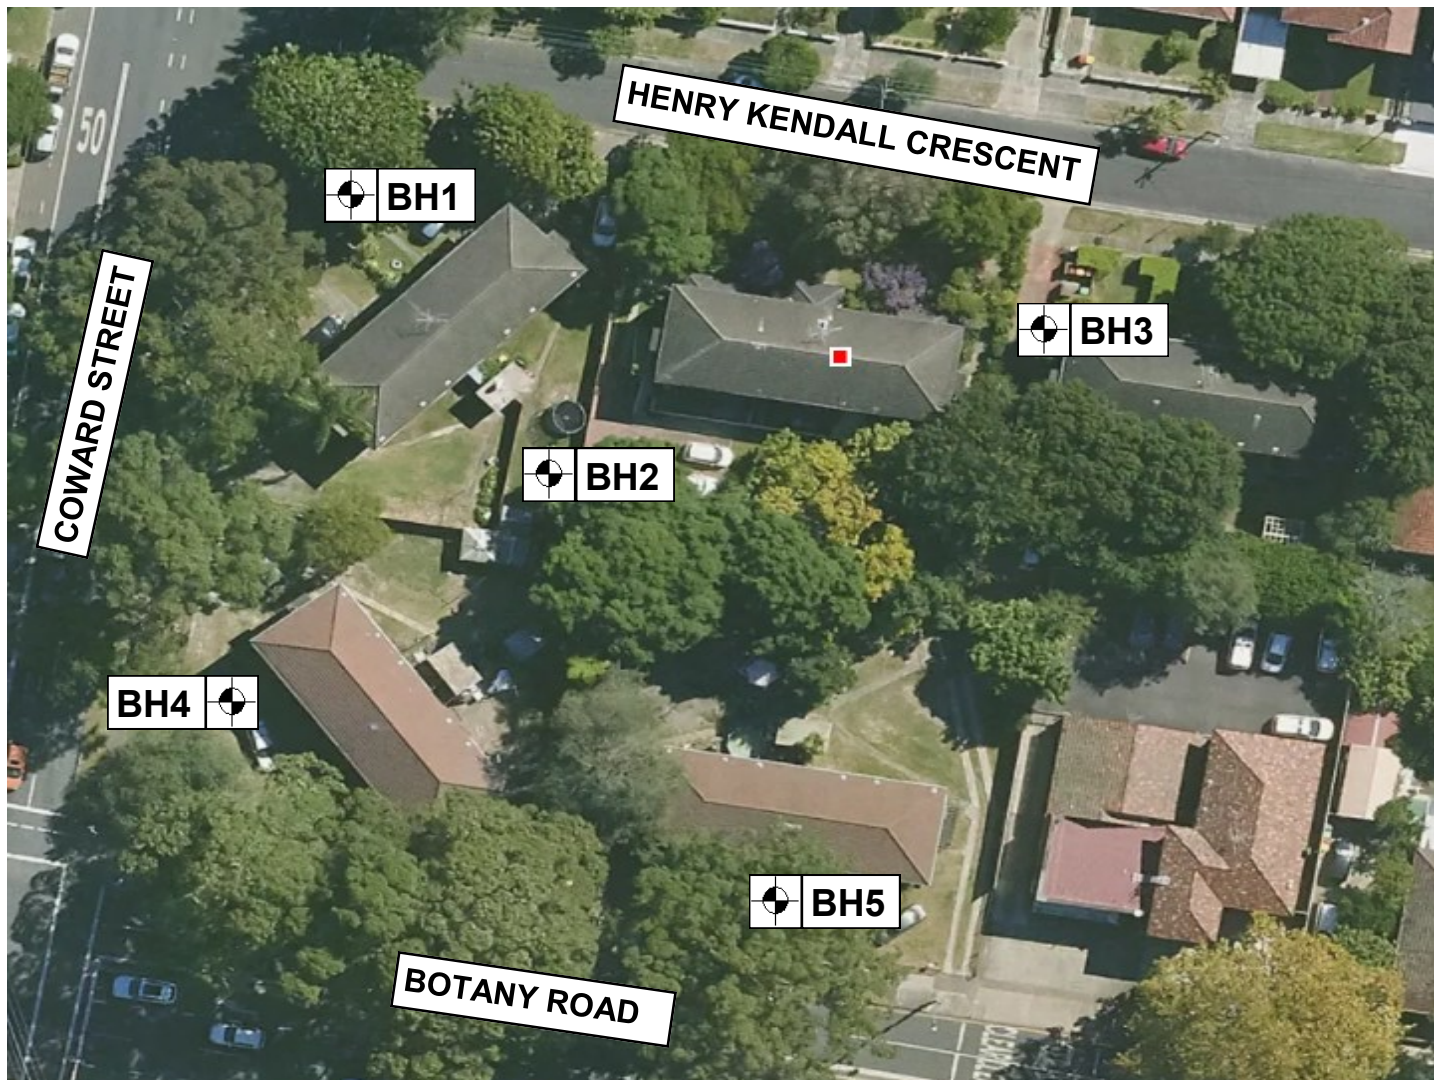
DRAWING NO. 24/0856 – BOREHOLE AND PENETROMETER LOCATIONS

Latitude (WGA84)	Longitude (WGA84)	Approximate Surface RL (m)
BH1	33.925271 347 S ^o	151.194771 732 E ^o	8.022
BH2	33.925104 803 S ^o	151.195018 428 E ^o	8.200
BH3	33.924806 412 S ^o	151.194890 642 E ^o	8.205
BH4	33.925353 044 S ^o	151.195235 940 E ^o	8.385
BH5	33.924973 511 S ^o	151.195465 3313 E ^o	8.283

Base map taken from MetroMaps. Groundwater monitoring wells installed in BH1 and BH5

The proposed development comprises demolition of existing buildings and construction of a residential flat building ranging in height between three and eight storeys to accommodate 126 social and affordable housing apartments, a communal room and on grade car parking including tree removal, associated landscaping and public domain works. A site plan is attached, drawing no. 24/0856.

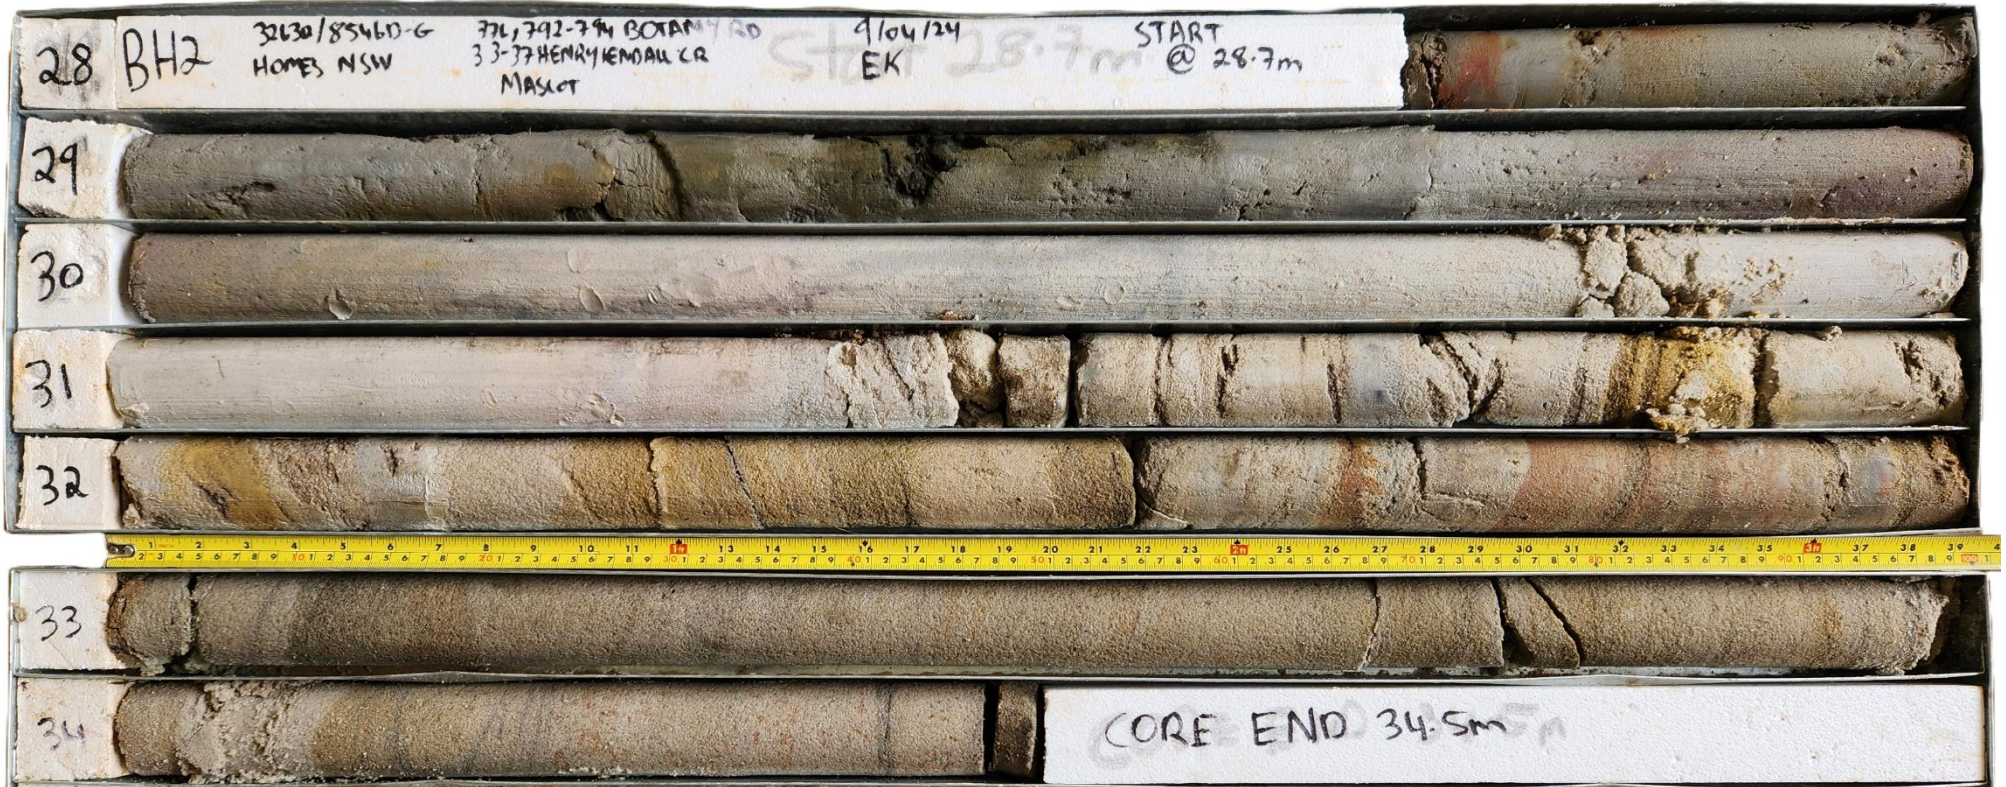
CORE PHOTOGRAPH OF BOREHOLE: BH2

Job No.	32630/8546D-G	East	33.925104803 S°	Contractor	Terratest
Location	776, 792 – 794 Botany Road, 33 – 37 Henry Kendall Crescent, Mascot	North	151.195018428 E°	Drill Rig	Commachio Geo 305
Client	Homes NSW	Surface RL	8.200 m	Logger	MT/EK
				Date	09/04/2024

The subsurface conditions observed are recorded on the borehole logs given in Appendix A together with photographs of the recovered rock core. An explanation of the terms used on the logs is also given in Appendix A. Notes relating to geotechnical reports are also given in Appendix A.

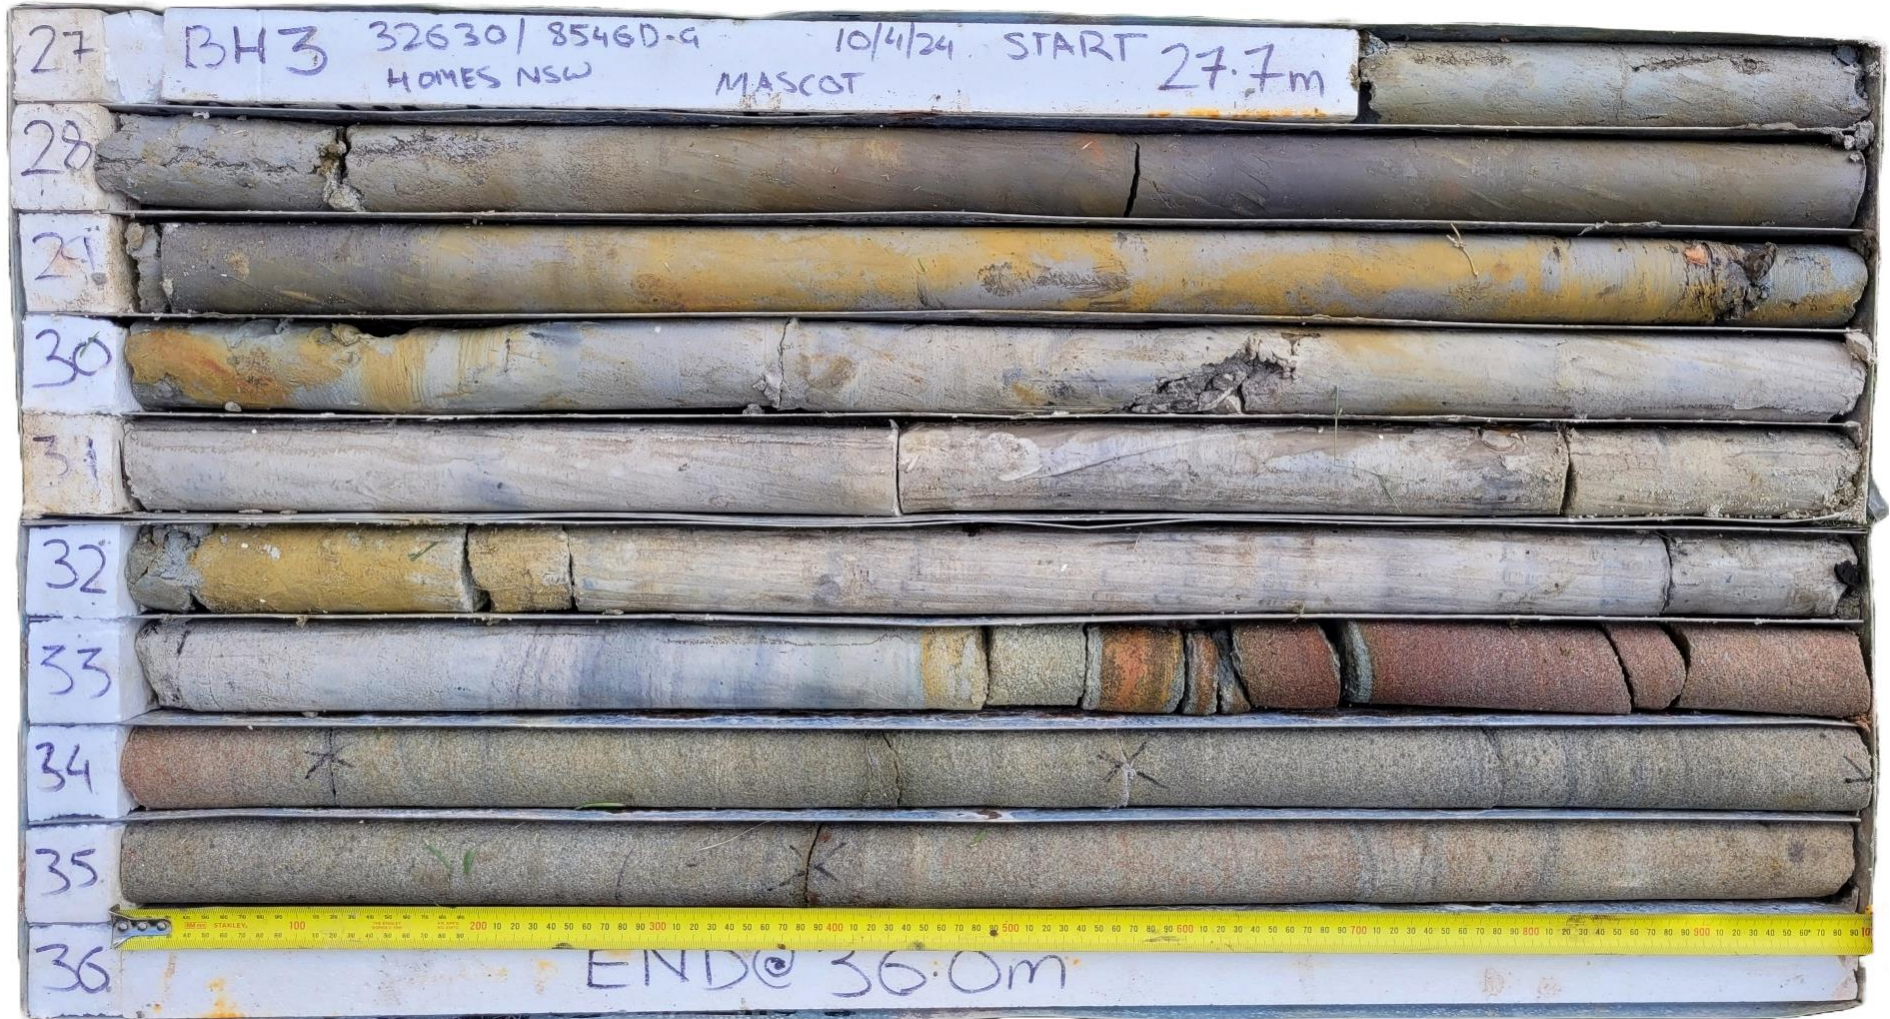
CORE PHOTOGRAPH OF BOREHOLE: BH3

Job No.	32630/8546D-G	Latitude	33.924806412 S°	Contractor	Terratest
Location	776, 792 – 794 Botany Road, 33 – 37 Henry Kendall Crescent, Mascot	Longitude	151.194890642 E°	Drill Rig	Commachio Geo 305
Client	Homes NSW	Surface RL	8.205 m	Logger	MT
				Date	10/04/2024

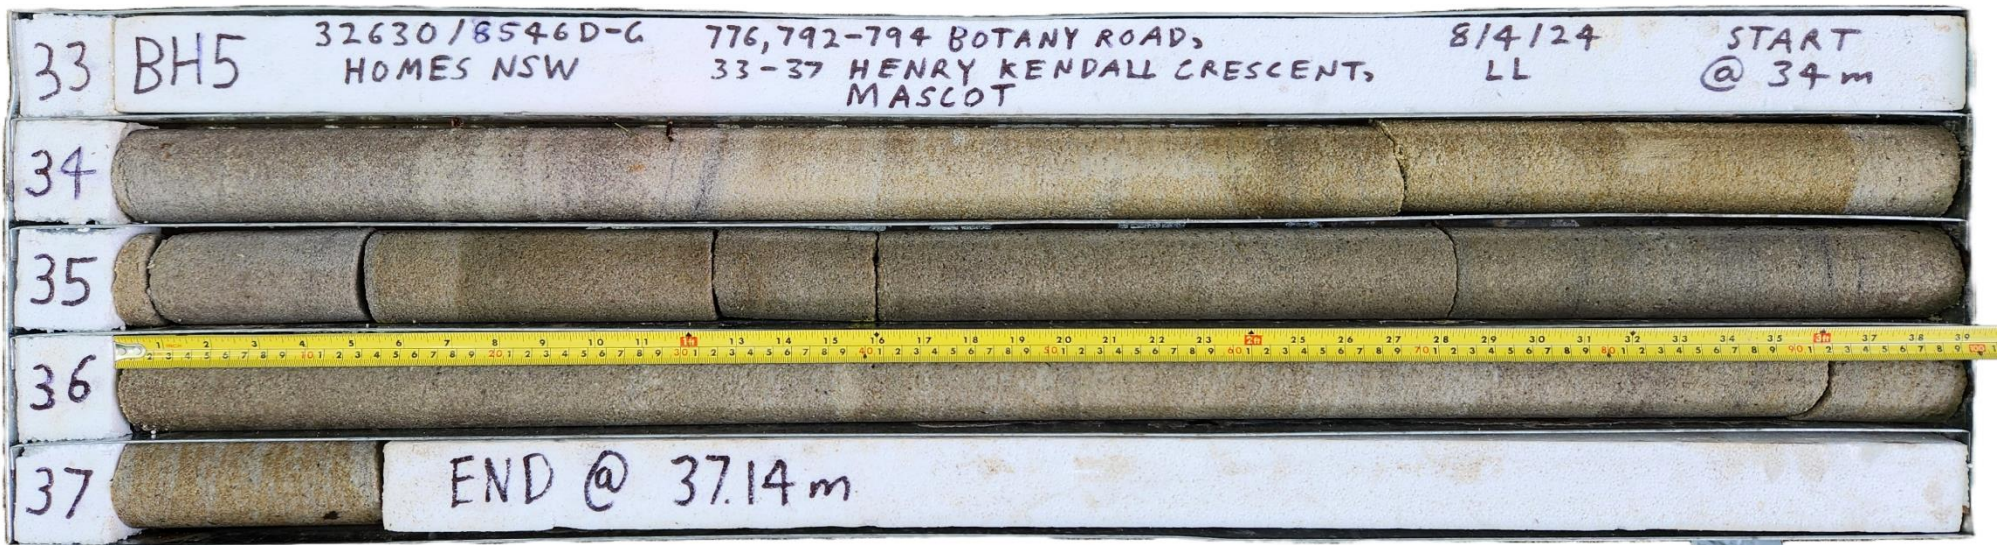
CORE PHOTOGRAPH OF BOREHOLE: BH5

Job No.	32630/8546D-G	East	33.924973511 S°	Contractor	Geosense Drilling Engineers		
Location	776, 792 – 794 Botany Road, 33 – 37 Henry Kendall Crescent, Mascot	North	151.1954653313 E°	Drill Rig	Commachio Geo 205		
Client	Homes NSW	Surface RL	8.283 m	Logger	LL	Date	07-08/04/2024

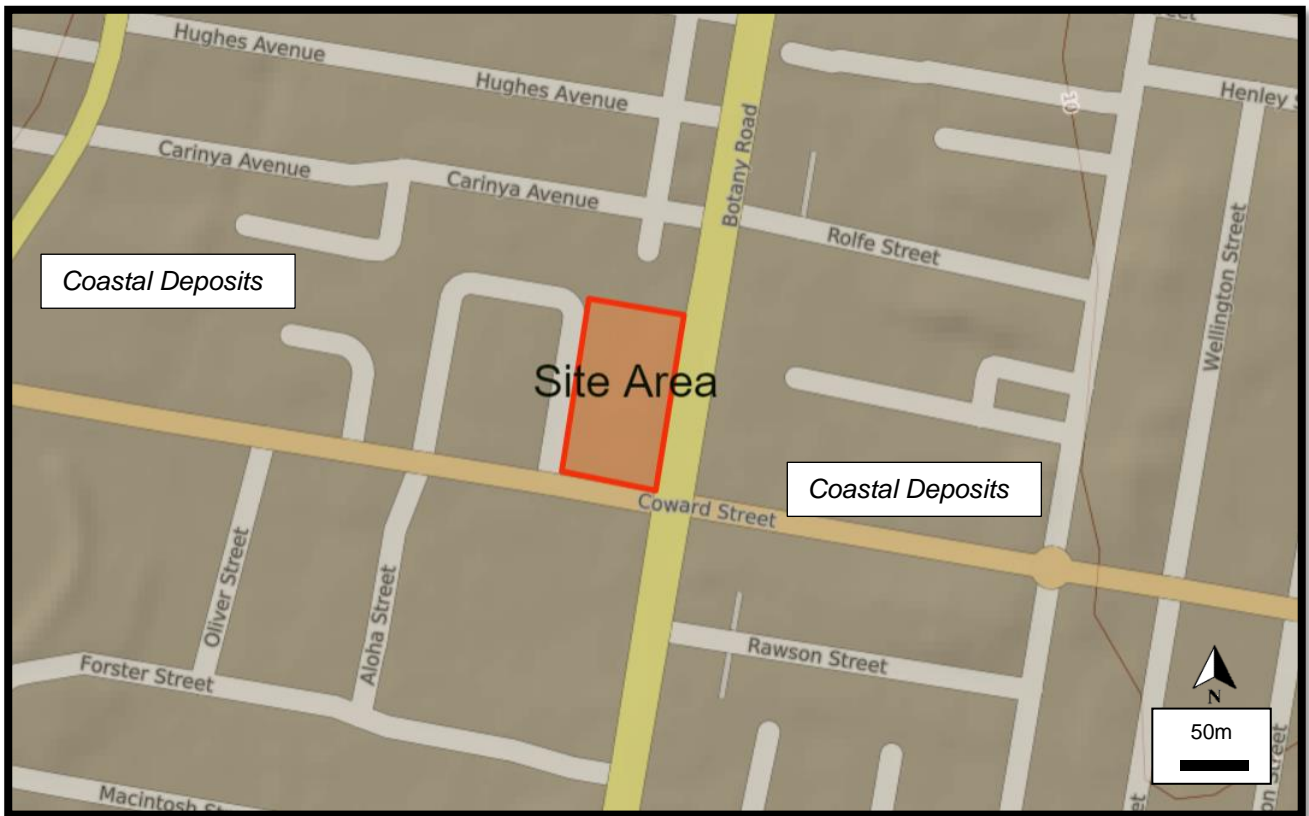
Figure 2 - Site Location with NSW Seamless Geology with 10m contours

The New South Wales Seamless Geology dataset, version 2.4 [Digital Dataset] published by the Geological Survey of New South Wales, indicates that the site is underlain by Coastal Deposits, which are Marine-deposited and aeolian-reworked coastal sand dunes.

The site overlaying NSW Seamless Geology with 10m contours map is presented in **Figure 2** below.

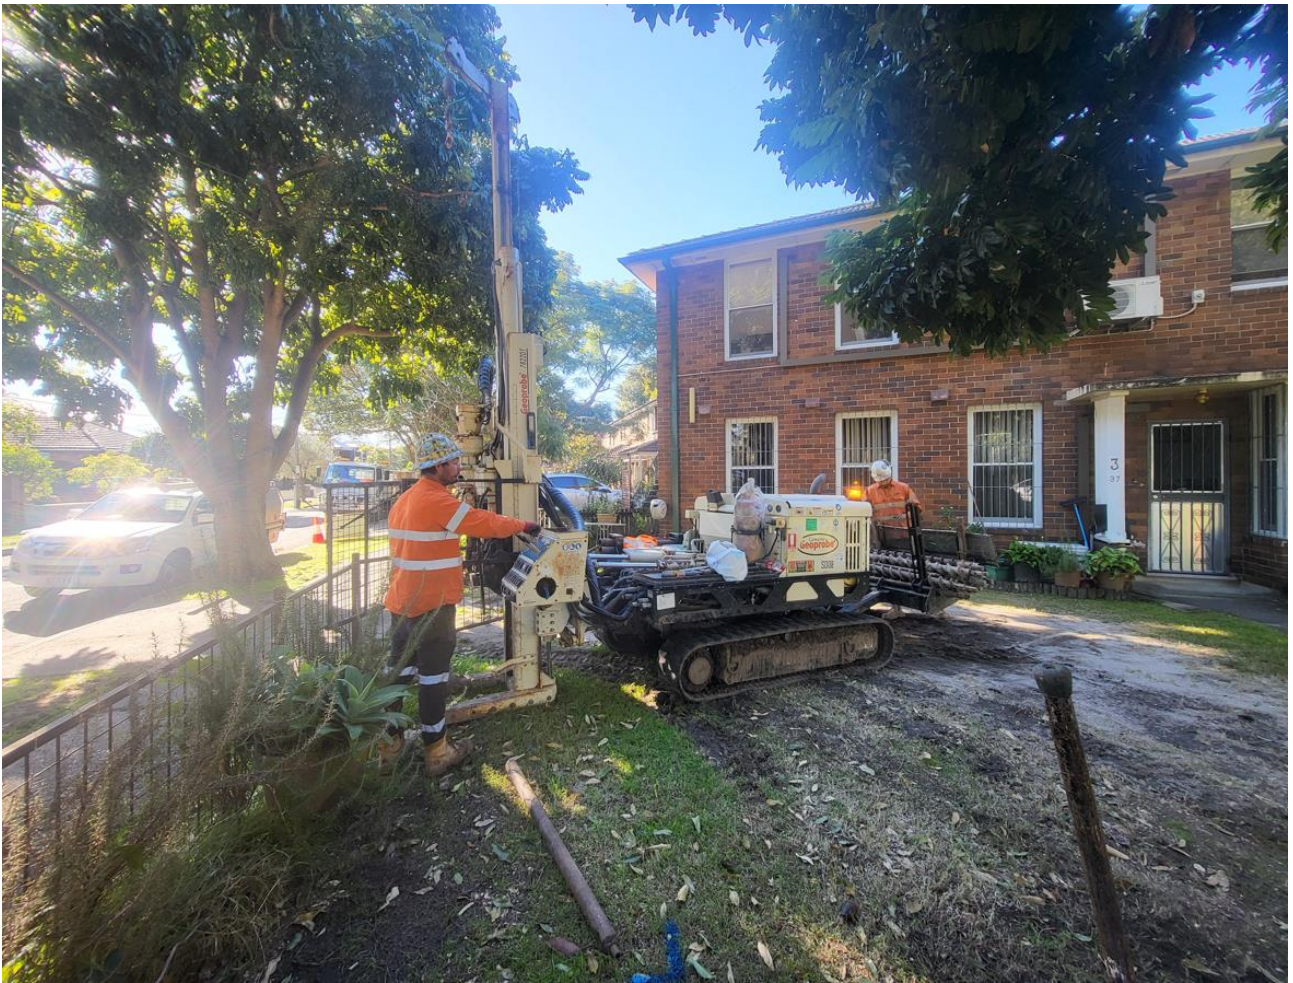
Photo 1 – Drilling set-up near CPT01

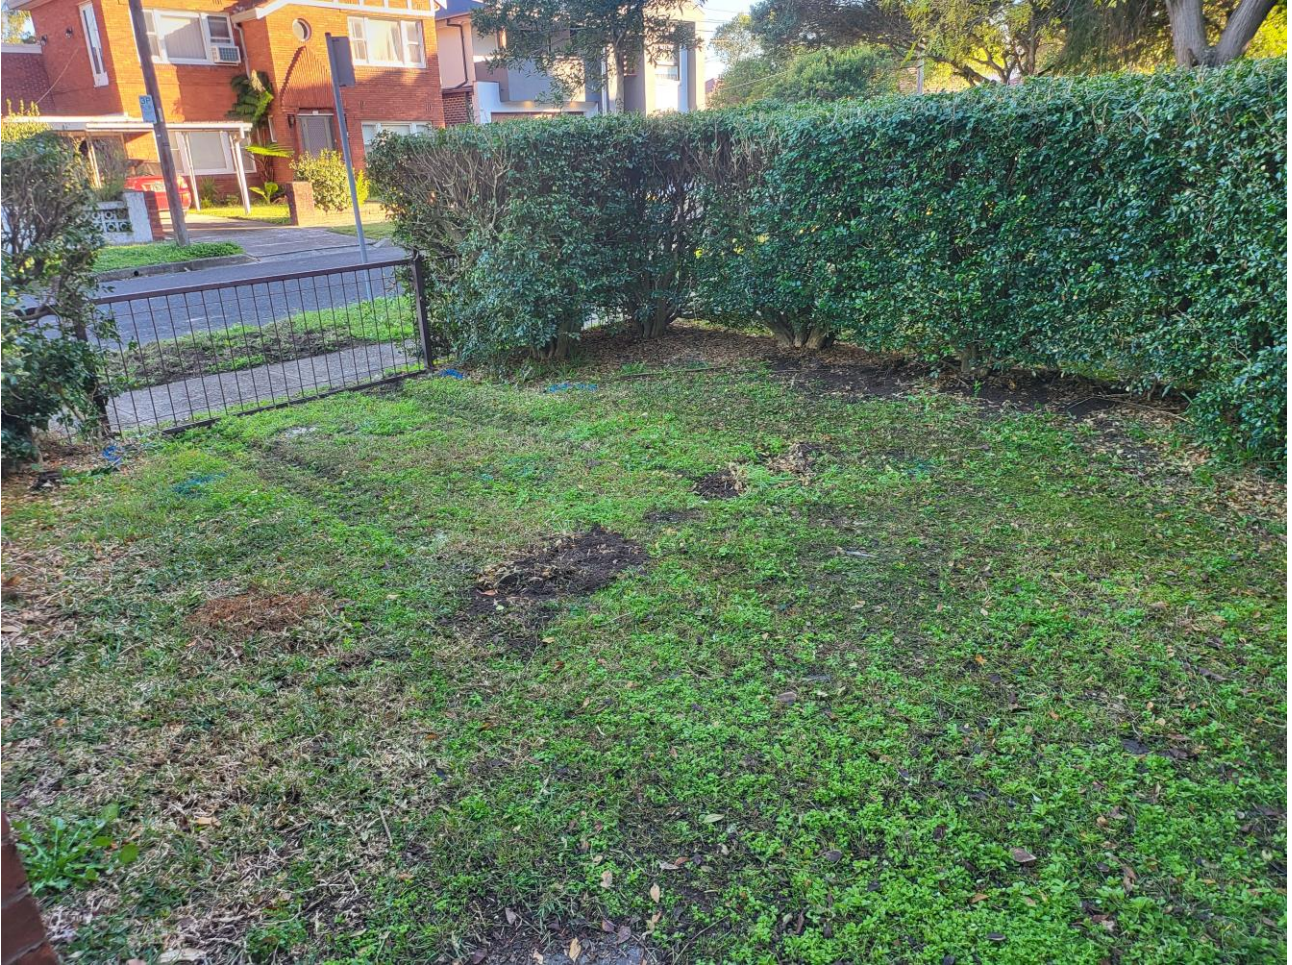
Photo 2 – CPT02 Location
