# Remedial Action Plan

**Project**  
**792-794 Botany Road and 33-37 Henry Kendall Crescent,**  
**Mascot, NSW**

**Prepared for**  
**New South Wales Land and Housing Corporation**  
**(ABN 24 960 729 253)**

**Report No**  
**17716.3-ER-1-2 Rev 1**

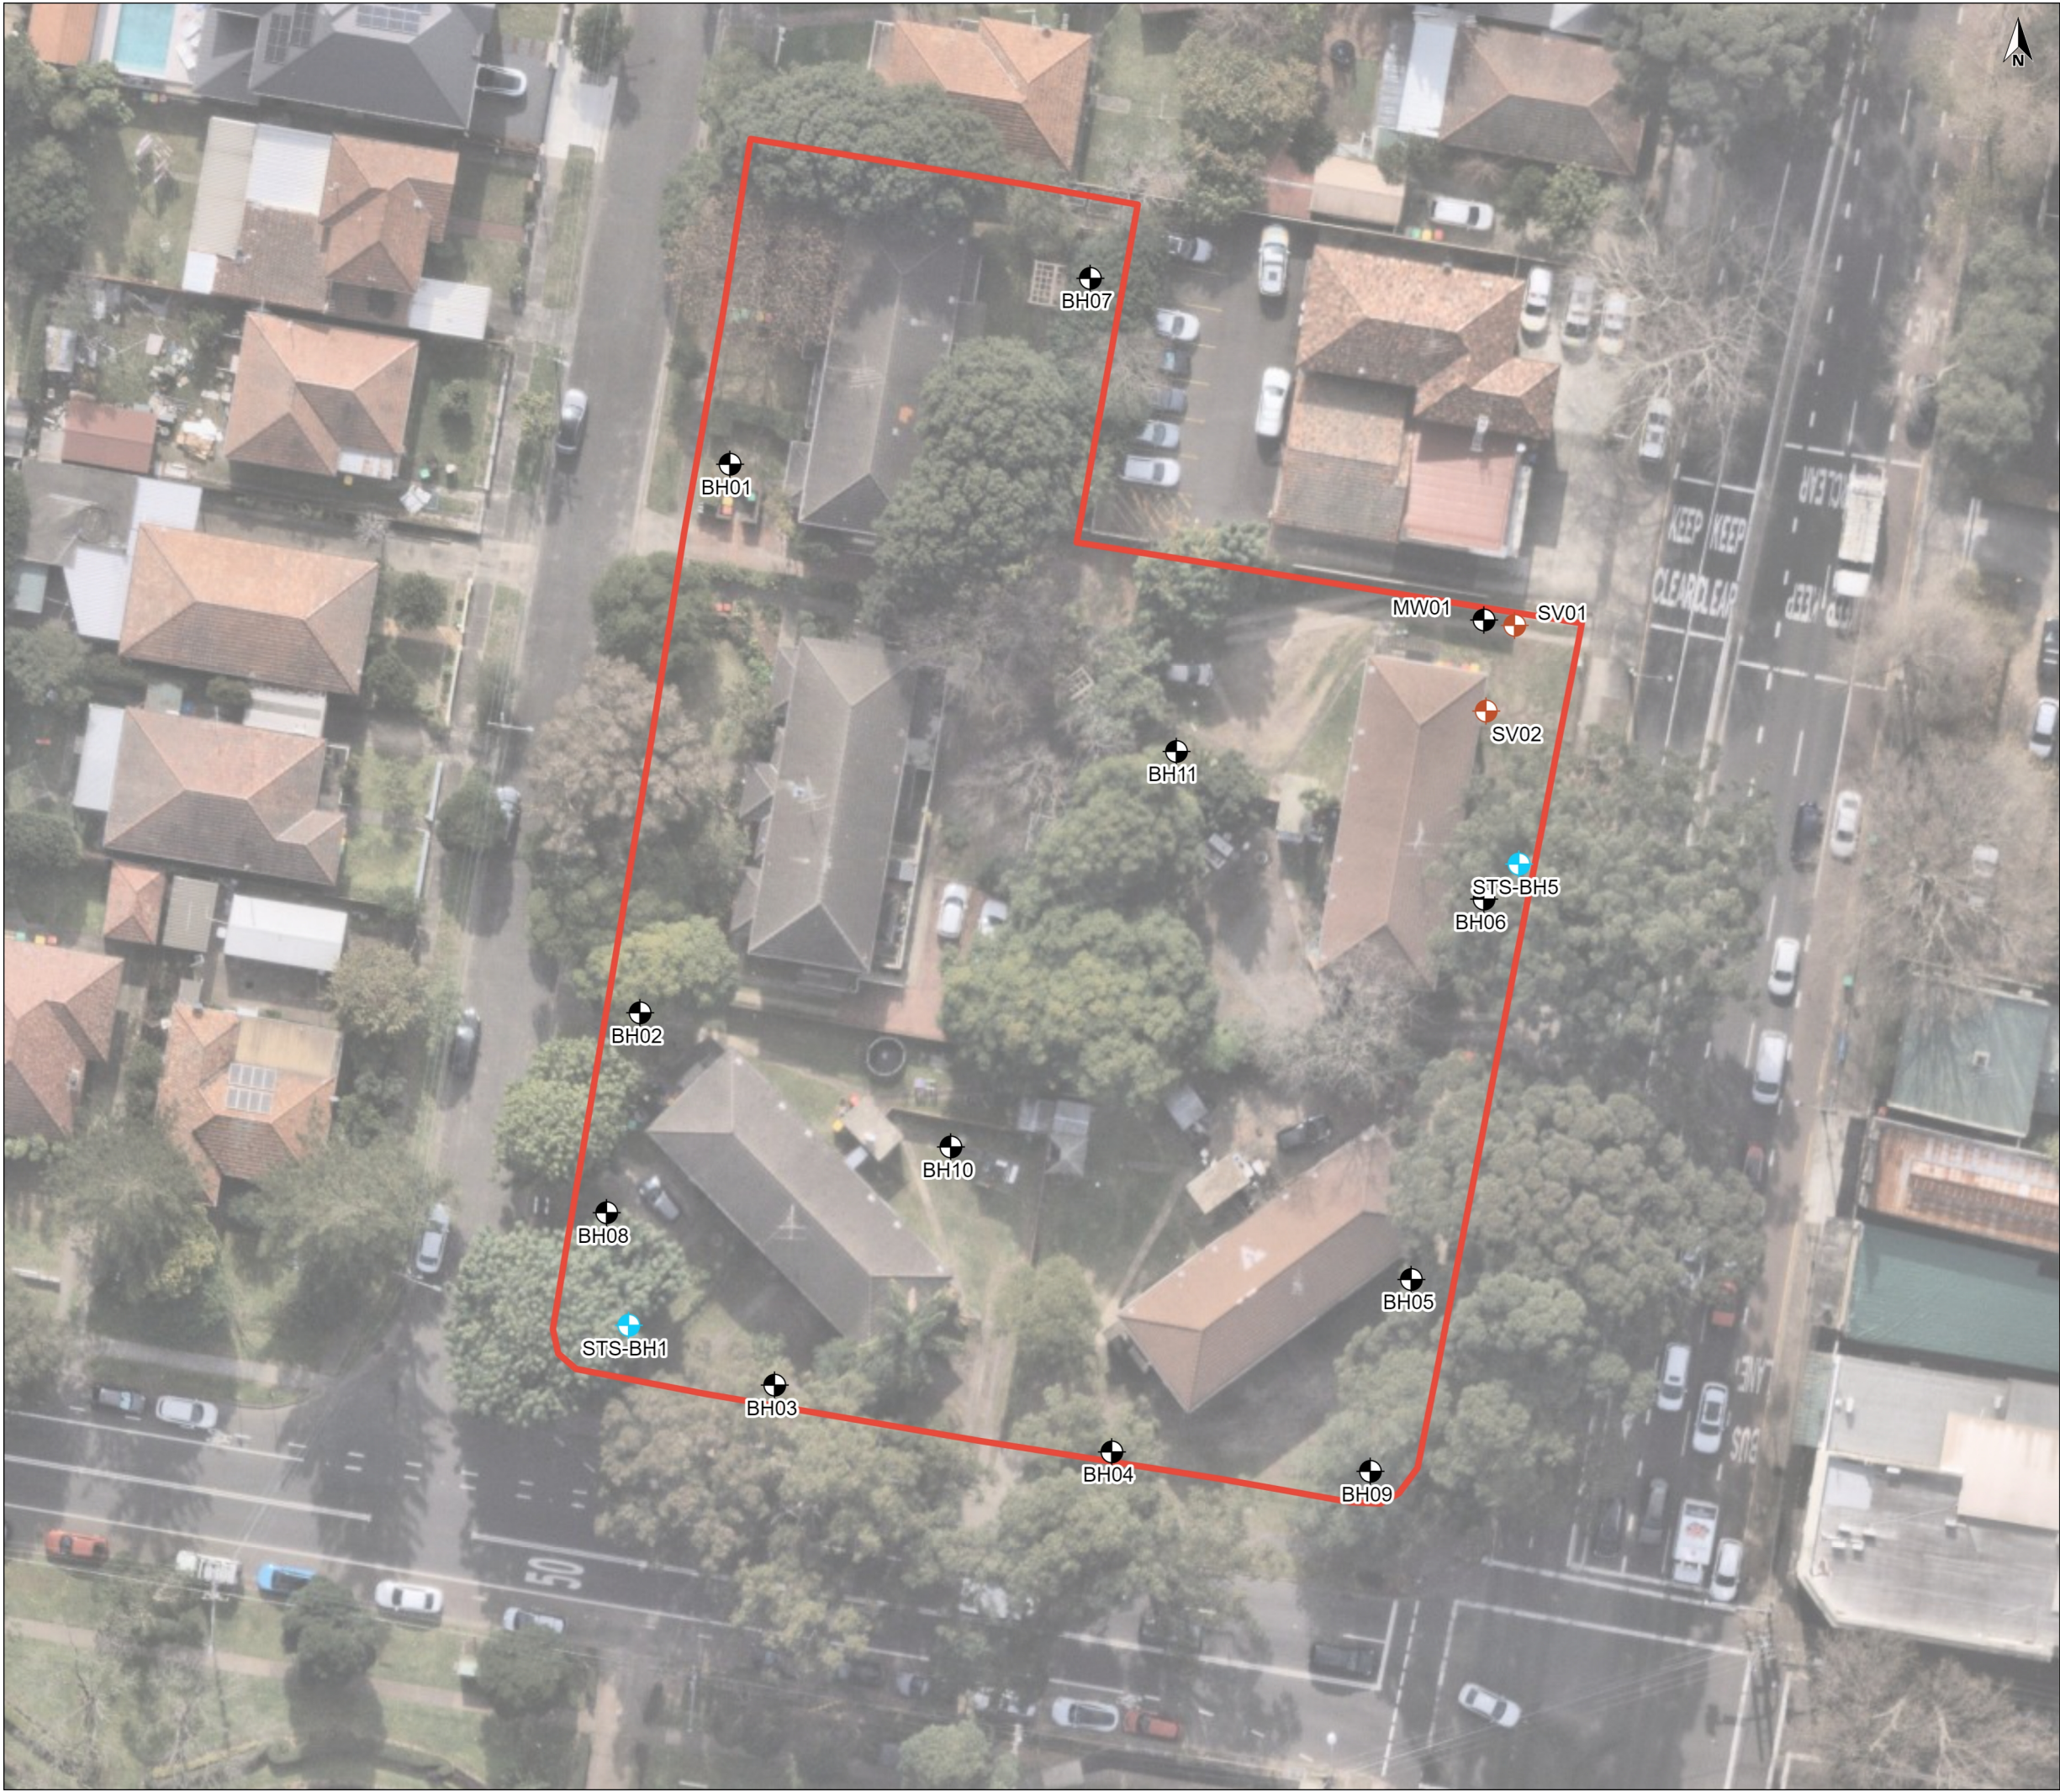
- STS Monitoring Wells
- Soil Vapour Locations
- Borehole Locations
- Site Boundary

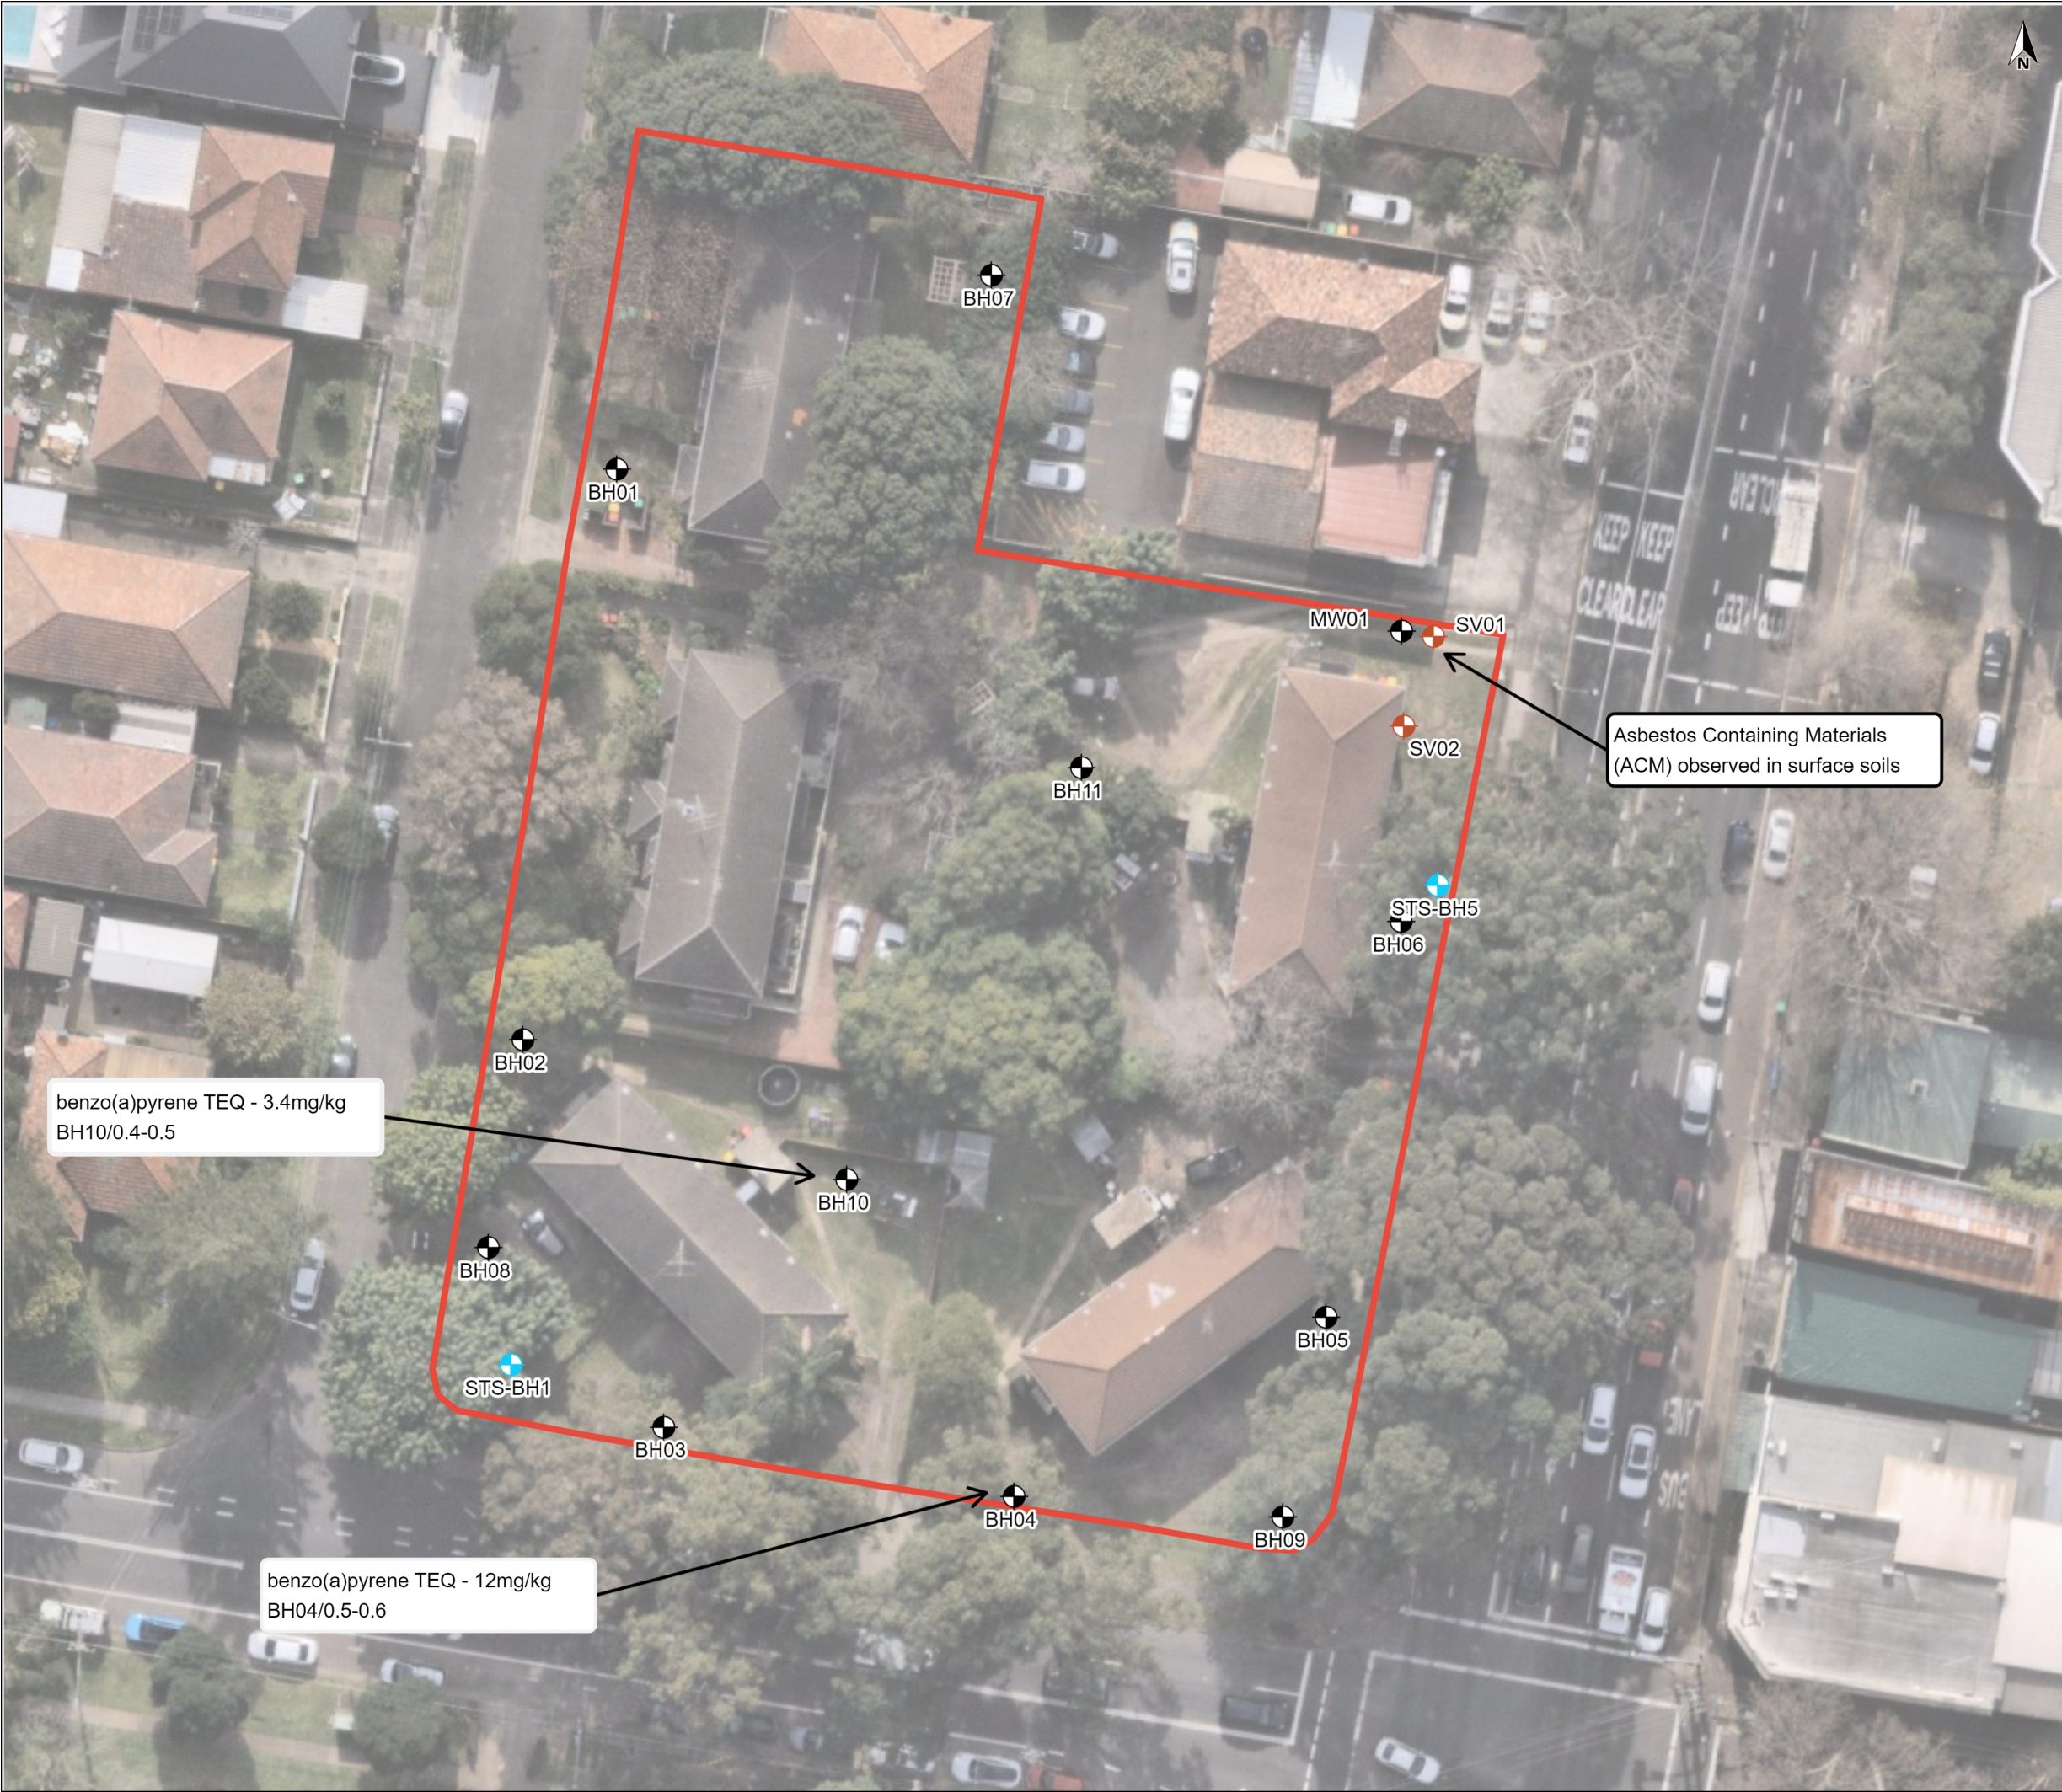
- STS Monitoring Wells
- Soil Vapour Locations
- Borehole Locations
- Site Boundary

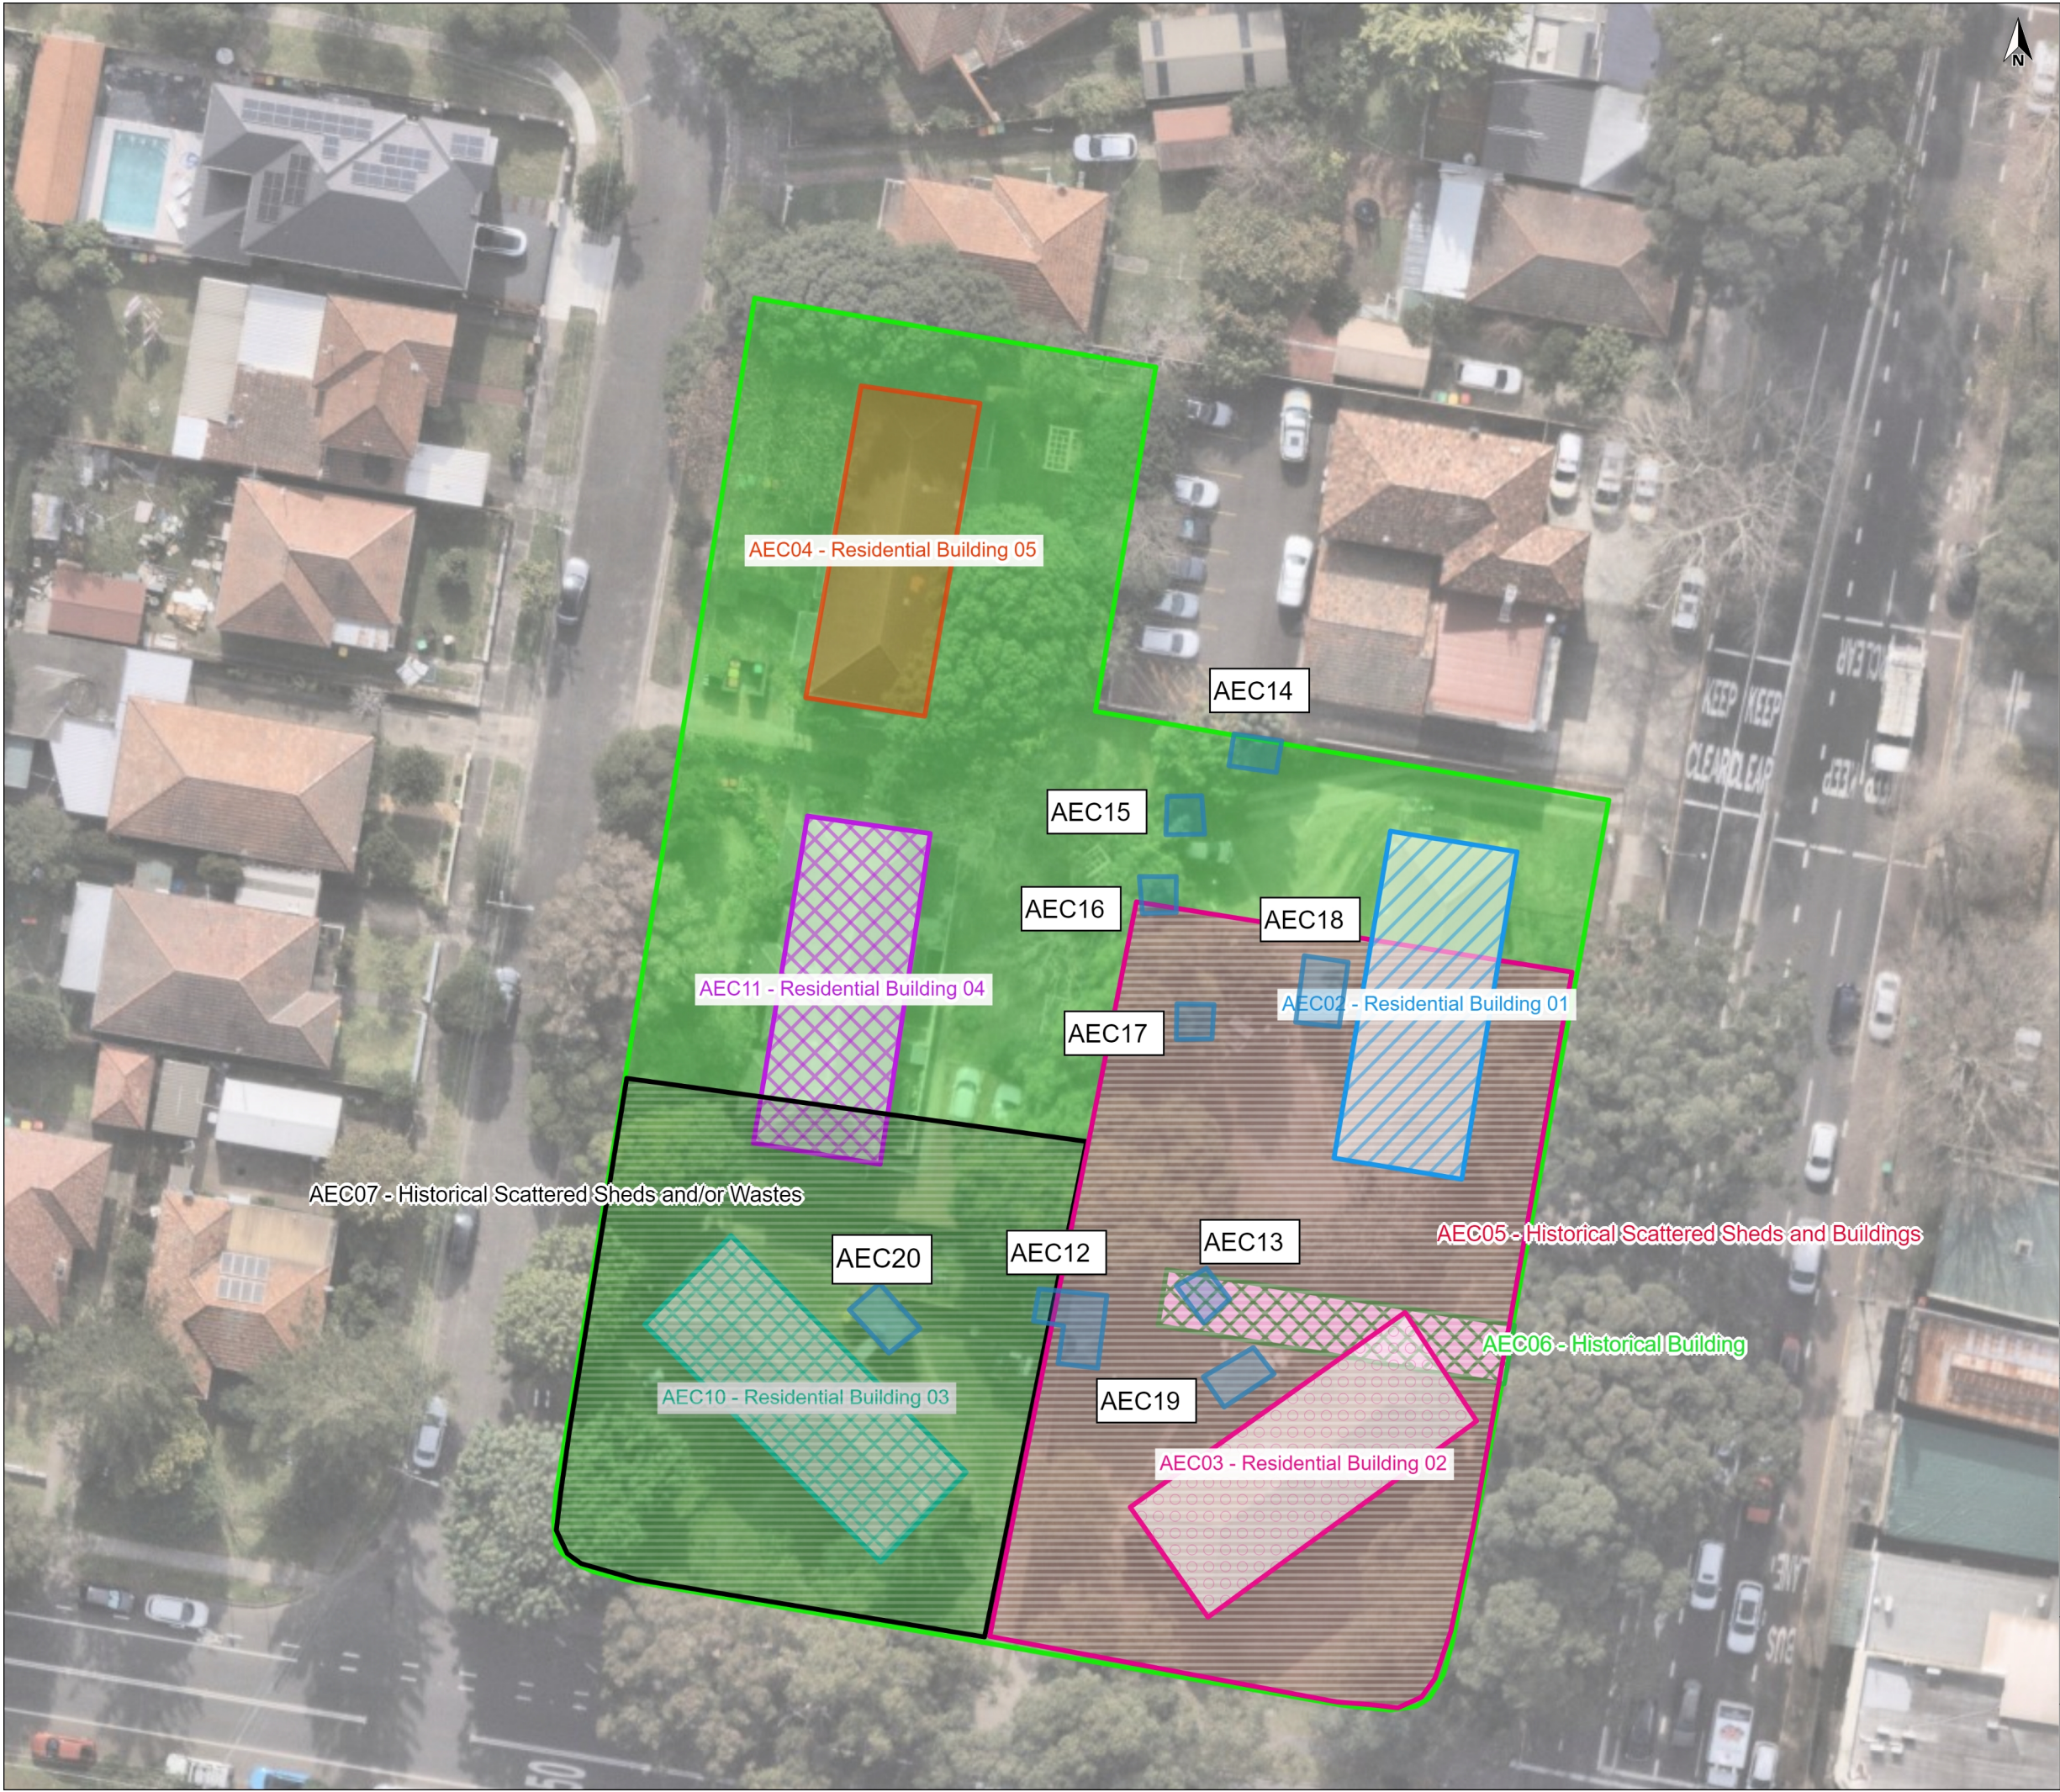
🟩 AEC01 - Site Footprint

| ID | AEC | Land Contaminating Activity (Source) | COPC |
|---|---|---|---|
| AEC01 | Site footprint (~4,904m <sup>2</sup> ) | Uncontrolled filling<br>Uncontrolled demolition<br>Use of hazardous building materials<br>Historic termite treatment. | Petroleum hydrocarbons, polycyclic aromatic hydrocarbons, pesticides, polychlorinated biphenyl, metals, asbestos. |

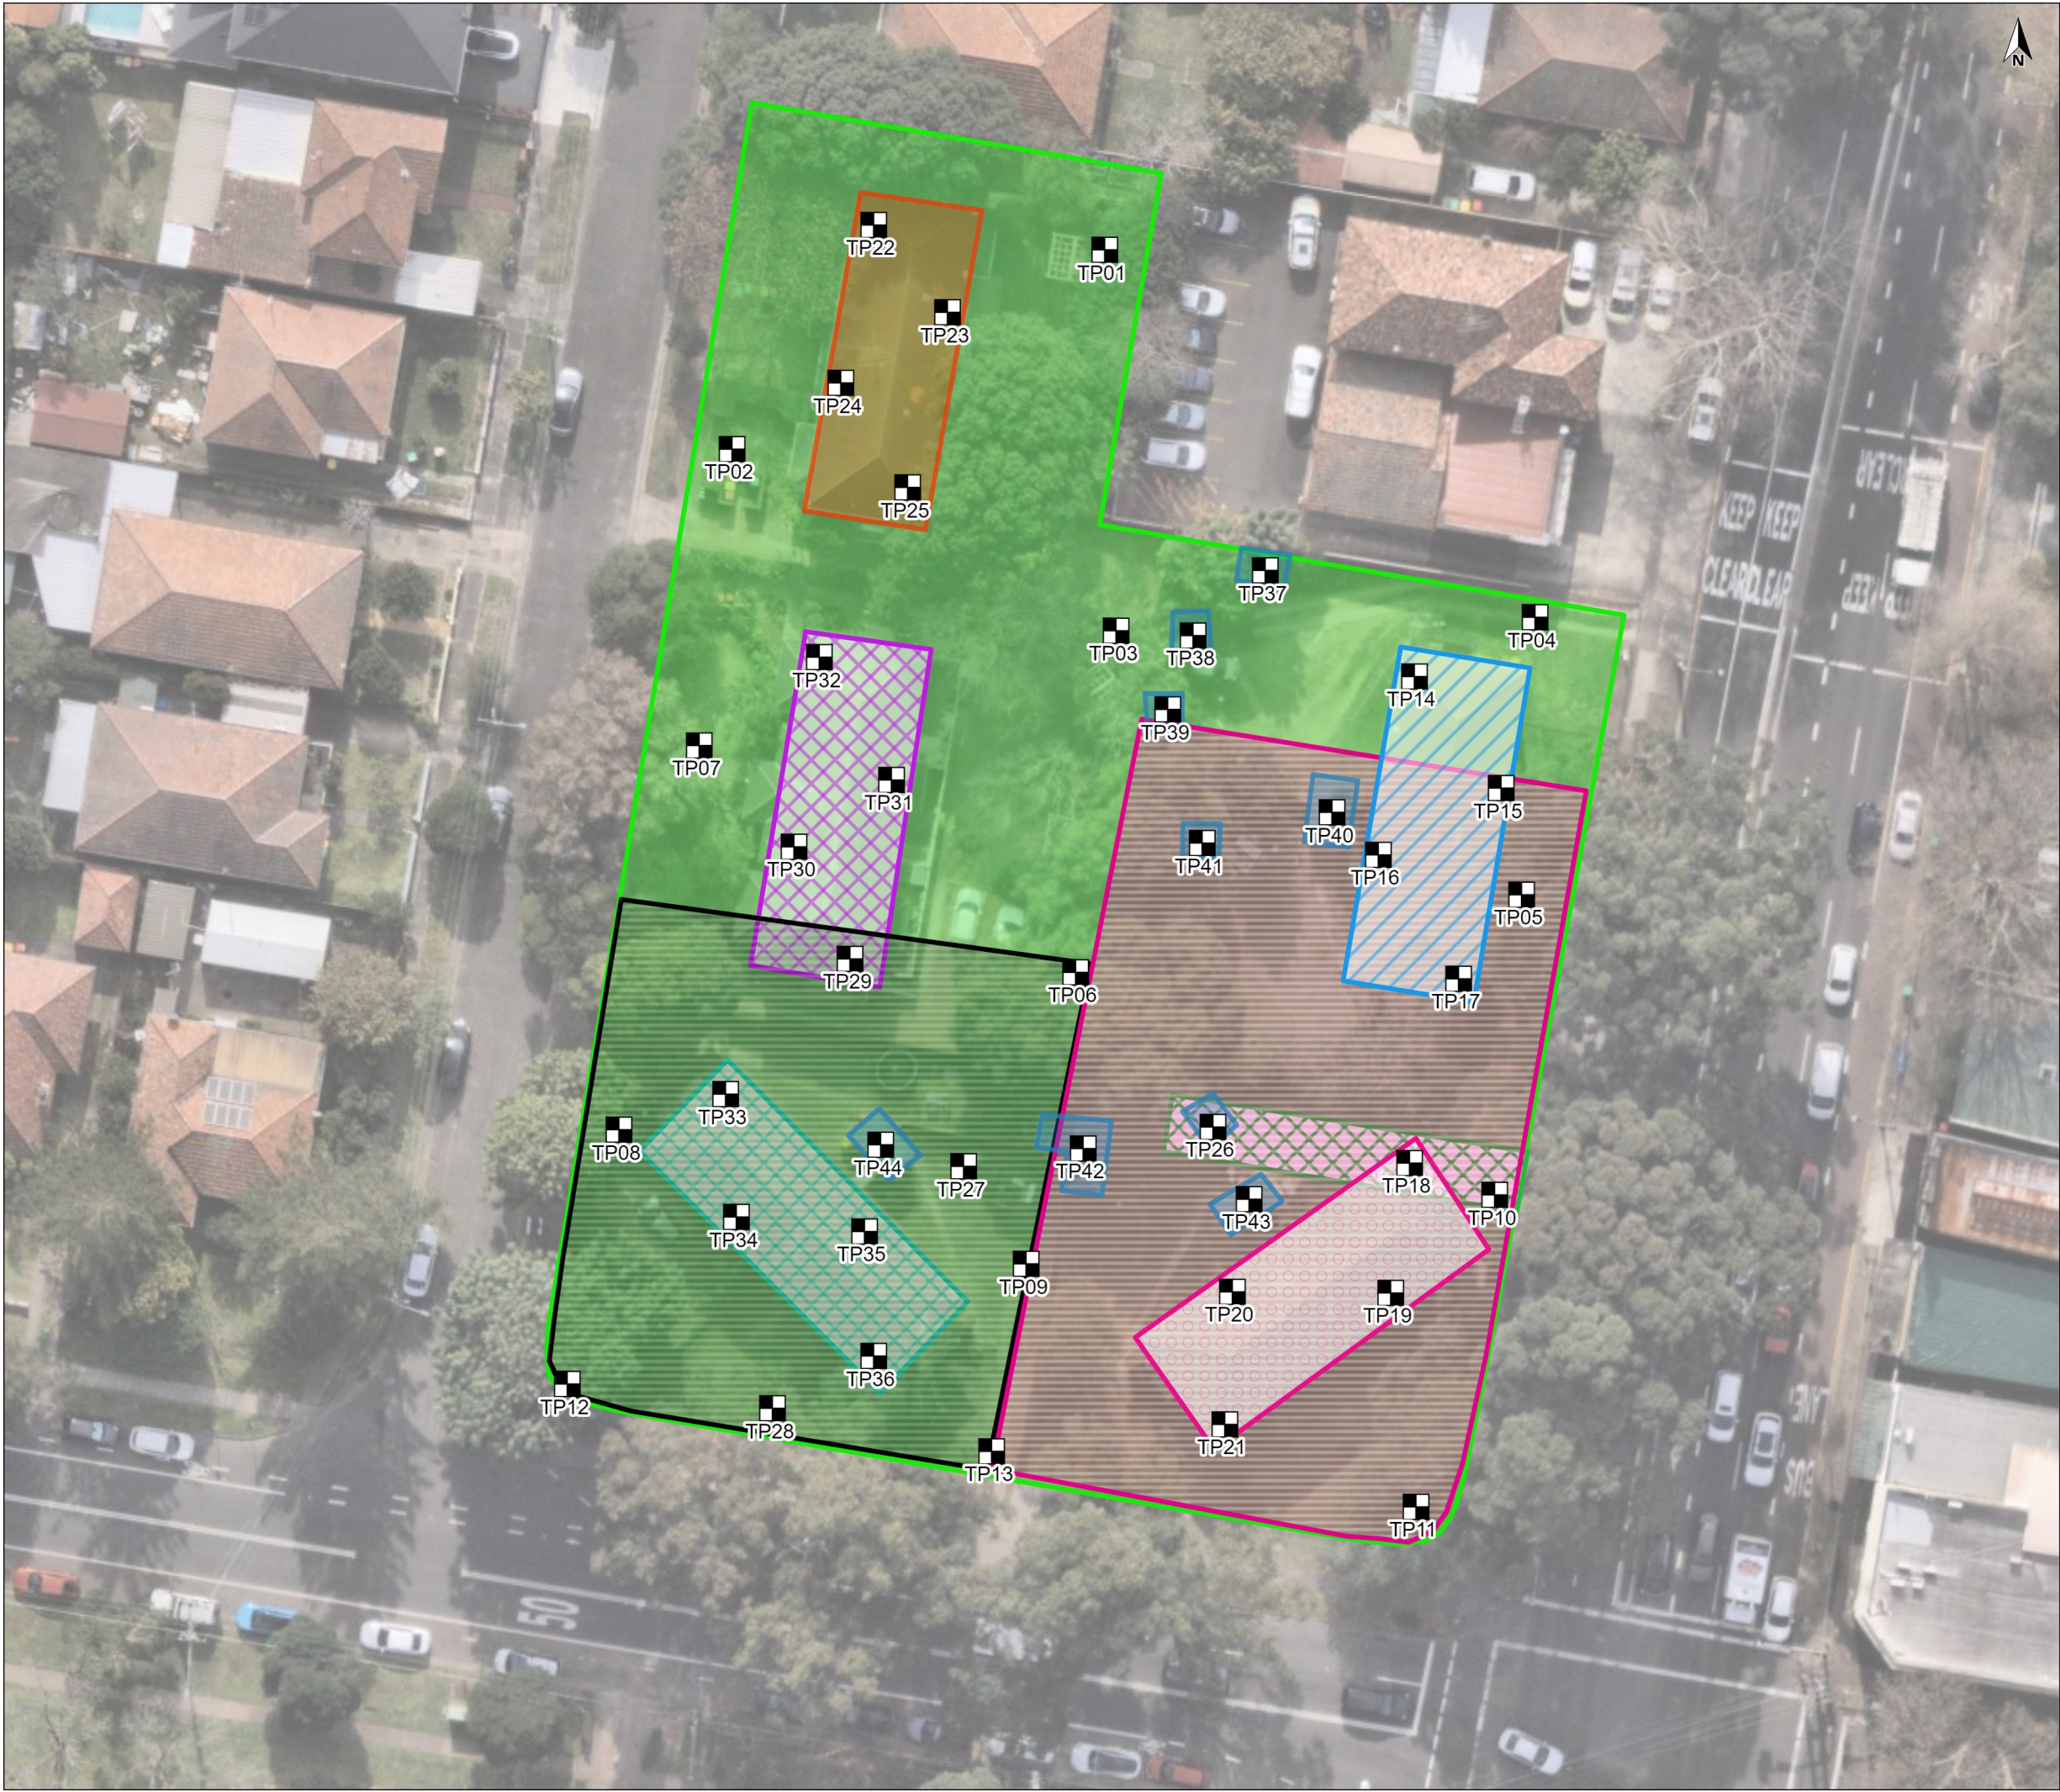
**Legend**  
■ SCA Sampling Points
