**RE: INTERIM AUDIT ADVICE LETTER NO. 1 - REMEDIAL ACTION PLAN, 792-794 BOTANY ROAD AND 33-37 HENRY KENDALL CRESCENT, MASCOT NSW**

As a NSW Environment Protection Authority (EPA) accredited Contaminated Sites Auditor, on behalf of Homes NSW, I am conducting an Audit (LW-059) under the NSW *Contaminated Land Management Act 1997* (CLM Act) in relation to the Homes NSW Mascot Project located at 792-794 Botany Road and 33-37 Henry Kendall Crescent, Mascot, NSW. This initial review has been undertaken to provide an independent review of the suitability and appropriateness of a Remedial Action Plan (RAP) and the investigations undertaken at the site to date.

- 1 Site Location
- 2 Proposed Development Ground Floor Layout
- 3 DSI Sample Location Plan
- 4 Areas of Environmental Concern for Supplementary Contamination Assessment
- 5 Proposed Supplementary Contamination Assessment Sample Locations
- 6 Proposed SCA Works
- 7 Conceptual Validation Strategies

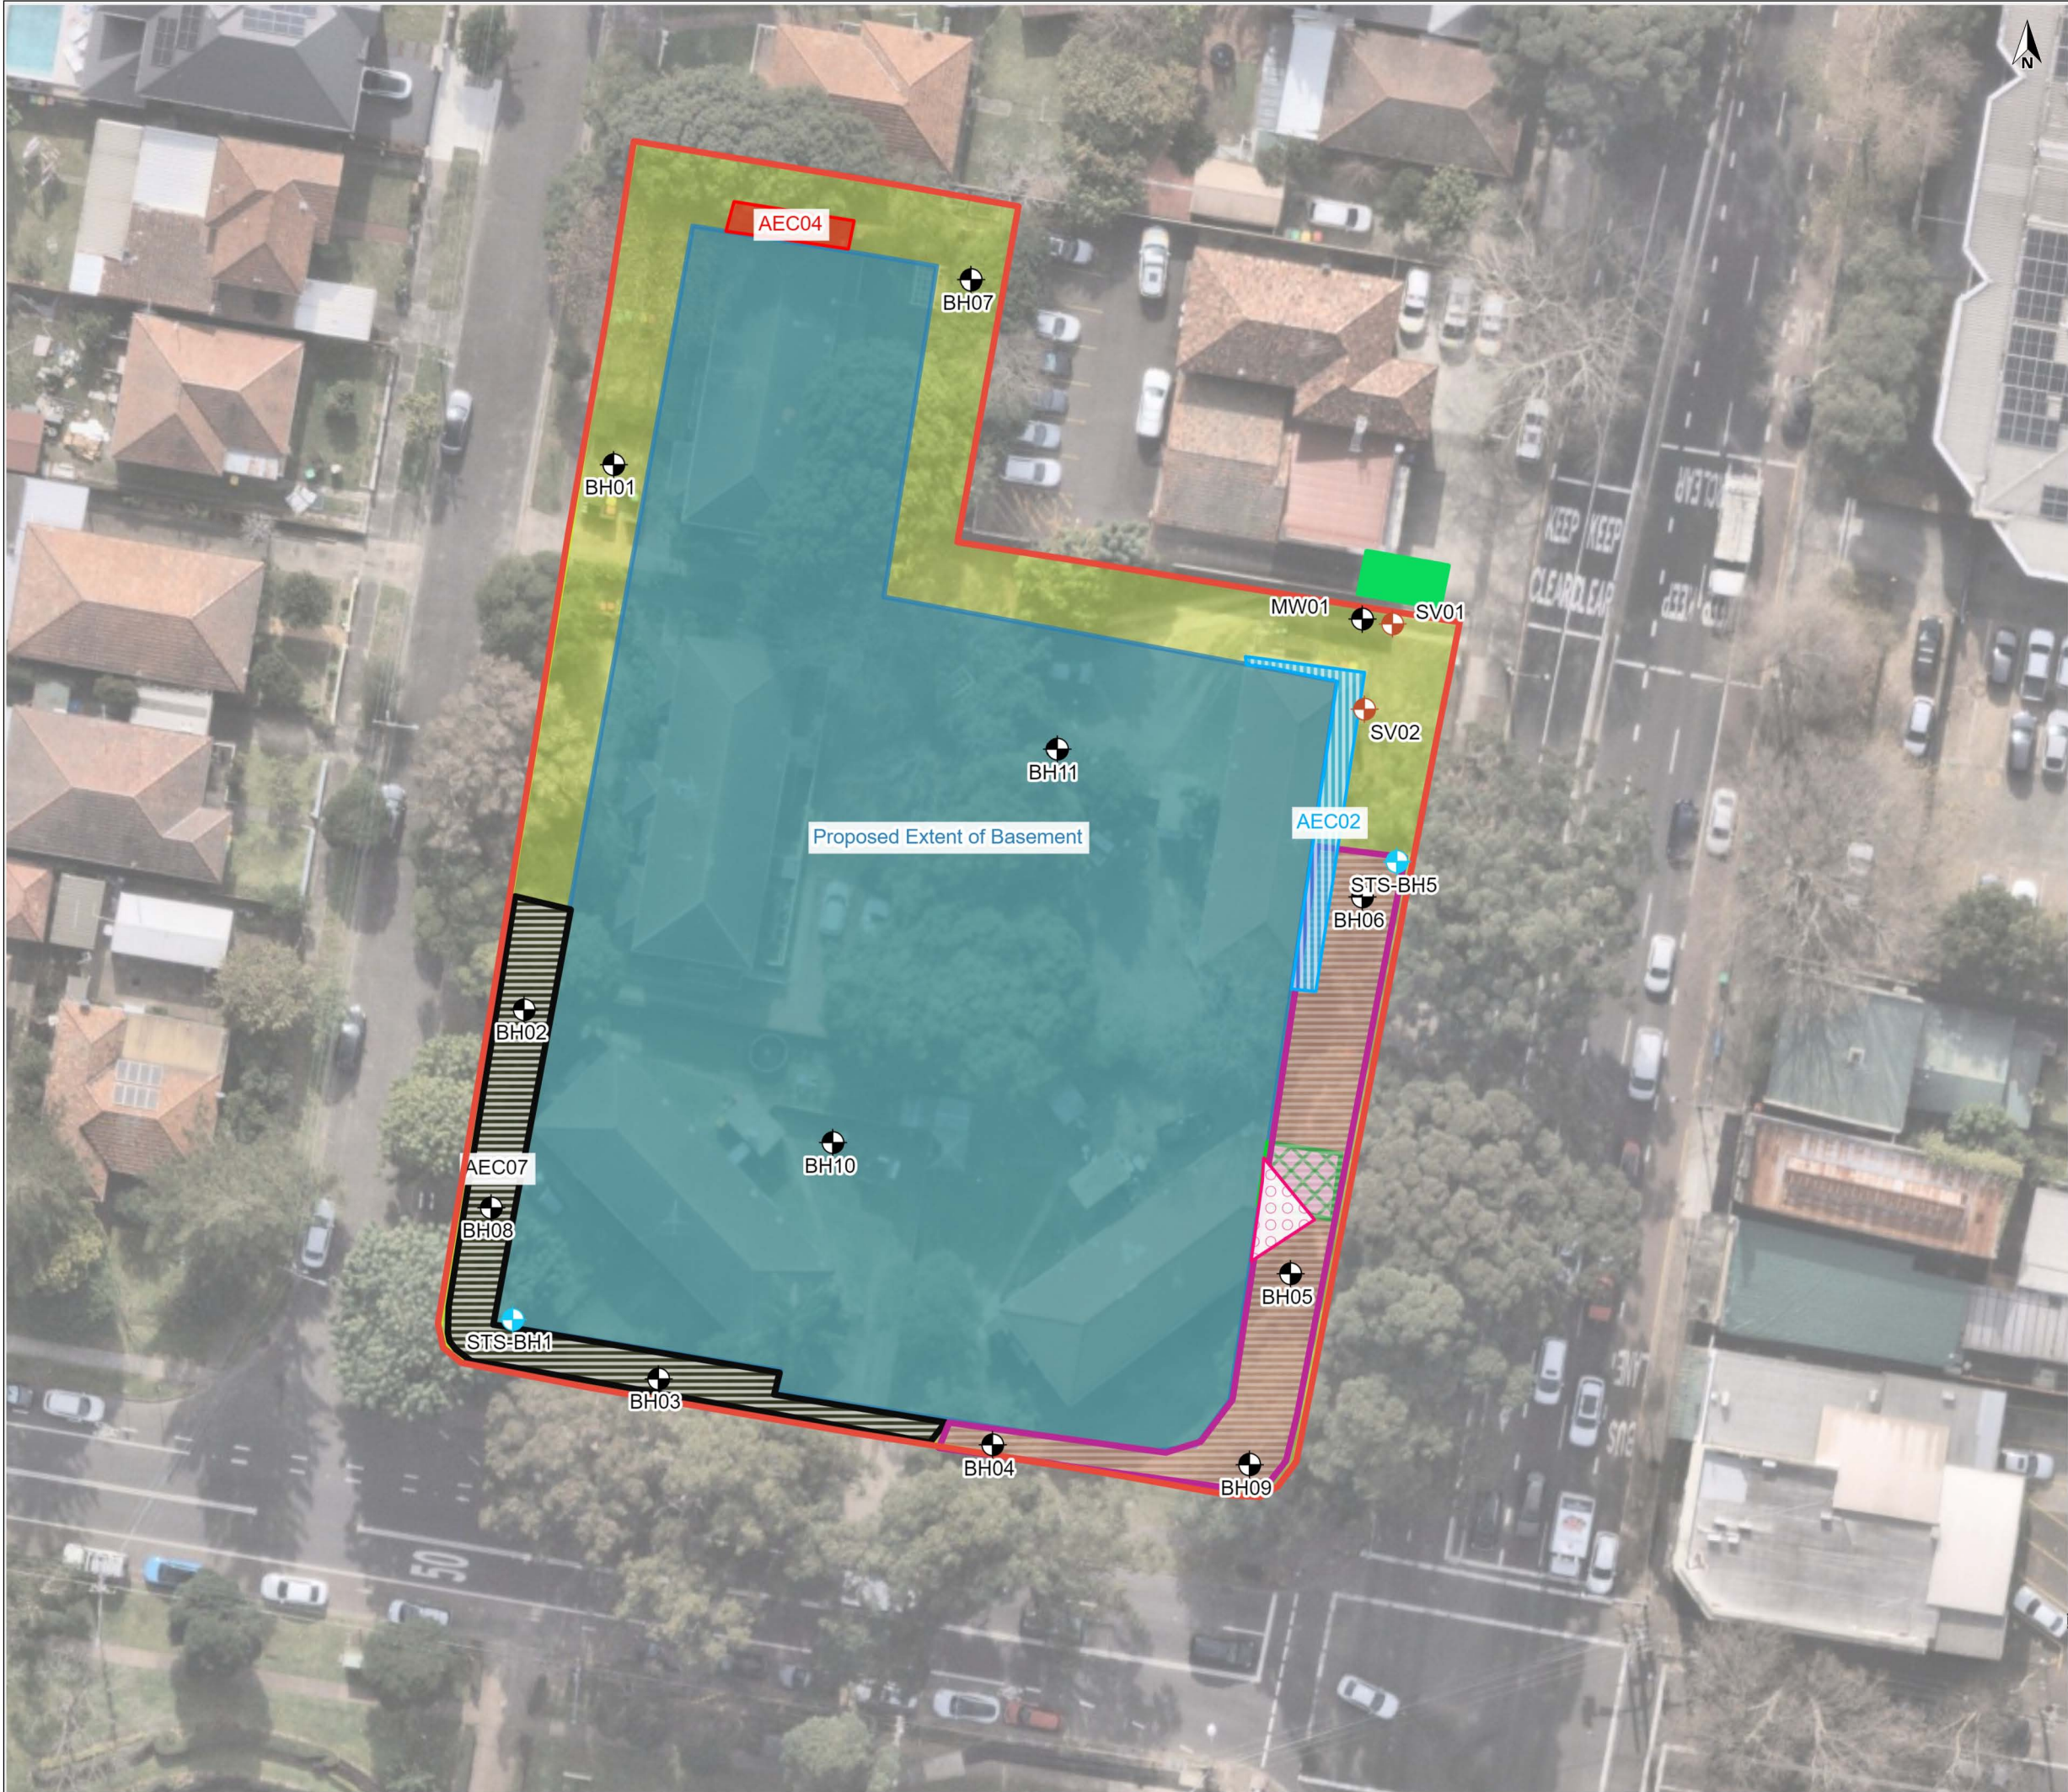
- STS Monitoring Wells
- Soil Vapour Locations
- Borehole Locations
- Site Boundary
- Proposed Extent of Basement

14 sample locations (BH01 to BH11, MW01, SV01 and SV02) were undertaken by Alliance during the DSI (**Attachment 3**). The sub-surface profile of the site has been summarised by the Auditor in **Table 5.1**.

STS installed groundwater monitoring wells in two boreholes (STS-BH1 and STS-BH5 on **Attachment 3**) during the ASS Assessment while Alliance installed one groundwater monitoring well (MW101) during the DSI. In April 2024, STS measured the SWLs in the two wells to be 1.5 mbgl. During the DSI, Alliance measured the SWLs in the three wells at between 1.05 (BH1) and 1.27 (MW101) mbgl. Based on the measured SWLs, Alliance inferred the groundwater flow direction to be towards the northwest.

The Auditor has assessed the overall quality of the data by review of the information presented in the referenced reports. The data sources are summarised in **Table 6.1**. Sample locations are shown on **Attachment 3**.

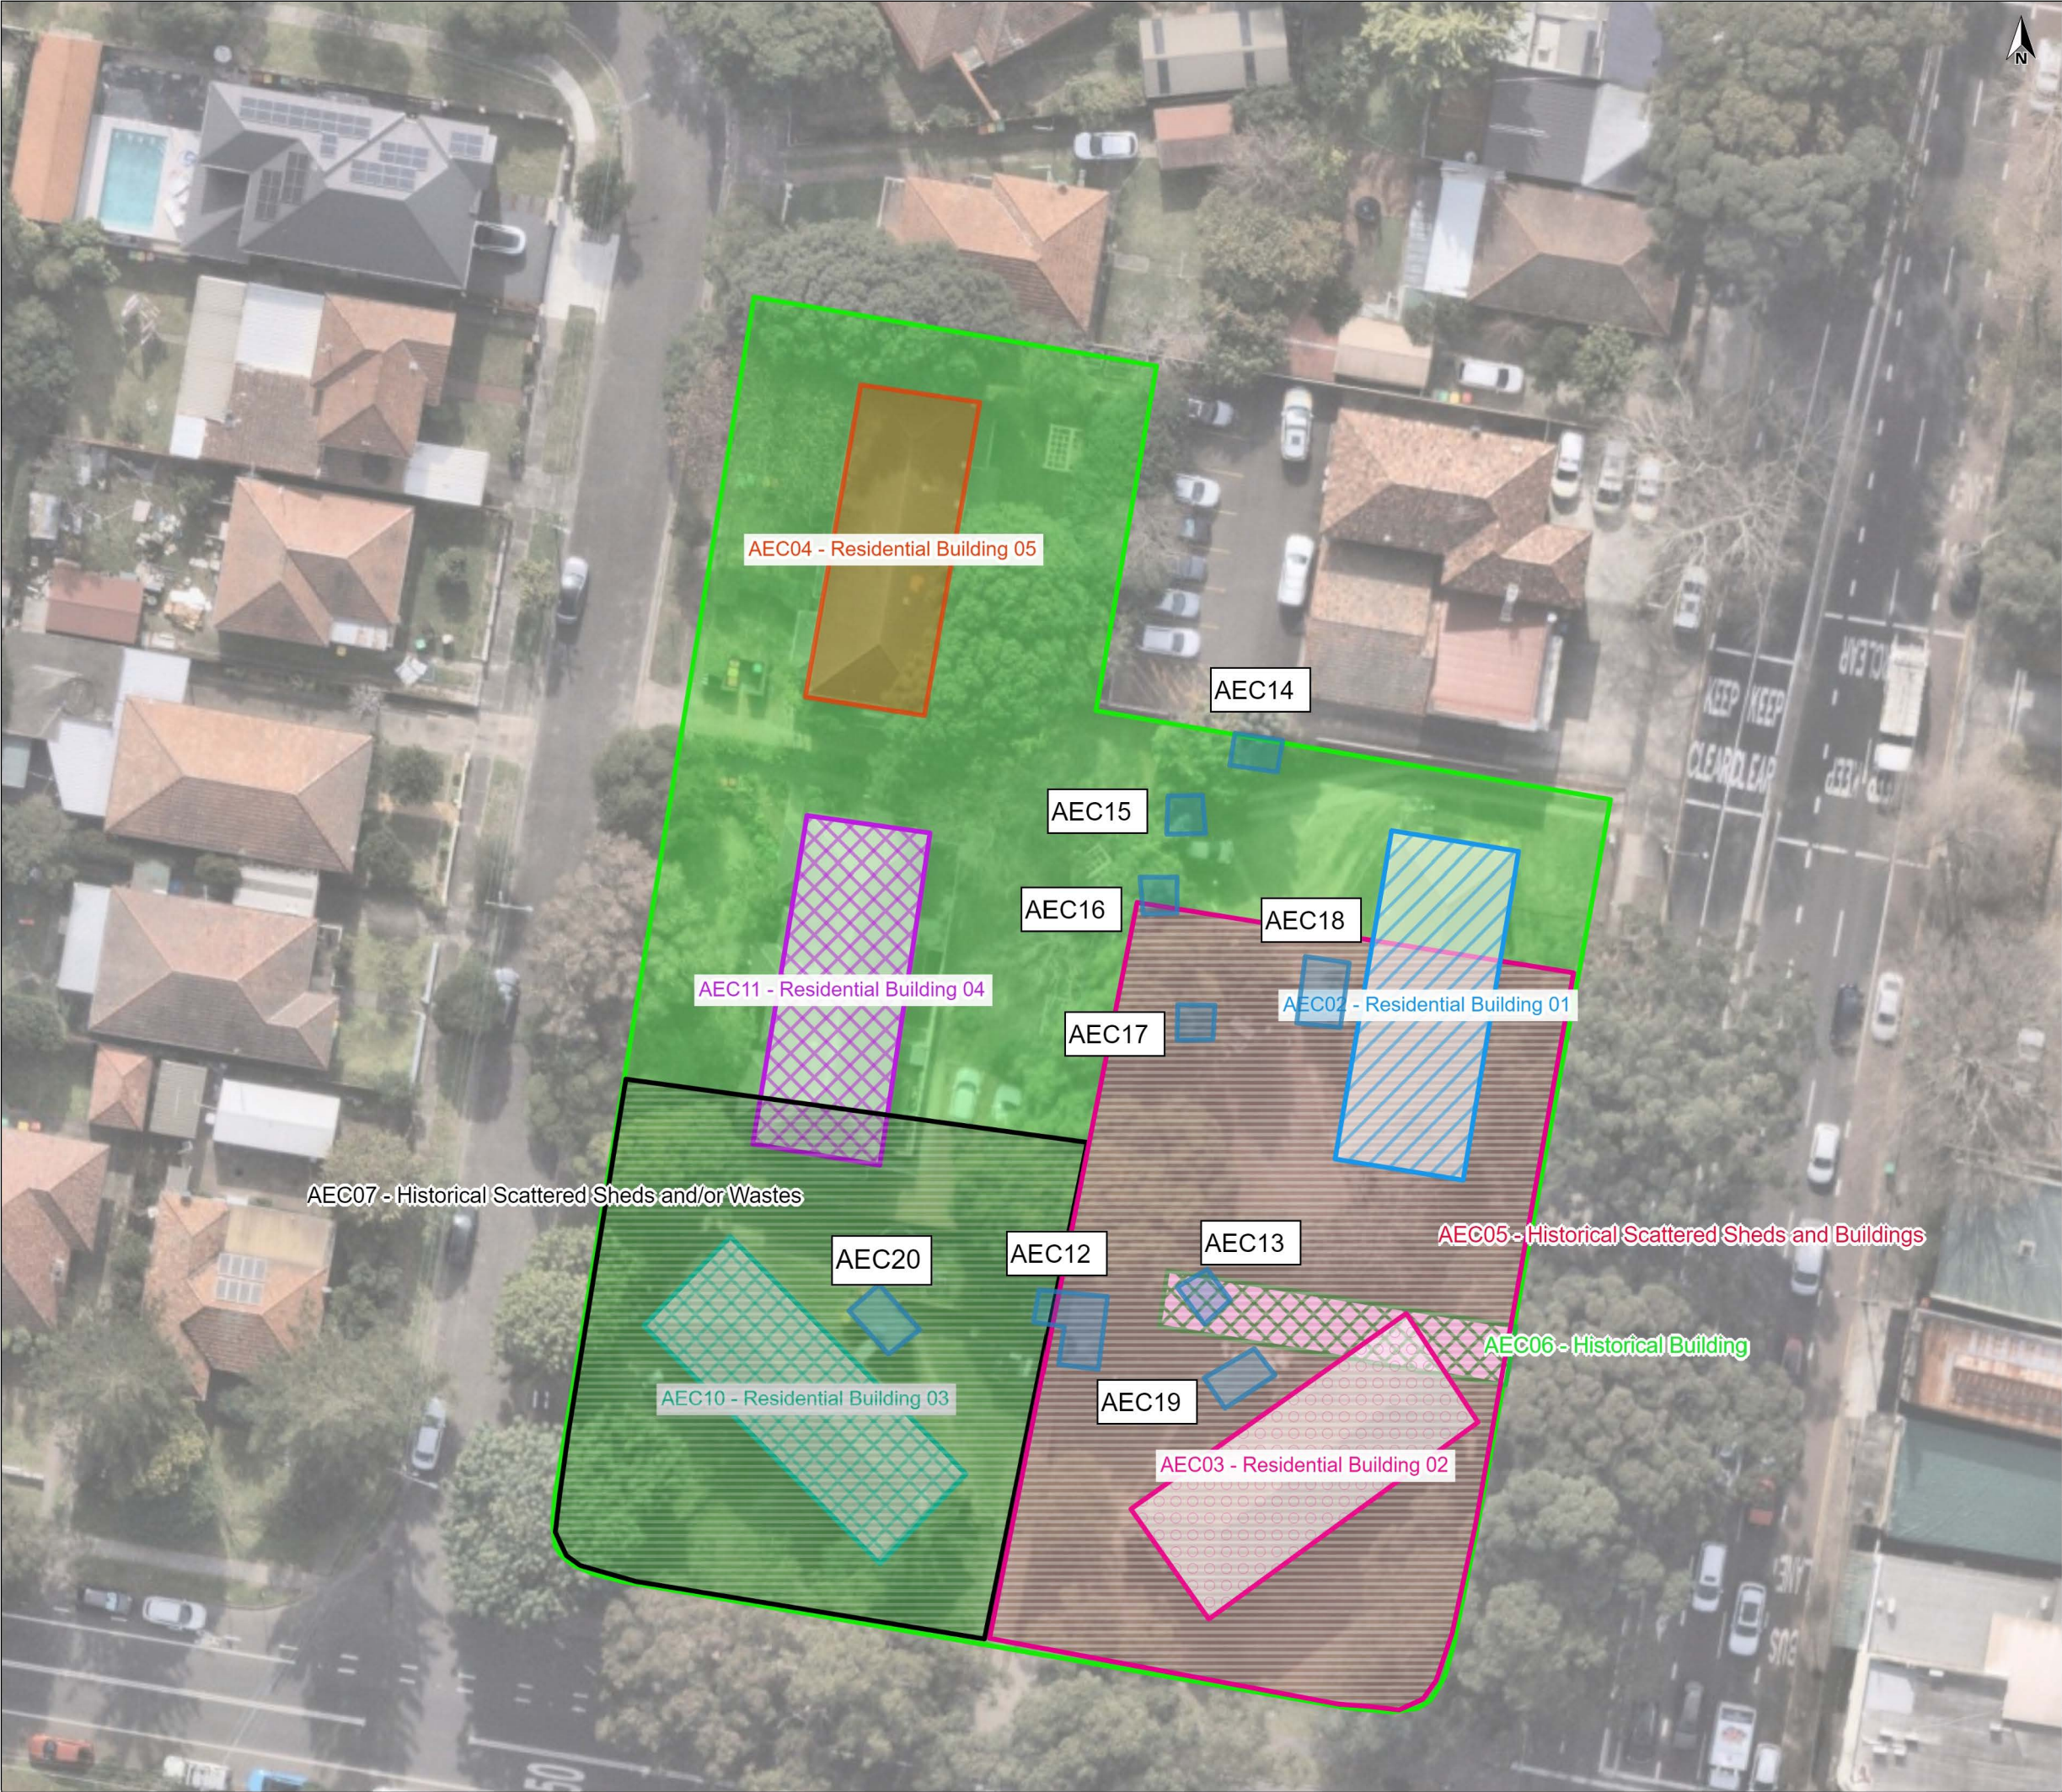
AEC01 - Site Footprint

The numbering of the 13 AEC identified by Alliance in the PSI was revised in the DSI and RAP. The RAP identifies 18 AEC (AEC01-AEC07 and AEC10 to AEC 20) relating to data gap areas requiring characterisation of soils for contaminants associated with potential uncontrolled filling, uncontrolled demolition, use of hazardous building materials, historic termite treatment and potential use as a council depot with contaminants identified as petroleum hydrocarbons, pesticides, PCBs, metals and asbestos.

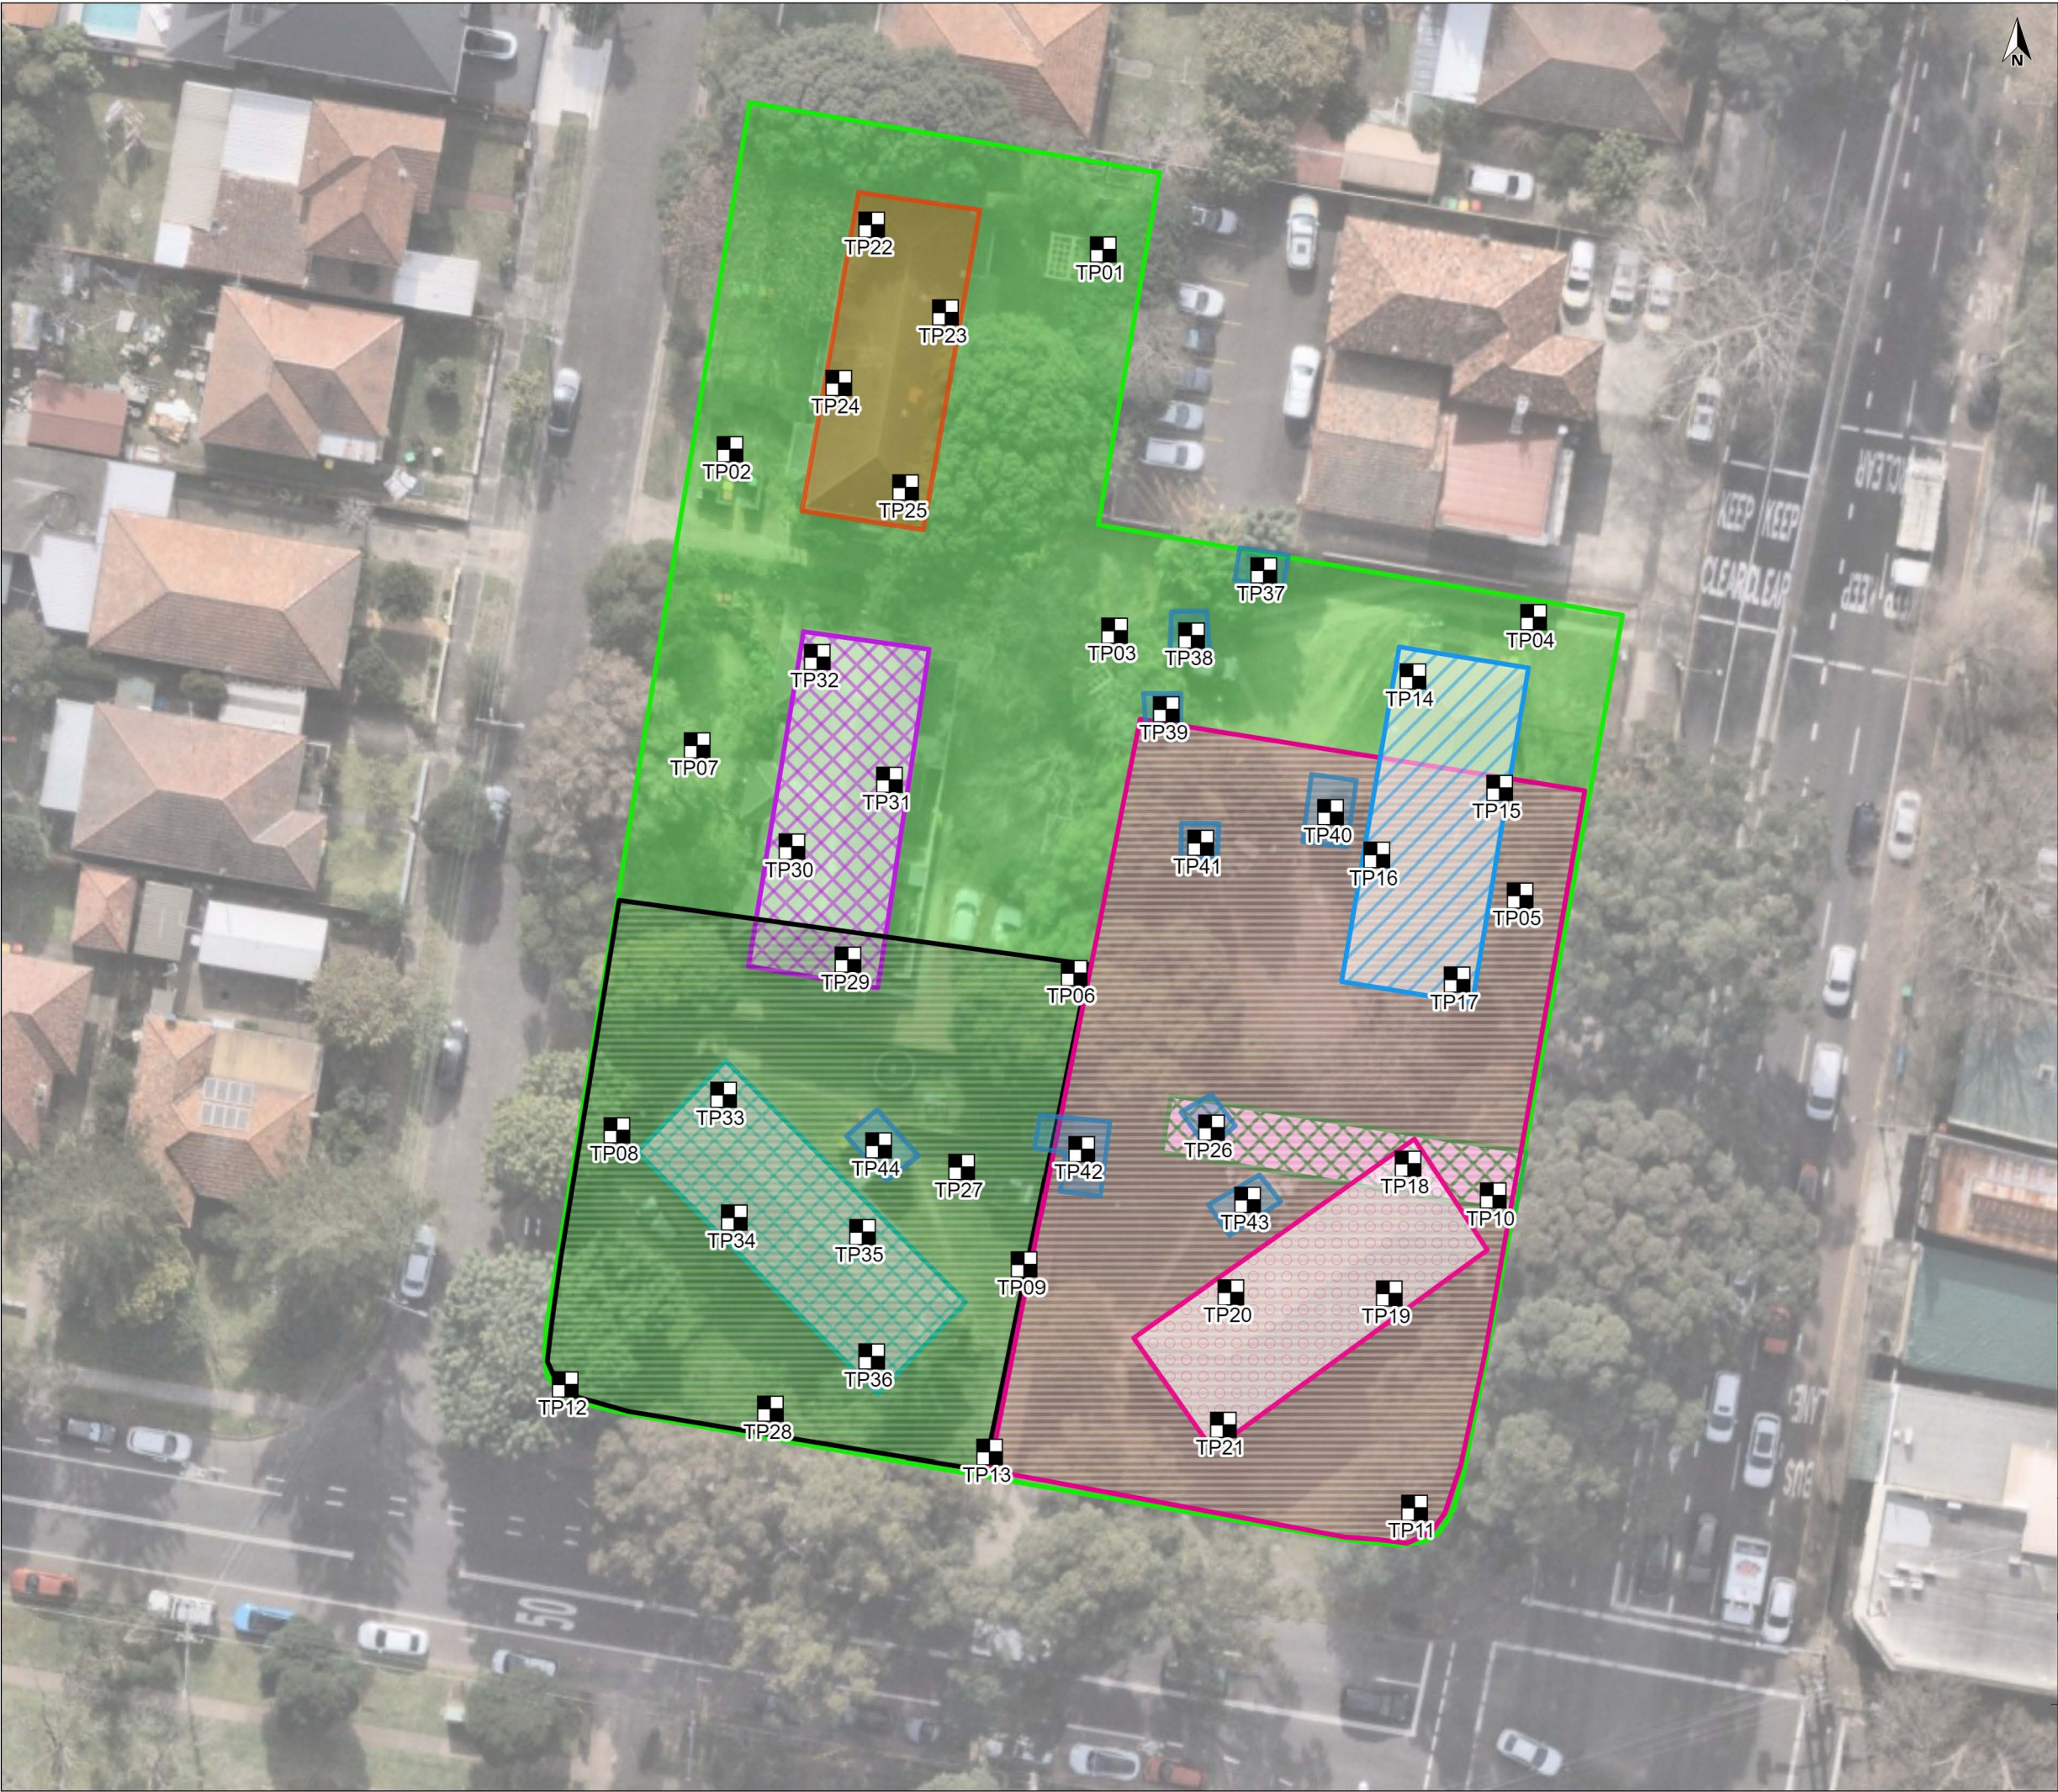
Legend  
■ SCA Sampling Points

The scope of the SCA does not specifically propose to delineate identified impacts at BH04, BH10 and SV01. It is recommended that, should delineation sampling be required, that these works be carried out prior to the preparation of the addendum to the RAP to ensure the extent of remediation is adequately defined.
