Soils and Groundwater Impact Assessment

Proposed Port Kembla Bulk
Liquids Terminal

TQ Reference: PJ-PK-0001-REPT-019

Prepared for
TQ Holdings Australia Pty Ltd

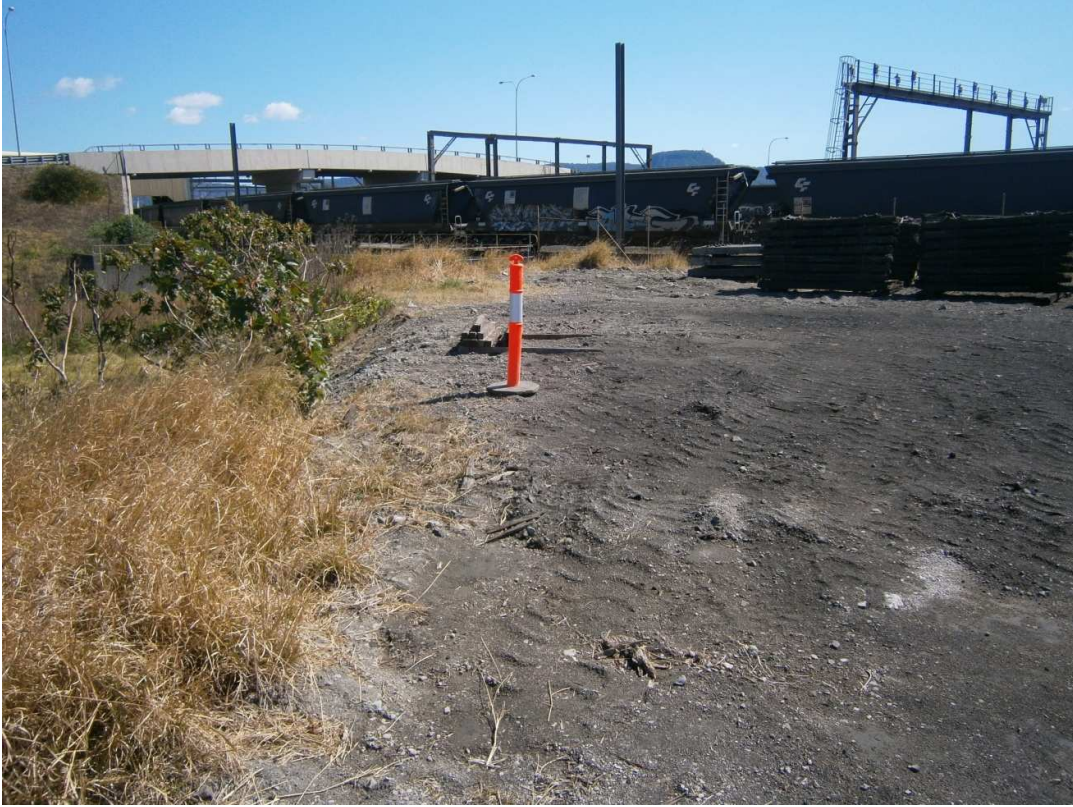
Photo 5: Railway sleeper piles observed in north-west portion of Zone 2

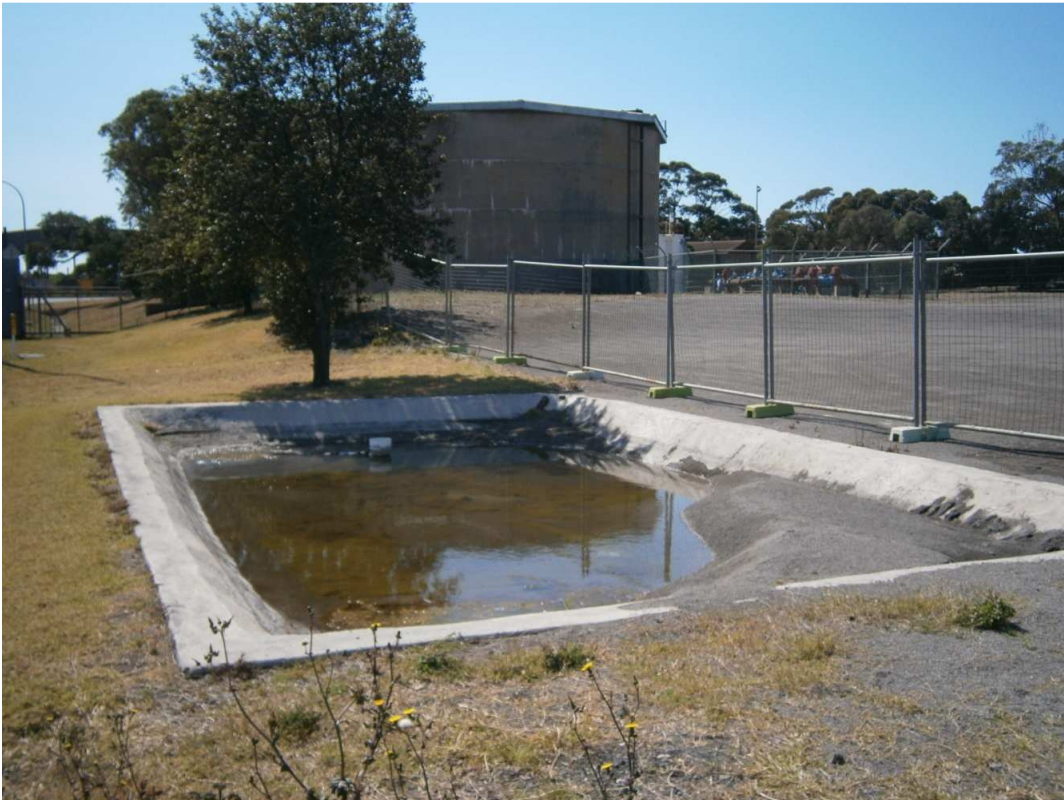
Photo 6: Concrete basin between Tom Thumb Road and southern area of Zone 2

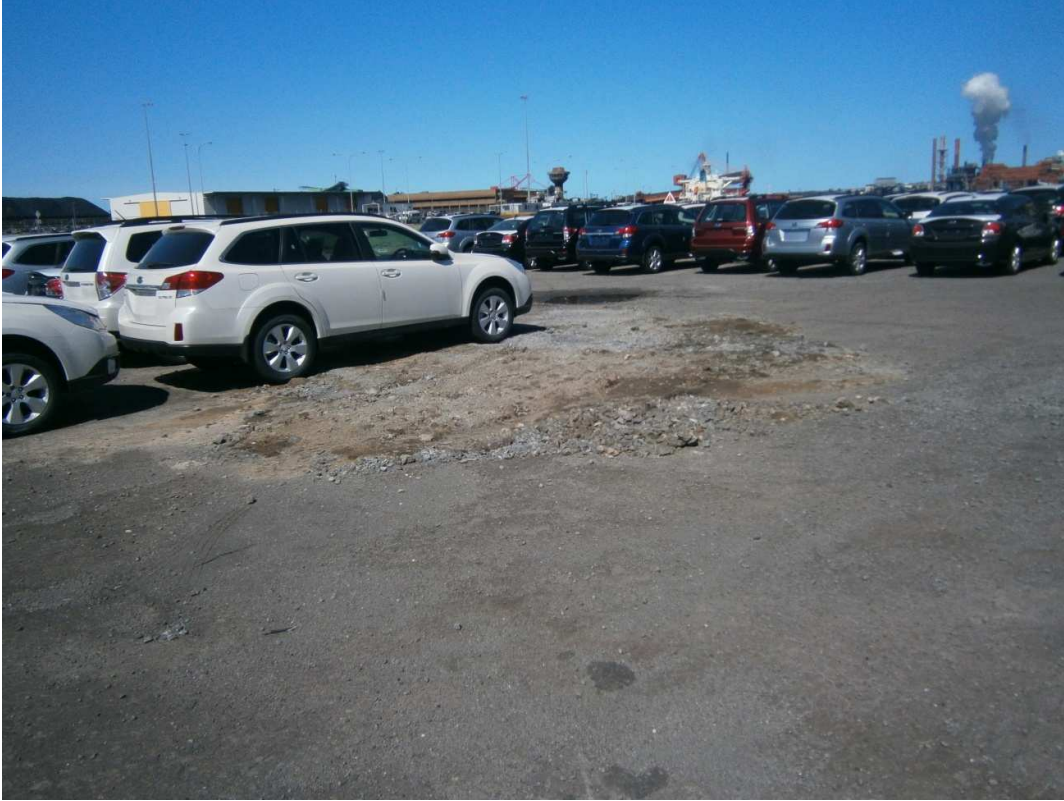
Photo 7: Soil disturbance (former test pit) on ground surface in Zone 1

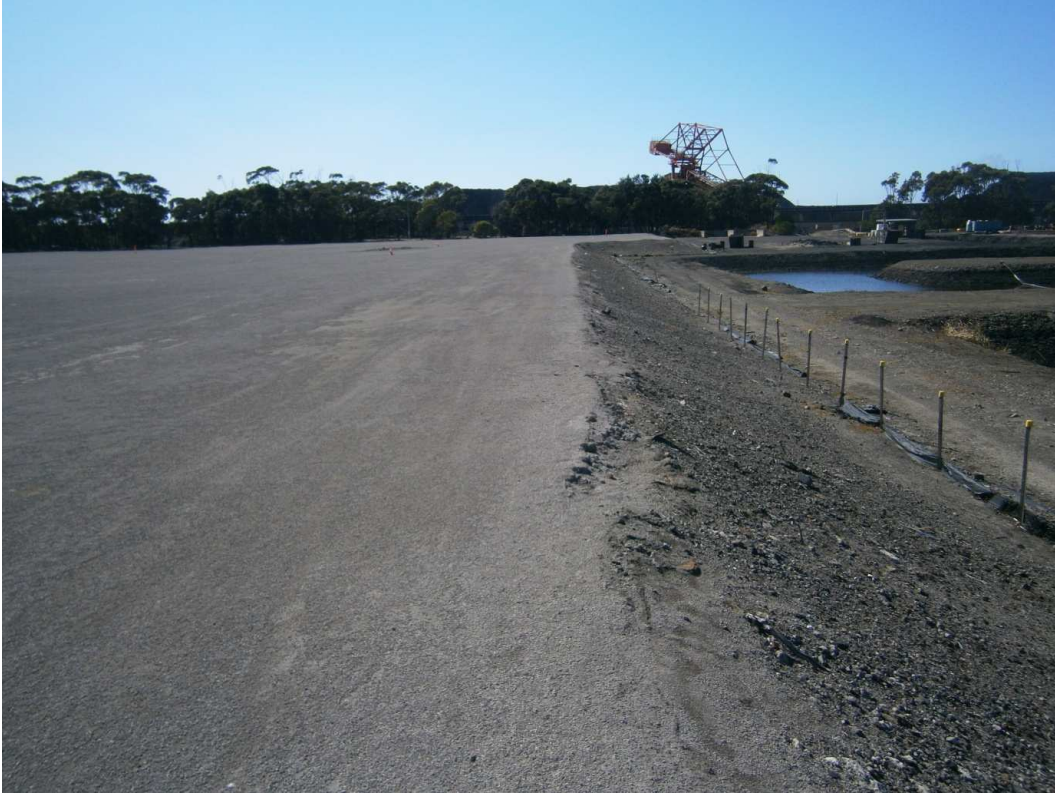
Photo 9: Looking east across the southern boundary of Zone 2 showing raised fill terrain

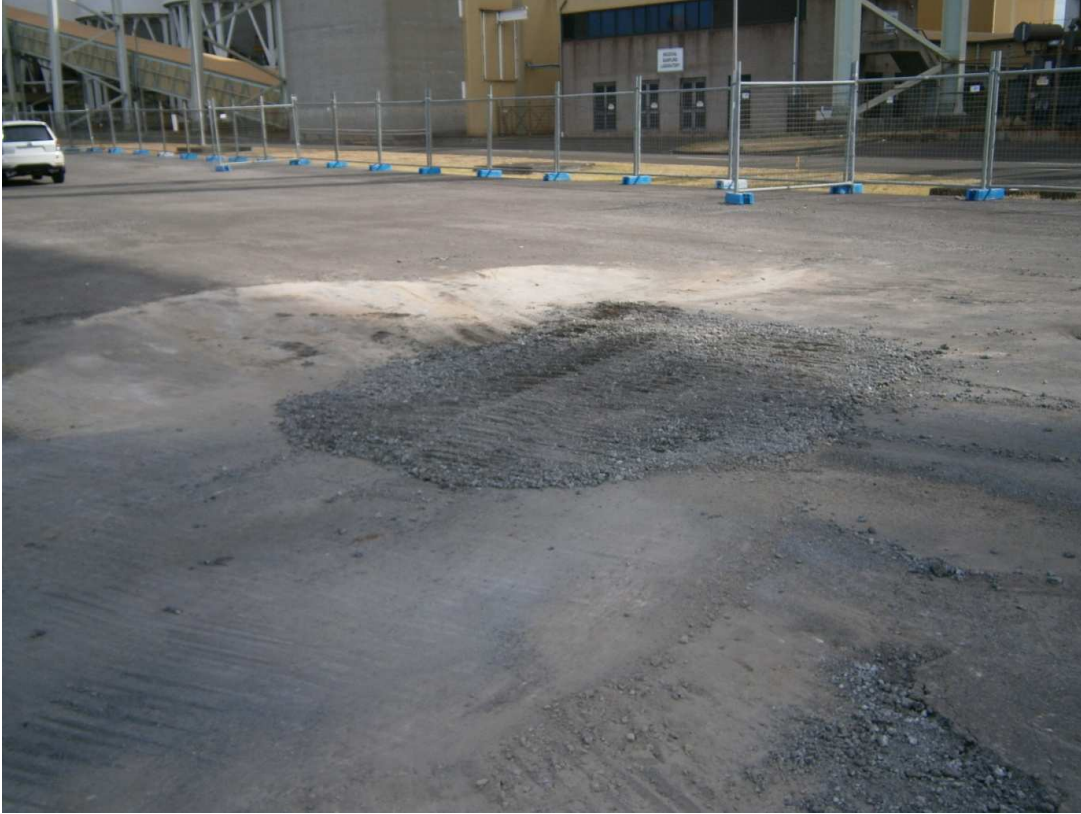
Photo 11: Test pit CTP01 (in Zone 1) after recompaction with backfill soils
