Project 94525.06  
1 July 2020  
R.001.Rev0  
GAR

**Supplementary Contamination Investigation - Railway Corridor  
Proposed St Marys Intermodal Freight Terminal  
Lot 2, Forrester Road, St Marys, NSW**

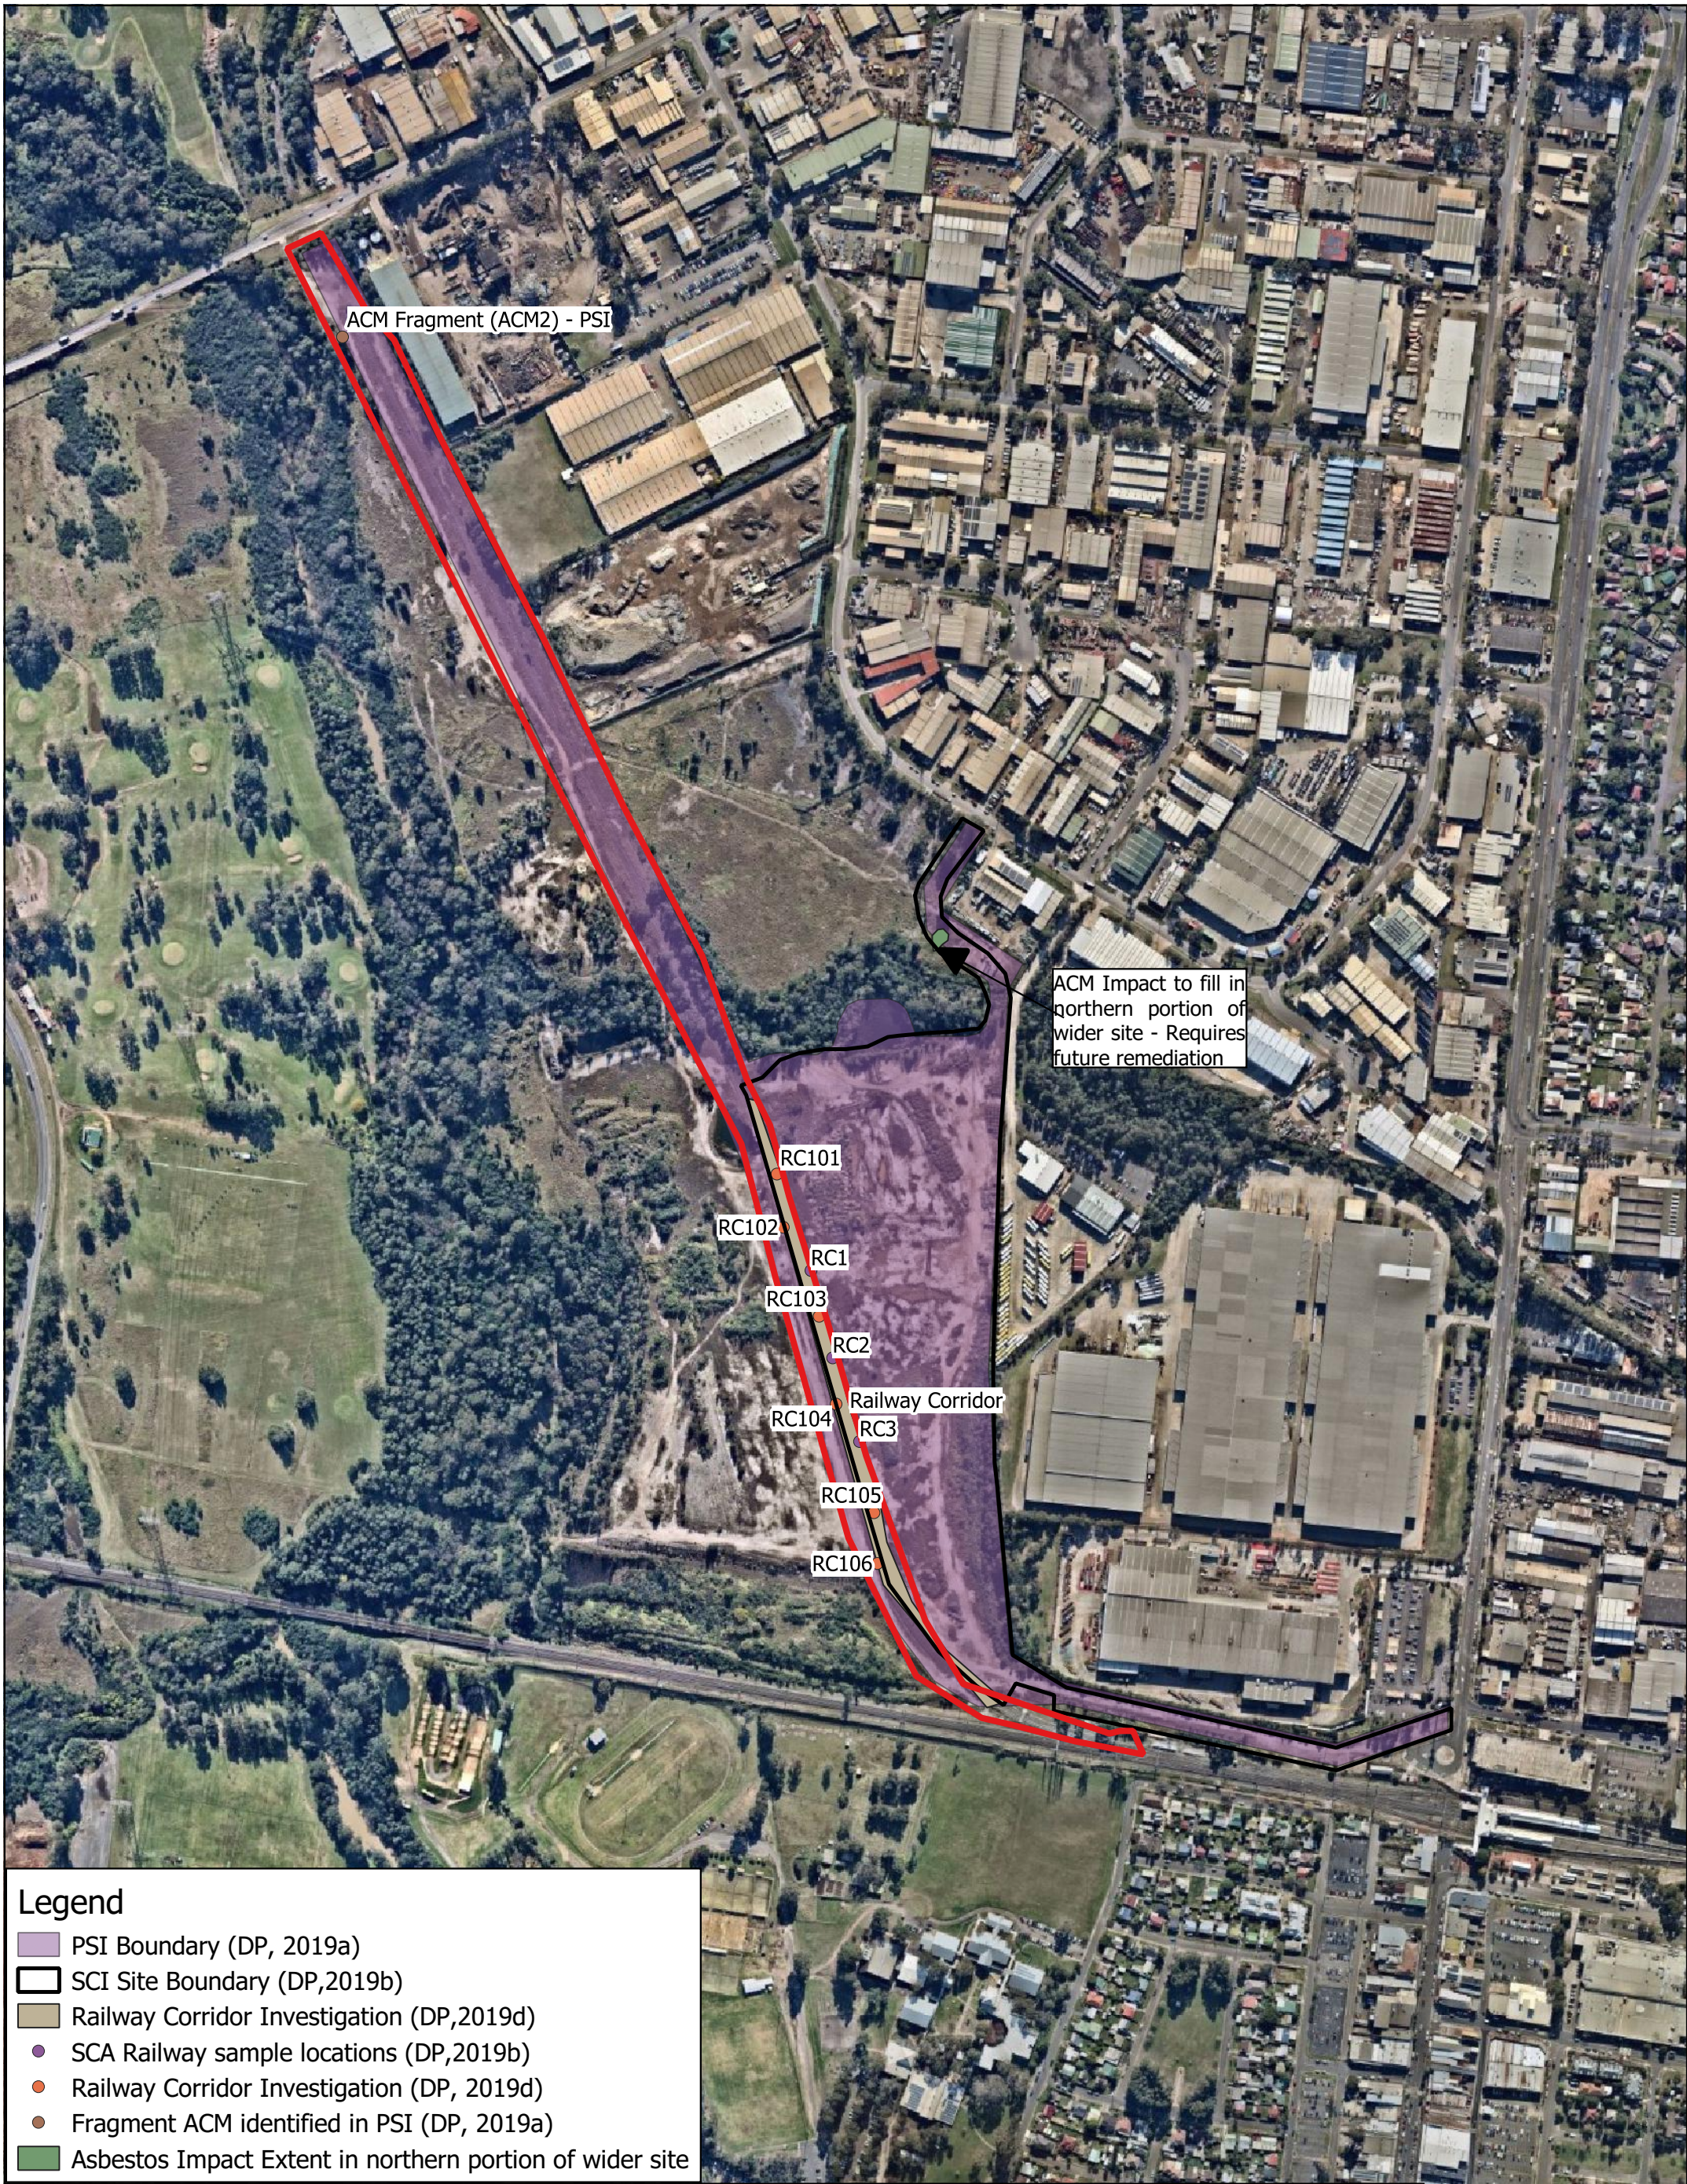
DRAWING No: 2

The following summarises the findings of the above contamination investigations relevant to the site and surrounds. The boundaries of the former investigations are shown on Drawing 2, Attachment A.

DP (2019b) was completed to further assess the PAEC identified during DP (2019a) and included the collection of three surface soil samples (RC1 to RC3 as shown on Drawing 2) in the vicinity of the southern portion of the subject site (PAEC 5 – Southern portion of the railway corridor) for laboratory analysis of asbestos.

TITLE: **Previous Investigation Boundaries and Sample locations**  
**Supplementary Contamination Investigation -**

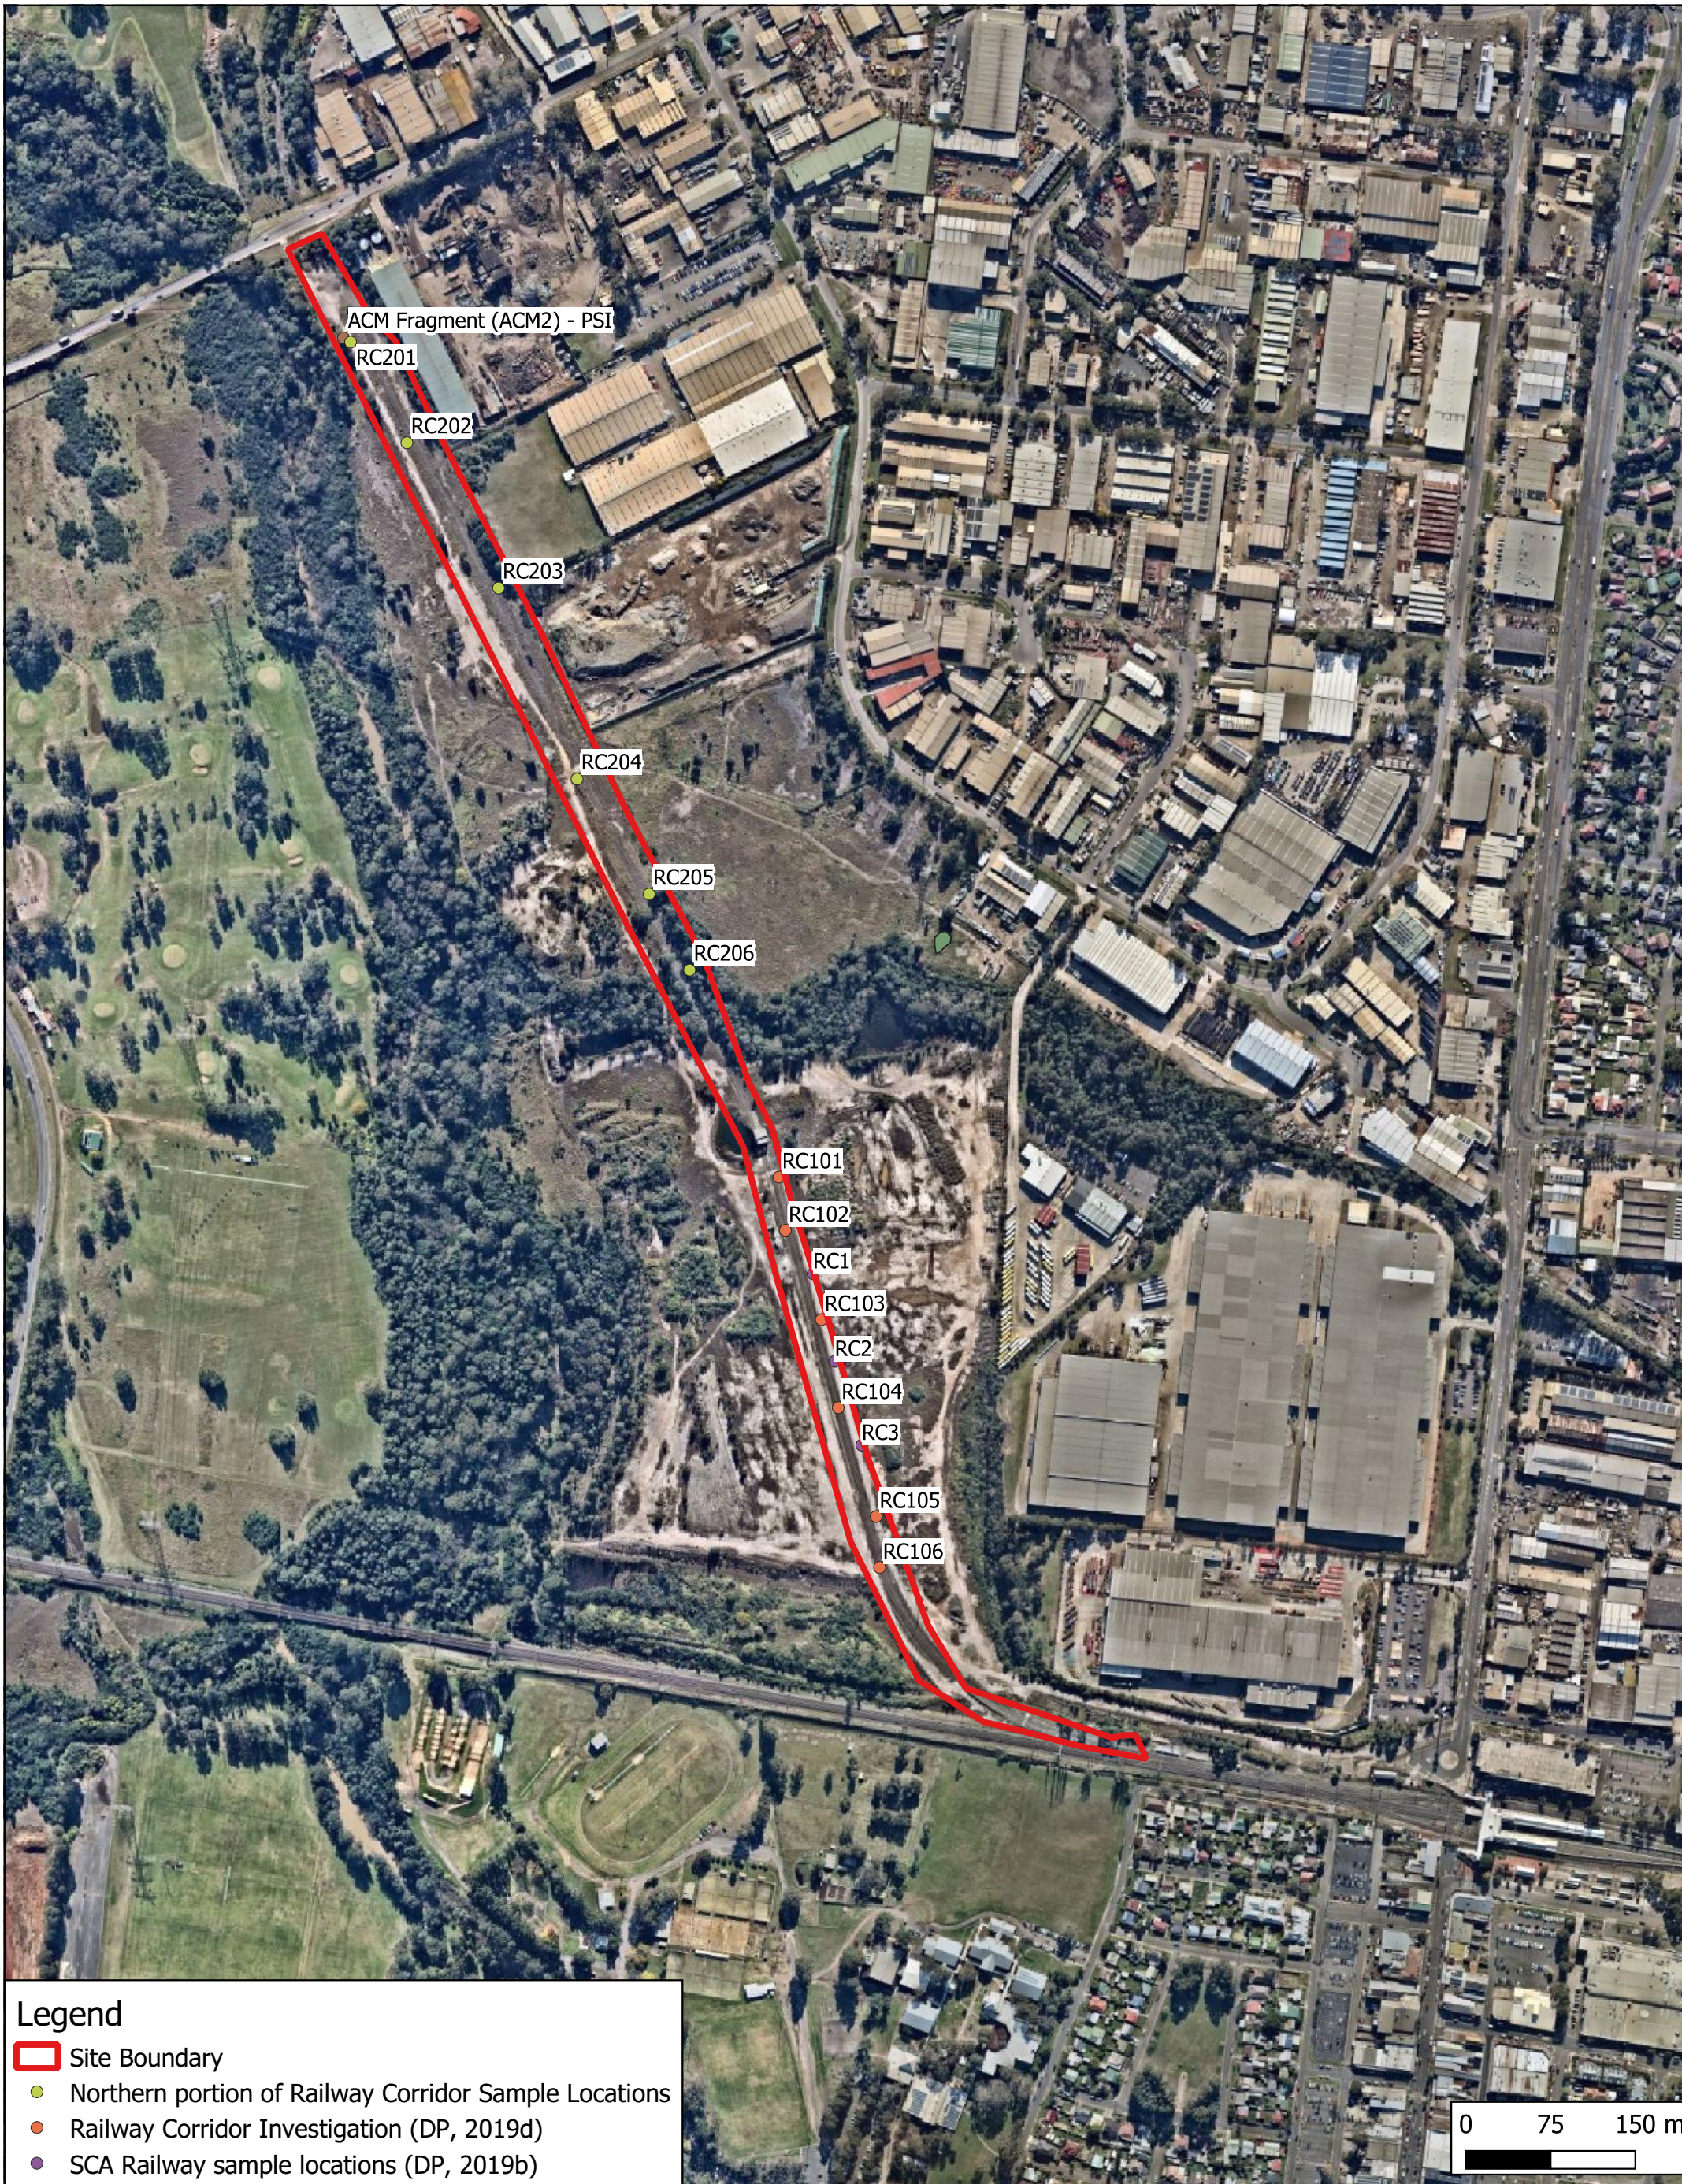
DRAWING No: 3

- Site walkover on a 2 m grid along the northern portion of the railway corridor for the visual assessment of asbestos on the site surface;;
- Collection of an additional six surface (0.0 - 0.1 m bgl) soil samples (RC201 to RC206) along the length of the northern portion of the railway corridor for the laboratory analysis of asbestos (one of the primary CoPC associated with railway corridors). One sample (RC201) was collected in the immediate vicinity of the ACM fragment identified in DP (2019a). The railway corridor sample locations from this investigation, the SCI (RC1 to RC3) and previous Railway Investigation (DP, 2019d) are presented on Drawing 3;

TITLE: **Supplementary Contamination Investigation  
Railway Corridor Sample Locations  
Lot 2 Forrester Road, St Marys NSW**

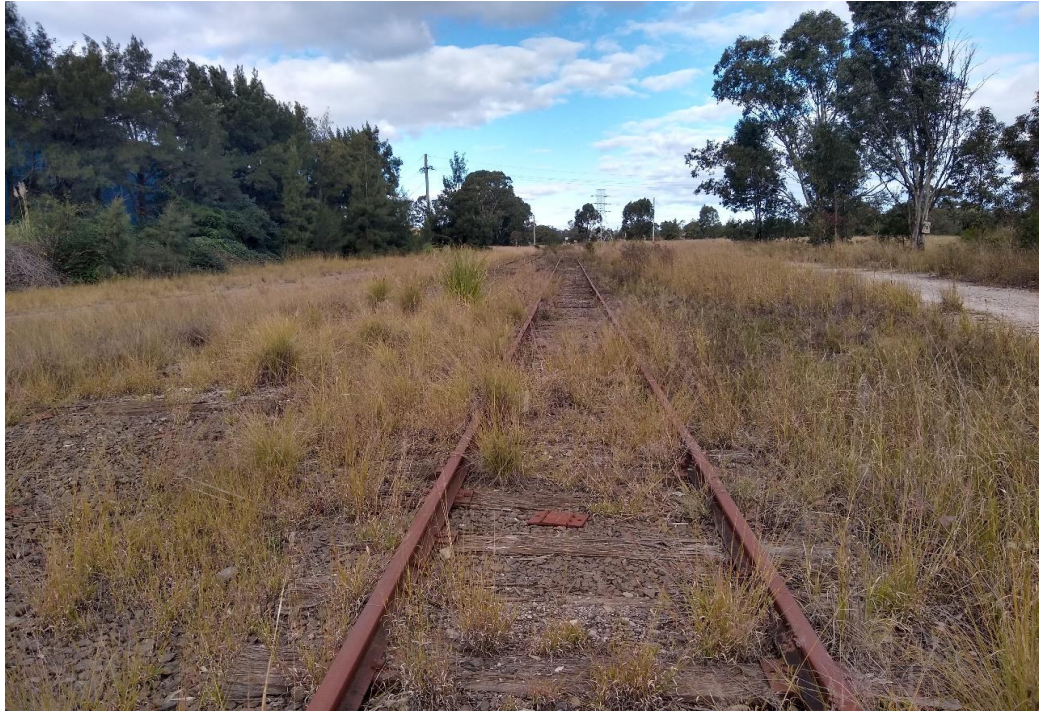
Surface soil encountered at soil sample locations within the railway corridor generally comprised clayey sand with trace gravels. No obvious ACM or building waste commonly indicative of ACM was evident during the site walkover of the railway corridor.

Photo 1 - Northern portion of the railway corridor

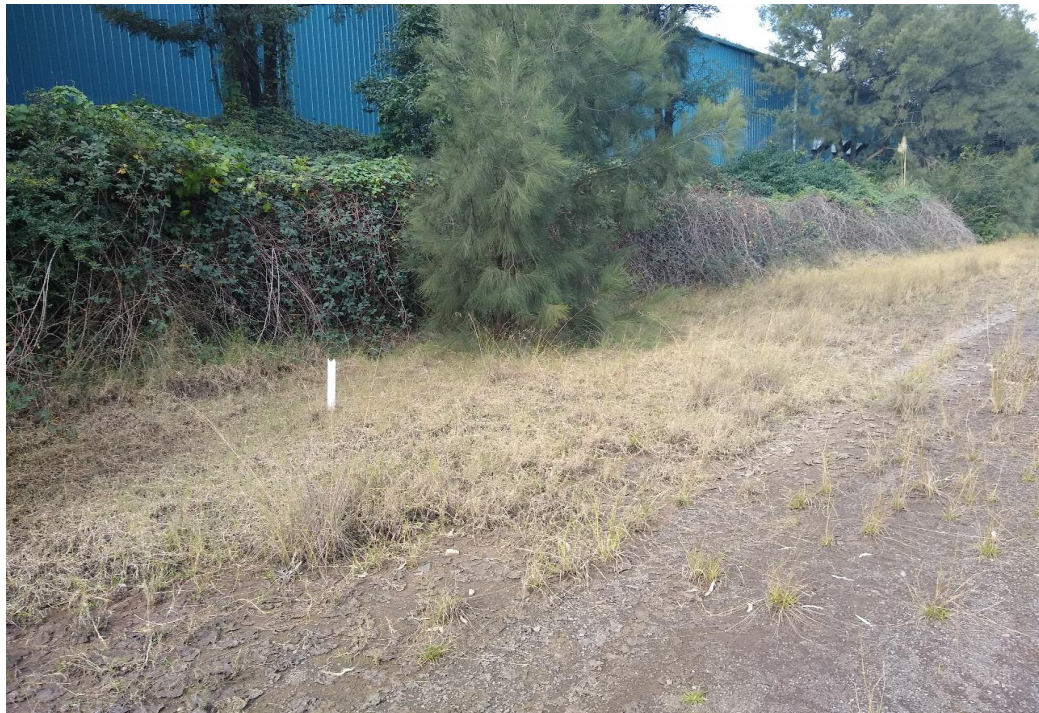
Photo 2 - Land immediately adjacent to railway lines in northern portion of site

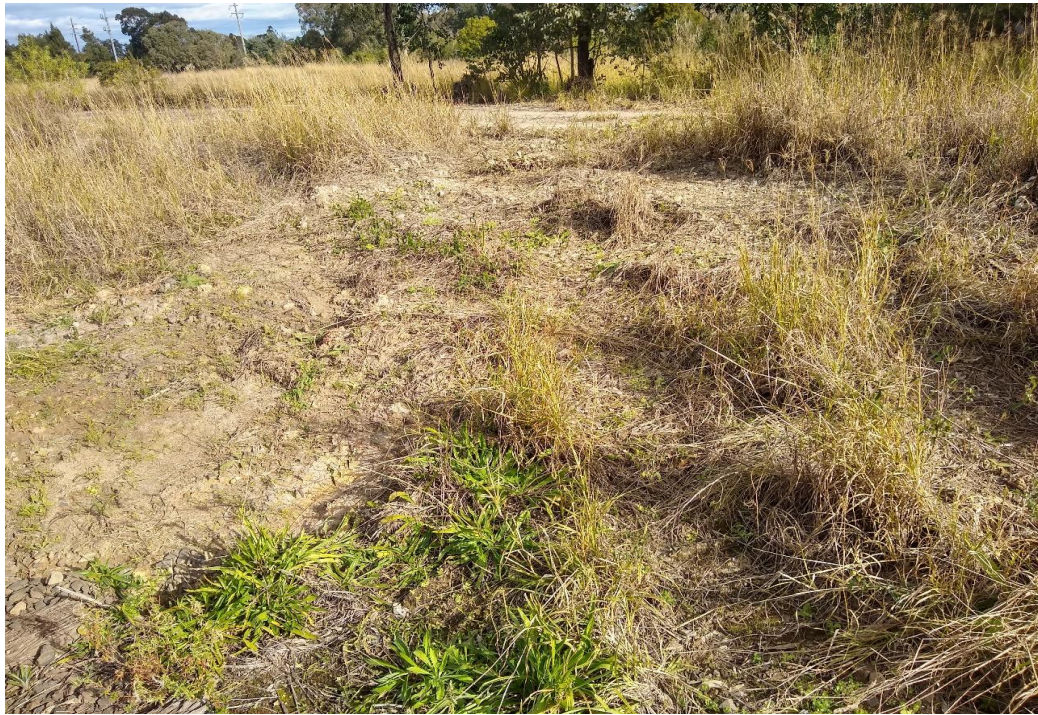
The PSI (DP, 2019a) identified one small fragment of ACM in the northern portion of the site. The fragment of ACM however, is considered to be representative of an anomalous isolated occurrence and not indicative of widespread impact within the railway corridor site given that:

Photo 3 - Area in vicinity of previously identified ACM fragment

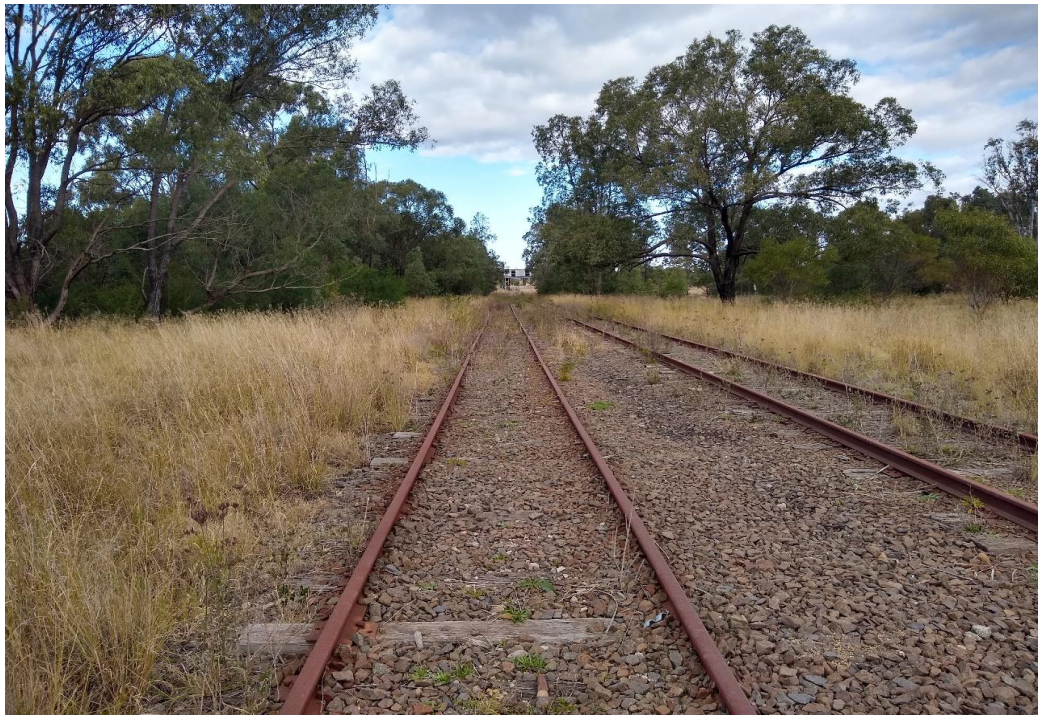
Photo 4 - Central northern portion of railway corridor

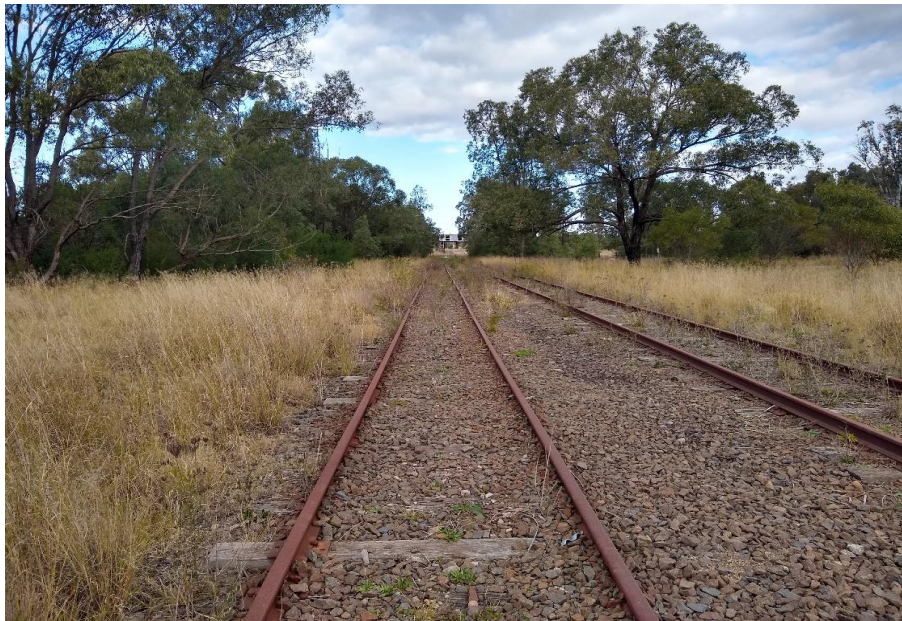
Photo 10 - central portion of railway corridor
