Taronga Zoo  
Institute of Science & Learning  
Heritage Impact Assessment  
9 December 2015

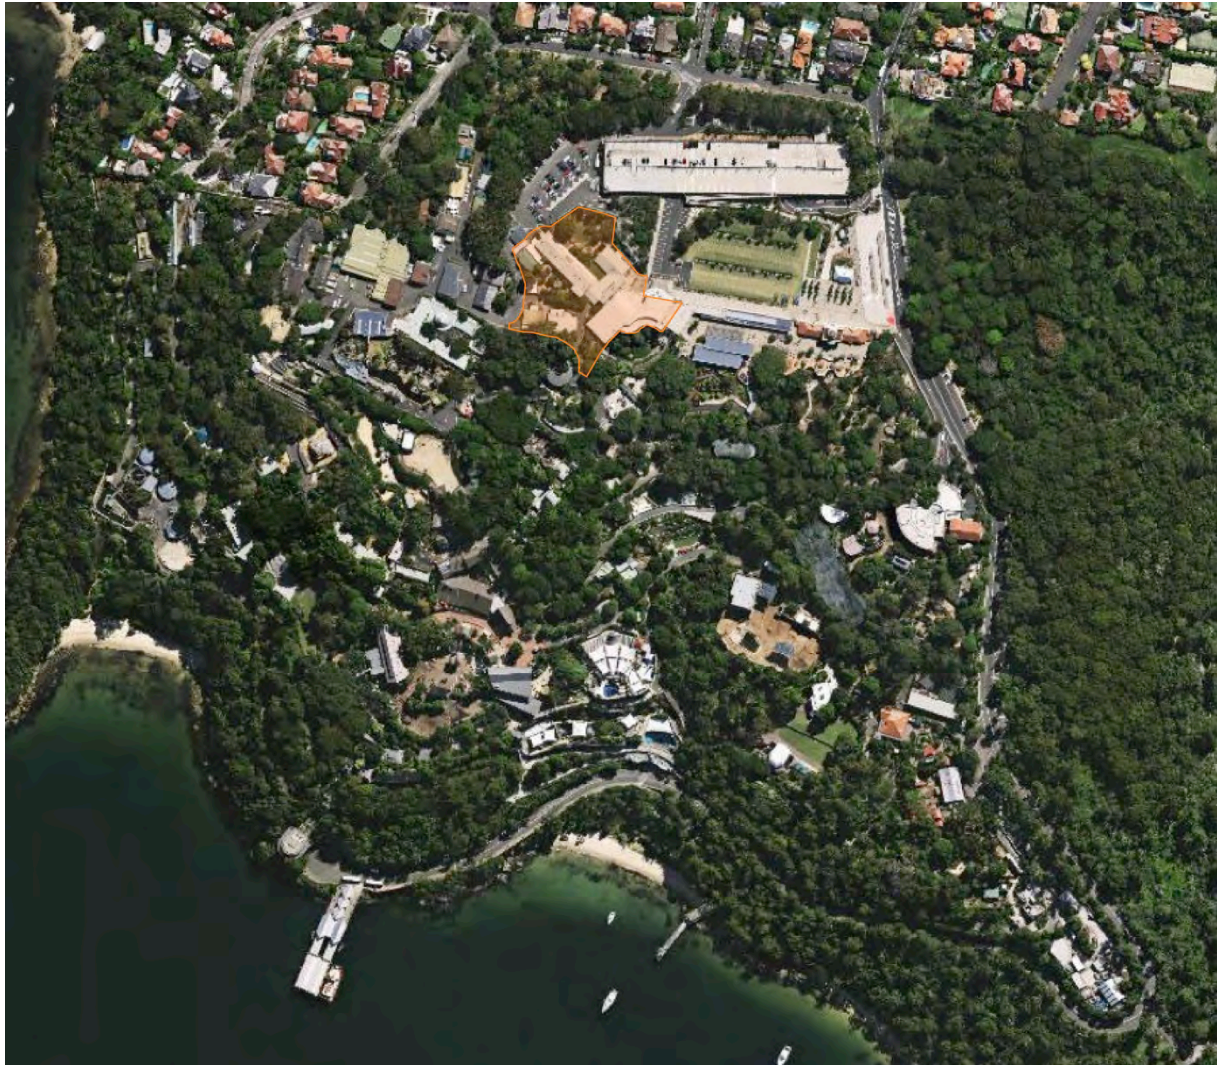
**Figure 1.1** Aerial photo of Taronga Zoo showing the location of the proposed Institute of Science and Learning, shaded in orange. Source: LPI SIX viewer annotated by Jean Rice Architect

The site is located in the northern part of the Zoo and straddles the original boundary wall (07L). The site is currently occupied by the Education Centre, which will be replaced by the proposed development. To the north of the site is the staff, contractor and bus parking area and an elevated naturally vegetated area maintained under a bush regeneration program. To the east is the top station of the cable car and to the west back of house facilities. To the south are the public areas of the Zoo including the Koala House and several aviaries (see Figures 1.1 and 1.2).

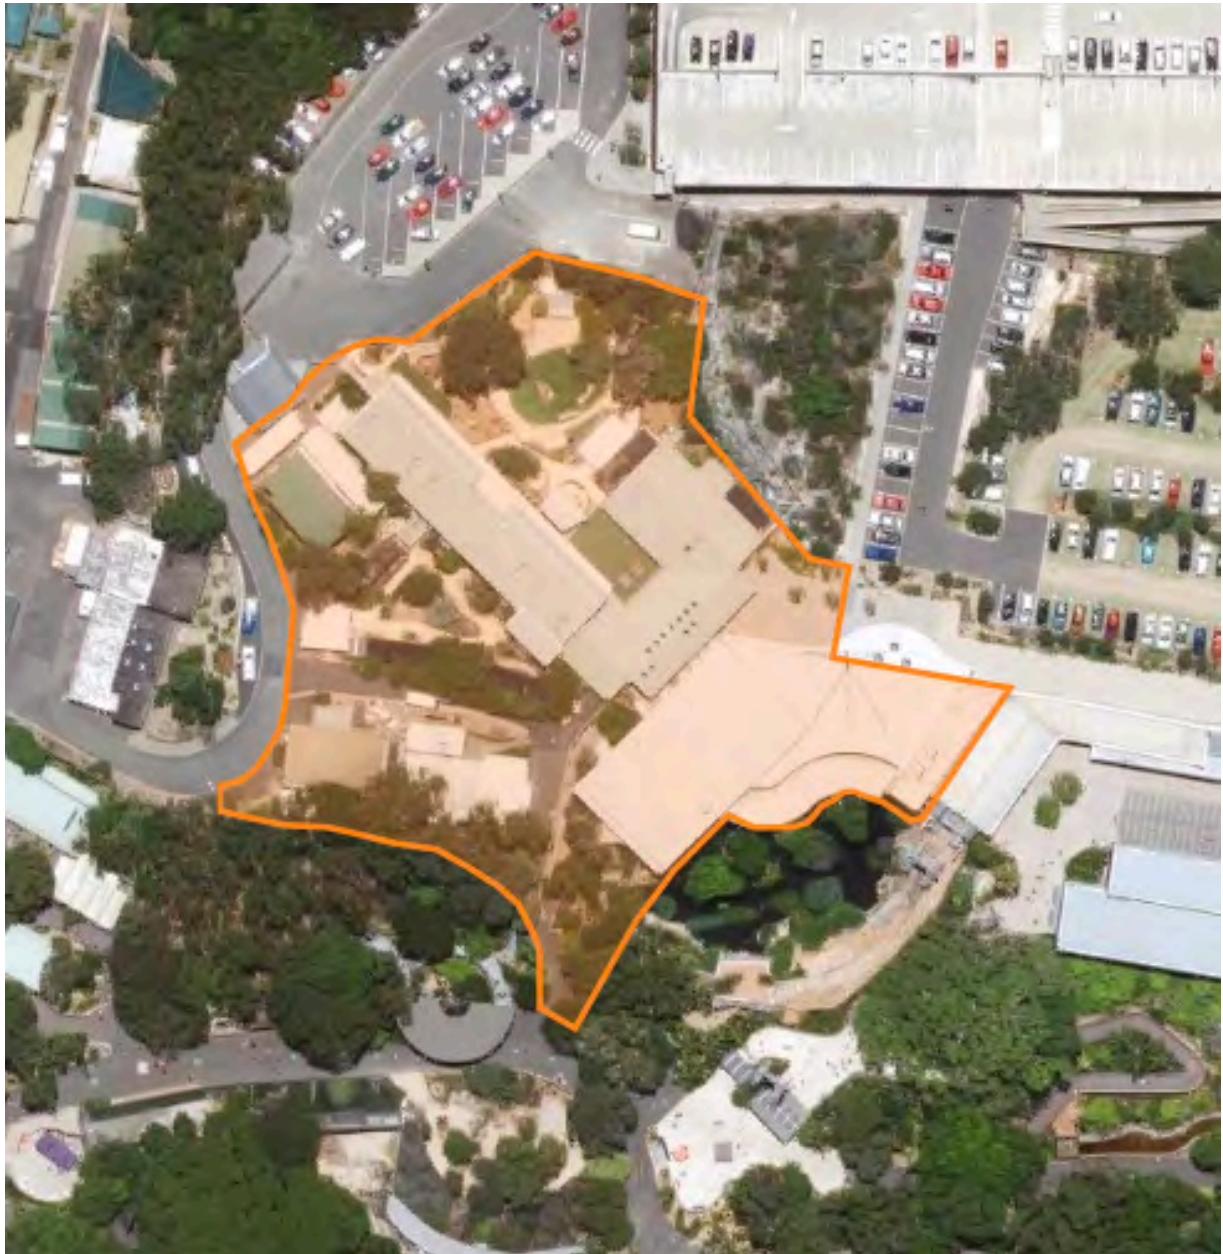
**Figure 1.2** Aerial photograph of the existing site showing the area of the proposal shaded orange. Source: LPI SIX viewer annotated by Jean Rice Architect

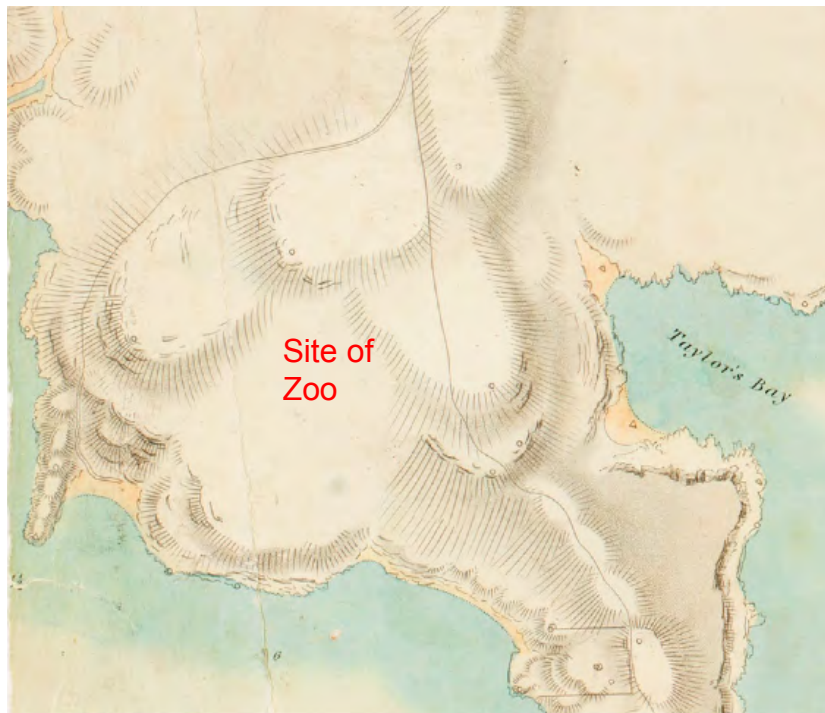
**Figure 2.1** Extract from Thomas Mitchell's Trigonometrical Survey of Port Jackson dated 1853 showing Bradley's Head. The later location of the Zoo is indicated. Source: SLNSW Z/M4/811.15/1853/1

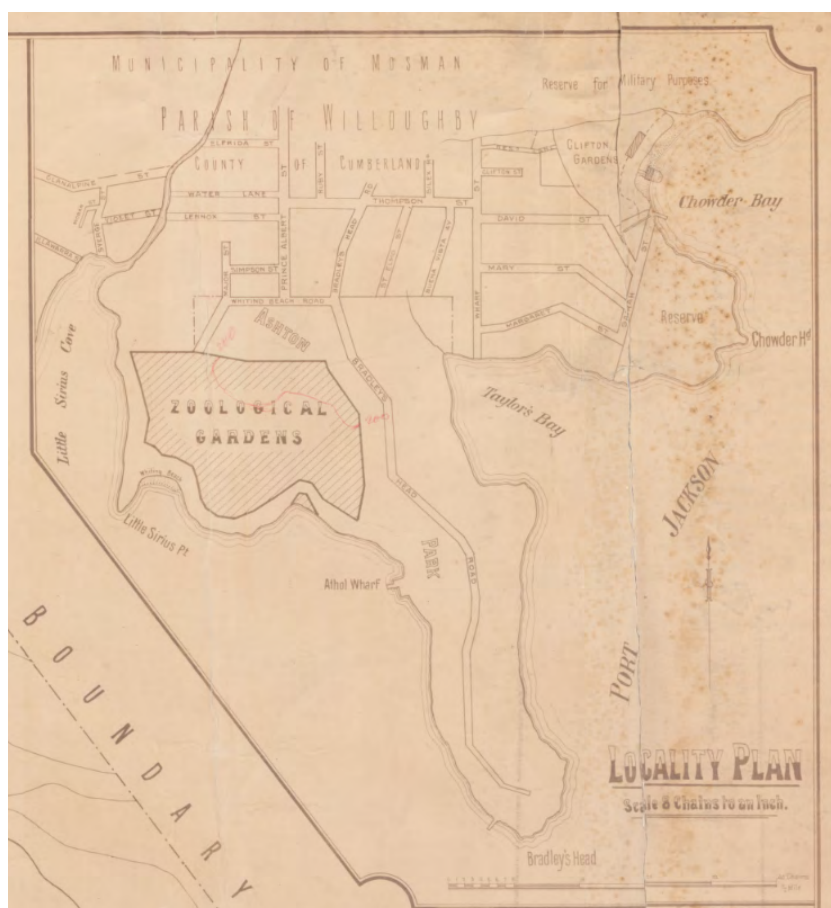
**Figure 2.2** Locality plan from the 1912 survey of the site of the Zoological Gardens prepared by the Public Works Department . Source: NLA Map RM 3875

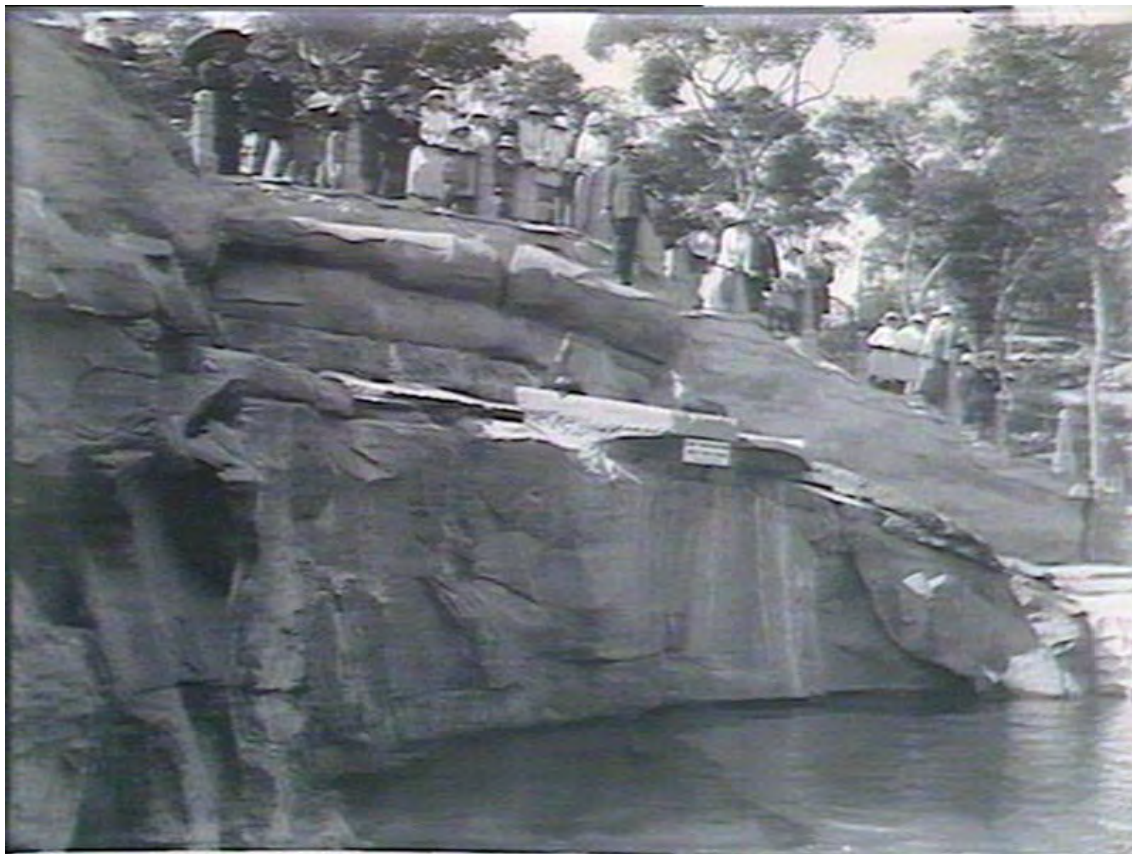
**Figure 2.4** Feeding the Seals in the pond created out of a former quarry, February 1917, ML GPO 1 Still 18467

A lower area that was also quarried was converted into the seal ponds in 1914-15. The Government Architect in his report noted that:

A large quarry excavation, now disused, is being adapted for seal and other ponds, and will be finished with ornamental balustrades and staircases &c. A great deal of work has been done in road making including kerbs and gutters, the conditions (rock excavation in parts and heavy filling in places) necessitating much labour.<sup>7</sup>

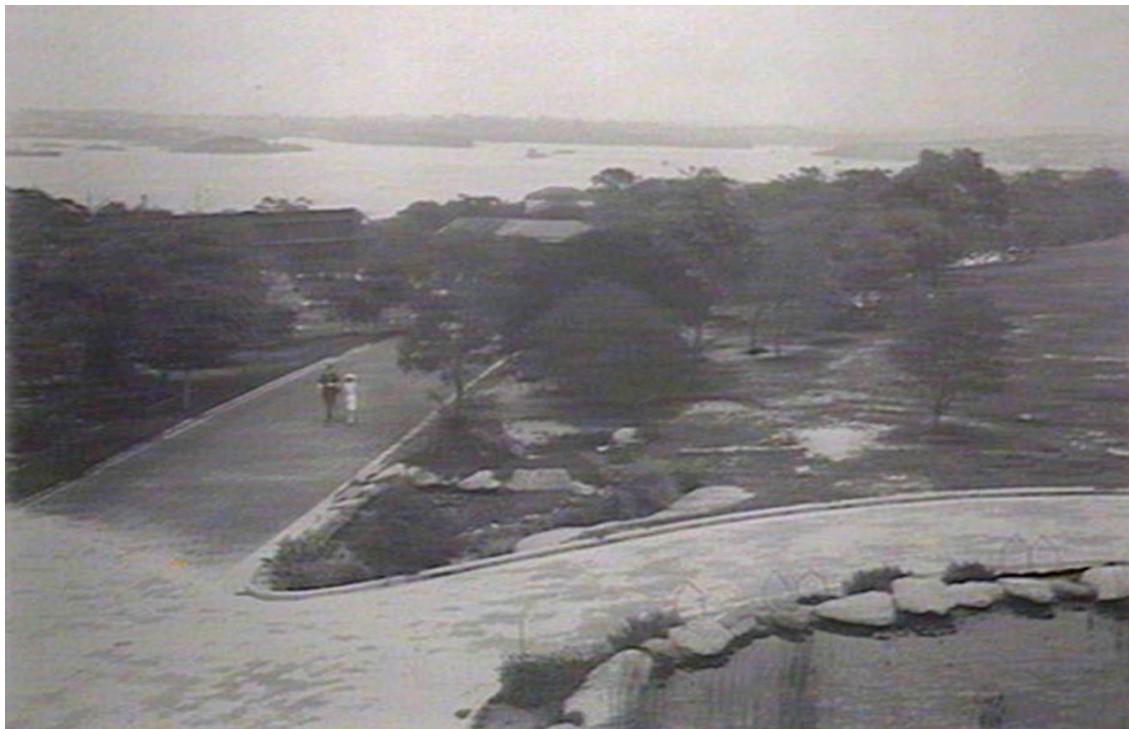
**Figure 2.5** Vegetation near the upper entrance to the Zoo. The quarry / reservoir would have been on the right and part of the water lily ponds is in the foreground. ML GPO 1 Still 19140

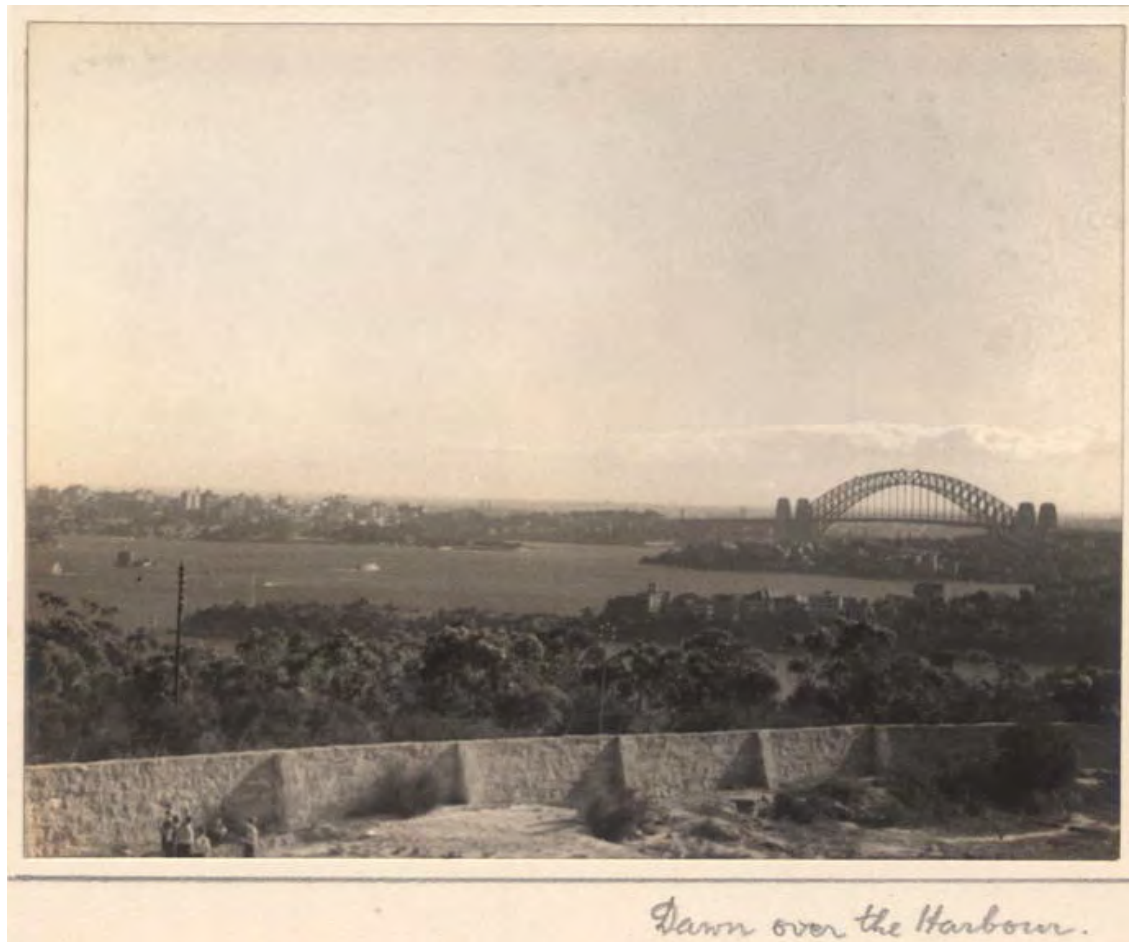
**Figure 2.7** Photograph entitled “Dawn over the Harbour”, showing the recently completed perimeter wall to the Zoo. Dated c. 1935, Source: RAHS Osborne Album

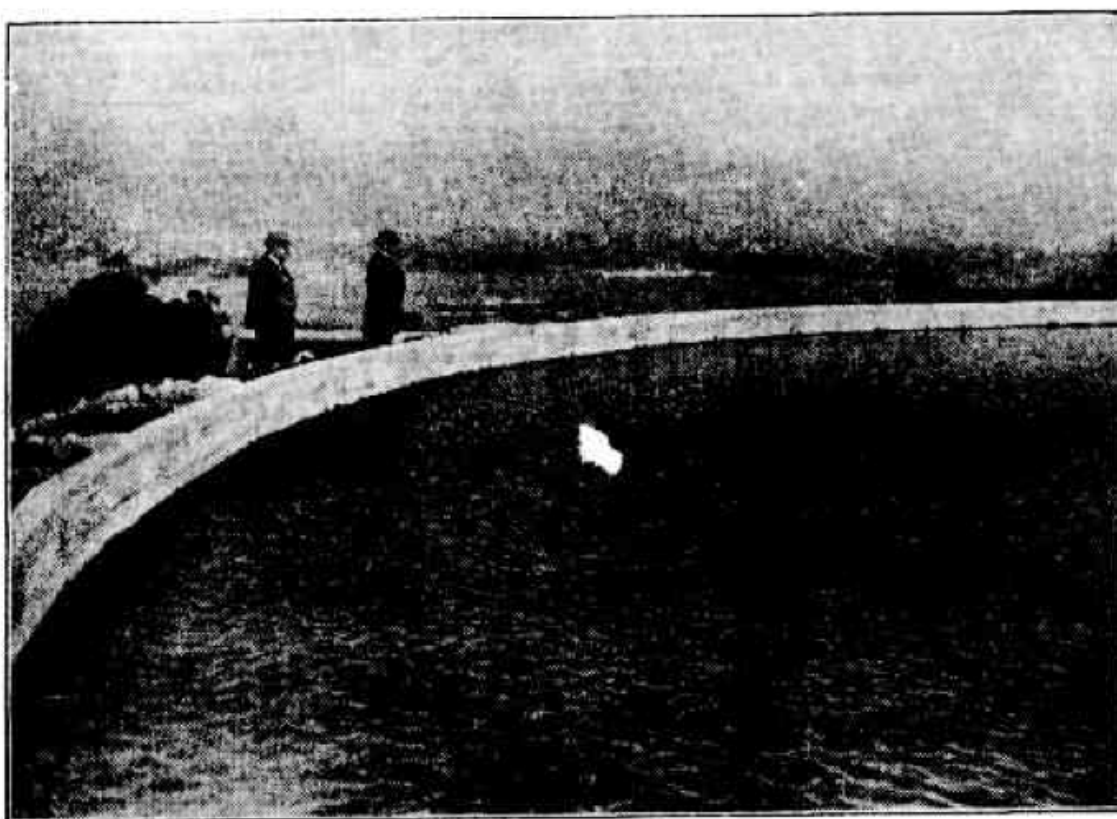
## NEW RESERVOIR AT TARONGA PARK ZOO.

For the purpose of increasing the water pressure, the Zoo authorities have completed this reservoir at Taronga Park. It has a depth of 30 feet.

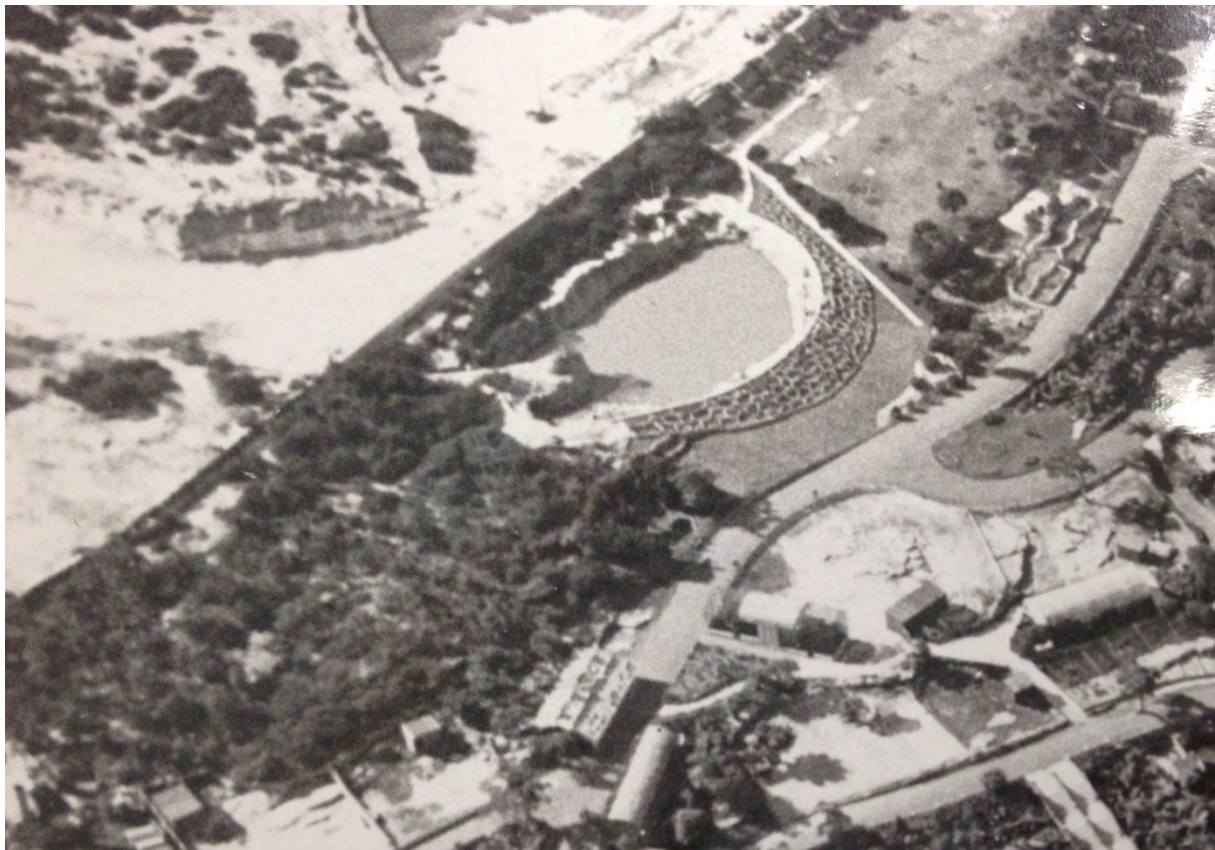
**Figure 2.10** This extract of a c1930 aerial photo shows the reservoir and the rockery below it. To the right is what may be the waterlily ponds and the alligator exhibit is a kidney shaped pool below the reservoir. The Zoo boundary wall runs diagonally across the photo. Source Rephotographed from c.1930 aerial, copy held by the GAO.

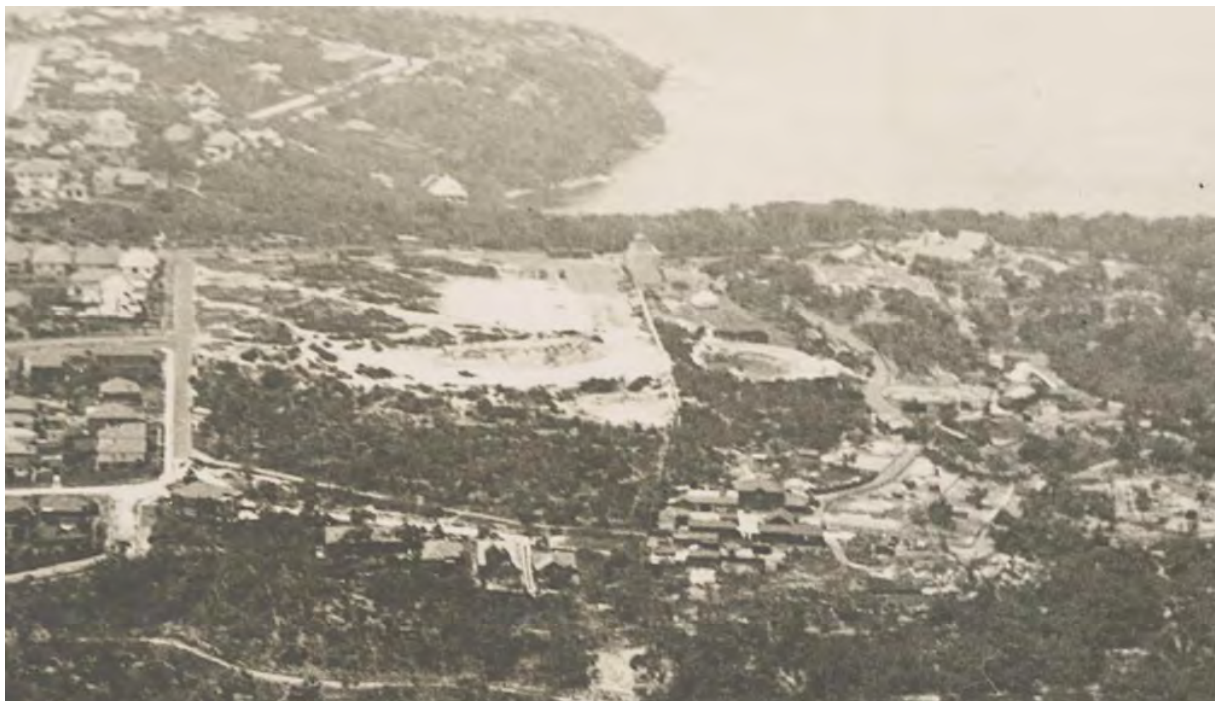
**Figure 2.11** Extract from a mid 1930s aerial of the Zoo viewed from the west. It shows the reservoir, the perimeter wall and the section of Ashton Park used as a source of materials to erect the perimeter walling. Source: NLA E .W. Searle Collection nla.obj-141915048/PIC P838/803a LOC Drawer Q43

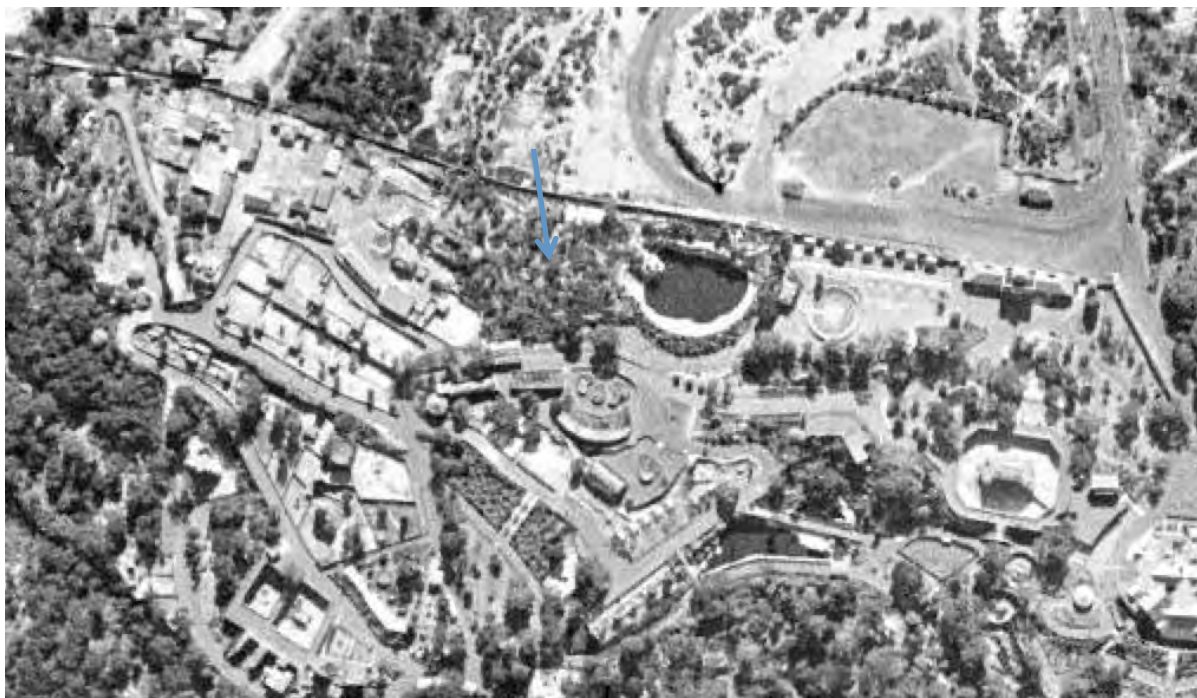
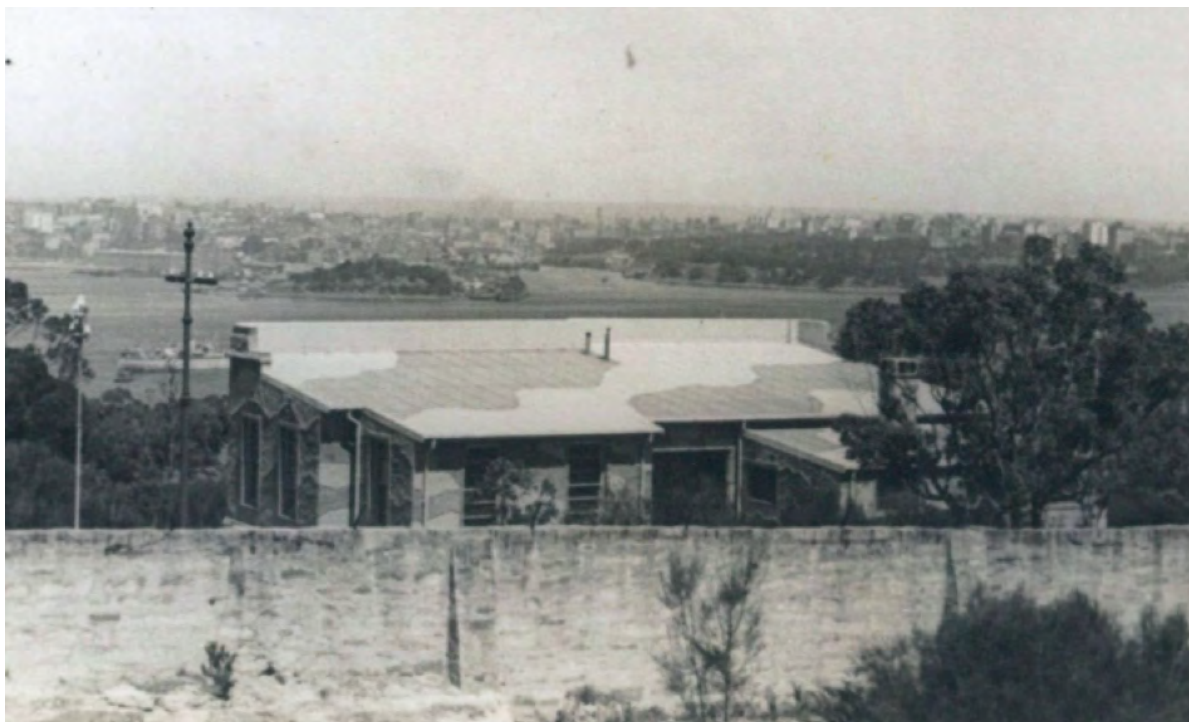
**Figure 2.14** View from the lookout in Ashton Park above the Zoo showing the former Staff Amenities building with its camouflage-painted roof – date unknown but after 1943. Source: Mosman Local Studies

By the mid 1950s a new building had been erected to the west of the reservoir, designed to blend into the surroundings. Although listed in the S170 register as dating from the 1930s or 40s, the building known as the former staff amenities block does not appear on plans until 1956 and is not on the 1943 aerial. Its purpose is not labelled so it was not built to house exhibits. A photograph at Mosman Local studies shows camouflage paint on roof, indicating that the building dated from the war (or utilised available materials). Other facilities at George's Heights and Bradleys Head were also painted with camouflage paint, including the Degaussing Station. The possibility that the building had a military function is not supported by research. There are no file references indicating that sections of the Zoo had been requisitioned though the Army had utilised part of Ashton Park.

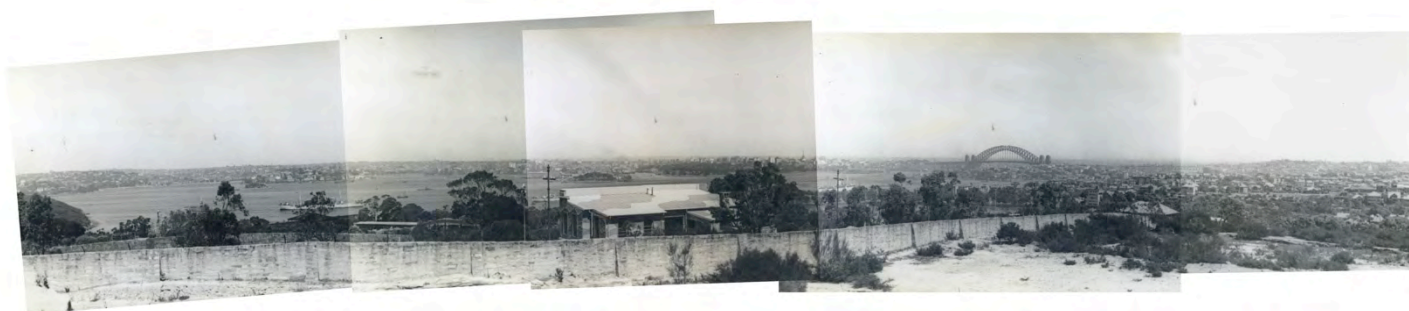
**Figure 2.15** View across the perimeter wall to the Harbour Bridge. Source: Mosman Local Studies, stitched together from five images. The centre image is that shown at Figure 2.14.

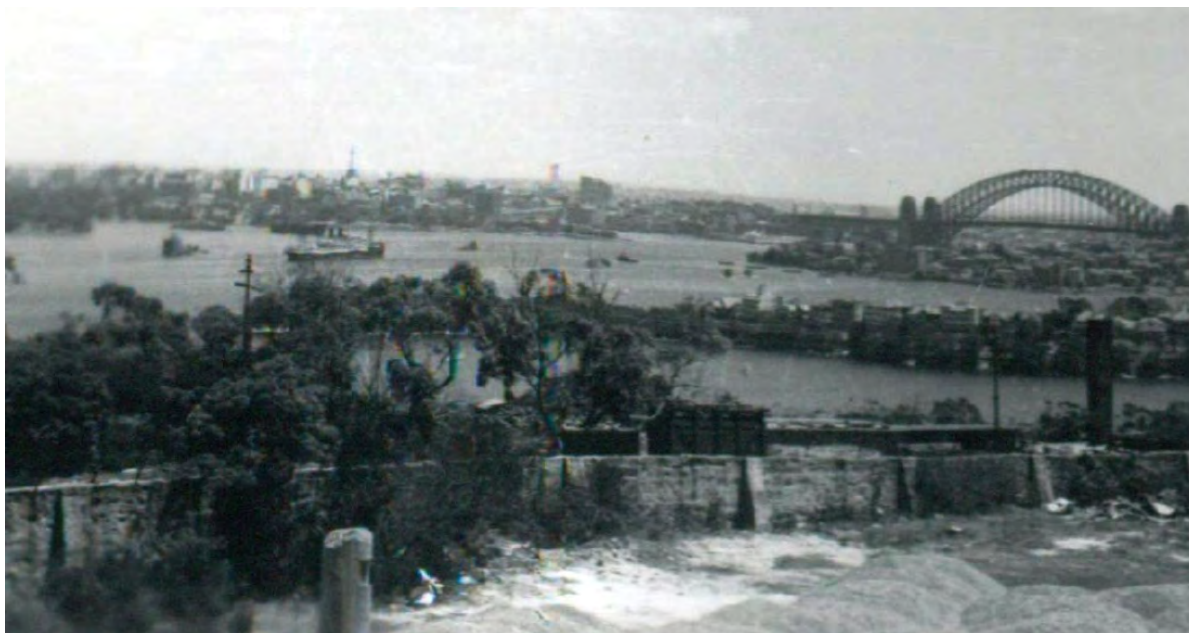
**Figure 2.16.** Source: One of the series of views of “Mosman tip” held in the Mosman Local Studies collection. It is clearly the Zoo wall but it is not clear where the tip was.

A photograph held by Mosman Council labelled Mosman tip also shows buildings within the zoological gardens just adjacent to the perimeter wall. The use as a tip was short-lived and appears to be outside the stone wall. 1962 aerial images show an extensive filled area that is the current staff carpark and this is likely to have been “the tip”.

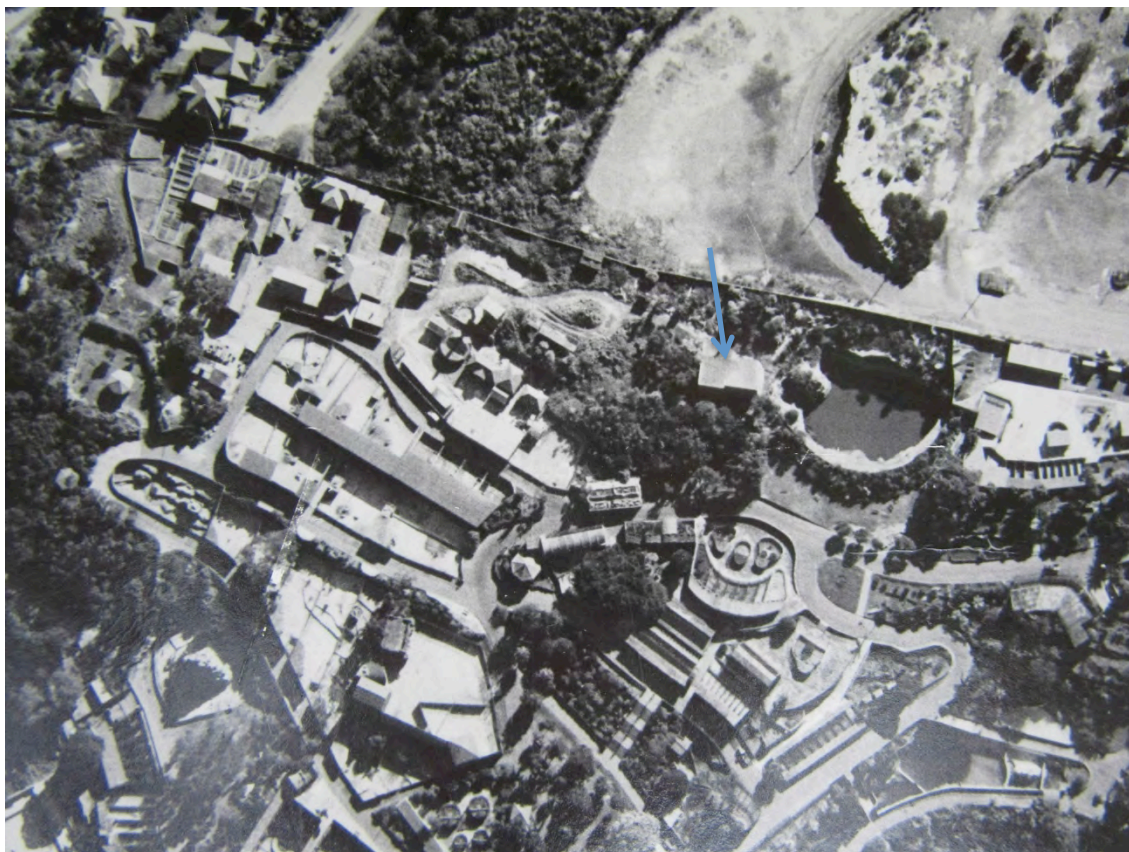
**Figure 2.18** Extract from the c1950 aerial image. The Staff Amenities building is shown with informal road access from the west. The stone boundary wall is intact and there is a roadway between the wall and the elevated bush remnant. Source: Framed print held at CWI, Taronga Zoo.

Plans do not show clearly how this building was approached. Aerial photos (Fig. 2.18 and 1962 images) indicate an informal access road from the west, set in from the boundary wall. Initially there does not appear to have been any access from the path below. The alligator exhibit was below the building.

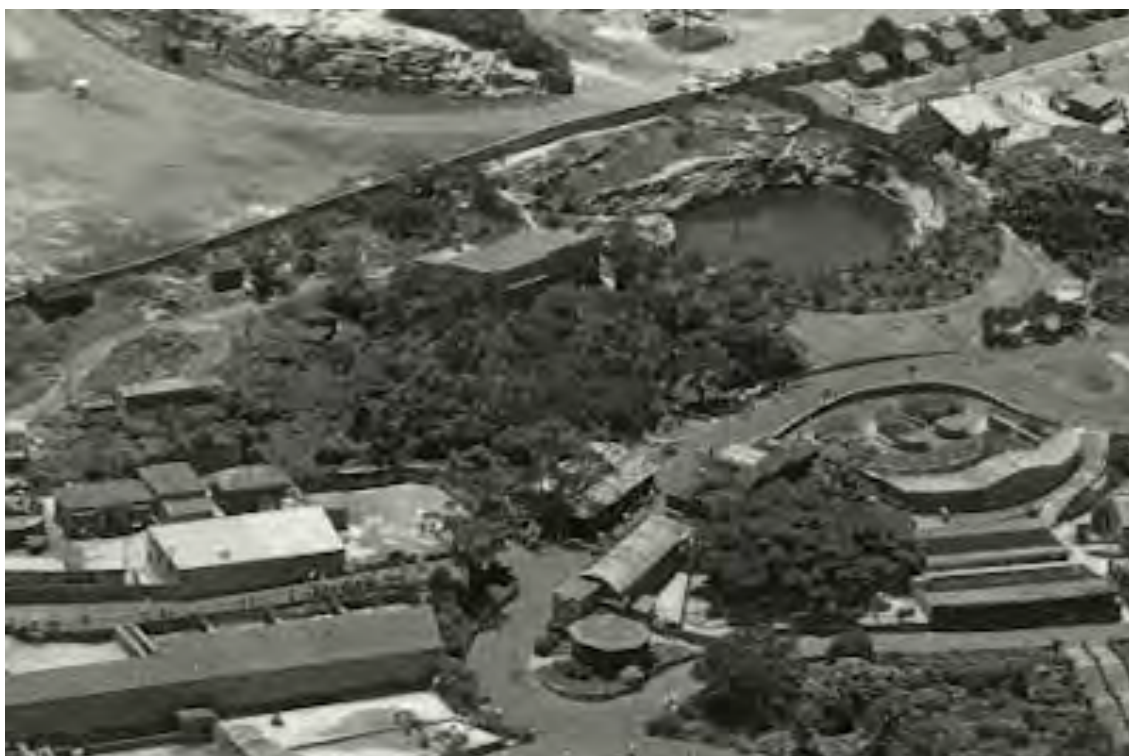
**Figure 2.19** Extract from a 1960 aerial image. It shows the Reservoir and the Staff Amenities building adjacent. There is dense vegetation between the amenities and the main path below but the parapet of the building can be seen clearly indicating that the tree tops are lower than today. Source: Taronga Zoo Archives

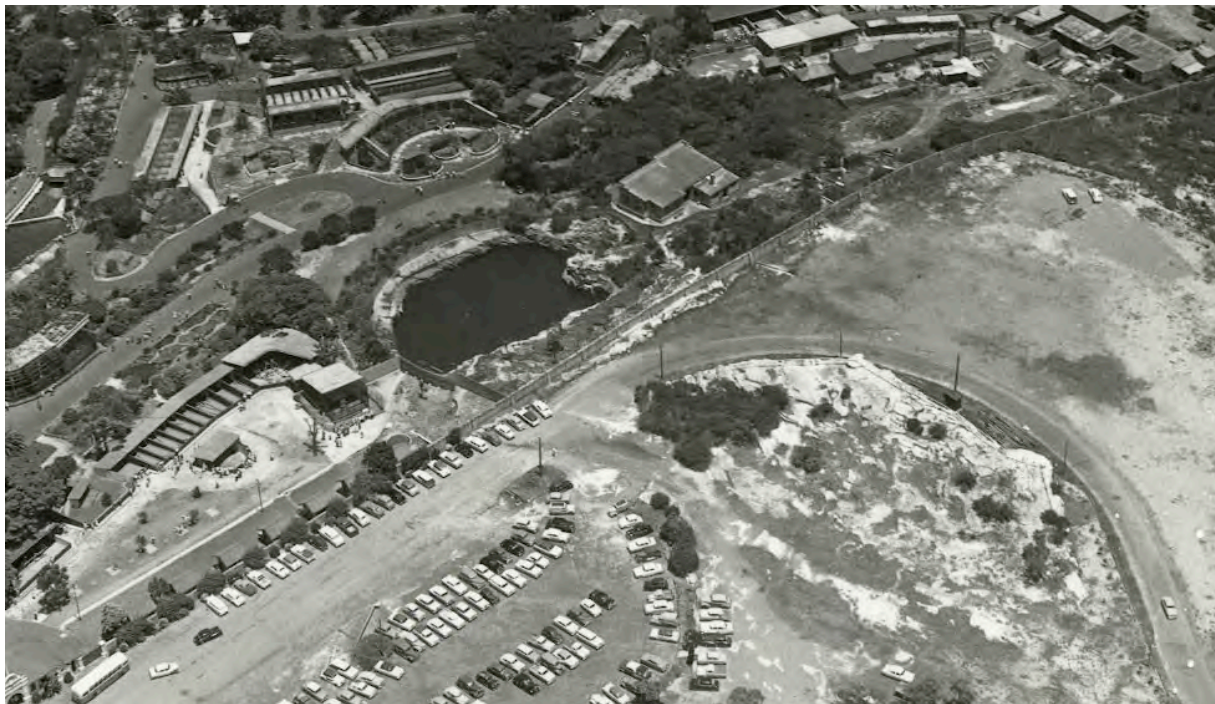
**Figure 2.20** Extract from the 1962 aerial photograph by Douglas Baglin showing the staff amenities building, reservoir, perimeter wall, carpark, loop road and the remnants of the lookout. Source: Taronga Zoo Archives

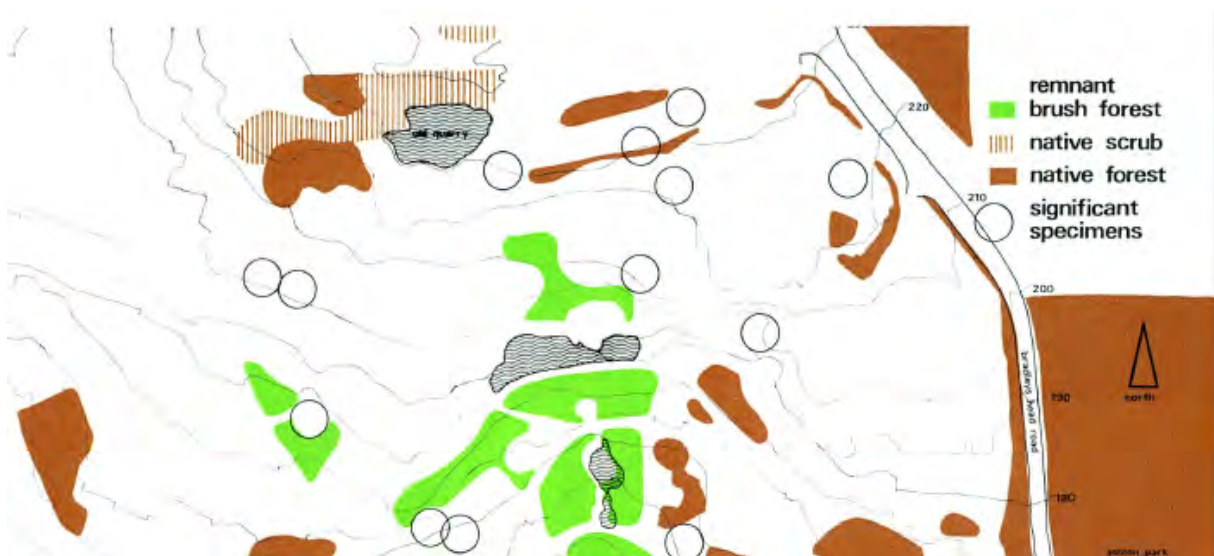
**Figure 2.21** 1970 masterplan, vegetation survey, Taronga Zoo Source: Architecture Australia December 1970

In 1970-71 a new Masterplan for the zoo was prepared by the Public Works Department, which sought to retain what remained of the natural topography and vegetation. New buildings were to be designed in the so called 'Sydney School' manner, which utilised a palette of natural materials and integrated the building into the landscape. This design approach is now termed Late Twentieth Century Sydney Regional. A new entrance was proposed at the centre of the north boundary - to the west of the reservoir. The analysis of the landform shows that the former quarry had been linked into the existing watercourses, and formed part of a series of water exhibits. Native scrub and forest is identified adjacent to the reservoir, with an unnatural straight edge to the north the result of the perimeter wall.

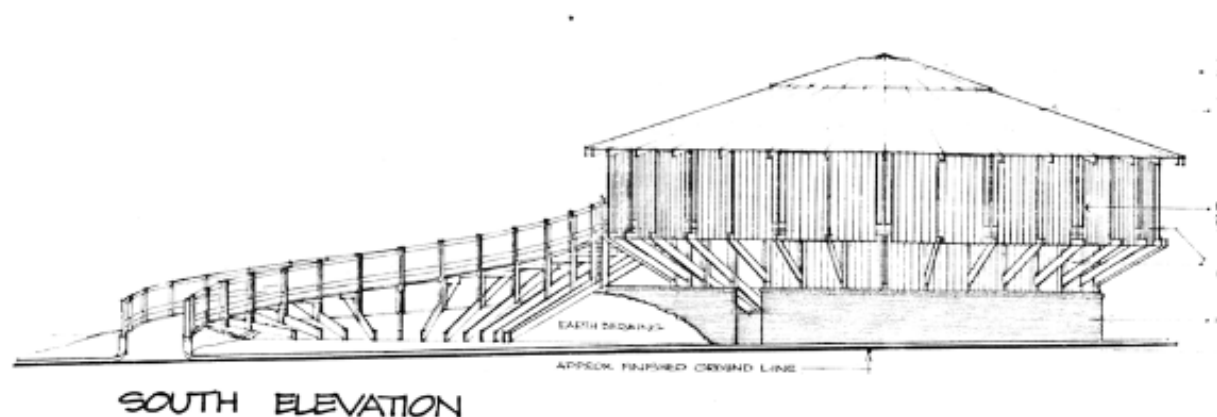
**Figure 2.23** Drawing of the proposed Koala house. Source: PWD Plan Room - Misc 198/135

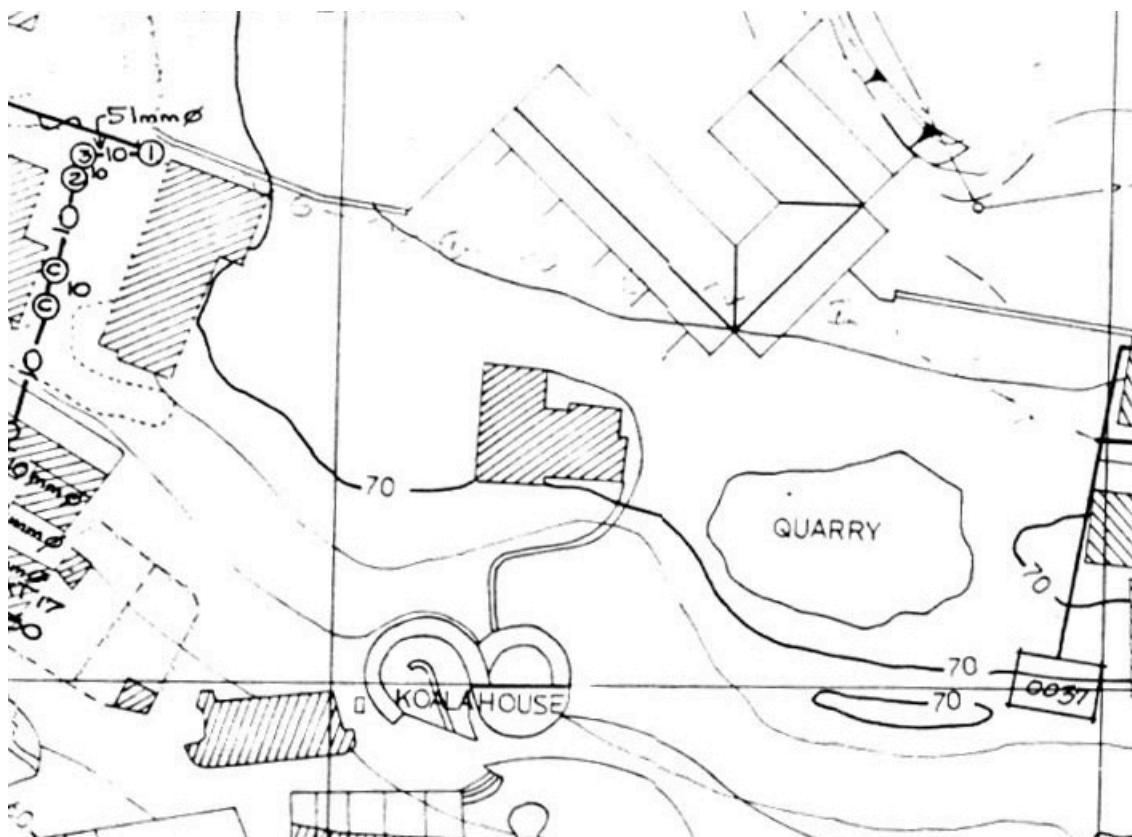
**Figure 2.25** This extract from the 1975 survey shows the Koala House and its ramp. The reservoir is shown as a quarry so was probably not the Alligator exhibit at this time. The staff amenities block is shown and a path between it and the Koala House. This path predated the Koala House. The site of the Education Centre is shown but as the roof is not hatched it may not have been built when the survey was done. Source: GAO

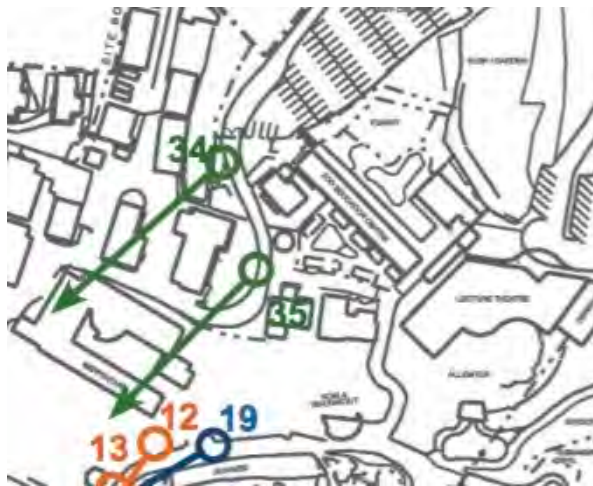
**Figure 2.28** Extract of the map in the Landscape Management Plan showing significant views in the vicinity of the site. Views 34 and 35 are glimpses of the Harbour bridge and city from the access road. This is outside the site and is not affected. Source: Design 5 & Others.

The CMP identifies no views at the site in the CMS. The LMP identified views shown on the plans following. Views 34 & 35 (534V & 535V in the s170 register) are identified as glimpses of the city skyline, Opera House and Harbour Bridge and rated as moderate significance. The LMP identifies two internal views (63 & 64) (563V & 564V in the s170 register) in the vicinity of the site. These are from the pathway to the Koala House and are outside the site and are not affected. They are rated as of Moderate to High significance. View 82 (582V) is identified as a lost view and was from the top of the rocky outcrop above the site.

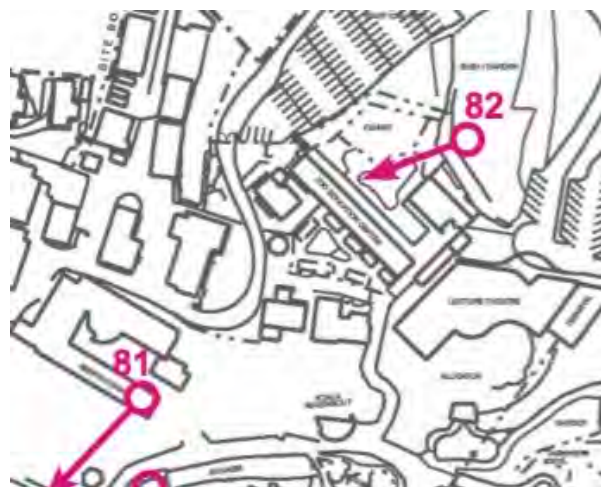
**Figure 2.30** Extract of the map in the Landscape Management Plan showing lost views in the vicinity of the site. View 82 was from the top of the rocky outcrop above the site. It is now blocked by the Education Centre. Source: Design 5 & Others.

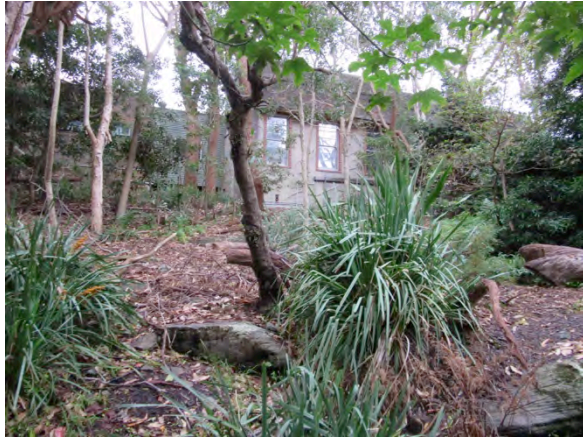
**Figure 2.31** View of former staff amenities building from Koala House with remnant vegetation. Source: Jean Rice

The building structure is substantial and is generally sound and watertight. Parts of the render, rusted ferrous metal embedments (such as arch bars) and the window hood are in poor condition. The building is damp and musty due to blocked sub-floor ventilation and inadequate or blocked stormwater drains.

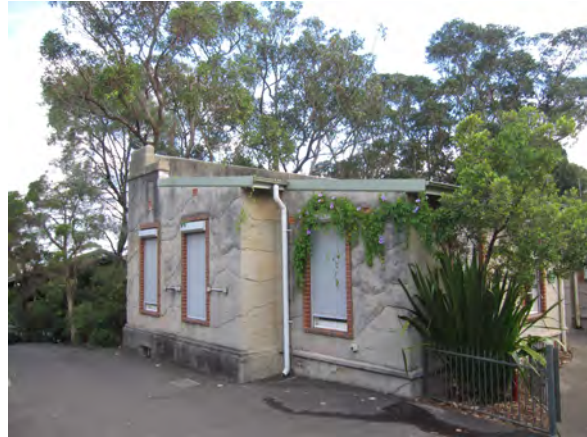
**Figure 2.32** View of former staff amenities building in 2015. Source: Jean Rice

The building is currently used as offices and to house the records. The wet areas are no longer used and are blocked off. The Zoo does not consider the building is suitable for continuing use. In particular it is unsuitable for records storage.

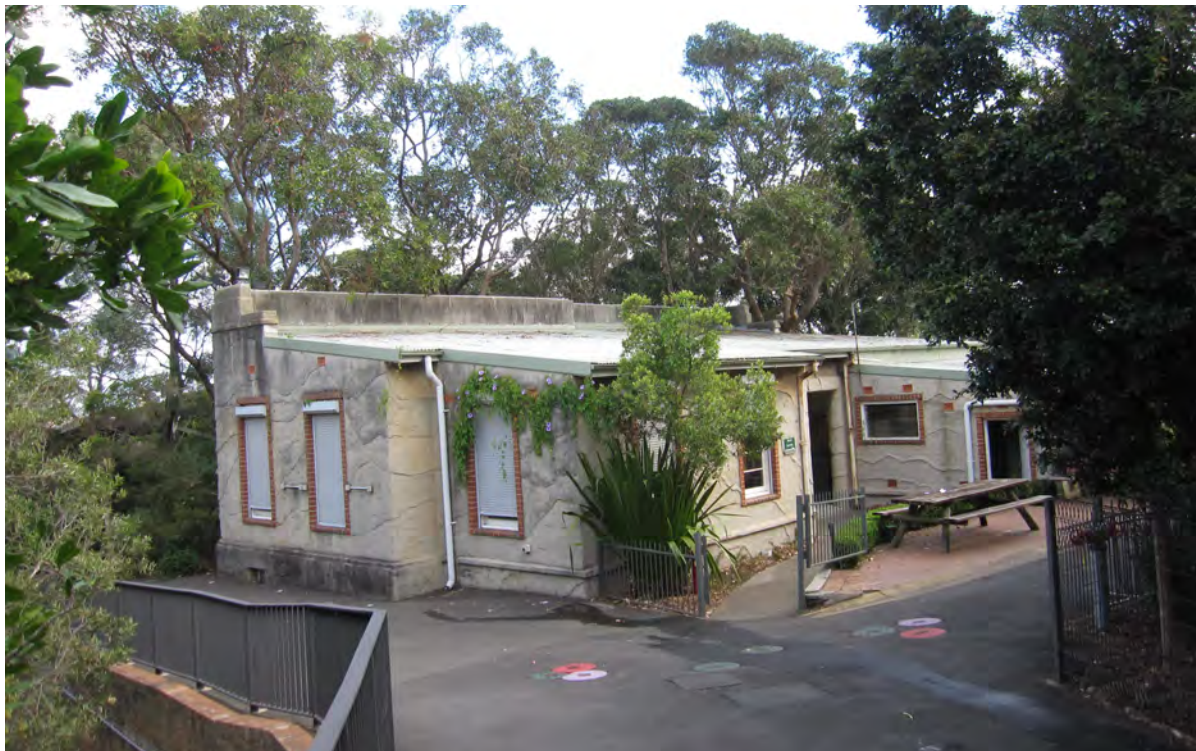
**Figure 2.33** General view of former staff amenities building in 2015. The brick retaining wall and railing is above the lower level entrance to the theatre. Source: Jean Rice

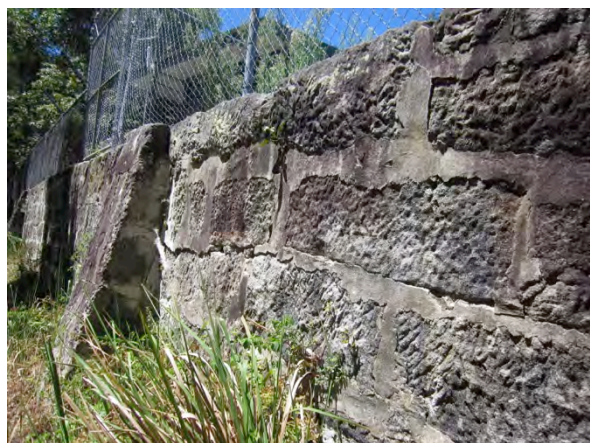
**Figure 2.34** View of typical section of stone boundary wall. Source: Jean Rice

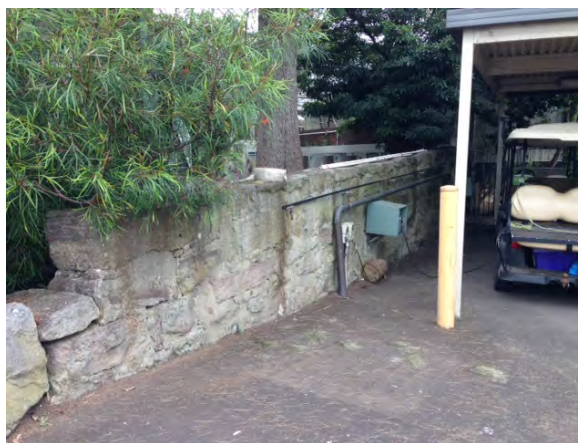
**Figure 2.35** View of remnant section of stone wall within site. Source: Kristine Marshall

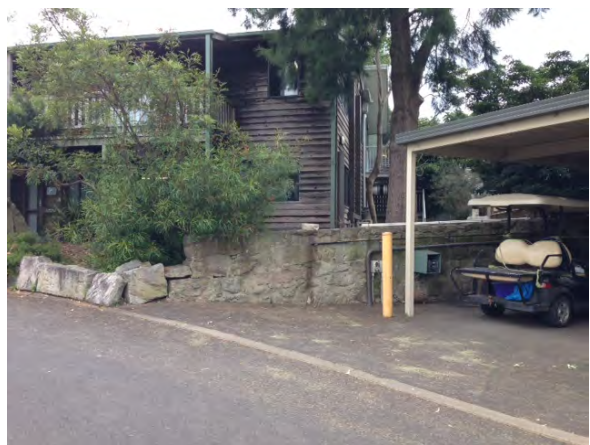
**Figure 2.36** View of remnant section of stone wall from the south showing it in relation to the two storey Capital Works office building. Source: Kristine Marshall
