Taronga Zoo  
Institute of Science & Learning  
Heritage Impact Assessment  
9 December 2015

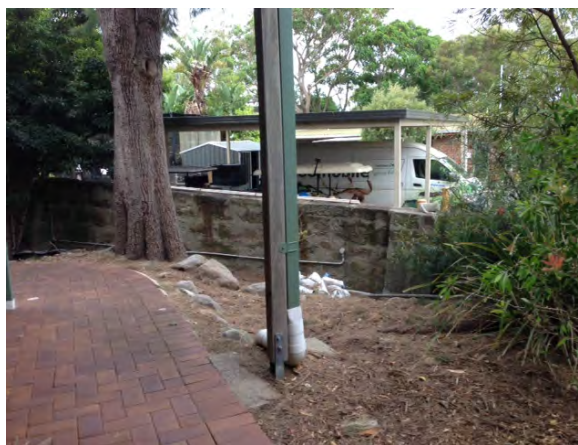
**Figure 2.37** North view of remnant section of stone wall from verandah of the two storey Capital Works office building Source: Kristine Marshall

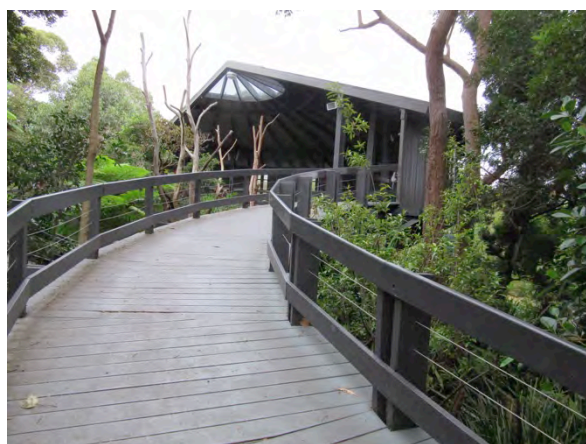
**Figure 2.38** View of Koala House looking up the exhibit exit ramp. Source: Jean Rice

The exhibit primary viewing area is designed to look north incorporating the natural rockface and so the remnant bushland and landscaped area forms a backdrop to the koalas which are in essentially bare tree trunks in the exhibit. A small section of ramp links the path above to the keepers area of the exhibit. This was probably added to facilitate access for keepers bringing fresh feed and may have been built when the coolroom adjacent the amenities was added.

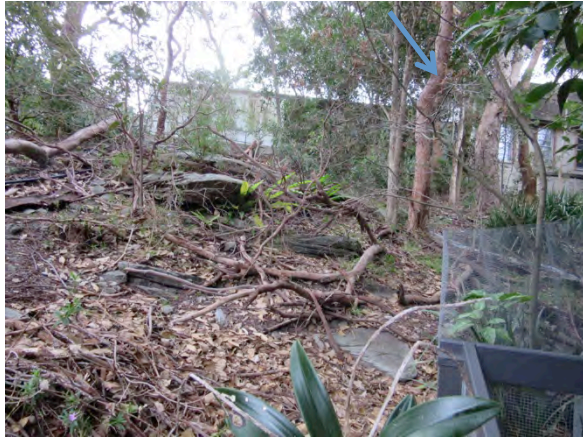
**Figure 2.40** Area 240L above and west of the Koala House showing rock shelves and one small *Angophora costata* (arrowed). Source: Jean Rice

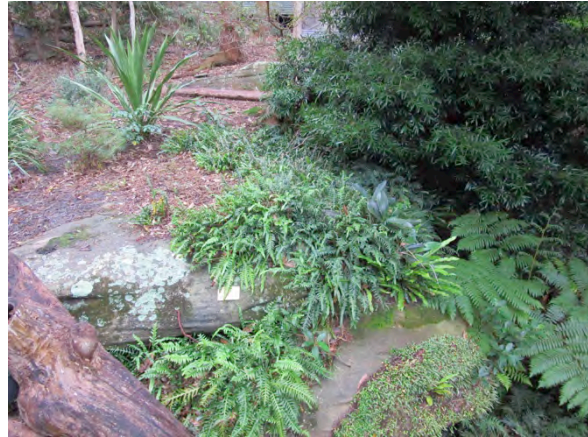
**Figure 2.41** This rockface adjacent the Koala House has plantings of orchids, ferns and a pittosporum (top right). Source: Jean Rice

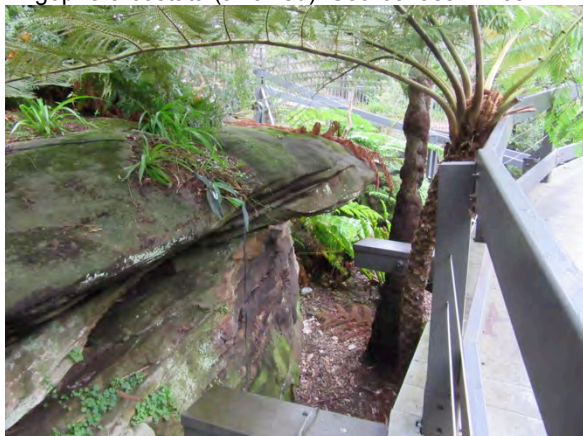
**Figure 2.42** View of the rockshelf from the Koala House exit ramp. Source: Jean Rice

The LMP has detailed recommendations for regeneration of these areas. There is also an intact original rock shelf and overhang running east west north of the Koala House which has landscape and possible Aboriginal heritage values.

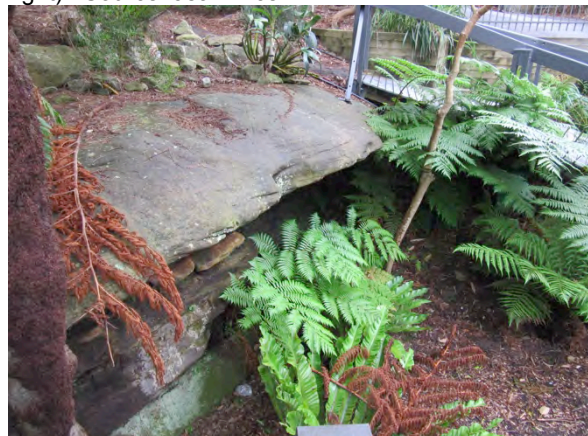
**Figure 2.43** View of the rockface adjacent the Koala House. The keepers access ramp top right is fixed to the top of the rock shelf. Source: Jean Rice

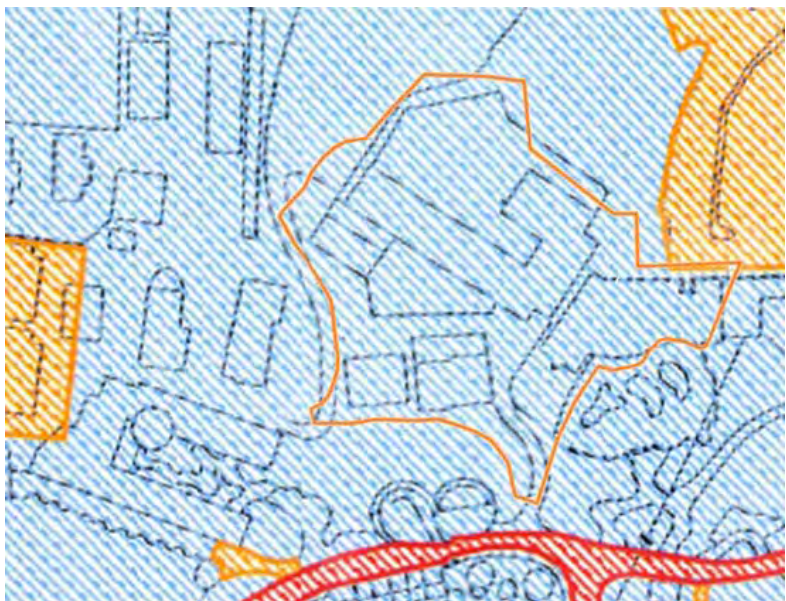
<div data-bbox="965 638 1364 1019"> <p><b>Historical Archaeological Management Zones</b></p> <p><b>Zone A</b></p> <p>Unassessed area outside Zoo boundary wall</p> <p><b>Zone B</b></p> <p>Areas of extant original Zoo path layout</p> <p><b>Zone C</b></p> <p>Areas where subsurface evidence of previous European activity has potential to remain</p> <p><b>Zone D</b></p> <p>Areas where there is no potential for subsurface archaeological evidence to remain</p> </div> <p>The project site is outlined in orange but the base map from the AMP is not accurate and some details do not align.</p>	
<p><b>Historical Archaeological Features</b></p>	
<p><b>Zone B (Zone 2) (Original path) (Not within site):</b></p> <p>Archaeological features identified in this zone should, where possible be retained in situ. Development plans should be designed to retain the features of this zone in their original condition. If the proposed development must destroy the features in this zone then provision needs to be made for an archaeological investigation, which may include monitoring, test or full excavation, prior to the commencement of work.</p>	<p>High archaeological sensitivity / potential and medium research potential.</p> <p>Avoid disturbance. Any excavation requires archaeological supervision in accordance with an excavation permit or exemption.</p>

<p><b>Zone D (Zone 4) (No potential):</b></p> <p>The advice of materials conservator may need to be sought if archaeological features are exposed. If uncovered, archaeological features would required archival recording and should be located on the site plan.</p>	<p>No archaeological sensitivity / potential.</p> <p>If excavation or disturbance exposes and archaeological feature call an archaeologist.</p>

Within the subject area the Archaeological Management Plan has identified no historical archaeological sensitivity or potential. It recommends that the advice of materials conservator may need to be sought if archaeological features are unexpectedly exposed. If uncovered, archaeological features would require archival recording and should be located on the site plan. The section of original path adjacent the site has higher archaeological potential but it is outside the site and no works are proposed to it.

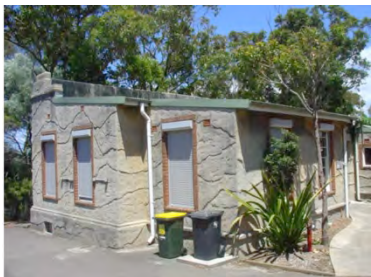
Designed for staff facilities this was never intended to be a structure in the public realm and was finished to enable to be hidden behind the trees. Proposed to be demolished.

The major negative heritage impact is the demolition of the former staff amenities building (78B). It has an assessed overall level of significance assessed as “some” (as opposed to “high” or “exceptional” or “low”). It is noted that the building has *“some aesthetic significance as representative of the use of rendered detailing to create a more ‘natural’ appearance”*. The register’s recommended conservation strategy is *“adaptation for continuous usage is acceptable”* and the conservation policy in the CMS is *“Conserve in accordance with heritage advice”*. This policy allows discretion on the part of the heritage advisor in assessing if and what level of conservation is necessary.

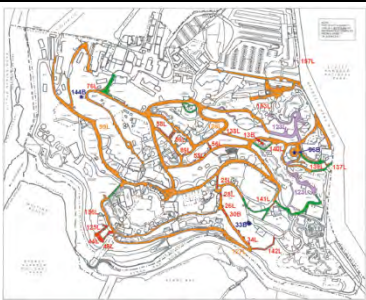
Early pathway alignment dating from pre-1940 Layout, including main paths following contours, paths and stairs linking levels, original balustrades and concrete kerb and gutters. Not affected.

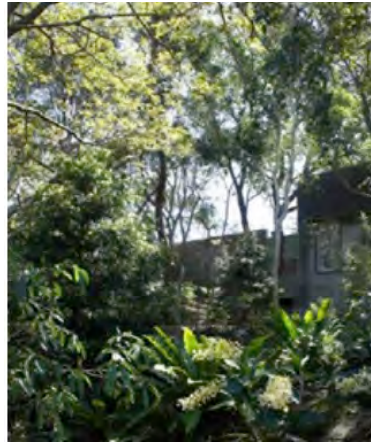
Remnant <i>Angophora costata</i> indigenous vegetation Association. A small area remains between Serpentina and the Koala House. This is not directly affected but there are potential impacts through tree removal and adjacent works discussed in more detail later in this report.

It is intended that the area 240L remains undisturbed other than the bush regeneration recommended in the LMP. See later comment re possible tree removal and planting in and adjacent the area. The removal of the former staff amenities building will expose the area to more sunlight improving regeneration conditions.

One tree T5 is proposed to be removed from area 240L as it is in poor condition. Care should be taken not to damage the adjacent significant vegetation associations or undisturbed natural rock shelves in the vicinity during tree removal.
