Ramboll Environ Australia Pty Ltd

June 2016

SITE AUDIT REPORT

REMEDIAL ACTION PLAN FOR AUSTRALIAN TECHNOLOGY PARK

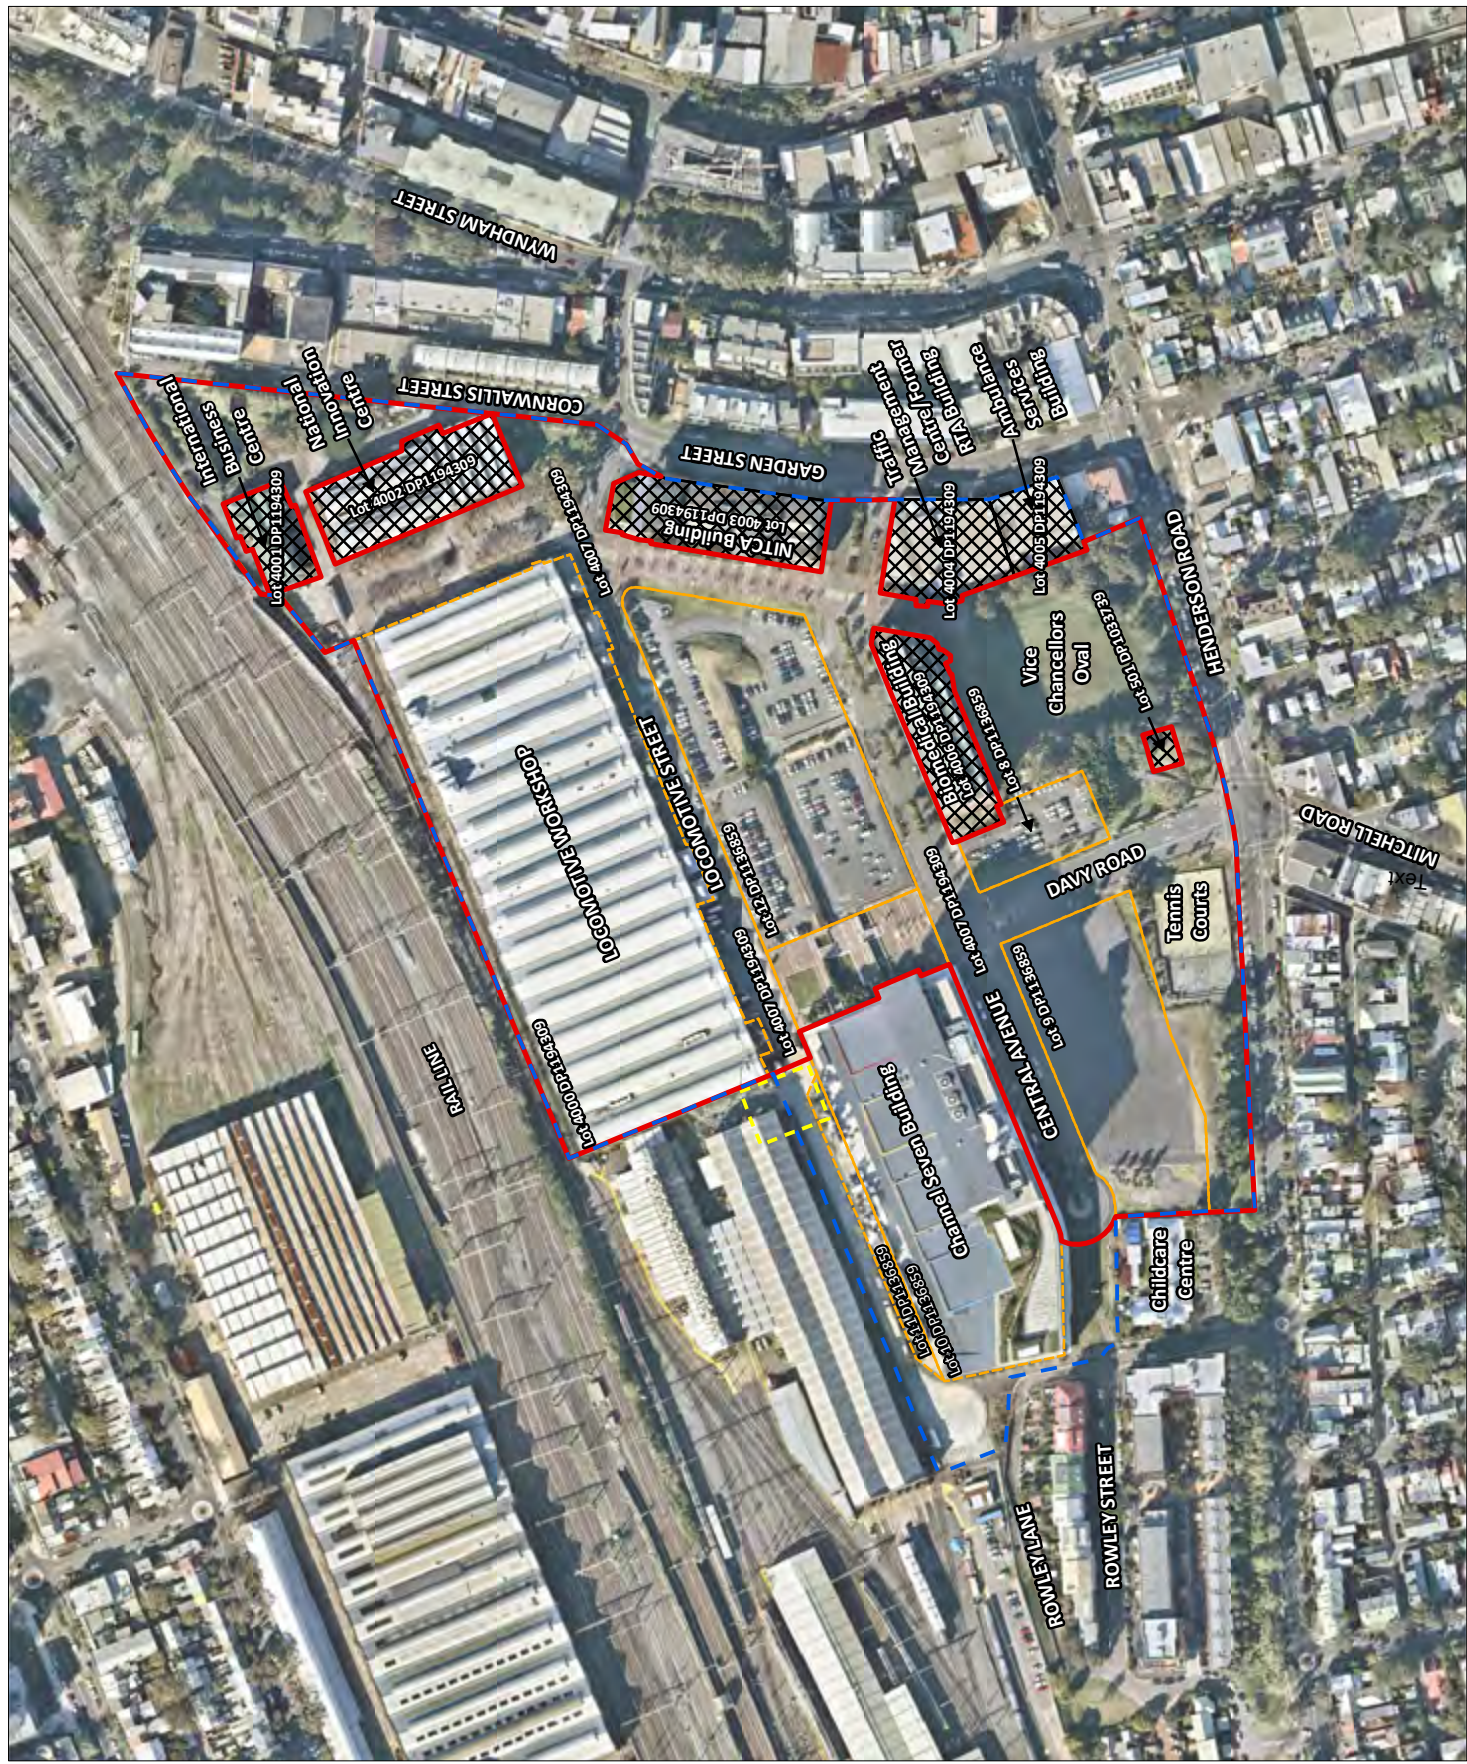
FIGURE 2:

SITE LAYOUT

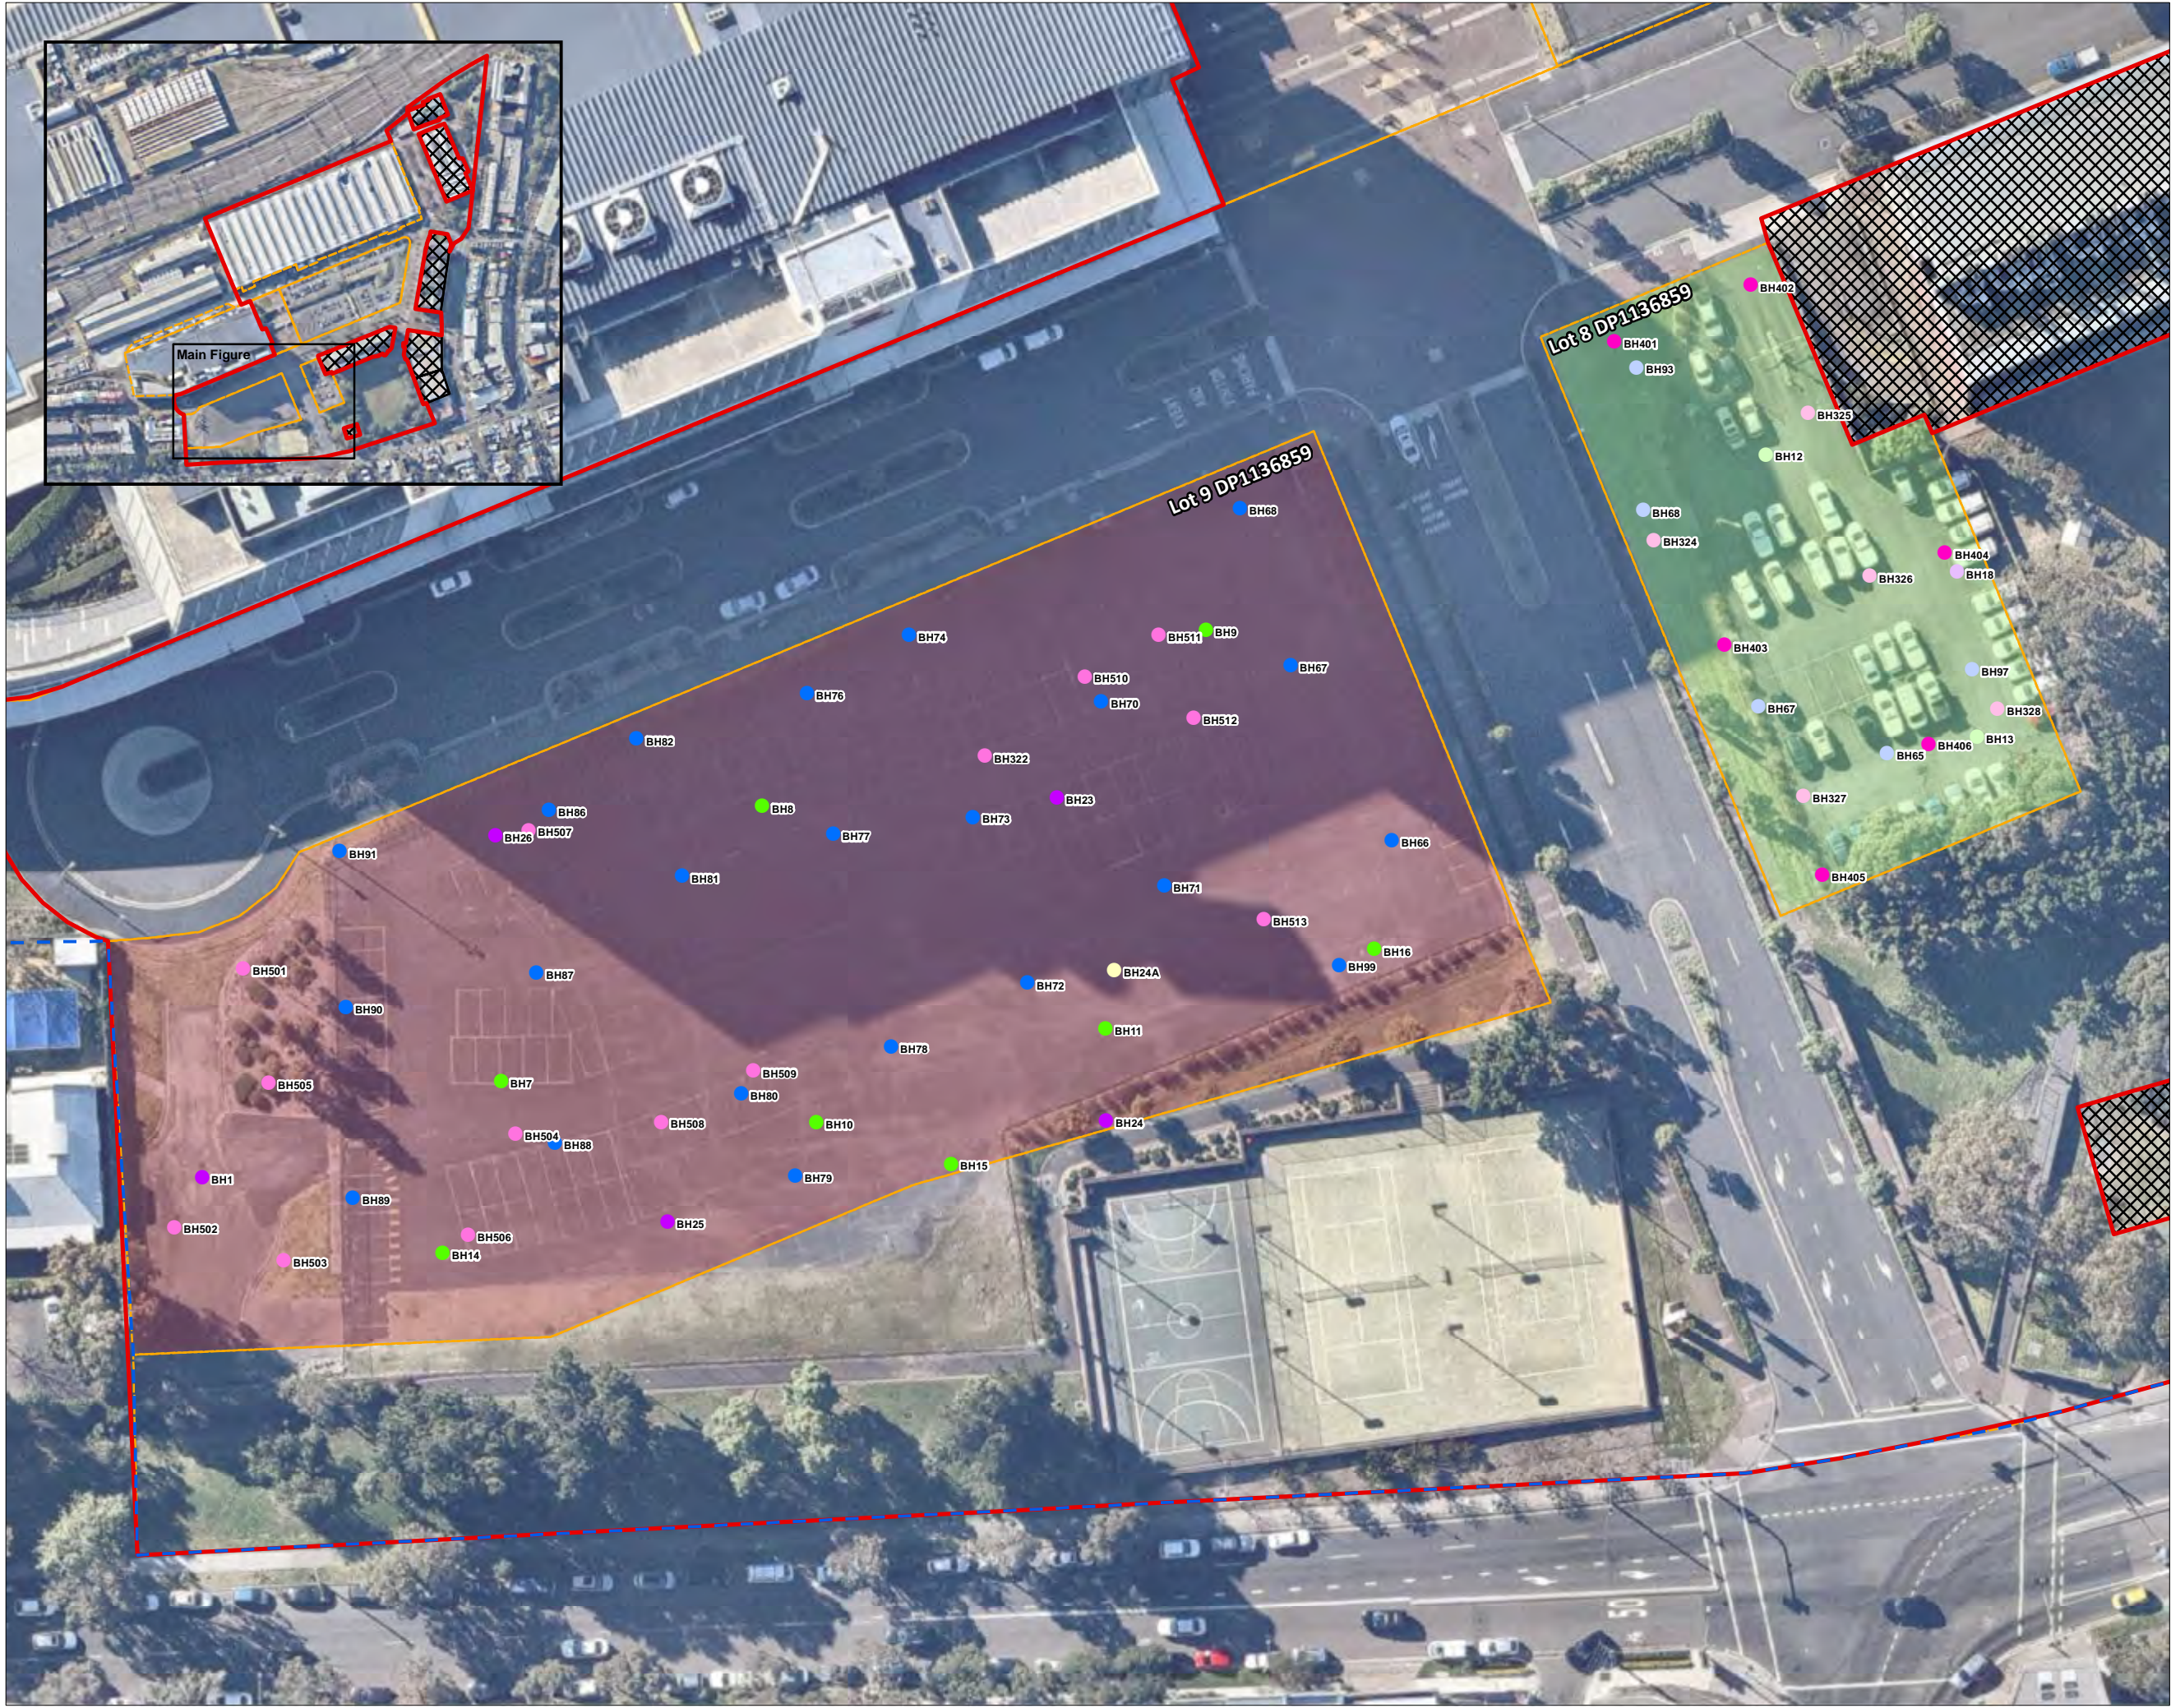
FIGURE 7D:

**HISTORIC GROUNDWATER
MONITORING WELL
LOCATIONS**

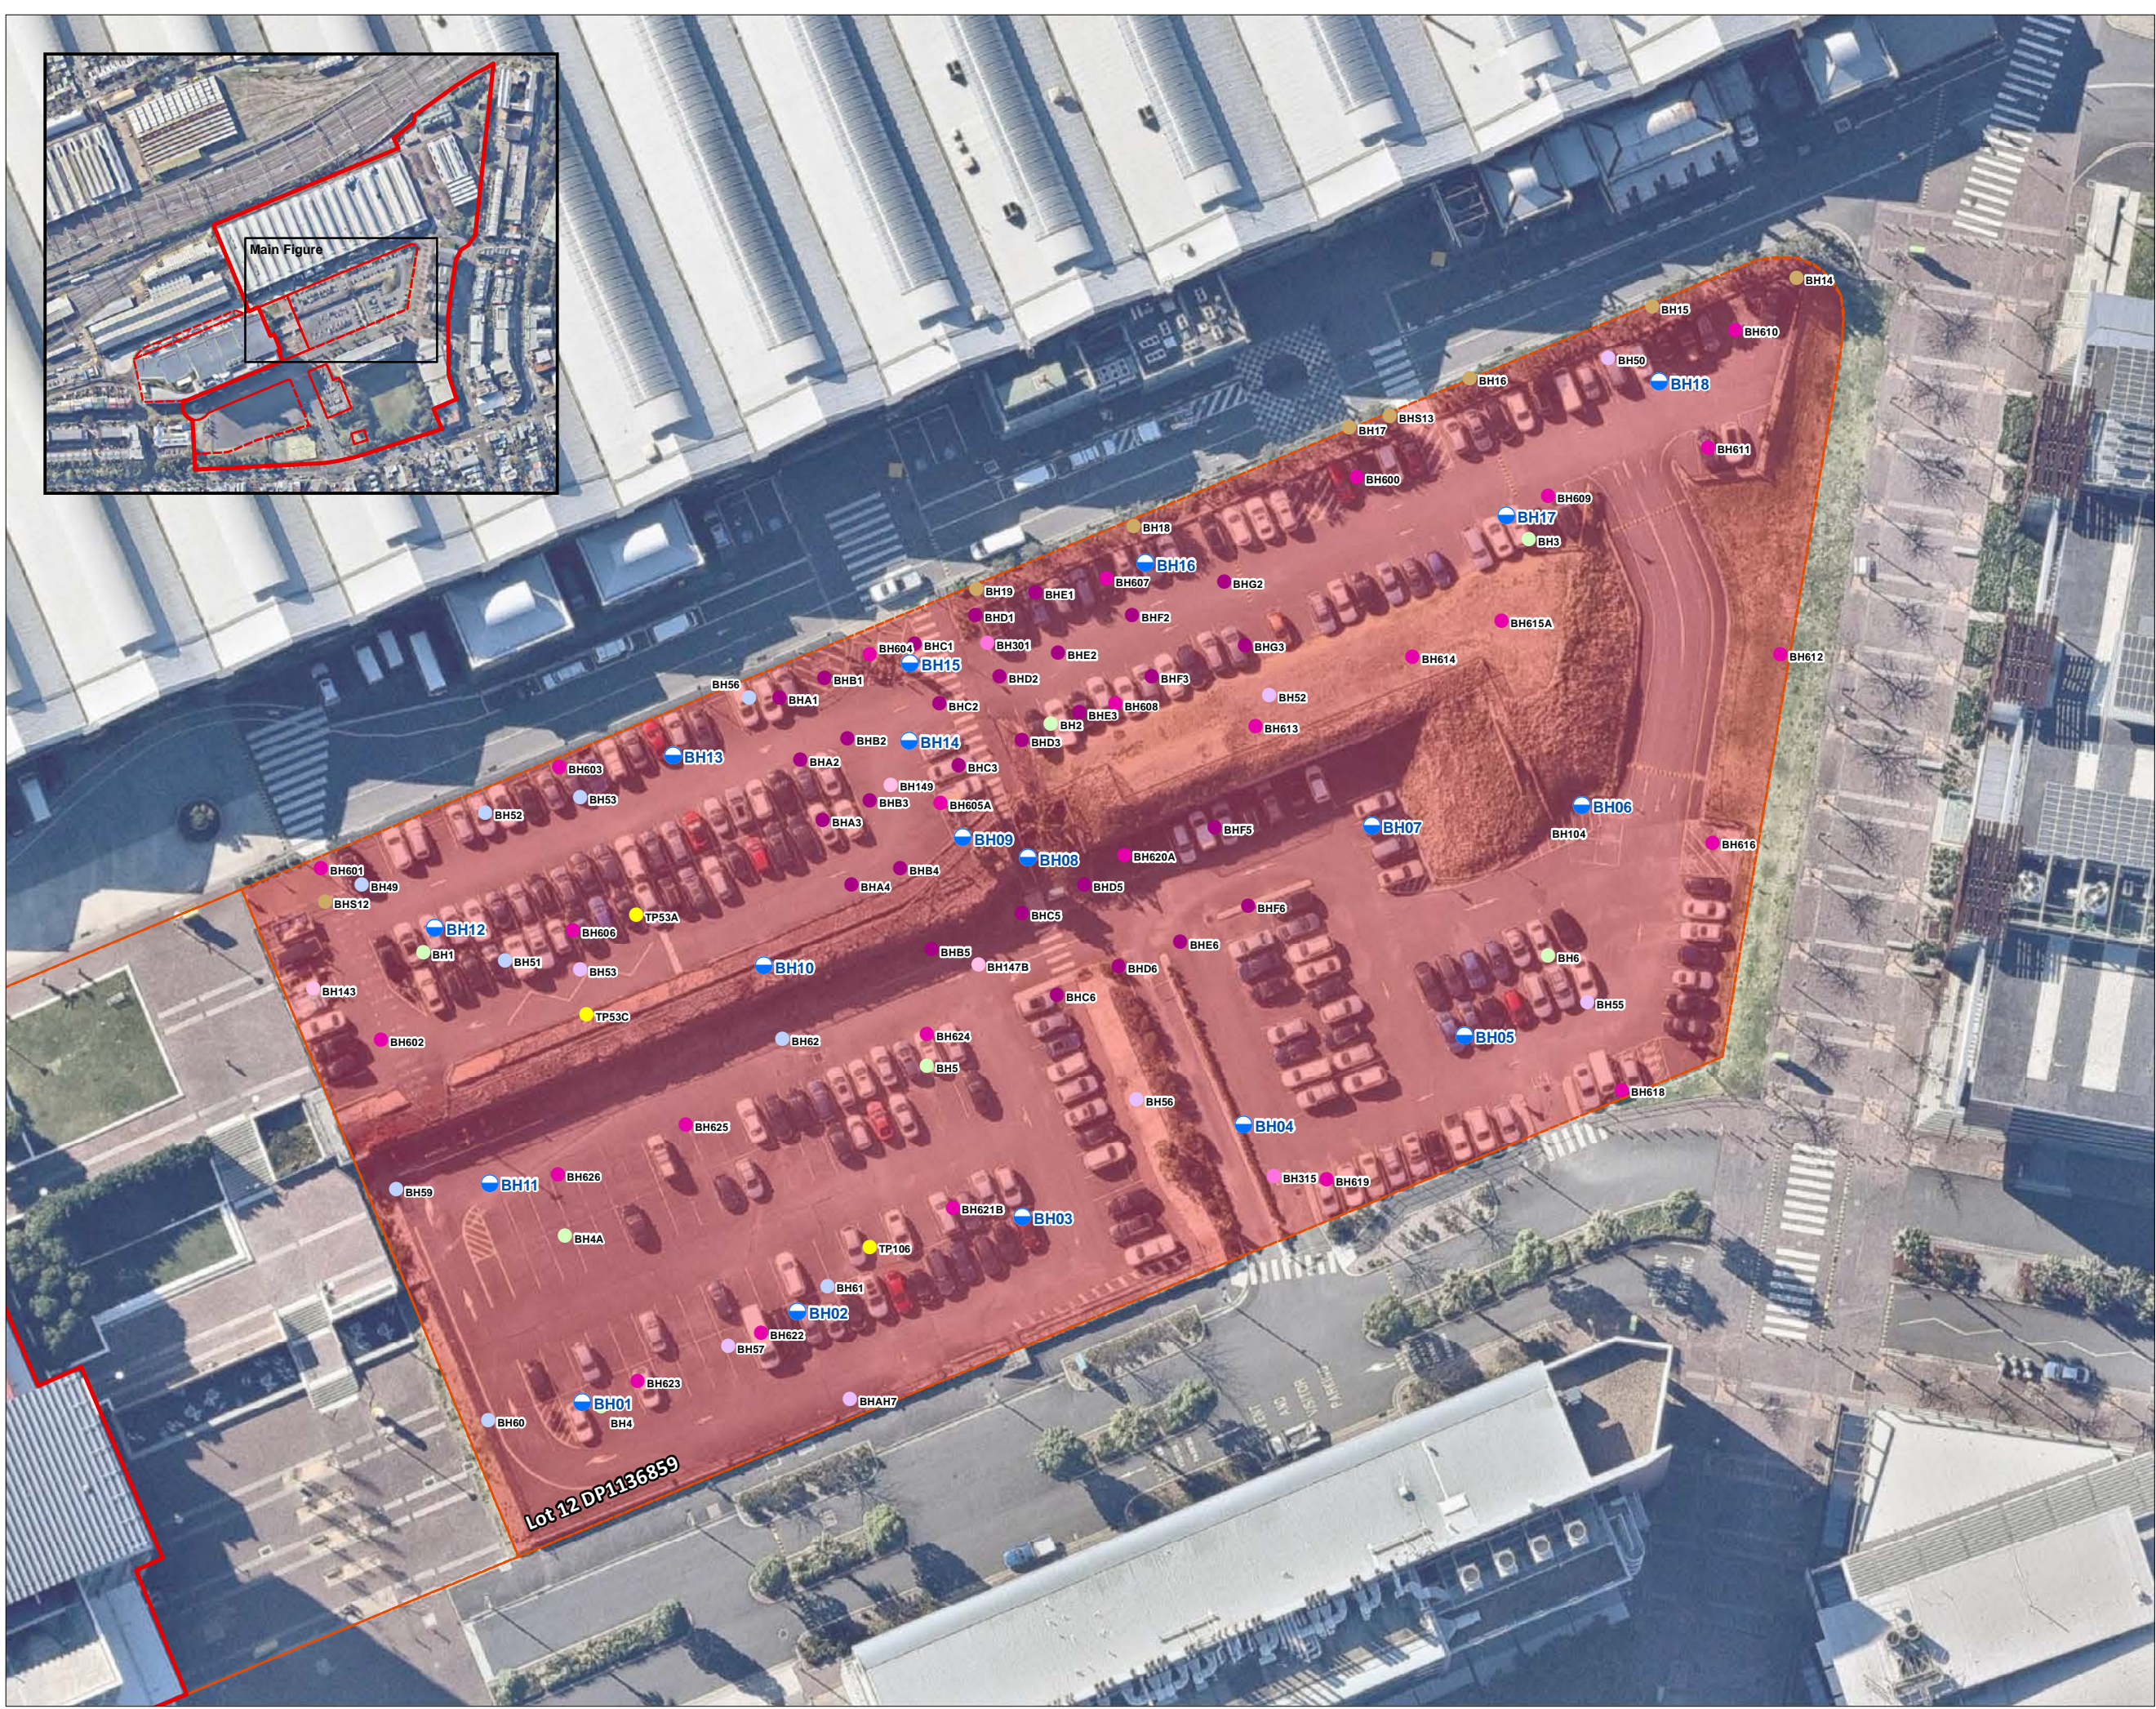
FIGURE 7A:

**HISTORIC SOIL SAMPLE
LOCATIONS LOT 8 AND 9**

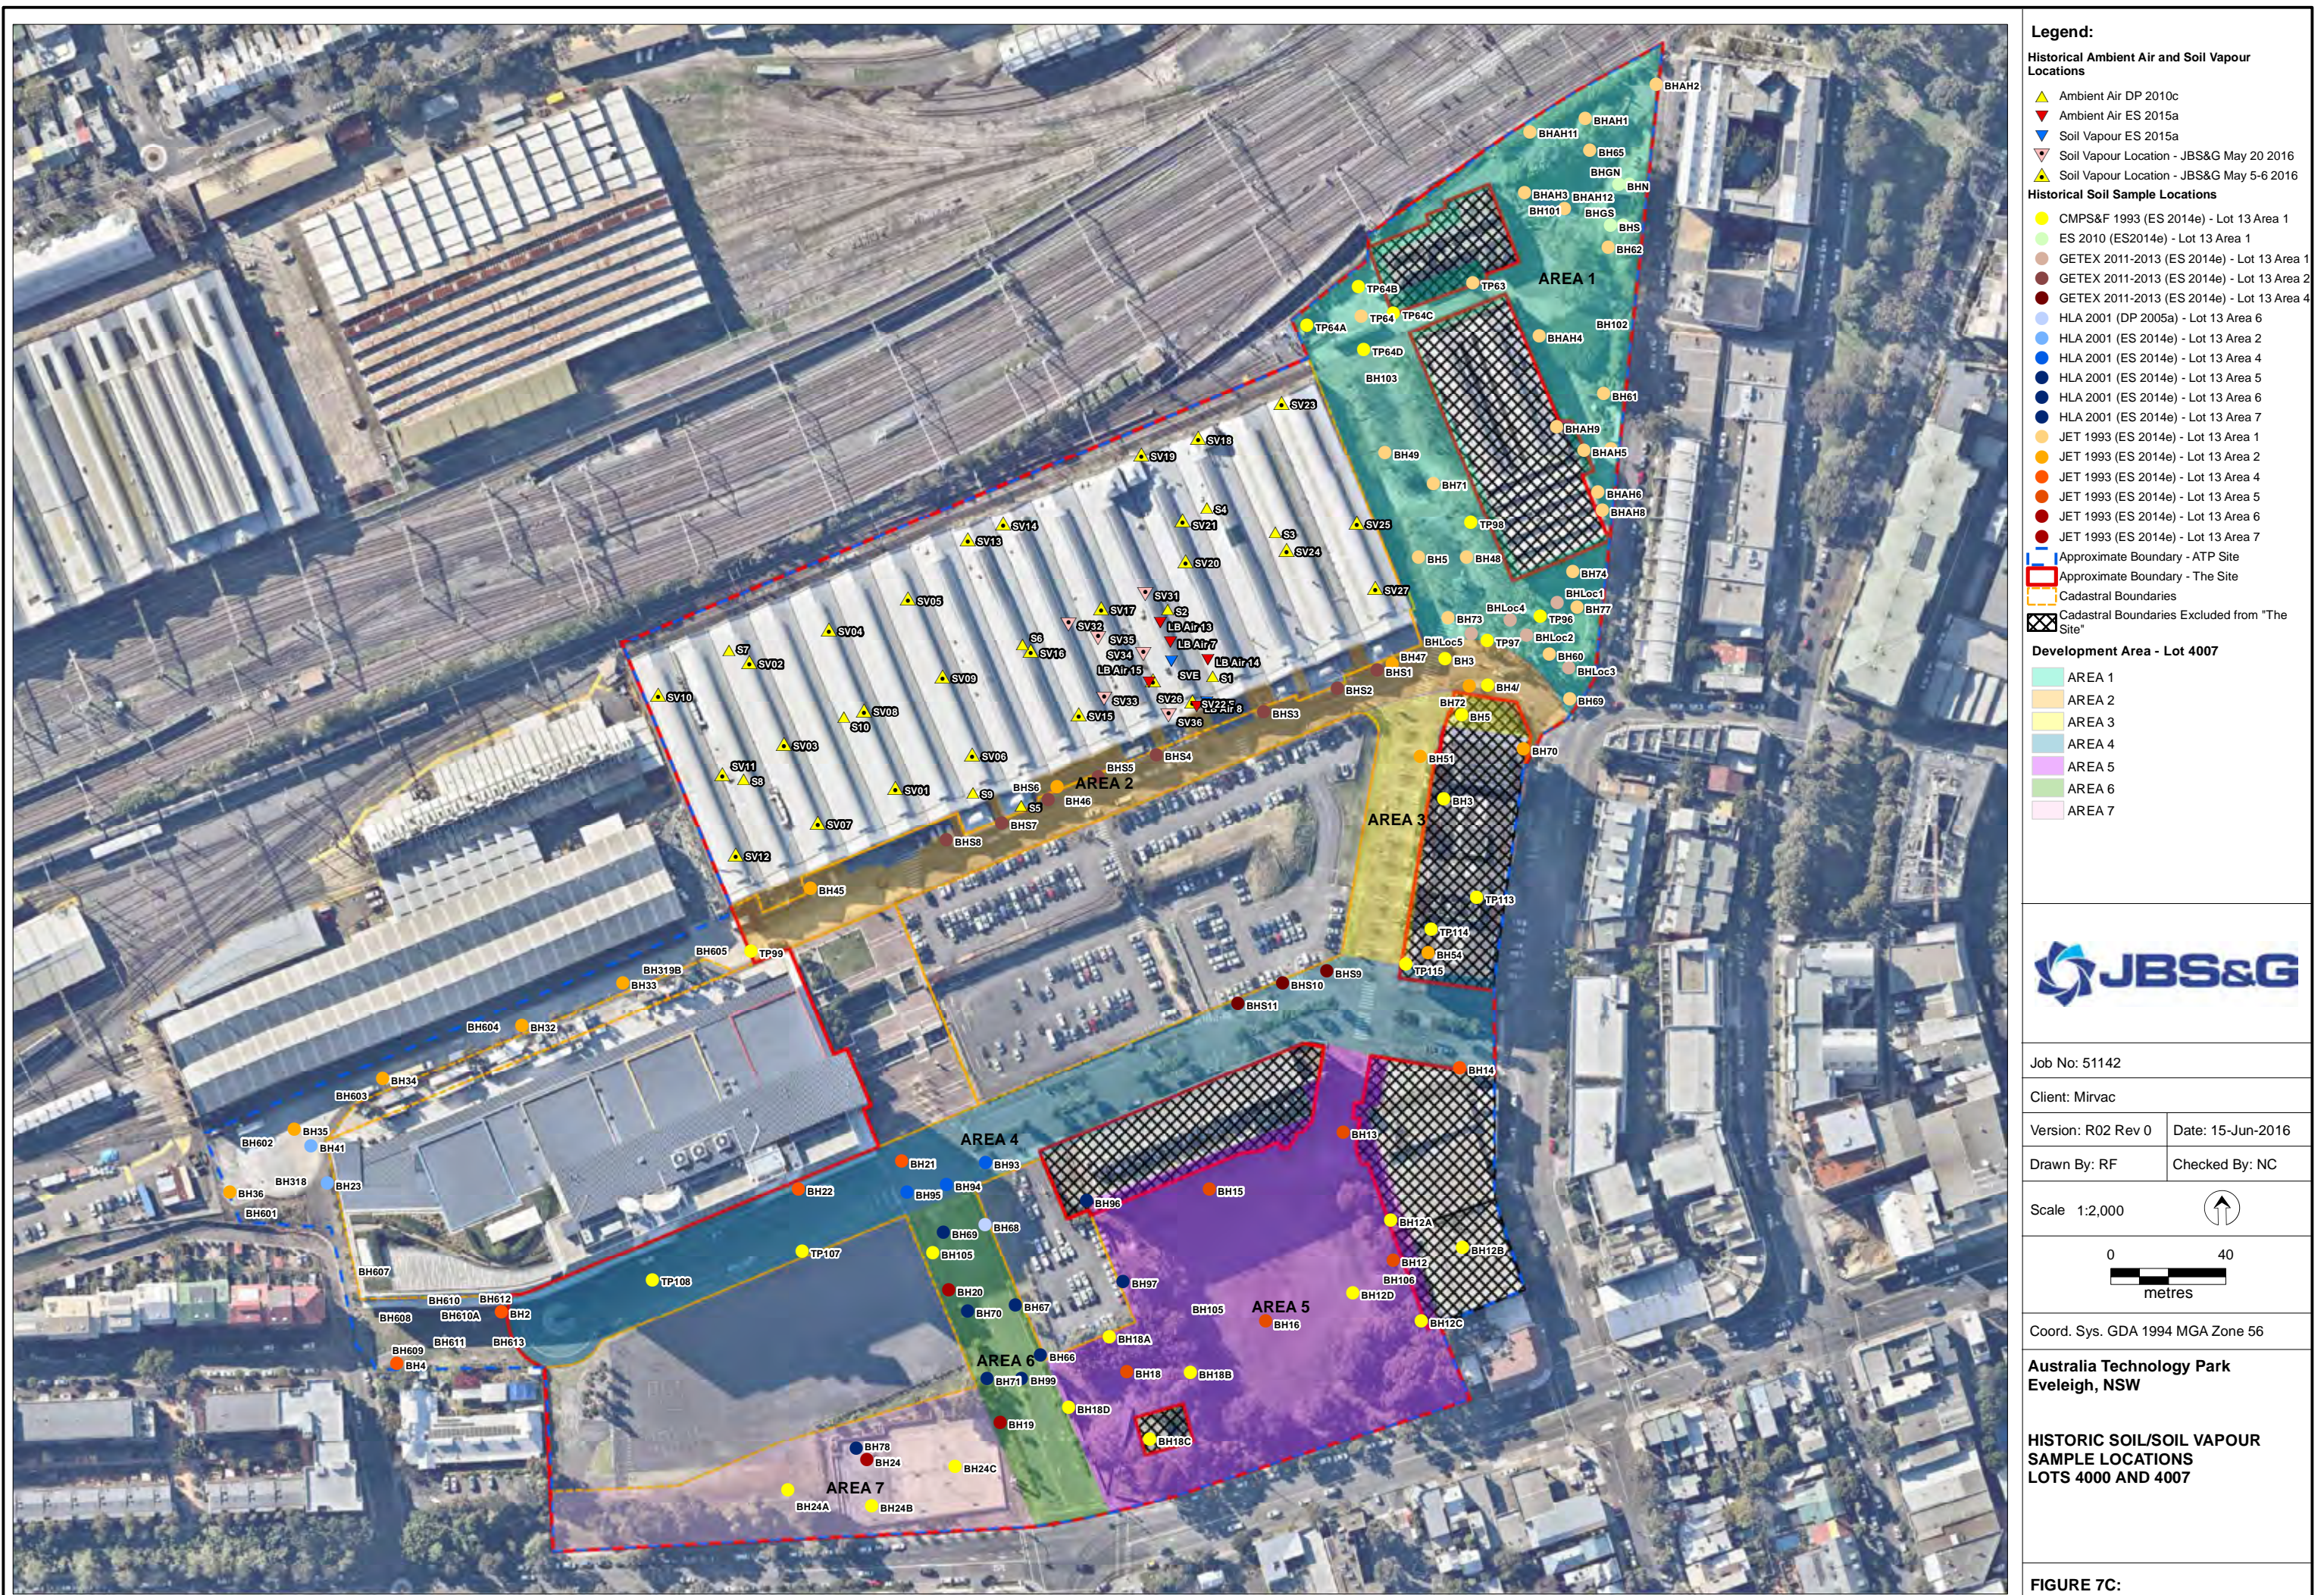
FIGURE 5:

**HISTORIC AND CURRENT
SOIL SAMPLE LOCATIONS LOT 12**
