Preliminary Geotechnical Investigation

37 Archer Street, Chatswood NSW

Report No: E26577.G03_Rev1

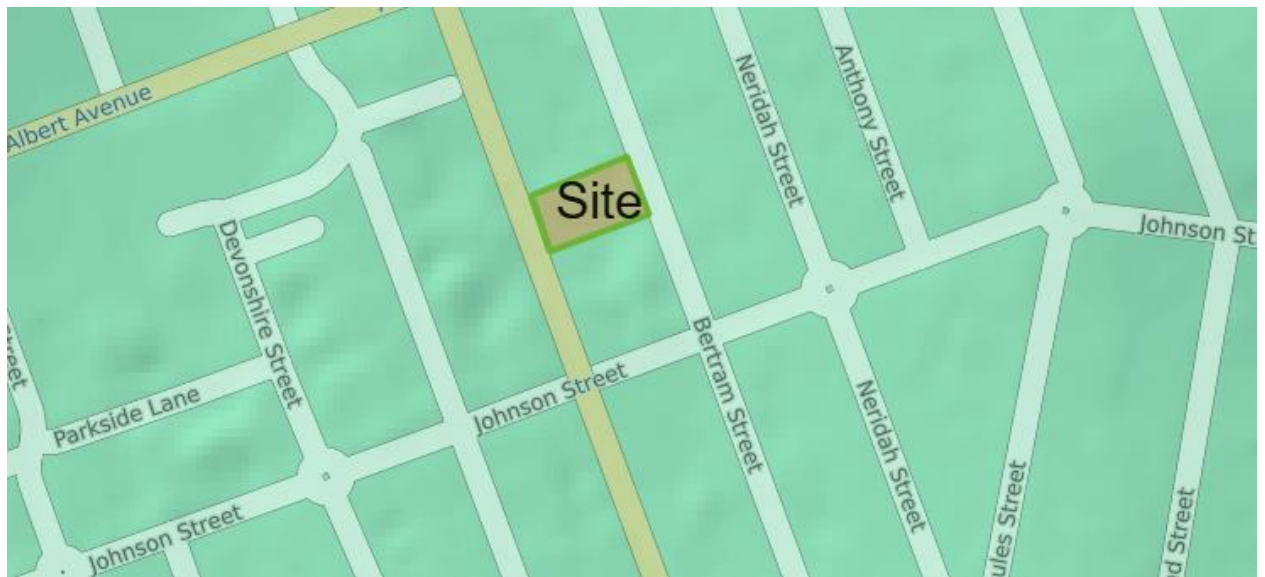
Plate 2 Excerpt of geological map, showing Ashfield Shale in green

Attribute	Description
Topography	The site is located on the eastern side of the road within relatively flat topography with approximate RL 91.10m AHD
Regional Geology	Information on regional sub-surface conditions, referenced NSW Seamless Geology dataset (Colquhoun et al., 2024, corresponding to the Sydney 1:100,000 Geological Series Sheet) indicates the site to be underlain by Ashfield Shale (Rwa), which consists of black to dark grey shale and laminite. Expected geology at the site and surrounds is presented in Plate 2 below, Ashfield Shale shown in green.

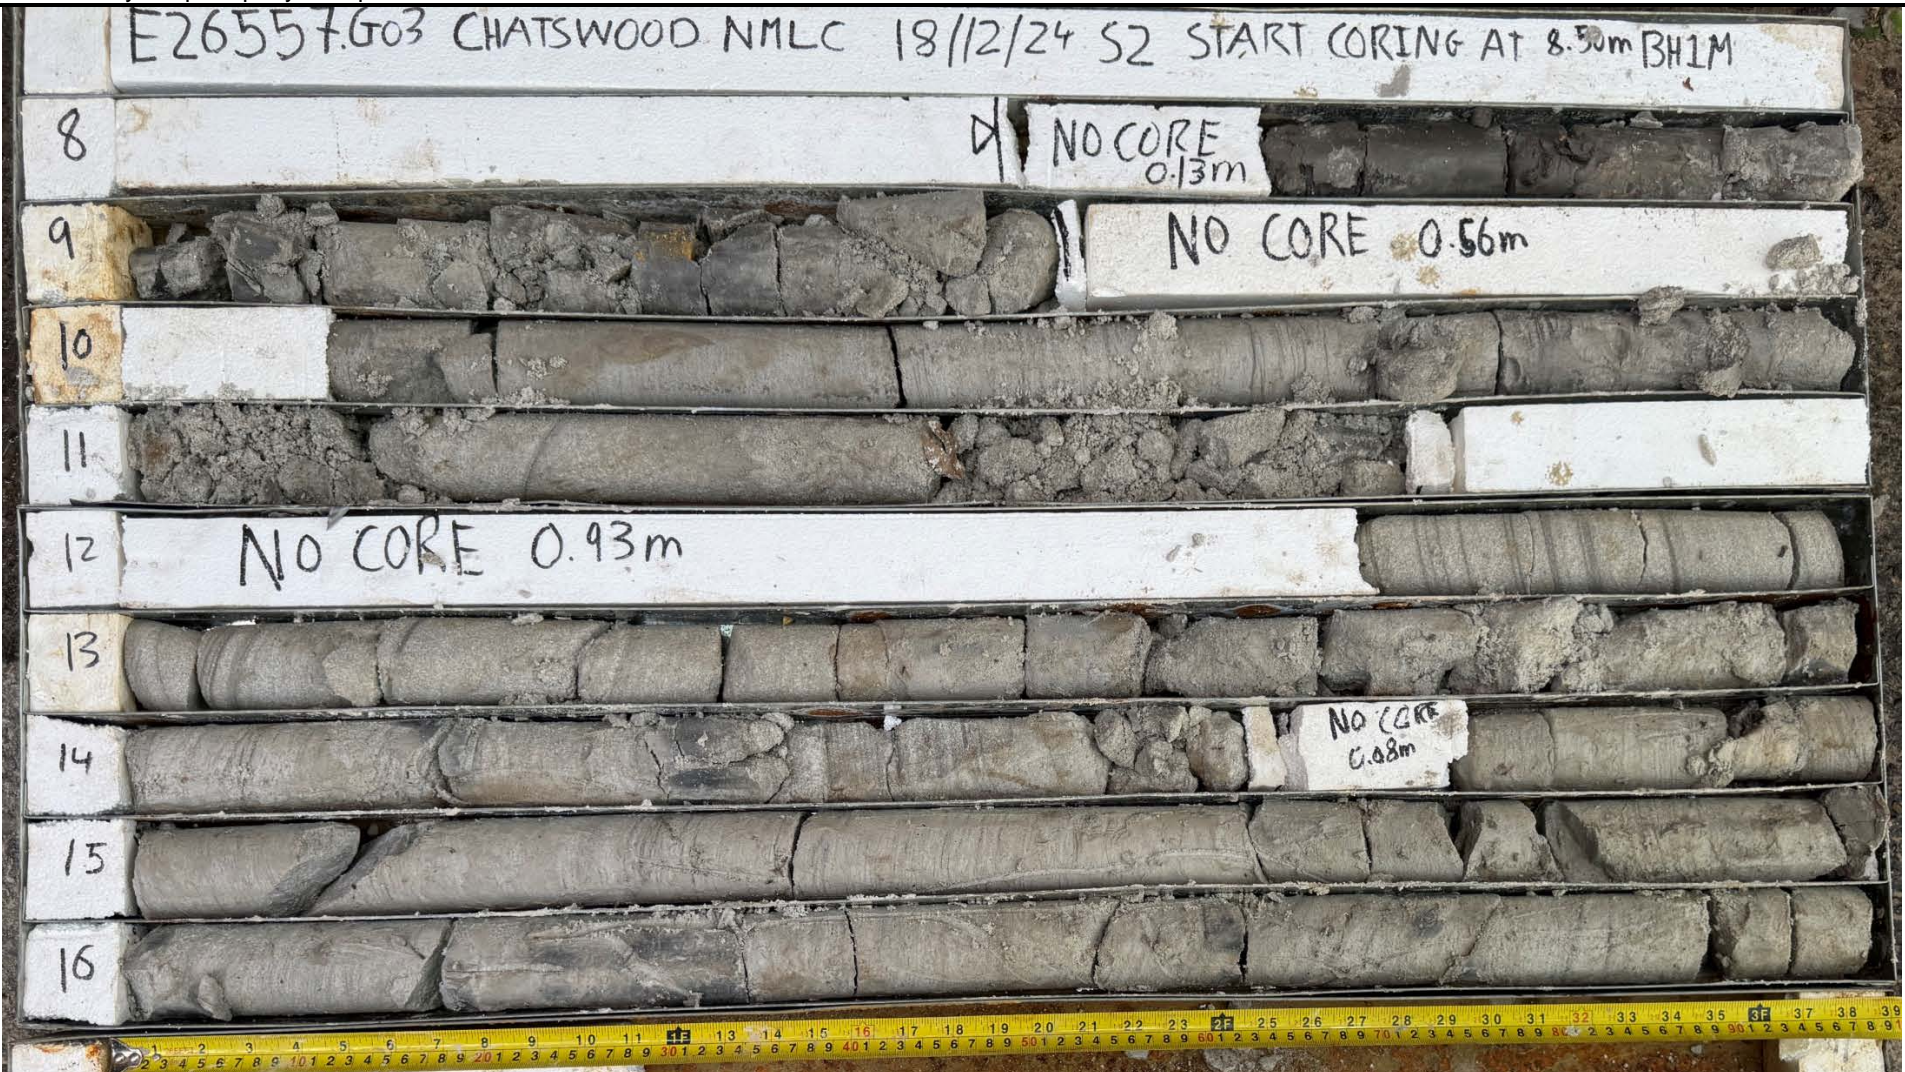
CORE PHOTOGRAPH OF BOREHOLE: BH1M

Project	New Development	Depth Range	8.50m to 17.0m BEGL	
Location	No. 37 Archer Street, Chatswood, NSW	Contractor	BG Drilling	
Position	See Figure 2	Drill Rig	Hanjin D&B 8D	
Job No.	E26577.G03	Logged	S2	Date 18 / 12 / 2024
Client	Hyecorp Property Group	Box	1-2 of 3	Checked Date
		Surface RL	≈ 90.10m (AHD)	
		Inclination	-90°

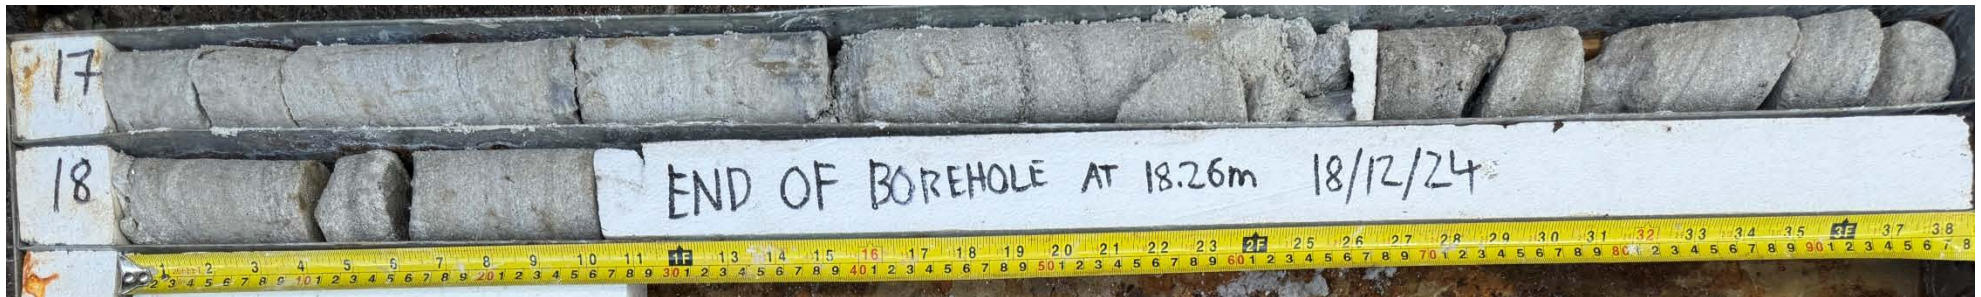
CORE PHOTOGRAPH OF BOREHOLE: BH1M

Project	New Development	Depth Range	17.0 m to 18.26m BEGL	
Location	No. 37 Archer Street, Chatswood, NSW	Contractor	BG Drilling	
Position	See Figure 2	Drill Rig	Hanjin D&B 8D	
Job No.	E26577.G03	Logged	S2	Date 18 / 12 / 2024
Client	Hyecorp Property Group	Inclination	-90°	Checked
		Box	3 of 3	Date

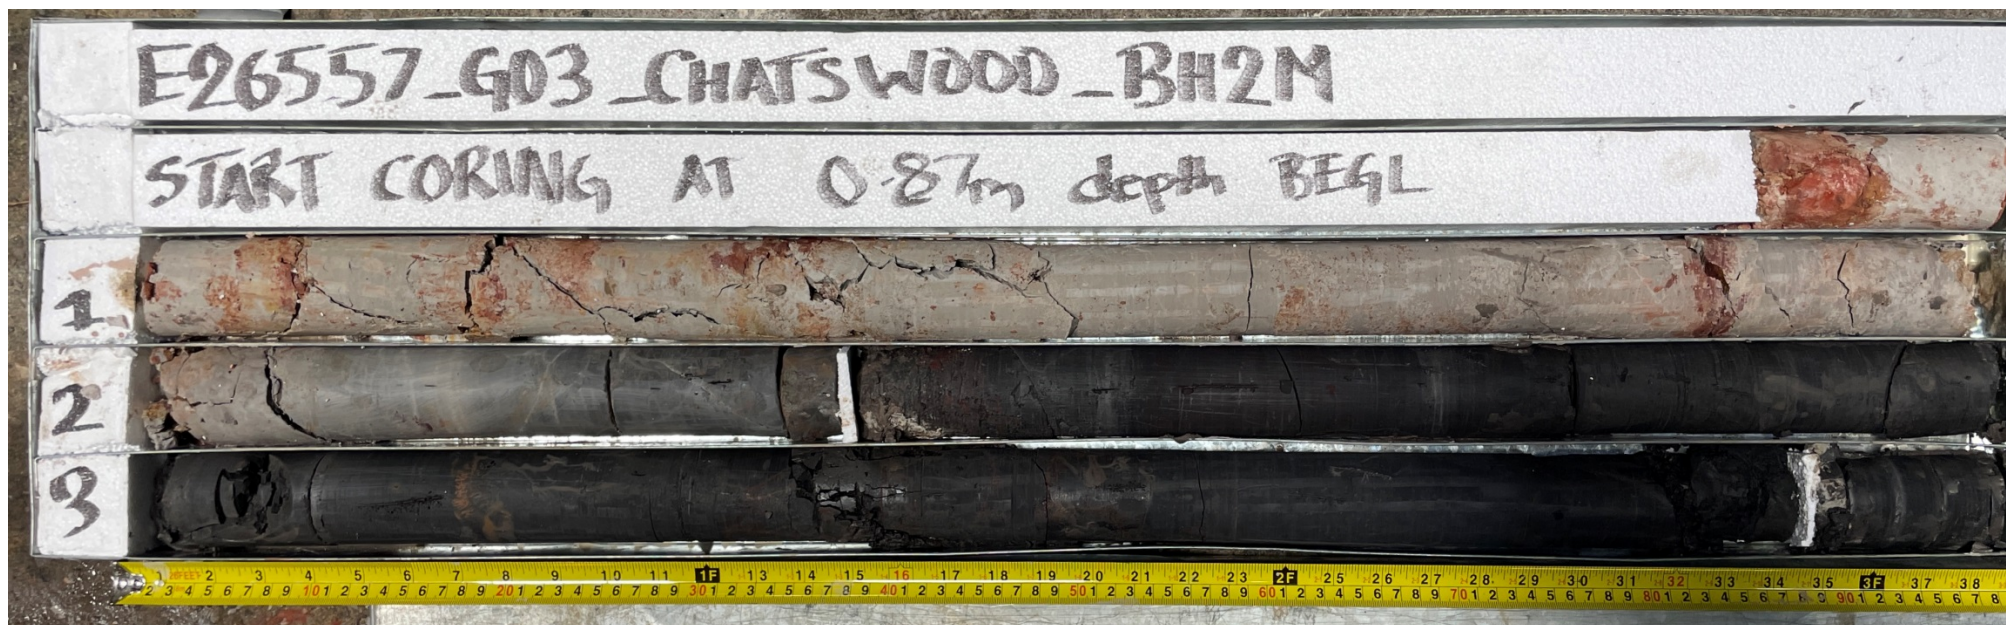
CORE PHOTOGRAPH OF BOREHOLE: BH2M

Project	New Development	Depth Range	0.87m – 4.0m BEGL	
Location	No. 37 Archer Street, Chatswood, NSW	Contractor	Hard Access Drilling	
Position	See Figure 2	Drill Rig	Man Portable Rig	
Job No.	E26577.G03	Logged	PS	Date 18 / 12 / 2024
Client	Hyecorp Property Group	Surface RL	≈ 88.01m (AHD)	
		Inclination	-90°	
		Box	1 of 4	
		Checked		Date

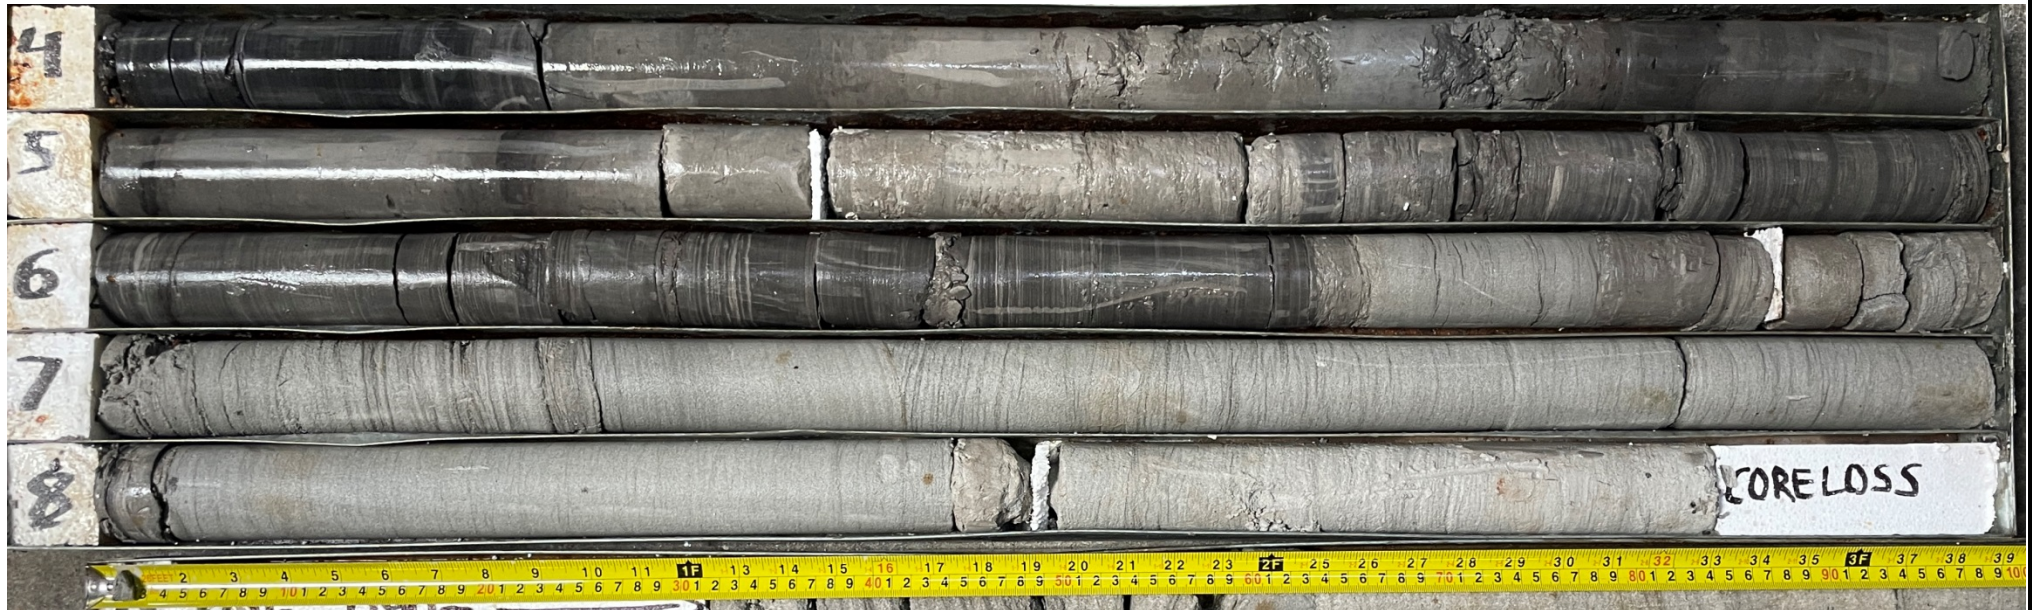
CORE PHOTOGRAPH OF BOREHOLE: BH2M

Project	New Development			Depth Range	4.0m to 9.0m BEGL		
Location	No. 37 Archer Street, Chatswood, NSW			Contractor	Hard Access Drilling		
Position	See Figure 2	Surface RL	≈ 88.01m (AHD)	Drill Rig	Man Portable Rig		
Job No.	E26577.G03	Inclination	-90°	Logged	PS	Date	18 / 12 / 2024
Client	Hyecorp Property Group	Box	2 of 4	Checked	Date

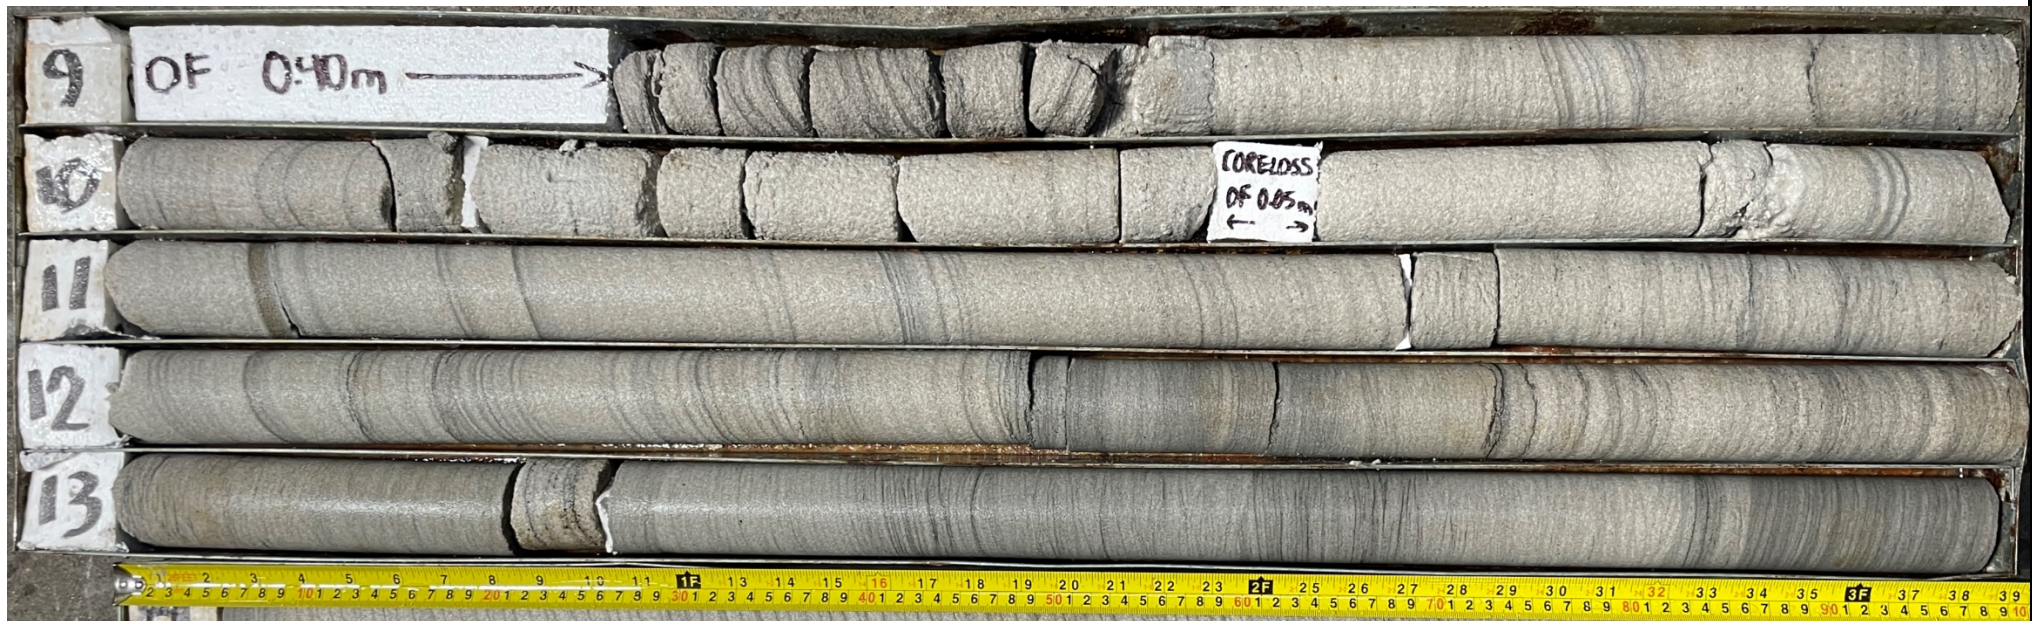
CORE PHOTOGRAPH OF BOREHOLE: BH2M

Project	New Development	Depth Range	9.0m to 14.0m BEGL	
Location	No. 37 Archer Street, Chatswood, NSW	Contractor	Hard Access Drilling	
Position	See Figure 2	Drill Rig	Man Portable Rig	
Job No.	E26577.G03	Logged	PS	Date 18 / 12 / 2024
Client	Hyecorp Property Group	Box	3 of 4	Checked Date

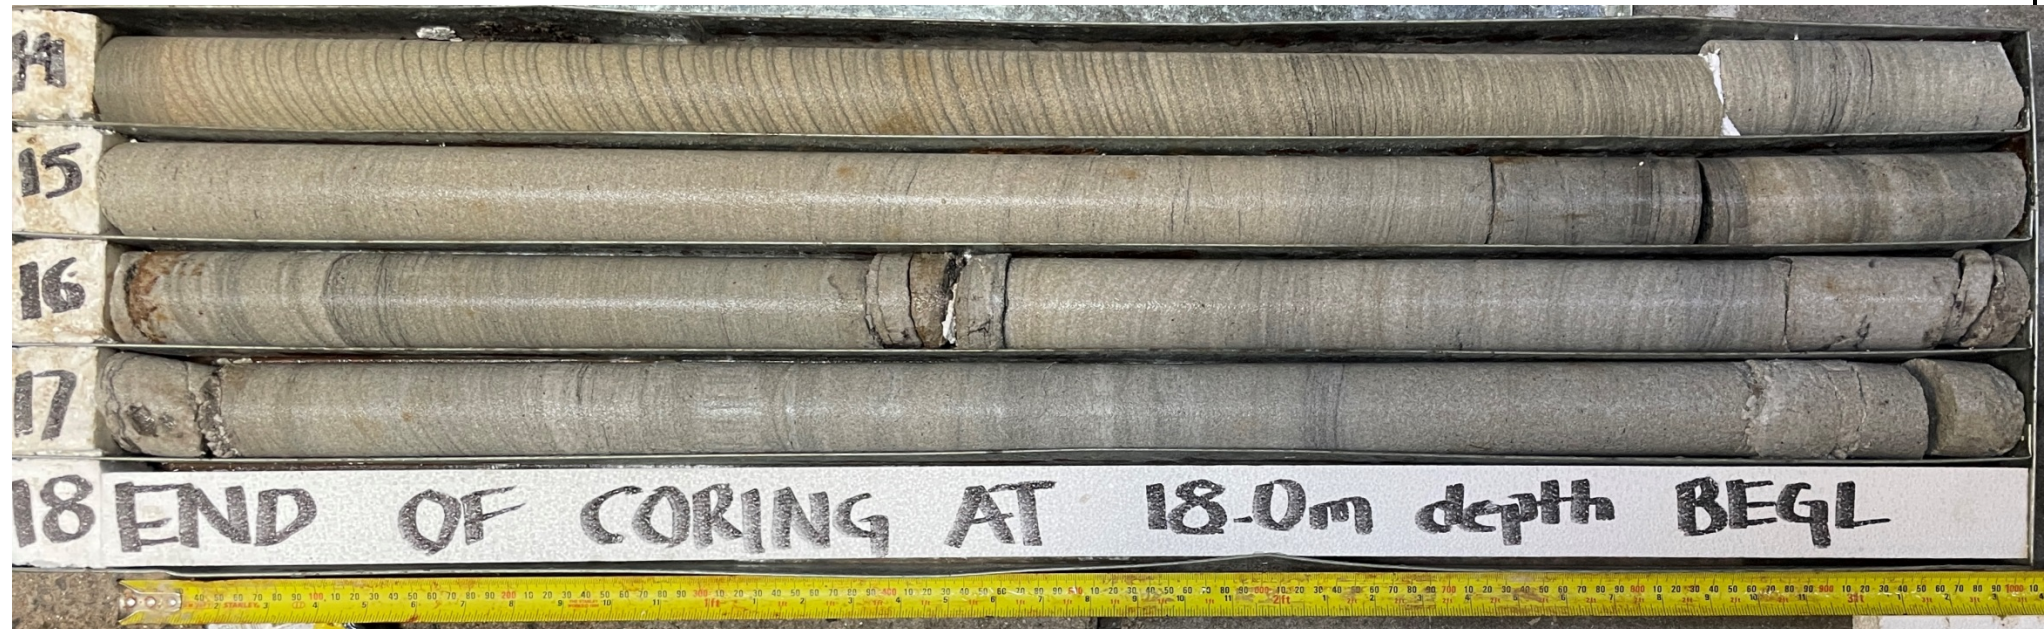
CORE PHOTOGRAPH OF BOREHOLE: BH2M.

Project	New Development	Depth Range	14.0m to 18.0m BEGL	
Location	No. 37 Archer Street, Chatswood, NSW	Contractor	Hard Access Drilling	
Position	See Figure 2	Drill Rig	Man Portable Rig	
Job No.	E26577.G03	Logged	PS	Date 19 / 12 / 2024
Client	Hyecorp Property Group	Box	4 of 4	Checked Date

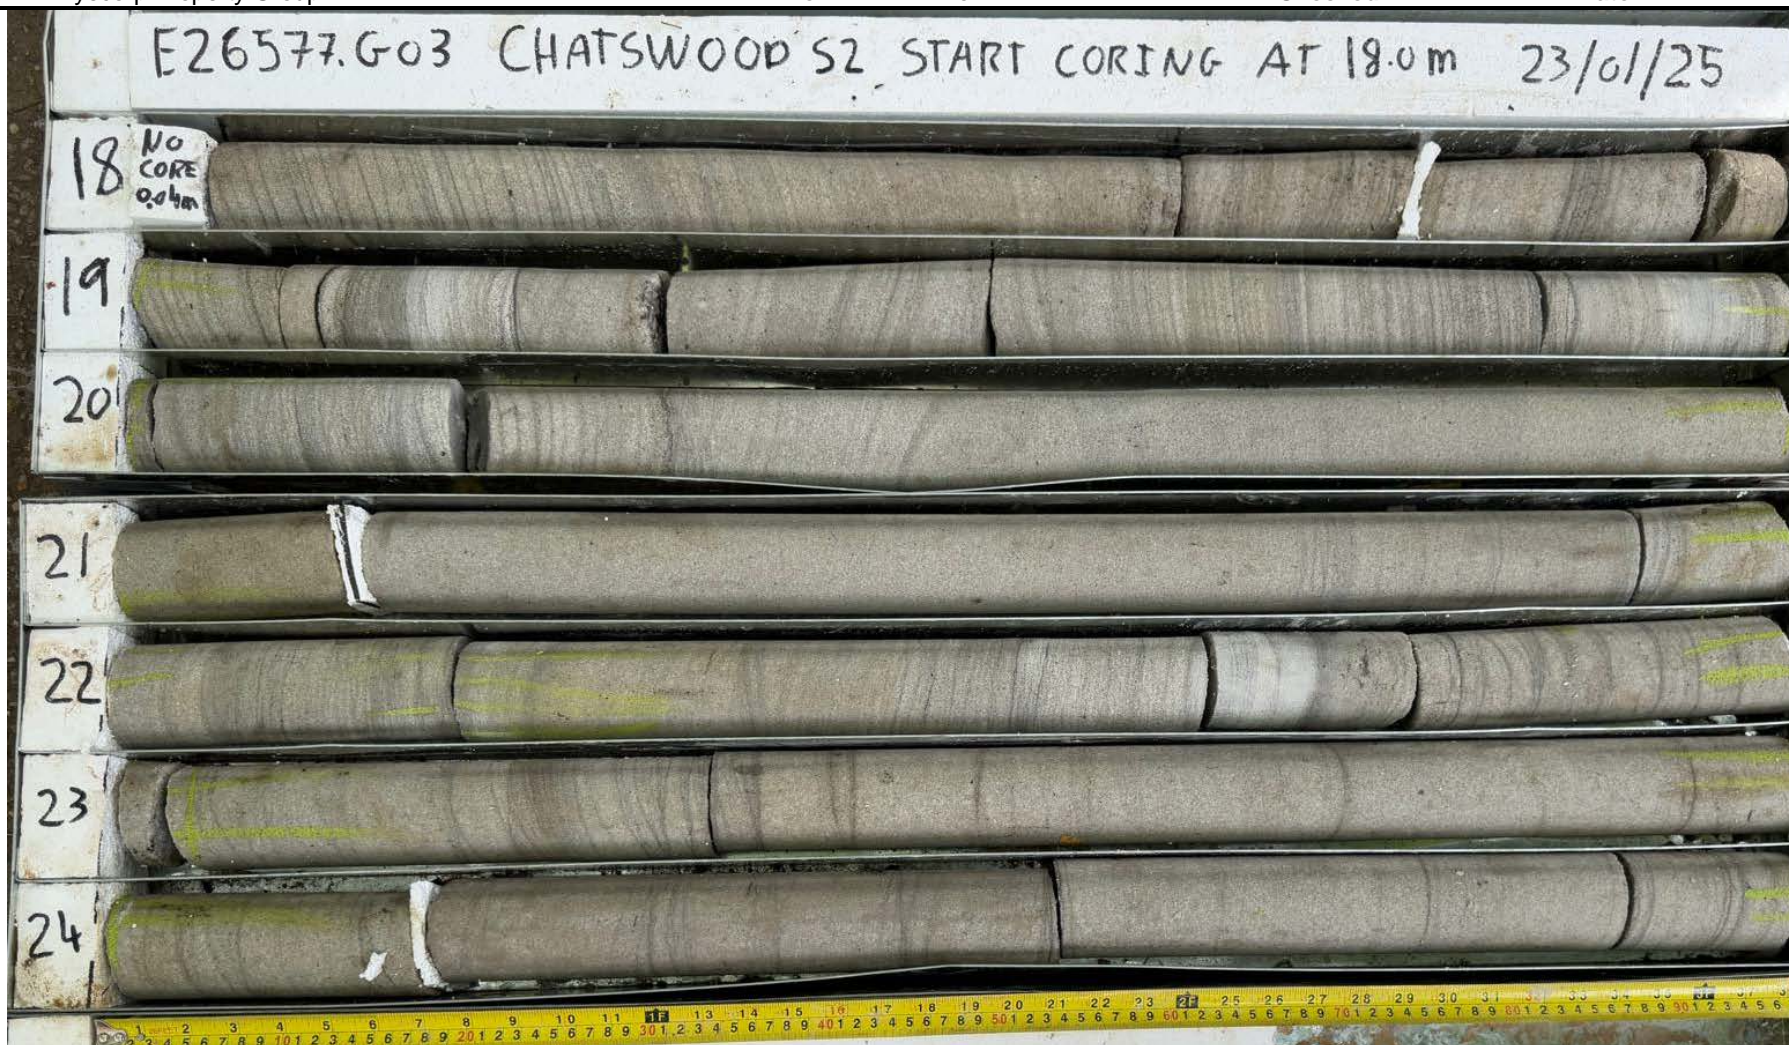
CORE PHOTOGRAPH OF BOREHOLE: BH3M

Project	New Development	Depth Range	18.0m to 25.0m BEGL	
Location	No. 37 Archer Street, Chatswood, NSW	Contractor	Stratacore Pty Ltd	
Position	See Figure 2	Drill Rig	Comacchio Geo 300	
Job No.	E26577.G03	Logged	S2	Date 23/01/2025
Client	Hyecorp Property Group	Box	1 of 2	Checked Date

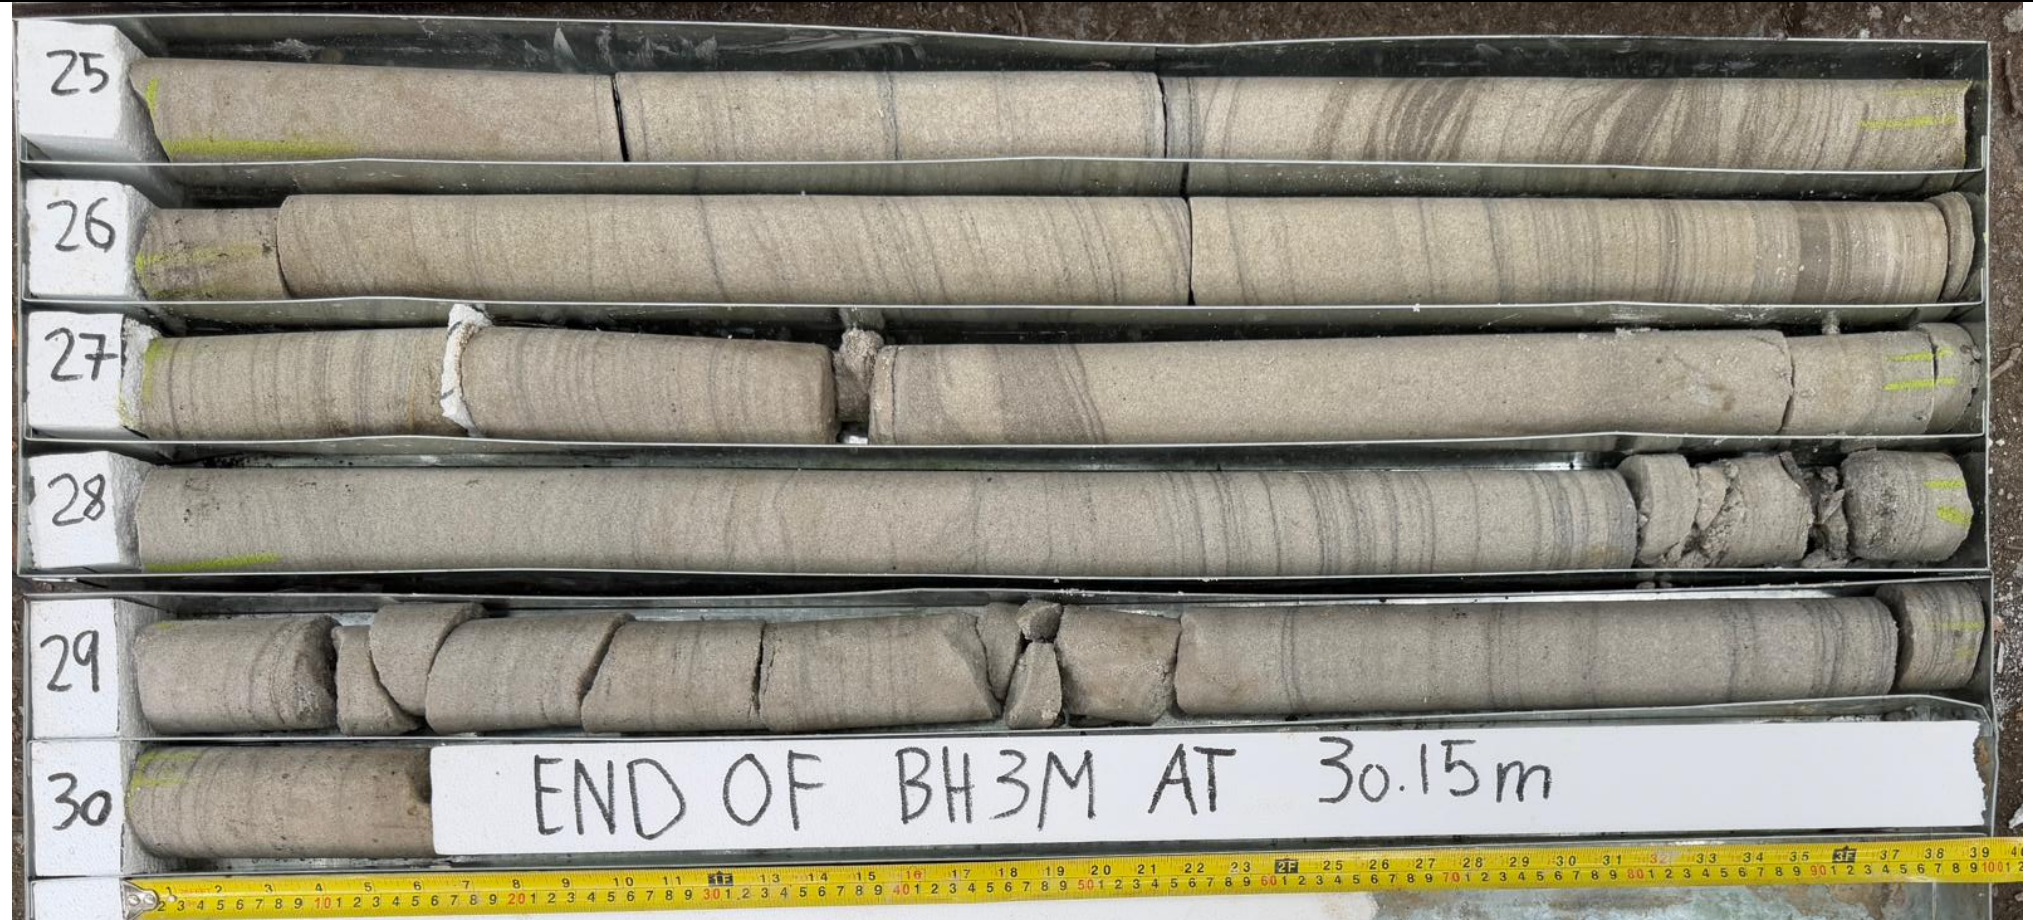
CORE PHOTOGRAPH OF BOREHOLE: BH3M

Project	New Development	Depth Range	25.0m to 30.15m BEGL	
Location	No. 37 Archer Street, Chatswood, NSW	Contractor	Stratacore Pty Ltd	
Position	See Figure 2	Drill Rig	Comacchio Geo 300	
Job No.	E26577.G03	Logged	S2	Date 23/ 01/ 2025
Client	Hyecorp Property Group	Box	2 of 2	Checked Date
