**6.5.5 Proposed Works to Group C Courtyard**

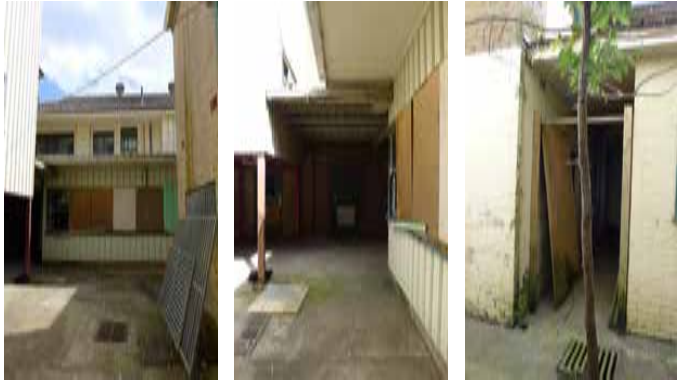
| Demolition | <ul style="list-style-type: none"> <li>Ground floor slabs</li> </ul> <div data-bbox="489 378 1169 757"> </div> <p>Figures 120, 121, 122: Intrusive structures within the courtyard, and the existing concrete floor slab, to be removed. Note: Demolition of the intrusive structures within the courtyard was included in the Early Works Package. Source: Tonkin Zulaikha Greer Architects, 2016.</p> |

| Conservation works | <ul style="list-style-type: none"> <li>Repairs to retained windows and doors facing courtyard (covered above).</li> <li>Brick cleaning and repointing. Removal of corrosive metal inserts.</li> <li>Render repairs.</li> <li>Repainting of painted surfaces. Includes removal and / or encapsulation of lead paint systems.</li> <li>Cleaning of stained exposed external walls.</li> <li>Repairs to existing copper rainwater disposal system where required.</li> <li>Clean pigeon guano and install pigeon proofing.</li> </ul> |
| Alterations + additions | <ul style="list-style-type: none"> <li>New covered external circulation including walkway, stairs and ramps.</li> <li>Landscape treatment to courtyard</li> </ul> |
