# O'CONNELL ST PRIMARY SCHOOL PARRAMATTA

FORMER OLD KINGS SCHOOL SITE  
STATEMENT OF HERITAGE IMPACT

SSD APPLICATION: REVISED 22.09.16

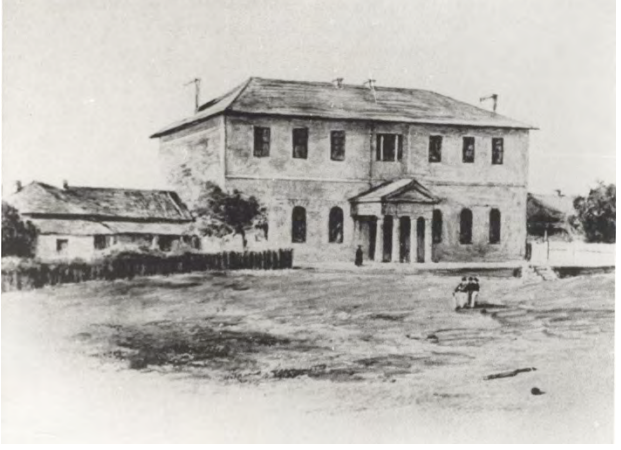
| <p>1850</p> <p>BUILDING<br/><b>B</b></p> | <p>A Deed of Grant was issued to the Trustees as the site for The Kings School. Additions to the original building were made during the first few years of headmastership of Reverend Frederick Armitage, and included:</p> <ul style="list-style-type: none"> <li>• Additional accommodation for boarders in rented houses (location unknown).</li> <li>• Two storey stone addition to the main building on the north side.</li> <li>• A temporary classroom was constructed – (demolished in 1869 when the school was re-opened. The materials were used to build new dormitories at this time).</li> </ul> | <p>Figure 17: Front elevation of King's School, c1850. Source: King's School Archives.</p> <p>CMP, 1994, p8.</p> |

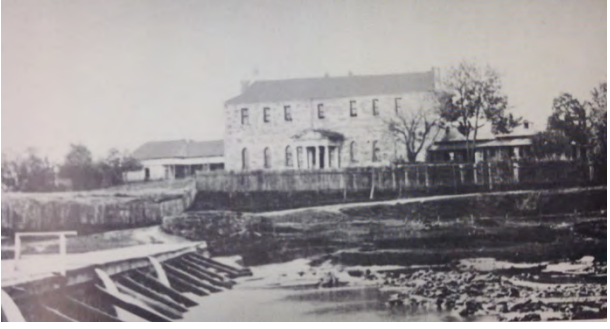
| <p>1869</p> <p>BUILDING</p> <p><b>B</b></p> | January – The school reopened following restoration of the building. The works most probably included partitioning two of the original dormitories on the first floor, forming four compartments each with twenty beds. The scope also included replacement of the original stone flagged floors on the ground floor of the main building with wooden flooring, the casing in of the stone staircase in cedar | |

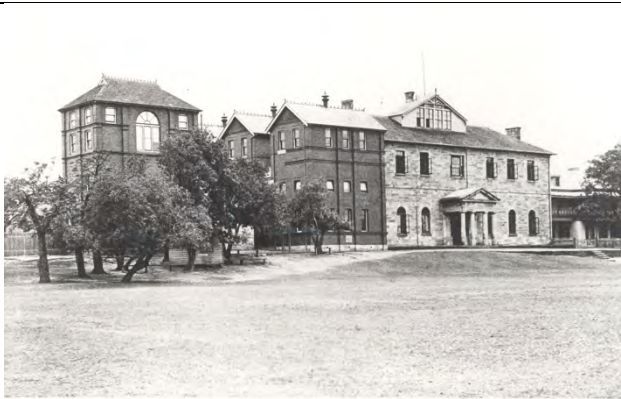
| 1902<br>BUILDING<br><b>C</b> | <p>A new three-storey block containing Armoury (ground floor), Science Room (second floor) and Museum (third floor) was completed to the west of the new Dining Hall.</p> <p>Prior to construction of this building the science room was a detached wooden building towards the river in front of the school. The exact date of construction of this building is unknown.</p> <p>Designs, estimates and tenders were called for development of the school along the riverfront, however it was not approved.</p> | <p>Figure 31: View of School, c1902.<br/>Source: King's School Archives.</p> <p><i>CMP</i>, 1994, p26.</p> |

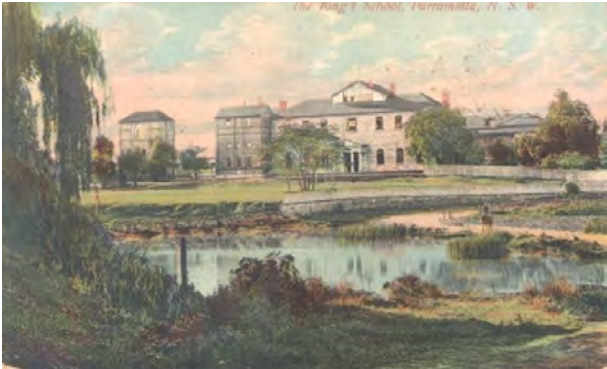
| 1906 | <p>The diagram to the right shows the additions for the Dining Room, and further additions for the Armoury, with Science Room and Museum above.</p> | <p>Figure 32: <i>Elevations Through Time, 1906 – Additions 1896 - 1906</i>, Kings School Group (Former), Land &amp; Property Information, NSW Government – Heritage Sites and Assets.</p> <p>Figure 33: <i>The King's School, Parramatta</i>, Kings School Group (Former), Land &amp; Property Information, NSW Government – Heritage Sites and Assets.</p> |

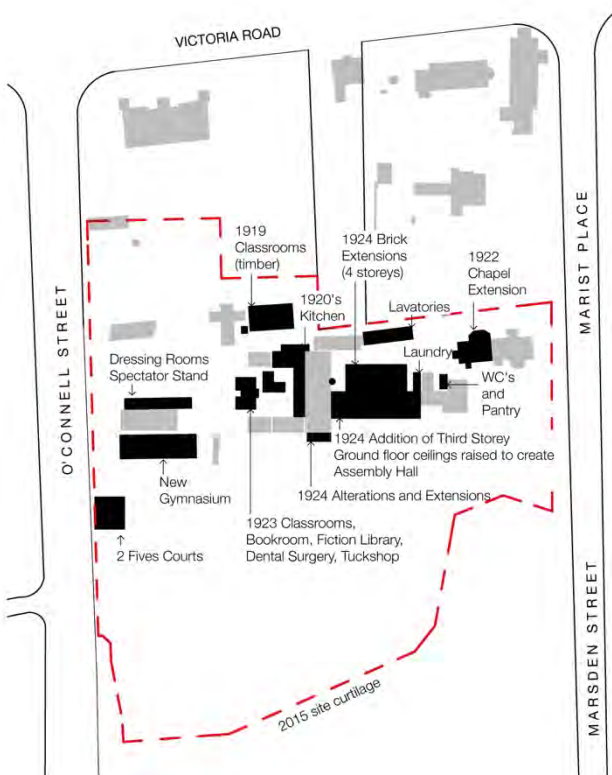
| | | <p>Figure 43: Plan showing phases of development, 1920s, Tonkin Zulaikha Greer Architects, adapted from 1994 <i>Conservation Management Plan</i>.</p> |

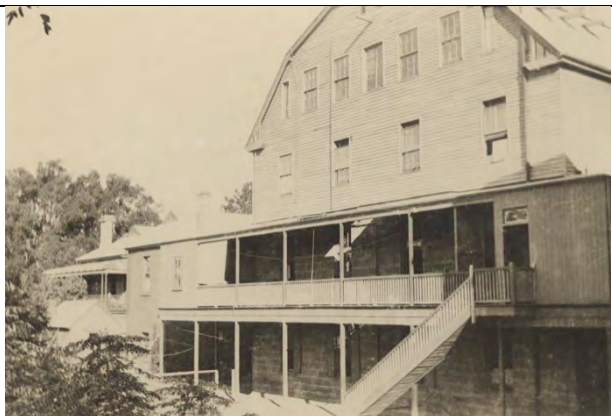
| 1920<br>BUILDING<br><b>B</b> | The School House Master's Cottage (former Cottage Hospital) was converted into physics and chemistry laboratories. | <p>Figure 44: North side of Main School Block (Building B) showing additions, c1920.<br/>Source: King's School Archives.</p> <p><i>CMP</i>, 1994, p28.</p> |

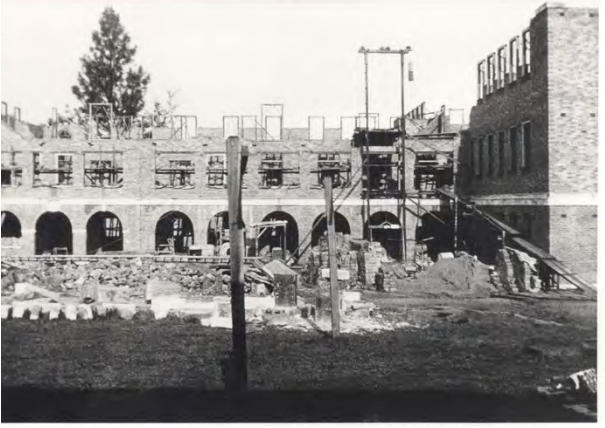
| <p>1934</p> <p>BUILDING<br/><b>D</b></p> <p>BUILDING<br/><b>B</b></p> <p>BUILDING<br/><b>C</b></p> | <p>Construction of new quarters was undertaken for boarders facing O'Connell Street (school houses Baker and Forrest). The building was ready for occupation in 1934 and was designed by architects Power, Adam &amp; Munnings.</p> <p>The interior of the Main Building was remodeled. Works included;</p> <ul style="list-style-type: none"> <li>• The western wall of the upper school was replaced and became the library;</li> <li>• The lower school took in the width of the corridor at its eastern end and became the Assembly Hall.</li> <li>• The corridors of the above floors were moved southwards about 8ft adding to the Masters' and Matron's quarters to make them suitable as classrooms;</li> <li>• The sewing room, work and locker room on top floor on north side of the building plus adjoining balcony were converted into a chemistry laboratory.</li> <li>• Dormitories above the Dining Hall were converted into a Physics Department;</li> <li>• The glassed in balcony on the west side of the dormitories became a special Gymnasium (later a Biology Laboratory).</li> <li>• The old Cottage Hospital, which had been science rooms was demolished as were temporary classrooms to east.</li> </ul> | <p>Figure 52: Construction of School House Baker and Forrest, c1933 (Building D). Source: King's School Archives.</p> |

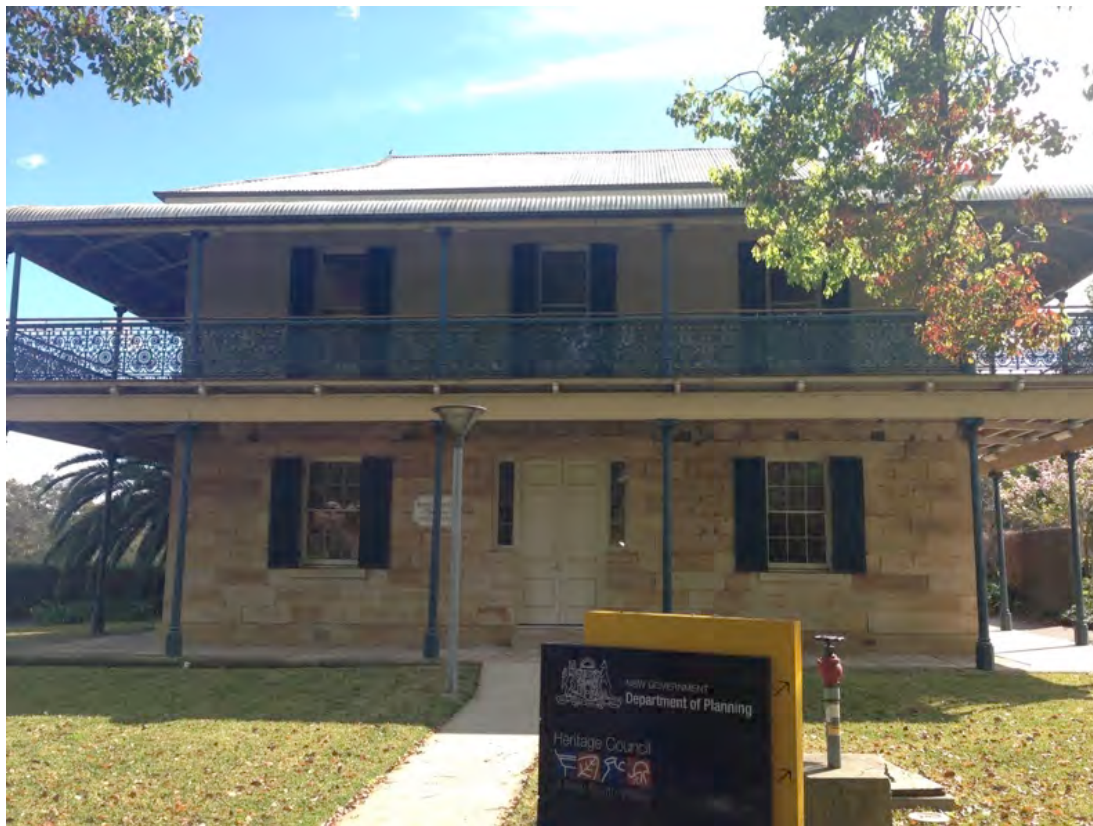
Figure 67: Building A Front elevation.  
Source: TZG Architects, 2015.

The residence was converted to administration offices when the Marsden Rehabilitation Centre occupied the site. The building was further refurbished in 2003 and has since been occupied and used as professional offices. It was recently vacated. The building is in good condition.

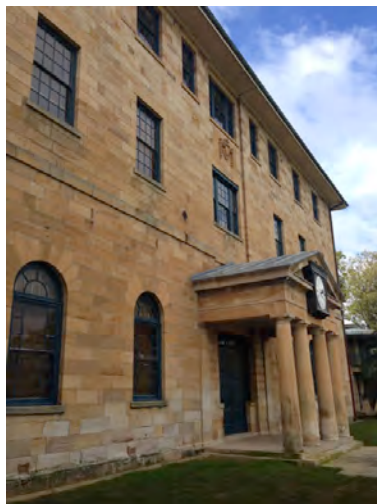
Figure 68: Building B1 Front elevation.  
Source: TZG Architects, 2015

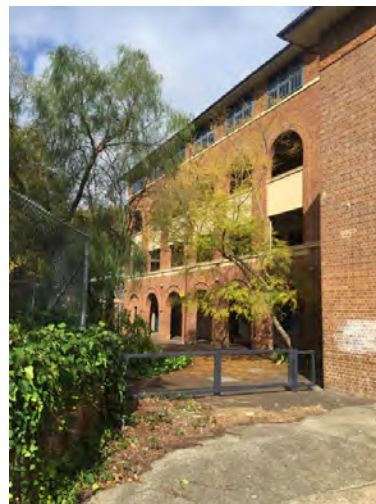
Figure 69: Building B2 Front elevation.  
Source: TZG Architects, 2015

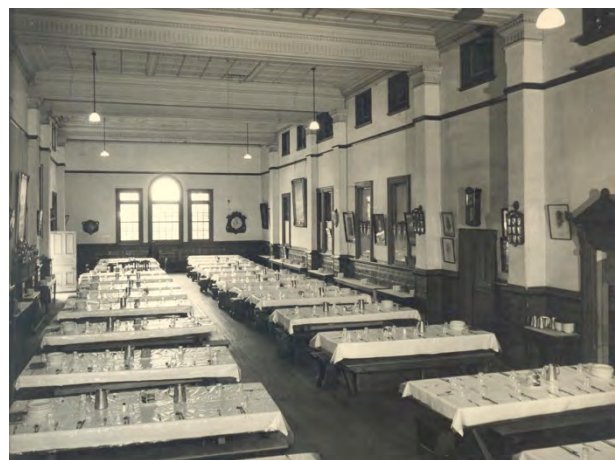
Figure 72: Former Dining Hall.  
Source: GAO, 2015

Extensive internal changes have been made to the former dining hall, including replacement of the original timber ground floor with reinforced concrete slab (c.1970). Additions that extended into the internal courtyard to enlarge the kitchen facilities were made to accommodate the Marsden Rehabilitation Centre.

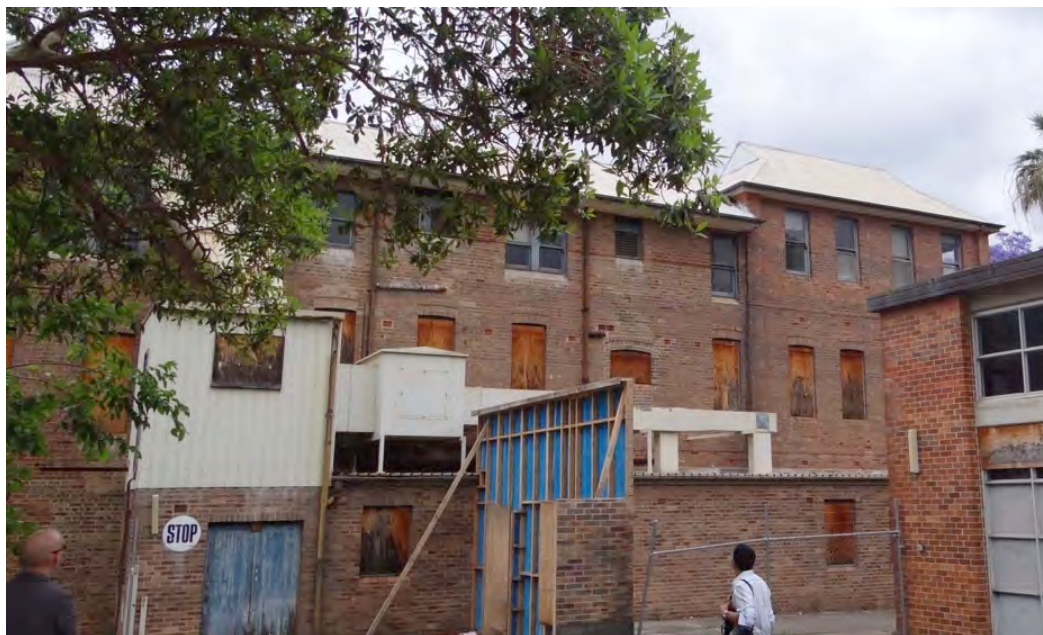
C2 contains the former kitchen of the Marsden Rehabilitation Centre on the ground floor and the upper floors were noted as being used for residential uses in the 1994 *Conservation Management Plan*. The building has been heavily modified internally. Today the wing is unoccupied and in a dilapidated condition, with pigeon infestations on the upper levels.

Figure 73: The northern side of Building C2.  
Source: TZG Architects, 2015.

- Removal of all redundant exposed services.
- Removal of the kitchen annex structure to ground slab level, including exhaust and ducting. Salvage bricks and brick vents where possible. Board up secure and make weather tight any resulting openings.
- Removal of certain hazardous materials, with the exception of lead paint systems and eaves linings.

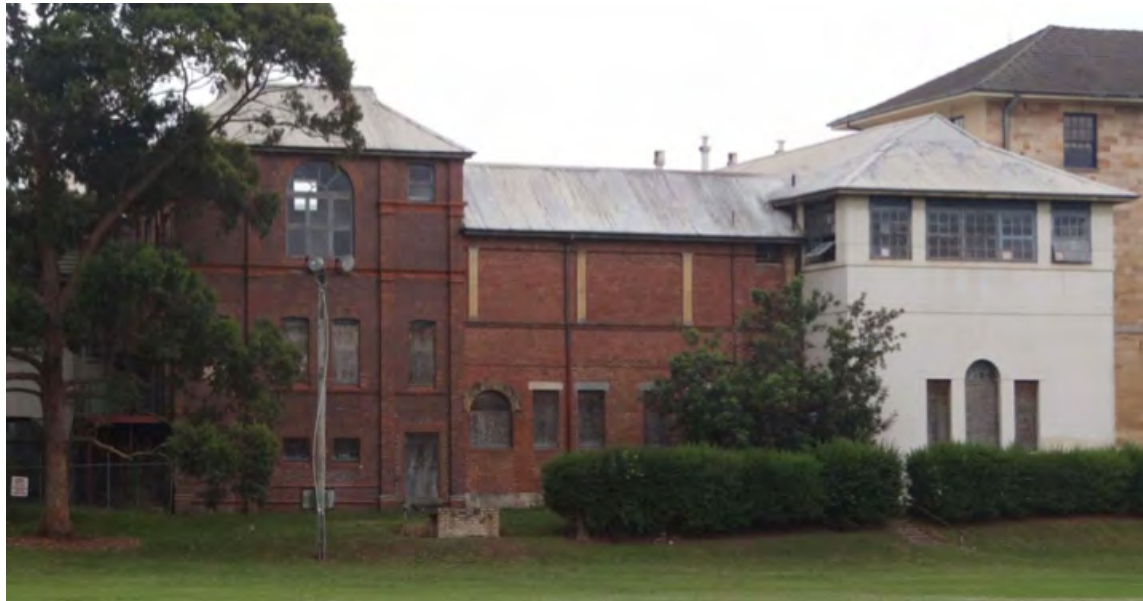
The white building shown to the right of this group constitutes the former dining hall (refer Section 4.3.2 above). The two storey brick building in the centre dates from 1908. It was built to bridge between the dining hall (right) and the armoury building (left). The building now contains disused toilet facilities on the ground floor and a former activity room above. The façade is divided into three bays. A rusticated stone arch suggests a former doorway at ground level. The ground floor openings were significantly altered c.1970. An earlier photograph suggests a projecting bay was present at ground level containing highlight windows, windows and a doorway. Windows facing the courtyard were filled in c.1970.

Figure 74: South face of Building C3. The two storey dining hall (white rendered building on right) was built first, followed by the three storey building on the left hand side. The central connecting building was the last completed. As a consequence, this wing is the most problematic for level differences across floors.

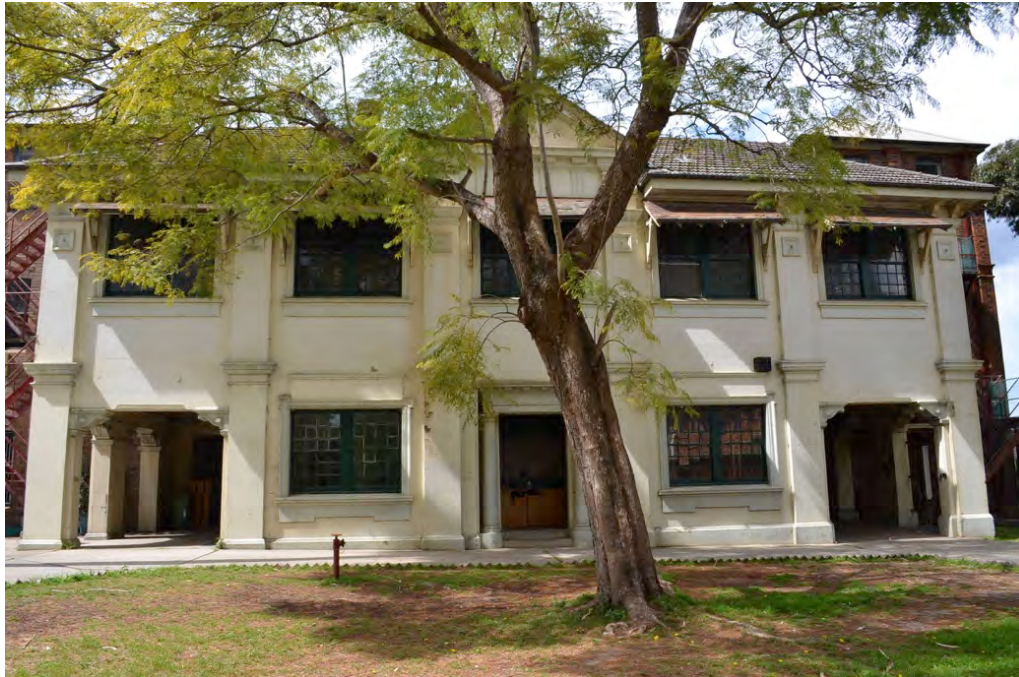
Figure 75: West face of Building C4. (Source: GAO)

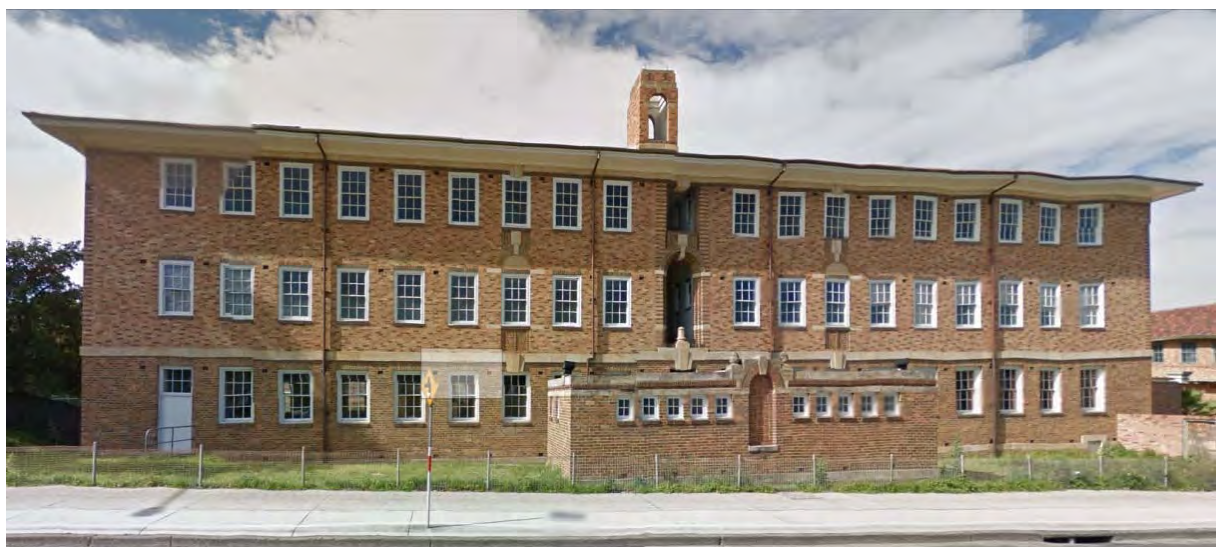
Figure 76: The O'Connell Street (western) elevation of Building D with single-storey toilet block at the front. (Source: Google street view).

The building generally consists of thick, solid external masonry walls and predominantly masonry internal walls. The masonry external and internal walls are considered to generally be loadbearing, supporting the masonry walls above, the suspended floors as well as the roof structure. The ground floor appears to generally be a suspended timber framed structure, with the exception of the wet areas. The masonry walls are typically supported on reinforced concrete strip footings. These shallow footings are considered to be generally bearing on a reactive clay foundation.

Work was carried out on Building D in 2011 to make it secure, and repair the windows and roof drainage. Several windows had their lead paint stripped from the external face and were re-painted. The copper gutters and downpipes were repaired and replaced where missing. The ground floor sections of the downpipes were replaced in cast iron, presumably to reduce the risk of theft whilst the buildings were unoccupied.

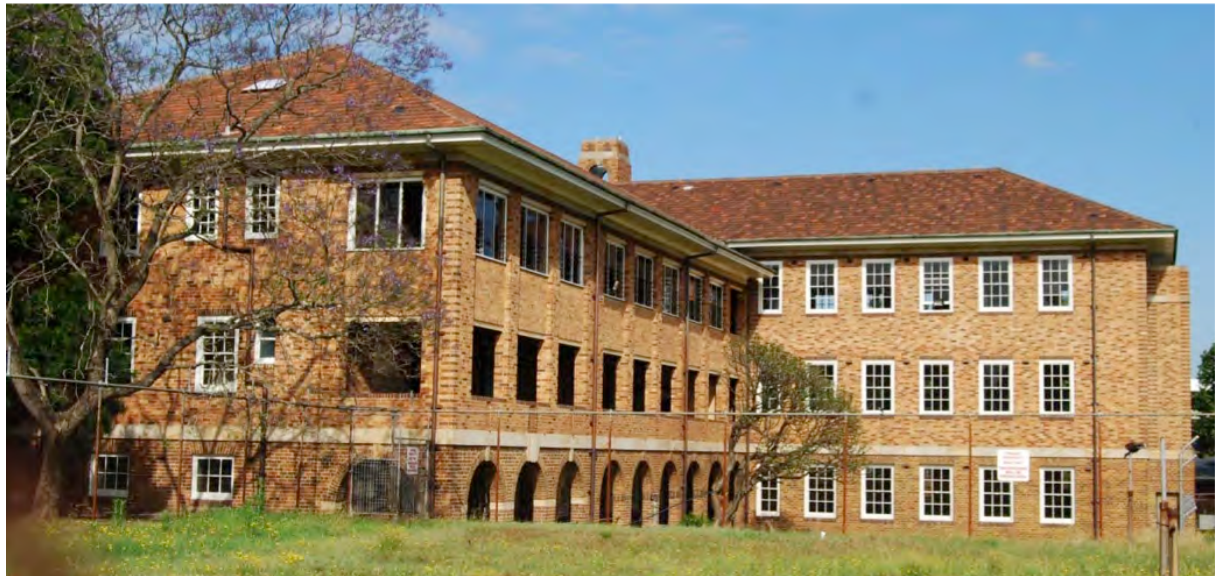
Figure 77: The rear north-east corner of Building D. The top floor of the balcony is enclosed. The different floor levels on the upper floors between the two wings of the building can be clearly seen. (Source: GAO)

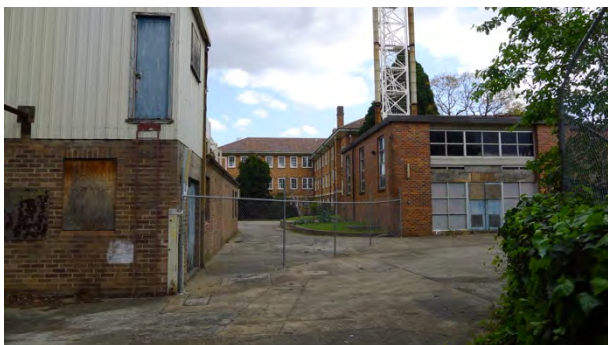
Figure 91: Concrete apron to rear of Building C and Building E (prior to Early Works package demolition of structures in the courtyard of Group C, Building E, F and H).

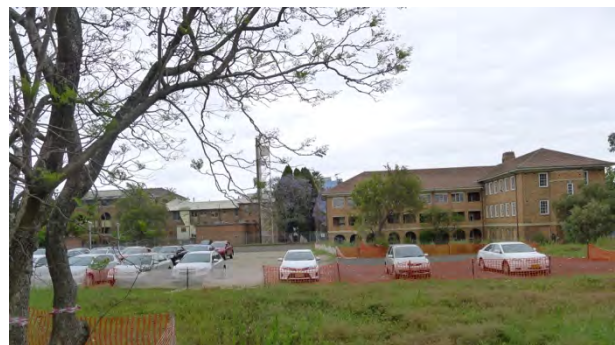
Figure 92: View to rear of Building D from neighbouring site (prior to Early Works package demolition of structures in the courtyard of Group C, Building E, F and H).

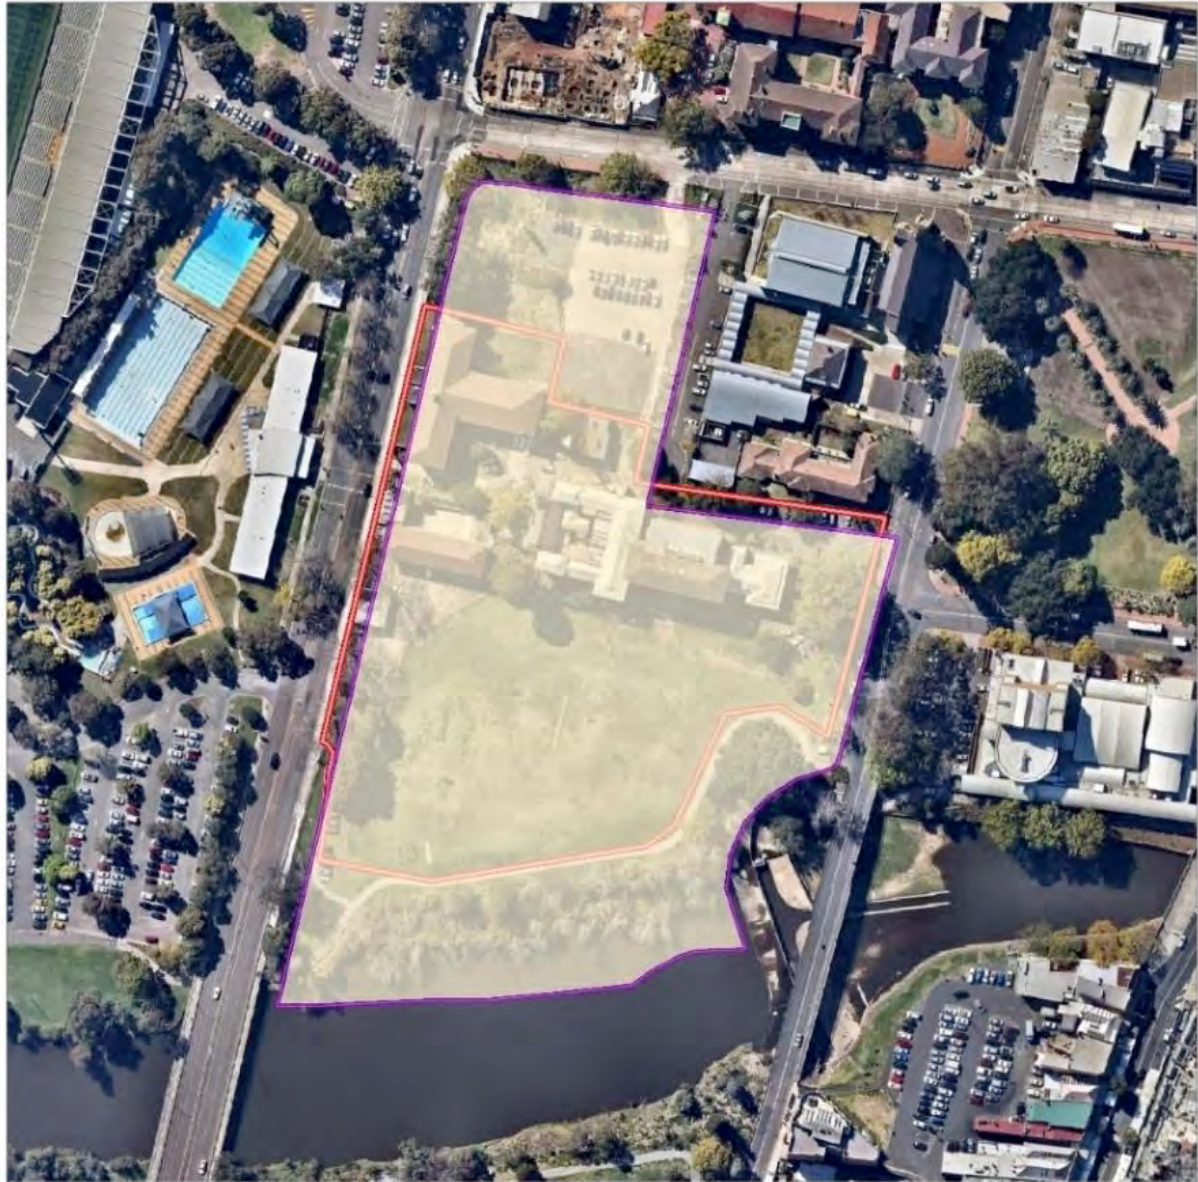
Figure 94: King's School (Former) curtilage established by CMP.

The proposed site is located within the curtilage of 'King's School Group (former)'. Other names for the site include Old King's School and Marsden Rehabilitation Centre.

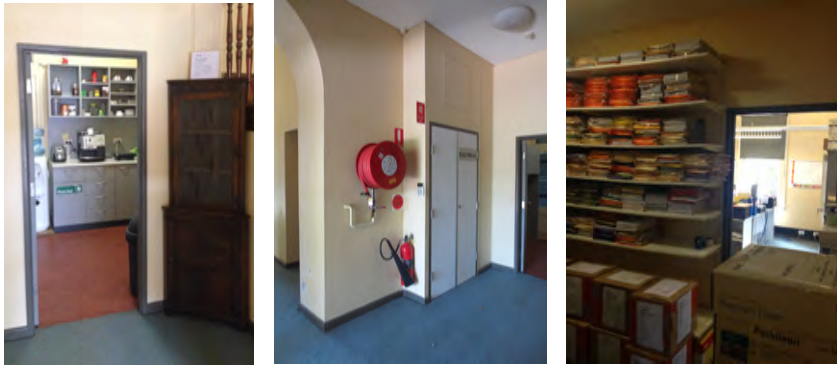
| Demolition | <ul style="list-style-type: none"> <li>Removal of lightweight partition walls (2003).</li> <li>Removal of plasterboard ceilings (2003).</li> <li>Removal of redundant services (2003).</li> <li>Removal of laminate joinery items (2003).</li> <li>Removal of certain wet area finishes and fittings (2003).</li> </ul> <div data-bbox="454 613 1295 976"> <p>The first photo shows a doorway with a red carpet and a dark wooden cabinet. The second photo shows a hallway with a red fire alarm pull station and a fire extinguisher. The third photo shows a storage area with shelves filled with boxes and a fire alarm pull station.</p> </div> <p>Figures 98, 99, 100: Internal joinery, services and ceilings (2003) to be removed.<br/>Source: Tonkin Zulaikha Greer Architects, 2016.</p> |
| Conservation works | <ul style="list-style-type: none"> <li>Verandah repairs, including replacement of decking on first floor.</li> <li>Repair of wall vents.</li> <li>Repairs to existing significant windows and doors.</li> <li>Repair, treatment and repainting of cast and wrought iron elements.</li> <li>Render repairs.</li> <li>Removal of corrosive inserts and other redundant services.</li> <li>Repainting of painted surfaces. Includes removal and / or encapsulation of lead paint systems.</li> <li>Pigeon proofing, where required.</li> <li>Replacement of corrugated metal roofing and reinstatement of vented gablets.</li> <li>Repairs to existing copper rainwater disposal system.</li> <li>Clean pigeon guano and install pigeon proofing.</li> <li>Structural stonework repairs.</li> </ul> <p>*Note: The scope of works for stonework repair and conservation is to be assessed by a stonework specialist.</p> <ul style="list-style-type: none"> <li>Structural strengthening of existing timber floor structures to be retained, through the installation of galvanised ties to existing masonry walls.</li> </ul> |

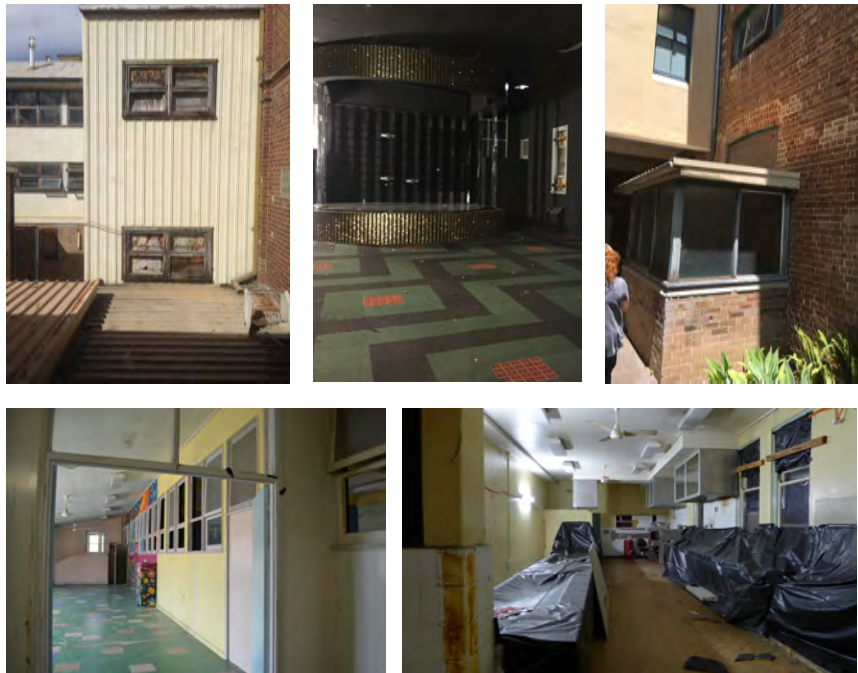
| Demolition | <ul style="list-style-type: none"> <li>Ground floor addition slab (facing courtyard)</li> <li>Enclosed 'verandah' wall facing courtyard on three levels, including all windows and doors.</li> <li>New openings in western side to connect to courtyard and external circulation on upper levels.</li> <li>New opening in eastern wall to connect to Building B on all levels.</li> <li>Remove existing corrugated iron roof (to be replaced).</li> <li>Removal of intrusive internal fit-out and finishes.</li> <li>Removal of partition walls on level 2.</li> <li>Demolition of small entrance porch on eastern side at northern end.</li> <li>Removal of lightweight walls on level two.</li> </ul> <div data-bbox="470 1059 1332 1729"> </div> <p>Figures 104, 105, 106, 107, 108: Enclosed verandah facing the courtyard, intrusive internal fit-out to the dining hall, the small entrance porch, partition walls on level two, and intrusive kitchen fit-out, all to be removed. Source: Tonkin Zulaikha Greer Architects, 2016.</p> |
| Conservation works | <ul style="list-style-type: none"> <li>Repairs to original windows and doors.</li> <li>Structural repairs to cracked masonry, if necessary.</li> <li>Repointing and cleaning of brickwork. Removal of corrosive inserts and other redundant services.</li> <li>Render repairs.</li> </ul> |

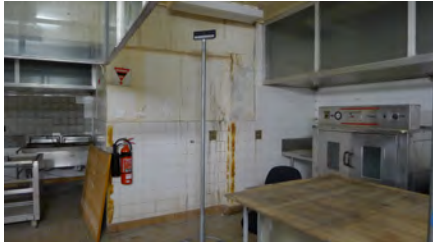
| Demolition | <ul style="list-style-type: none"> <li>Removal of kitchen northern annex slab and part of ground floor slab.</li> <li>Openings in northern wall on ground floor and first floor to new annex (salvage of bricks where possible).</li> <li>Removal of all plant and existing services associated with kitchen.</li> <li>Removal of timber framed floors to first floor and second floor and internal walls on levels one and two.</li> <li>New openings southern elevation (courtyard).</li> <li>Remove existing corrugated iron roof (to be replaced).</li> <li>Removal of intrusive internal fit-out and finishes.</li> <li>Removal of external steel framed fire stairs, and doors to fire stairs.</li> </ul> <div style="display: flex; flex-wrap: wrap;"> </div> <p>Figures 109, 110, 111, 112, 113: Intrusive kitchen fit-out (2003), typical walls and floors on second floor, sanitary fittings and the external steel fire stairs all to be removed.</p> <p>Note: Demolition of the kitchen annex on the northern side was included in the Early Works Package. Source: Tonkin Zulaikha Greer Architects, 2016.</p> |
| Conservation works | <ul style="list-style-type: none"> <li>Repairs to original windows and doors.</li> <li>Render repairs.</li> <li>Repainting of painted surfaces. Includes removal and / or encapsulation of lead paint systems.</li> <li>Repointing and cleaning of brickwork. Removal of corrosive inserts.</li> <li>Salvage of bricks and wall vents for re-use wherever feasible.</li> <li>Cleaning of stained exposed external walls.</li> <li>Replacement of corrugated metal roof.</li> <li>Repairs (and replacement where HAZMAT present) of soffits and barge boards.</li> <li>Repairs to existing copper rainwater disposal system. Repainting of metal downpipes at ground level.</li> <li>Clean pigeon guano and install pigeon proofing where required.</li> <li>Structural strengthening of existing timber floor structures to be retained, through the installation of galvanised ties to existing masonry walls.</li> <li>Installation of cross bracing within the ceiling void on the second floor for structural strengthening.</li> </ul> |

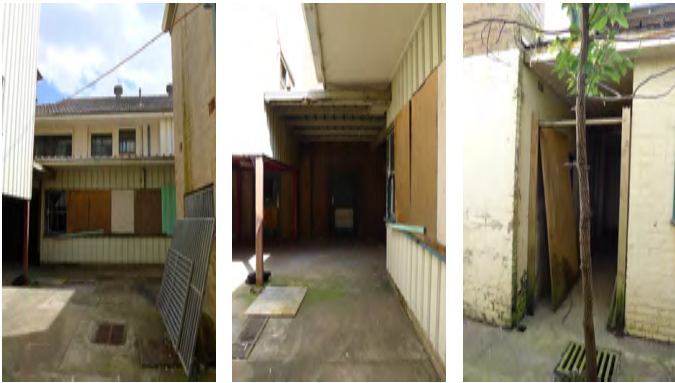
| Demolition | <ul style="list-style-type: none"> <li>Ground floor slabs</li> </ul> <div data-bbox="491 376 1169 757"> </div> <p>Figures 120, 121, 122: Intrusive structures within the courtyard, and the existing concrete floor slab, to be removed. Note: Demolition of the intrusive structures within the courtyard was included in the Early Works Package. Source: Tonkin Zulaikha Greer Architects, 2016.</p> |
| Conservation works | <ul style="list-style-type: none"> <li>Repairs to retained windows and doors facing courtyard (covered above).</li> <li>Brick cleaning and repointing. Removal of corrosive metal inserts.</li> <li>Render repairs.</li> <li>Repainting of painted surfaces. Includes removal and / or encapsulation of lead paint systems.</li> <li>Cleaning of stained exposed external walls.</li> <li>Repairs to existing copper rainwater disposal system where required.</li> <li>Clean pigeon guano and install pigeon proofing.</li> </ul> |

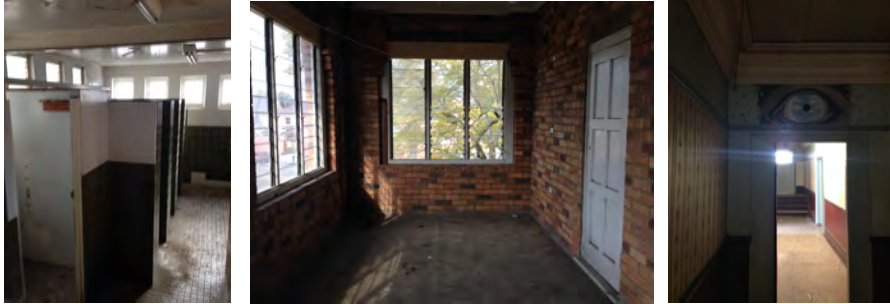
| Demolition | <ul style="list-style-type: none"> <li>• Internal floors and walls to eastern wing on three levels and amenities areas in the centre of the north / south wing.</li> <li>• Amenities on the ground floor.</li> <li>• New opening on eastern elevation of northern wing to ground floor.</li> <li>• Creation of central lift shaft extending through the building (not through the roof – overrun accommodated within roof space). Windows and doors in this area to be removed.</li> <li>• Removal of redundant sewer lines and vents.</li> <li>• Removal of roof over the former ablutions wing at ground level (western side).</li> <li>• Removal of louvre windows to level two verandahs on northern side.</li> </ul> <div data-bbox="363 840 1257 1142"> </div> <p>Figures 123, 124, 125: Amenities on the ground floor, the louvre windows to the level two verandahs, and the typical internal floors and walls at level two, all to be removed.</p> <p>Source: Tonkin Zulaikha Greer Architects, 2016.</p> |
| Conservation works | <ul style="list-style-type: none"> <li>• Repairs to original windows and doors.</li> <li>• Brick repointing and cleaning.</li> <li>• Render repairs.</li> <li>• Repainting of painted surfaces. Includes removal and / or encapsulation of lead paint systems.</li> <li>• Repairs (and replacement where HAZMAT present) to soffits and barge boards.</li> <li>• Rainwater goods – repairs as required and repainting of existing down pipes at ground level.</li> <li>• Repairs to existing tile roof.</li> <li>• Repairs to existing copper rainwater disposal system.</li> <li>• Clean pigeon guano and install pigeon proofing.</li> <li>• Minimal stonework repairs and repointing.</li> </ul> <p>*Note: The scope of works for stonework repair and conservation is to be assessed by a stonework specialist.</p> <ul style="list-style-type: none"> <li>• Structural strengthening of existing timber floor structures to be retained, through the installation of galvanised ties to existing masonry walls.</li> </ul> |

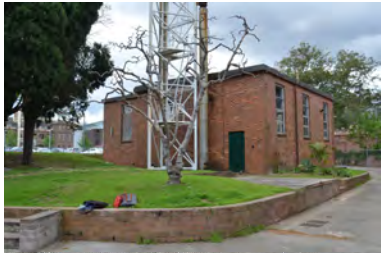
| Demolition | <p>Demolition of Building E (Boiler House) ground level slab and nearby 'in-ground' structures. Removal and capping off of redundant services.</p> <p>Figure 126: Building E and adjacent 'in-ground' structures.<br/>Note: Demolition of Building E (to ground slab level) was included in the Early Works Package.<br/>Source: Tonkin Zulaikha Greer Architects, 2016.</p> |

| Proposal | <ul style="list-style-type: none"> <li>• New open area for sport, covered with steel roof to 7m height.</li> <li>• A new 2.15m high fence along the northern boundary. The fence sits on a concrete retaining wall, with contiguous piling.</li> <li>• New sports court to be excavated to achieve required levels.</li> </ul> |

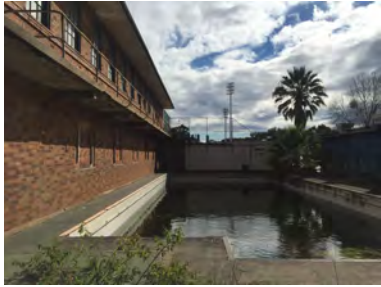
| Demolition | <ul style="list-style-type: none"> <li>• Demolition of Building F ground floor slab.</li> <li>• Retention of the swimming pool and retaining wall on northern side.</li> <li>• Removal and capping off of redundant services.</li> </ul> <p>Figure 127: View across the existing swimming pool, to be retained and adaptively re-used. The floor slab of Building F is to be removed. Note: Demolition of Building F (to ground slab level) was included in the Early Works Package. Source: Tonkin Zulaikha Greer Architects, 2016.</p> |

| Proposal | <ul style="list-style-type: none"> <li>• New single-storey multi-purpose School Hall and associated facilities with steel roof and external verandahs. The facades of the new Hall and its adjoining western service wing will be face brick, with the verandas screened with steel mesh, which will be paint finished.</li> <li>• Adjoining store and facility wing along the O'Connell Street frontage.</li> <li>• Roof vents and photovoltaic panels for ESD requirements.</li> <li>• A new approx.200m2 COLA adjacent to the new Hall on the northern side. Part paved / part grass area.</li> <li>• Covered walkways or 'learning verandahs' to serve as additional COLAs.</li> <li>• Adaptive re-use of the former swimming pool as a stormwater detention tank.</li> </ul> |

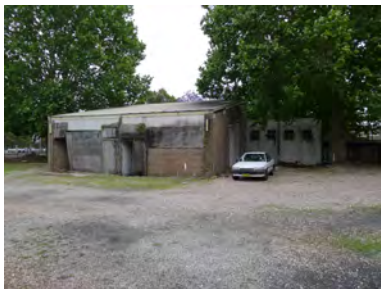
| Demolition | <ul style="list-style-type: none"> <li>• Demolish remaining floor slabs if required for upgraded floor.</li> <li>• Demolish roof and small part of nib-walls facing east, if not already undertaken under Early Works package.</li> </ul> <p>Figure 128: Building G is to be largely retained and adaptively re-used. Minor demolition works proposed. Source: Tonkin Zulaikha Greer Architects, 2016.</p> |

| Proposed use | <ul style="list-style-type: none"> <li>• Incorporation of part of existing building into new School Hall support facilities.</li> <li>• O'Connell Street façade and part of east / west walls to be conserved and adapted as a maintenance store and to enclose the courtyard.</li> </ul> |

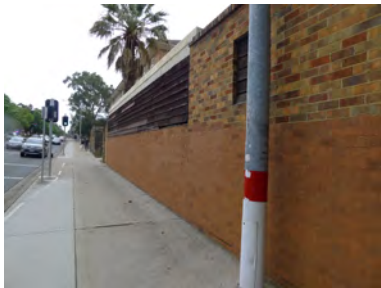
| Demolition | <ul style="list-style-type: none"> <li>• Demolition of Building H ground slab.</li> </ul> <p>Figure 129: The ground slab of Building H is to be removed. Note: Demolition of Building H (to ground slab level) was included in the Early Works Package. Source: Tonkin Zulaikha Greer Architects, 2016.</p> |

| Proposed use | <ul style="list-style-type: none"> <li>• Incorporation of part of existing building into new School Hall support facilities.</li> <li>• Interpretation of former building in construction of ancillary wing containing plant, amenities and out of school hours care spaces.</li> </ul> |

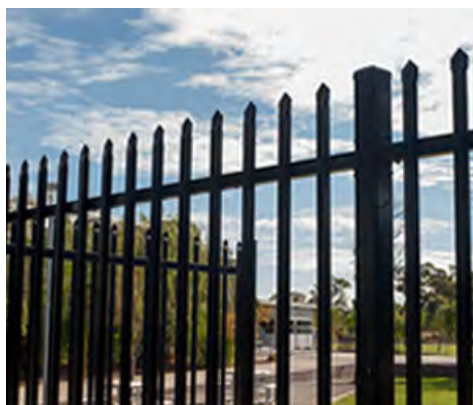
Figure131: Example of proposed revised security fence.  
Source: TZG 2016.
