GLENDENNING ROAD DATA CENTRE

*2 Glendenning Road,  
Glendenning, NSW*

## Archaeological Assessment

*FINAL | February 2025*

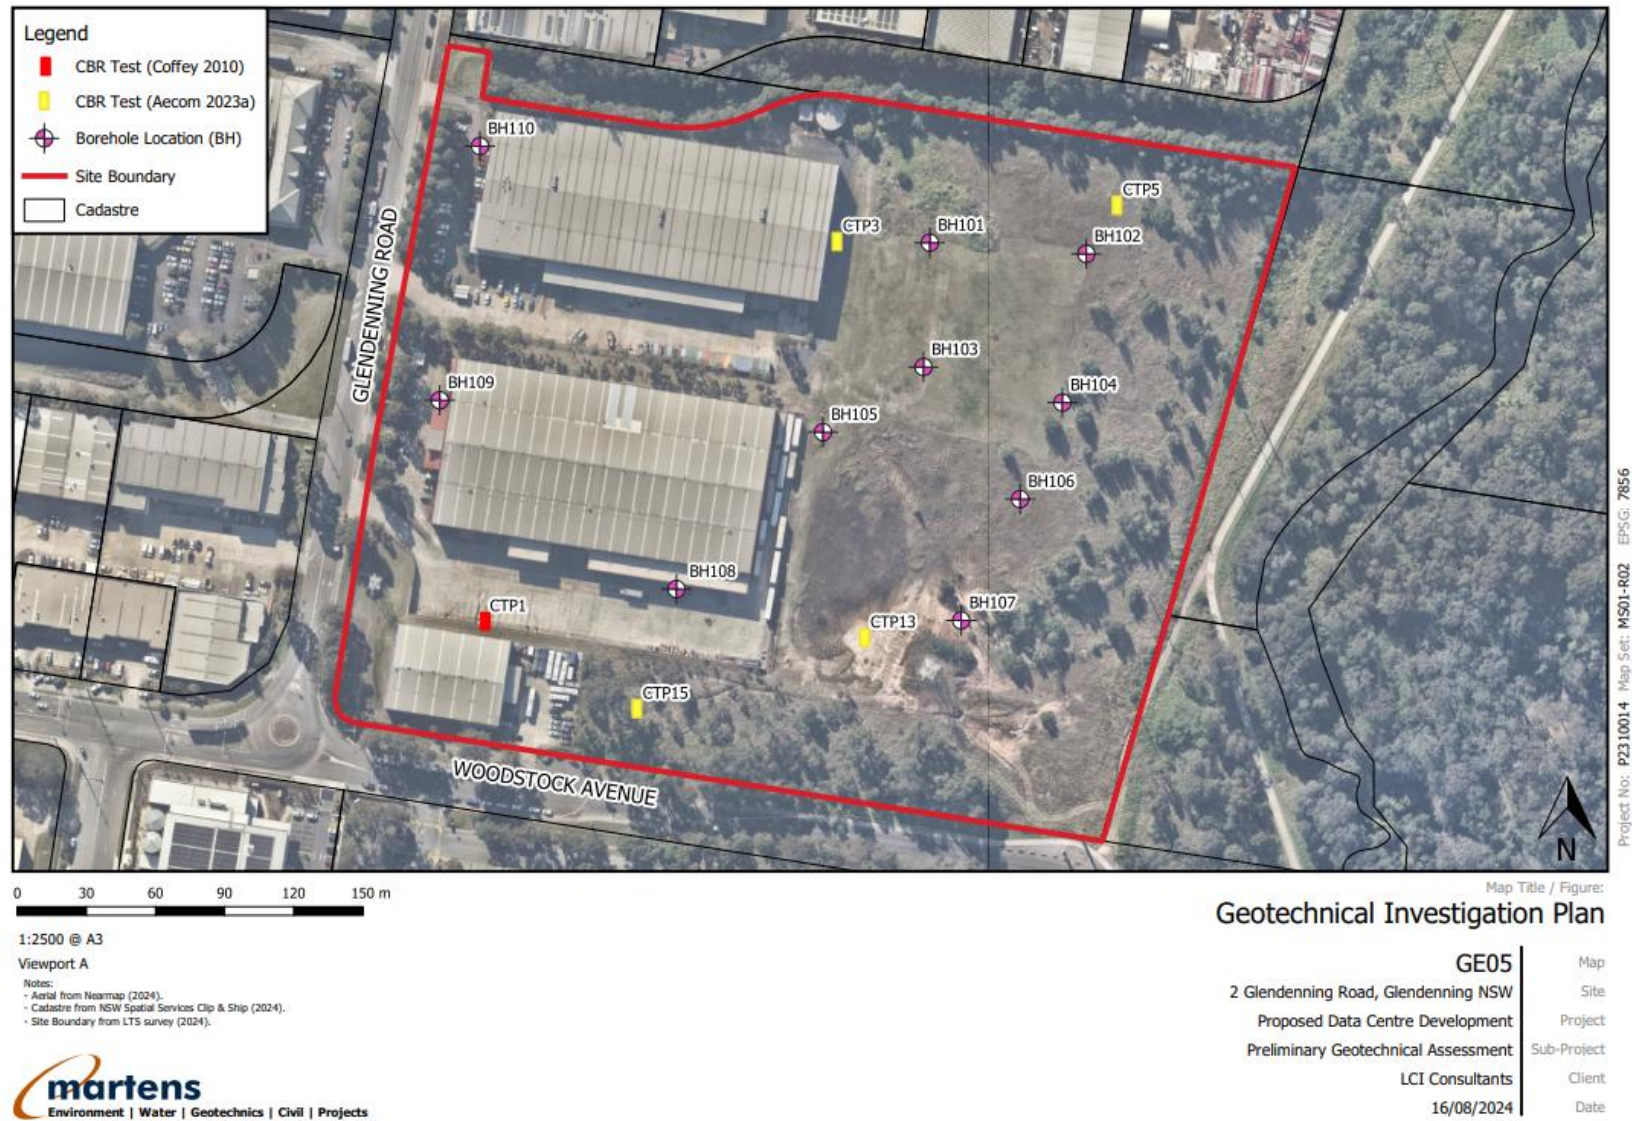
The test pit and borehole data indicate the absence of original A horizon soils, with residual B1–C3 stiff silty clay alluvium and residual soil units surviving ~1.3–3m below imported fills across the majority of the project area (Martens 2024). Alluvium has been identified on the site to depth of 9m. The alluvium consists of stiff to hard clay with some fine to coarse grained gravel, medium and high plasticity, with moderate to high shrink–swell potential’ (AECOM 2023:18). The high clay content of the project area may have impacted the depositional condition of stone artefacts, if extant, and contributed to movement. If Aboriginal objects have survived north of CTP1 (AECOM 2023, as cited in Martens 2024), these objects are likely to have been significantly displaced through land use, earthworks and imported fill.

Figure 4. Distribution of geotechnical investigations across the project area (Martens 2024).

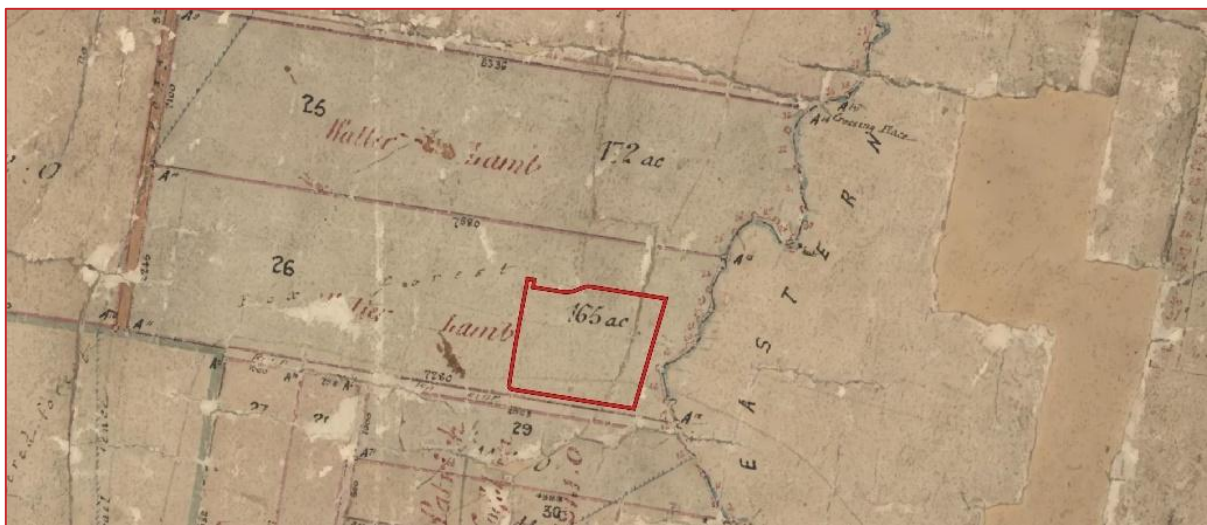
Figure 5. Project area defined in red on 1835 map of Rooty Hill government stock farm which had been reduced in size and transferred to the Church and School Corporation by 1829 (light green area). Base map: Historical Land Records Viewer, Parish of Rooty Hill, 1835, Sheet:1.

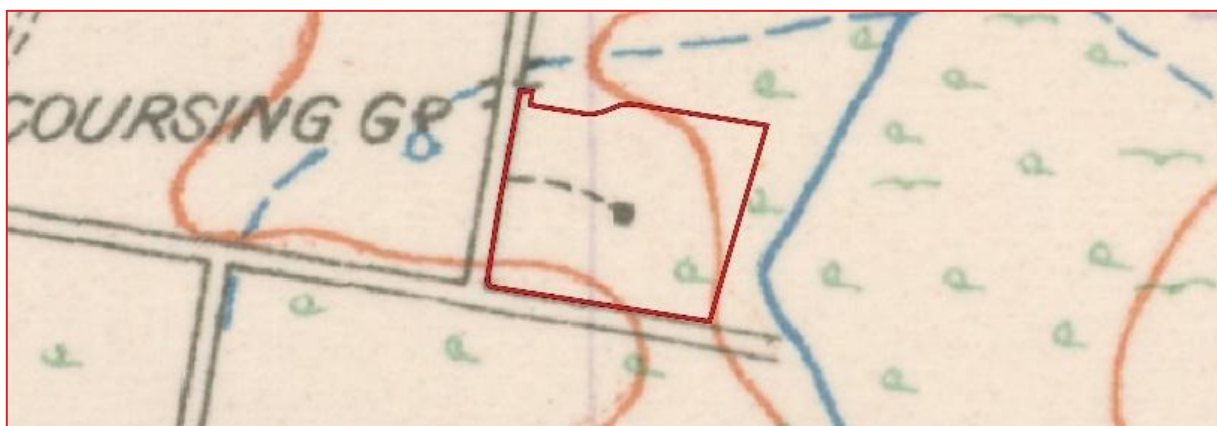
Figure 6. Crown Plan showing the 165-acre allotment purchased by Walter Lamb in 1872, which encompasses the project area (shown in red). It was one of many allotments in the area taken up by Lamb for his pastoral pursuits. Base map: NSW Land Registry Service, Crown Plan 51-2030, Dec. 1871.

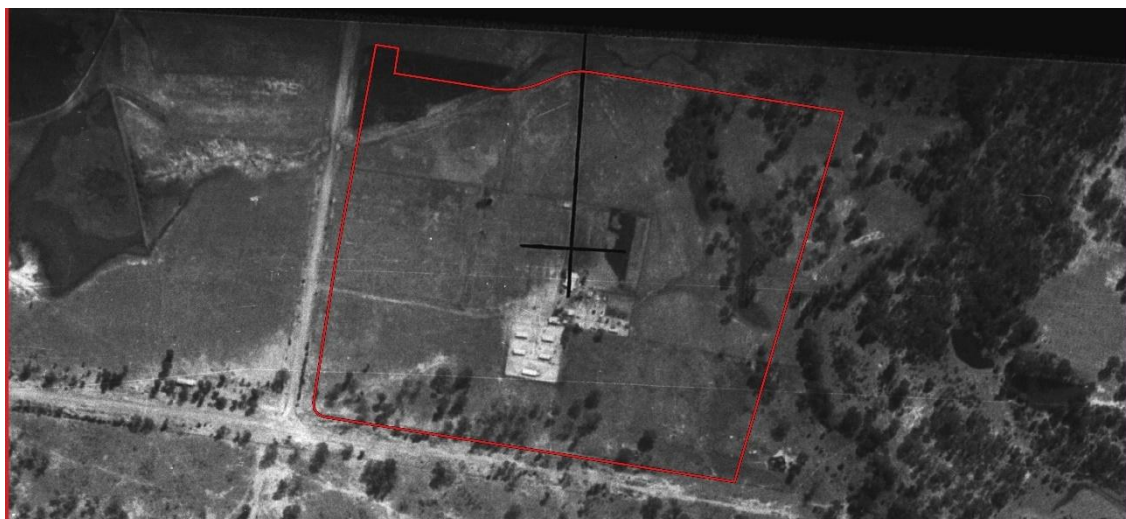
Figure 7. 1929 Blacktown map showing a dwelling and access way in the centre of the project area, defined in red. This was the weatherboard cottage and poultry sheds owned by Hugh Owen. Source: Australian Section Imperial General Staff, Australia 1:63360, 1929.

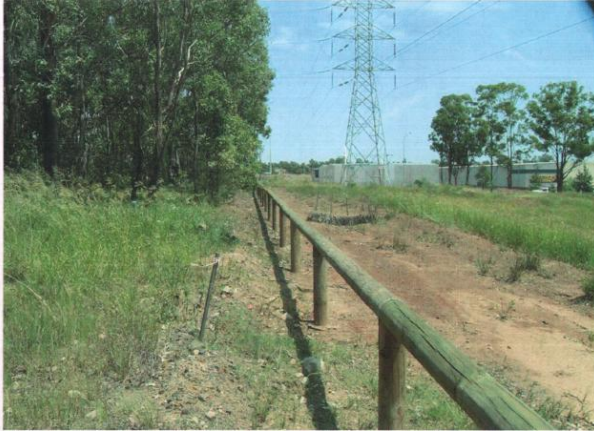
*Figure 17. View looking west from the break of slope of the low ridge line on the southern boundary of the project area (Source: Jo McDonald 2005: 12). The slope and electricity easement has been substantially modified since this date.*

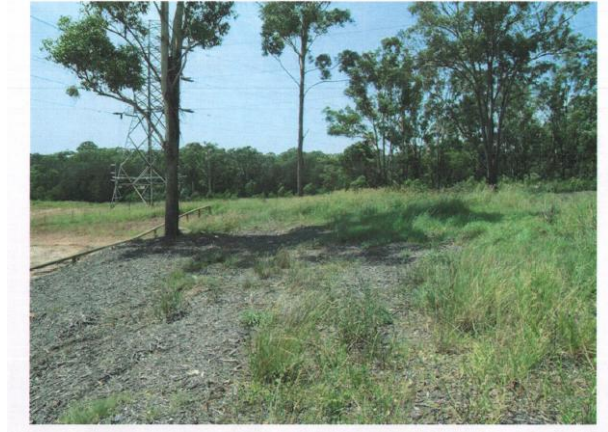
*Figure 18. View looking east across the southern boundary of the project area, looking NE across area identified by Jo McDonald as a PAD, with transmission line and eastern creek in the background (Source: Jo McDonald 2005: 12). This terrain has been substantially altered.*

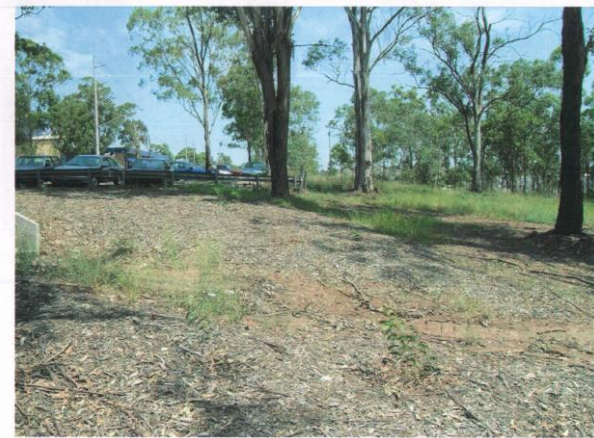
*Figure 19. The culvert and land depicted above in 2005 now contains a water retention basin and warehouse (Jo McDonald 2005: 13)*

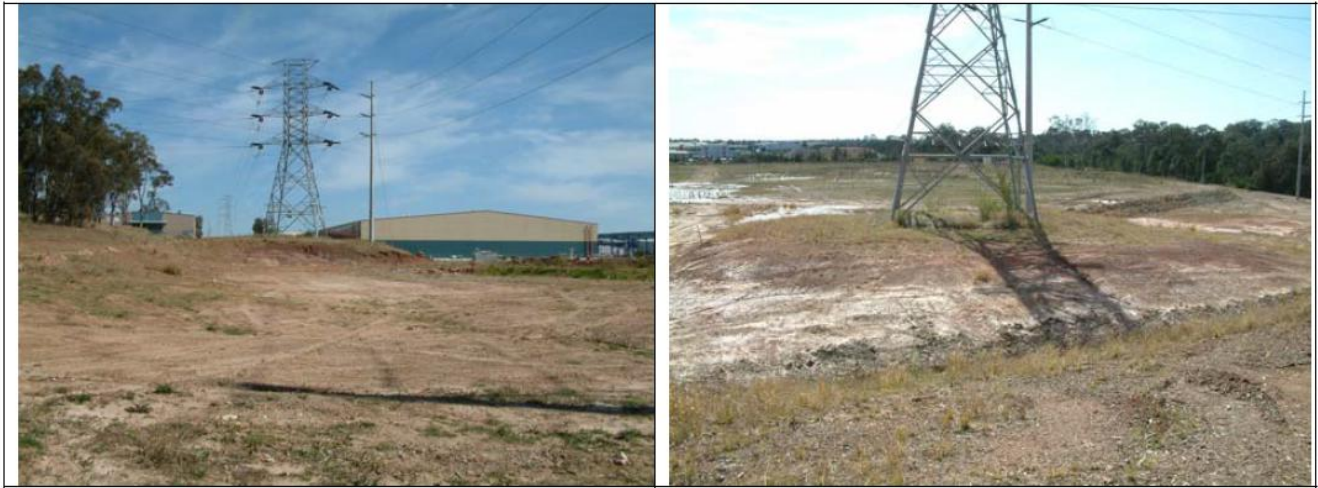
*Figure 21. The project area, looking west and north-east (Source; Brown 2008: 37). The warehouse assessed by Jo McDonald (2005) has been constructed.*

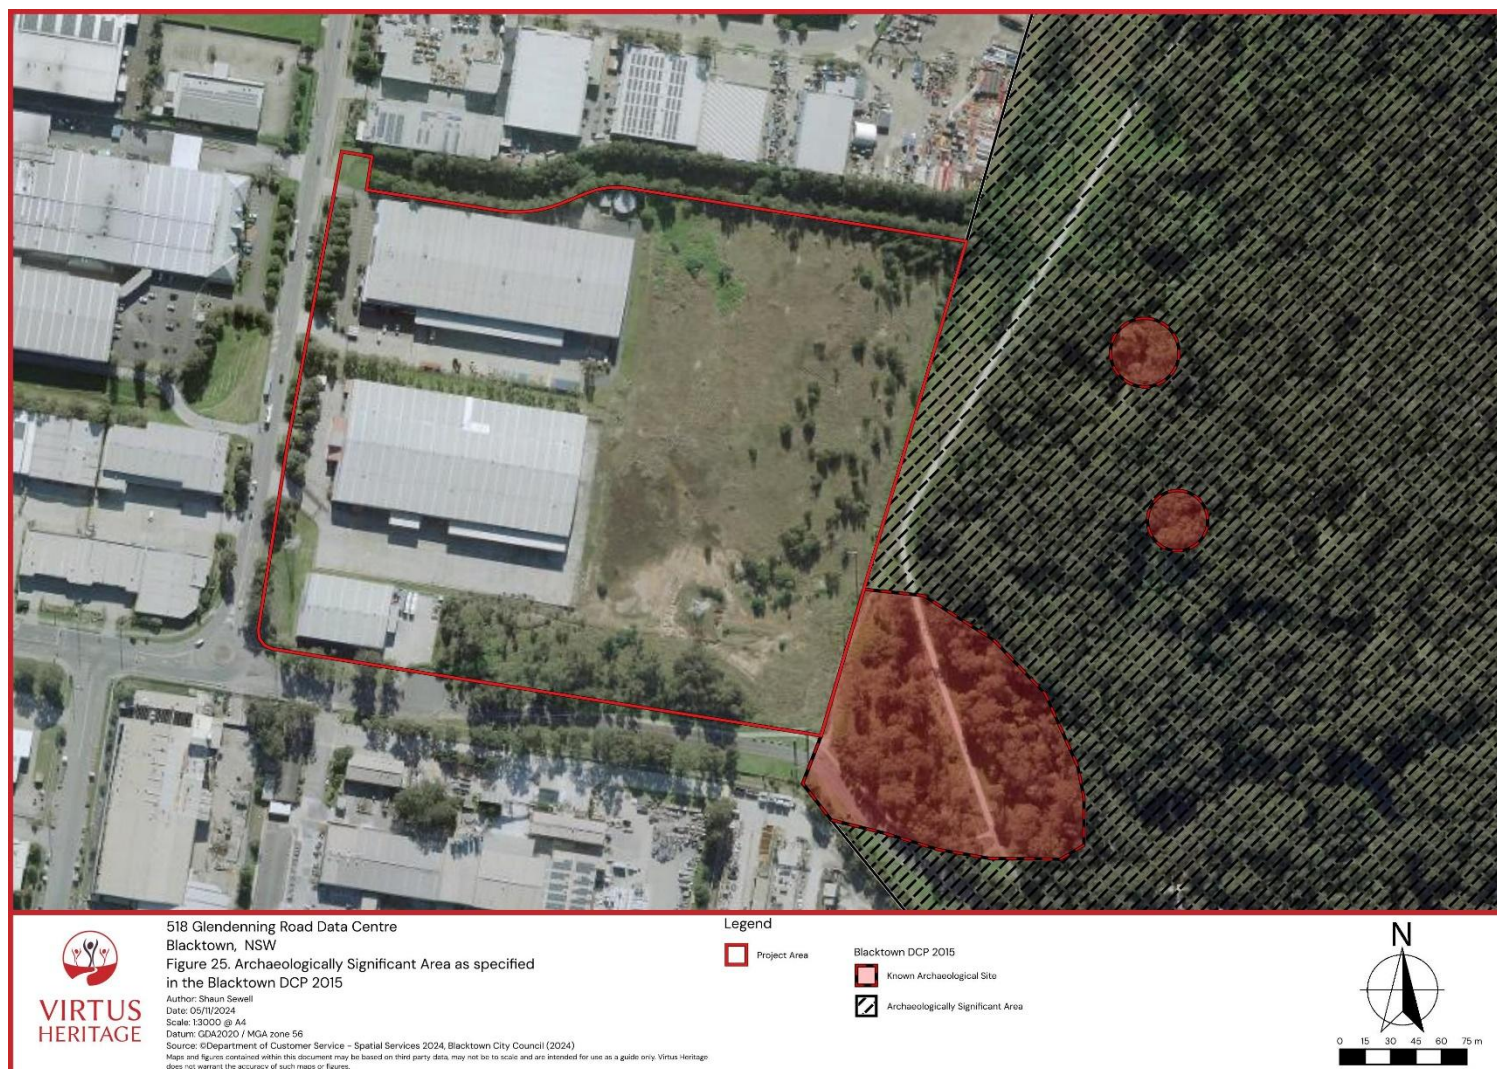
Figure 25. Archaeologically Significant Area as specified in the Blacktown DCP 2015.

The BDCP identifies an 'Archaeologically Significant Area', which primarily refers to Aboriginal archaeology. BDCP (2015:25). This is shown in **Figure 25**.

The BDCP's 'Archaeologically Significant Area' follows the parameters of the 'Area of Archaeological Potential' (discussed above and illustrated in **Figure 24**) and appears to utilise the previous work of McDonald (CHM 2001:4, Figure 2). Registered AHIMS site 45-5-0475 (Southeast Plumpton 3) is associated with the 'Known Archaeological Site' (refer to **Figure 25**). This site was registered in 1985 as an open artefact scatter (refer to **Appendix A**). Archaeological salvage undertaken by Kohen (2001) also occurred in this area. No additional registered AHIMS sites are associated with the BDCP 2015's 'Known Archaeological Site', none are mapped within the project area. The BDCP (2015) does not identify any sites or areas of archaeological significance within the project area.

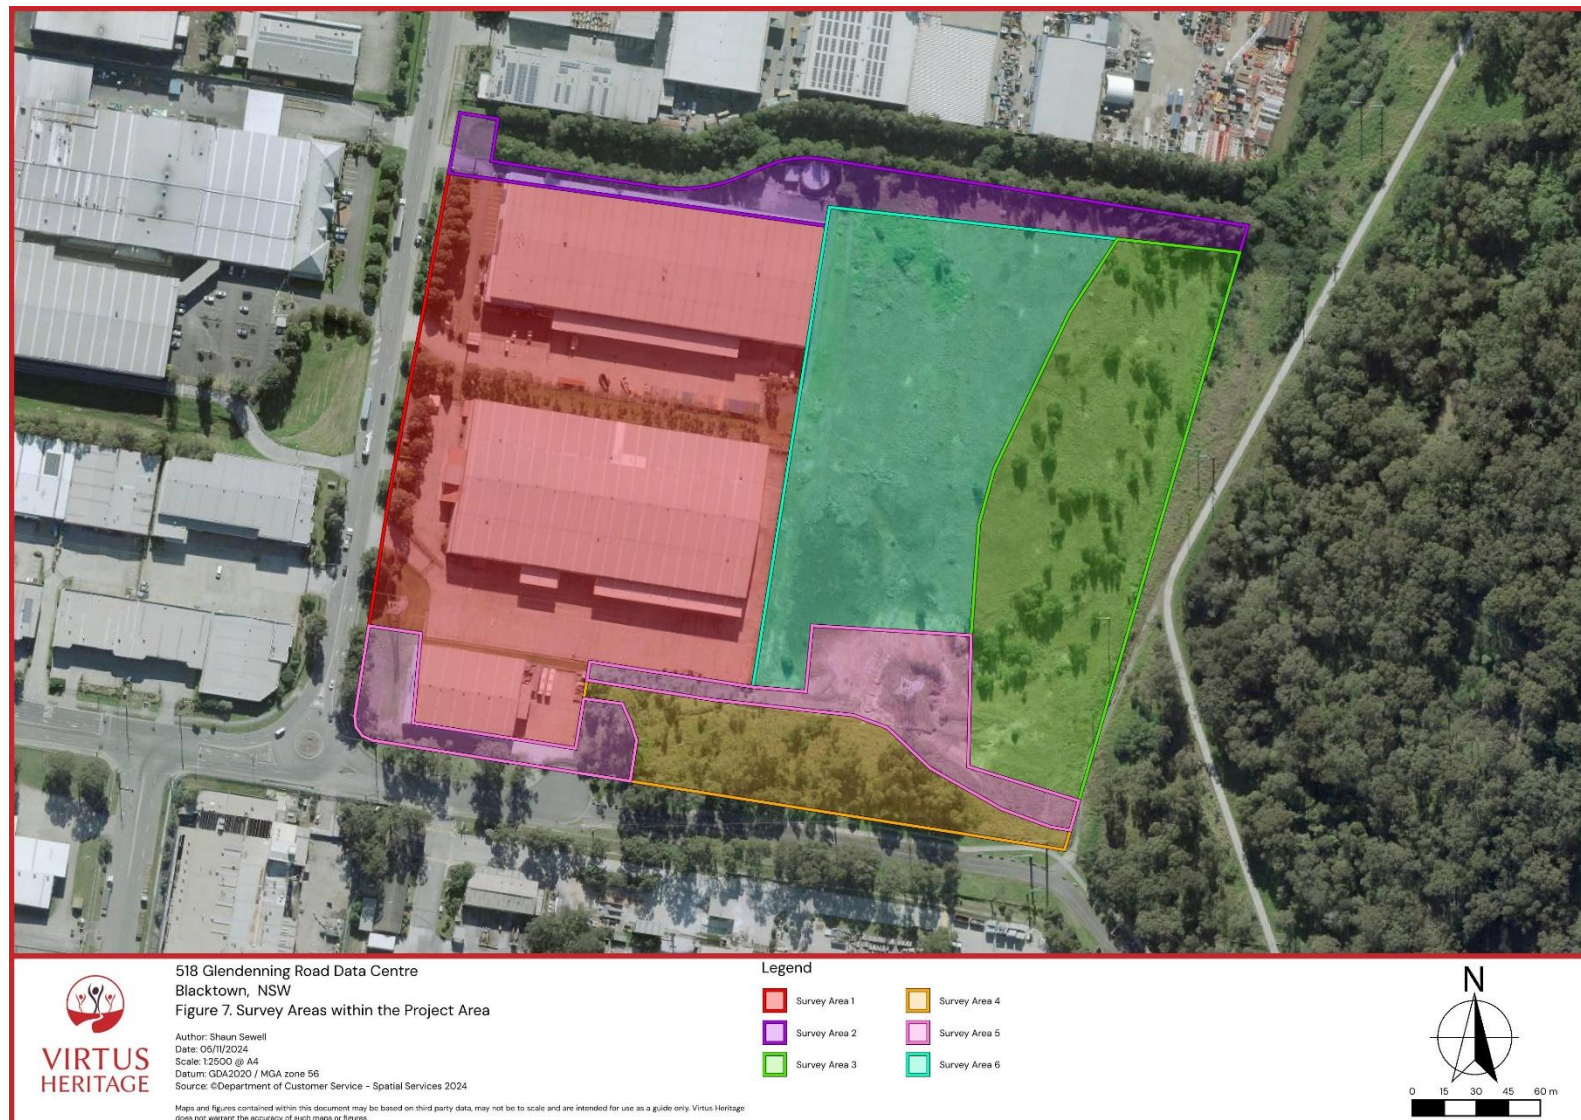
Figure 26. Survey Areas within the Project Area.

- Survey Area 1: Existing industrial infrastructure
- Survey Area 2: Northern project area boundary
- Survey Area 3: Land within 200m of Eastern Creek (as shown in **Figure 24**)
- Survey Area 4: Moderately disturbed ridge line and biodiversity zone
- Survey Area 5: Highly disturbed ridge line, spur and slope
- Survey Area 6: Highly disturbed terrain

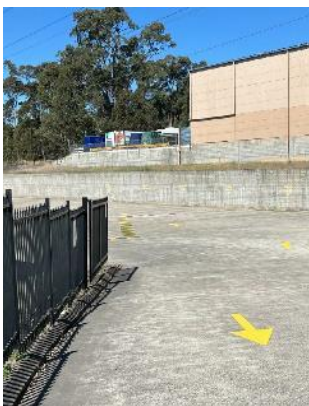
*Figure 27. View to east. Inspection of Survey Area 1, showing current industrial buildings and infrastructure.*

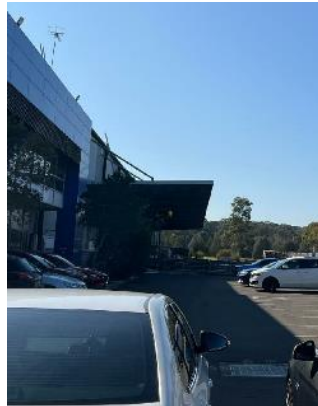
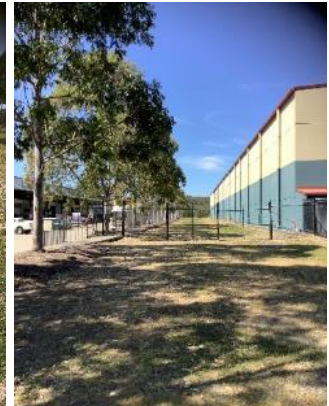
*Figure 28. View to west and east respectively. Inspection of Survey Area 1, showing subsurface utilities and modified landscape between existing industrial buildings.*

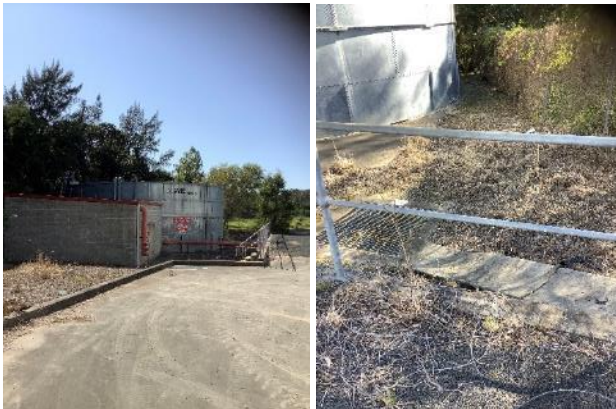
*Figure 30. View to east and north respectively. Inspection of Survey Area 2, showing industrial tank, subsurface drainage associated with industrial infrastructure.*

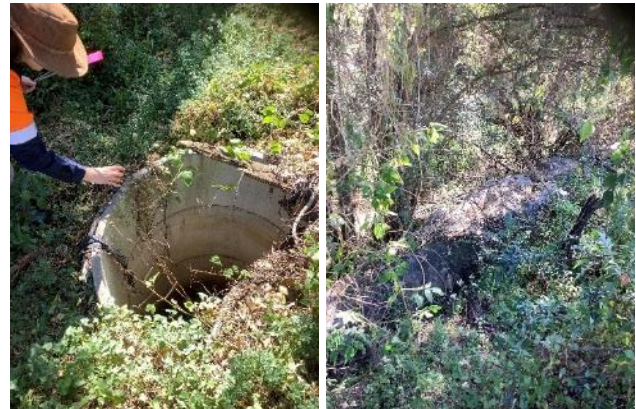
*Figure 31. View to north. Inspection of Survey Area 2, showing subsurface drainage and overgrown vegetation surrounding sandstone retaining wall.*

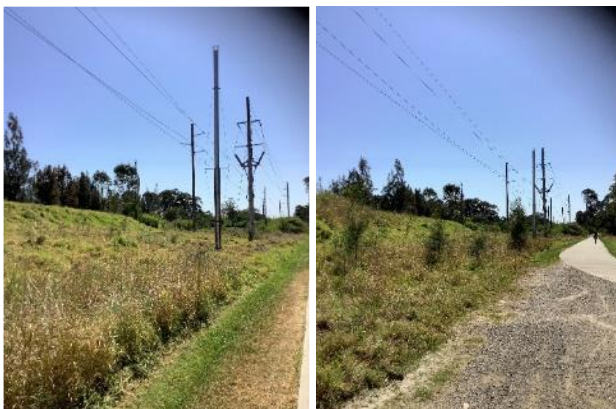
*Figure 32. View to north west looking up to project area. Inspection of Survey Area 3, showing modified landscape of project area, elevated surface indicating fill deposit.*

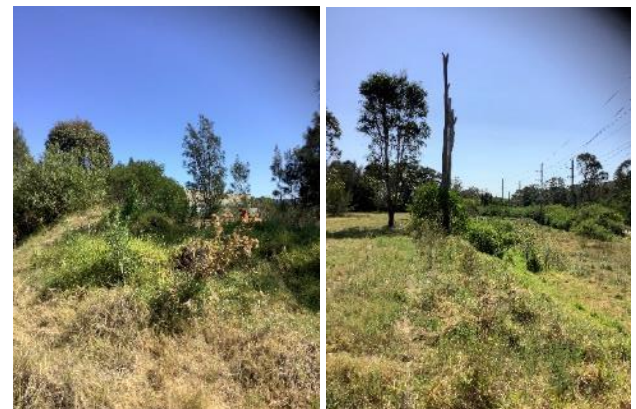
*Figure 33. View to south west and north respectively. Inspection of Survey Area 3, showing overgrown vegetation and modified/elevated surface.*

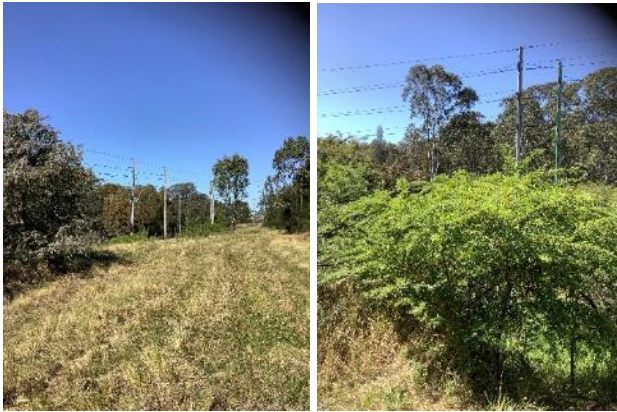
*Figure 34. View to south and east respectively. Inspection of Survey Area 3, showing elevated surface/fill and native vegetation (possibly revegetation for erosion control).*

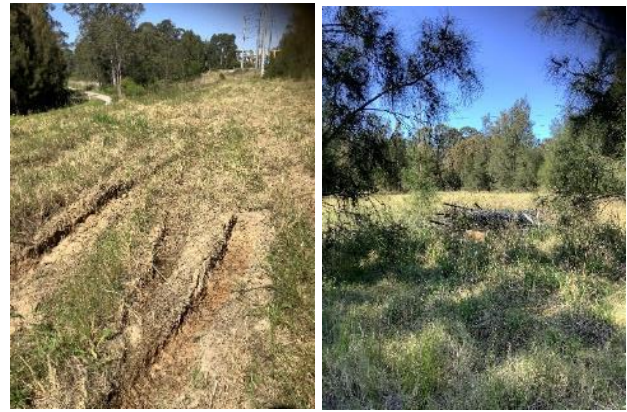
*Figure 35. View to south and east respectively. Inspection of Survey Area 3, showing vehicle damage, dumped material and overgrown vegetation.*

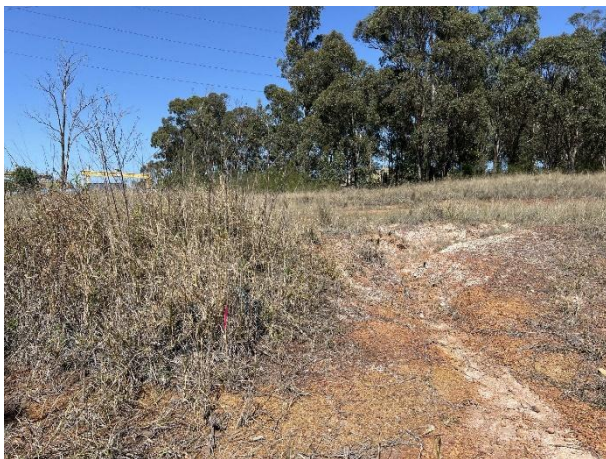
*Figure 36. Location of stone artefact (GDC06) in proximity to previous recordings for 45-5-0456 and 45-5-2462.*

During the additional site inspection, one pink silcrete retouched flake (GDC06) was located within Survey Area 3, approximately 15 metres from previously recorded artefacts (GDC01–GDC05 within Survey Areas 4 and 5 (**Figure 36**, **Figure 37**). This artefact (like GDC01–GDC05) is in proximity to other Aboriginal objects previously associated with 45–5–0456 and 45–5–2462 and has been displaced from its original context by erosion, earthworks or machinery use. It is located within an area that was previously salvaged by Kohen (2001).

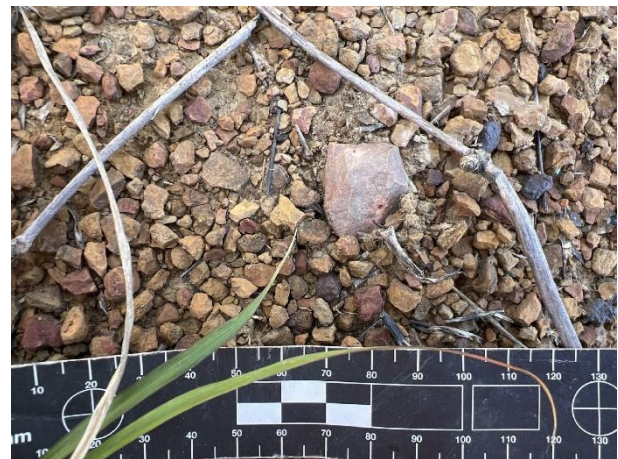
*Figure 37. Pink silcrete retouched flake (thumbnail scraper) (GDC06).*

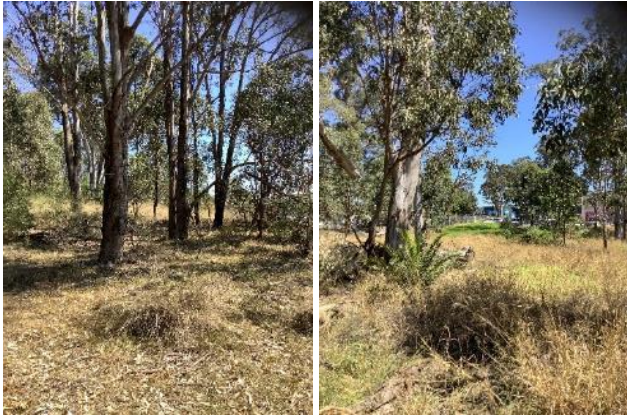
*Figure 38. View to west and south-west respectively. Inspection of Survey Area 4, showing ridge line and established vegetation, leaf litter, and overgrown vegetation.*

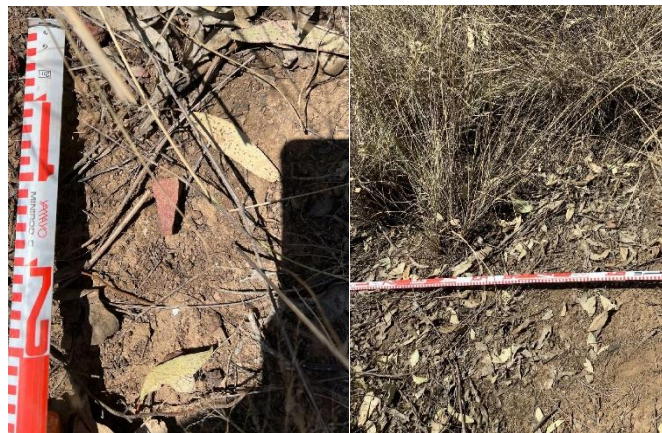
AHIMS sites 45-2462 and 45-5-2461 were associated with this survey area and were not re-identified during this survey, most likely due to low visibility. A silcrete stone artefact (GDC04) was identified in proximity to 45-5-2462, 45-5-2461, 45-5-0456 and previous stone artefacts recorded by McDonald (2005) in this area and has been attributed to 45-5-0456 to be consistent with Brown (2008). Survey Area 4 retains high archaeological potential (high likelihood of Aboriginal objects with moderate archaeological integrity).

*Figure 40. Silcrete stone artefact (GDC04), attributed to 45-5-456.*

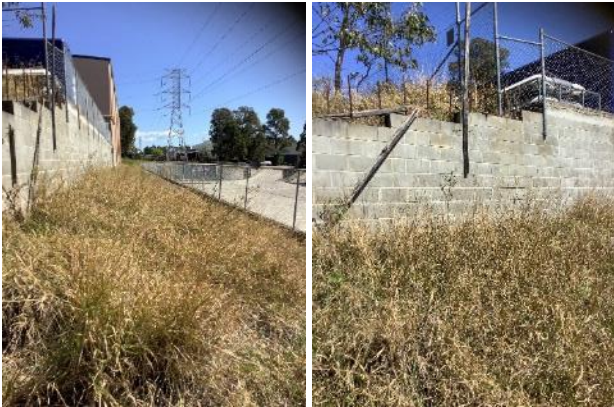
*Figure 41. View to west and south respectively. Inspection of Survey Area 5, showing modified landscape.*

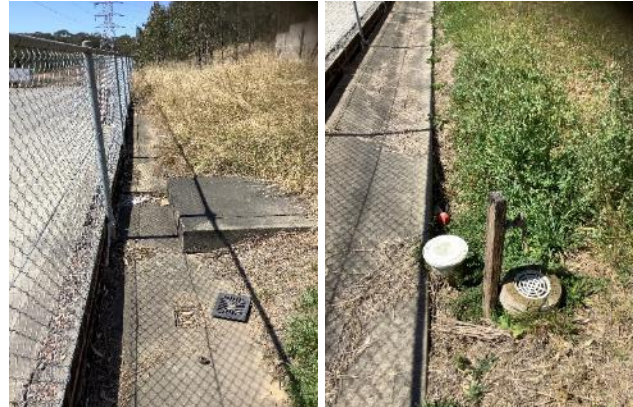
*Figure 42. View to east. Inspection of Survey Area 5, showing subsurface utilities*

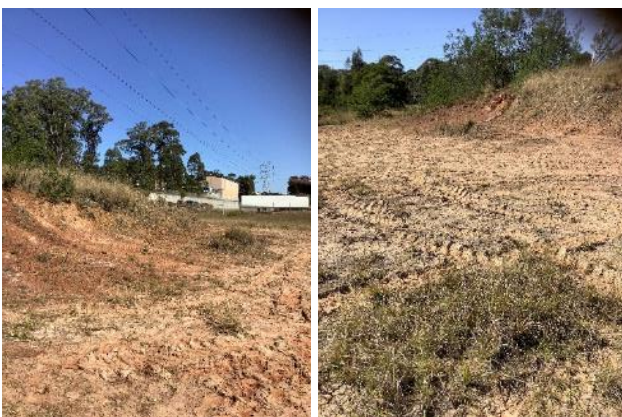
*Figure 43. View to west and east respectively. Inspection of Survey Area 5, showing vehicle disturbance, erosion and GSV.*

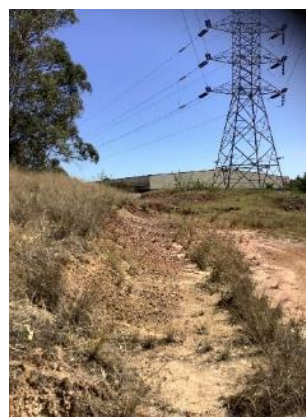
*Figure 44. View to west. Inspection of Survey Area 5 showing vehicle damage, erosion and GSV.*

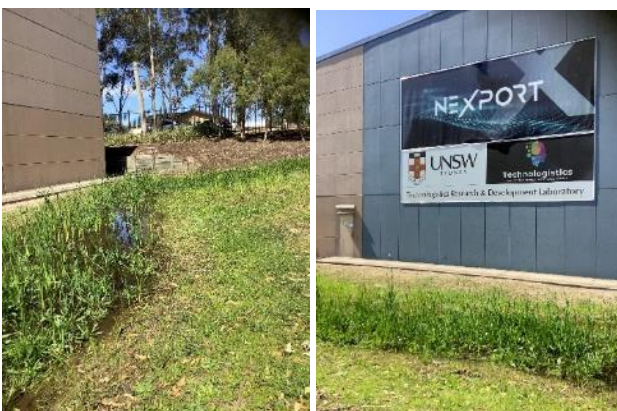
*Figure 45. View to south and east respectively. Inspection of Survey Area 5 showing existing building and drainage channel and approximate location of 45-50483.*

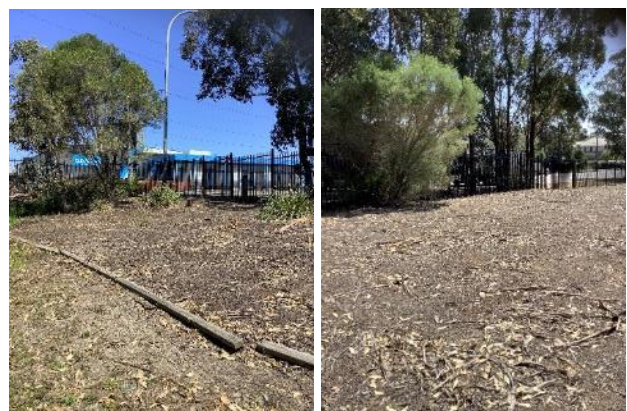
*Figure 46. View to south west and west respectively. Inspection of Survey Area 5 at approximate location of 45-5-0483 showing garden bed, introduced soil, fencing and some established vegetation.*

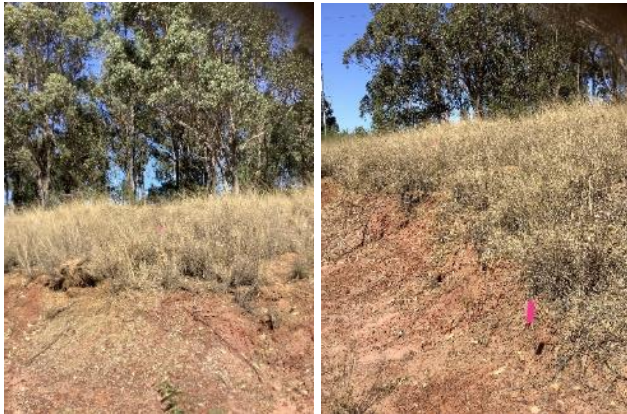
*Figure 47. View to south and south west respectively. Inspection of Survey Area 5 showing erosion and GSV with flag showing locations of stone artefacts.*

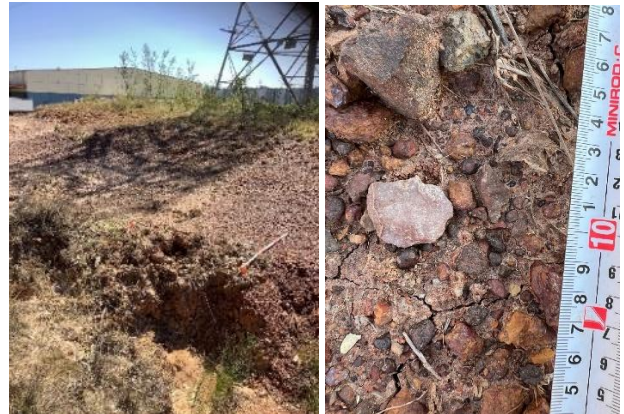
*Figure 48. View to north west. Inspection of Survey Area 5, showing disturbance, erosion and GSV. Mini rod positioned in location of stone artefact.*

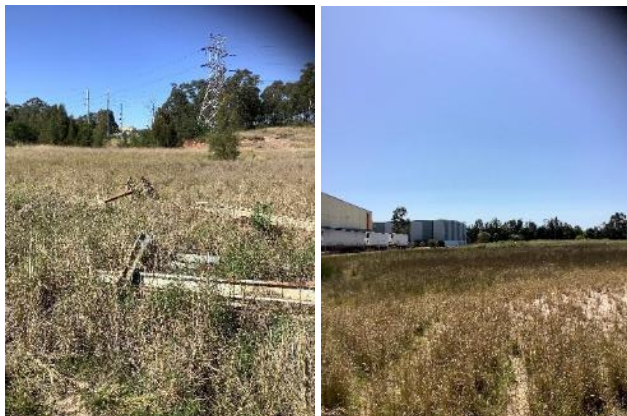
*Figure 49. View to south and north respectively. Inspection of Survey Area 6 showing dumped material, overgrown grass and limited GSV.*

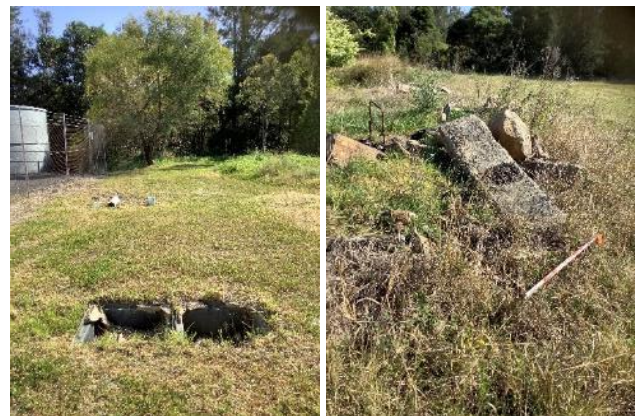
*Figure 50. View to north and south respectively. Inspection of Survey Area 6 showing subsurface utilities and surface disturbances.*

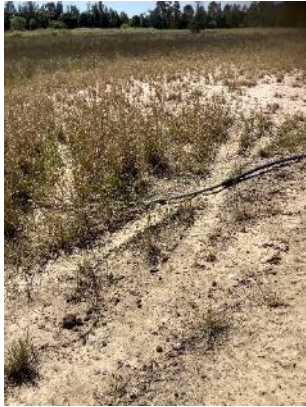
*Figure 51. View to north east. Inspection of Survey Area 6, showing imported inclusions, vehicle disturbances, and dumped material.*

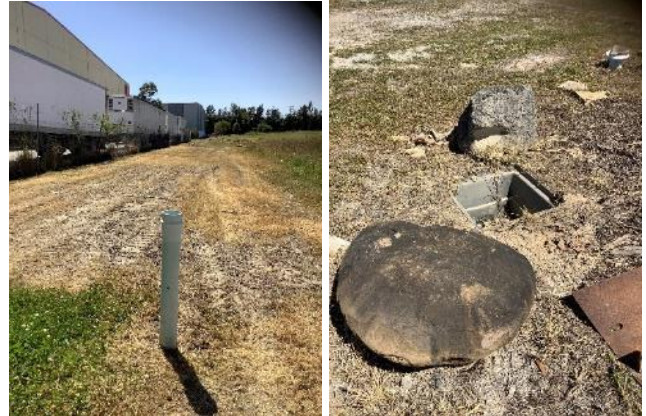
*Figure 52. View to north and west respectively. Inspection of Survey Area 6, showing subsurface utilities, vehicle disturbance and dumped material.*

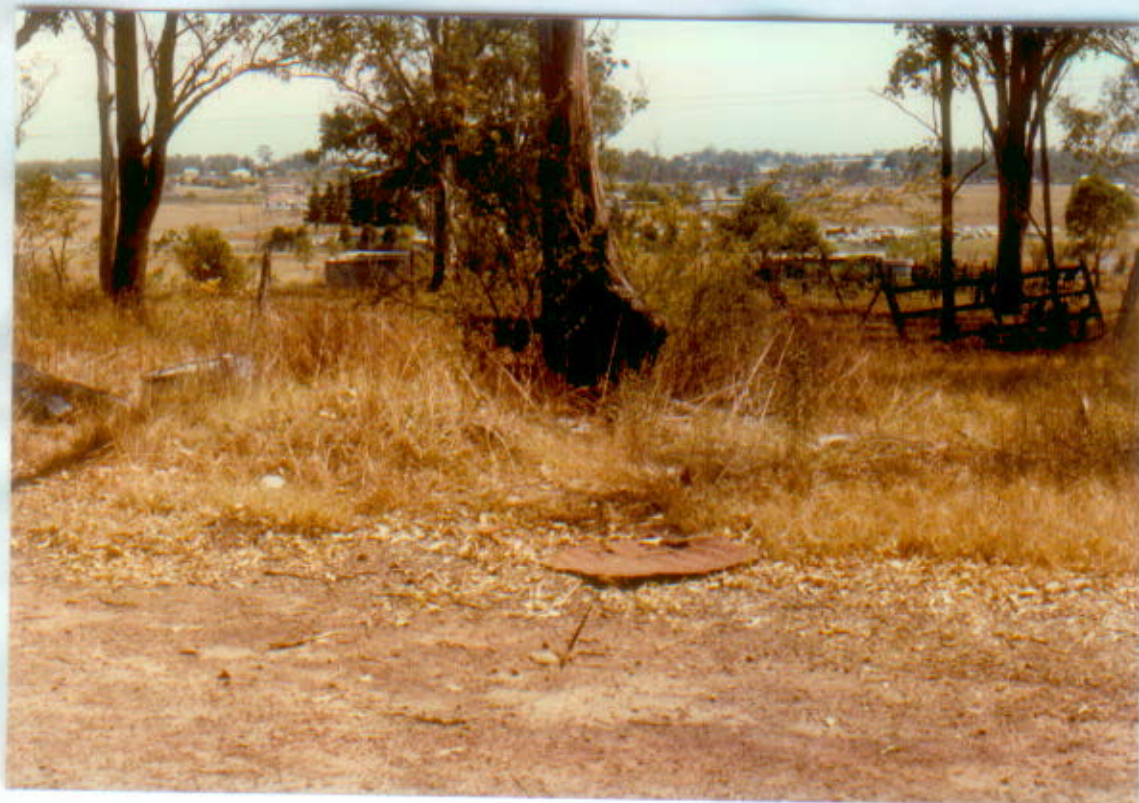
SOUTHEAST PLUMPTON 5 FACING NORTH

FLAKED BASALT PEBBLE INDICATED

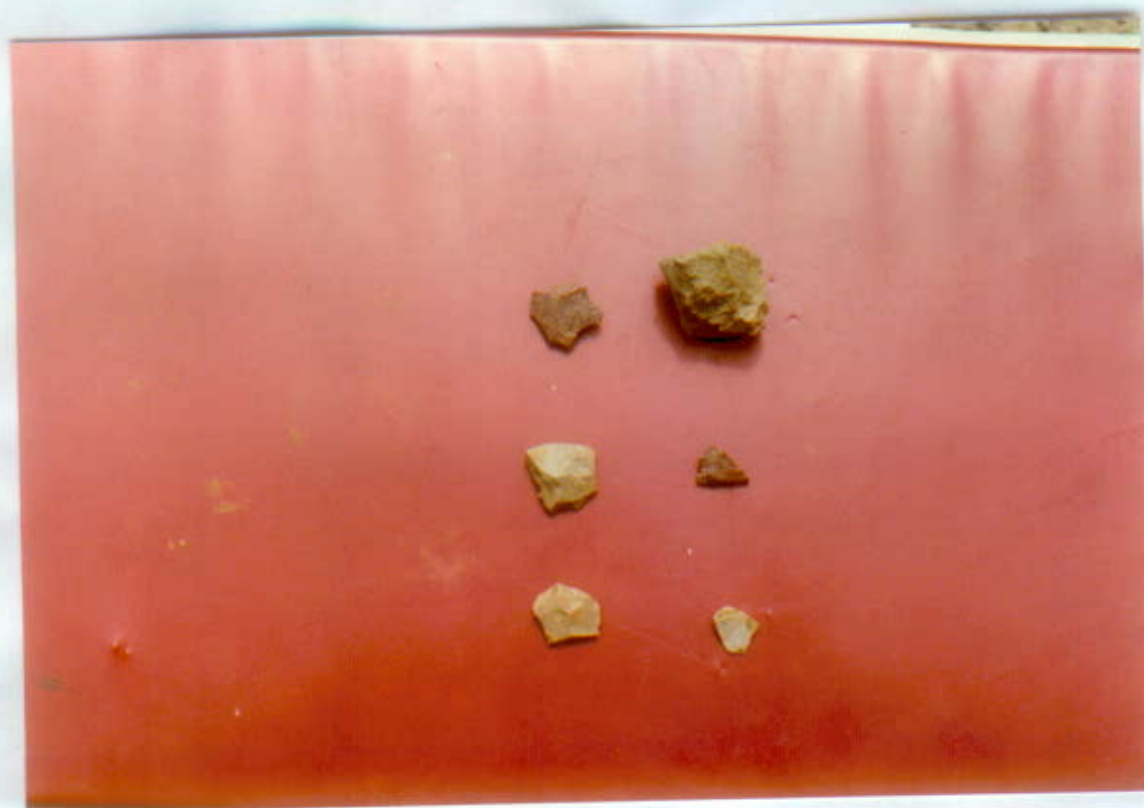
CORES AND FLAKES FROM SOUTHEAST PLUMPTON 4

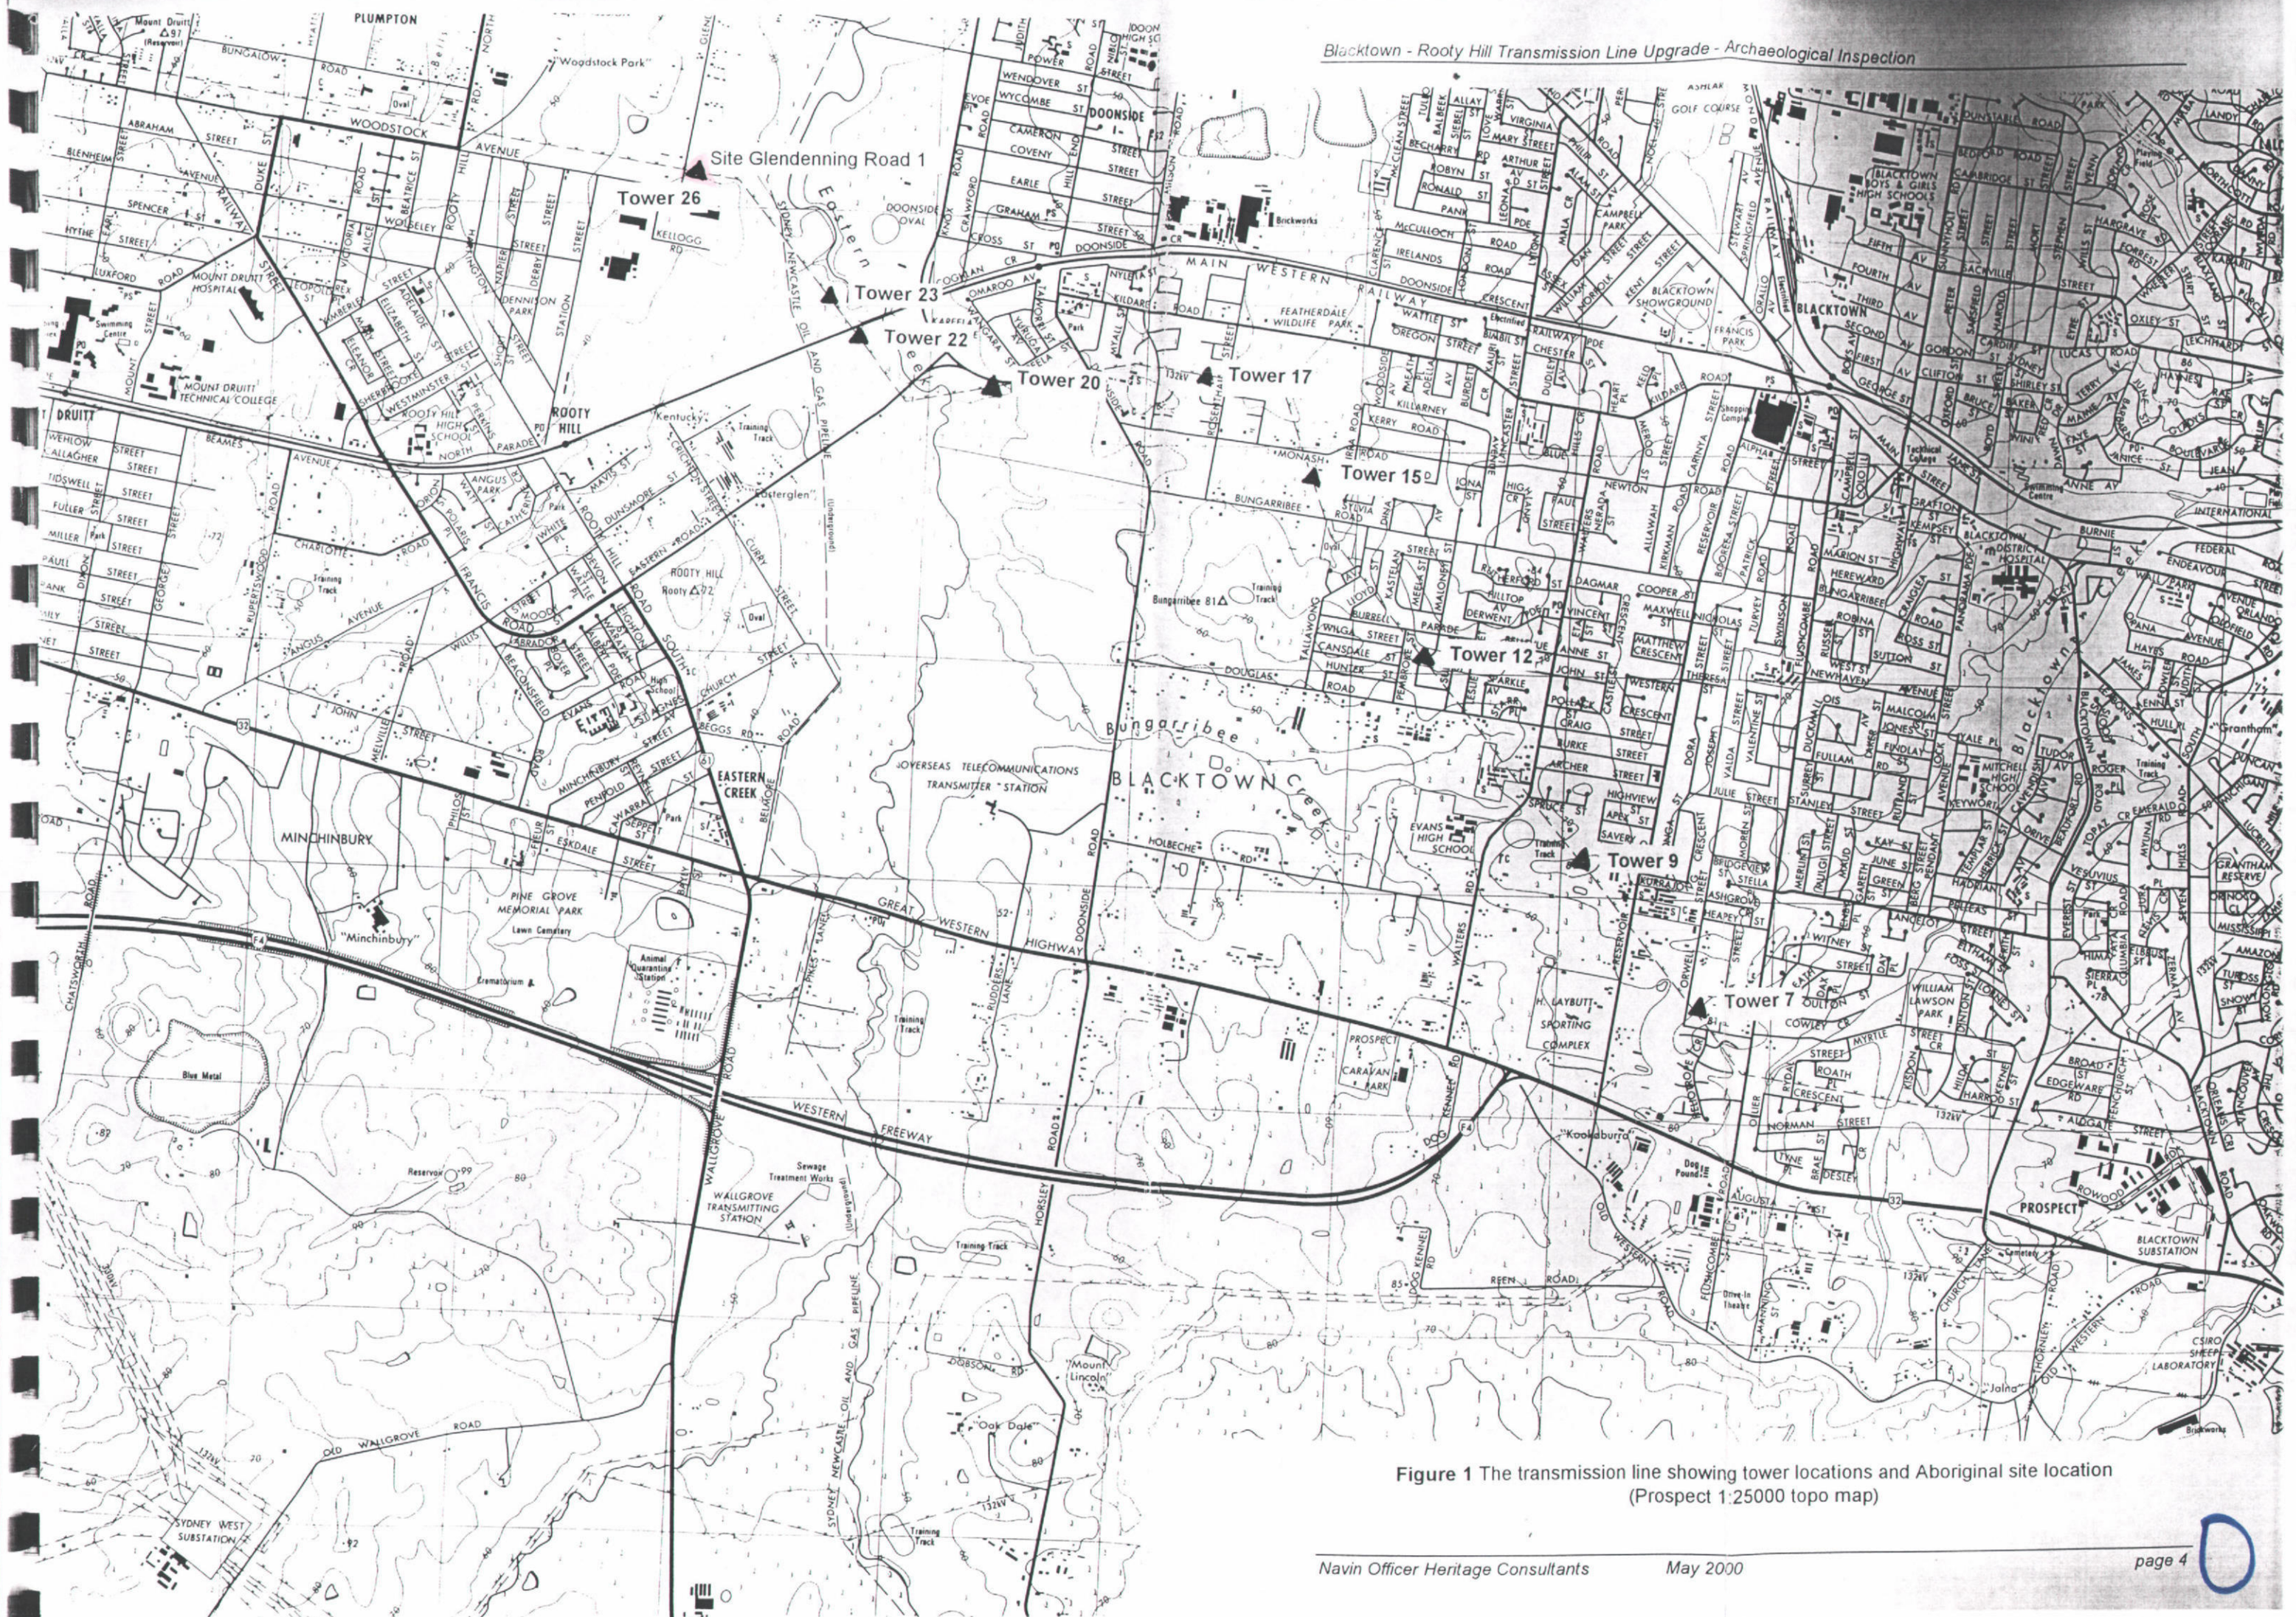
Figure 1 The transmission line showing tower locations and Aboriginal site location  
(Prospect 1:25000 topo map)

This artefact was located approximately 8 metres to the east of Tower 26 on a small area of exposed ground.
