Salinity Assessment – Lot 846, Gregory Hills Corporate Park

Report on
Salinity Investigation and Management Plan

Proposed Subdivision
Lot 701 in Deposited Plan 1154772
Gregory Hills Drive
Gledswood Hills

Project 76510.00
May 2012

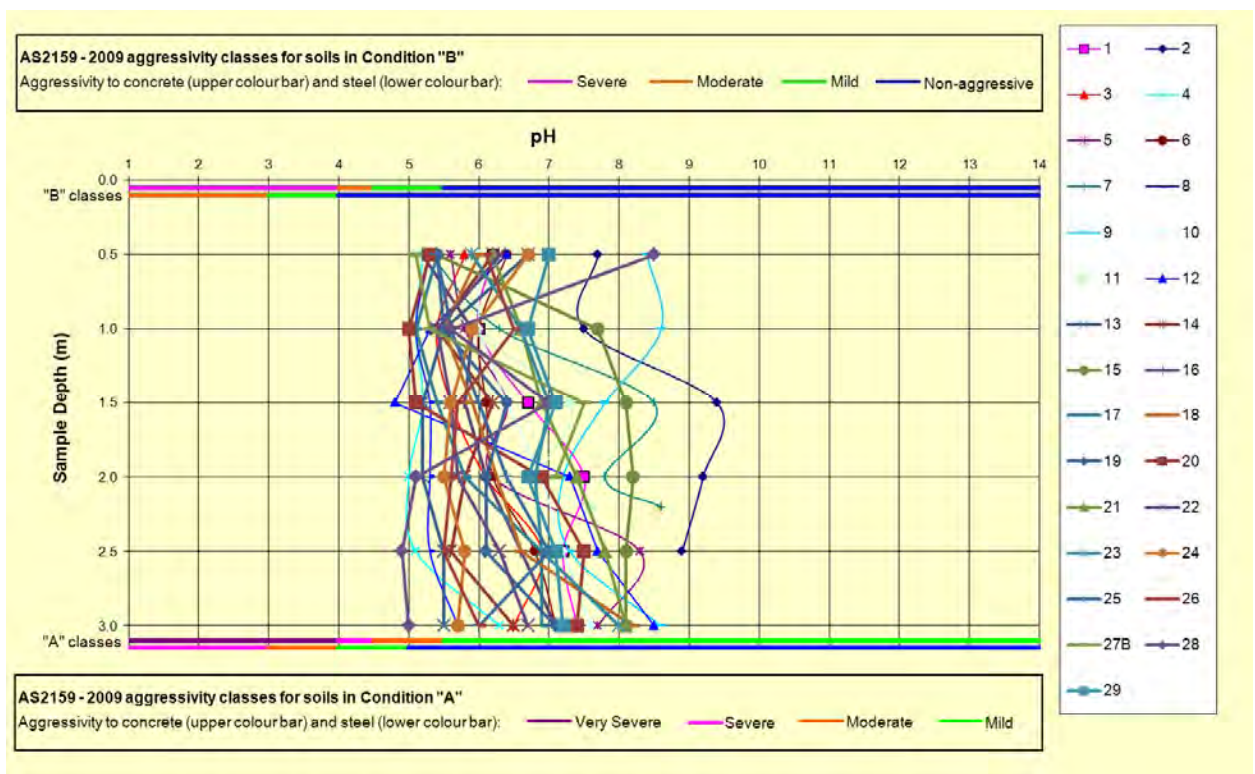
Figure 1: Vertical pH Profiles and Aggressivity Classes

Figure 1 (following page) presents variations of aggressivity with depth, based on pH profiles at deep test pit locations, together with the aggressivity class ranges indicated in Australian Standard AS2159 (2009). The absence of free groundwater from the majority of test pits and the impermeability of the sampled clay-rich materials indicate that materials from most test pits are in Condition “B” as defined by AS2159. Condition “A” materials were encountered at TP12, TP15, TP18, TP23, and TP57 at depths close to groundwater level. These locations were in relatively low-lying areas and adjacent to drainage lines within and adjacent to the Site.

The pH profiles of Figure 1 indicate that the materials throughout the Site, at all investigated depths, are non-aggressive to steel. The chloride concentration guidelines of AS2159 support this non-aggressive classification. However, based on resistivity criteria (Appendix D), samples were classified as non-aggressive to severely aggressive to steel.

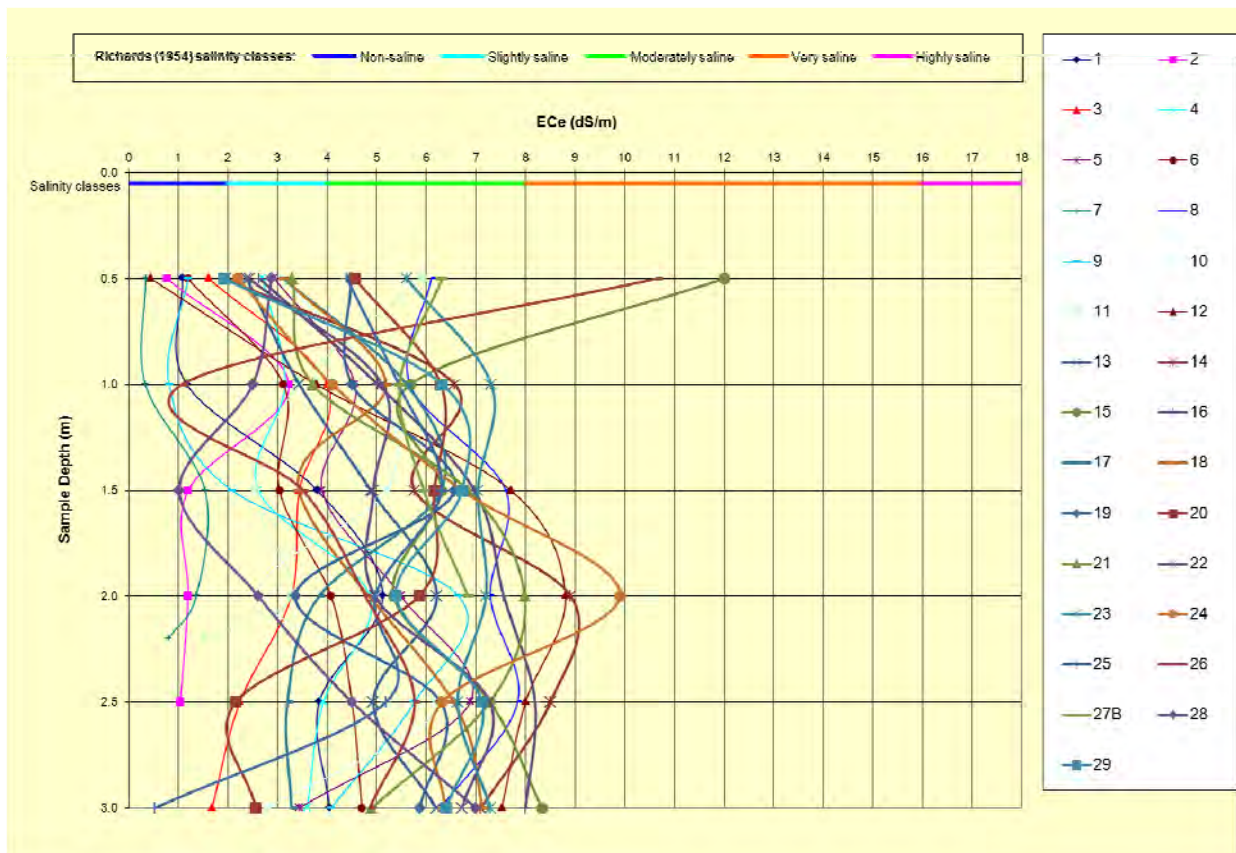
Figure 2: Vertical Salinity Profiles and Salinity Classes

Figure 2 (below) presents the variations of salinity with depth, based on salinity (ECe) profiles at deep test pit locations, together with the salinity classifications of Richards (1954).

The Summary Table (Appendix D) indicates that 19% of all soil samples were non-saline, 32% were slightly saline, 45% were moderately saline and 4% were very saline.

Moderately saline and very saline conditions were found within the investigated depth zones as indicated in Drawing 6 (Appendix A), flagging the potential for salt-induced damage to susceptible services, slabs and shallow footings and the need for appropriate salinity management

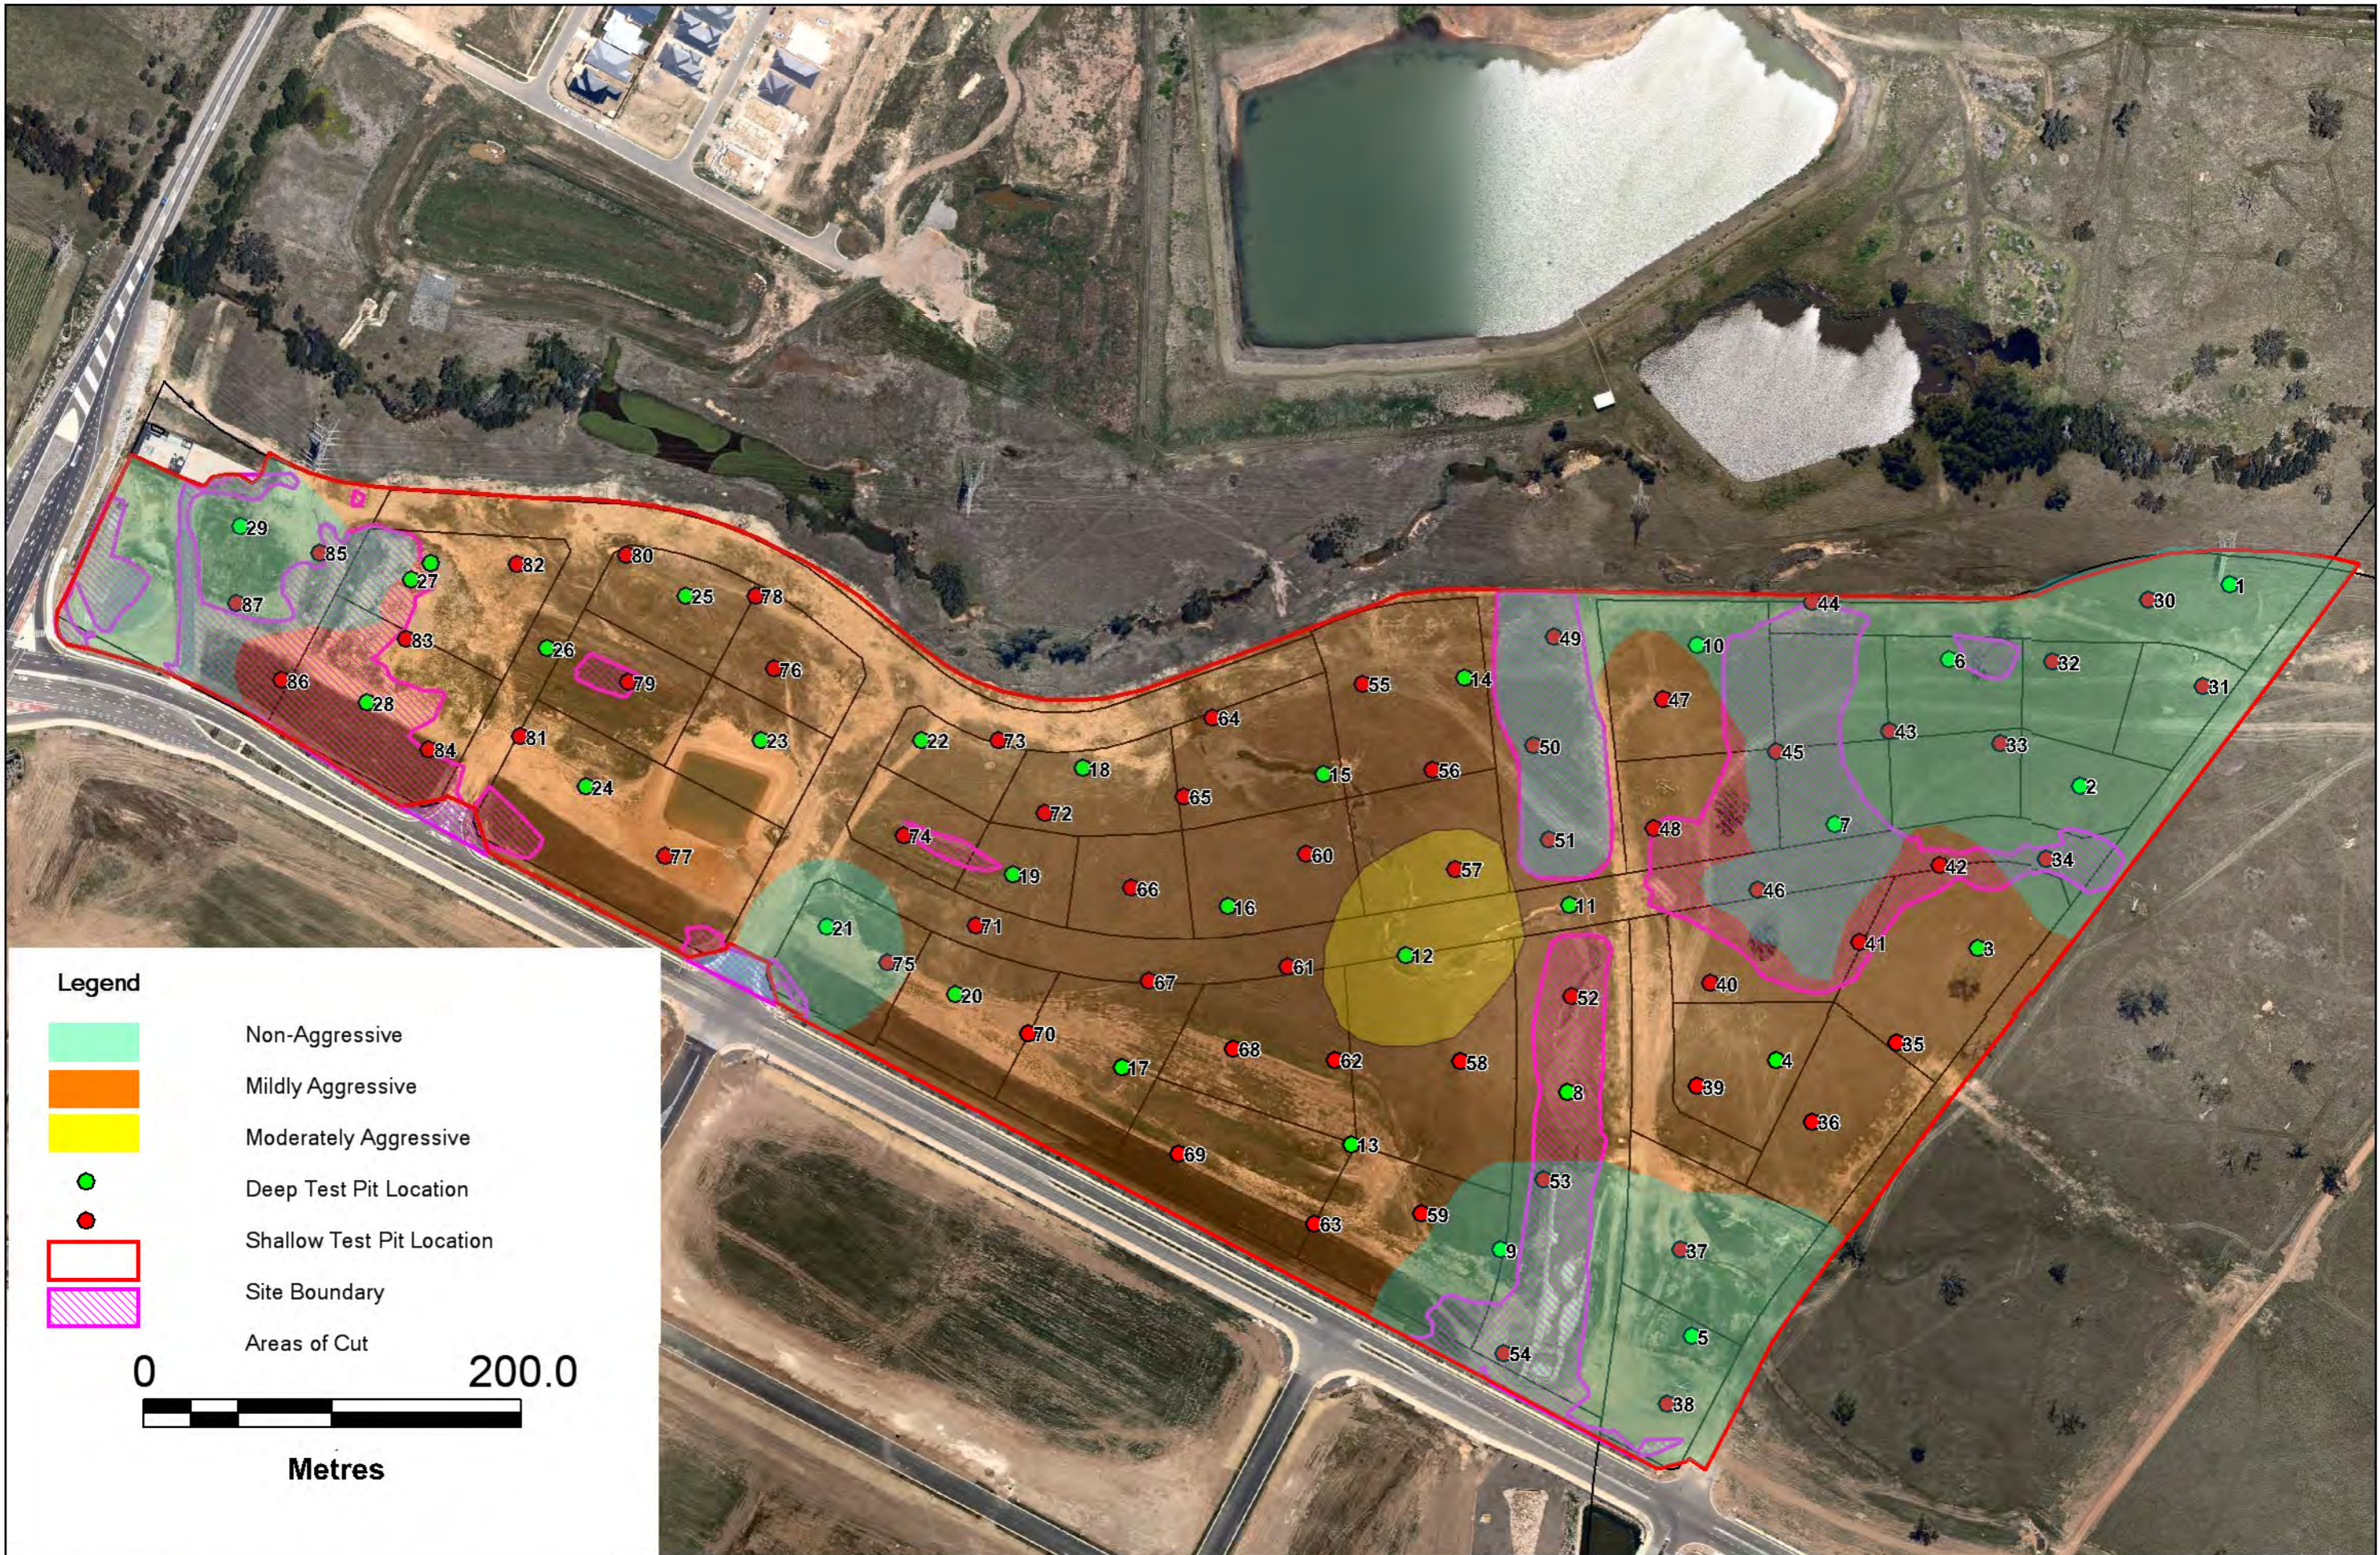
PROJECT No: 76510.00
 DRAWING No: 4
 REVISION: B

TITLE: **Aggressivity to Concrete Piles below Proposed Cut Surface and Fill Base**
Salinity Investigation And Management Plan
 Lot 701 in Deposited Plan 1154772, Gregory Hills Drive, Gledswood Hills

- H. Where materials are classified as non-aggressive to concrete piles (refer Drawing 4), piles should nevertheless have a minimum strength of 32 MPa and a minimum cover to reinforcement of 45 mm (as per AS2159).
- I. Where materials are classified as mildly aggressive to concrete piles (refer Drawing 4), piles should have a minimum strength of 32 MPa and a minimum cover to reinforcement of 60 mm (as per AS2159) to limit the corrosive effects of the surrounding materials (in accordance with AS2159).
- J. Where materials are classified as moderately aggressive to concrete piles (refer Drawing 4), piles should have a minimum strength of 40 MPa and a minimum cover to reinforcement of 65 mm (as per AS2159) to limit the corrosive effects of the surrounding materials (in accordance with AS2159).
