## Soil Mapping Unit: Acidic Texture-contrast Soils

**Representative Site No:** 5

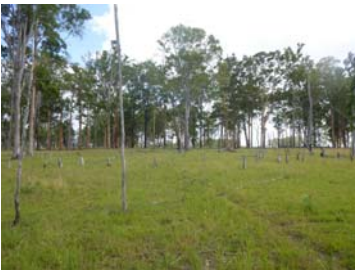
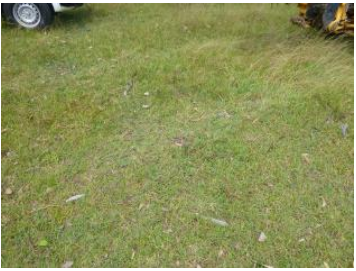
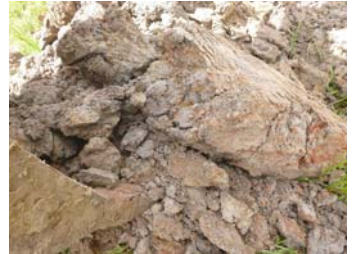
**General comments on the soils of this mapping unit:** Acidic soils with primary and secondary structure and displaying hardsetting characteristics. Smooth-faced peds are evidence of clay translocation down the profile resulting in clay coatings on peds. Many old roots and root channels in-filled with soil from above horizons.

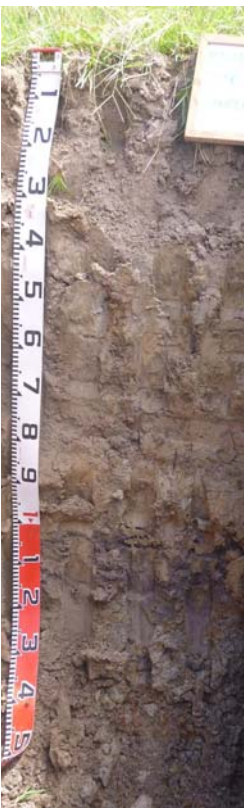
| Landscape Photos | Profile Photo | Horizon | Moist Colour | Texture | Structure | Consistence | Rooting depth | pH & EC |
|---|---|---|---|---|---|---|---|---|
| | | A<br>0 – 0.1 m | 10YR 3/3<br>Dark brown | Silty Clay Loam | Polyhedral<br>Moderate structure | Firm (dry) | Many (25-200)<br>Coarse –<br>Very fine | N/A |
| | | B21<br>0.1 – 0.35 m | 10YR 4/2<br>Dark greyish brown<br>(Yellowish brown mottling) | Medium Heavy Clay | Subangular blocky<br>parting to platy<br>Moderate structure | Very strong<br>(moderately moist) | Many (25-200)<br>Medium –<br>Very fine | pH: 5.9<br>EC: 0.044<br>dS/m |
| | | B22<br>0.35 – 1.2 m | 10YR 4/2<br>Dark greyish brown<br>(Yellowish brown mottling) | Heavy Clay | Subangular blocky<br>parting to platy<br>Moderate structure | Strong (moist) | Common (10-25)<br>Medium –<br>Very fine | pH: 5.3<br>EC: 0.190<br>dS/m |
| | | B23<br>1.2+ m | 10YR 4/1<br>Dark grey<br>(Olive brown mottling) | Medium Clay | Subangular blocky<br>parting to platy<br>Moderate structure | Firm (moist) | Few (1-20)<br>Medium –<br>Very fine | N/A |

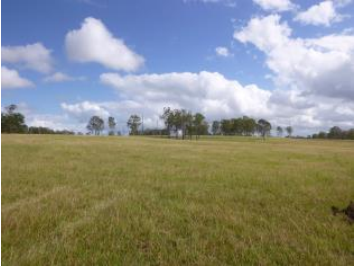
**Representative Site No:** 4

**General comments on the soils of this mapping unit:**

Landscape varies between hummocky and flat. Gently undulating topography. Moderately well drained profiles. Lighter clays present. Evidence of yellow/grey mottling down the profile.

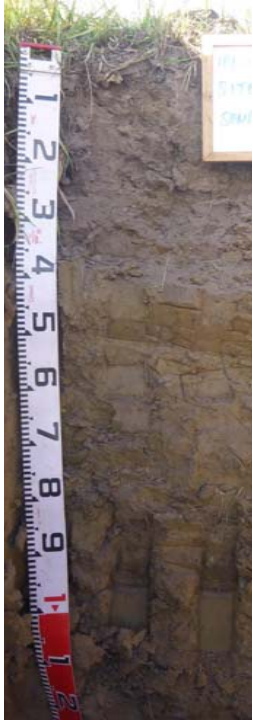
| Landscape Photos | Profile Photo | Horizon | Moist Colour | Texture | Structure | Consistence | Rooting depth | pH & EC |
|---|---|---|---|---|---|---|---|---|
| | | A11<br>0 -0.1 m | 10YR 3/3<br>Dark brown | Light Clay | Polyhedral<br>Weak to moderate structure | Strong (dry) | Many (25-200)<br>Coarse –<br>Very fine | N/A |
| | | A12<br>0.1 –<br>0.35 m | 10YR 4/2<br>Dark greyish brown | Light Medium Clay | Angular blocky<br>Moderate structure | Firm (moist) | Many (25-200)<br>Medium –<br>Very fine | pH: 5.7<br>EC: 0.085<br>dS/m |
| | | B21<br>0.35 –<br>0.9 m | 2.5Y 5/6<br>Light olive brown<br>(yellow mottling) | Heavy Clay | Subangular blocky<br>parting to platy<br>Moderate structure | Firm (moist) | Common (10-25)<br>Medium –<br>Very fine | pH: 5.6<br>EC: 0.330<br>dS/m |
| | | B22<br>0.9 –<br>1.2+ m<br>Refusal<br>at 1.8 m | 2.5Y 5/1<br>Grey<br>(Yellow/grey mottling) | Heavy Clay | Subangular blocky<br>parting to platy<br>Moderate structure | Firm (moist) | Few (1-20)<br>Medium –<br>Very fine | N/A |

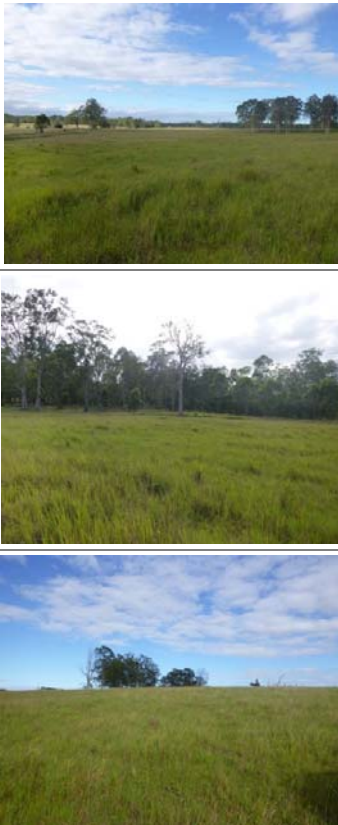
| Landscape Photos | Profile Photo | Horizon | Moist Colour | Texture | Structure | Consistence | Rooting depth | pH & EC |
|---|---|---|---|---|---|---|---|---|
| | | A1<br>0.0 – 0.2 m | 7.5 YR 3/2<br>Dark Brown | Silty Clay Loam | Subangular blocky<br>Moderate structure | Very strong (dry) | Many (25-200)<br>Coarse – Very fine | pH: 5.6<br>EC: 0.13 dS/m |
| | | B<br>0.2 – 0.8 m | 10 YR 5/2<br>Grayish brown | Heavy Clay | Angular blocky<br>parting to platy<br>Moderate structure | Strong (moist) | Common (10-25)<br>Medium – Very fine | pH: 5.8<br>EC: 0.07 dS/m |

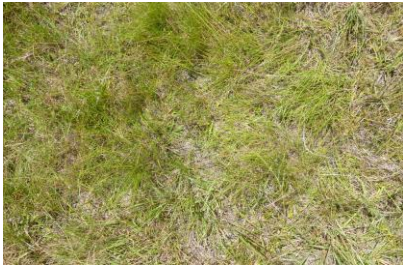
| <b>Landscape Photo (North)</b><br> | | <b>Landscape Photo (East)</b><br> | | | <b>Soil Surface Condition Photo</b><br> | | <b>Site Type</b><br>Detailed + Sampled for Lab<br><br><b>Microrelief</b> Yes<br><br><b>Type</b> Hummocky or normal gilgai<br><br><b>Vertical (m)</b> ~ 0.3 m<br><br><b>Horizontal (m)</b> 1-3 m<br><br><b>Described/ sampled</b> Mound<br><br><b>Other Information:</b><br>Site located in drainage line which runs alongside a hill identified as having cultural heritage significance. Microrelief (most likely to be normal gilgai) is evident. Imperfectly drained due to weak structure and heavy clay texture. | |

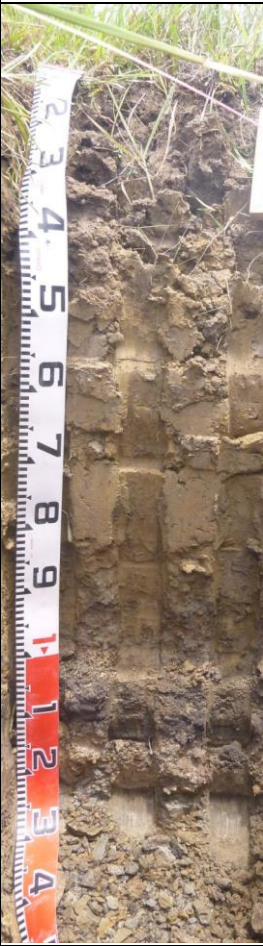
| Horizon | Depth (m) | Profile Photo | Boundary | Texture | Moist Colour | Mottle (colour, abundance) | Segregations (abundance, nature) | Coarse fragments (abundance, size) | Structure (type) | Structure (grade) | Consistence (soil water status) | Roots (abundance, size) | pH | EC (dS/m) | Depth of Sample for Lab (m) |
|---|---|---|---|---|---|---|---|---|---|---|---|---|---|---|---|
| A1 | 0 - 0.05 | | Abrupt | Silty Clay Loam | Dark brown (7.5 YR 3/3) | Nil | Nil | 0-2% 2-6 mm | Polyhedral | Moderate | Weak (dry) | Many (25-200) coarse, fine, very fine | Lab | Lab | 0-0.05 |
| B1 | 0.05-0.25 | | Abrupt | Medium Heavy Clay | Dark greyish brown (10YR 4/2) | 10-20% distinct yellowish brown (10YR 5/6) | <2% fine, white, soft, unidentified | Nil | Subangular blocky | Moderate | Firm (moderately moist) | Few (10-25) coarse, many (25-200) fine and very fine | - | - | - |

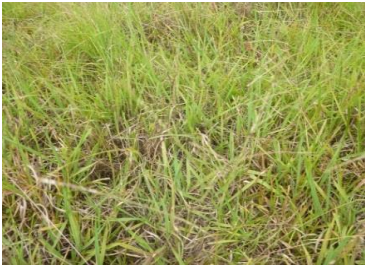
| Landscape Photo (North)<br> | | | Landscape Photo (East)<br> | | Soil Surface Condition Photo<br> | | <div>Site Type<br/>Detailed + Sampled for Lab</div> <div>Microrelief<br/>Yes</div> <div>Type<br/>Hummocky or normal gilgai</div> <div>Vertical (m)<br/>~ 0-0.3 m</div> |
| Landscape Photo (South)<br> | | | Landscape Photo (West)<br> | | Other Photo | | <div>Horizontal (m)<br/>1-3 m</div> <div>Described/<br/>sampled<br/>Mound</div> <div>Other Information:<br/>Microrelief likely to be gilgai. More difficult to interpret due to dense vegetation cover. Imperfectly drained due to weak structure and heavy clay texture.</div> |

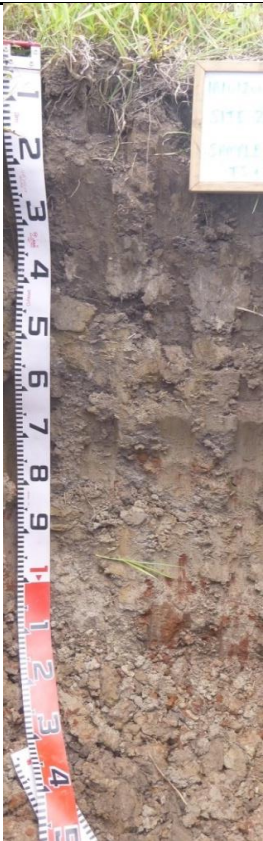
| Horizon | Depth (m) | Profile Photo | Boundary | Texture | Moist Colour | Mottle (colour, abundance) | Segregations (abundance, nature) | Coarse fragments (abundance, size) | Structure (type) | Structure (grade) | Consistence (soil water status) | Roots (abundance, size) | pH | EC (dS/m) | Depth of Sample for Lab (m) |
|---|---|---|---|---|---|---|---|---|---|---|---|---|---|---|---|
| A1 | 0-0.08 | | Abrupt | Silty Clay Loam | Very dark greyish brown (10 YR 3/2) | Nil | Nil | Nil | Polyhedral | Moderate | Firm (dry) | Many (25-200) coarse, fine, very fine | Lab | Lab | 0.08 |
| B21 | 0.08-0.35 | | Gradual | Light Clay | 10 YR 3/2 | Nil | Nil | Nil | Subangular blocky | Moderate | Strong (moderately moist) | Few (10-25) coarse, many (25-200) fine and very fine | - | - | - |

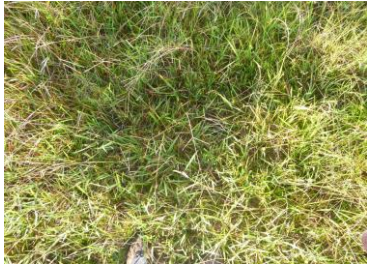
| Landform<br>Mid-slope | | Soil Surface Condition (dry)<br>Firm | | | Land Use<br>Grazing | Erosion State<br>None evident | |
| Landscape Photo (North)<br> | | Landscape Photo (East)<br> | | | Soil Surface Condition Photo<br> | | <b>Site Type</b><br>Detailed + Sampled for Lab<br><hr/> <b>Microrelief</b> Yes<br><hr/> <b>Type</b> Hummocky or normal gilgai<br><hr/> <b>Vertical (m)</b> Not recorded<br><hr/> <b>Horizontal (m)</b> Not recorded<br><hr/> <b>Described/ sampled</b><br><hr/> <b>Other Information:</b><br>Imperfectly drained due to weak structure and heavy clay texture. |

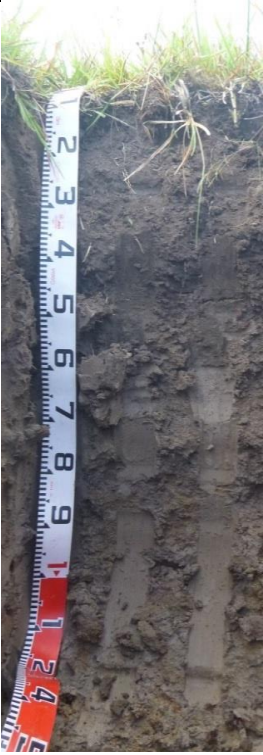
| Horizon | Depth (m) | Profile Photo | Boundary | Texture | Moist Colour | Mottle (colour, abundance) | Segregations (abundance, nature) | Coarse fragments (abundance, size) | Structure (type) | Structure (grade) | Consistence (soil water status) | Roots (abundance, size) | pH | EC (dS/m) | Depth of Sample for Lab (m) |
|---|---|---|---|---|---|---|---|---|---|---|---|---|---|---|---|
| A | 0 - 0.15 | | Abrupt | Silty Clay Loam | 7.5 YR 3/1 | Nil | Nil | 0 - 2% | Polyhedral | Moderate | Firm (moderately moist) | Many coarse, medium, fine, very fine | — | — | — |
| B1 | 0.15 - 0.35 | | Clear | Medium Heavy Clay | 7.5 YR 4/1 | 5 YR 5/8 | Nil | 2 - 10% | Subangular blocky | Moderate | Firm (moist) | Many medium, fine, very fine | — | — | — |

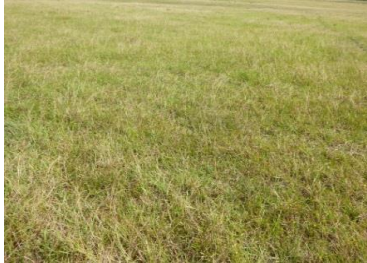
| Landform<br>Upper slope | | | Soil Surface Condition (dry)<br>Firm | | | Land Use<br>Grazing | | Erosion State<br>None evident |
| Landscape Photo (North)<br> | | | Landscape Photo (East)<br> | | | Soil Surface Condition Photo<br> | | <b>Site Type</b><br>Detailed + Sampled for Lab<br><br><b>Microrelief</b> Yes, but not as abundant<br><br><b>Type</b> Hummocky or normal gilgai<br><br><b>Vertical (m)</b><br><br><b>Horizontal (m)</b><br><br><b>Described/ sampled</b><br><br><b>Other Information:</b><br>Less hummocky than previous sites.<br>Topography is gently undulating.<br>Drainage differs from previous sites.<br>As per previous sites, vegetation cover is 100%. |

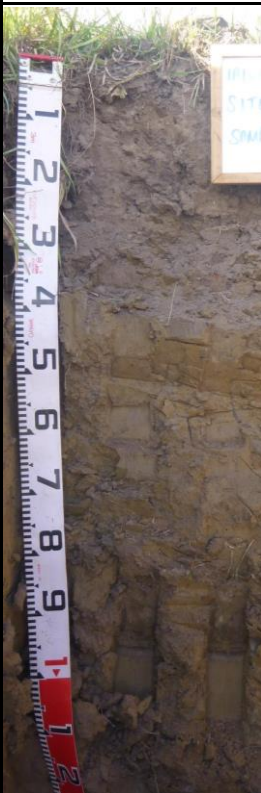
| Horizon | Depth (m) | Profile Photo | Boundary | Texture | Moist Colour | Mottle (colour, abundance) | Segregations (abundance, nature) | Coarse fragments (abundance, size) | Structure (type) | Structure (grade) | Consistence (soil water status) | Roots (abundance, size) | pH | EC (dS/m) | Depth of Sample for Lab (m) |
|---|---|---|---|---|---|---|---|---|---|---|---|---|---|---|---|
| A11 | 0 -0.1 | | Clear | Light Clay | 10 YR 3/3 | Nil | 0 - 2% Unidentified | 0 - 2% Sub-angular ( 2-4 mm) | Polyhedral | Weak to moderate | Strong (dry) | - | - | - | - |
| A12 | 0.1 - 0.35 | | Gradual | Light Medium Clay | 10 YR 4/2 | Nil | Nil | 0 - 2% Sub-angular ( 2-4 mm) | Angular blocky | Moderate | Firm (moist) | Many medium, fine, very fine | Lab | Lab | 150 - 250 |

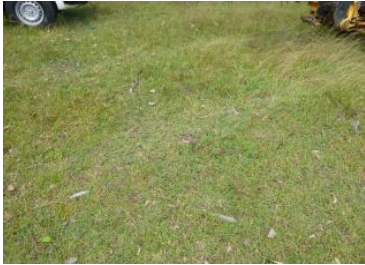
| Landform<br>Upper slope | | | Soil Surface Condition (dry)<br>Poached | | | Land Use<br>Grazing | | Erosion State<br>None evident |

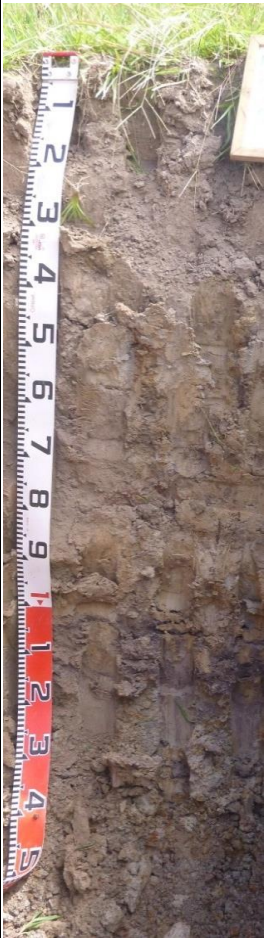
| Horizon | Depth (m) | Profile Photo | Boundary | Texture | Moist Colour | Mottle (colour, abundance) | Segregations (abundance, nature) | Coarse fragments (abundance, size) | Structure (type) | Structure (grade) | Consistence (soil water status) | Roots (abundance, size) | pH | EC (dS/m) | Depth of Sample for Lab (m) |
|---|---|---|---|---|---|---|---|---|---|---|---|---|---|---|---|
| A | 0 - 0.1 | | Abrupt | Silty Clay Loam | 10 YR 5/2<br>10 YR 3/3 | Nil | 0 - 2%<br>Unidentified | 0 - 2% | Polyhedral | Moderate | Firm (dry) | Many coarse, medium, fine, very fine | – | – | – |
| B1 | 0.1 - 0.35 | | Clear | Medium Heavy Clay | 10 YR 4/2 | 10 YR 5/8 many, fine | Nil | Red sandstone (10-20 mm) | Subangular blocky parting to platy | Moderate | Very strong (moderately moist) | Many medium, fine, very fine | Lab | Lab | 150 - 250 |

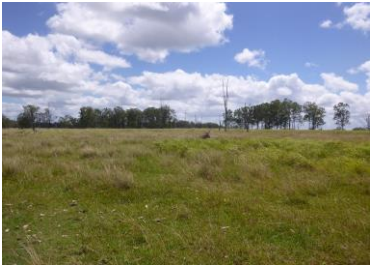
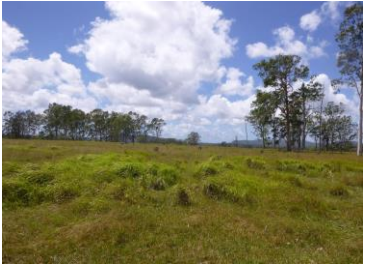
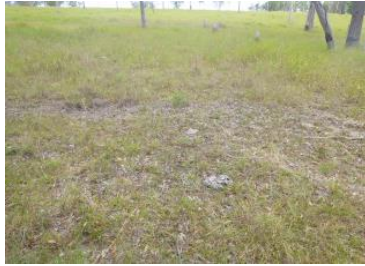
| Landscape Photo (North)<br> | | | Landscape Photo (East)<br> | | | Soil Surface Condition Photo<br> | | Site Type<br>Detailed + Sampled for Lab<br><br>Microrelief<br>Yes<br><br>Type<br>Hummocky or normal gilgai<br><br>Vertical (m) |

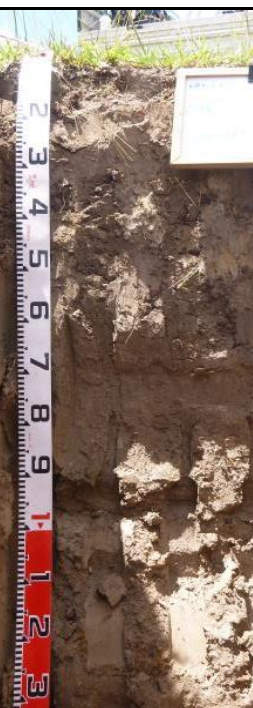
| Horizon | Depth (mm) | Profile Photo | Boundary | Texture | Moist Colour | Mottle (colour, abundance) | Segregations (abundance, nature) | Coarse fragments (abundance, size) | Structure (type) | Structure (grade) | Consistence (soil water status) | Roots (abundance, size) | pH | EC (dS/m) | Depth of Sample for Lab (mm) |
|---|---|---|---|---|---|---|---|---|---|---|---|---|---|---|---|
| A | 0 - 0.3 | | Clear | Silty Clay Loam | 7.5 YR 3/2 | Nil | Nil | 10-20% siltstone | Subangular blocky | Moderate | Firm (dry) | Many coarse, medium, fine, very fine | Lab | Lab | 200 - 300 |
| B1 | 0.3 - 0.6 | | Gradual | Light Clay | 7.5 YR 3/2 | Mottling present | Nil | 2-10% siltstone and 2% red, unidentified (coarser-grained than siltstone) | Subangular blocky parting to platy | Moderate | Very strong (moderately moist) | Many medium, fine, very fine | – | – | – |

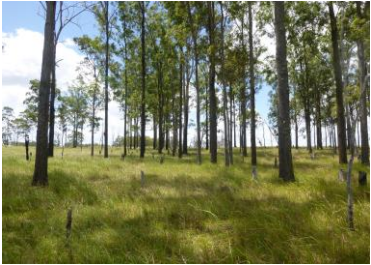
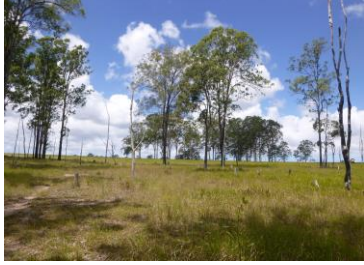
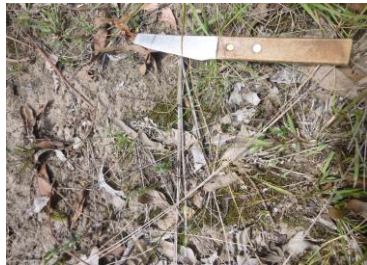
| Landform<br>Mid-slope | | Soil Surface Condition (dry)<br>Trampled and cryptogram | | | | Land Use<br>Grazing | Erosion State<br>Stabilised | |
| Landscape Photo (North)<br> | | Landscape Photo (East)<br> | | | | Soil Surface Condition Photo<br> | | <div>Site Type</div> <div>Detailed + Sampled for Lab</div> |

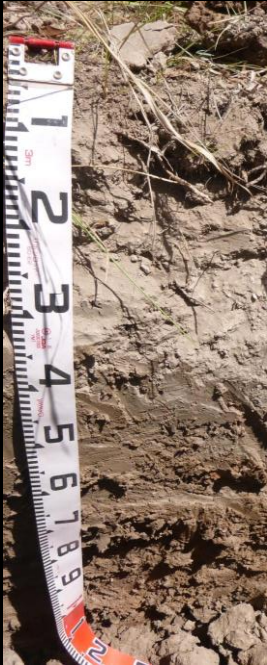
| Horizon | Depth (mm) | Profile Photo | Boundary | Texture | Moist Colour | Mottle (colour, abundance) | Segregations (abundance, nature) | Coarse fragments (abundance, size) | Structure (type) | Structure (grade) | Consistence (soil water status) | Roots (abundance, size) | pH | EC (dS/m) | Depth of Sample for Lab (mm) |
|---|---|---|---|---|---|---|---|---|---|---|---|---|---|---|---|
| A | 0 - 0.1 | | Abrupt | Silty Clay Loam | 10 YR 3/2 | Nil | Charcoal (5 - 10%) | 2 - 10% | Subangular blocky | Weak | Firm (dry) | Many coarse, medium, fine, very fine | – | – | – |
| B1 | 0.1 - 0.3 | | Clear | Medium Heavy Clay | 10 YR 3/2 | 10 YR 7/6 faint, fine | Charcoal (5 - 10%) | 2 - 10% | Subangular blocky parting to platy | Moderate | Very strong (moderately moist) | Common medium, fine, very fine | Lab | Lab | 100 - 200 |

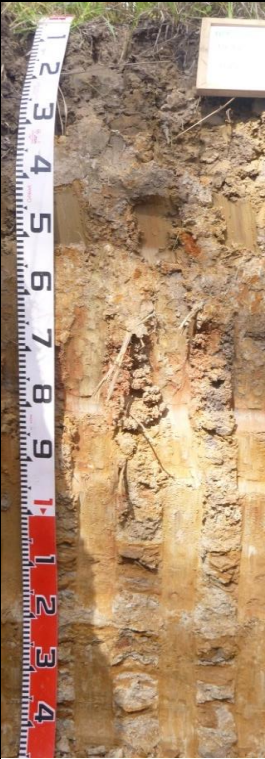
| Horizon | Depth (m) | Profile Photo | Boundary | Texture | Moist Colour | Mottle (colour, abundance) | Segregations (abundance, nature) | Coarse fragments (abundance, size) | Structure (type) | Structure (grade) | Consistence (soil water status) | Roots (abundance, size) | pH | EC (dS/m) | Depth of Sample for Lab (m) |
|---|---|---|---|---|---|---|---|---|---|---|---|---|---|---|---|
| A | 0 - 0.05 | | Clear | Silty Clay Loam | 7.5 YR 3/3 | Nil | Nil | 2 - 10% | Subangular blocky | Weak to moderate | Firm (dry) | Many coarse, medium, fine, very fine | – | – | – |
| B21 | 0.05 - 0.3 | | Abrupt | Light Medium Clay | 7.5 YR 4/2<br>10 YR 4/3 | Many, medium (7.5 YR 6/1) and (2.5 YR 4/6) | Nil | 10% | Subangular blocky parting to platy | Moderate | Very strong (moderately moist) | Common medium, fine, very fine | – | – | – |

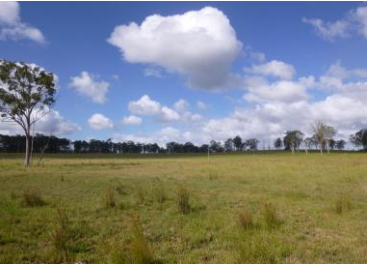
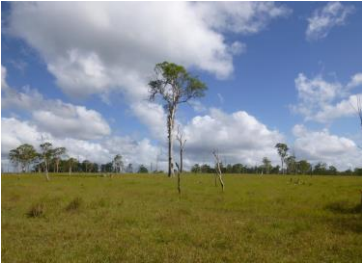
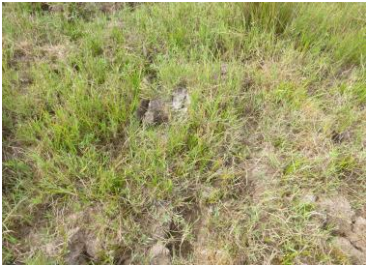
| Landscape Photo (North)<br> | | | Landscape Photo (East)<br> | | | Soil Surface Condition Photo<br> | | Site Type<br>Detailed + Sampled for Lab<br><br>Microrelief<br>Yes<br><br>Type<br>Hummocky or normal gilgai<br><br>Vertical (m)<br>~ 0-0.3 m |

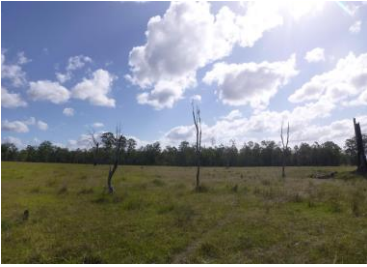
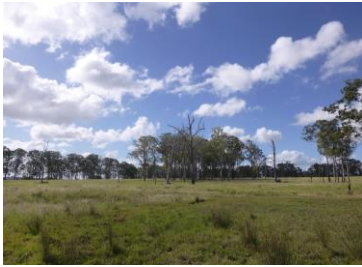
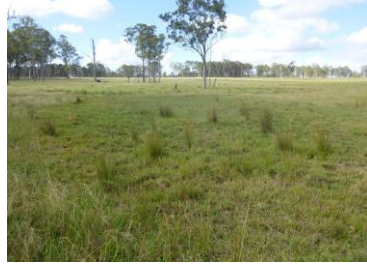
| Landscape Photo (South)<br> | | | Landscape Photo (West)<br> | | | Other Photo<br> | | Horizontal (m)<br>3-10 m<br><br>Described/<br>sampled<br>Mound<br><br>Other Information:<br>Mounds and depressions are evident |

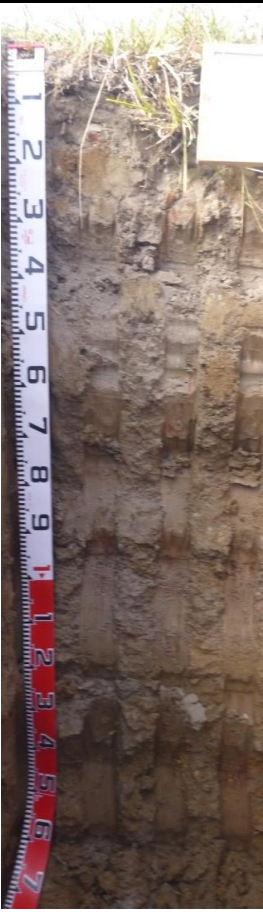
| Horizon | Depth (mm) | Profile Photo | Boundary | Texture | Moist Colour | Mottle (colour, abundance) | Segregations (abundance, nature) | Coarse fragments (abundance, size) | Structure (type) | Structure (grade) | Consistence (soil water status) | Roots (abundance, size) | pH | EC (dS/m) | Depth of Sample for Lab (mm) |
|---|---|---|---|---|---|---|---|---|---|---|---|---|---|---|---|
| A | 0 - 0.05 | | Abrupt | Clay Loam | 7.5 YR 3/2 | 7.5 YR 5/8 | Nil | 2 - 10%, unidentified | Subangular blocky | Weak | Very strong (dry) | Many coarse, medium, fine, very fine | – | – | – |
| B1 | 0.05 - 0.2 | | Clear | Light Clay | 7.5 YR 4/2 | Common, faint, strong brown (7.5 YR 5/8) | Nil | 2 - 10%, unidentified | Angular blocky parting to platy | Moderate | Very strong (moderately moist) | Common medium, fine, very fine | Lab | Lab | 100 - 200 |

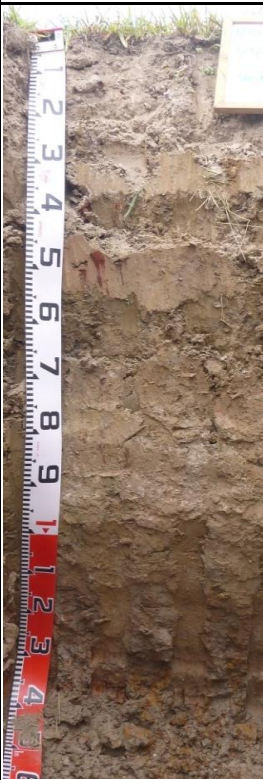
| Horizon | Depth (mm) | Profile Photo | Boundary | Texture | Moist Colour | Mottle (colour, abundance) | Segregations (abundance, nature) | Coarse fragments (abundance, size) | Structure (type) | Structure (grade) | Consistence (soil water status) | Roots (abundance, size) | pH | EC (dS/m) | Depth of Sample for Lab (mm) |
|---|---|---|---|---|---|---|---|---|---|---|---|---|---|---|---|
| A | 0 - 0.15 | | Abrupt | Silty Clay Loam | 7.5 YR 3/2 | Nil | Nil | Unidentified and varied lithologies, smooth and rounded as well as angular | Subangular blocky | Weak to moderate | Very strong (dry) | Many coarse, medium, fine, very fine | Lab | Lab | 0 - 150 |
| B2 | 0.15 - 1.2 | | Gradual | Medium Heavy Clay | 7.5 YR 5/1 | Fine, many, faint yellowish red (5 YR 5/6) and red (2.5YR 4/6, 10R 4/6) | Nil | | Subangular blocky parting to platy | Moderate | Firm (moist) | Common medium, fine, very fine | Lab | Lab | 600 - 700 |

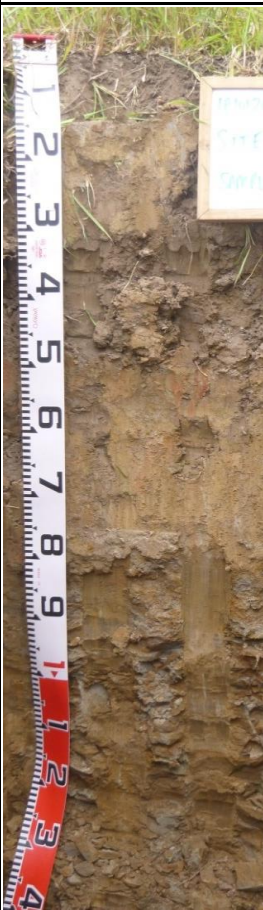
| Horizon | Depth (mm) | Profile Photo | Boundary | Texture | Moist Colour | Mottle (colour, abundance) | Segregations (abundance, nature) | Coarse fragments (abundance, size) | Structure (type) | Structure (grade) | Consistence (soil water status) | Roots (abundance, size) | pH | EC (dS/m) | Depth of Sample for Lab (mm) | |
|---|---|---|---|---|---|---|---|---|---|---|---|---|---|---|---|--|
| A | 0 - 0.2 | | Sharp | Silty Clay Loam | 7.5 YR 4/2 | Nil | Nil | Unidentified and varied lithologies, smooth and rounded as well as angular | Subangular blocky | Moderate | Very strong (dry) | Many coarse, medium, fine, very fine | Lab | Lab | 100 - 200 | |
| B21 | 0.2 - 0.8 | | Gradual | Medium Heavy Clay | 7.5 YR 4/1 | Many, coarse (10 YR 5/6) and common medium (2.5 YR 4/6) | Nil | | | Moderate | Firm (moist) | Few medium, fine, very fine | Lab | Lab | 600 - 700 | |

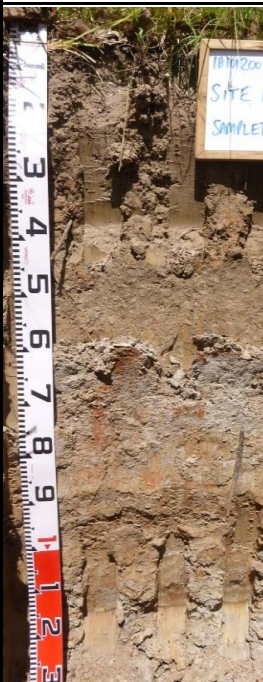
| Horizon | Depth (mm) | Profile Photo | Boundary | Texture | Moist Colour | Mottle (colour, abundance) | Segregations (abundance, nature) | Coarse fragments (abundance, size) | Structure (type) | Structure (grade) | Consistence (soil water status) | Roots (abundance, size) | pH | EC (dS/m) | Depth of Sample for Lab (mm) |
|---|---|---|---|---|---|---|---|---|---|---|---|---|---|---|---|
| A | 0-0.1 | | Abrupt | Silty Clay Loam | 7.5 YR 3/2 | Nil | Nil | Nil | Subangular blocky | Moderate | Very strong (dry) | Many coarse, medium, fine, very fine | – | – | – |
| B1 | 0.1-0.4 | | Clear | Medium Heavy Clay | Grey (7.5 YR 5/1) | Many, medium to coarse distinct yellowish red (5 YR 5/6) and red (2.5YR 4/6, 10R 4/6) | Nil | Unidentified and varied lithologies, smooth and rounded as well as angular | Subangular blocky parting to platy | Moderate | Firm (moist) | Common medium, fine, very fine | Lab | Lab | 0.5-0.6 (QC1) |

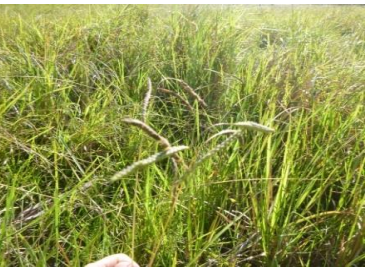
| Dominant Vegetation Photo 1<br> | | | Dominant Vegetation Photo 2<br> | | | Other Vegetation Photo | | Horizontal (m) |

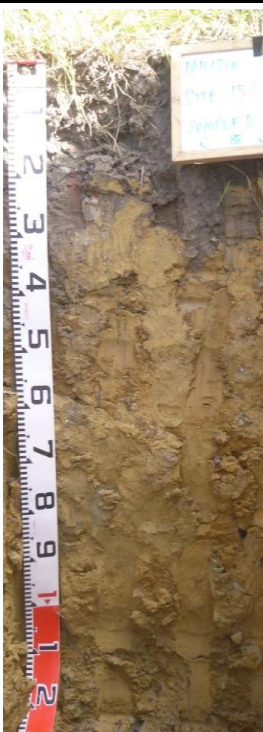
| Horizon | Depth (m) | Profile Photo | Boundary | Texture | Moist Colour | Mottle (colour, abundance) | Segregations (abundance, nature) | Coarse fragments (abundance, size) | Structure (type) | Structure (grade) | Consistence (soil water status) | Roots (abundance, size) | pH | EC (dS/m) | Depth of Sample for Lab (m) |
|---|---|---|---|---|---|---|---|---|---|---|---|---|---|---|---|
| A | 0-0.1 | | Abrupt | Light Medium Clay | Dark brown (7.5YR 3/3) | Nil | Nil | 2-5% (2-5 mm) unidentified subangular | Subangular blocky | Moderate | Very strong (dry) | Many coarse, medium, fine, very fine | Lab | Lab | 0.01-0.02 (QC2) |
| B21 | 0.1-0.35 | | Clear | Medium Heavy Clay | Brown (7.5YR 4/3) | Few, medium red (2.5YR 5/6) | Nil | 5-10% (5-10 mm) unidentified subangular | Subangular blocky parting to platy | Moderate | Very strong (moderately moist) | Common medium, fine, very fine | — | — | 0.2-0.3 |
