REPORT TO
CITY OF PARRAMATTA COUNCIL

ON
REMEDIATION ACTION PLAN

FOR
**PROPOSED RIVERSIDE THEATRES
REDEVELOPMENT**

AT
351-353 CHURCH STREET, PARRAMATTA, NSW

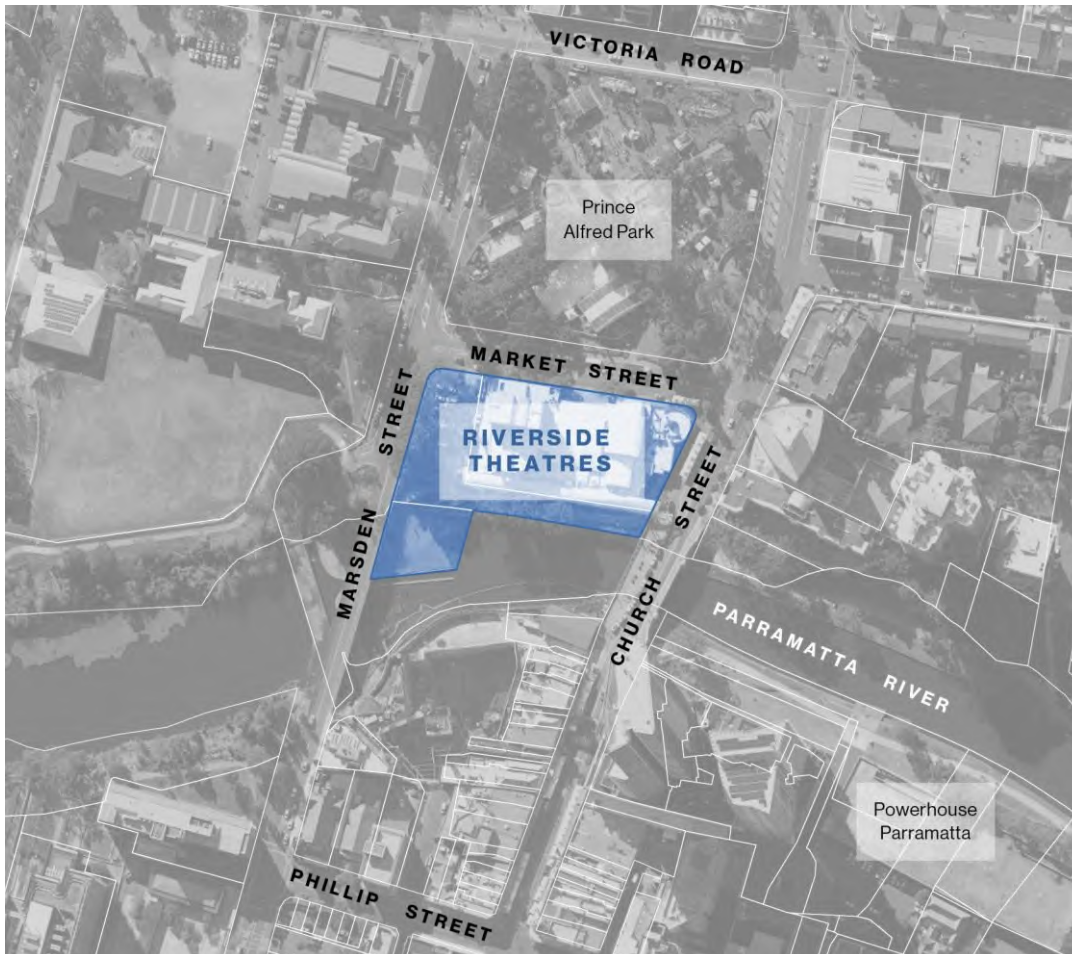
Plate 2 Riverside Theatres redevelopment site boundary (source: Arup)

The site is bordered by Church Street in the east, the Parramatta River in the south, Marsden Street to the west and Market Street to the north (refer to Plate 2).
