Australia Habitat and Taronga Wildlife Retreat

Electrical Services Existing and Proposed Infrastructure Report

Taronga Zoo,
Mosman, NSW 2072

Revision: 02
Job No: 2098
Date: 4 March 2016

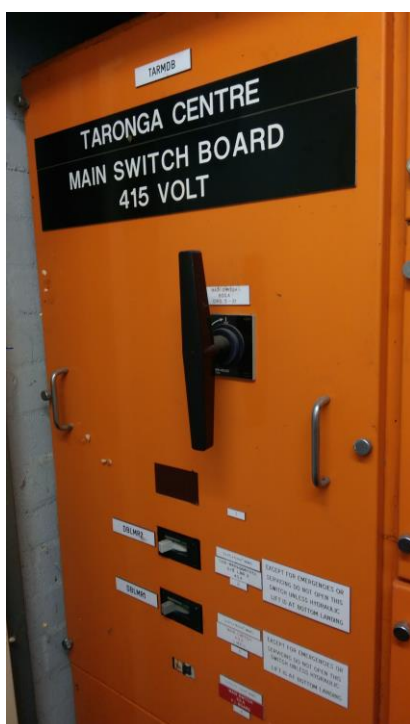
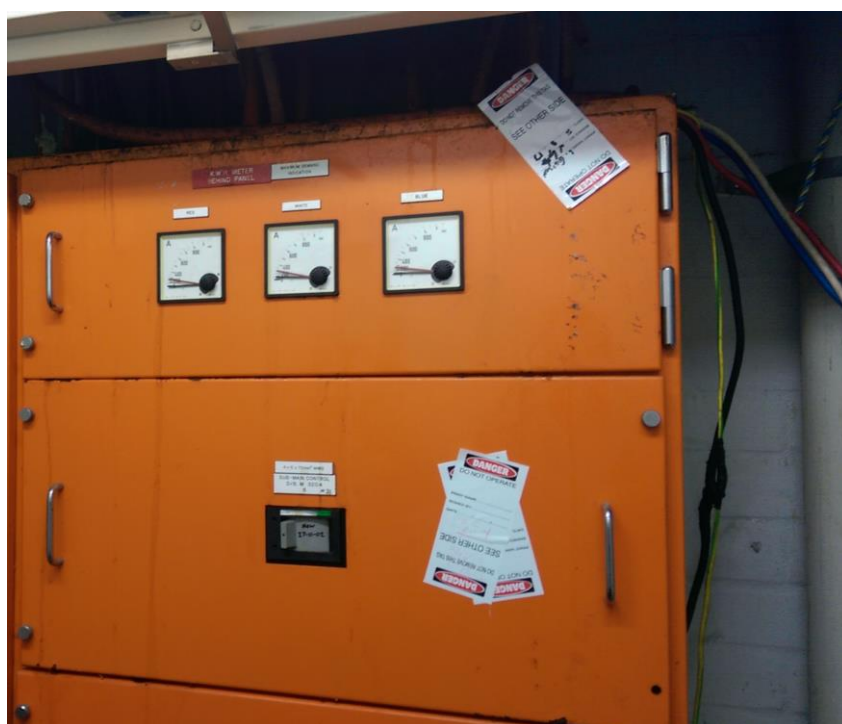
From observation, the MSB has an 800A main switch, however, is fed from a circuit breaker with a maximum rating of 630A.

The existing electrical distribution boards within the Taronga Centre are of an age similar to the building itself, and visual inspection of the boards revealed them to be in generally poor condition. Distribution boards throughout the building were not equipped with RCD protection, and multiple surface mounted conduits ran between distribution boards and plant or outlets.

The existing low voltage supply would be retained to feed a new MSB located on the lower ground floor of the Restaurant Pod. This would re-feed the existing main switchboard in the Taronga Centre, along with rising submains reticulating up the building to common floor distribution boards and services switchboards, such as HVAC. Submains will also reticulate out to individual distribution boards in each Pod and the Guest Lodge.

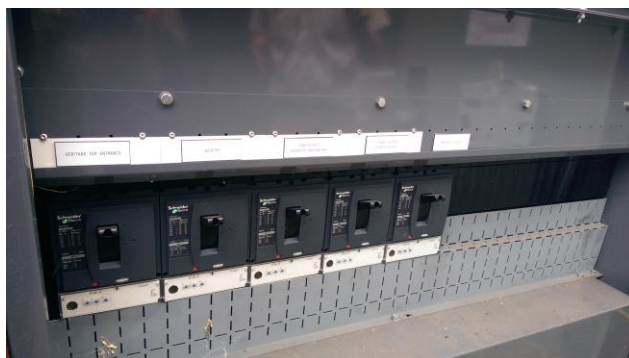
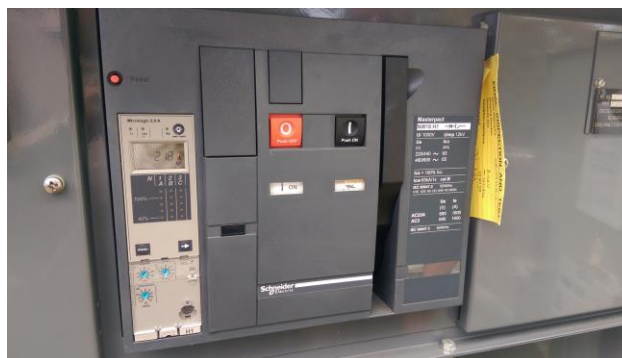
The substation and generator have been installed or upgraded within the last 5 years, and are of an excellent condition.

The existing substation and generator would be retained as is. There are no alterations required to the existing high voltage infrastructure.

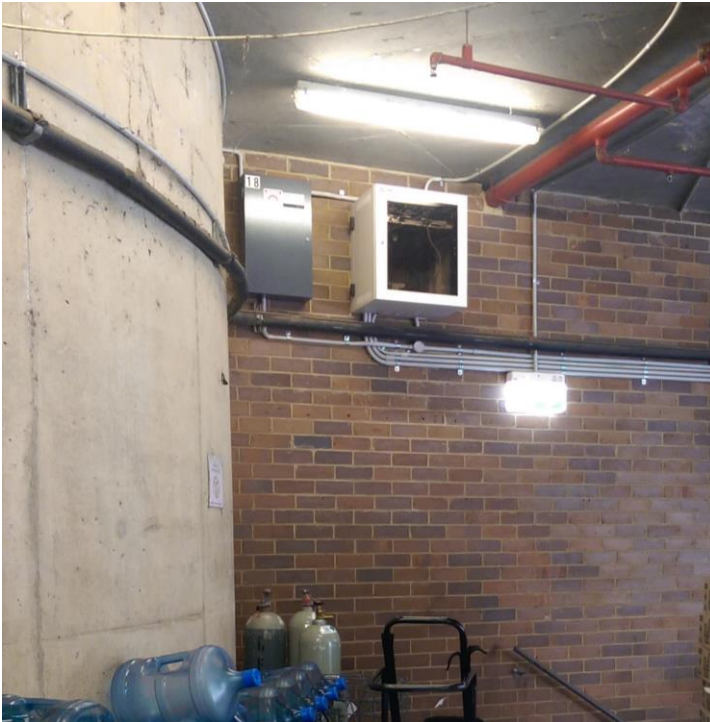
The site is covered by an extensive fibre and telecommunications network, with a fibre optic building distributor (BD) and telecommunications intermediate distribution frame (IDF) located within the Taronga Centre. The telecommunications main distribution frame (MDF) is housed in the adjacent Admin building. Network units are installed in various locations throughout the centre with cabling reticulated generally in surface mounted conduits.

Telecoms equipment is in generally good condition and is monitored by Taronga Zoo IT Services.

It is recommended that the existing communications backbone infrastructure be retained as much as is practicable. New building distributor and local distributors would be required to reticulate data through the Restaurant Pod, the new Wildlife Retreat Pods, and Guest Lodge.
