Australia Habitat and
Taronga Wildlife Retreat
Heritage Impact Assessment
March 2016

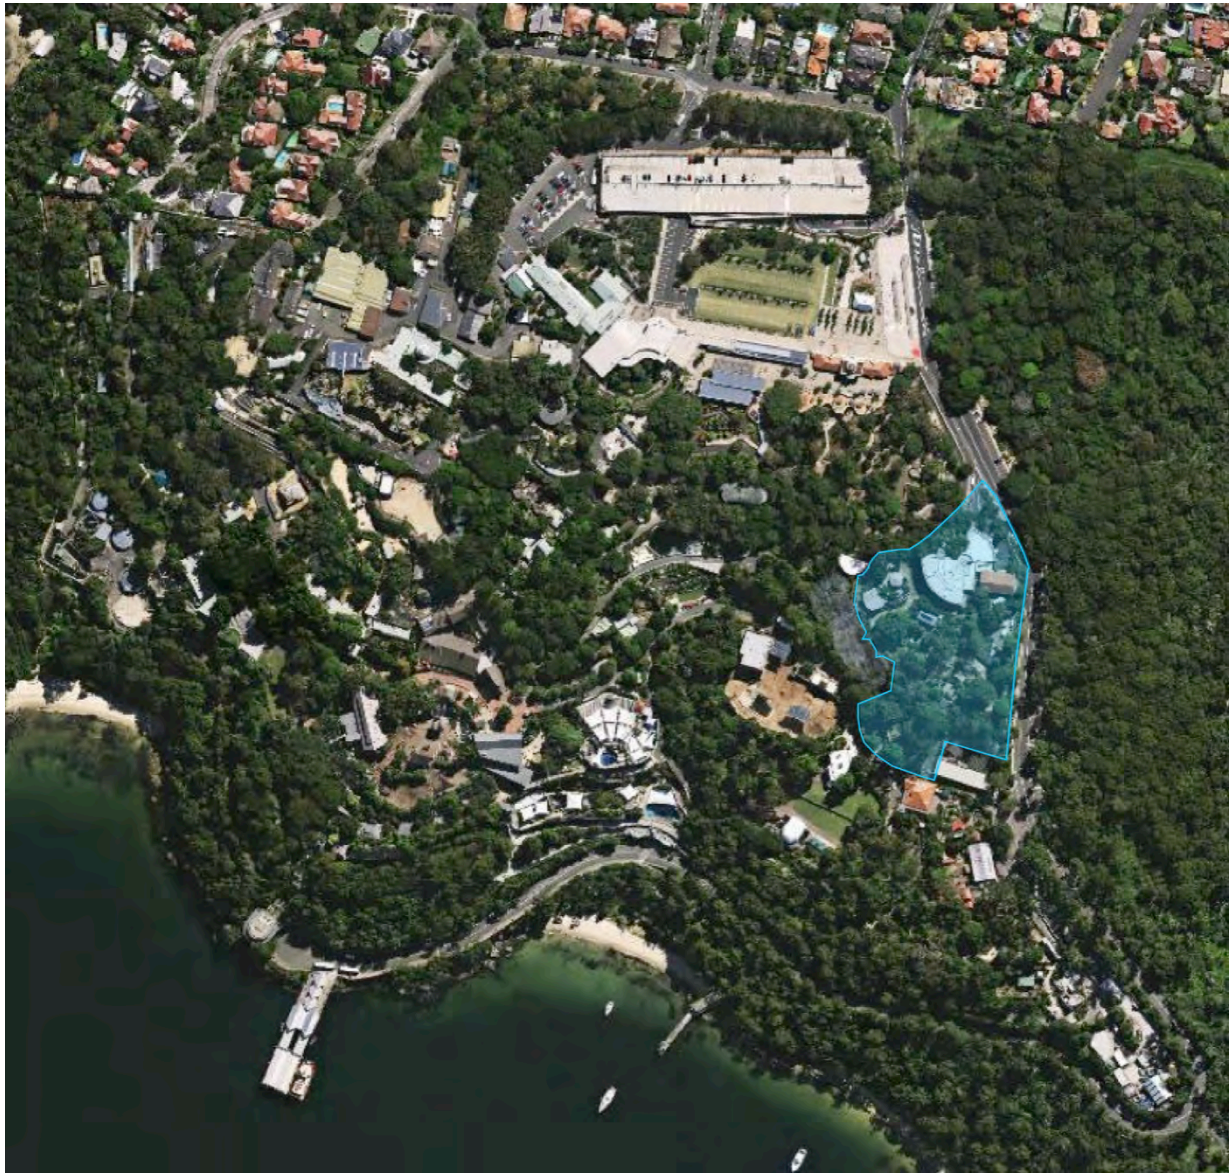
Figure 1.1 Aerial photo of Taronga Zoo showing the approximate study area shaded in blue.

The site is located near to the eastern side of Taronga Zoo (see Figures 1.1 and 1.2).

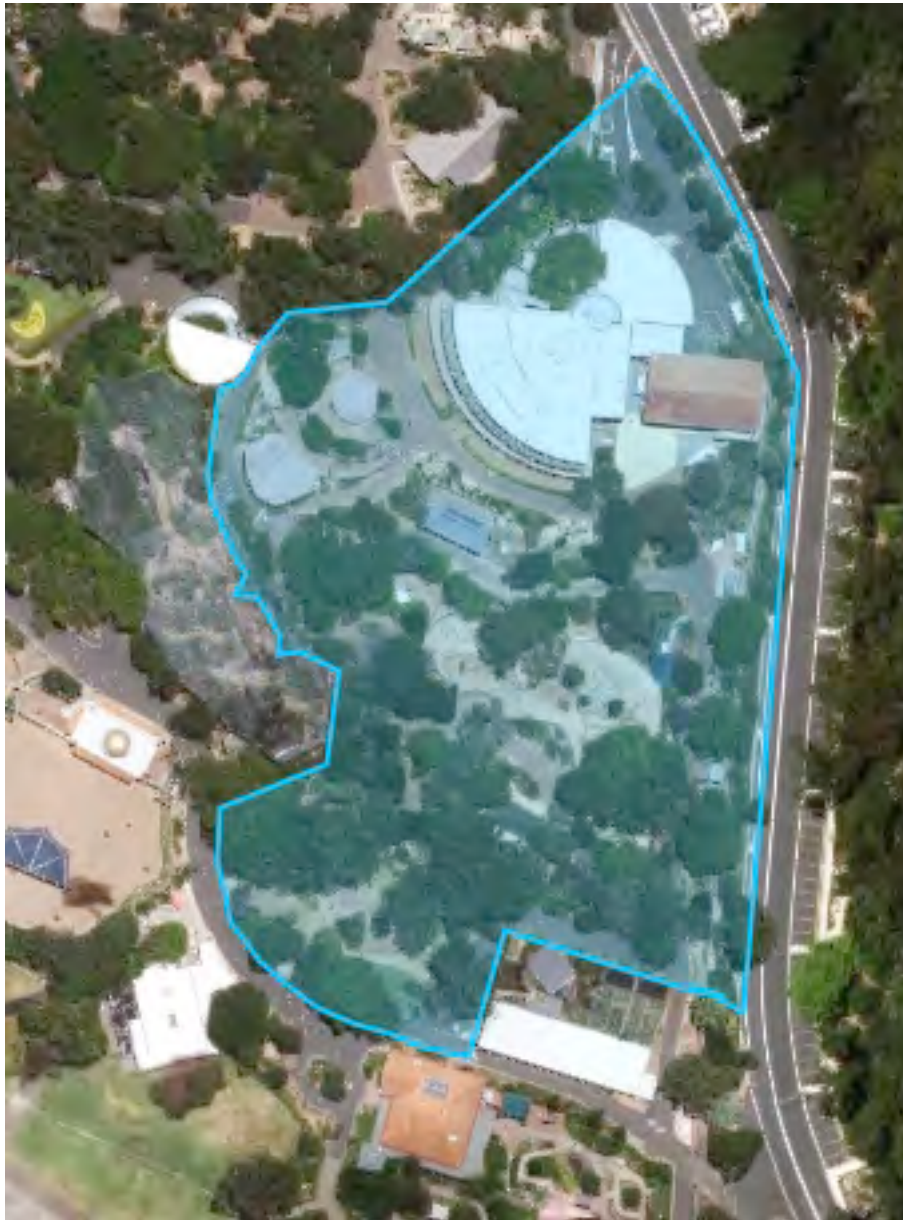
Figure 1.2 Aerial photograph of the study area and the surrounding site with the approximate site boundary shown in blue.

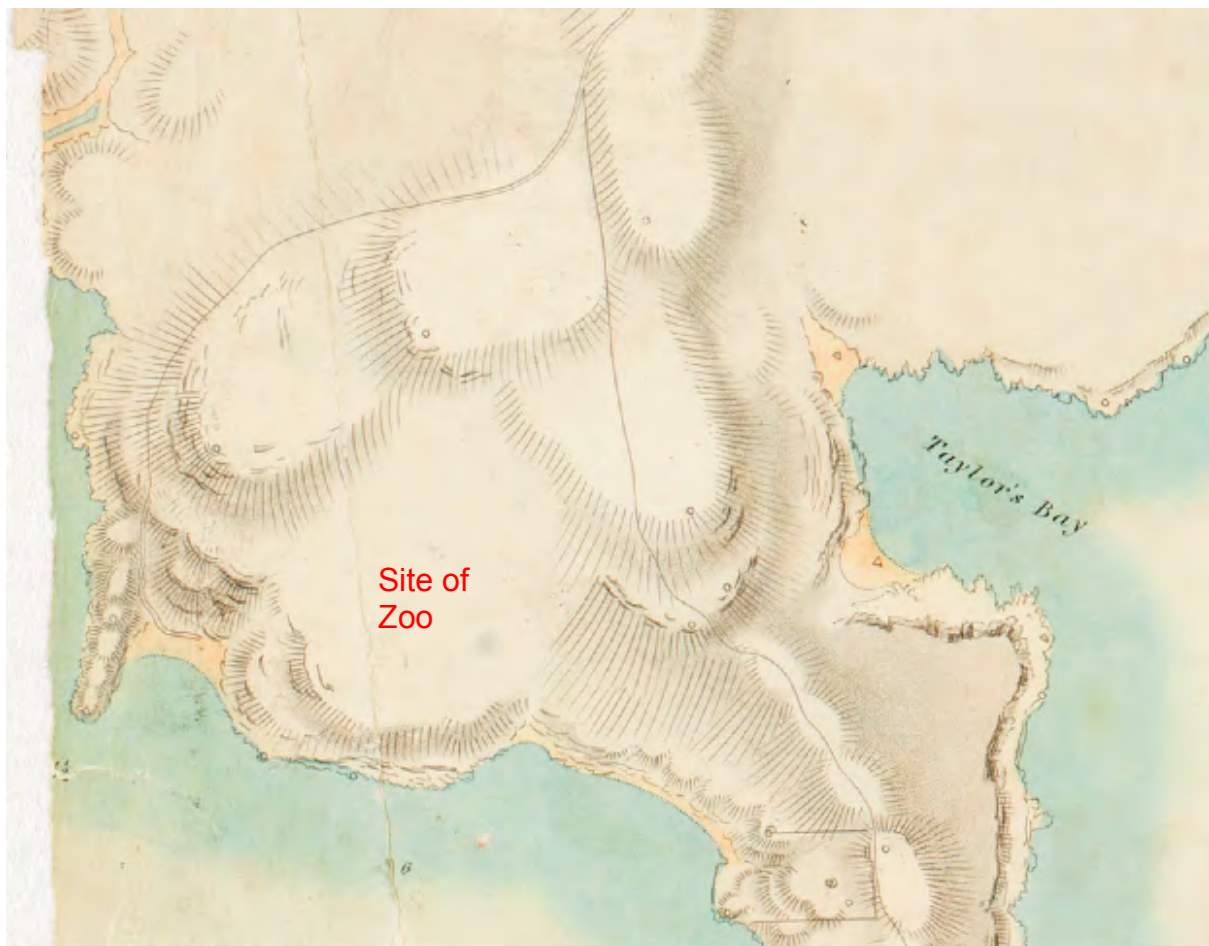
Figure 2.1 Extract from Thomas Mitchell's Trigonometrical Survey of Port Jackson dated 1853 showing Bradley's Head. The later location of the Zoo is indicated. Source: SLNSW Z/M4/811.15/1853/1

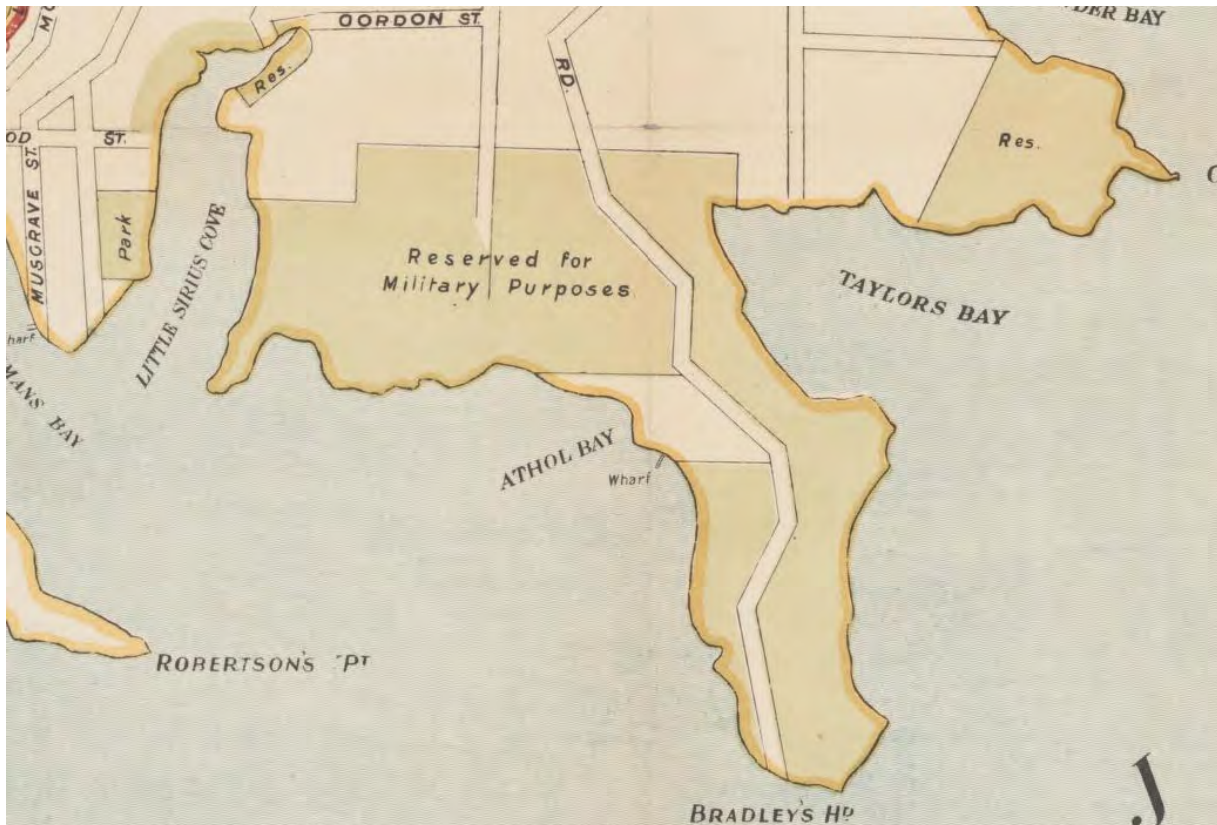
Figure 2.2 Extract from an 1890s map of Sydney showing the extent of the Military Reserve at Bradley's Head.
Source: NLA RM2358

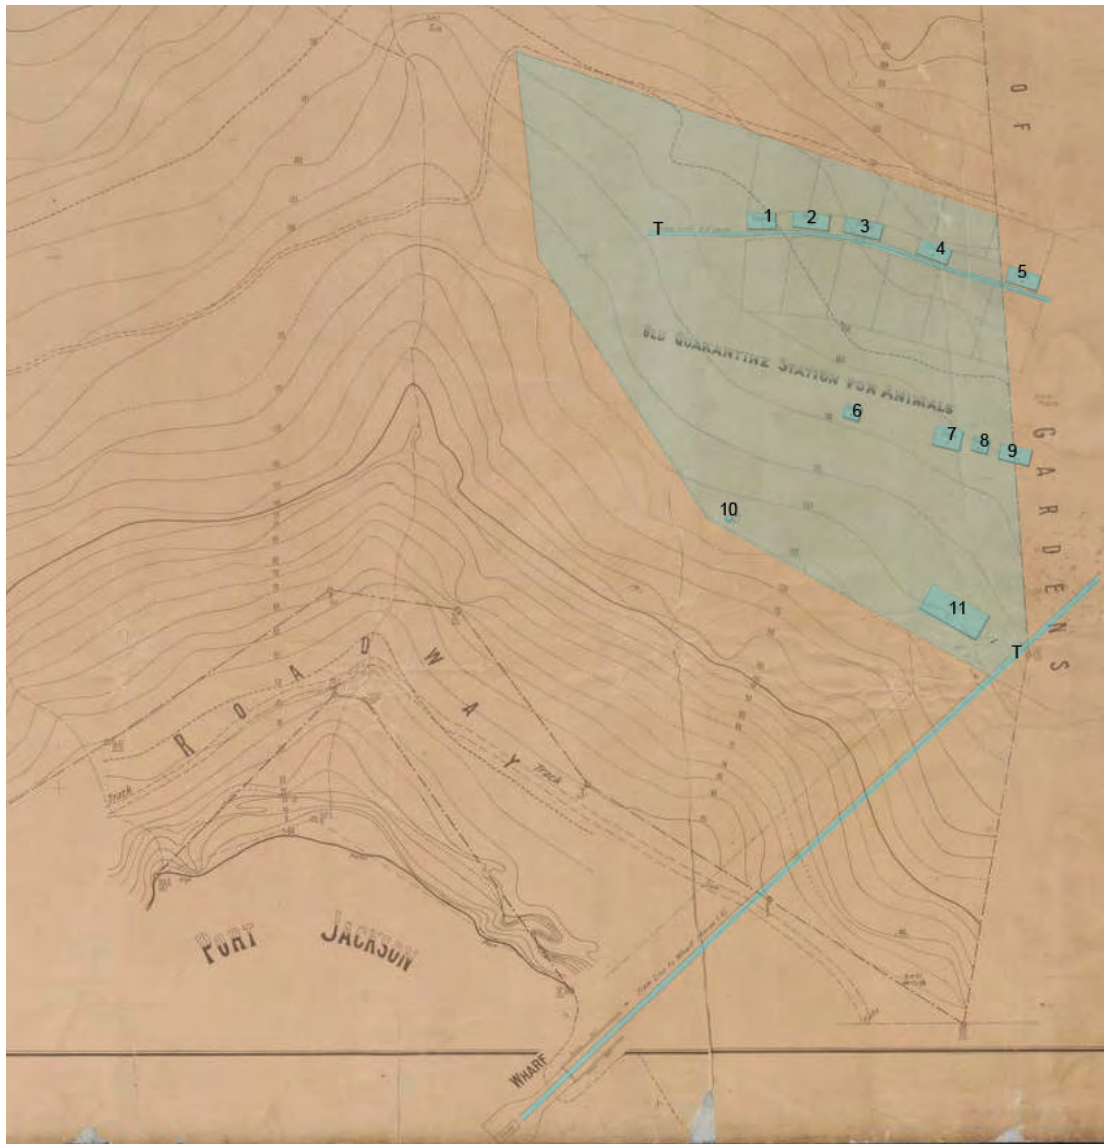
Figure 2.3 Extract from the 1912 survey prepared by the PWD showing the 'old quarantine station for animals'. The extent of the quarantine station within the zoo is shaded in blue, as are the buildings and the tramway. Note that the right hand boundary is not the current boundary. Source: NLA RM 3875

The lower buildings shown on the 1912 survey may be those built for the Zoo rather than for the earlier Stock Quarantine Station. A report, dated September 6th 1912, by the Secretary of the Zoological Trust notes "a staff of six men have been engaged in the clearing of ground" and "the survey plan will be ready towards the end of this month" and that a "shed is in the course of erection in the Quarantine Grounds and should be finished in a few days". The September report notes a WC and other sheds, had been erected. An undated survey held by PWD shows additional sheds, including a hexagonal structure to the west, and an unidentified building north east of the quarantine area, which may have been the caretaker's residence.

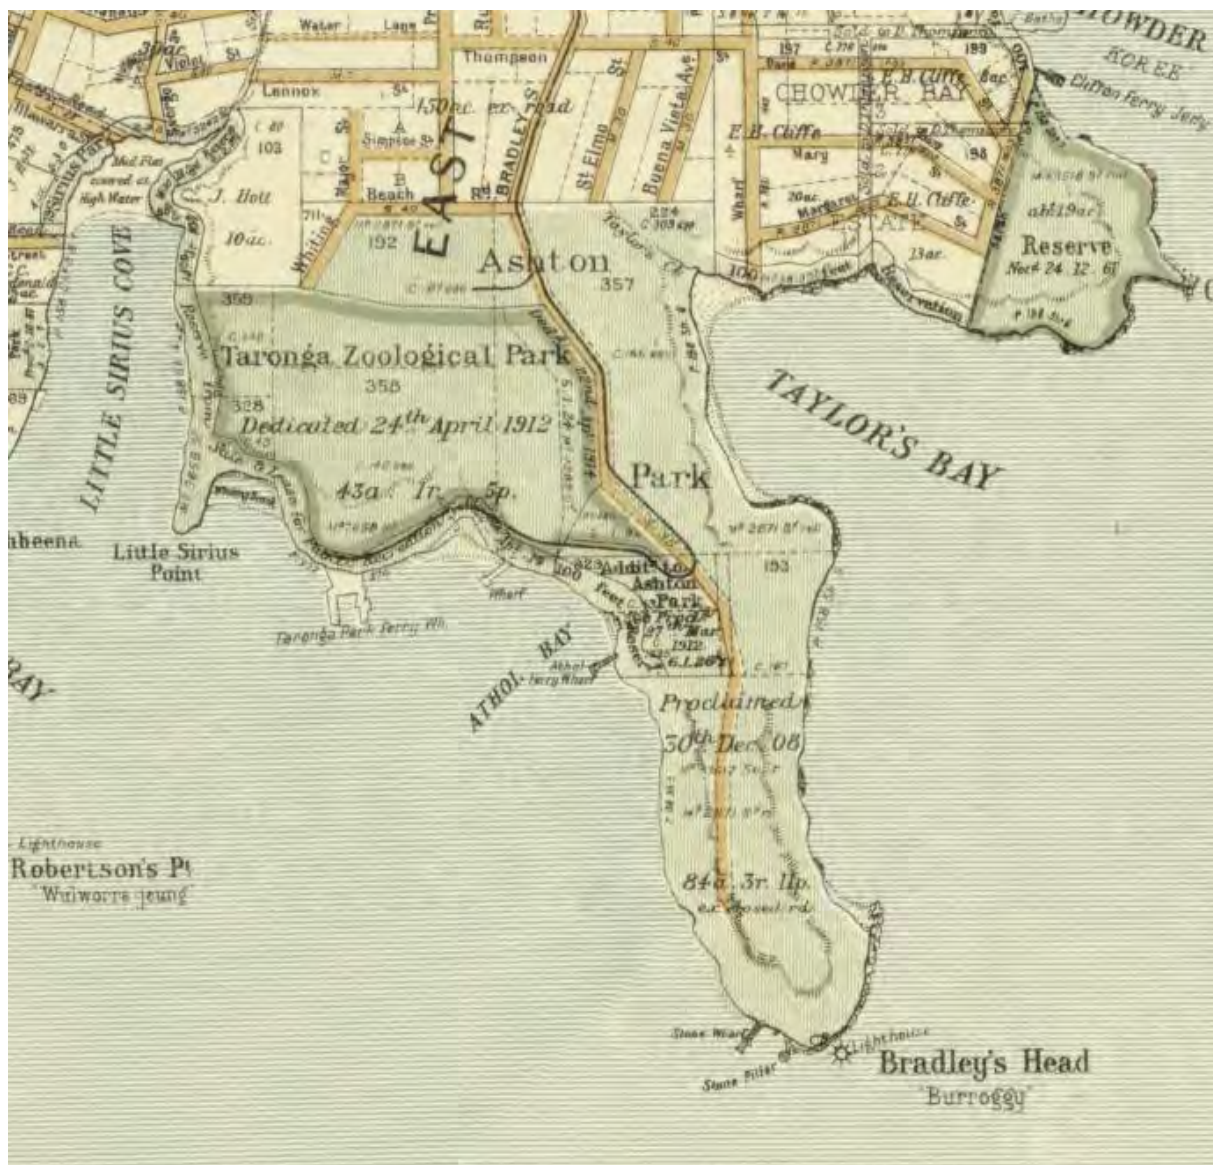
Source : NLA Maps G8974.S9G46

Figure 2.5 1917 Map of Sydney showing the dedicated reserves at Bradley's Head

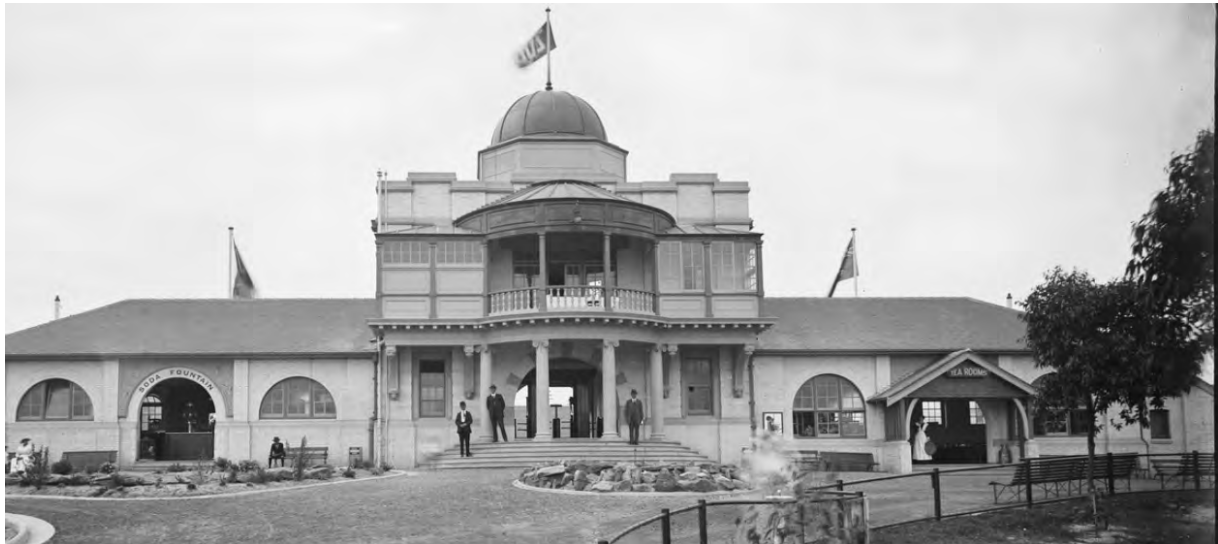
Figure 2.7 View of the recently completed main entrance to the new zoo at Taronga Park taken by Arthur Ernest Foster, Source: ML ON 30 Box 90 No 498

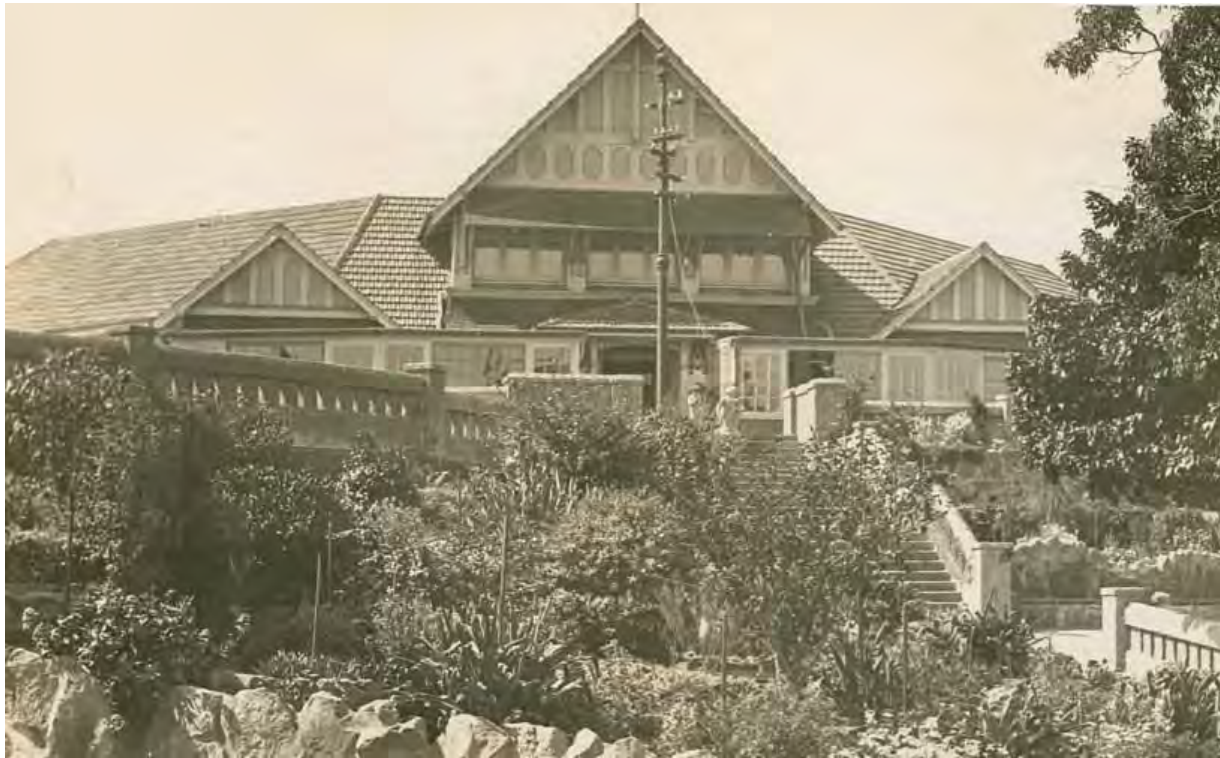
Figure 2.8 The refreshment rooms with the westmost of the radiating staircases, undated. The balustrade on the left is to the path east of the fountain/shelter. Source: State Records

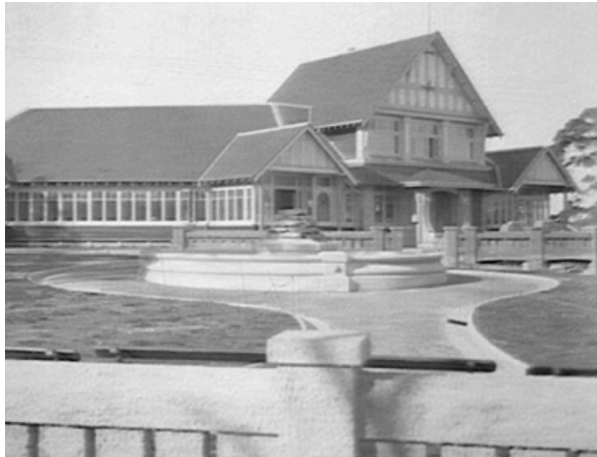
Figure 2.10 This photo from the GPO collection held in the Mitchell Library taken in July 1917 shows the completed fountain and paths with the Refreshment Rooms behind. Note the detail of the pier in the near face of the fountain and the pile of rocks at the centre of the fountain. Source: ML GPO 1 image d1_18521

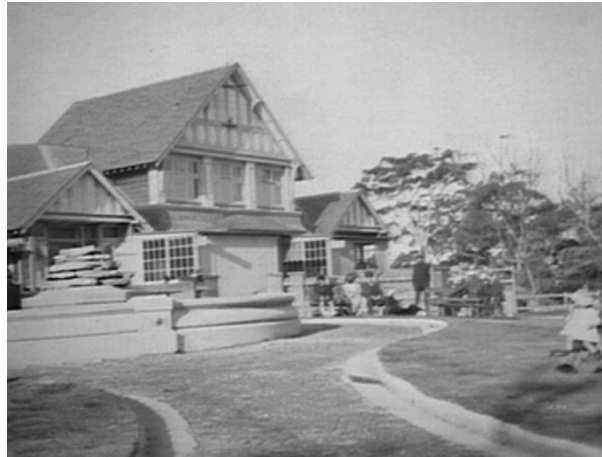
Figure 2.11 This photo from the GPO collection in Mitchell library taken in May 1920 shows the completed fountain and paths with alterations underway to the entry of the Refreshment Rooms behind. Source: ML GPO 1 image d1_14095

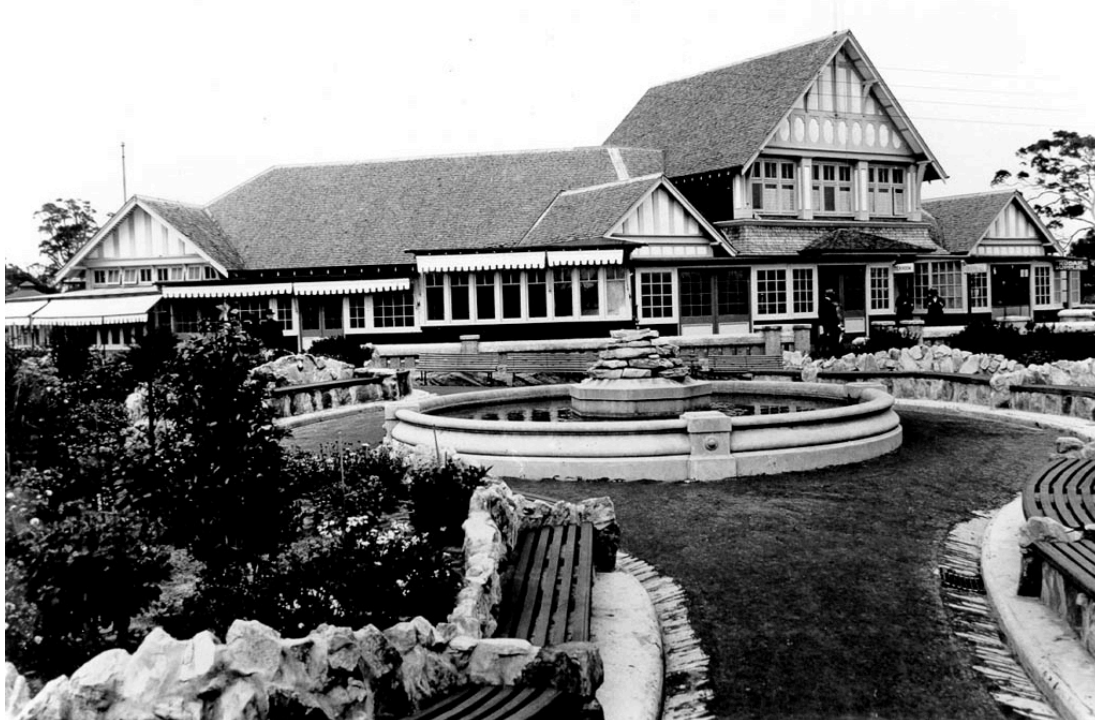
Figure 2.12 View of the fountain in its original condition, surrounded by slightly later rustic stone and timber seating and gardens. Alterations have already been made to the Refreshment Rooms entrance. Source: ML GPO 1 image d1_19165

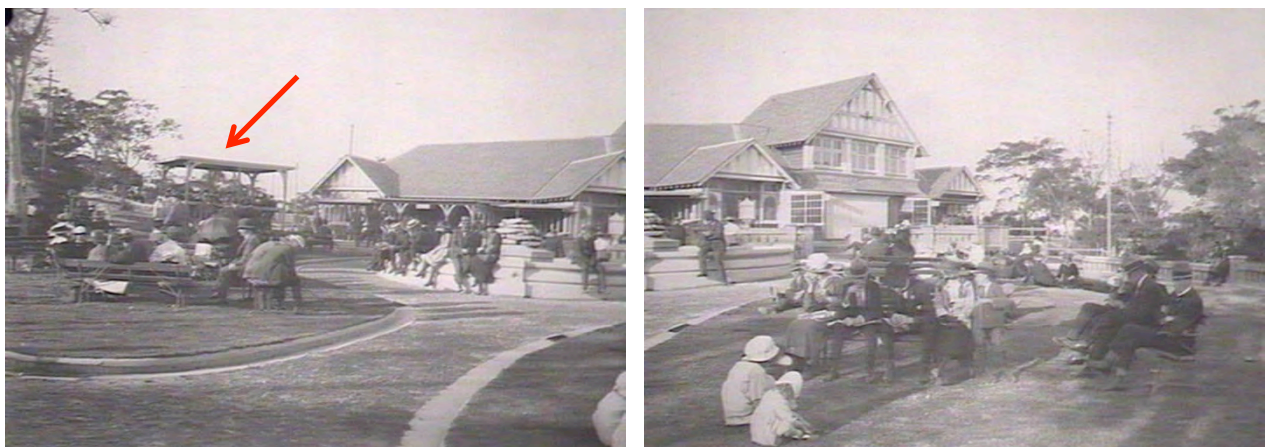
Figure 2.16 This pair of photos from the GPO collection in Mitchell library taken in May 1920 shows the completed fountain and paths with the Refreshment Rooms behind. Note the alterations underway to the entry of the Refreshment Rooms and the visitors seated on moveable benches and on the grass. The square freestanding structure in the left photo is a temporary bandstand (arrowed) and there is a band in it in the photo. This bandstand is also shown on the later drawing, dated 1922, for the new larger Bandstand.

The proposal to erect a bandstand on the fountain base did not proceed and a small and less elaborate temporary bandstand was built nearby. This temporary bandstand is evident in a 1920s photo of the fountain also showing people seated on the grass or on park benches. This photograph also shows that the entry to the Refreshment Rooms was being altered at this time.

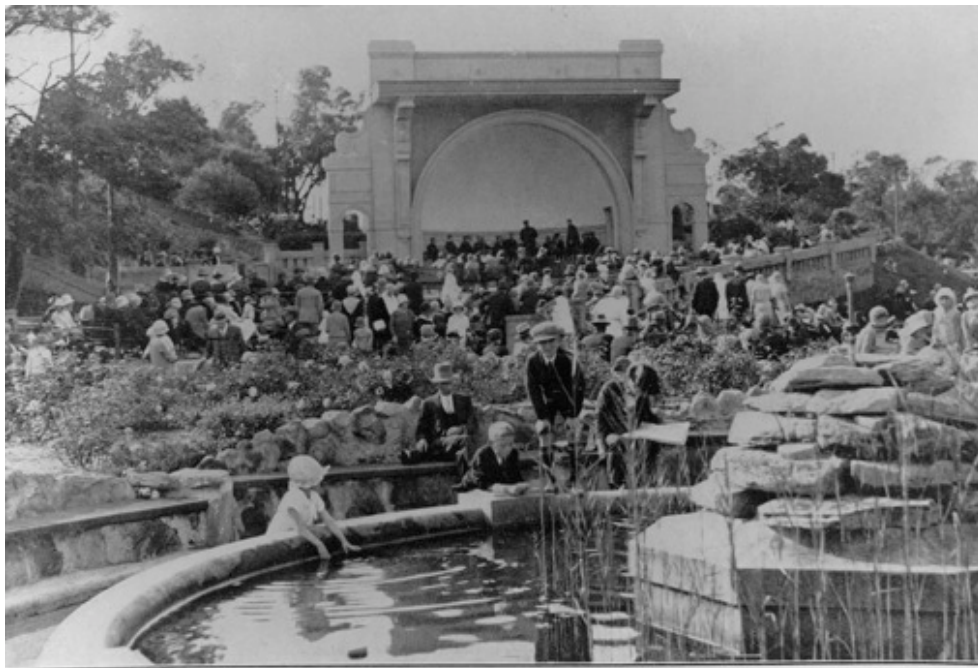
BAND STAND AND ROSE GARDEN.

Figure 2.18 View of the new bandstand with the fountain in the foreground, probably in the mid 1920s. From a later guidebook. Source: Taronga Zoo archives

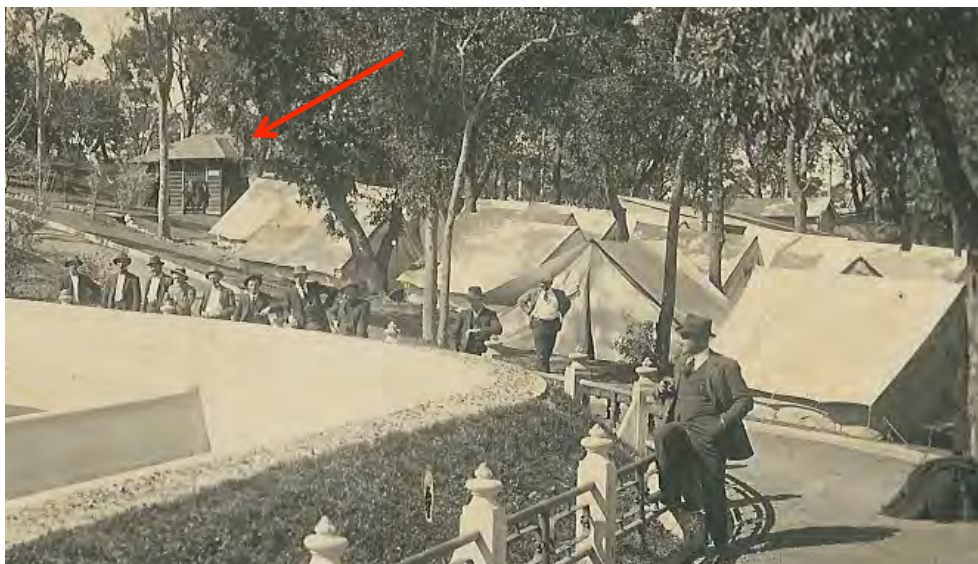
Figure 2.19 Enlargement of one of the views taken during the 1917 strike showing the mens toilet in the picnic area at the top left. Source: Taronga Zoo archives

These improvements included paths flanked by the characteristic curved rustic seats employed throughout the Zoological gardens. Improvements were made to the Picnic Lawns south of the Refreshment Rooms, with the male toilets replaced by separate Men's and Women's toilets. Garden beds, picnic shelters and additional paths were added. Although part of the area had been hived off to build a residence for the Superintendent this section was still largely picnic lawn. Water, including hot water was available. Large numbers of these small shelters were built in the interwar years however none survive at the Zoo. A photograph of a masonry 'rest house' at Taronga Zoo survives in the GPO collection. The weatherboard men's lavatory demolished in the 1920s can be seen in the distance in the strike photographs.

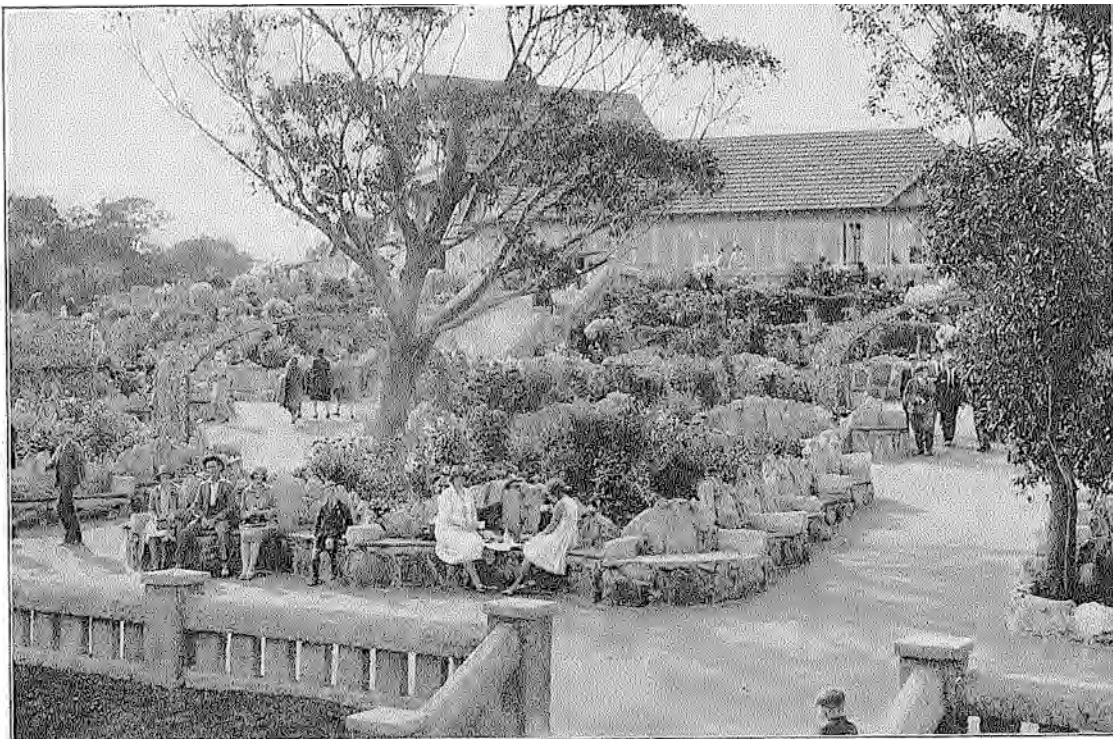
ONE OF THE ROCKERY GARDENS BELOW THE REFRESHMENT ROOMS.

Figure 2.23 View taken from one of the guidebooks showing the rockery gardens below the Refreshment Rooms. The pipe rail canopies can also be seen at centre left and right. In the foreground is the top of one of the staircases to the lawns below. Source: Taronga Zoo Archives

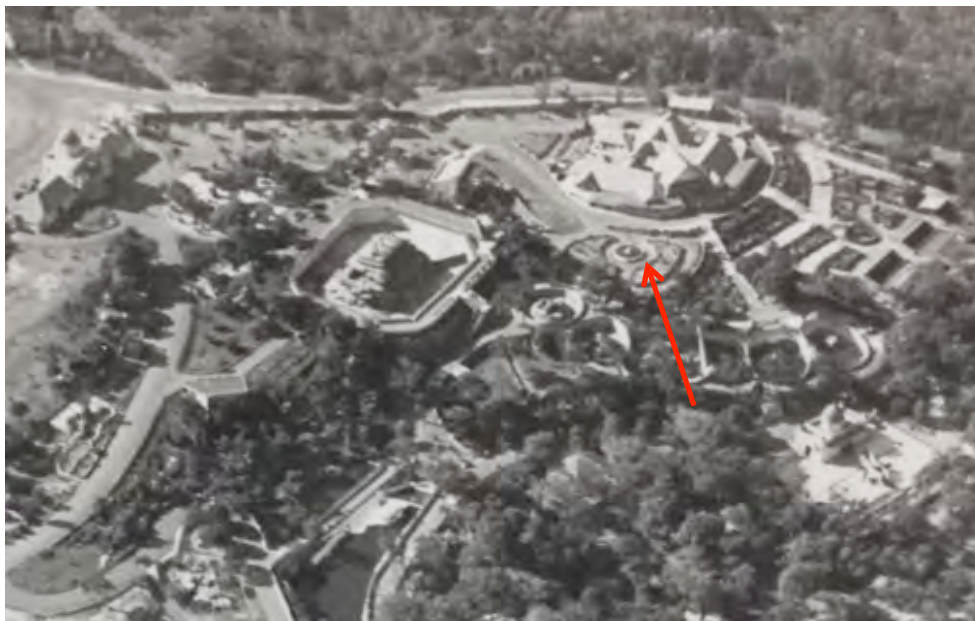
Figure 2.24 Circa 1930 aerial photo showing the fountain (arrowed) surrounded by seats and garden beds. The bandstand is to the left and the refreshment rooms above. Source, ML rephotographed at Govt Architects Office.
