# Salinity Management Plan

1 Art Gallery Road, Campbelltown, NSW, 2560

**Project No. 24263**

Version 3

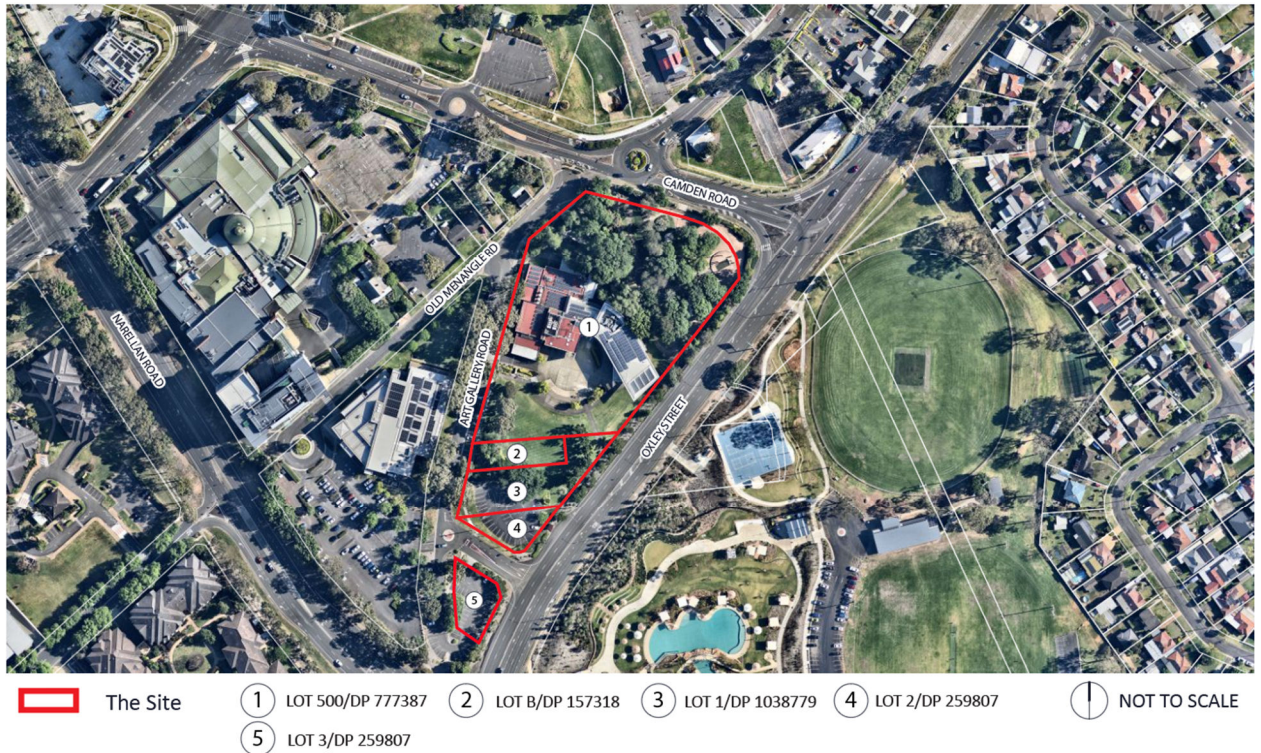
**Figure 1. Site Aerial**

The site is bounded by Art Gallery Road to the west, Narellan Road to the south, Oxley Street to the east and Camden Road to the north. The northern part of the site is separated from the southern portion by Art Gallery Road as shown in **Figure 1**. The site comprises a total site area of approximately 18,877 m<sup>2</sup>.
