# Proposed Campbelltown Arts Centre Expansion Project - 1 Art Gallery Road, Campbelltown, NSW

## **Proposed Campbelltown Arts Centre Expansion Project – Campbelltown Arts Centre, 1 Art Gallery Road, Campbelltown, NSW 2560**

### **Geotechnical Investigation Report**

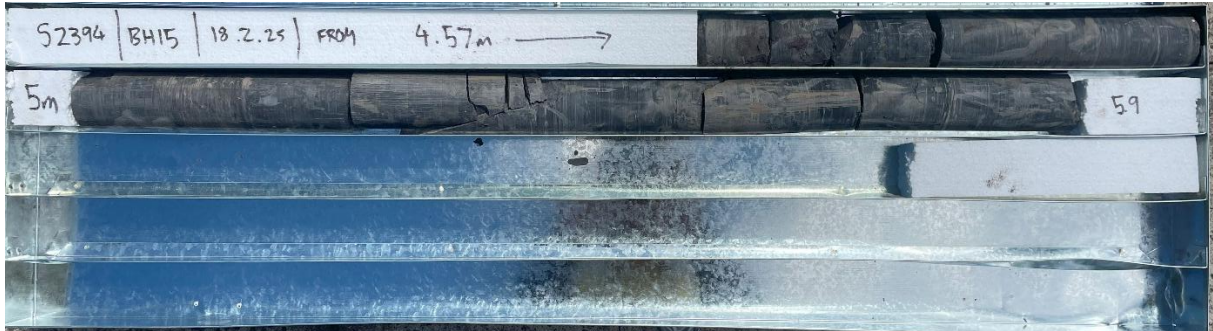
**BOREHOLE BH15**  
**4.57m to 5.9 m depth**

Rock Core Photos
