## **Remediation Action Plan**

**UNSW G25 Education Building**

**8 High Street, Kensington, NSW**

**Project 227492.04**

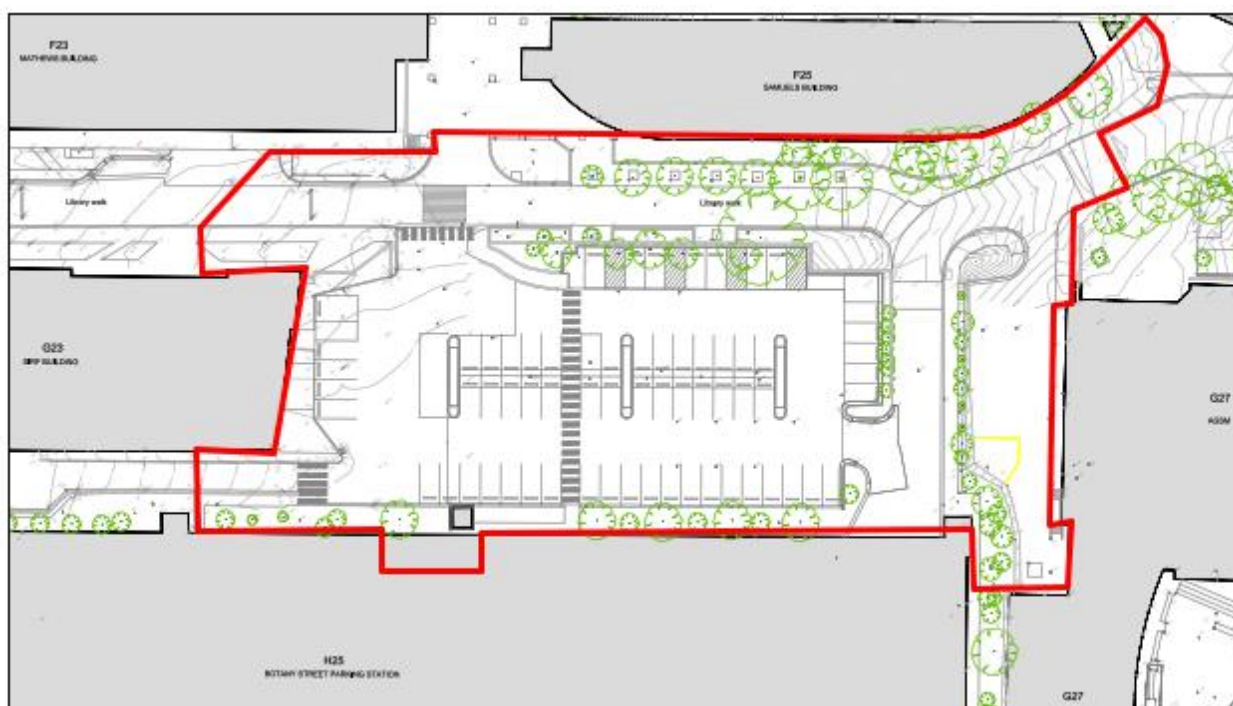
**Figure 3: Site boundary in red outline (refer to Drawing 1 for full legend)**

The site boundary is shown on Figure 3.

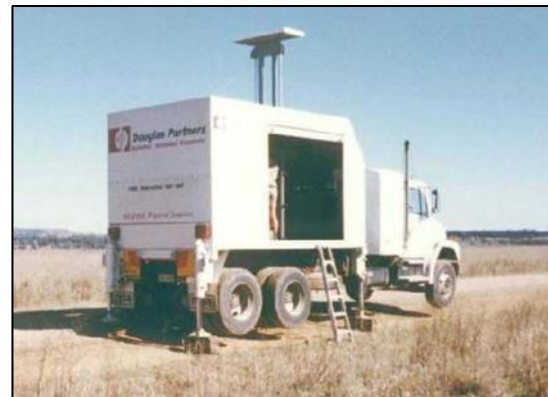
The cone is thrust into the ground at a steady rate of about 20 mm/sec, usually using the hydraulic rams of a purpose built CPT rig, or a drilling rig. The testing is carried out in accordance with the Australian Standard AS1289 Test 6.5.1.

Figure 2: Purpose built CPT rig

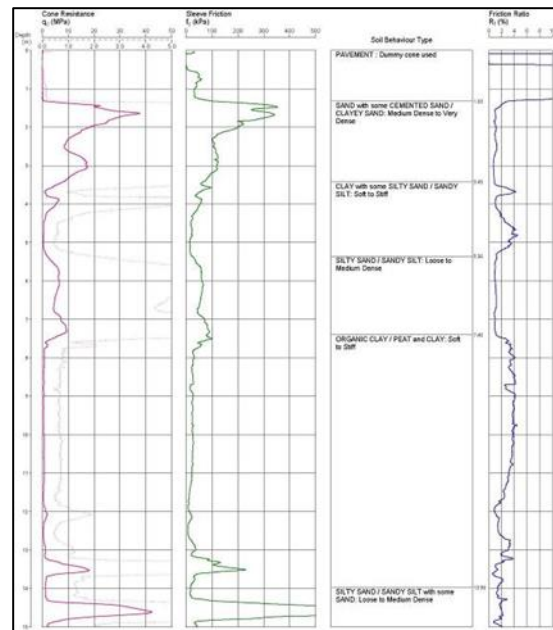
Figure 4: Sample Cone Plot
