# **Arboricultural Impact Assessment & Tree Protection Management Plan**

**Version 4**

**UNSW G25 Education Building**  
8 High Street,  
Kensington NSW 2031

Inspection Date: 8 August 2024

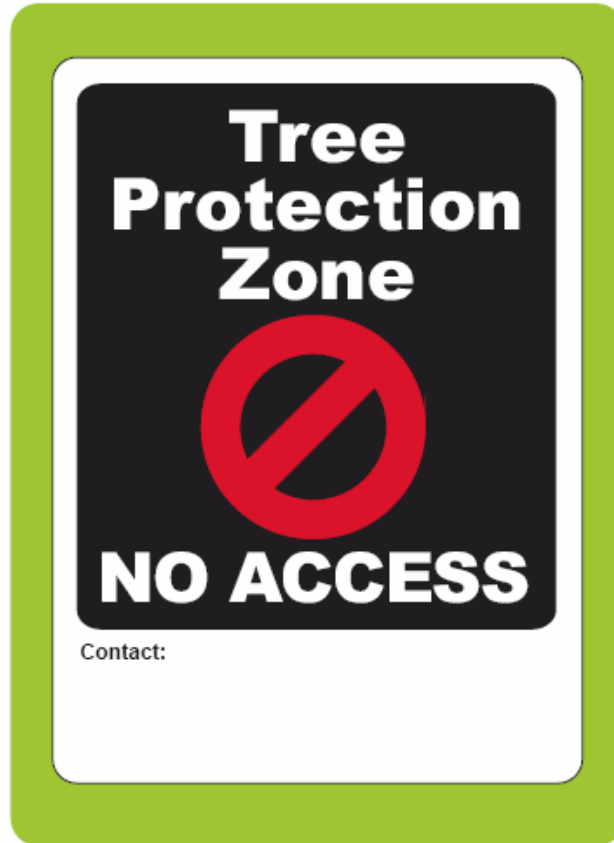
**Figure 8:** Example of tree protection signage. (Standards Australia, 2009)

Signs identifying the TPZ are to be installed on the tree protection fencing in 10m intervals. An example is shown below in Figure 8.
