## **CONSERVATION MANAGEMENT PLAN**

The Lands Building, 23-33 Bridge Street, Sydney

October 2016

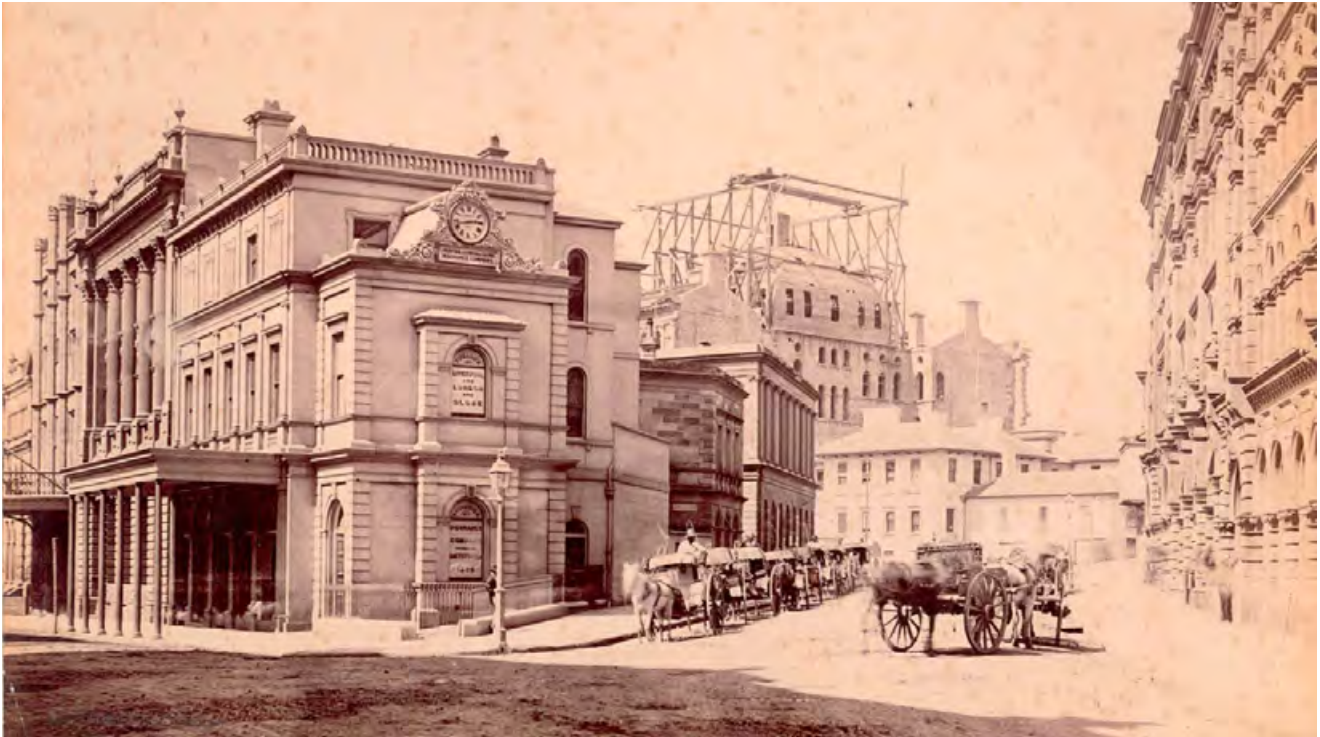
**Figure 2.8**

Photograph of the Lands Building under construction, as seen from the corner of Pitt and Spring Streets, c1880. The scaffolding is for the main northern observatory dome, with the lift shaft visible above the dome. The rear elevations of the side wings are also visible. According to White, L, *The Observatory at the Lands Department Building Sydney*, *Proc. ASA* 5 (4), 1984, pp607-608, the dome was likely not used for astronomical research, as that was the domain of the nearby Sydney Observatory. Instead, it could have been used for the teaching of astronomical techniques for surveying and for the proving of surveying instruments. The transit of Venus on 7 December 1882 may have been an additional stimulus for the construction of the observatory dome. There is no evidence for it to have ever contained any instruments  
Source: *State Library of NSW, Bayliss Collection, Call No. SPF / 594, Digital Order No. a089594h*

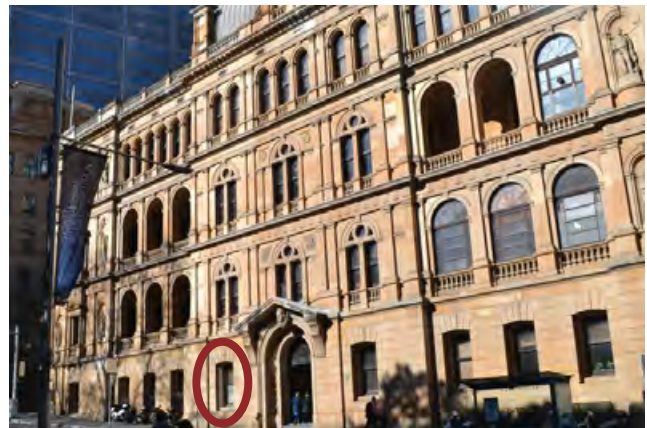
**Figure 3.20**

Open and enclosed verandahs, timber windows and later metal windows, on the Bridge Street elevation. Some original windows have been fitted with secondary glazing at some point in the past. Glazing in all the timber and metal framed windows (with the exception of the Ground Floor window facing Bridge Street with signage identifying "Publication Sales", circled red) and associated timber glazing beads has been replaced at some point in the recent past and, for the most part, has been fixed with silicone.

*Remaining enclosed verandahs can be seen on the Bridge Street Elevation. These verandahs currently house kitchenettes and en-suites. Some of these areas are currently causing damage to the external stone wall, located by the large white salt bloom on the external wall face caused by leaking drainage.*

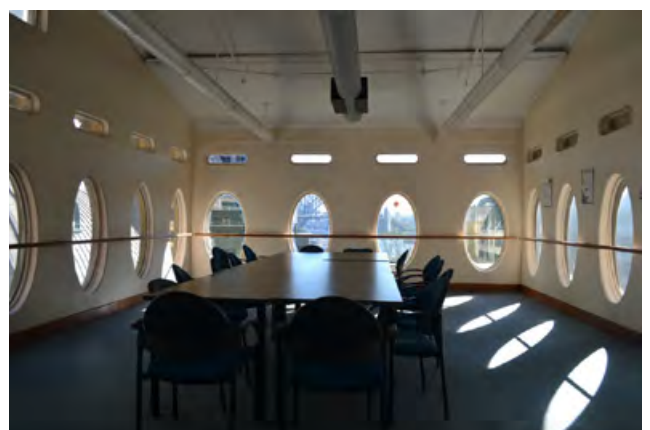
**Figure 3.30**  
Internal view of the eastern pavilion (tempietto mansard) room. Glazing in all the metal framed windows has been replaced at some point in the recent past and, for the most part, has been fixed with silicone.

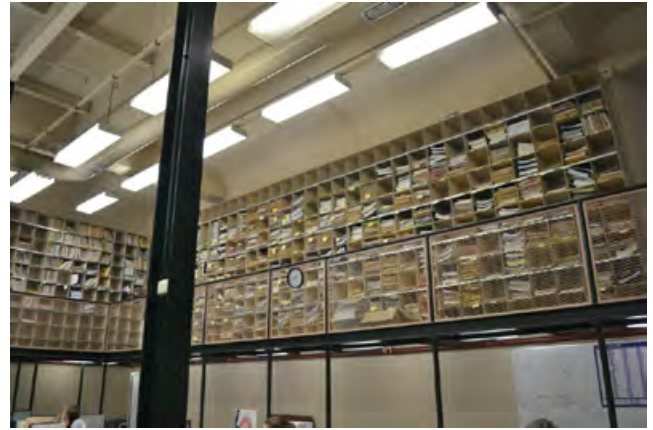
**Figure 3.64**  
Internal view of the strong room, showing the cast iron mezzanine floor and catwalks

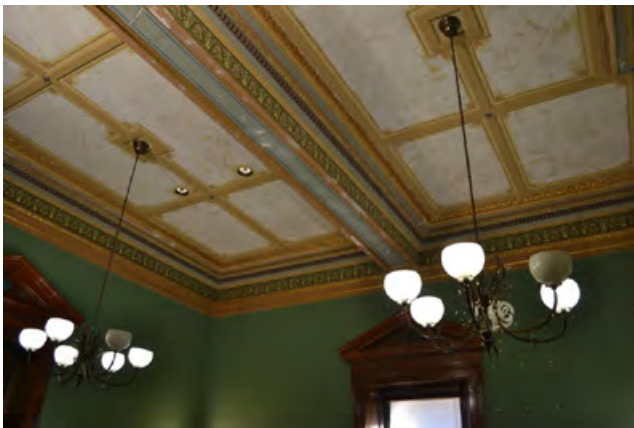
**Figure 3.74**  
Ceiling of Room 107 currently being repaired

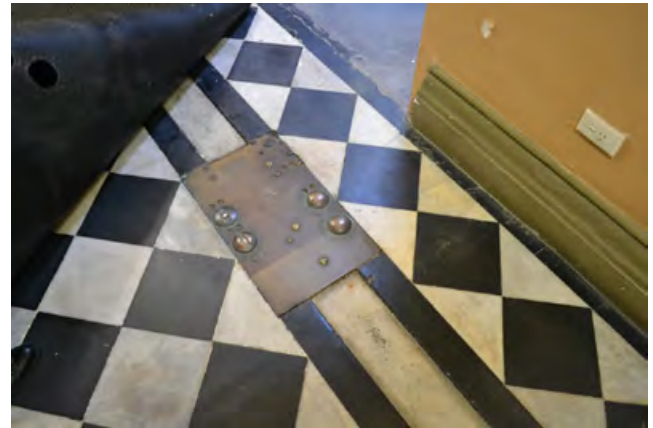
**Figure 3.79**  
The surveyor's base line in the ground floor corridor

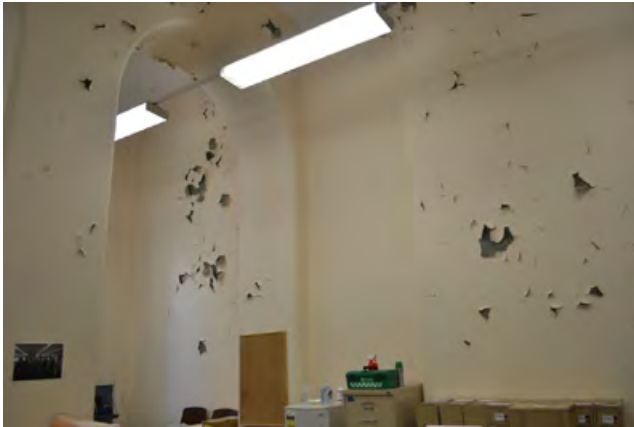
**Figure 3.85**  
Example of failing paint in ground floor offices

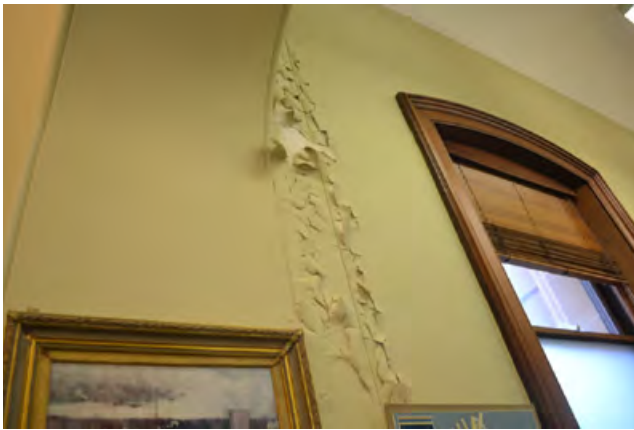
**Figure 3.86**  
Example of failing paint in Bridge Street ground floor offices

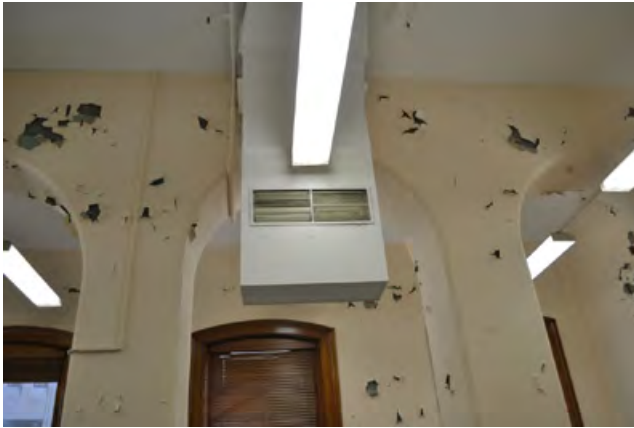
**Figure 3.87**  
Air conditioning system in ground floor offices
