# **SALVAGE METHODOLOGY**

Lands Department Building,  
23-33 Bridge Street, Sydney

**PONTIAC LAND (AUSTRALIA) PTY LTD**

14 May 2018

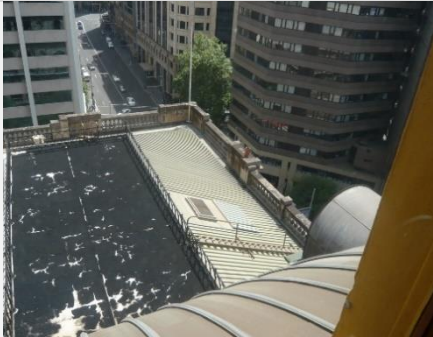
| Identified significant fabric | Reference image | Reuse, storage, or recycling initiatives |
|---|---|---|
| Cast iron balustrading on ancillary roofs approved to be demolished | | Cast iron balustrading should be reused or stored on site in the Heritage Store. |

| Identified significant fabric | Reference image | Reuse, storage, or recycling initiatives |
|---|---|---|
| 1970s Copper cladding on ancillary roofs approved to be removed | See above. | To be transferred to a metal and electronics recycler such as Sims Metal Management. |

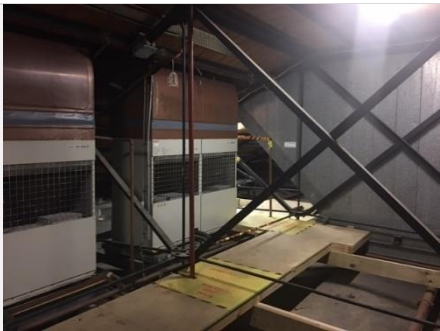
| Identified significant fabric | Reference image | Reuse, storage, or recycling initiatives |
|---|---|---|
| Steel Trusses located within ancillary roofs approved to be removed | | <p>Two samples (one from the northern stage 1 phase and one from the southern stage 2 phase) of the trusses are to be dismantled and stored in the Heritage Store or may be reused as an interpretive initiative - potentially as part of the building's art program.</p> <p>The remainder to be separated to stockpiles and transferred to a metal and electronics recycler such as Sims Metal Management.</p> |

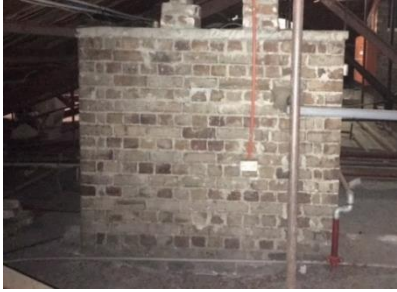
| Identified significant fabric | Reference image | Reuse, storage, or recycling initiatives |
|---|---|---|
| Brickwork (that is lime mortar rendered or not rendered) approved to be removed | | <p>Face bricks or lime rendered and plastered bricks are to be carefully removed by hand.</p> <p>One palette of bricks is to be retained on site in the Heritage Store - to be available for future repairs. The excess is to be transferred to a second hand architectural element recycling company for reuse.</p> <p>Brickwork that has been cement rendered or that otherwise is unable to be reasonably dismantled and salvaged will be separated and transferred to a specialist recycler such as Rock &amp; Dirt Recycling facility for crushing. The crushed brick is a recyclable material used as sub-base, granular fill or a blended road base.</p> |

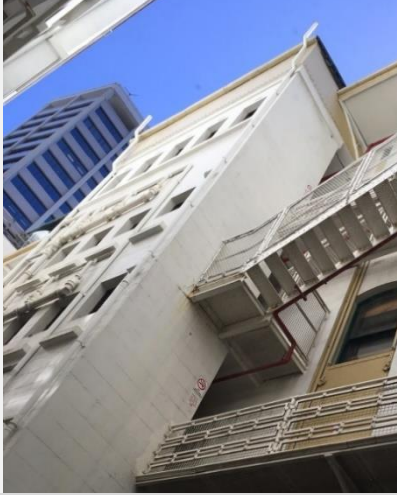
| Identified significant fabric | Reference image | Reuse, storage, or recycling initiatives |
|---|---|---|
| Cement rendered brickwork approved to be removed | | Cement rendered brickwork will be separated and transferred to a specialist recycler such as Rock & Dirt Recycling facility for crushing. The crushed brick is a recyclable material used as sub-base, granular fill or a blended road base. |

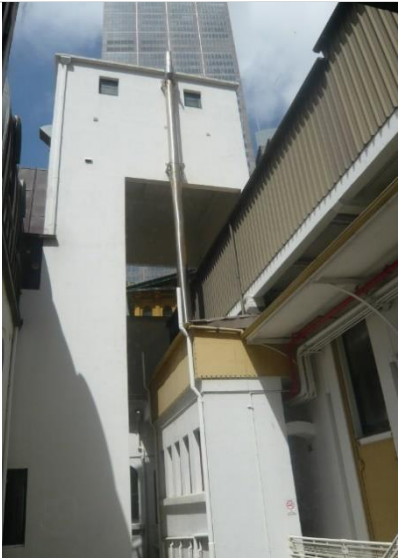
| Identified significant fabric | Reference image | Reuse, storage, or recycling initiatives |
|---|---|---|
| <p>Concrete structure approved to be removed including but not limited to: the aerial walkway, concrete floor slabs, northern lifts shafts and staircases and zones within corridors required to create access hatches</p> | | <p>Concrete will be separated and carted to a specialist recycler such as Rock &amp; Dirt Recycling for crushing. The concrete produces sub-base, 20mm crushed concrete road base and a blended road-base.</p> |

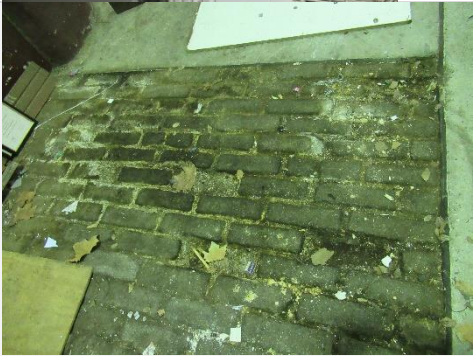
| Identified significant fabric | Reference image | Reuse, storage, or recycling initiatives |
|---|---|---|
| <p>Bituminous brick pavers approved to be removed in the north and south courtyards</p> | | <p>Samples (five) of original bituminous pavers are to be tagged and stored in the Heritage Store for future research purposes. The remainder are to be disposed of to a second hand architectural element recycling companies if they can be reused. The recent brickwork pavers are to be sent to a specialist recycler such as Rock &amp; Dirt Recycling for crushing.</p> |

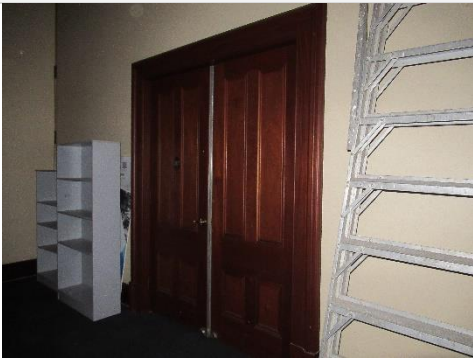
| Identified significant fabric | Reference image | Reuse, storage, or recycling initiatives |
|---|---|---|
| <p>Reconstructed joinery including timber doors, architraves and skirting blocks approved to be removed</p> | | <p>To be either reused on site, sold to an architectural element recycling company or, if these two options are unrealistic, then carted to Kurnell waste facility for landfill. If hazardous materials are detected in fire doors, then dispose of in accordance with the hazmat consultant's recommendations.</p> |

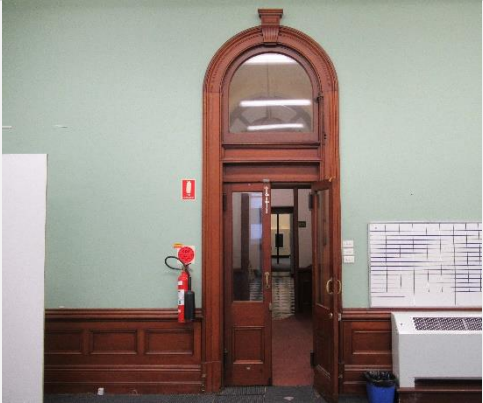
| Identified significant fabric | Reference image | Reuse, storage, or recycling initiatives |
|---|---|---|
| Original timber joinery including sections of wainscoting and skirting boards required to be altered to accommodate new partitions and any doors, windows, architraves and skirting blocks approved to be removed | | To be either reused on site, stored within new wall or ceiling cavities or stored in the Heritage Store to enable future reinstatement or reuse. To be carefully removed by a suitably experienced joiner. Original brass hardware is to be retained in situ on original doors. |

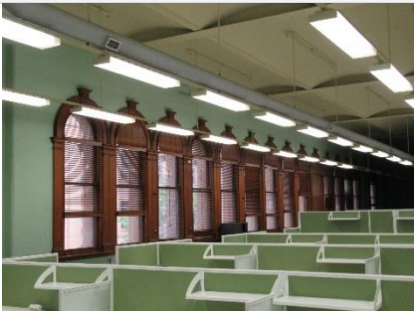
| Identified significant fabric | Reference image | Reuse, storage, or recycling initiatives |
|---|---|---|
| Continuous timber architraves in the Level 02 southern office that will interface with approved new partitions | | Where new partitions are to interface with timber architrave fabric, carefully remove discrete entire sections of affected timber fabric, tag and store them in the adjacent partition cavity or the Heritage Store to enable future reinstatement. To be carefully removed by a suitably experienced joiner. (New matching sections of timber architraves can then be milled up to accommodate the interface with the proposed new partition) |

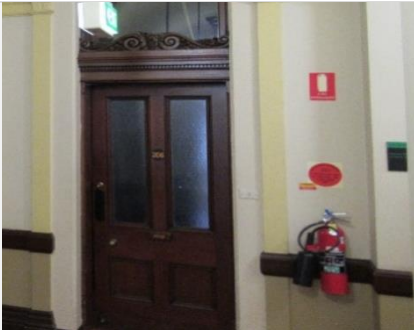
| Identified significant fabric | Reference image | Reuse, storage, or recycling initiatives |
|---|---|---|
| Variously patterned obscured glass in the upper panels of doors approved to have timber panels installed | | Representative examples to be either reused on site or stored in the Heritage Store to enable future reinstatement or reuse. To be carefully removed by a suitably experienced joiner. |

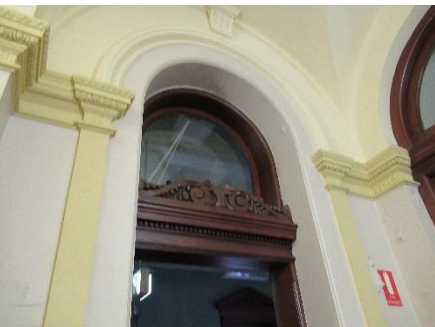
| Identified significant fabric | Reference image | Reuse, storage, or recycling initiatives |
|---|---|---|
| Clear glass in doors, windows highlights, clerestories etc approved to be replaced | | To be carefully removed to ensure no damage is caused to the framing and disposed of to a glass recycler. |

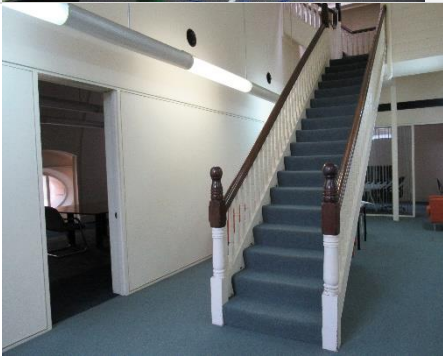
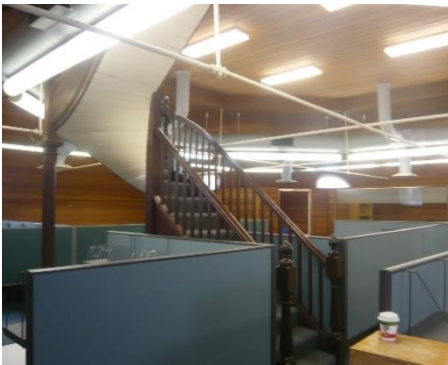
| Identified significant fabric | Reference image | Reuse, storage, or recycling initiatives |
|---|---|---|
| <p>Original timber staircases approved to be removed in the northern dome and east and west tempietti</p> | | <p>To be carefully removed by a suitably experienced joiner and transferred to an architectural element recycling company for reuse.</p> |

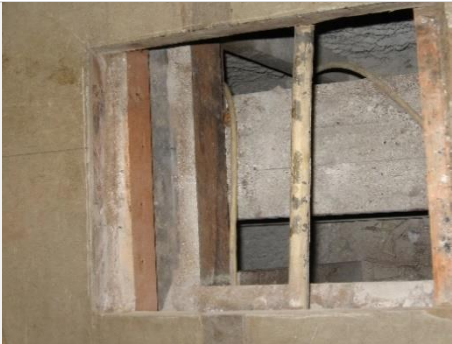
| Identified significant fabric | Reference image | Reuse, storage, or recycling initiatives |
|---|---|---|
| Structural timber and steel approved to be removed | | <p>Timber to be either reused on site or sold to an architectural element recycling company or a timber yard. Structural steel to be either reused on site or sold to an architectural element recycling company or a metal recycler such as Sims Metal Management.</p> |

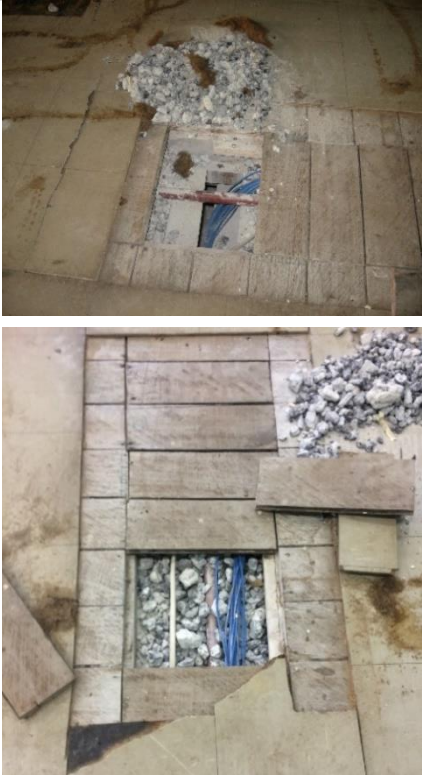
| Identified significant fabric | Reference image | Reuse, storage, or recycling initiatives |
|---|---|---|
| Timber floorboards approved to be removed | | <p>To be carefully removed by a suitably experienced tradesperson. Timber floorboards, greater in length than 1.8 metres and in good condition (to be advised by the project heritage consultant), are to be salvaged for installation in other publicly accessible parts of the building including the lower ground floor public spaces (other than marble clad floors), the west tempietti and the northern dome. Timber floorboards, greater in length than 1.8 metres, but excess to the requirements of the project are to be either stored in wall and ceiling cavities or disposed of to a second hand architectural element recycling companies or timber yard. Floorboards of lesser length may be disposed of to a second hand architectural element recycling company, timber yard or go to landfill.</p> |

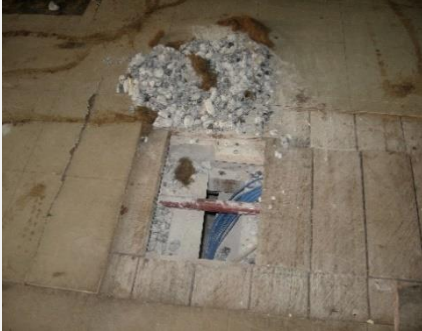
| Identified significant fabric | Reference image | Reuse, storage, or recycling initiatives |
|---|---|---|
| Coke breeze concrete rubble within floor cavities | | <p>Removed and disposed of safely. A sample should be safely bagged in accordance with the hazmat consultant's advice, tagged and stored on site for future research purposes.</p> |

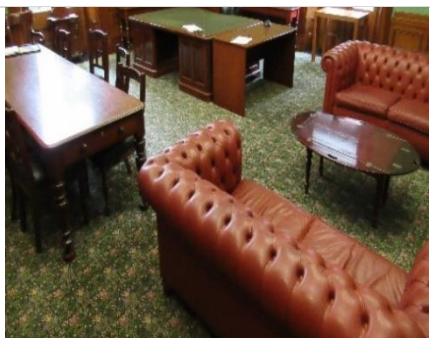
| Identified significant fabric | Reference image | Reuse, storage, or recycling initiatives |
|---|---|---|
| Floral fitted carpet in the former Minister's suite on Ground Level | | The carpet should be removed and stored in the Heritage Store. |

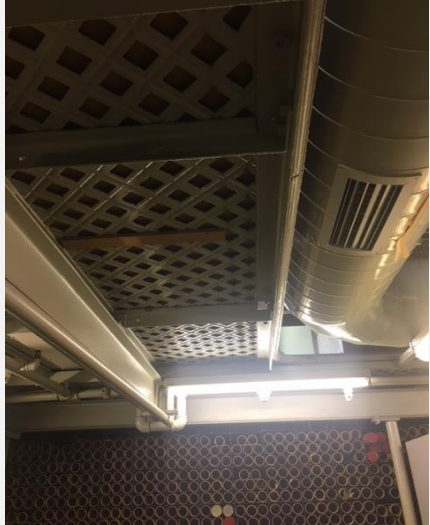
| Identified significant fabric | Reference image | Reuse, storage, or recycling initiatives |
|---|---|---|
| Cast iron grills approved to be removed on Level 2 | | To be salvaged and reused to patch areas of damage or missing sections on lower levels. |

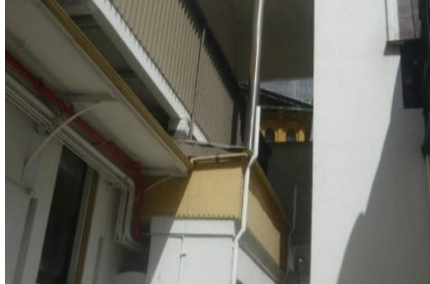
| Identified significant fabric | Reference image | Reuse, storage, or recycling initiatives |
|---|---|---|
| Miscellaneous steel, aluminium and copper elements approved to be removed | | Miscellaneous steel, aluminium and copper elements and cabling will be separated to stockpiles and transferred to a metal and electronics recycler such as Sims Metal Management. |

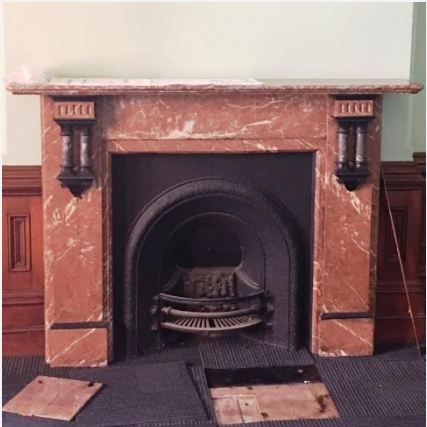
| Identified significant fabric | Reference image | Reuse, storage, or recycling initiatives |
|---|---|---|
| Fireplaces approved to be removed | | Fireplaces, approved to be removed, should be reinstated on chimneybreasts in rooms where fireplaces have been removed in the past. |

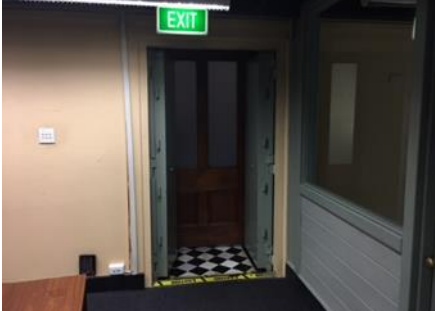
| Identified significant fabric | Reference image | Reuse, storage, or recycling initiatives |
|---|---|---|
| Milners 212 doors approved to be removed | | The Milners 212 doors are to be lifted off their hinges and mounted on the adjacent walls within the Strong Room. |

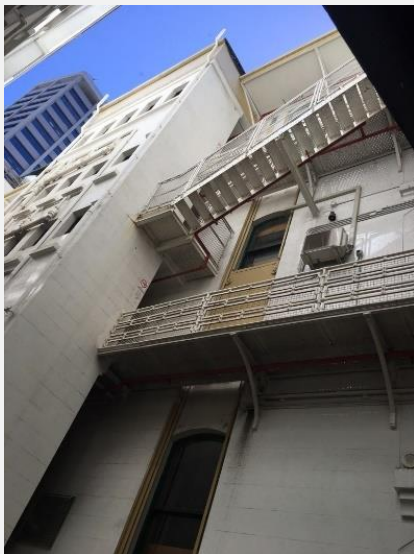
| Identified significant fabric | Reference image | Reuse, storage, or recycling initiatives |
|---|---|---|
| Portions of the existing courtyard gantries (temporary removal only) | | <p>Portions of the gantries approved for temporary removal are to be carefully removed to ensure no undue damage to adjacent significant fabric, tagged, protected, stored securely, and securely reinstated as existing once the temporary works are complete.</p> <p>Reinstate in accordance with the approved reinstatement methodology prepared to fulfil condition B49B of SSD7484.</p> |
