MINTO WAREHOUSING AND LOGISTICS HUB

Geotechnical Investigation for Warehousing Development

Report Number. 1648232-002-R-Rev0

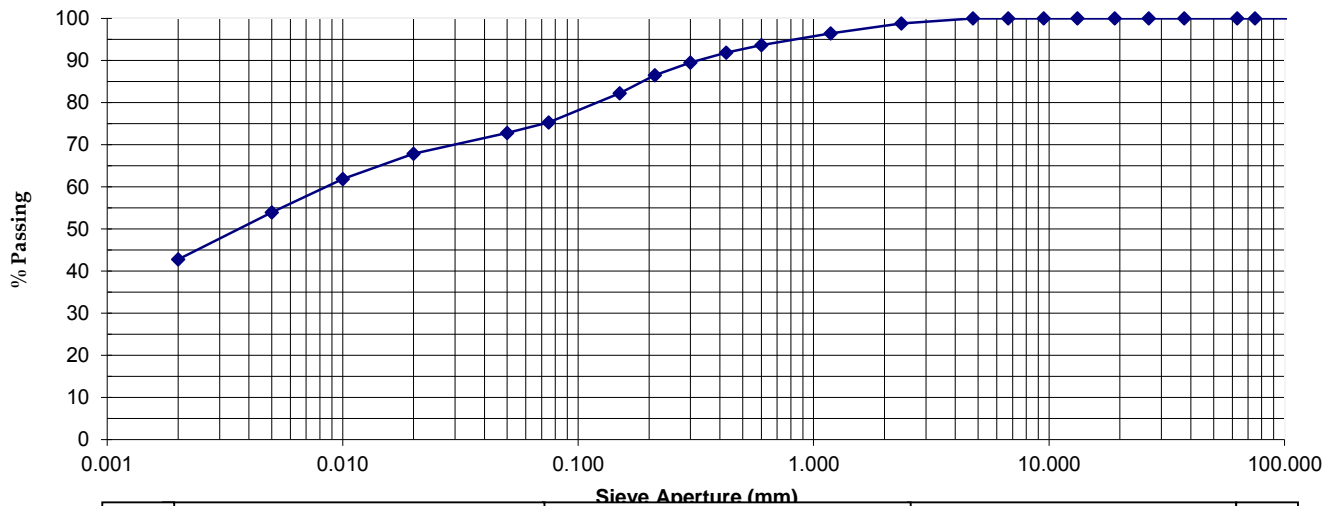
Sieve Aperture: (mm)	% Passing	Specification (..) Envelope	Sieve Aperture: (mm)	% Passing	Specification (..) Envelope
200	-		1.180	96	
75	-		0.600	94	
63	-		0.425	92	
37.5	-		0.300	90	
26.5	-		0.212	87	
19.0	-		0.150	82	
13.2	-		0.075	75	
9.5	-		0.050	73	
6.7	-		0.020	68	
4.75	100		0.010	62	
2.36	99		0.005	54	
			0.002	43

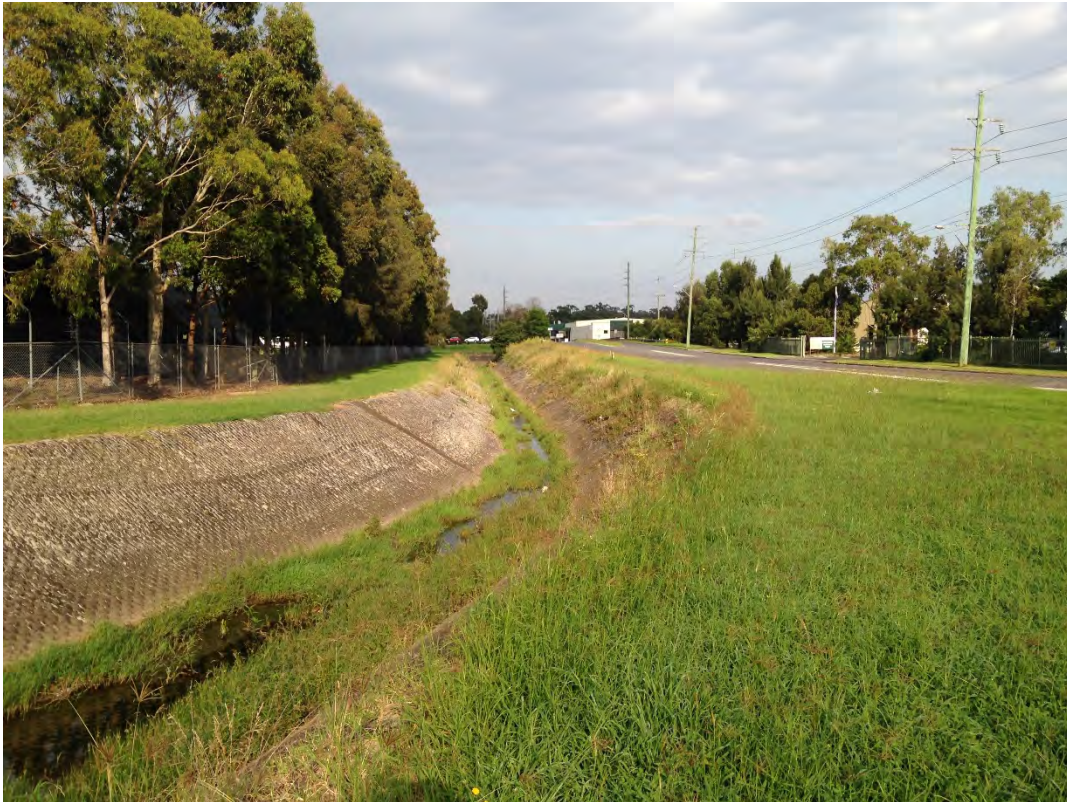
13. Drainage channel at north part of the site, typical of drainage channels encompassing the site

It is worth noting that the site is bounded by concrete water channels on all sides, and erosion control is recommended (despite the non-dispersive soil characteristics) to prevent sediments entering the surrounding waterways during construction.
